HERITAGE IMPACT ASSESSMENT OF PORT SHEPSTONE GAOL, KWAZULU- NATAL

Robert J W Brusse Architect

The firm Mazibuko Wessels Architects appointed Robert J W Brusse Architect to undertake a Heritage Impact Assessment of the Port Shepstone Gaol in August 2014.

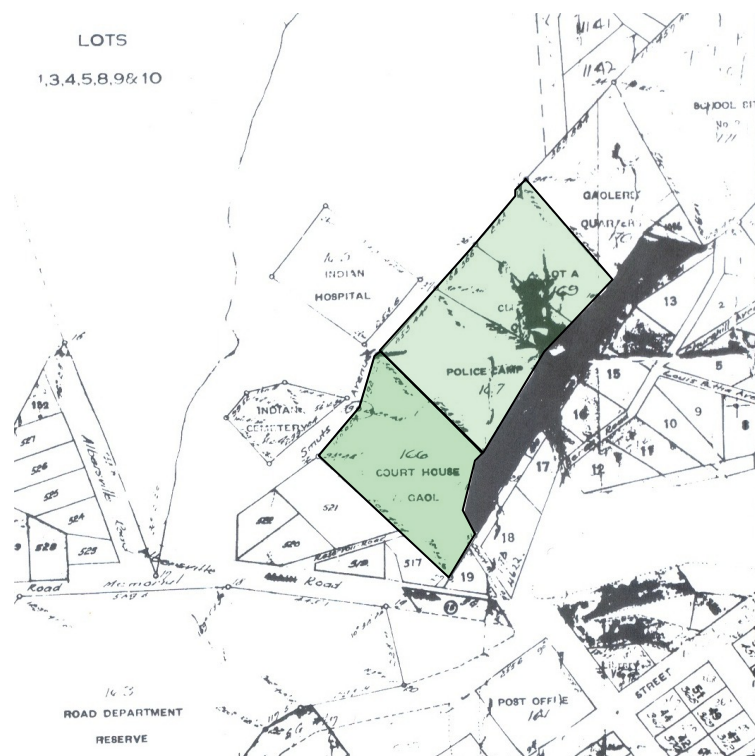
- A site plan used to demarcate road closures, first compiled before 1940. This plan indicates an existing Lot 166 noted as "Court House" and "Gaol". Adjacent to it are Lot 167 (Police Camp), Lot 1(6?)8 (use obliterated), Lot 169 (use unknown), Lot 170 (Gaolers Residence).

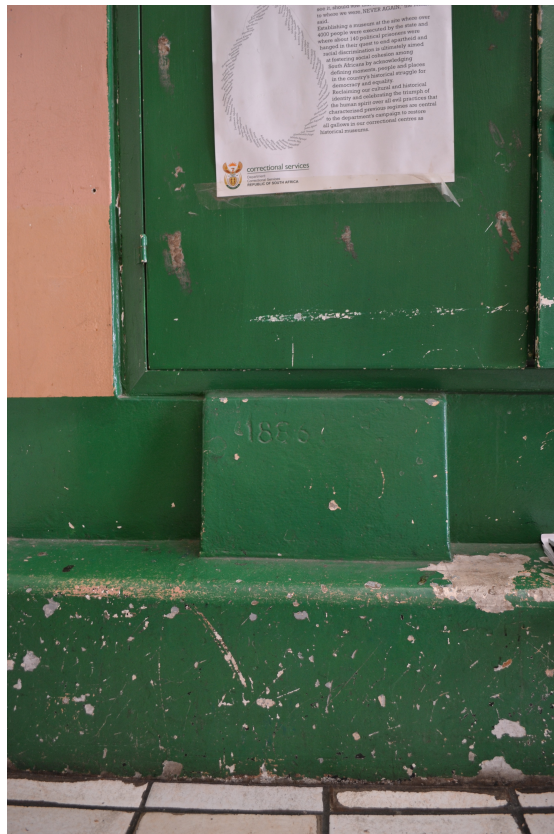
Photo 1. Dated stone in Entrance Passage

The exact date of construction of the magistrates Court is open to conjecture. However, there is a simple stone on the southern side of the main entrance passage, curiously protruding from the centre of some stairs leading to a doorway, engraved with the date 1886, which has been assumed to be the founding date of the building. This stone is problematic as its physical location in the stairs is most unusual and is not located in any part of the original building! It may have been part of a mounting block, or it may have been moved to its present location during the extension of the original court-house. It would also indicate that the foundation of the Magistrates Court was laid three years before the first Magistrate arrived in Southern Shepstone.

- the incorporation of a "foundation stone" (1886) in the steps of a door way opening into the entrance passage. It may have been moved forward from its original position to avoid it ending up under the new floors, but that remains pure speculation until further confirmatory evidence is found.
- in the roof space there is evidence that the building had two skylights at some time in its history, - one either side of the entrance passage. A more careful investigation and locating of these skylights over the rooms below may elucidate their purpose.

- This dated stone in the entrance passage is of historic importance and should be carefully cleaned off all paint by a recognised and competent restoration specialist such a professional from the S.A. Institute of Object Conservation. The retention or relocation of the "foundation stone" in its current position should be carefully considered in the light of pedestrian access over it and on-going conservation.

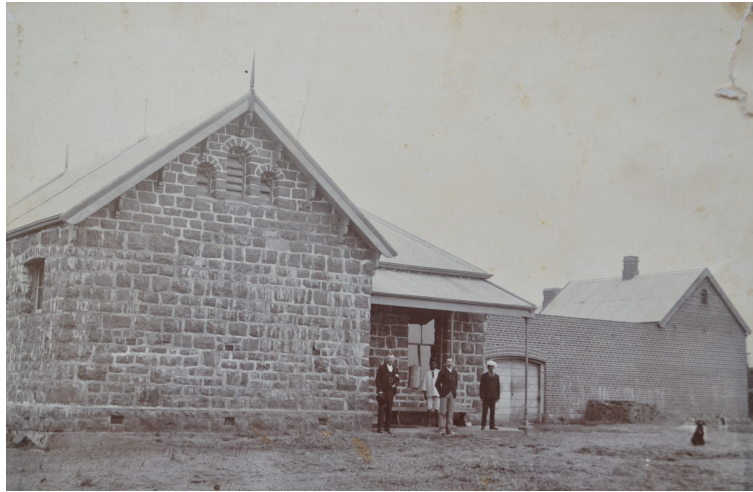
Photo 2. Court House Port Shepstone (O9/P 1225 P.S. Museum)

Photographic evidence shows us that the original Magistrates Court than would be apparent today. It was a building consisting of the court-room, and two ancillary spaces. It was built with an external stone facing lining an internal brickwork skin.

To the north east of the stone clad Court House there was a high brick wall, with a generous arched gateway, and a simple rectangular brick building at its northern end. It may be assumed that this was the first permanent brick gaol.

We believe that the brickwork wall that is shown extending northwards from the Court House in photo 2, was incorporated as the back wall of the additions, and clad in matching stone work. There is otherwise no rational explanation for the step in the stonework at the rear of the building, relative latter extensions. The new building copied the proportions and details of the court Room gable, but incorporated two windows for additional light and ventilation.

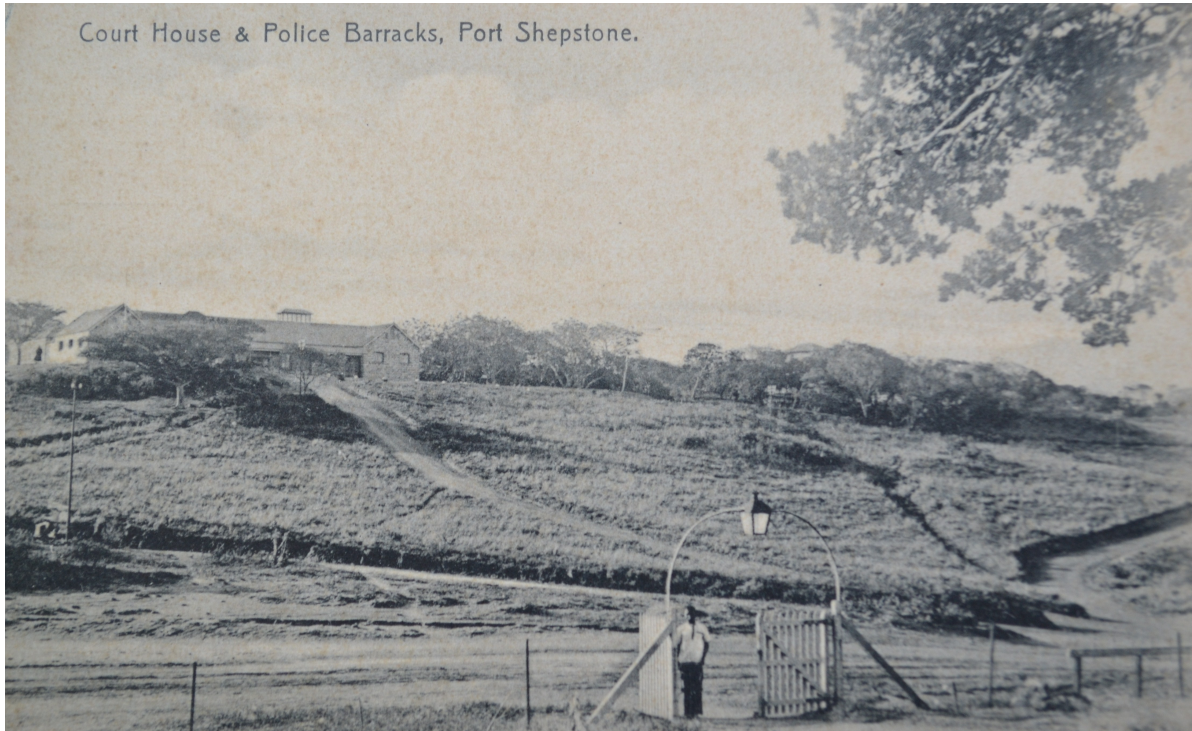
Court House & Police Barracks, Port Shepstone.

Photo 3. Court House and Police Barracks, Port Shepstone (post card in P.S. Museum archives)

- The remaining skylight structures should be respected - even not incorporated in the new layout - as they form a part of the history of the building. Careful observation of Photo 3 shows what may have been a catwalk, or skylight, over part of the ridge of the building.

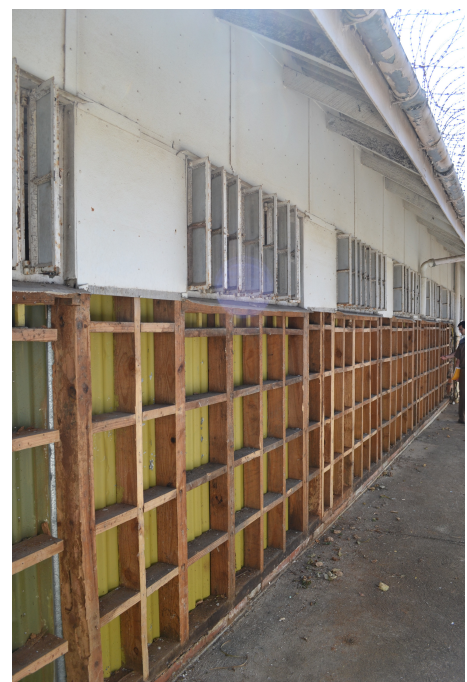
Photo 4. Timber-framed construction Blocks 6 & 7, partly exposed.

These latter buildings were primarily constructed using a timber frame technology, with corrugated iron cladding on the interior and with asbestos cement panels as an external cladding. Ceilings were constructed of mild steel plate with mild steel flat bar cover strips. In the oeuvre of wood-and-iron buildings this construction may prove to be unique.

The two blocks (6) & (7) were build during 1985 / 1986. For some reason, not fully understood at present, the prison cells were erected in a timber frame construction with corrugated galvanised sheet metal cladding internally (Photo 7 above) and asbestos cement cladding externally (photo 4) - while the facilities for administration, and the later "Klubgebou" alterations were executed in plaster brickwork, all under corrugated asbestos roofing.

We have mentioned that blocks 6 & 7 are not protected by current legislation as they were constructed less than 60 years ago. However, we are of the opinion that the particular construction technology employed could become significant in the body of architectural conservation of the future. While we acknowledge that these buildings do not necessarily fulfill the functional requirements of a contemporary prison, nor do they strictly comply with the current health and safety requirements (the use of asbestos cement cladding) we are of the opinion that serious consideration should be given to the retention of a single communal cell, appropriately modified to comply with current legislation, and integrated to an appropriate function.

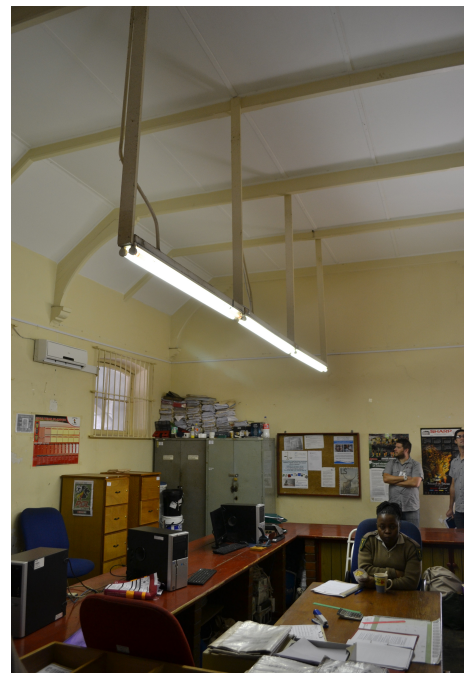
Photo 5, Current interior of the Court Room used as an office.

The Court House portion of the Gaol consisted of the Court Room, and two adjacent rooms. The former Court Room is a single volume, simple yet dignified, with a coved ceiling and partially exposed trusses resting on stone bosses. The current ceiling is of a latter date (there might be vestiges of the original ceiling - presumably T & G boarding - in the roof space).

The building appears to have been constructed with a brick inner face and a stone external face. Generally the stonework is in excellent condition. Much of the building's plastered walls have been painted with "PWD-issue" enamel paints, which contributes very little to the architectural merit of the building.

The doors and windows appear to be original, and are in relatively good condition. Most have been painted, though a few appear to have been recently stripped to clear timber. Very little of the original brass fittings appear to have survived.

We recommend that this building be treated with care and consideration. That its external form be retained so that it can be appreciated in its totality, including the details such as the eaves overhang, gallows brackets, and the original door and window pattern. In this regard we are concerned that

- It is recommended that all internal and external timber faces of windows and doors must be painted both as protection to the fabric and to be historically correct.

- While alterations to the internal walls may be necessary, this should be kept to a minimum, bearing in mind that the buildings proposed layout may well change again within a decade or so. The loss of historic fabric should be avoided where not absolutely necessary. The opening up of doorways should be undertaken after investigation of previous doorways that may have been bricked up. Where re-use of such earlier doorways is possible, it should be seriously considered.

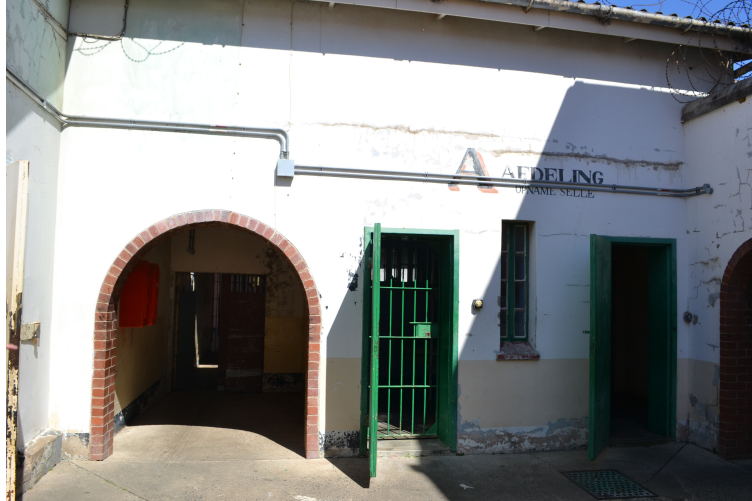
Photo 6. South side of Block 4

It is assumed that the original brick cells were demolished to make way for Cell Block 4. Both Blocks 4 & 5 consist of communal cell blocks located around central courtyards. A central kitchen facility was located in Block 4. During the 1980's the western most communal wing of Block 4 was converted to a series of single cells.

Both buildings were constructed in plastered brickwork, with cement rendered floors under corrugated asbestos cement roofs. There are a few arched openings that relieve the harshness of the building, but there is very little else that need be considered of architectural interest or merit.

Blocks 4 and 5 are protected by current legislation, but we do not find any reason to recommend the retention or protection of any portion of these buildings.

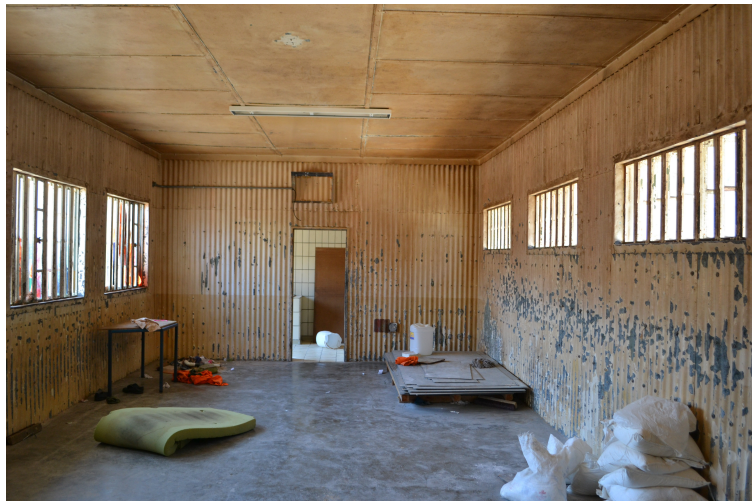
Photo 7. Interior of a Communal Cell Blocks 6 & 7.

Block 6 consists of a series of communal cells located around a central courtyard. One corner of the building was converted to a "Klubgebou" (8) during 1993. Block 7 consists of some larger and smaller communal cells located around three sides of an open courtyard, with administrative offices to the north of the cells. A high wall closes the fourth side of the courtyard.

We are not aware of other prison facilities that have been built in this manner. If this use of timber framed construction technology at this gaol is unique within the correctional services environment, then careful consideration for the retention of a typical example is warranted, if the buildings are less than 60 years old - see recommendations.
