Prince Albert Conservation Survey
Block 19

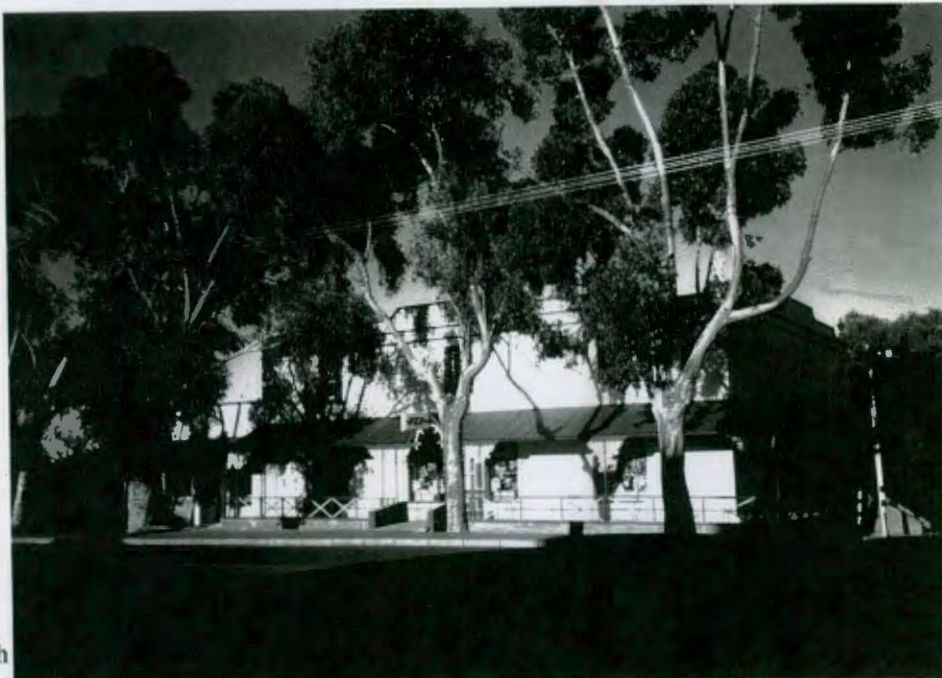
BLOCK/SITE : 19.01
PHOTOS : 08.17, 30.16

ERFNO : 560
ZONING :
TYPE : Commercial
PRESENT USE : shop
CONDITION : good
GRADING : A
TODJAPH : BC
ARCHITECT :
CONSDATE : c. 1860
ARCHSTYLE : Victorian
MATERIALS : brick : corrugated iron

DESCRIPTION : Double storey building with
upper floor; timber shopfronts to ground level, with recessed entrances on both streets, with zinc
panelled doors with fanlights. Raised verandah on two sides.

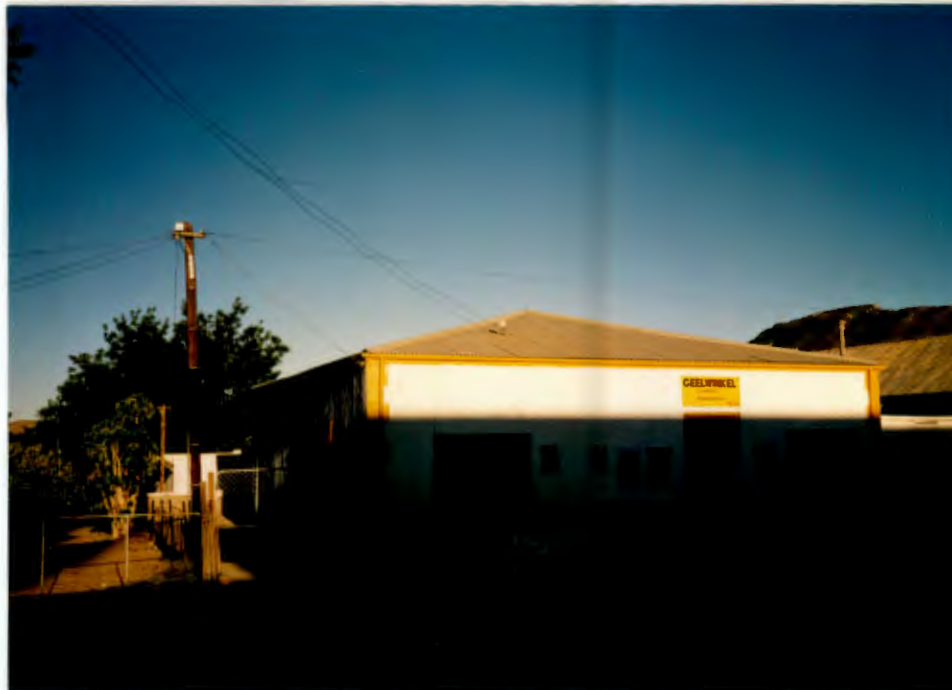
BLOCK/SITE : 19.03
PHOTOS : 08.19

ERFNO : 565
ZONING :
TYPE : Commercial
PRESENT USE : shop
CONDITION : good
GRADING : C
TODJAPH : FF
ARCHITECT :
CONSDATE :
ARCHSTYLE : Victorian/utilitarian
MATERIALS : brick : corrugated iron

DESCRIPTION : On front boundary. Hipped roof; rusticated quoins at corners. Double door with 2-pane fanlight, timber shopfront windows.

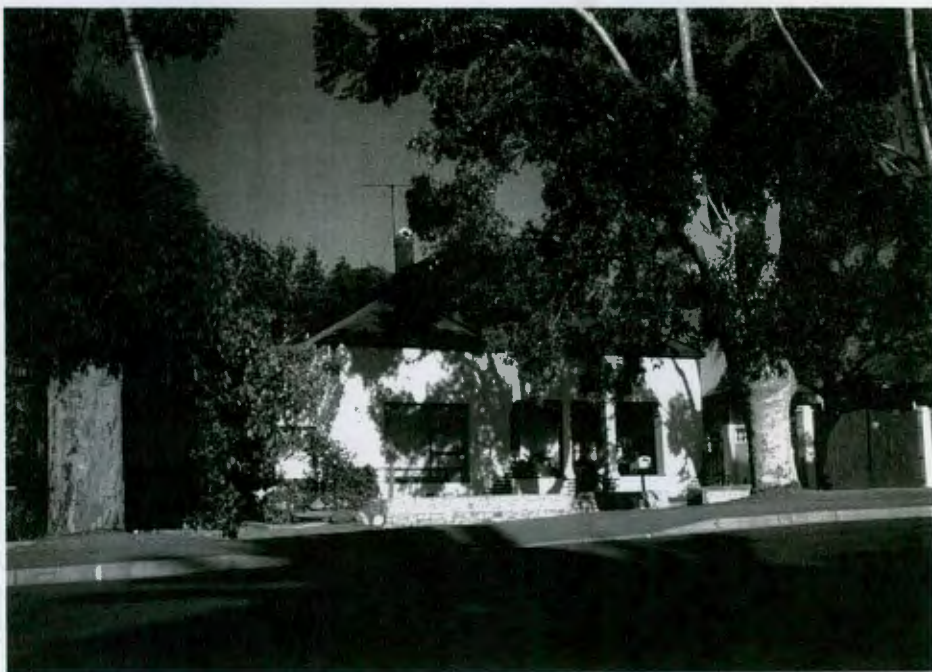
NAME :
ADDRESS : 44 Church Street

ERFNO : 673
ZONING :
TYPE : Residential
PRESENT USE : house
CONDITION : good
GRADING : I
TODJAPH :
ARCHITECT :
CONSDATE :
ARCHSTYLE : Modern
MATERIALS : brick : thatch

DESCRIPTION : Hipped thatched roof; recessed porch with rusticated square section columns, low wall with facebrick trim. Timber picture windows; glazed door with side and fanlights.

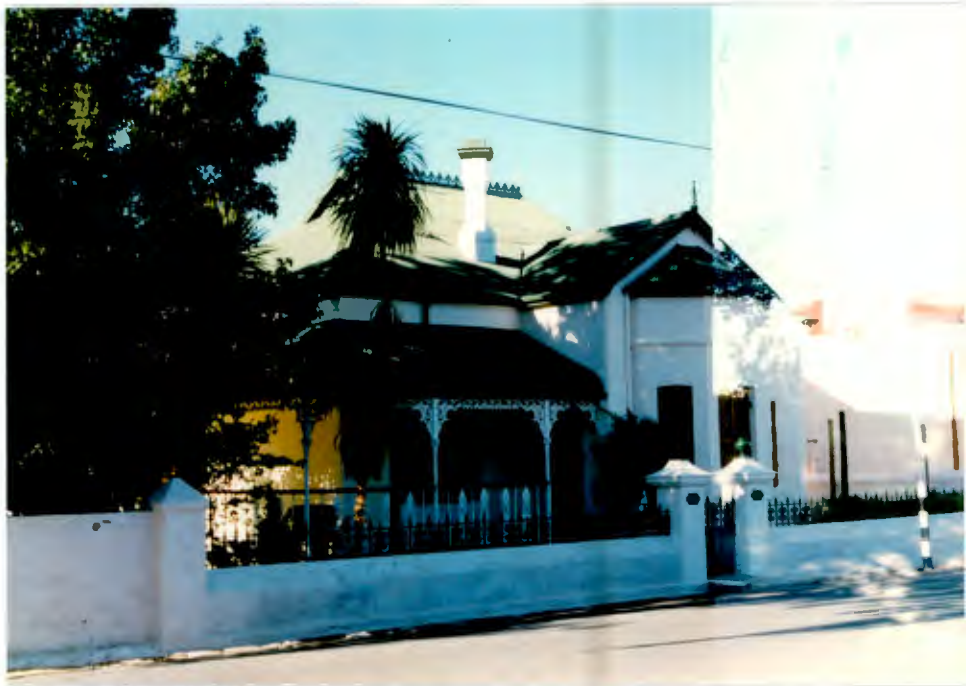
NAME : Bona Vista
ADDRESS : 7 Parsonage Street, cnr de
Beer Street

ERFNO : 570
ZONING :
TYPE : Residential
PRESENT USE : house
CONDITION : good
GRADING : NM
TODJAPH : A
ARCHITECT : Christiaan Stadler Combri
CONSDATE : 1906
ARCHSTYLE : Victorian
MATERIALS : brick : corrugated iron

DESCRIPTION : Asymmetrical Victorian villa with hipped roof with cast iron cresting, projecting gables on two sides with bay windows. Tall chimneys twisted on base. Rusticated quoins. Sashes with louvred shutters, panelled doors. Bullnose verandah on corner with cast

ALTERATIONS :
SITE FEATURES: large garden; plastered boundary wall with ball-capped posts, part with cast iron cresting and gate; various outbuildings

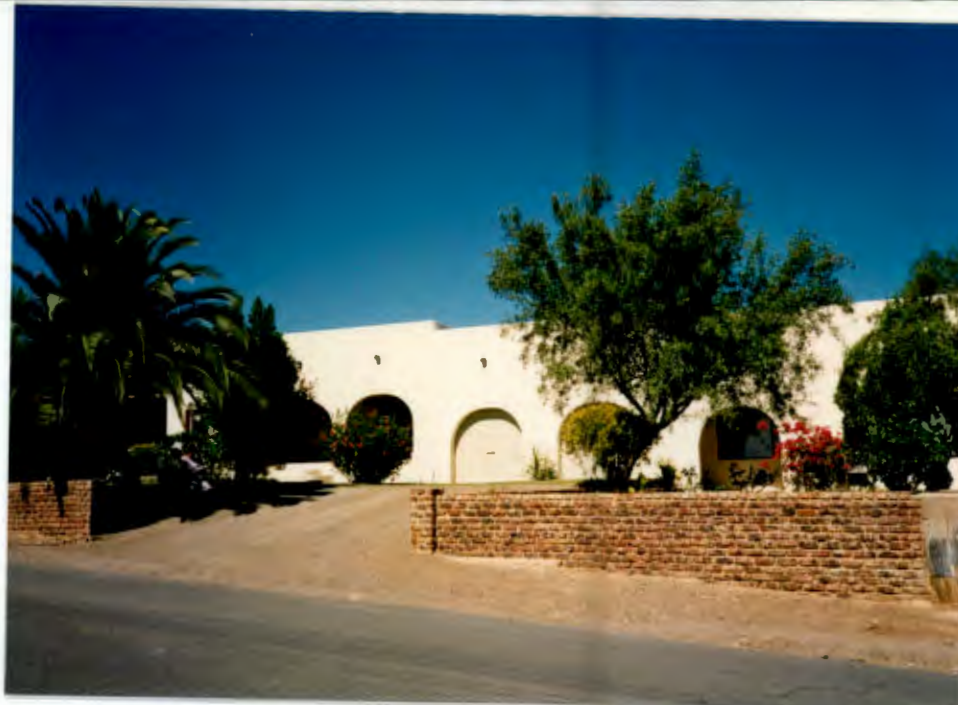
NAME :
ADDRESS : 59 Nieuwe Street

ERFNO : 235
ZONING :
TYPE : Residential
PRESENT USE : house
CONDITION : good
GRADING : I
TODJAPH :
ARCHITECT :
CONSDATE : 1970s
ARCHSTYLE : Mediterranean
MATERIALS : brick : corrugated iron

DESCRIPTION : Modern parapetted "Mediterranean" style house with arched openings.

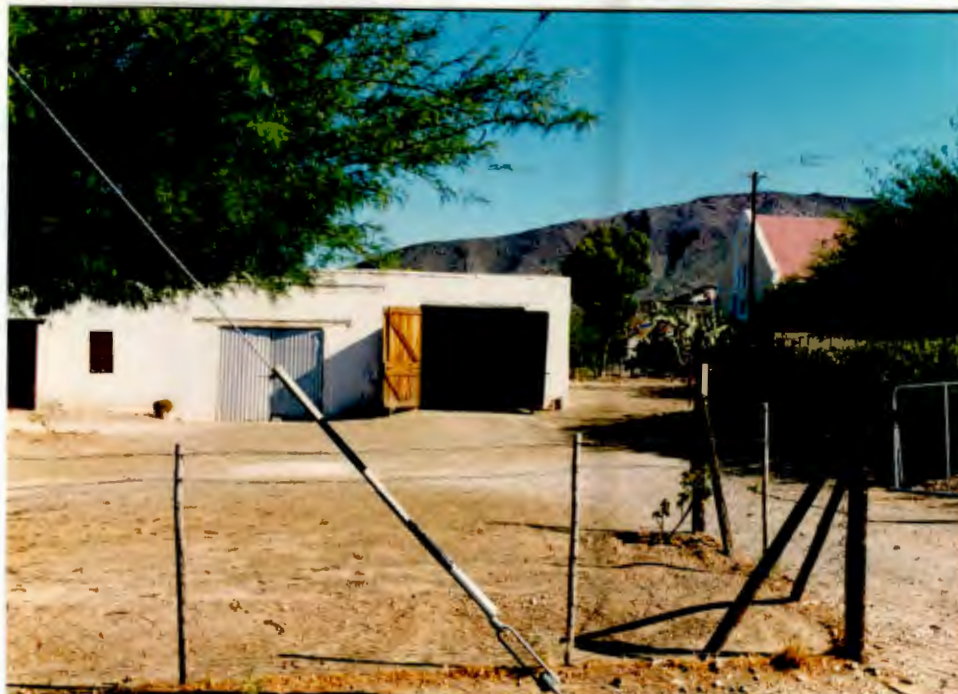
NAME :
ADDRESS : Nieuwe Street, cnr Doordrift
Street

ERFNO : 228
ZONING :
TYPE : Outbuilding
PRESENT USE : storage/house
CONDITION : fair
GRADING : C
TODJAPH : DEF
ARCHITECT :
CONSDATE :
ARCHSTYLE : Karoo
MATERIALS : brick : corrugated iron

DESCRIPTION : Parapetted outbuilding with double timber doors, double corrugated iron doors a single door and a small casement.

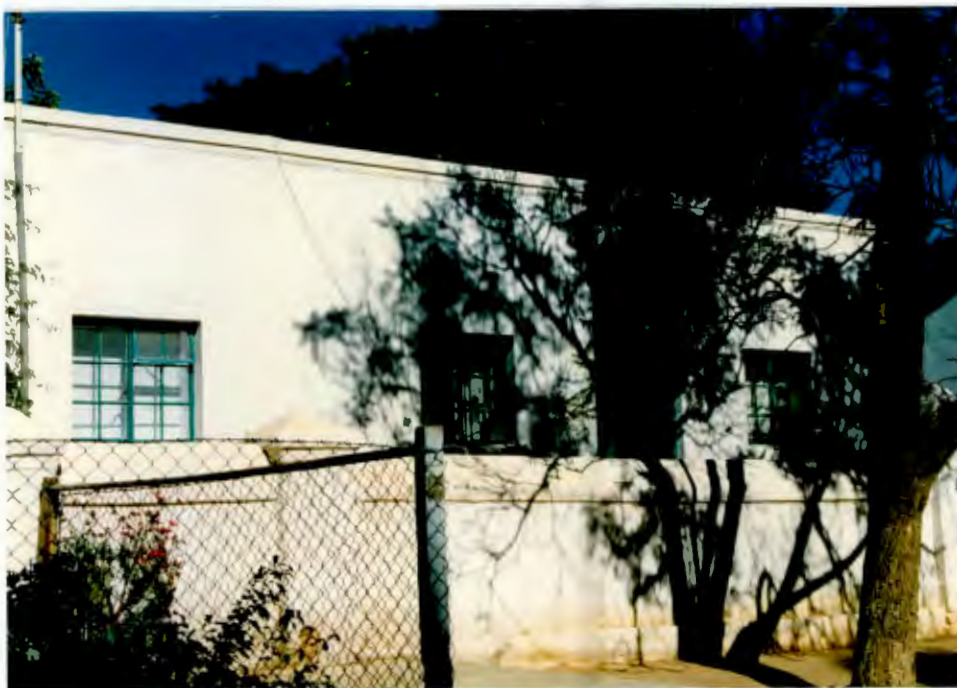
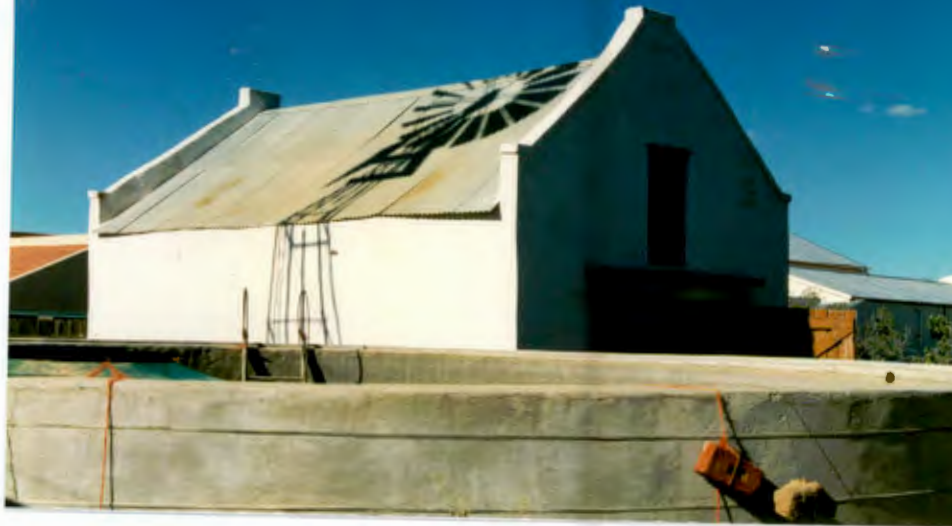
BLOCK/SITE : 24.04
PHOTOS : 03.26, 04.10 (outbuilding)

ERFNO : 210
ZONING :
TYPE : Residential
PRESENT USE : house
CONDITION : good
GRADING : C
TODJAPH : DEF?
ARCHITECT :
CONSDATE : c. 1860 (F)
ARCHSTYLE : Cape, altered
MATERIALS : brick : asbestos slate

DESCRIPTION : House was thatched (see F&C), roof destroyed by fire: now has asbestos slate saddle roof, large overhang forms verandah with plastered columns and timber fretwork. 12x12 sashes, louvred shutters; 2x2 door with spoked fanlight. Parapetted addition right.

ALTERATIONS : thatched roof replaced

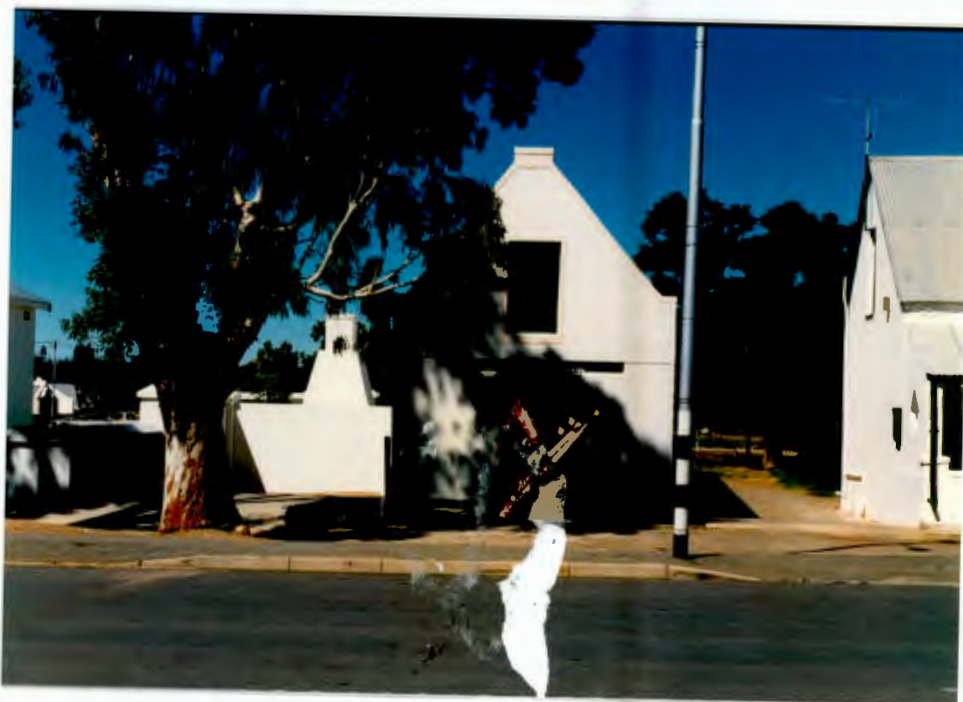
BLOCK/SITE : 27.10

ENVIRONMENT : old gum trees

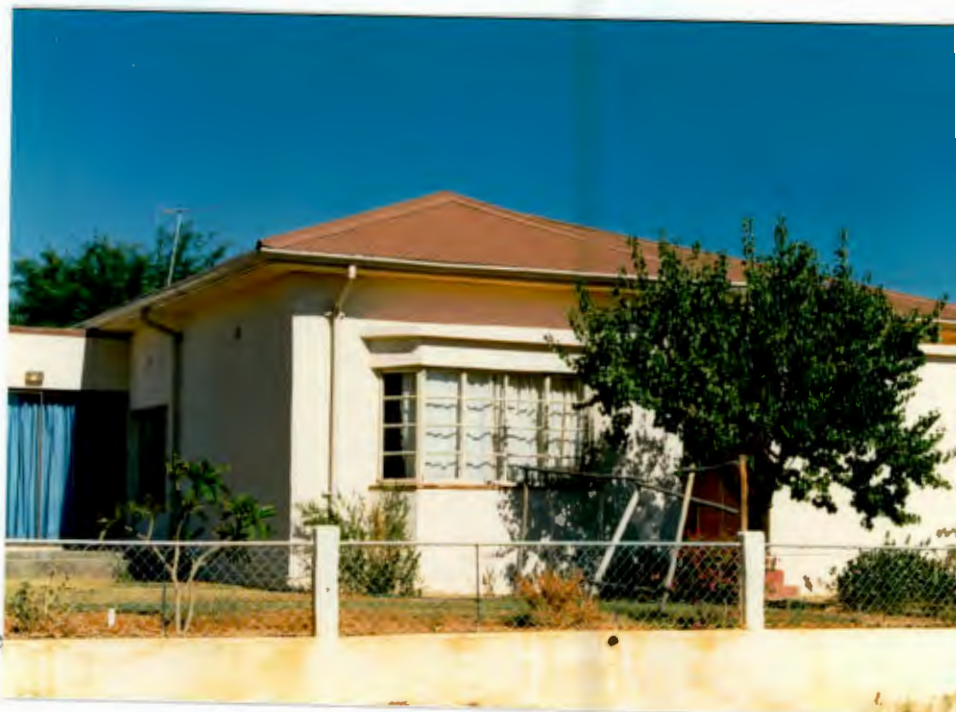
ERFNO : 115
ZONING :
TYPE : Residential
PRESENT USE : house
CONDITION : good
GRADING : I
TODJAPH :
ARCHITECT :
CONSDATE :
ARCHSTYLE : modern
MATERIALS : brick : corrugated iron

DESCRIPTION : House with projecting hippe

ALTERATIONS :
SITE FEATURES: pipe and mesh fence with masonry columns and base
