REVISED PRELIMINARY REPORT

Tower 167: Phase 2 - Archaeological Excavation

400KV TABOR-WITKOP TRANSMISSION LINE, LIMPOPO PROVINCE

January 14, 2013

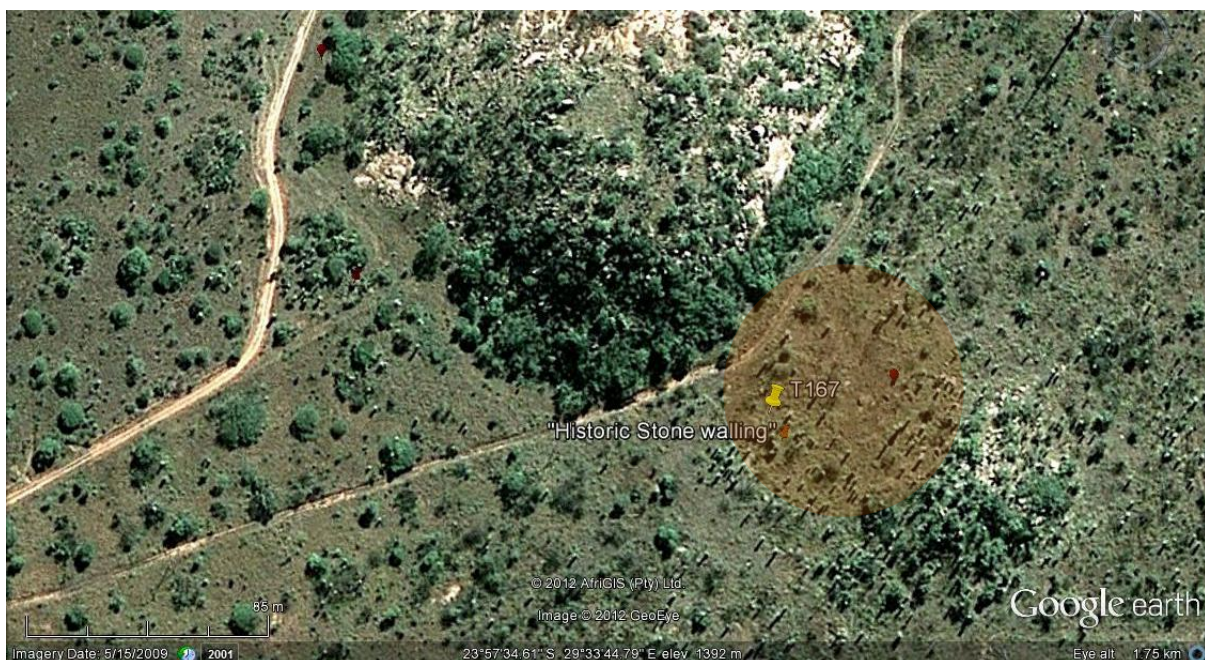
Figure 01. The entire plateau between the two hills is a Late Iron Age archaeological site, roughly indicated in the image with a brown circle. One tower of a previous line intrudes on the archaeological remains and had caused damage. The present access road also cuts through the site. Tower 167 will be placed among the stone wall remains. The yellow pin shows the first planned position of the tower which was since moved to a higher position, approximately 50 m in a north-eastern direction.

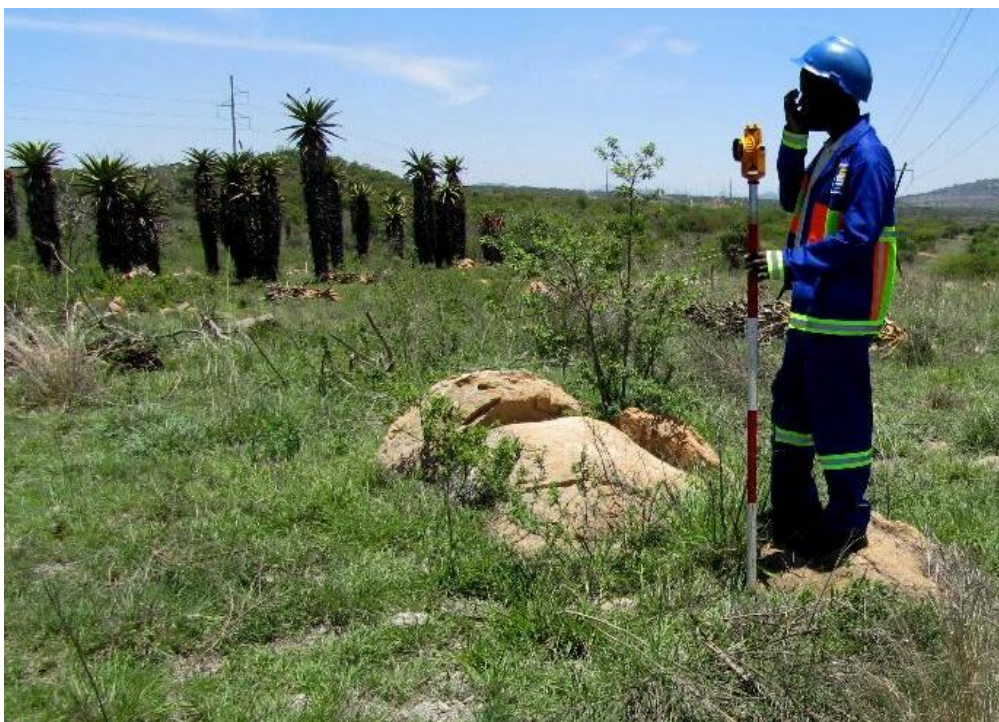
Figure 05. The site being surveyed. All visible stone walls and other features (such as rocky outcrops which were incorporated into the walling, and finds such as grinding stones) were mapped.

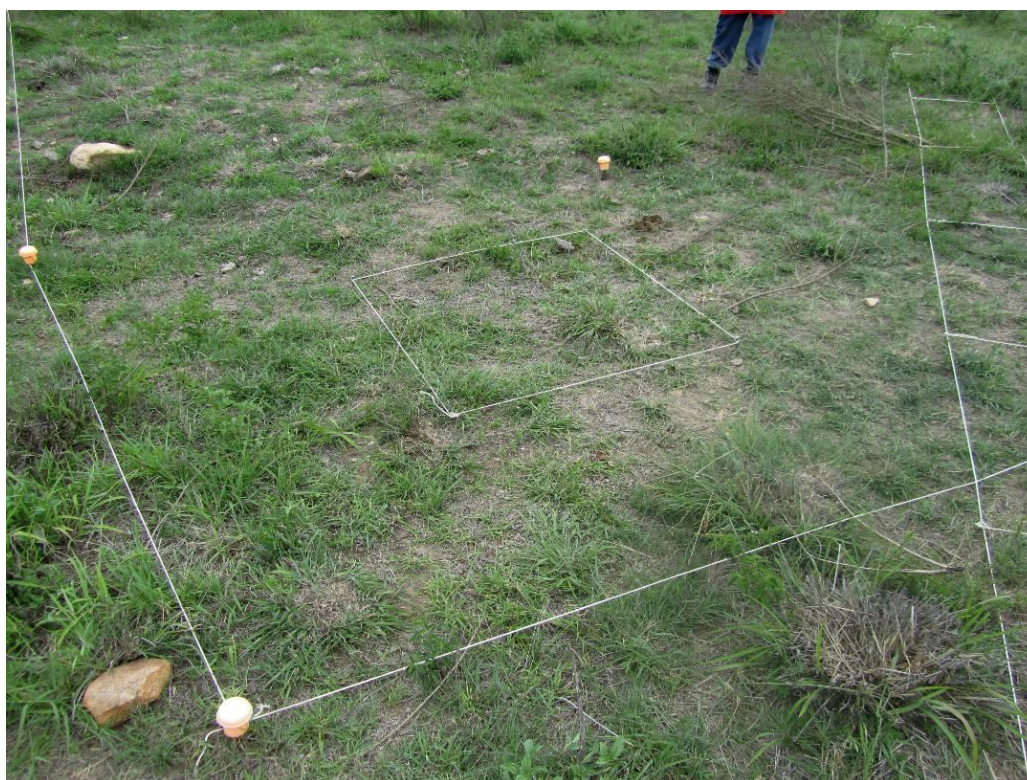
Figure 06. The 1 m x 1 m excavation units which were marked out in each of the tower's legs. These were all completely excavated to rock bottom.

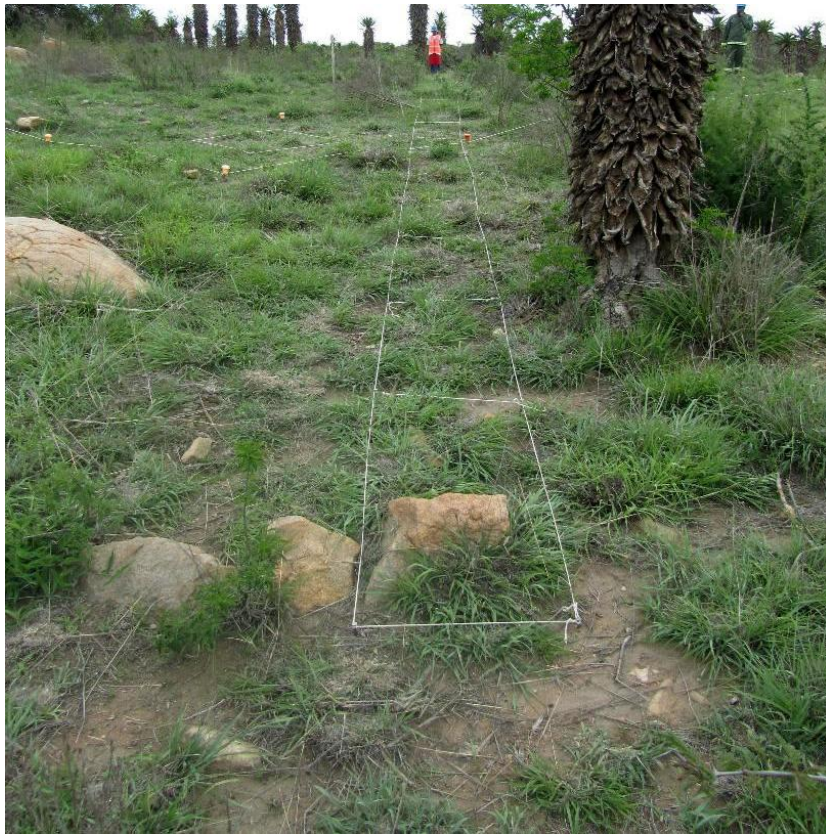
Figure 07. The trench which stretched from one stone wall (in the foreground) to another on the opposite side of the tower. Every second block was excavated.

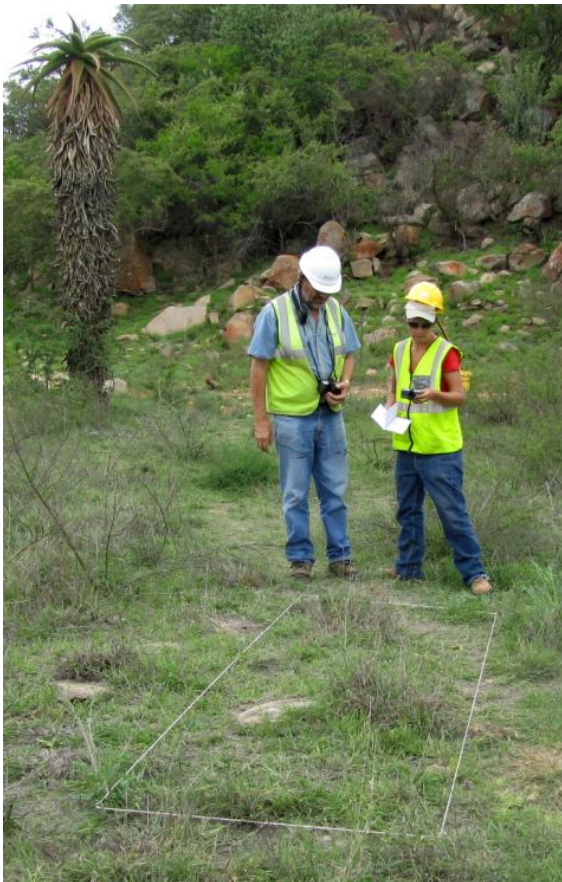
Figure 08. One of the two excavation units located in the area which was identified as the access road.

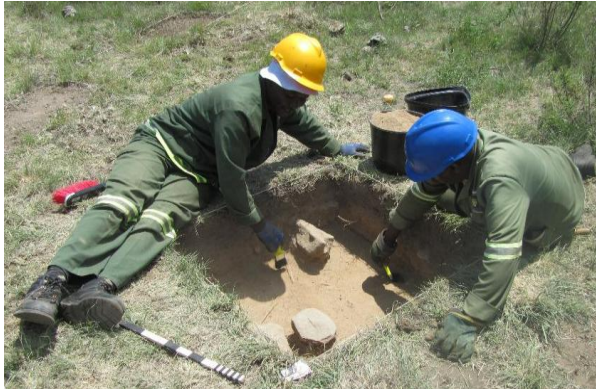
Figure 09. Careful excavation of each layer. One excavator per team was handed a measure stick in order to monitor the depth of the excavation.

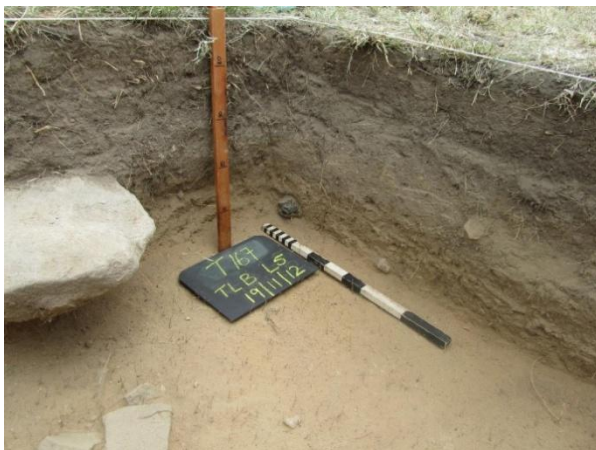
Figure 10. Each layer of each unit was photographically documented; where stratigraphy was observable, it was photographed and drawn.

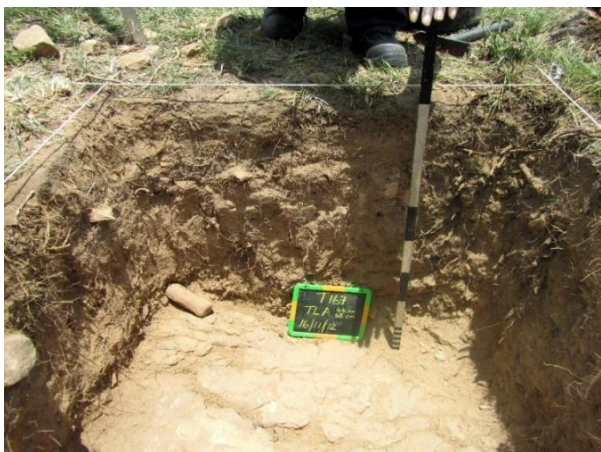
Figure 12. In the excavation units exhibiting distinct and varied stratigraphy, the walls were photo documented and drawn.

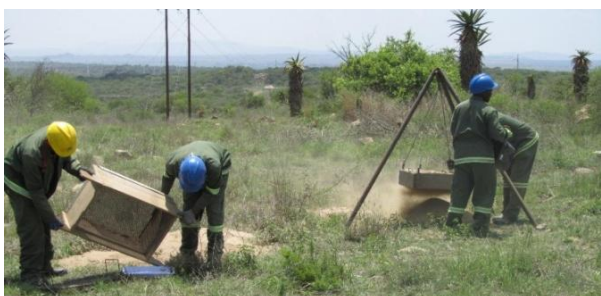
Figure 13. Two sieves (each consisting of two different mesh sizes) were utilised in order for the sieving process to progress quicker. One sieve is operated by two people, while the other is easily used by a single person. Each excavation team was responsible for sieving their own excavated material.

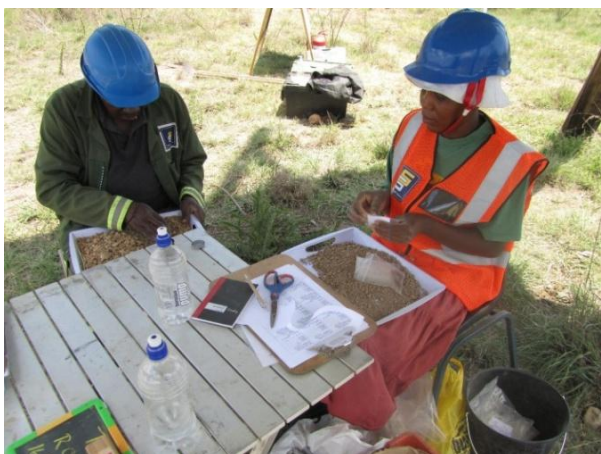
Figure 14. Once sieved, the material was brought to the sorting area. Provisional sorting of finds is an integral part of the fieldwork. As soon as the finds were sorted, it was labelled and packaged. Final cleaning is done in the laboratory (washing of the pottery sherds and other inorganic finds, dusting of the bones) prior to sending it for analysis. Charcoal samples for radiocarbon dating was directly removed from the excavations and sealed in plastic containers to prevent contamination.

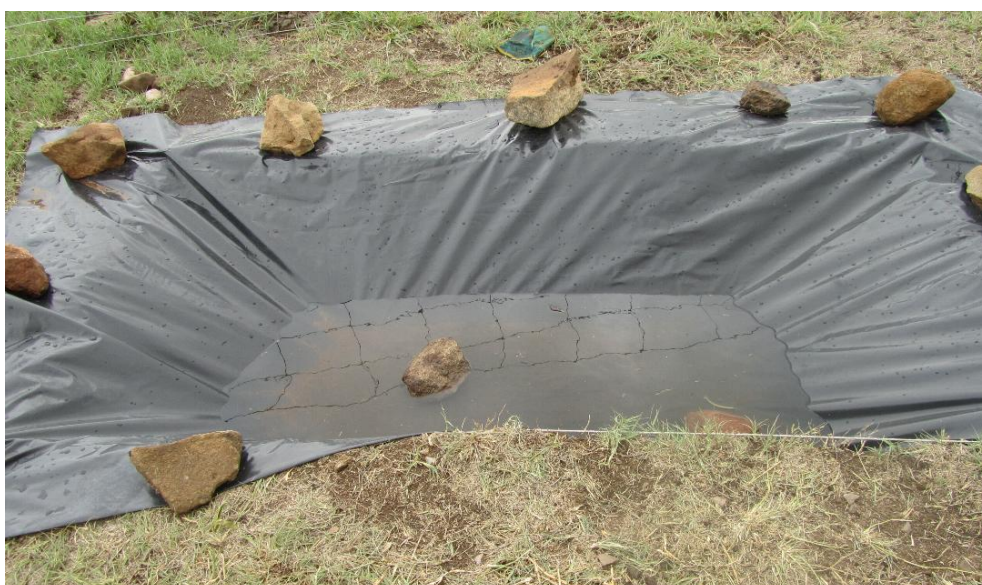
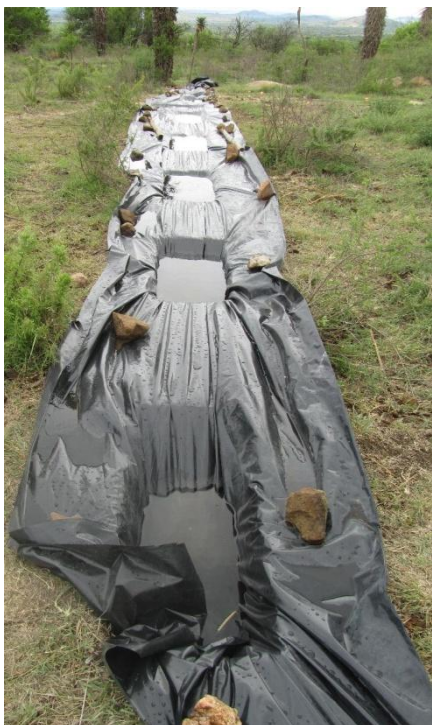
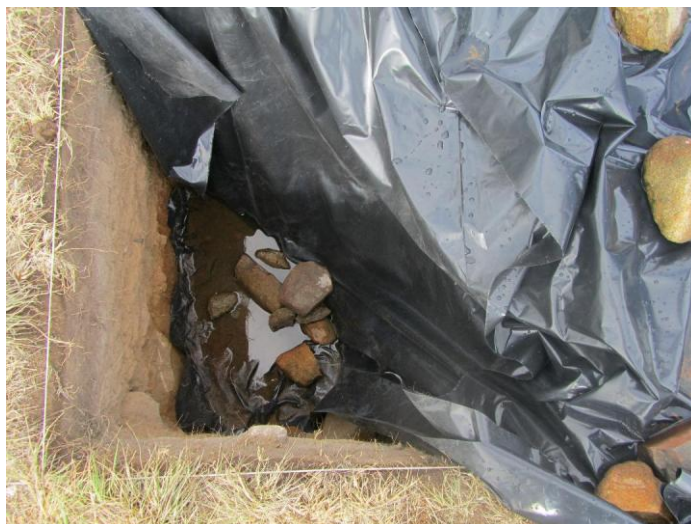
Figures 15, 16 & 17. Although the excavations were closed each evening with plastic sheeting, heavy rain prohibited work for two days. The weight of the water actually dragged the plastic, together with the retaining rocks, down into the excavations.

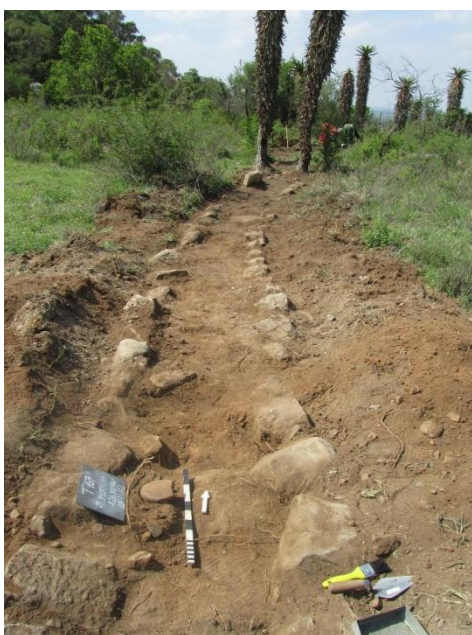
Figure 18. Many of the stone walls or parts of it were not visible on the surface. Picks, shovels and brooms were used to clear it before final surveying of the site.

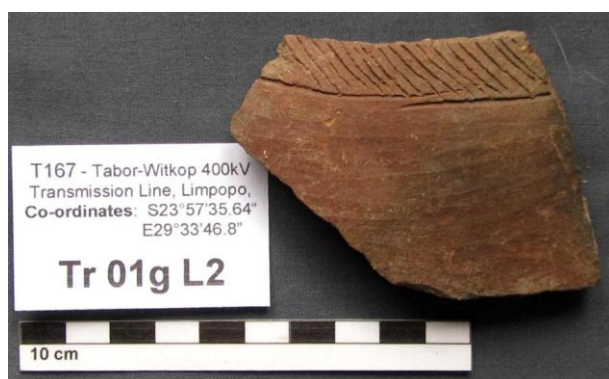
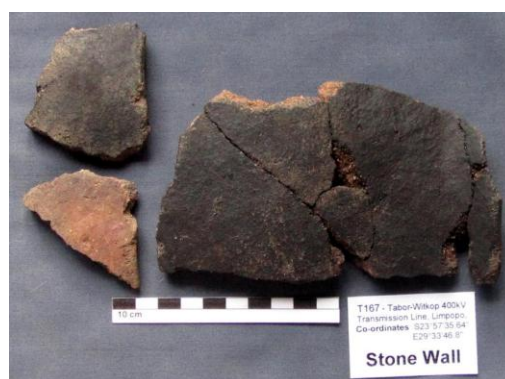
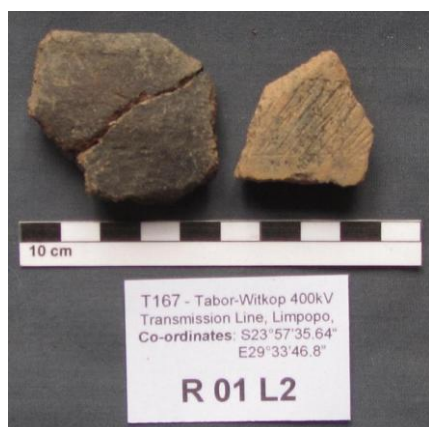
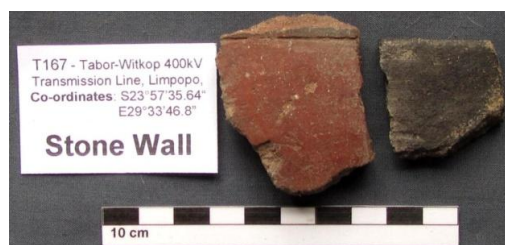
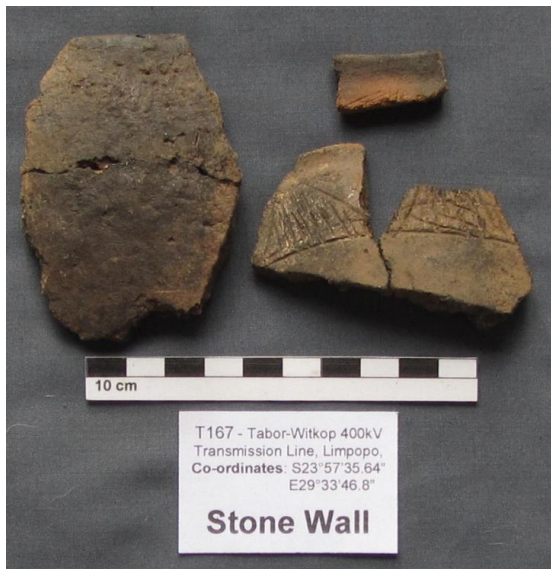
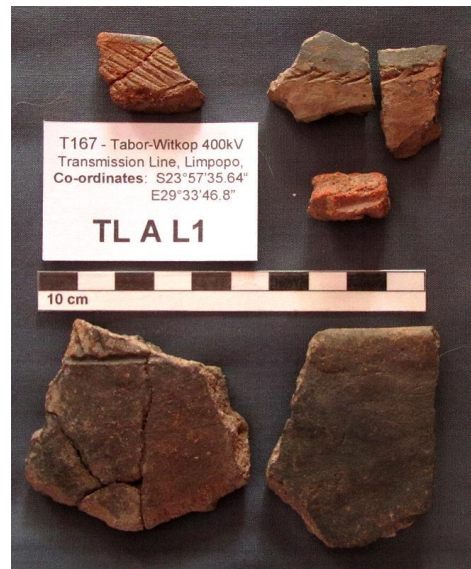
POTTERY (Letaba facies)

The pottery sherds and faunal material are very fragmented. However, some diagnostic pottery was recovered. The pottery belongs to the **Letaba** facies and is in accordance to what Loubser described at Ndebele and Koni sites on the plateau. Some glass fragments were also recovered from the top layers, while two glass beads and two OES beads as well as part of an adze was collected. Upper grinders and polishing stones as well as one complete and one broken grinding stone were also found. Some finds were also made along the stone walls during clearing. The final report will contain more detailed information relating to its exact position.

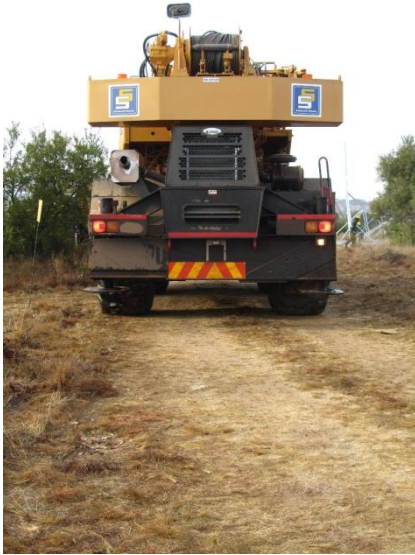
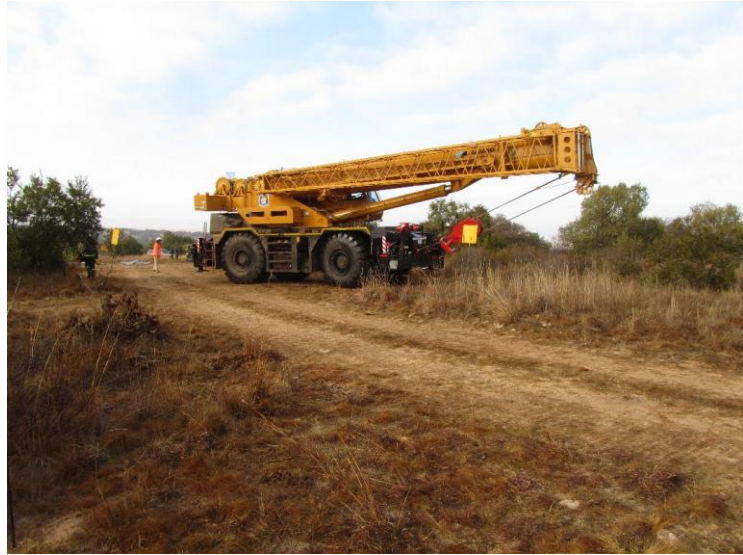
Figure 19 & 20. The width of the crane is at least five metres. These photographs were taken at T205 with the express purpose to establish its width and the space needed for manoeuvring. In the second photograph it is clear that it needs to deviate from the 5 metre access route in order to turn. If this has to happen at T167, it will mean that it will move onto a part of the site which was supposed to be excluded from the archaeological study.

The archaeologist was present during construction of the tower at T205, where observation proved that large and heavy machinery, like TLB's and cranes, are utilised. The archaeologist's concern is their movement across the site, which is the main purpose for documenting a larger area than prescribed by SSP. It is, however, imperative that the archaeologist be present on site during **all** the construction activities, including the delivery of the material, as well as during the stringing process.

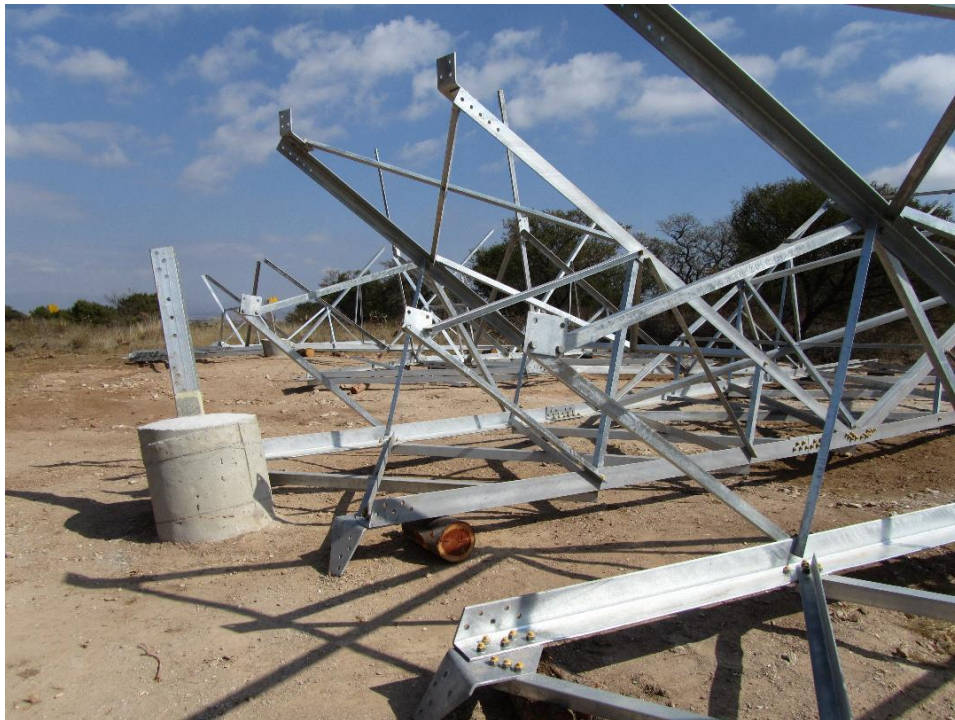
Figure 21. In this image (from T205) it clearly can be seen that the assembled material, awaiting construction, stretches beyond the tower's legs – the tower being similar (self-supporting) to the one to be erected at T167. The area is definitely wider than the 5 metre that was demarcated for the material and assembly at T167.

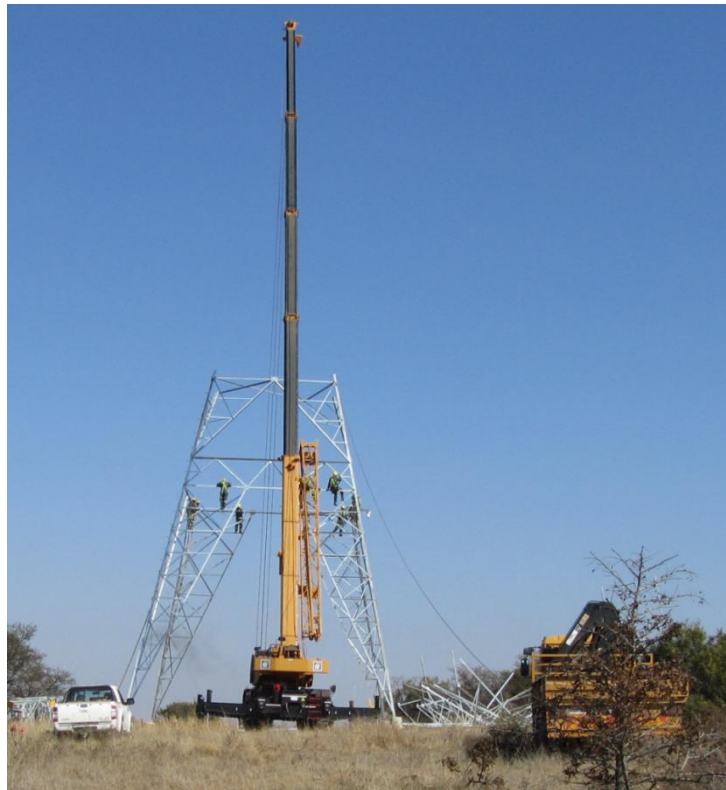
Figure 22. In this image (T205) the two vehicles in the foreground (the white bakkie and the excavator) assist in supporting the various parts of the tower as it is being assembled. This means that the anchors are attached to them; the higher the tower rises, the further into the field they have to move. This effectively means that they will have to move across the archaeological features that were excluded from the study and which were thus not documented. How far exactly they have to move is unclear since the archaeologist was asked by an Eskom representative to leave the site prior to the completion of the tower.
