**PROPOSED RESIDENTIAL / HOTEL DEVELOPMENT,
49 CASUARINE ROAD, TONGAAT, KWAZULU-NATAL**

Phase 1 Heritage Impact Assessment

19 February 2019

**Author: JLB Consulting
Jean Beater**

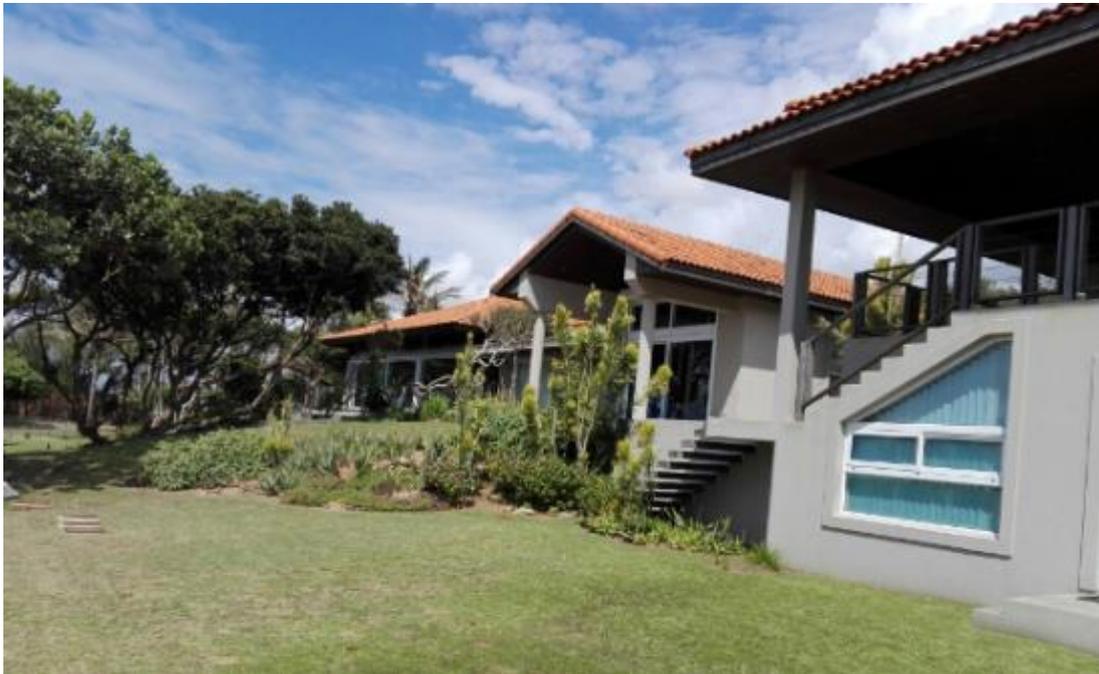
There are several structures on the proposed development area. The main residence and guest house was built in 1994 according to the architect working on the project. The residence is currently used by the applicant.

Figure 3: View of front of main residence

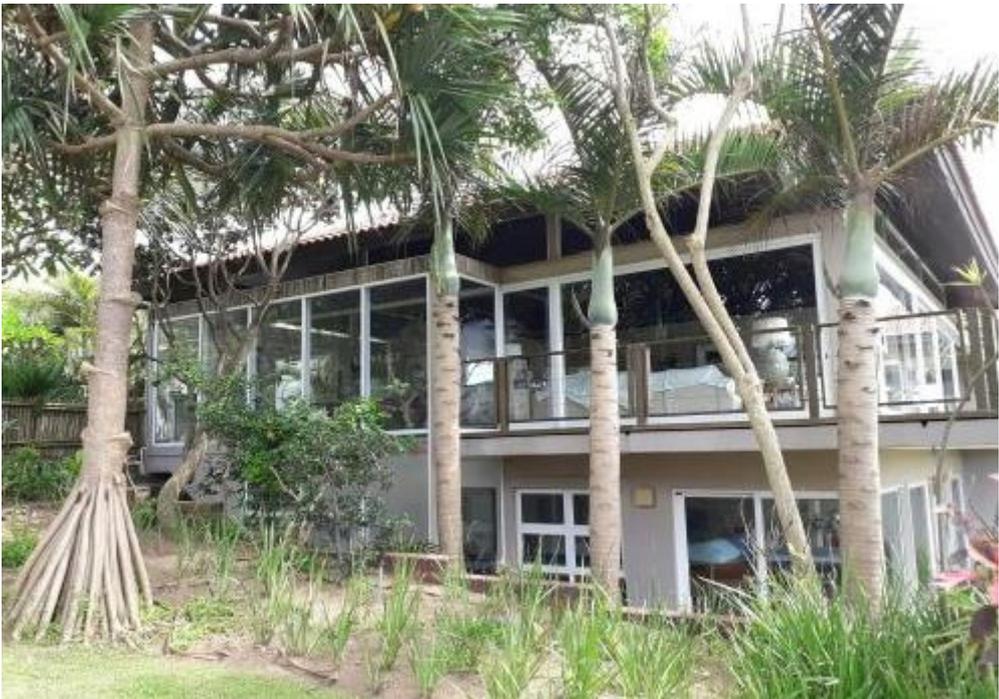
Figure 4: Side of main residence

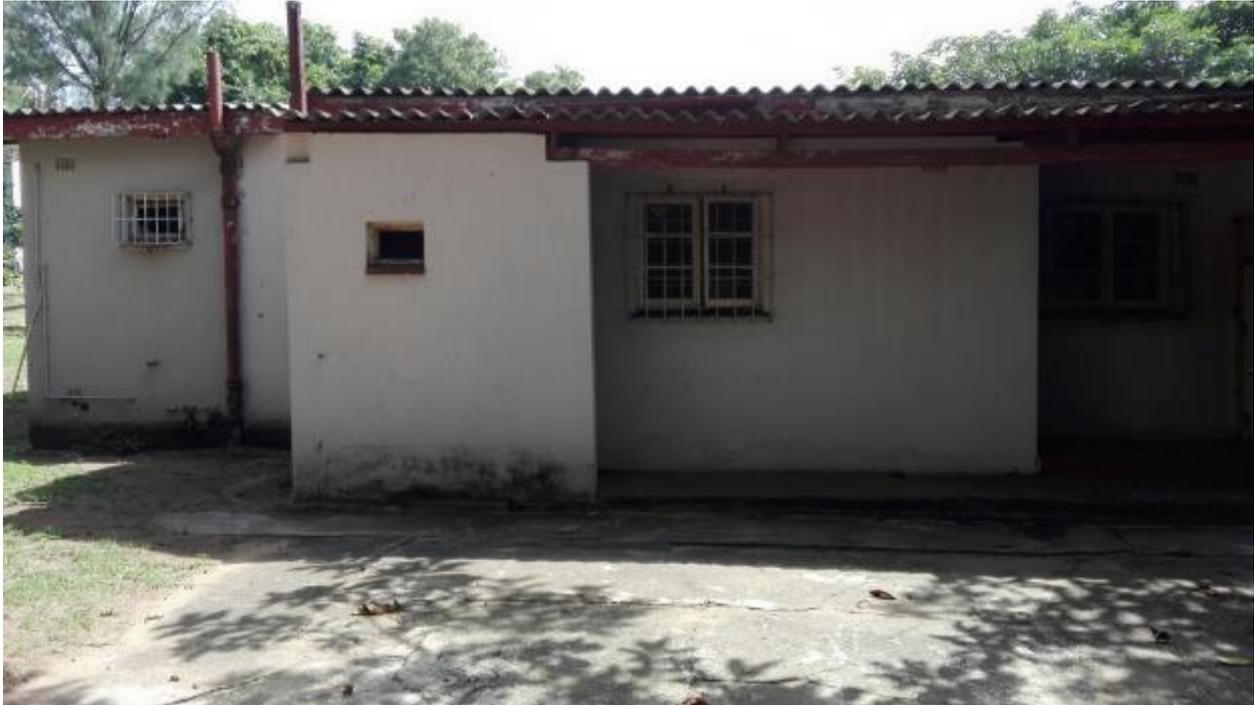
The three structures referred to are not in good condition with visible cracks in the house and trees growing into the structure of the carport as well in the third structure. Wooden window frames, wooden supports and asbestos roofing are found in the structures.

Figure 5: Back of old house

It is therefore recommended that if the client does not want to apply for a permit to destroy the three structures, then the client should find documentation indicating the date of the three structures to prove that they are not older than 60 years.

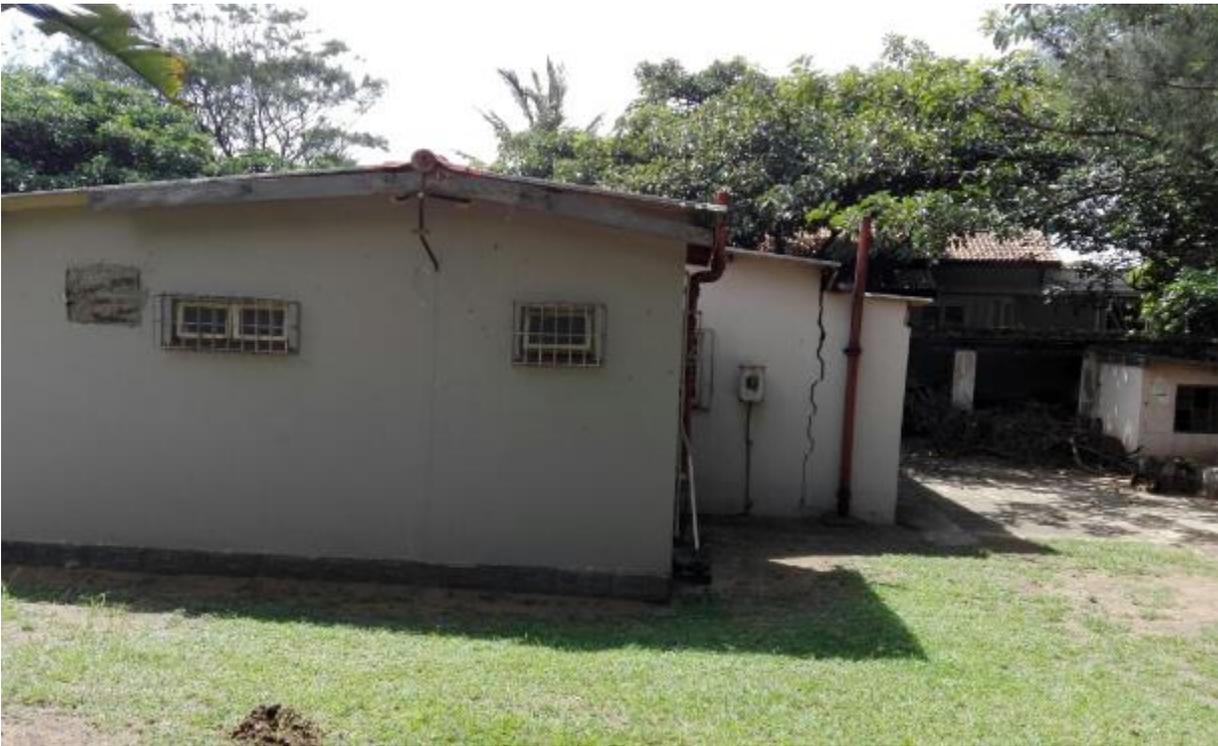
Figure 6: Side of house showing large crack

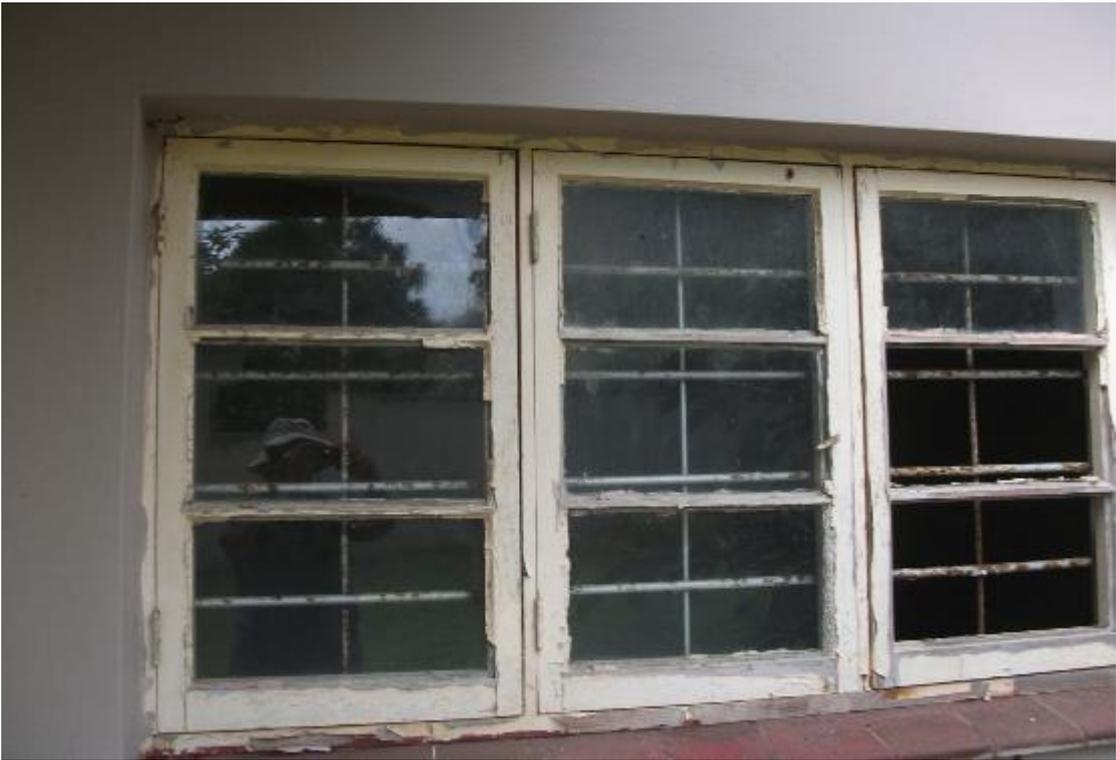
Figure 7: Wooden window frames

The Built Environment section of Amafa, after perusing photographs of the structures that could be older than 60 years, stated that the windows of the house put the house between the late 1940's and pre 1960's. They also stated that there were features that do not tie in with that period such as the air vents which were required up to 1962. The Built Environment section advised that the applicant make application to Amafa for the demolition of the structures unless it is proven that the structures are not older than 60 years.

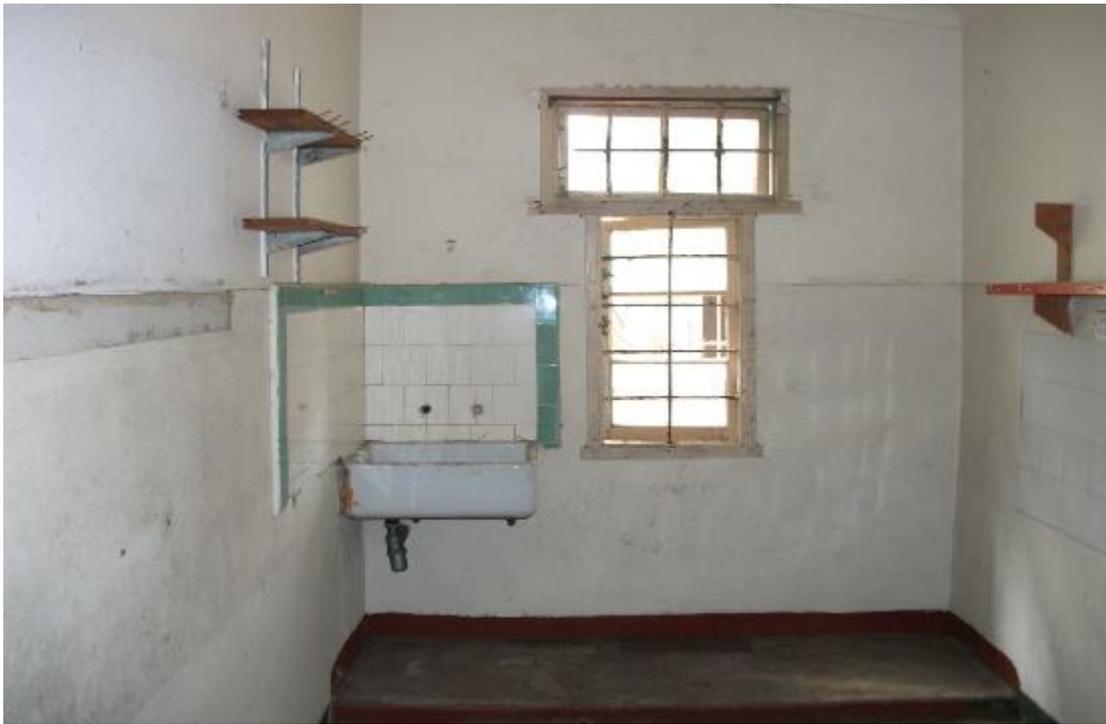
Figure 8: Interior of house showing scullery

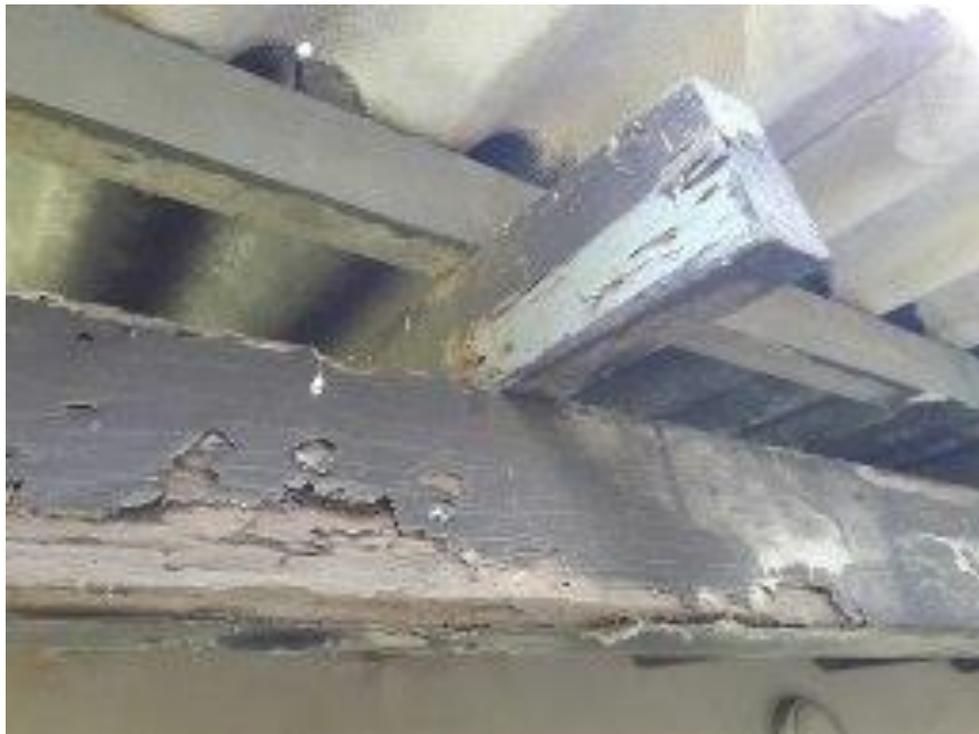
Figure 9: Wooden pillar supporting asbestos roof

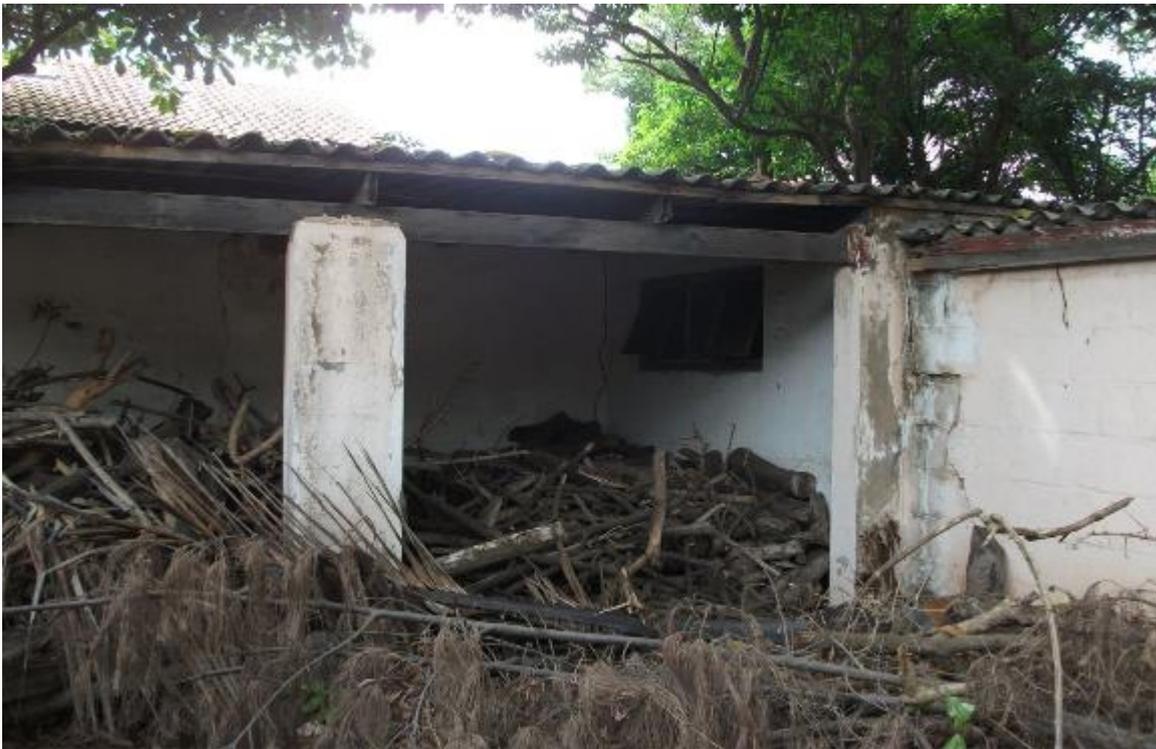
There are several other structures situated on the property, three of which could be older than 60 years. One is a house or residence, the second a car port which is currently used for the storage of wood and garden refuse and the purpose of the third structure is unknown. It may have been a guard house or a pump house.

Figure 10: Car port

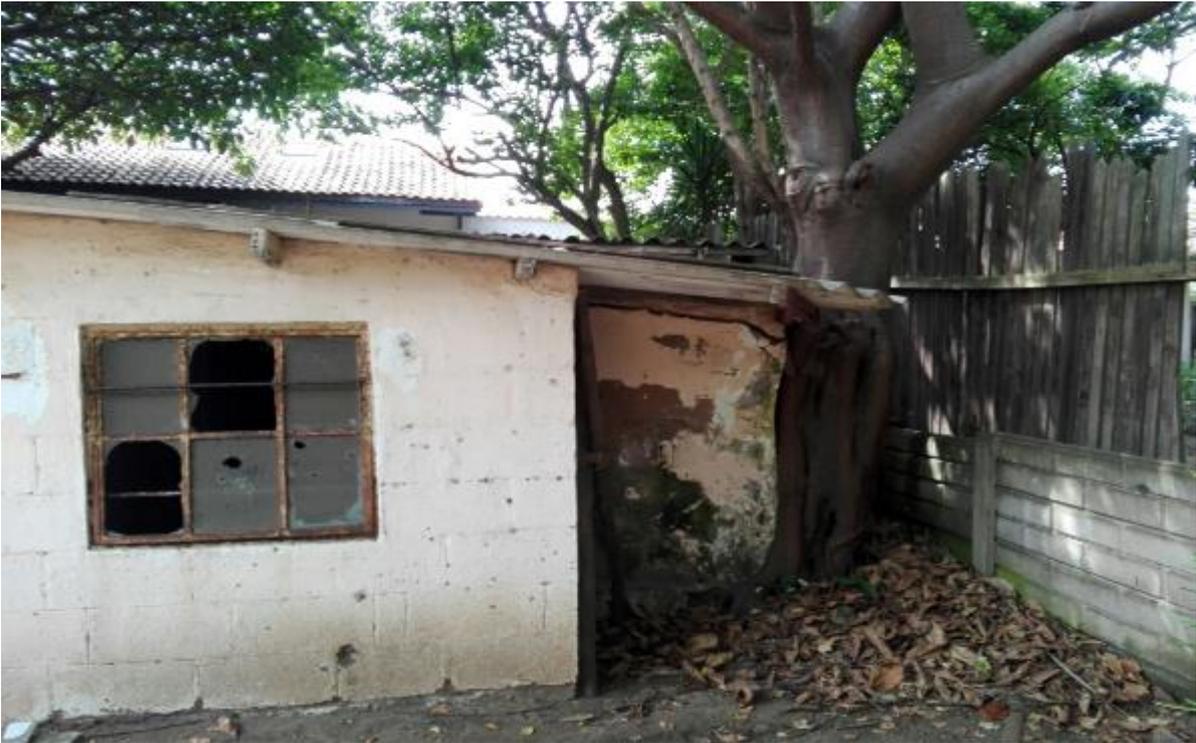
Figure 11: Tree growing out of car port

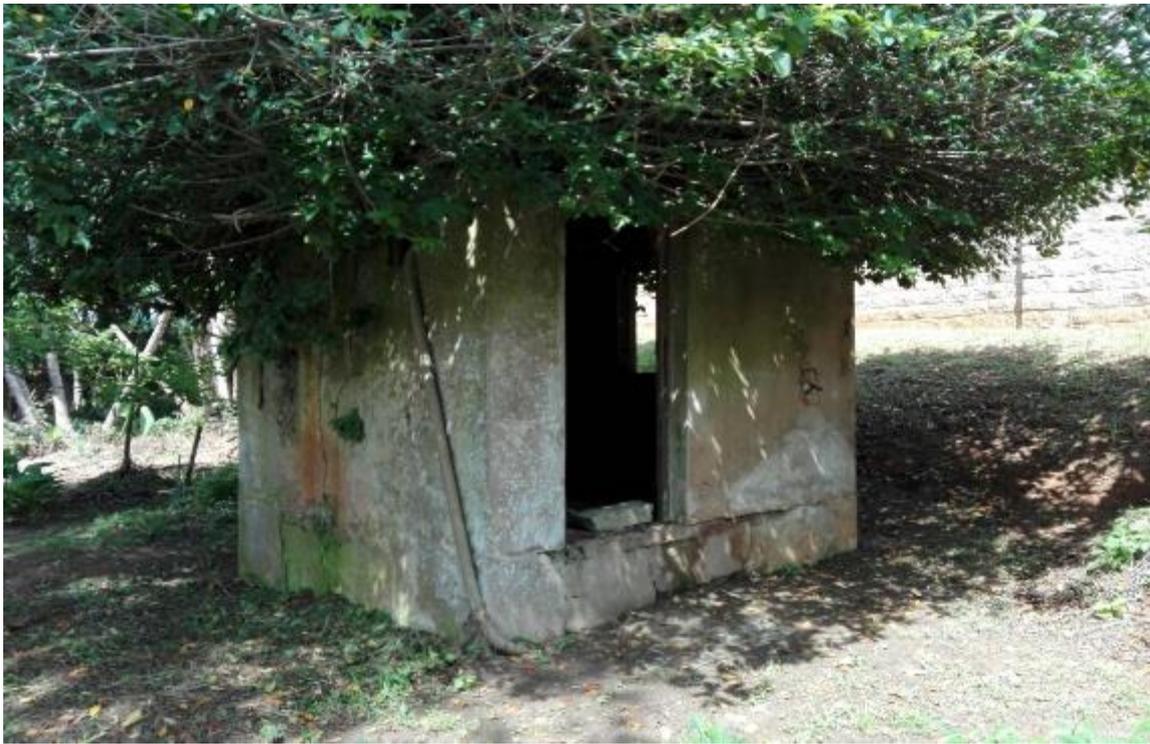
Figure 12: Old structure with tree

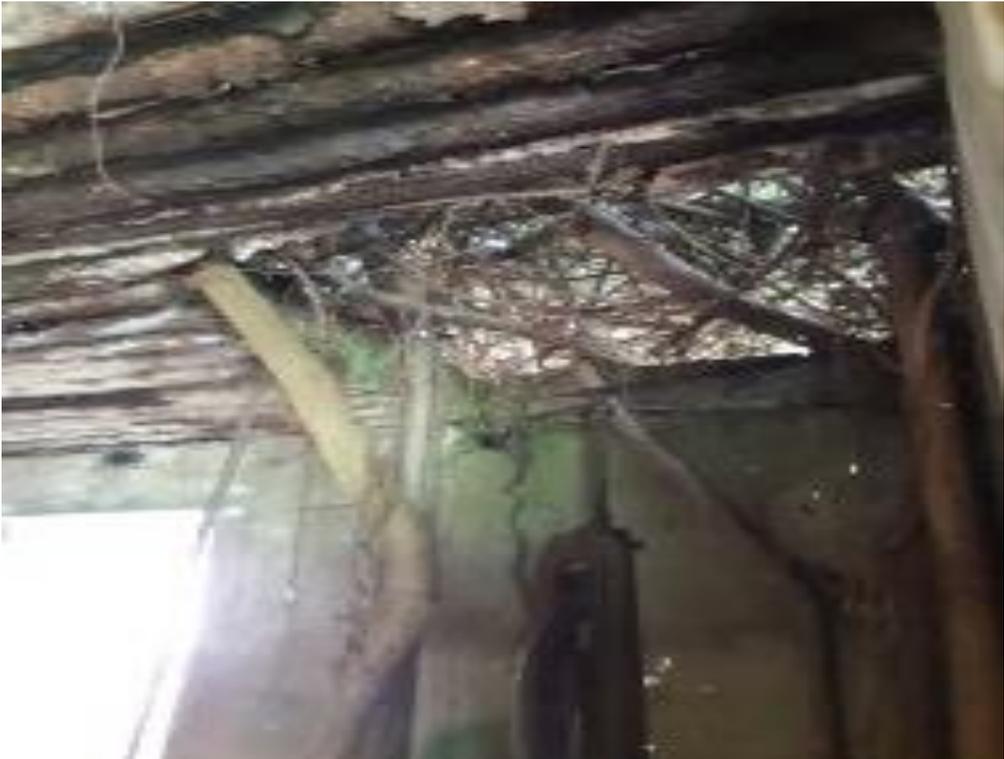
Figure 13: Interior of structure

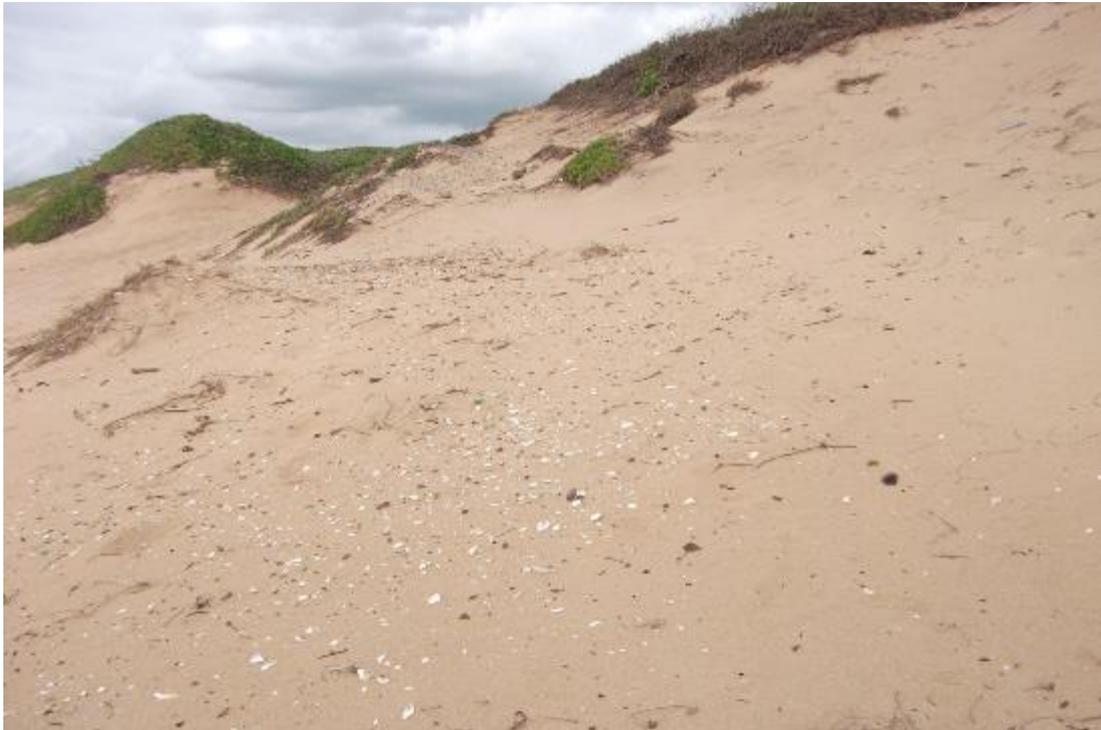
An inspection of the beach and dunes showed evidence of a shell midden located close to the path used by the applicant to access the beach. The middens consists of shells possibly of brown mussels, oysters and other shell species. Such middens can extend inland for several meters and are an indication of the presence of archaeological remains of early inhabitants of the area.

Figure 14: Evidence of a shell midden

It is also recommended that no activity, developmental or otherwise, take place within 30 m of the beach due to the presence of shell middens that could be damaged by such activity. If development does take place in this area, then prior to any construction activity, the removal of vegetation from the dunes must be monitored by an archaeologist to prevent any damage to shell middens or any other archaeological remains that may be found in the dunes.

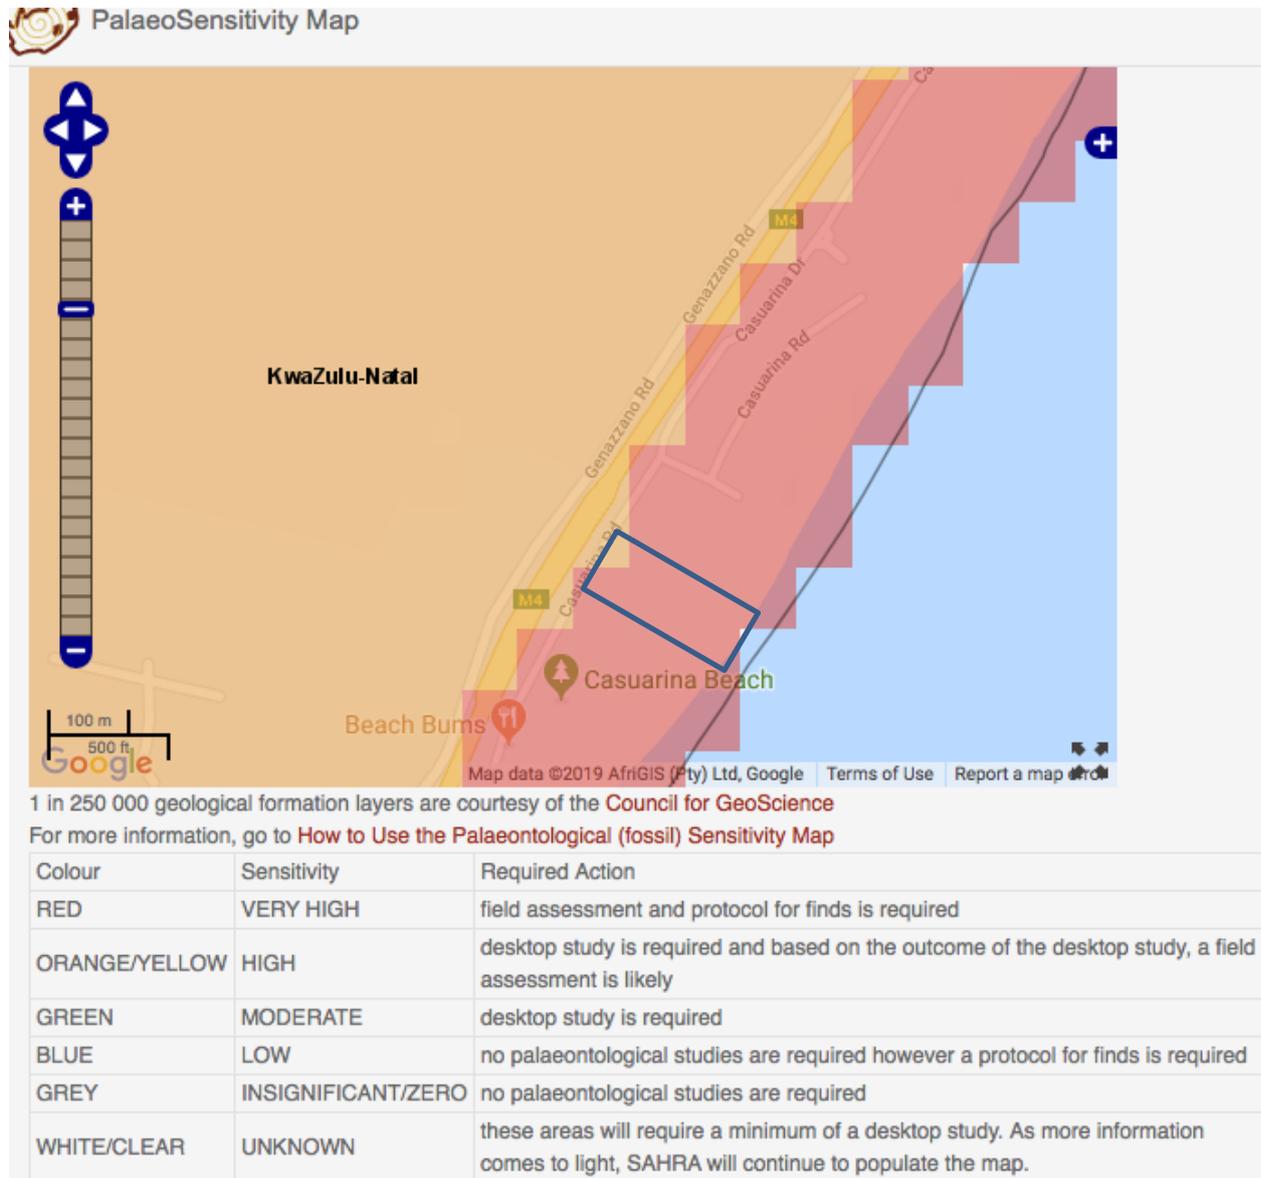
The South African Fossil Sensitivity Map indicates that the project area is situated in an area of very high fossil sensitivity as indicated by the red colour in **Figure 15** below with a very small overlap into high fossil sensitivity.

Figure 15: Fossil sensitivity of property to be developed outlined in blue

- all areas where trenching or excavation for infrastructure will be deeper than 1.5m must be identified during geotechnical surveys. Where the trenches and excavations will reach this depth, a suitably qualified palaeontologist must be appointed to record and collect the fossils according to South African Heritage Resources Agency (SAHRA) and Amafa specifications as part of a Phase 1 palaeontological impact assessment during the initial stages of excavation.
- The ECO of the project must be informed of the fact that significant plant fossils may be found because the area is underlain the Vryheid Formation.
- These recommendations must form part of the EMP for the project.

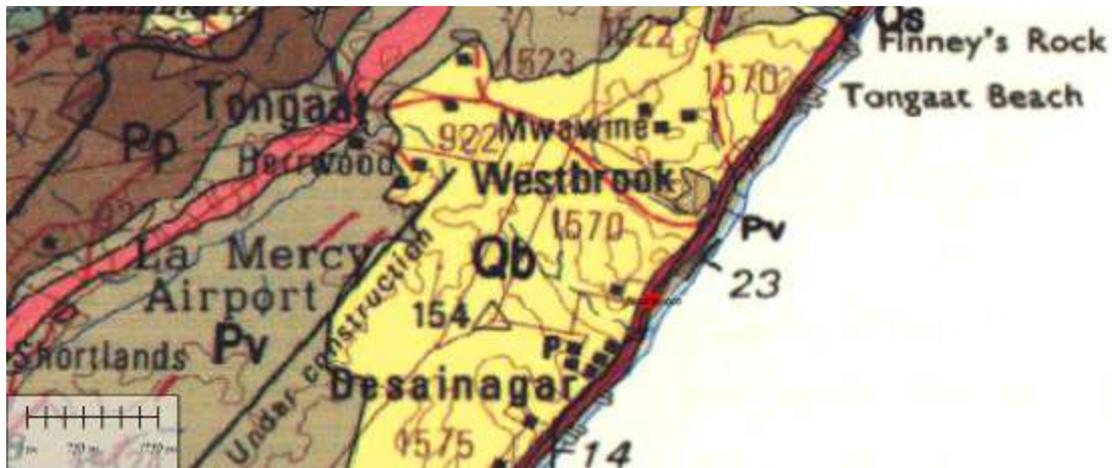
Both project areas are underlain by Permian-aged rocks of the Vryheid Formation of the Ecca Group, Karoo Supergroup that extends to the north and south of the project area (see **Figure 16** below). The Permian aged Vryheid Formation is a thick sequence of sedimentary rocks dominated by light grey sandstones with interbedded grey shale and thick coal seams. These sandstones were deposited along ancient sandy shorelines behind which lay vast swamplands. Burial of vegetation in the swamps eventually formed coal which is mined at various localities in South Africa. Very rich assemblage of plant fossils, coal beds and significant trace fossils have been described from the Vryheid Formation (Anderson 2016:38).

Figure 16: Geology of larger area underlain by sedimentary rocks of the Vryheid Formation (Anderson:37)

The palaeontological sensitivity of the development is related to the specific geology that underlies the development footprints. Trenching of more than 1.5m depth will expose bedrock of the Vryheid Formation during excavation for foundations and infrastructure (Anderson 2016:39). Management measures recommended in the 2016 study to avoid or minimise potential impacts on sensitive fossil finds are provided in the Chapter below.

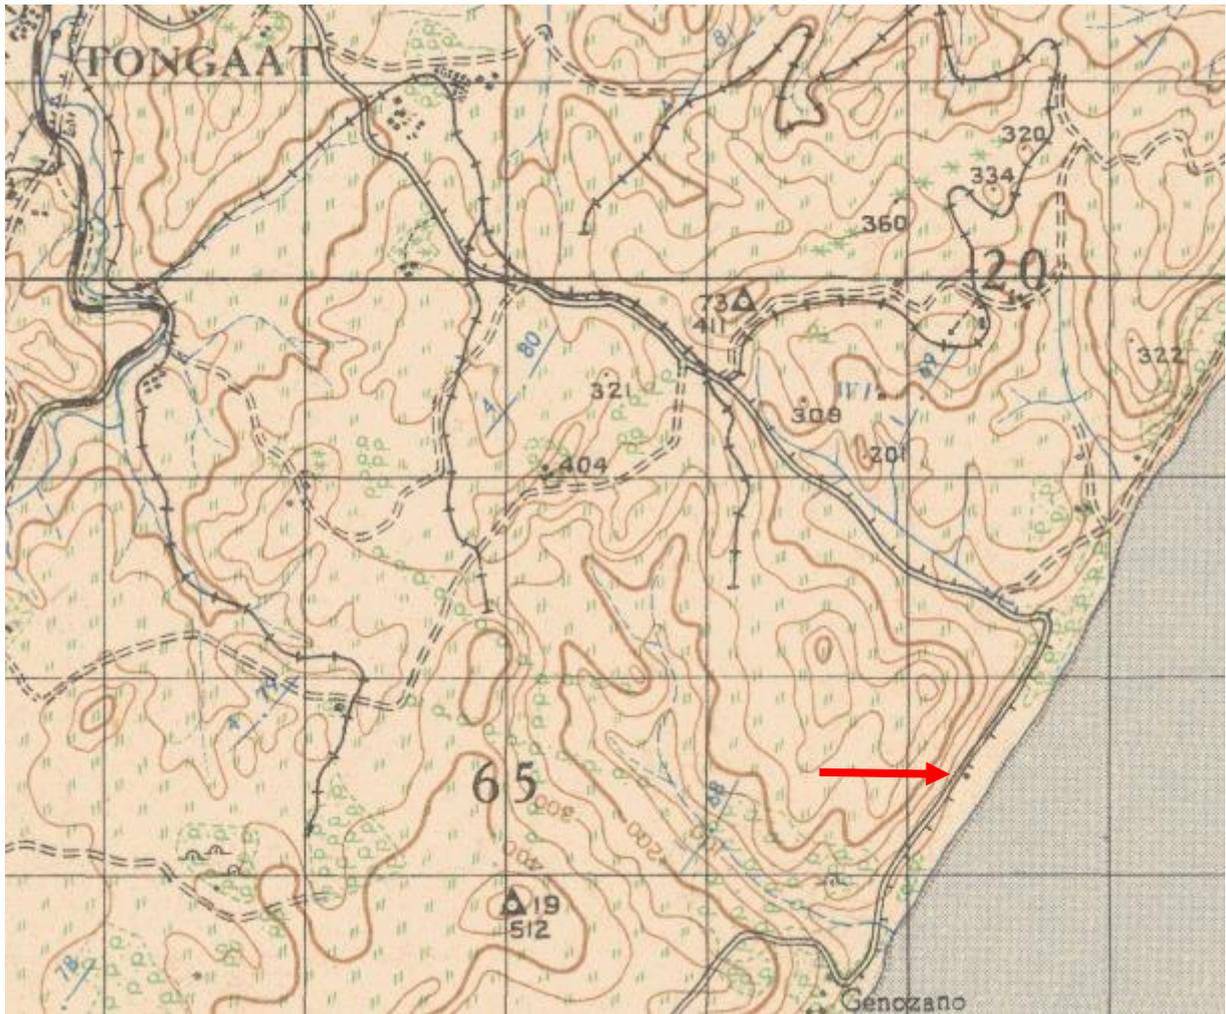
The 1942 1:50000 topographical map (2931CA) of the area shows one structure (see **Figure 17** below) on or in the vicinity of the property and the 1969 topographical map shows 2 structures (see **Figure 18**) on or in the vicinity of the property under discussion. No maps from the intervening years could be found. Therefore, at least one of the structures could be over 60 years and it is possible that a second structure could be over 60 years.

Figure 17: 1942 topographical map showing structure indicated with red arrow

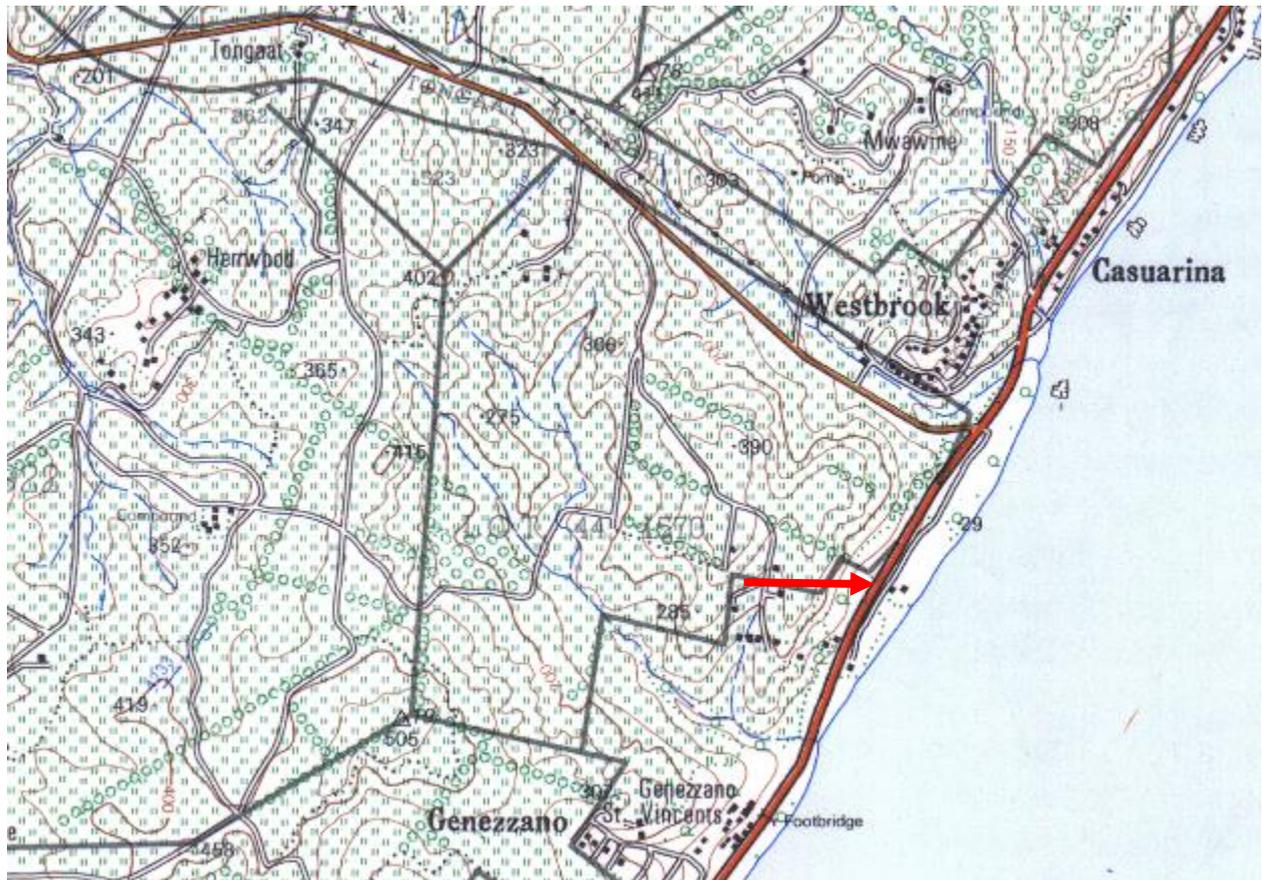
Figure 18: 1969 topographical map showing structures
