**UMDLOTI BEACH FAR SOUTH SEWAGE  
INFRASTRUCTURE PROJECT, ETHEKWINI  
MUNICIPALITY, KWAZULU-NATAL**

**Phase 1 Heritage Impact Assessment**

**16 April 2018  
Updated 16 August 2018**

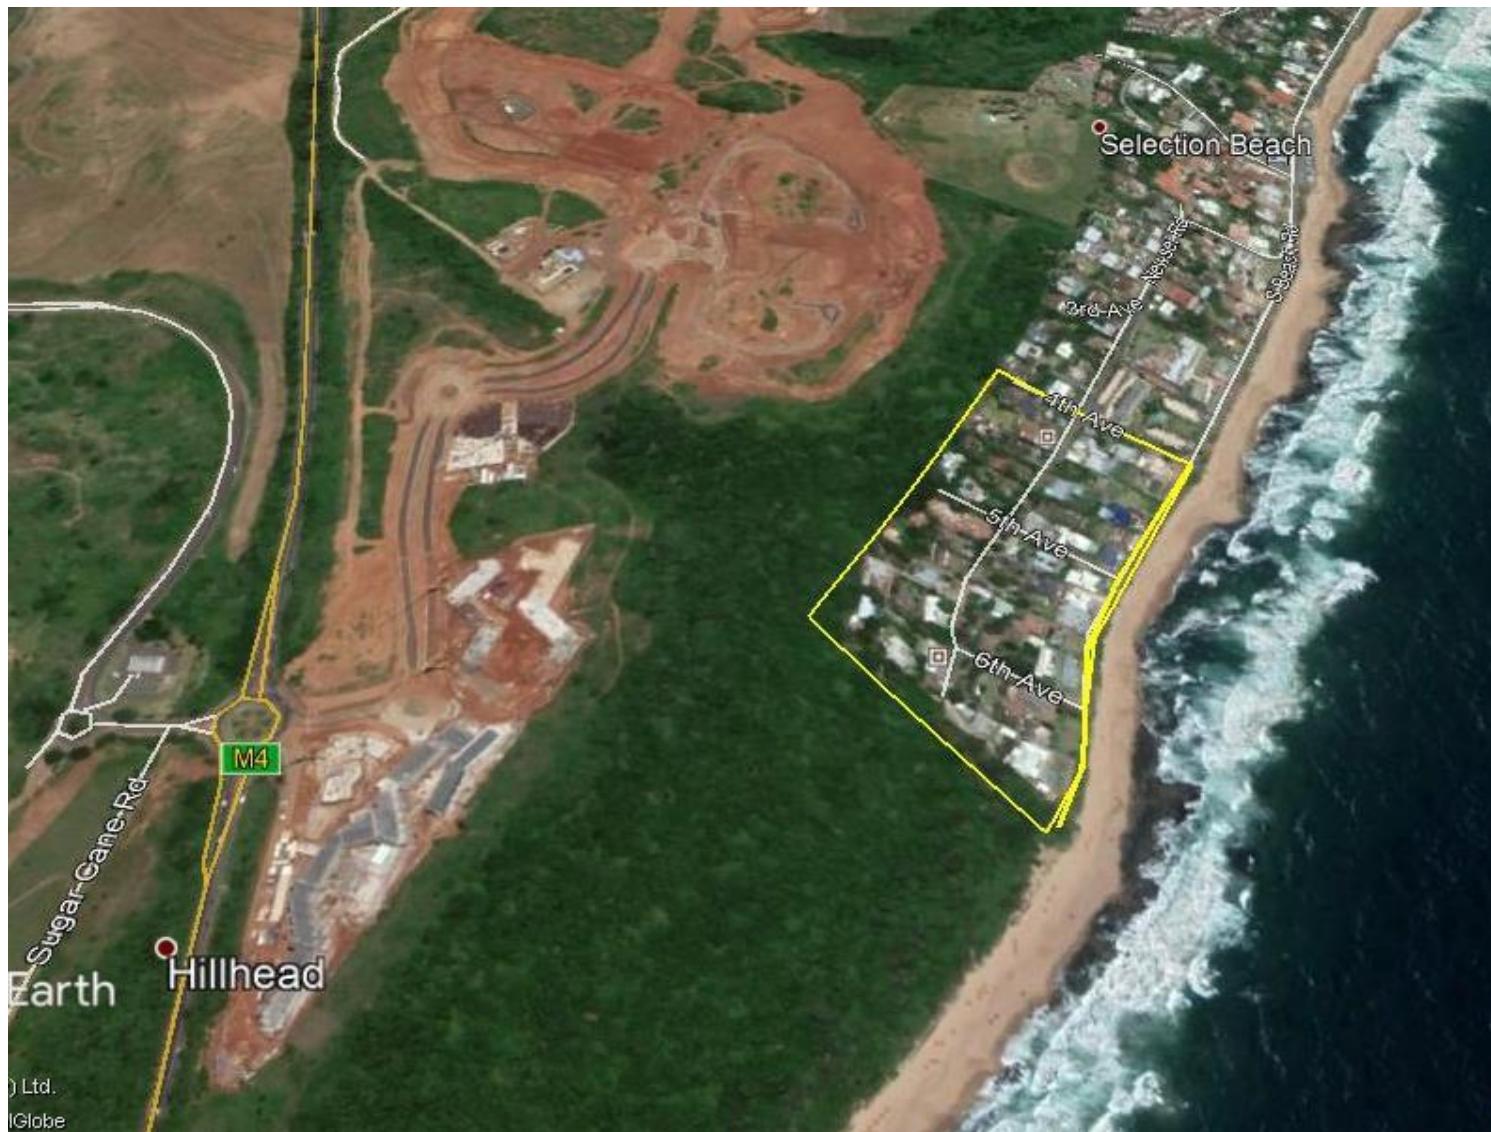
**Figure 1: Project area outlined in yellow with pump station indicated with orange square and access road by red line**

Umdloti Beach is situated approximately 25km north of the centre of Durban and approximately 7km north of Umhlanga Rocks. The project area is located on the southern tip of Umdloti (see **Figures 1 and 2**).

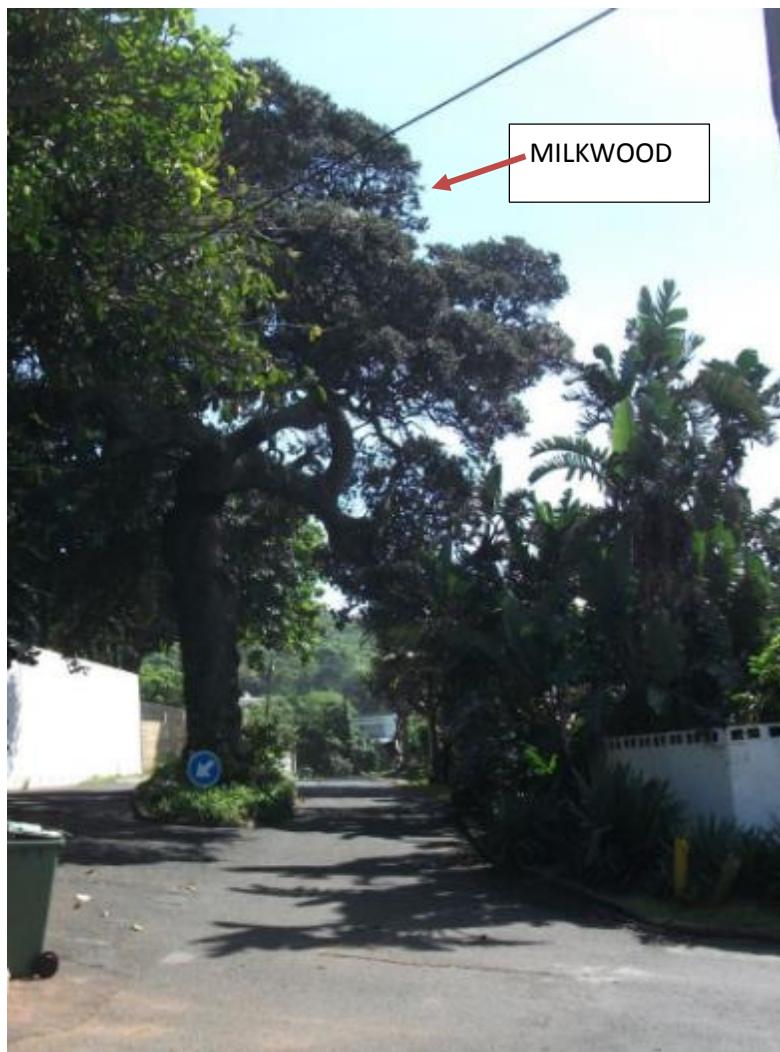
**Figure 3: Milkwood in Newsel Road**

The streets along which the reticulation for the sewage project will be laid were inspected (Fourth, Fifth and Sixth Avenues, South Beach and Newsel Roads). Along Newsel Road close to the intersection with Sixth Avenue a large coastal red milkwood is found that stands in the middle of the road. Local residents refer to it being very old and it is recommended that the laying of the pipelines does not impact on the tree.

The red milkwood tree situated close to the corner of Sixth Avenue and Newsel Road must not be disturbed by the proposed sewage reticulation.

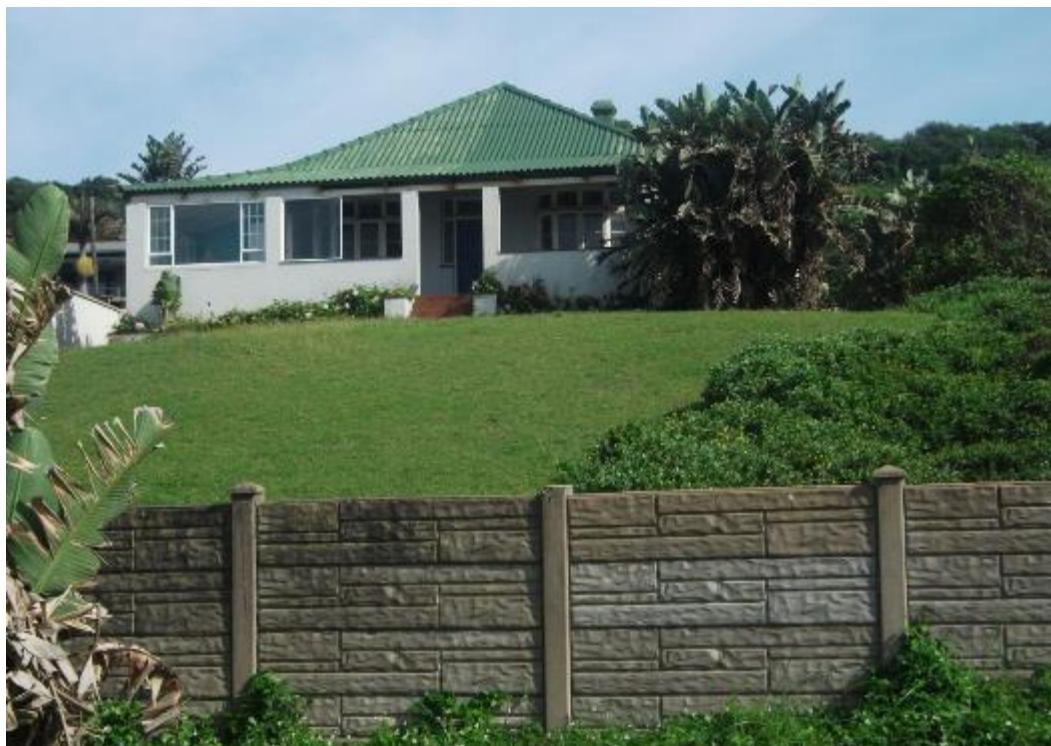
**Figure 7: Dwelling at 45 South Beach Road**

The house at No. 45 South Beach Road is over 60 years of age therefore it is protected by the NHRA. It could be one of the original holiday houses referred to in Chapter 6 or from that era. However, it is the understanding of the specialist, that no residential structures will be impacted by the proposed sewage reticulation project.

No dwellings or structures should be impacted by the proposed sewage reticulation. If structures are to be impacted, then an application for permission to alter any structure older than 60 years will have to be made to Amafa in terms of section 33 (1) (a) of the KZN Heritage Act.

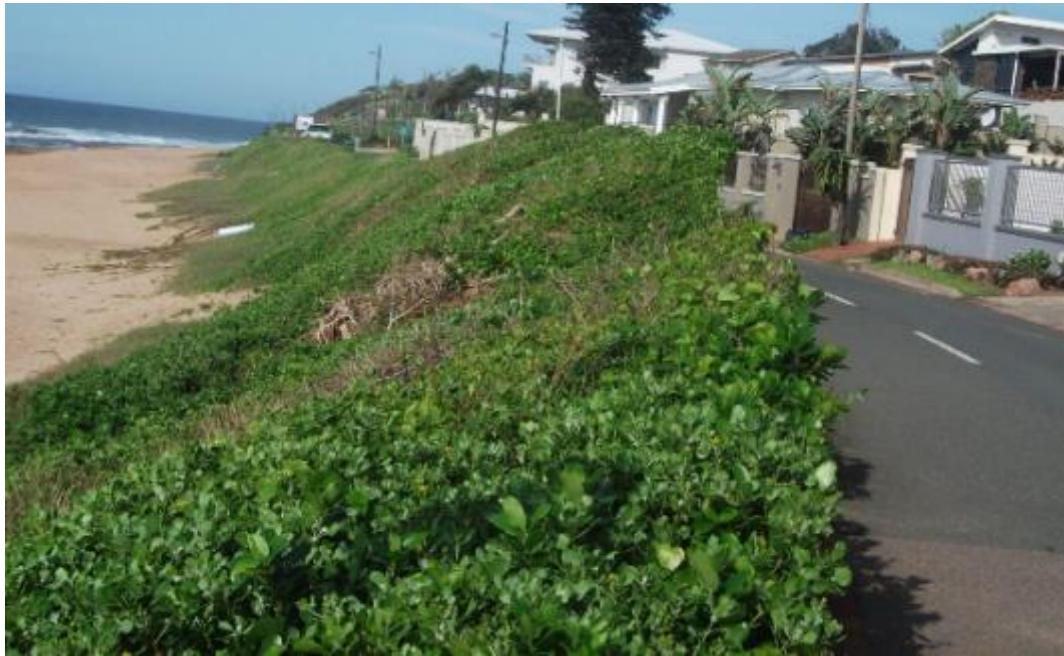
**Figure 8: Area of proposed rising main**

The site of the proposed rising main which is situated along the eastern boundary of South Beach Road is located in an area overgrown by dune vegetation. No heritage sites were noted during the site inspection.

Due to difficulties accessing specific aspects of the proposed project, it is recommended that when the vegetation is removed in preparation of constructing the rising main, pump station and access road, the ECO inspects the cleared areas for ash deposits (unnaturally grey appearance of the soil in comparison to the surrounding soil); bone concentrations, (either animal or human), shell middens, ceramic fragments such as pottery shards and beads. If such finds are discovered, then work in the immediate area must stop and the services of a heritage specialist must be obtained in order to verify the significance of the find.

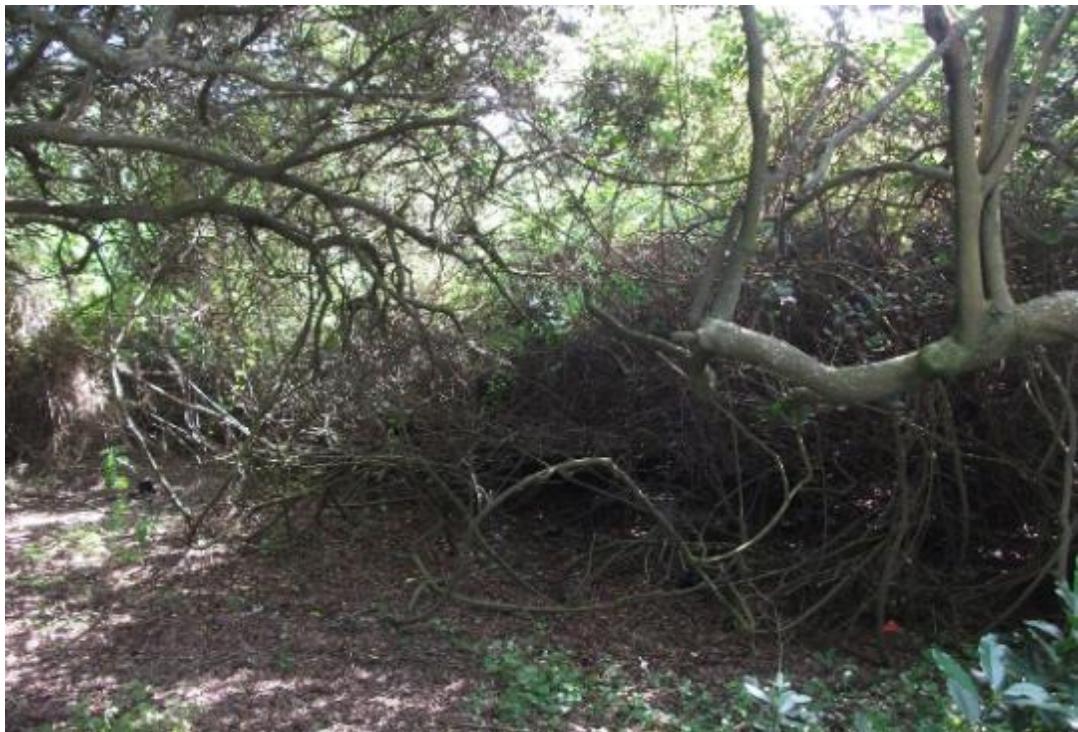
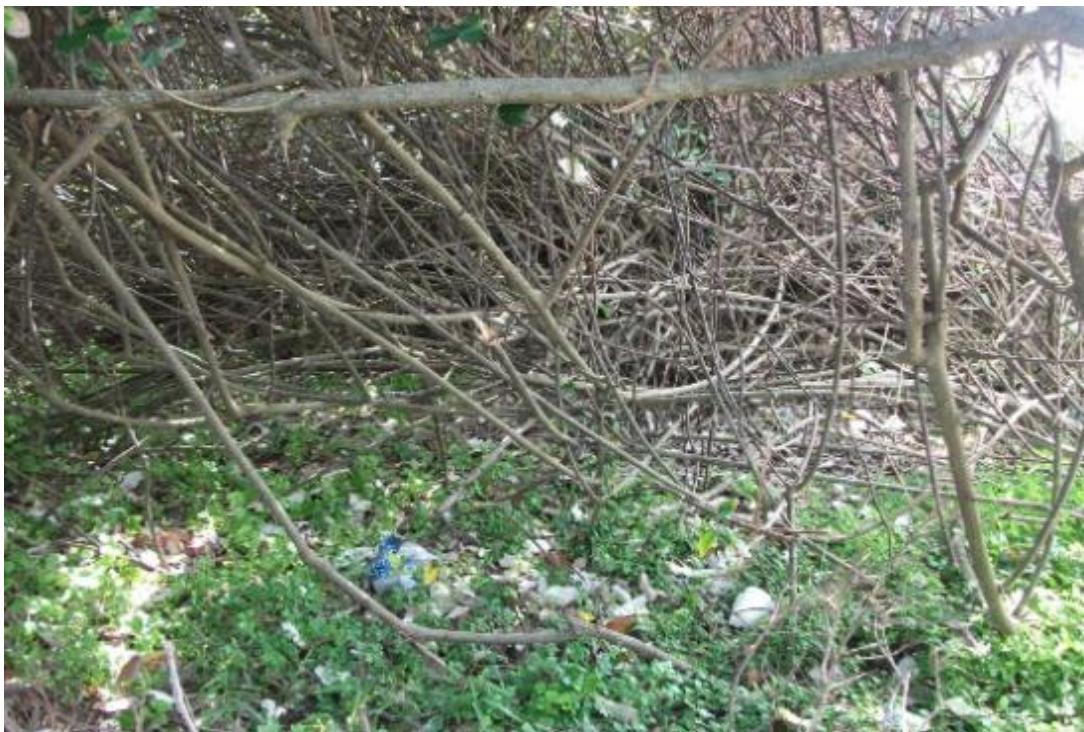
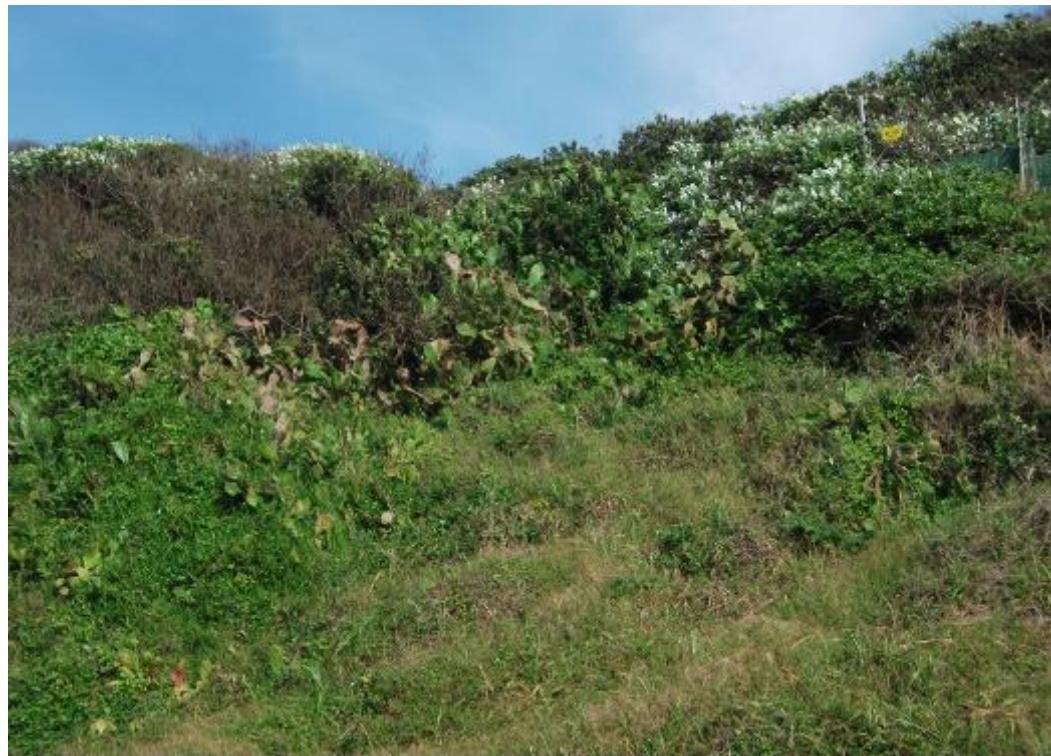
The site of the proposed pump station and access road is overgrown with very dense vegetation making both areas virtually impossible to access. The specialist found a footpath to the top of the dune in the vicinity of the proposed pump station site and inspected this area. No heritage resources were observed during the inspection. The area on top of the dune in the vicinity of the pump station is depicted in **Figures 9, 10 and 11**.

**Figure 9: Area on top of dune in vicinity of pump station**

**Figure 10: Dense vegetation on top of dune in vicinity of pump station**

**Figure 11: Dense bush on top of dune**

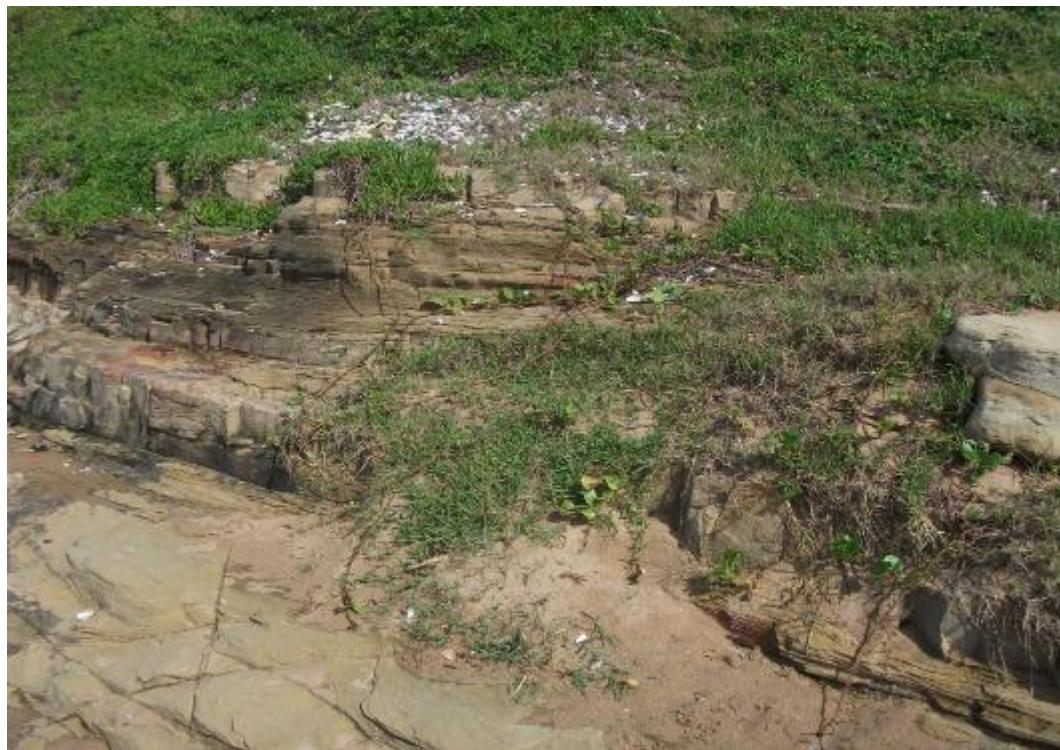
**Figure 12: Shell midden above beach**

Close to and north of the path to the top of the dune described above, a shell midden was observed on a rock shelf immediately above the beach. Shell middens are indicators of previous use of resources by early inhabitants of the area and can indicate the presence of archaeological and other remains that could be impacted by the proposed project.

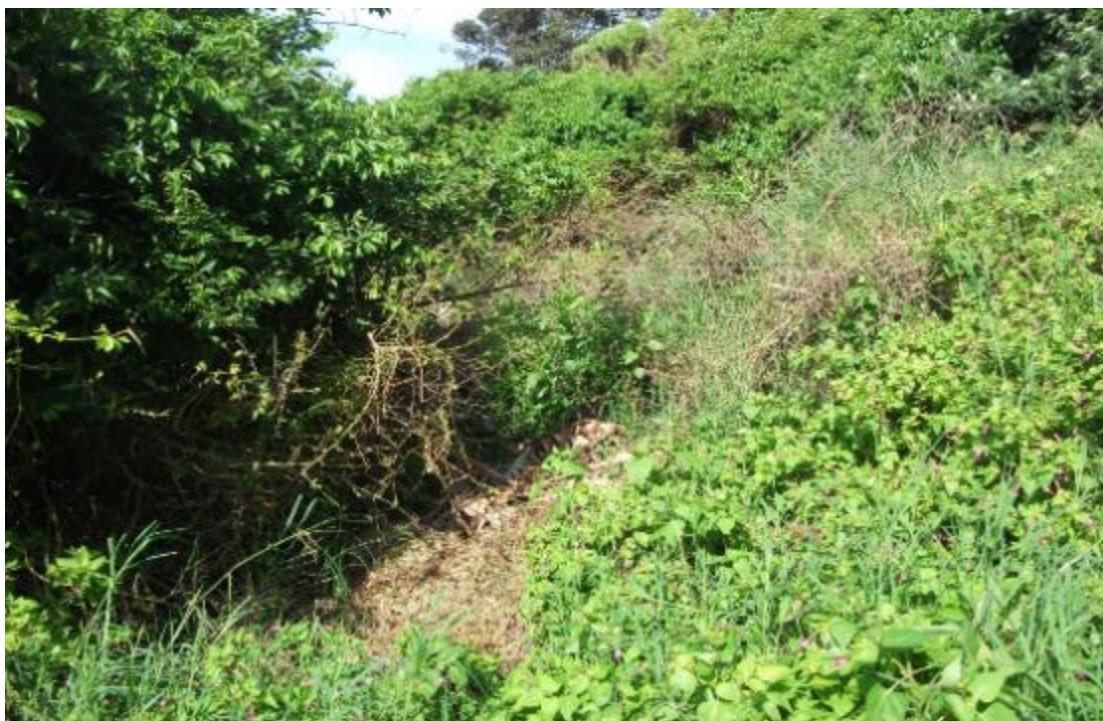
**Figure 13: Start of proposed access road**

The proposed access road area could not be inspected due to the very thick vegetation cover across the length of road (see **Figure 13** below).

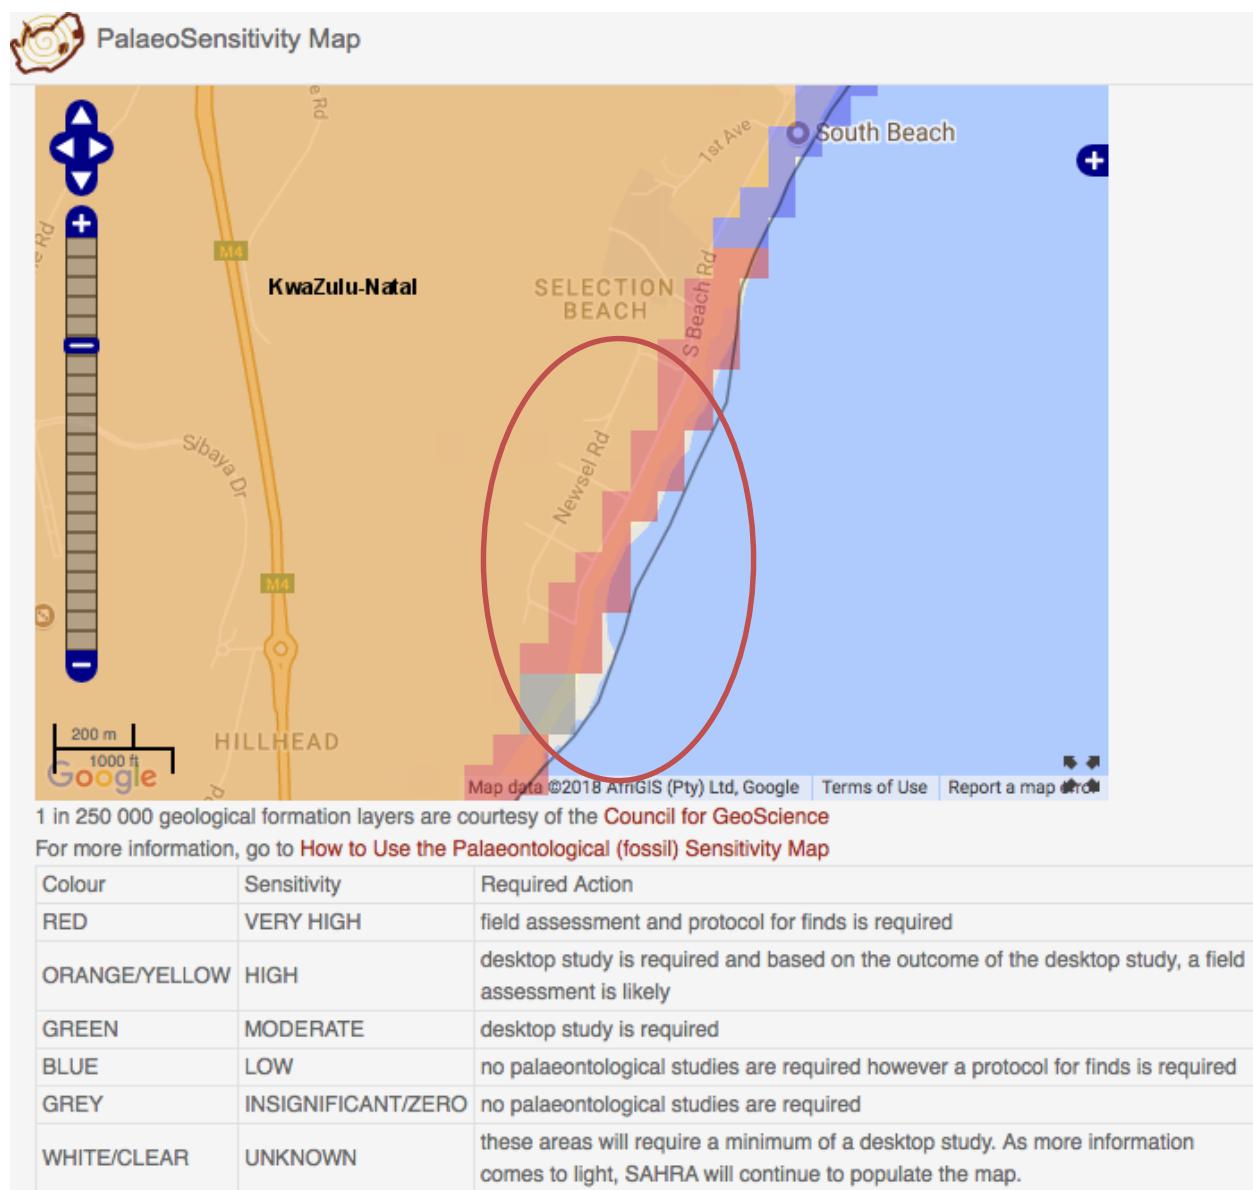
The South African Fossil Sensitivity Map indicates that the project area is situated in an area of high to very high fossil sensitivity as indicated by the red and orange colours on **Figure 14** below. Due to the highly disturbed nature along the streets where the pipeline reticulation will be placed, it is recommended that no further study of these areas of the project be undertaken as any fossils that may have been present will have been destroyed during the development of the roads and residences.

A desktop palaeontological study was undertaken as per the above recommendation. The study found that the geological units that are most relevant to the project are the overlying Maputaland Group that represent coastal deposits. At the base are the coquina and conglomerates of the Uloa Formation, then the Umkwelane Formation aeolianites with “Berea-type” rubrified sand. Above that are possible dune sands and the fossiliferous Port Durnford Formation’s muds, peats and sands. The basal layer of the Maputaland Group, the Uloa Formation, is composed of calcified coquina and shelly conglomerates representing the littoral zone of the palaeo shoreline. The Port Durnford Formation is also potentially fossiliferous with mammal bones, and peats

**Figure 14: Fossil sensitivity map with project area indicated by red circle**

Based on the geology of the area and the palaeontological, the study found that it can be assumed that the formation and layout of the calcified coquina, conglomerates, aeolianites, sand dunes and sands are typical for the country, there is a moderate chance of finding fossils of shells, fish, mammal bones, wood or pollen because such fossils have been recorded from other exposures along the coast north of Durban. The proposed project is likely to penetrate some or part of these fossiliferous deposits.

The study therefore recommended that either a professional palaeontologist/geologist or a well-informed environmental control officer be present when excavations commence. The responsible

person should photograph and record the position of any fossils (if any) before collecting them (with an Amafa permit). The fossils should be deposited in a recognized local museum. Given that the pump station, access road and pipeline footprint will be very narrow and likely to cross cut the potentially fossiliferous strata, rescue is recommended rather than *in situ* preservation. Moreover, the environment is physically unstable and people live close by so it would be difficult to preserve and protect any exposed fossils.

Either a professional palaeontologist/geologist or a well-informed environmental control officer be present when excavations commence. The responsible person should photograph and record the position of any fossils before collecting them (with an AMAFA permit). The fossils should be deposited in a recognized local museum. Rescue of any fossils is recommended instead of *in situ* preservation.
