**PHASE TWO ARCHAEOLOGICAL ASSESSMENT:  
THE REMAINDER OF PORTION 46 OF THE FARM  
OLIFANTSFONTEIN 410 JR  
CENTURION GAUTENG PROVINCE**

January 2018

**AFRICAN HERITAGE CONSULTANTS CC**

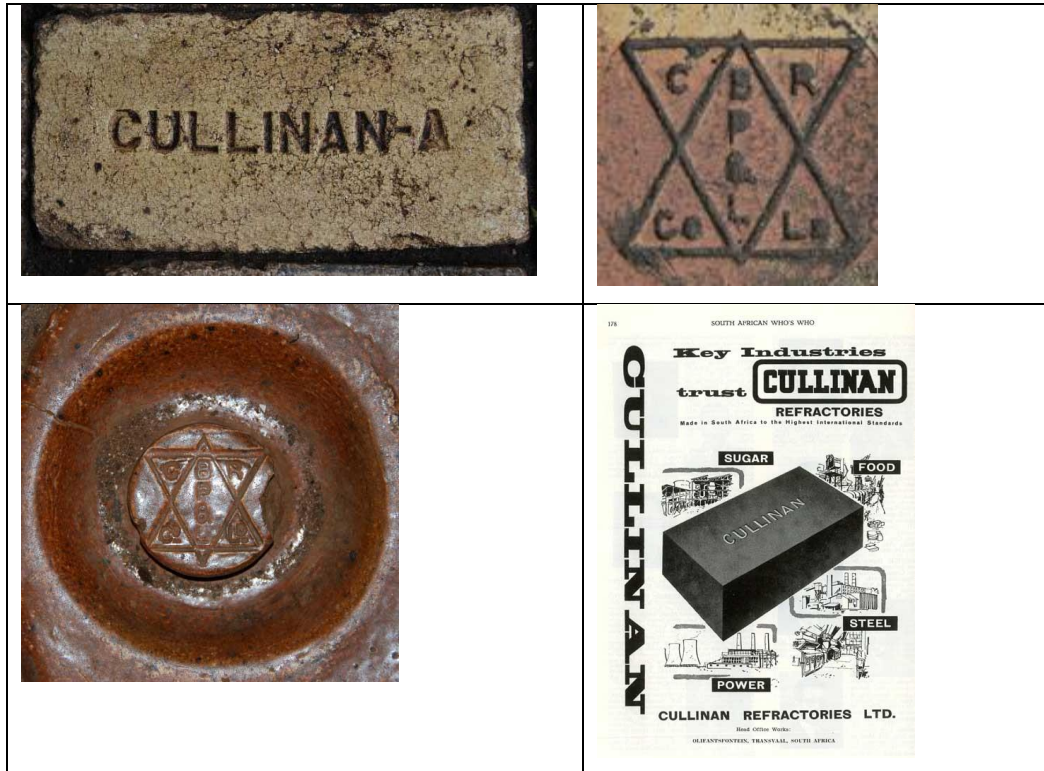
Figure 5. A Cullinan brick showing the manufacturer's mark or initials, in this case CRBP & L Co. Ltd) from paving bricks at the house of R Cullinan, Sunlawns, and an advertisement ([http://www.artefacts.co.za/main/Buildings/style\\_det.php?styleid=789](http://www.artefacts.co.za/main/Buildings/style_det.php?styleid=789)).

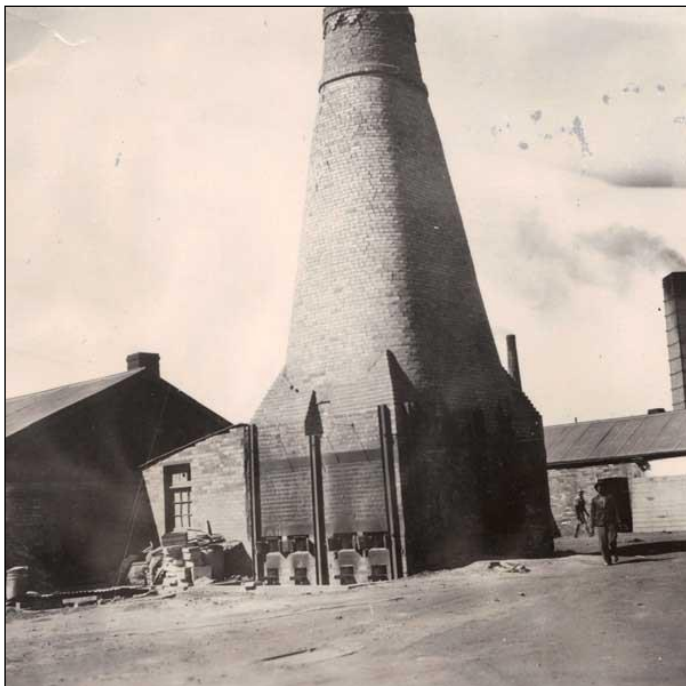
Figure 8. A brick downdraft kiln at Olifantfontein used in the production of ceramics by the Ceramic Studio (<http://www.artefacts.co.za/>).

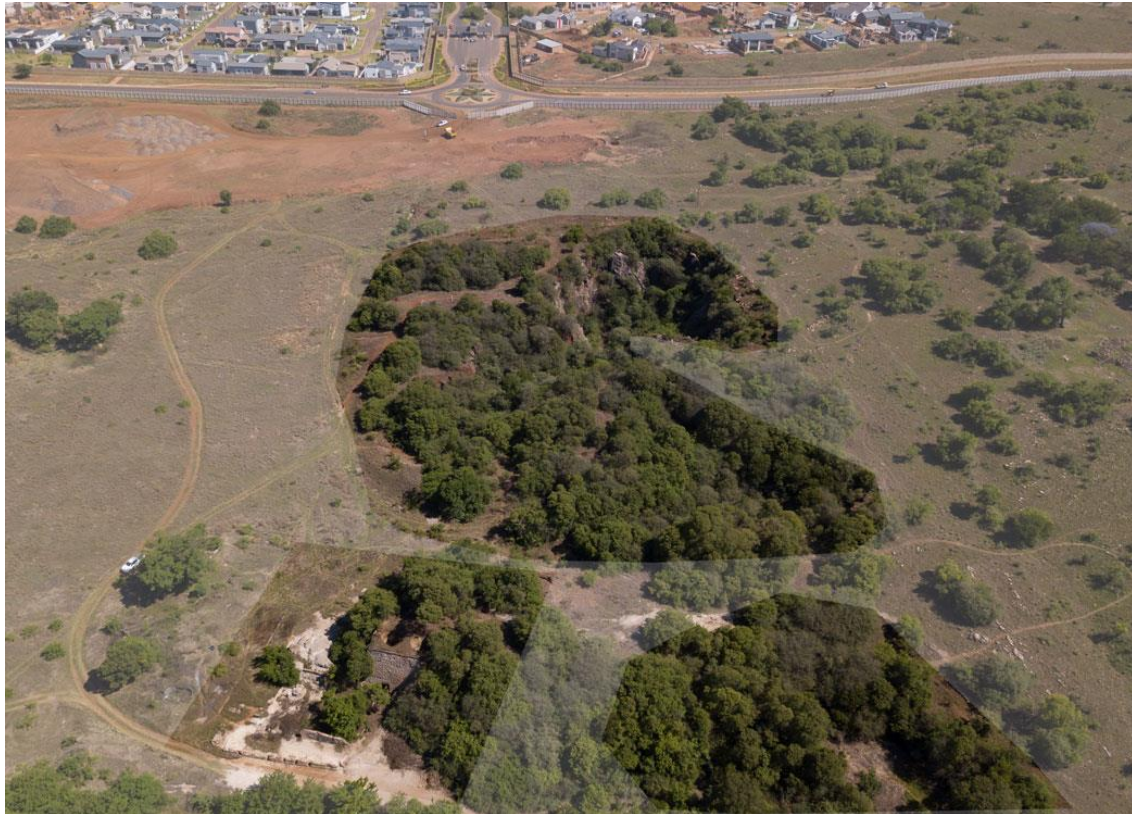
*Figure 17. General view of the quarries showing the production area at the bottom left.*

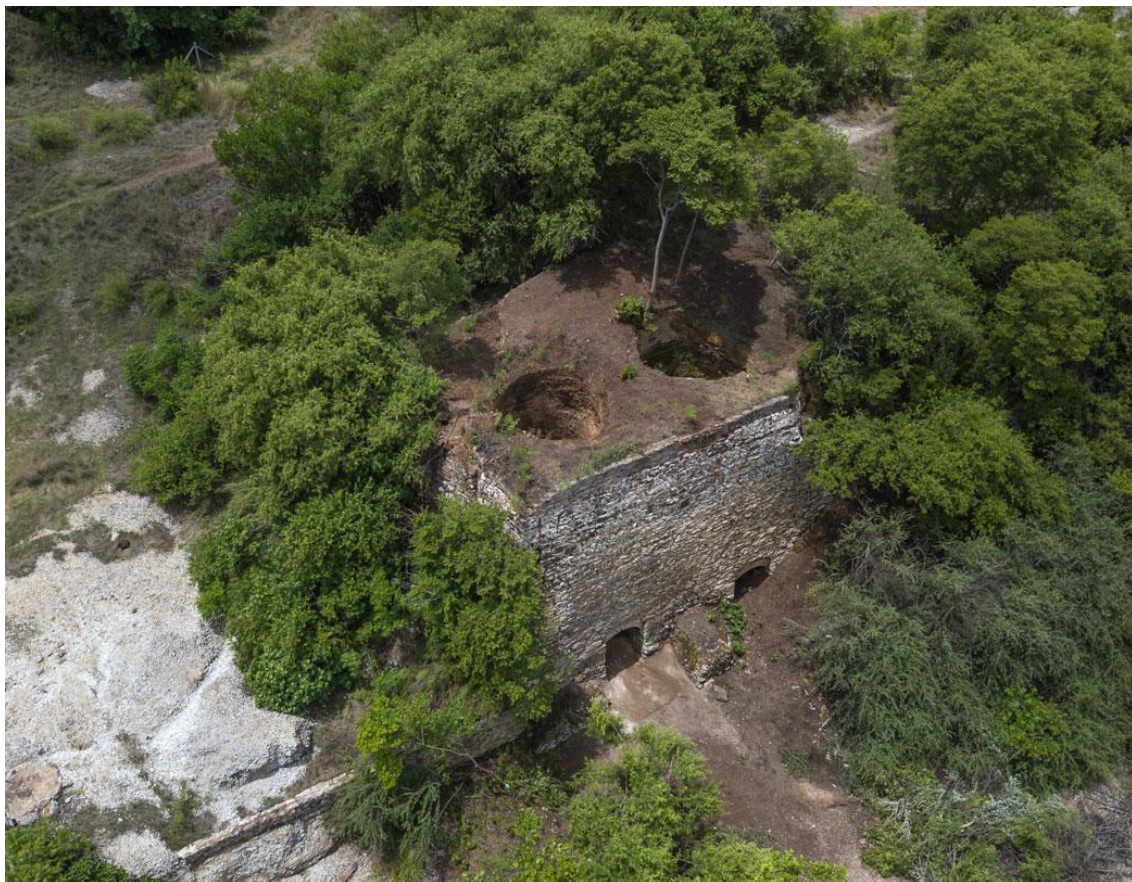
*Figure 18. Oblique aerial photograph of the double kilns.*

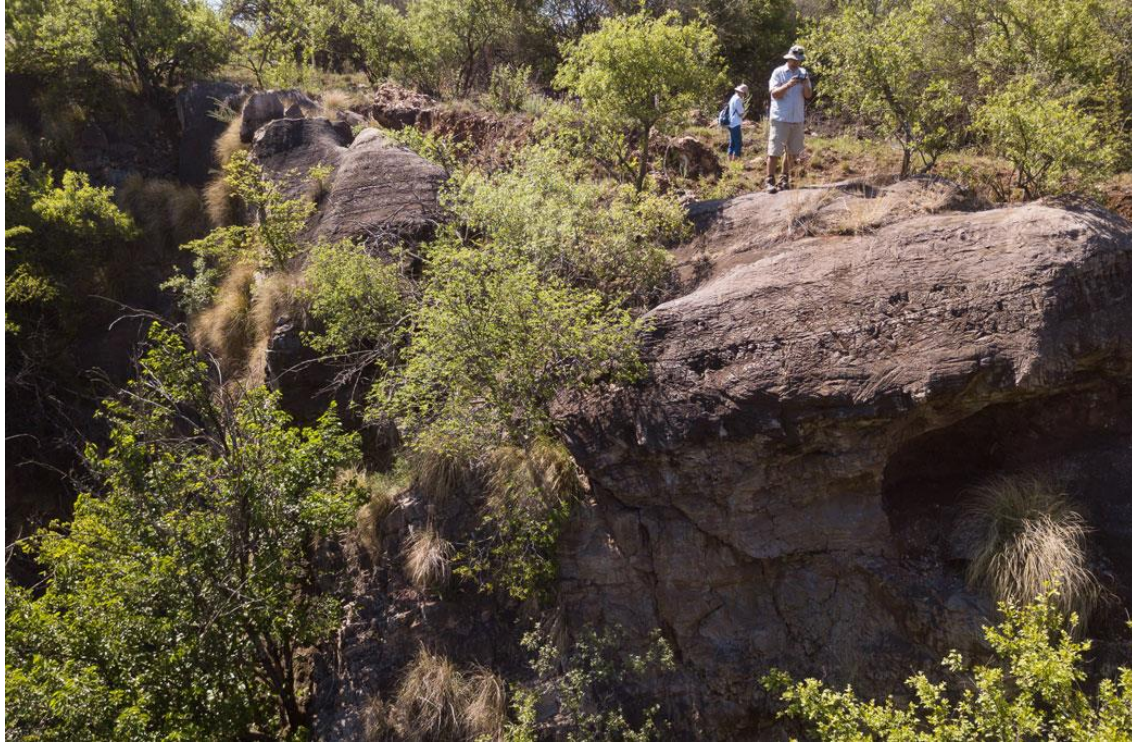
*Figure 19. Metamorphosed primary limestones (light grey) overlaid by dolomites with characteristic elephant skin weathering (dark grey).*

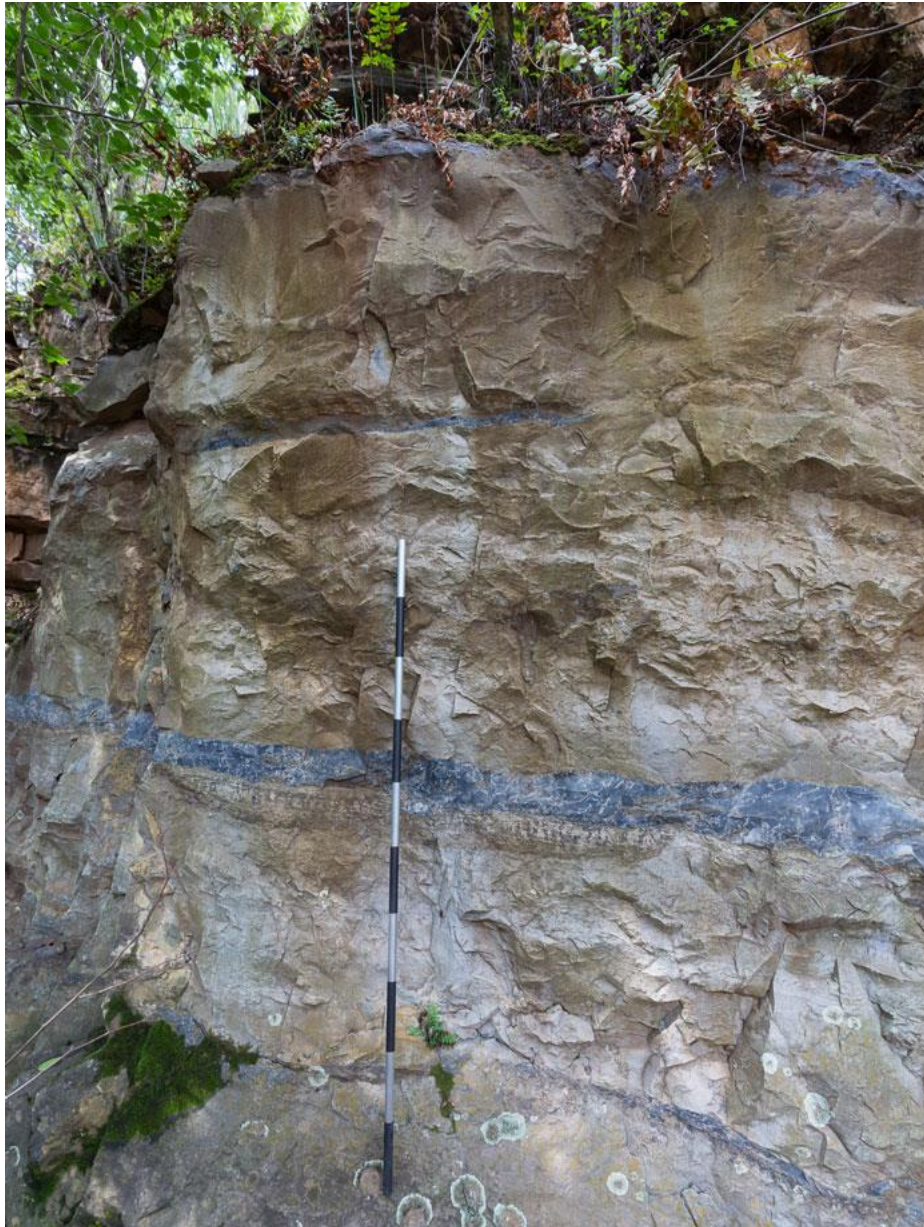
*Figure 20. Vertical wall of limestone in an area of the quarry mined pre-1936. Also note the horizontal chert layers. The spall marks are indicative of hand mining by hammer and chisel.*

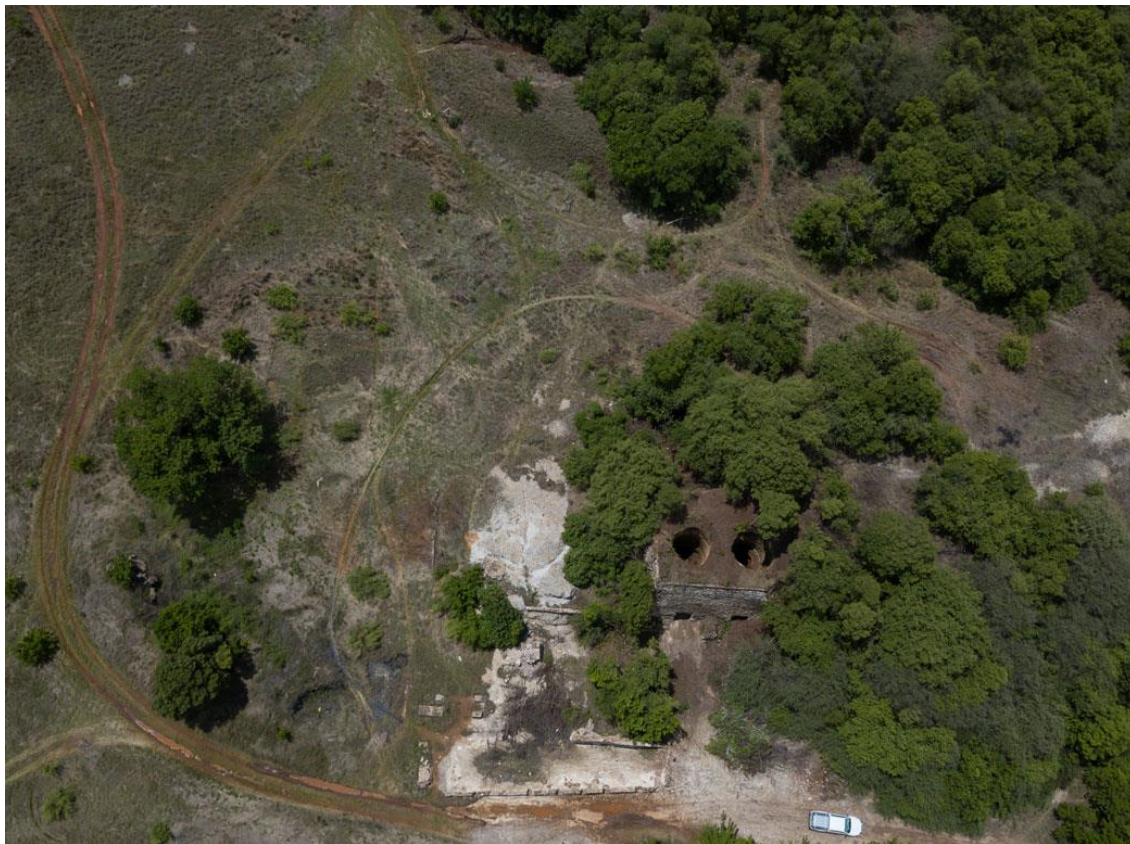
*Figure 21. Remains of the kilns and production area showing the remains of several structures, walls, discard piles and building foundations (scale: vehicle length 5 m).*

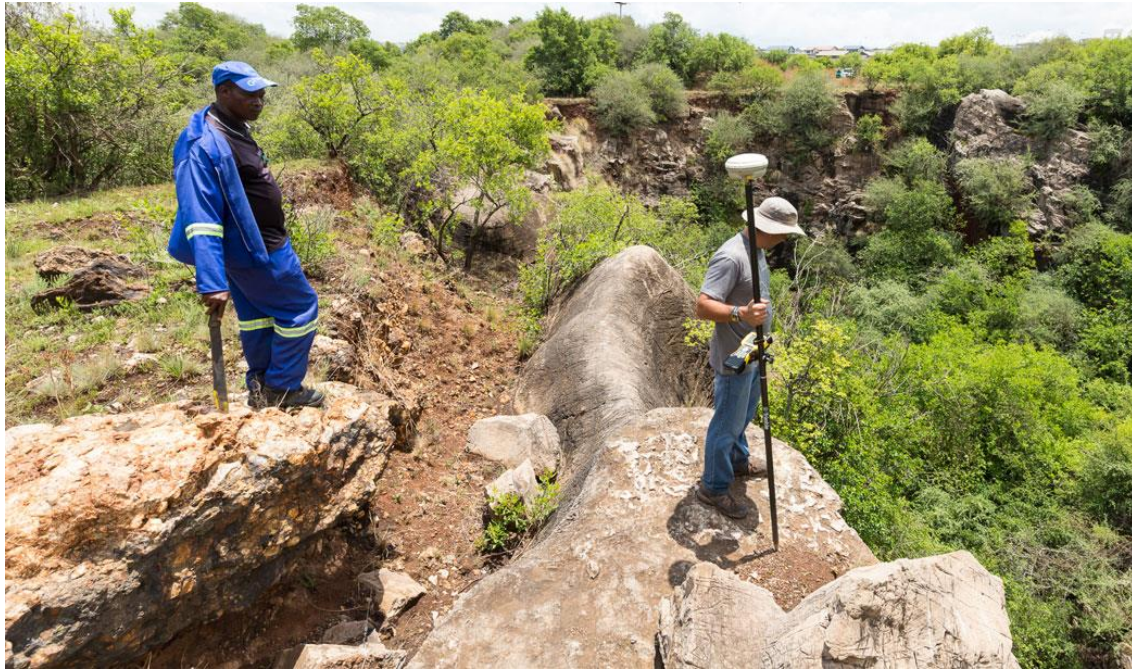
*Figure 22. Area where overburden has been excavated behind a large dolomite boulder on the edge of the quarry.*

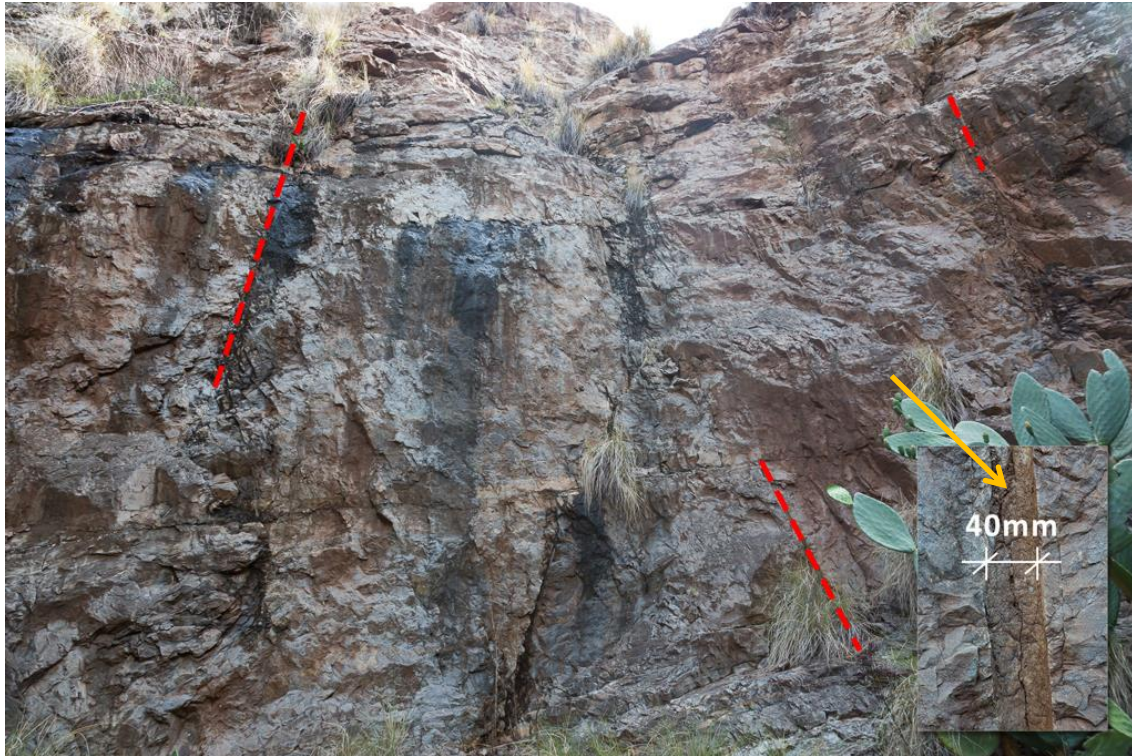
In some sections of the quarry that pre-date the 1936 aerial photograph, it appears that extraction was by hand as no evidence of drilling could be found. The spalling marks visible on the vertical rock faces are typical of hammer- and chisel-based quarrying. Throughout the quarry the limestones have been fractured and broken by metamorphic processes and are eminently suitable for this type of extraction. In some of the later quarry sections drill scars are present that indicate the use of pneumatic drills and jack hammers. This is especially the case on the western-most wall of the largest quarry (No. 3).

*Figure 23. Drill marks on a vertical wall of a quarry. Also see insert showing scar width.*

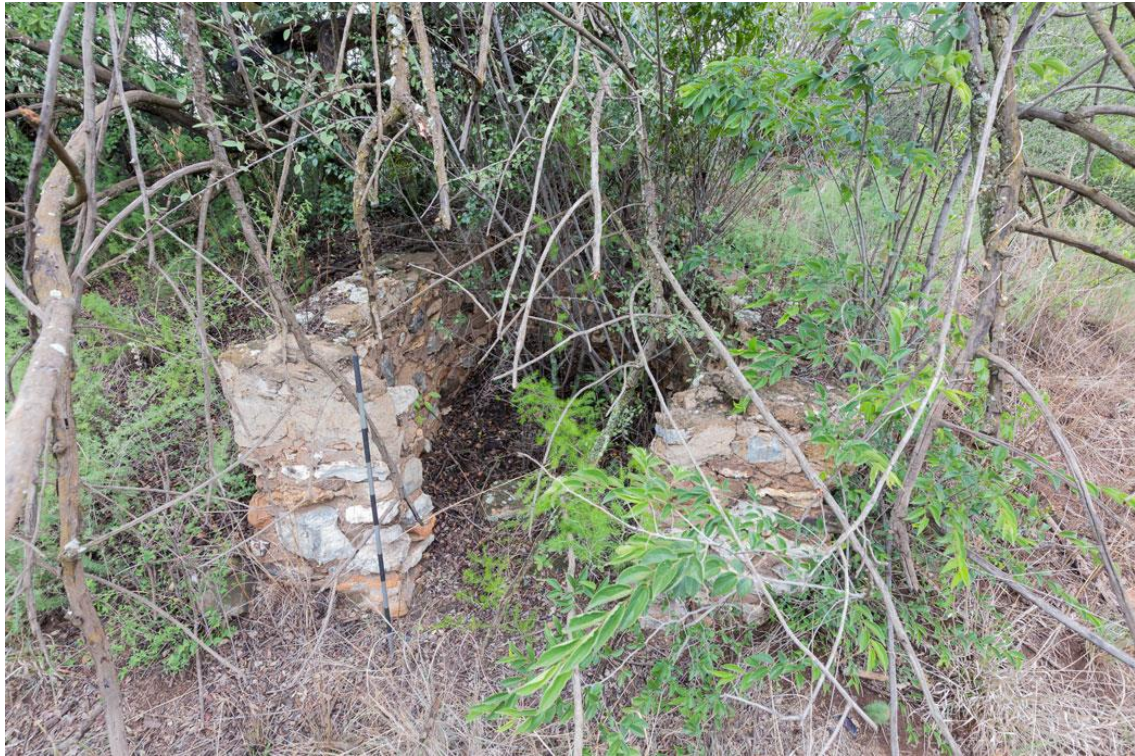
Holes were drilled into the limestone and the stone was broken with the use of explosives. Some evidence of localised explosives holding areas remains along the northern edge of the quarry. These are normally 2 m x 3 m in size surrounded by a 1 m high wall and enclosed by a soil embankment to direct accidental blasts upwards. These are typical short-term holding areas designed to store only the daily charges.

*Figure 24. Remains of an explosives-holding area along the northern edge of the quarry.*

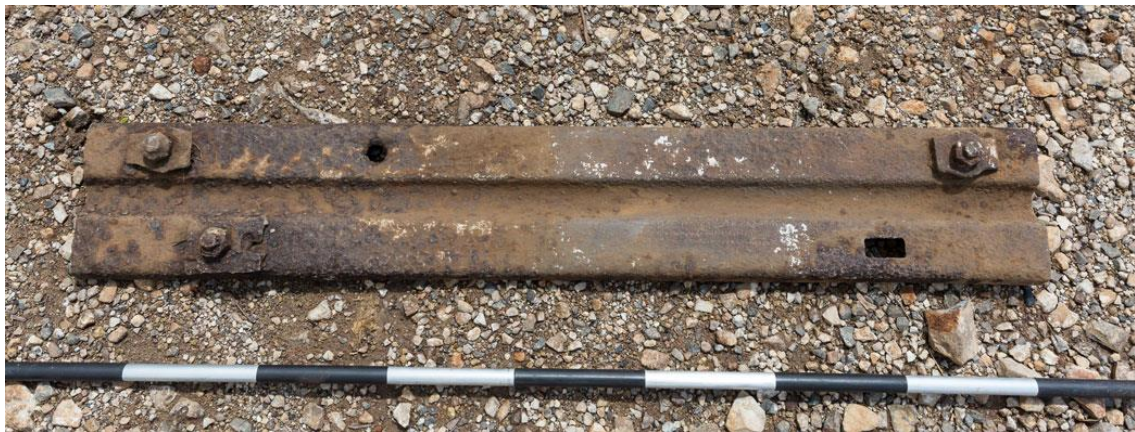
At each of the quarries the quarried limestone was transported to the crushing area and kilns by means of an inclined stope. In all likelihood a narrow gauge cocopan rail was constructed between the mining area and the crushing plant. This was the typical method employed during this era. During the field survey a single steel sleeper was observed on site.

*Figure 25. Detail of the steel rail sleeper measuring 773 mm x 123 mm. Gauge width 600 mm, weight 3.740 kg. Note the white lime residue on the steel sleeper. The residue is present on both sides.*

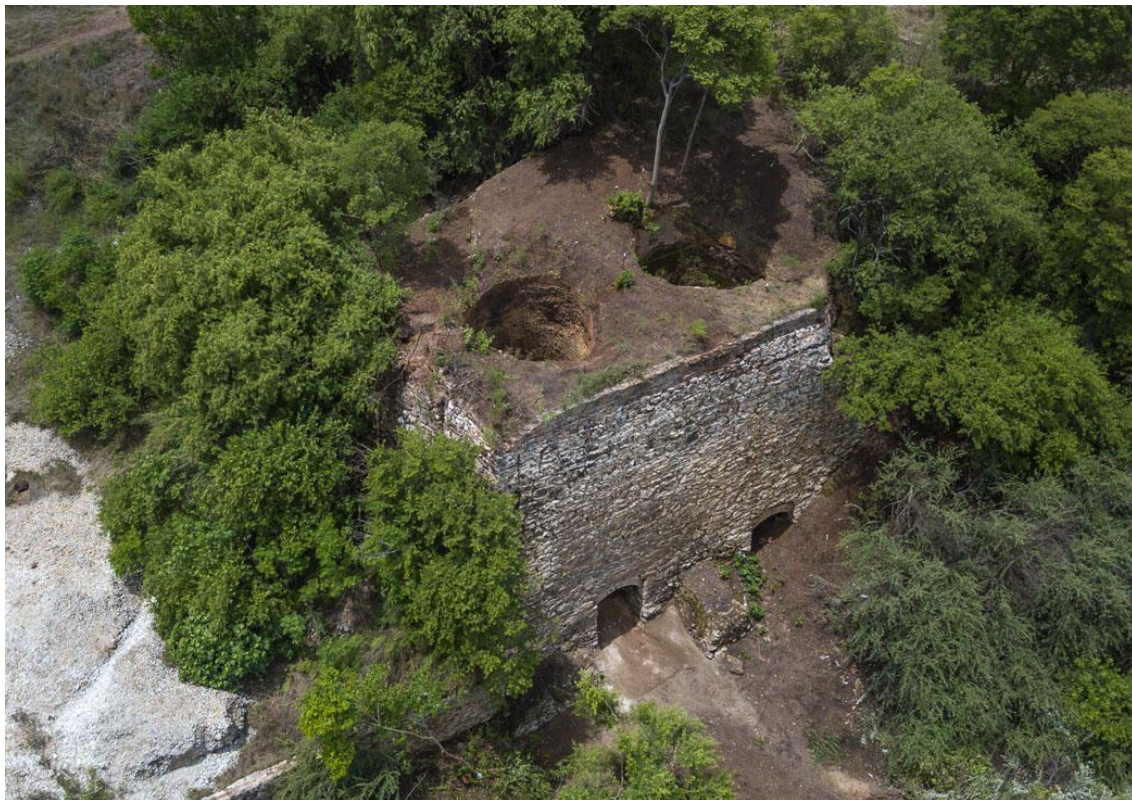
*Figure 28. The kilns viewed from the southeast. The eastern wall is the most stable and intact while the southern wall (concealed by trees) had partially collapsed and was repaired at some stage.*

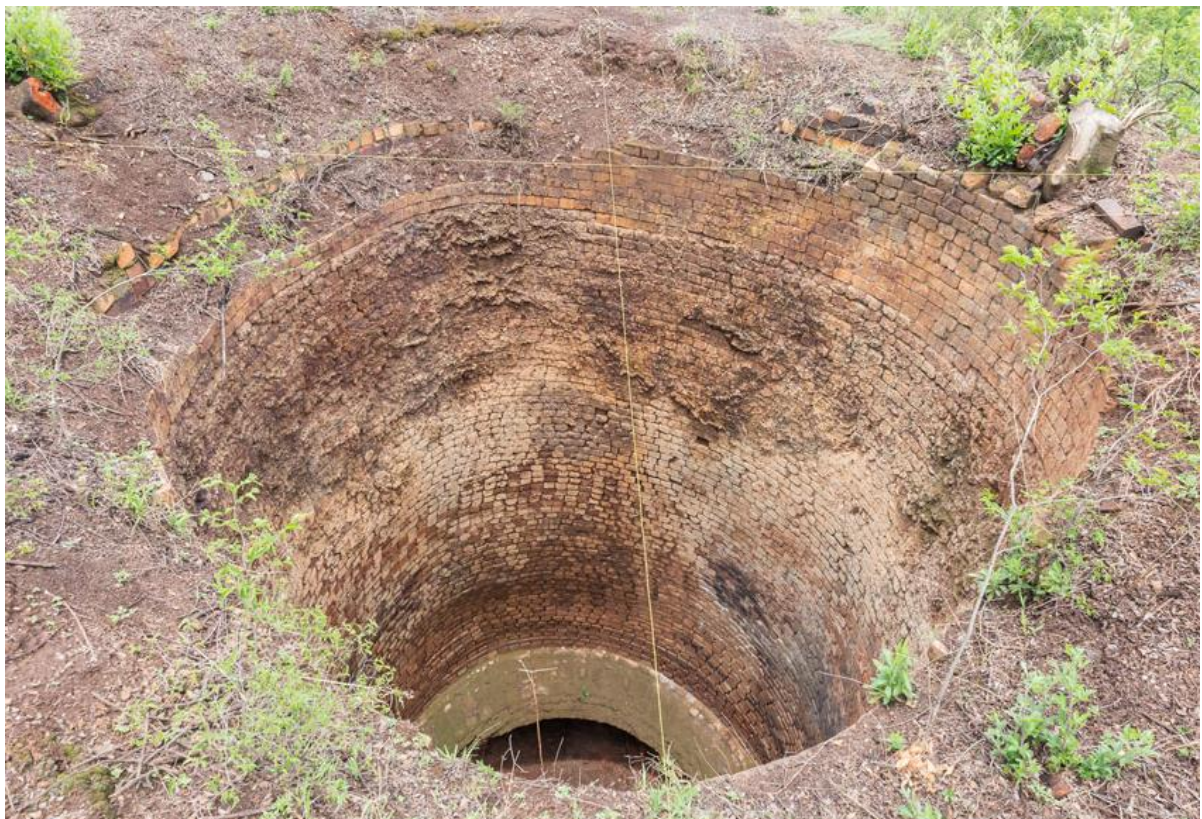
The distinctive maker marks stamped on the fire bricks from inside the kilns provide the most reliable evidence for dating the kilns. During the life cycle of the kiln and the burning process the fire brick lining gets damaged and needs to be replaced. There is strong evidence for the repeated replacement of the lining both inside the kilns and in the waste or discard piles around the kilns. The firebricks in the top two thirds of the kilns are the most prone to fire damage and need to be replaced periodically.

*Figure 30. Top view of the southernmost kiln. Note the double brick lining of the kiln and the extensive damage to the brick lining caused by the firing of the kiln. Most of the*

*undamaged bricks in the top layer are replacement bricks.*

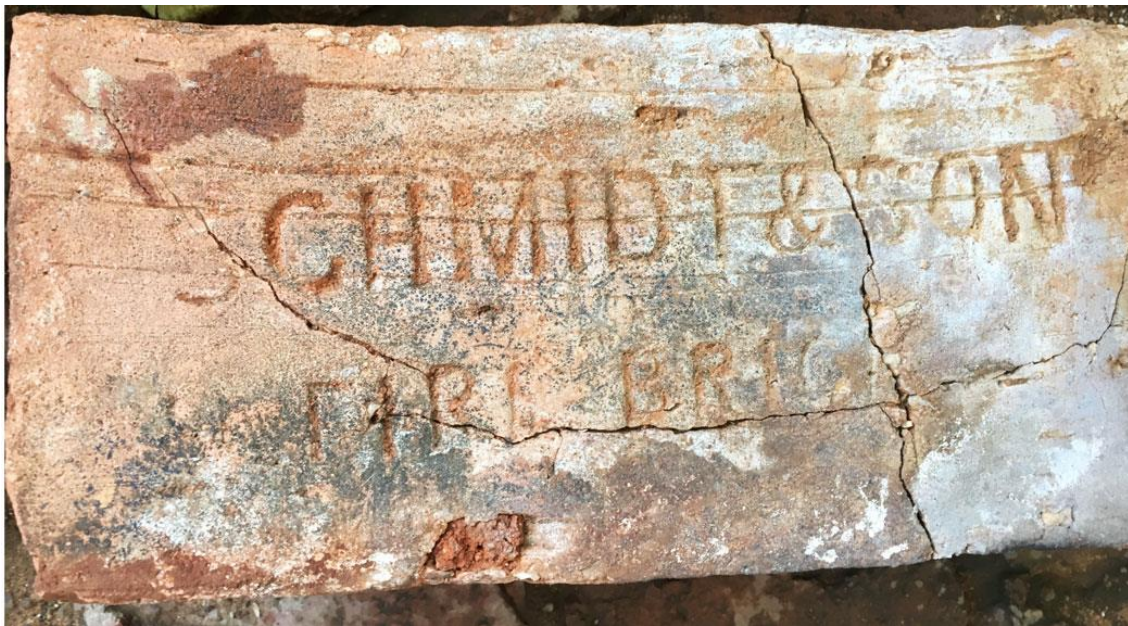
*Figure 32. A brick produced by Schmidt & Son Fire Brick Co. that likely dates to the 1890s. Note the horizontal extrusion marks and also warping of the brick.*

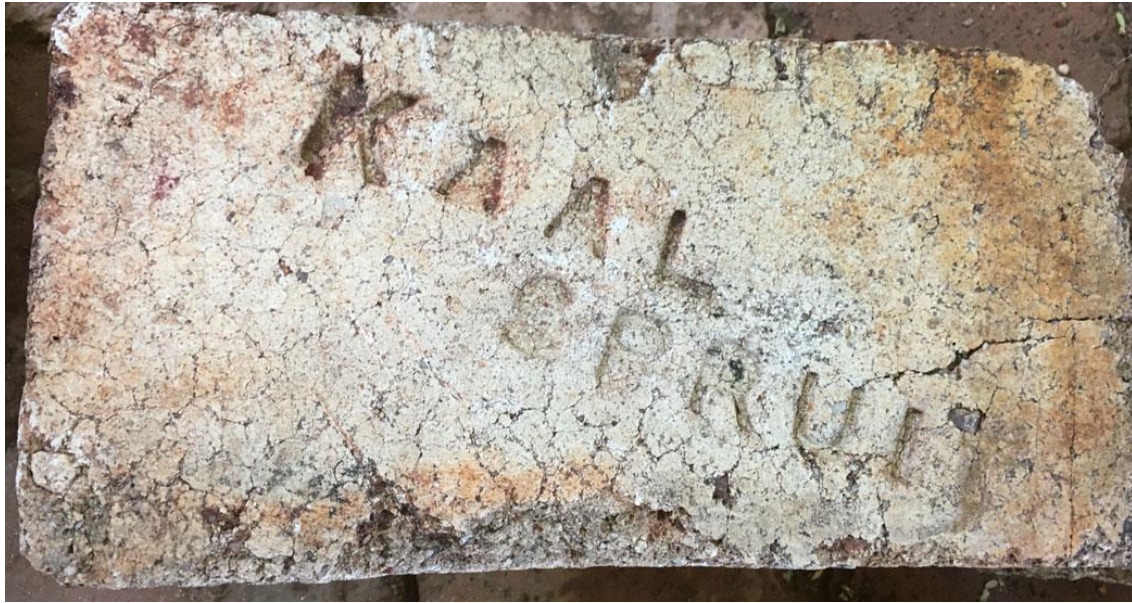
The Kaal Spruit bricks were manufactured with clay extracted from the Olifantsfontein quarries at a brick plant founded by Holmes in 1896, known as the Kaal Spruit Fire Brick Company. Similar to the Schmidt & Son brick, the Kaal Spruit brick is also an extruded brick but with less warping evident. The application of the makers mark is also much more consistent. The Kaal Spruit bricks are the main bricks used in the bottom interior lining of the kilns, thereby confirming the construction of the kilns after 1896.

*Figure 33. Kaal Spruit brick manufactured between 1896 and 1902. Although extrusion marks are not clear the warping and cracking of the brick allude to the manufacturing process.*

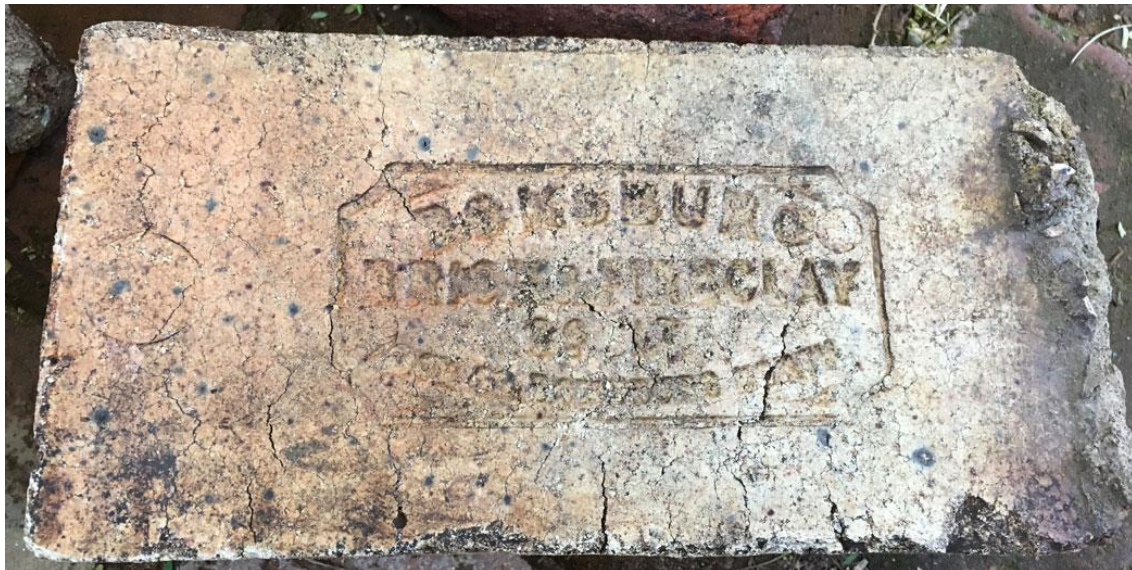
The third brick present in the kiln interior is a pressed brick type manufactured by Cullinan's Rand Brick and Tile Company based in Boksburg. Only a limited number of these were observed in and around the kilns. These bricks were produced from around 1896 up to 1906.

*Figure 34. A clay brick from Cullinan's 1896 company*

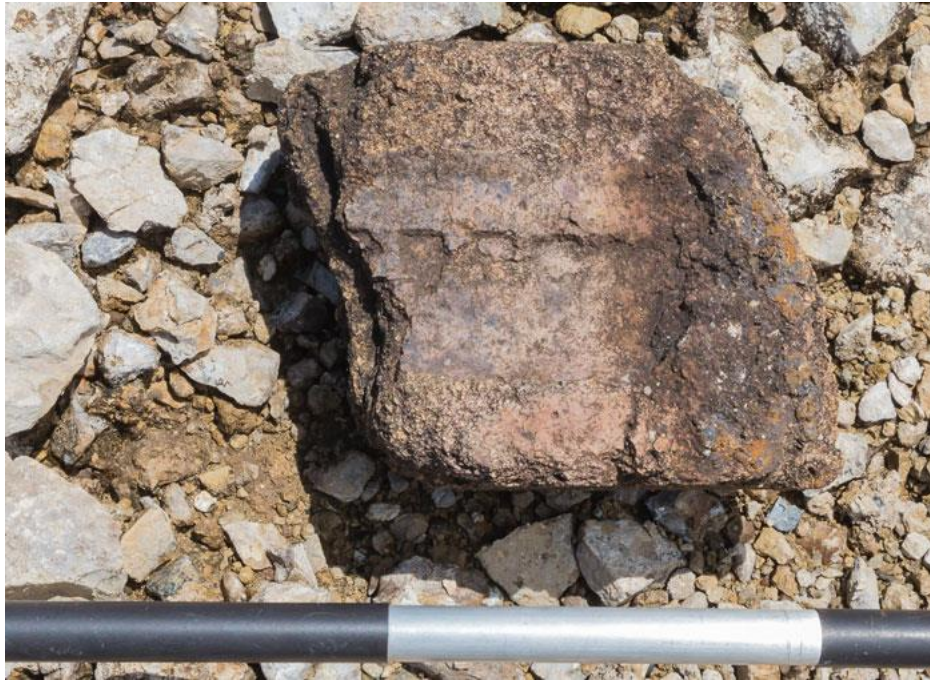
*Figure 35. Example of the CRBP & L Co. Ltd mark within the frog of a brick manufactured by the Consolidated Rand Brick, Pottery and Lime Company founded 1902. This brick is from the waste stockpile to the east of the water furrow.*

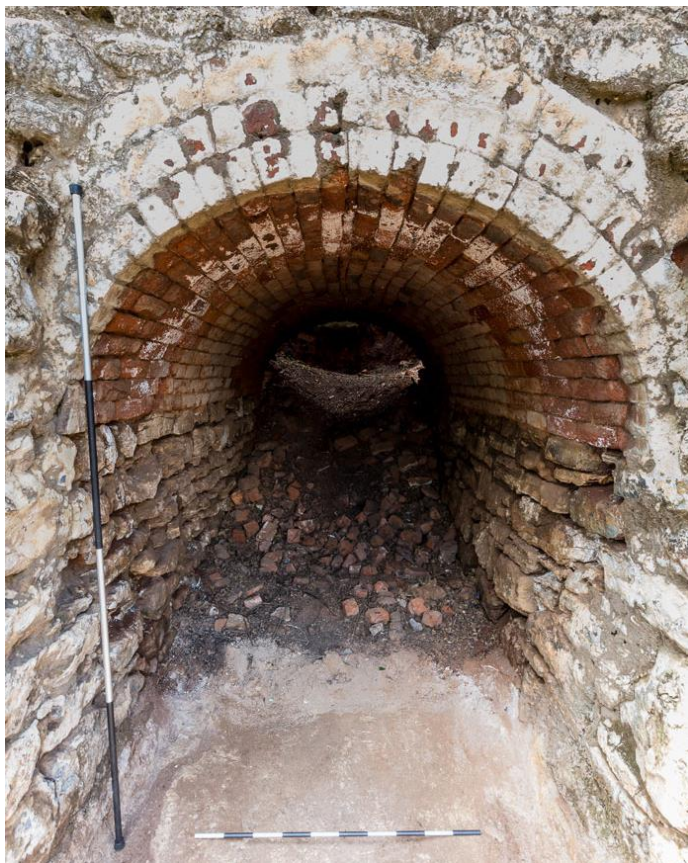
Figure 37. Detail of the kiln entrance showing the rock and brick construction. Note the lime floor and debris that have accumulated in the interior of the kiln. The scale on the ranging rod on the left is demarcated in 500 mm sections with a total length of 2000 mm.

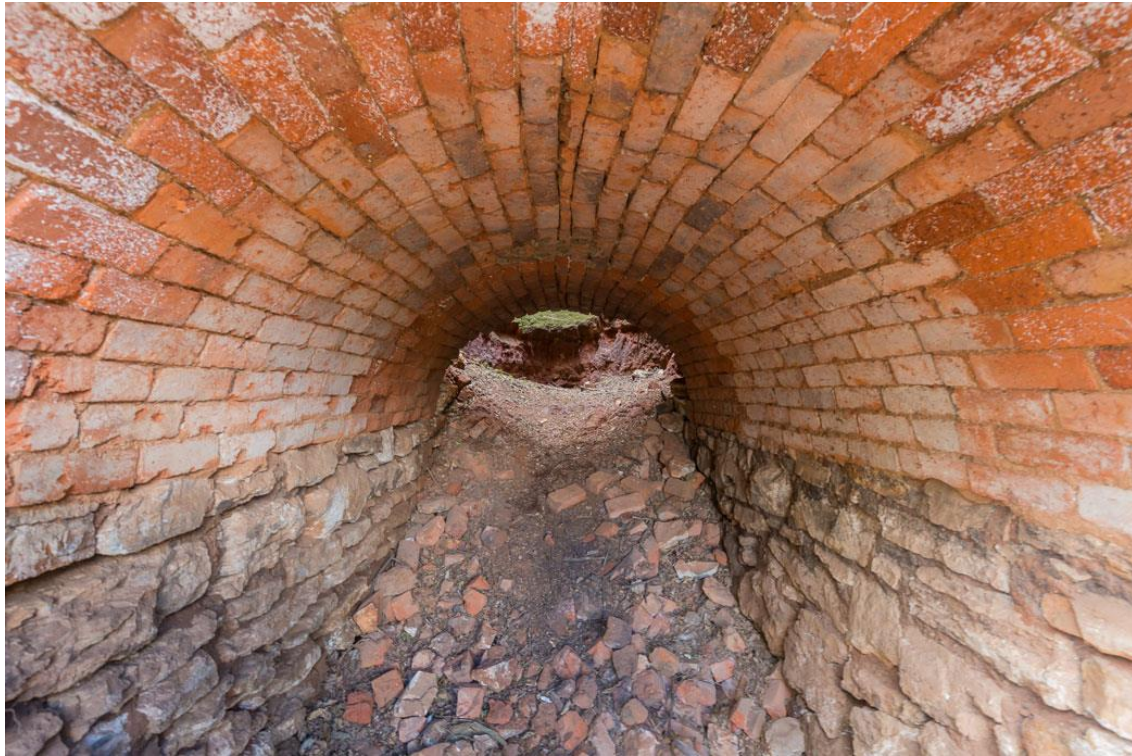
*Figure 38. Interior view of the draw hole. Note how the bricks in the top of the arch were cut as key stones.*

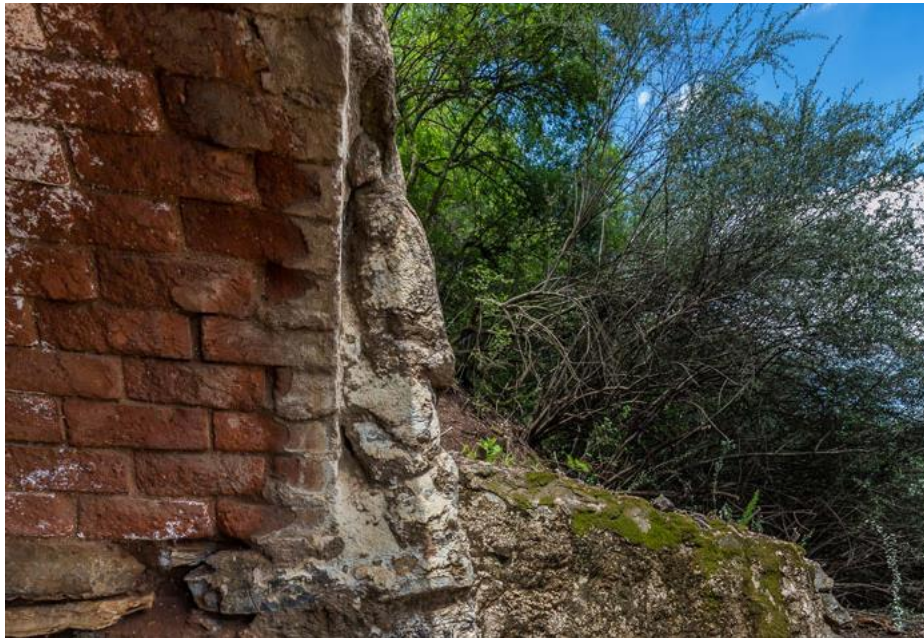
*Figure 39. Detail of the exterior stone cladding and brick vault joint.*

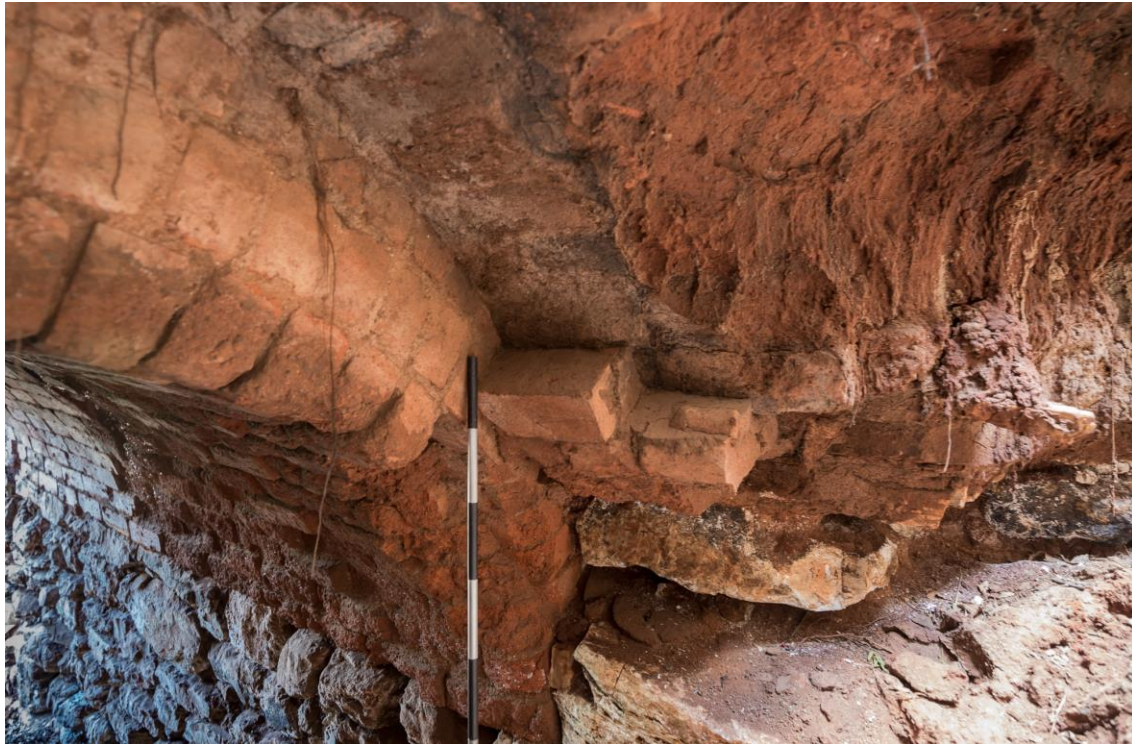
*Figure 40. Detail of the joint between the brick vaulting and the kiln base. Note the erosion of the low quality bricks and the frog imprint.*

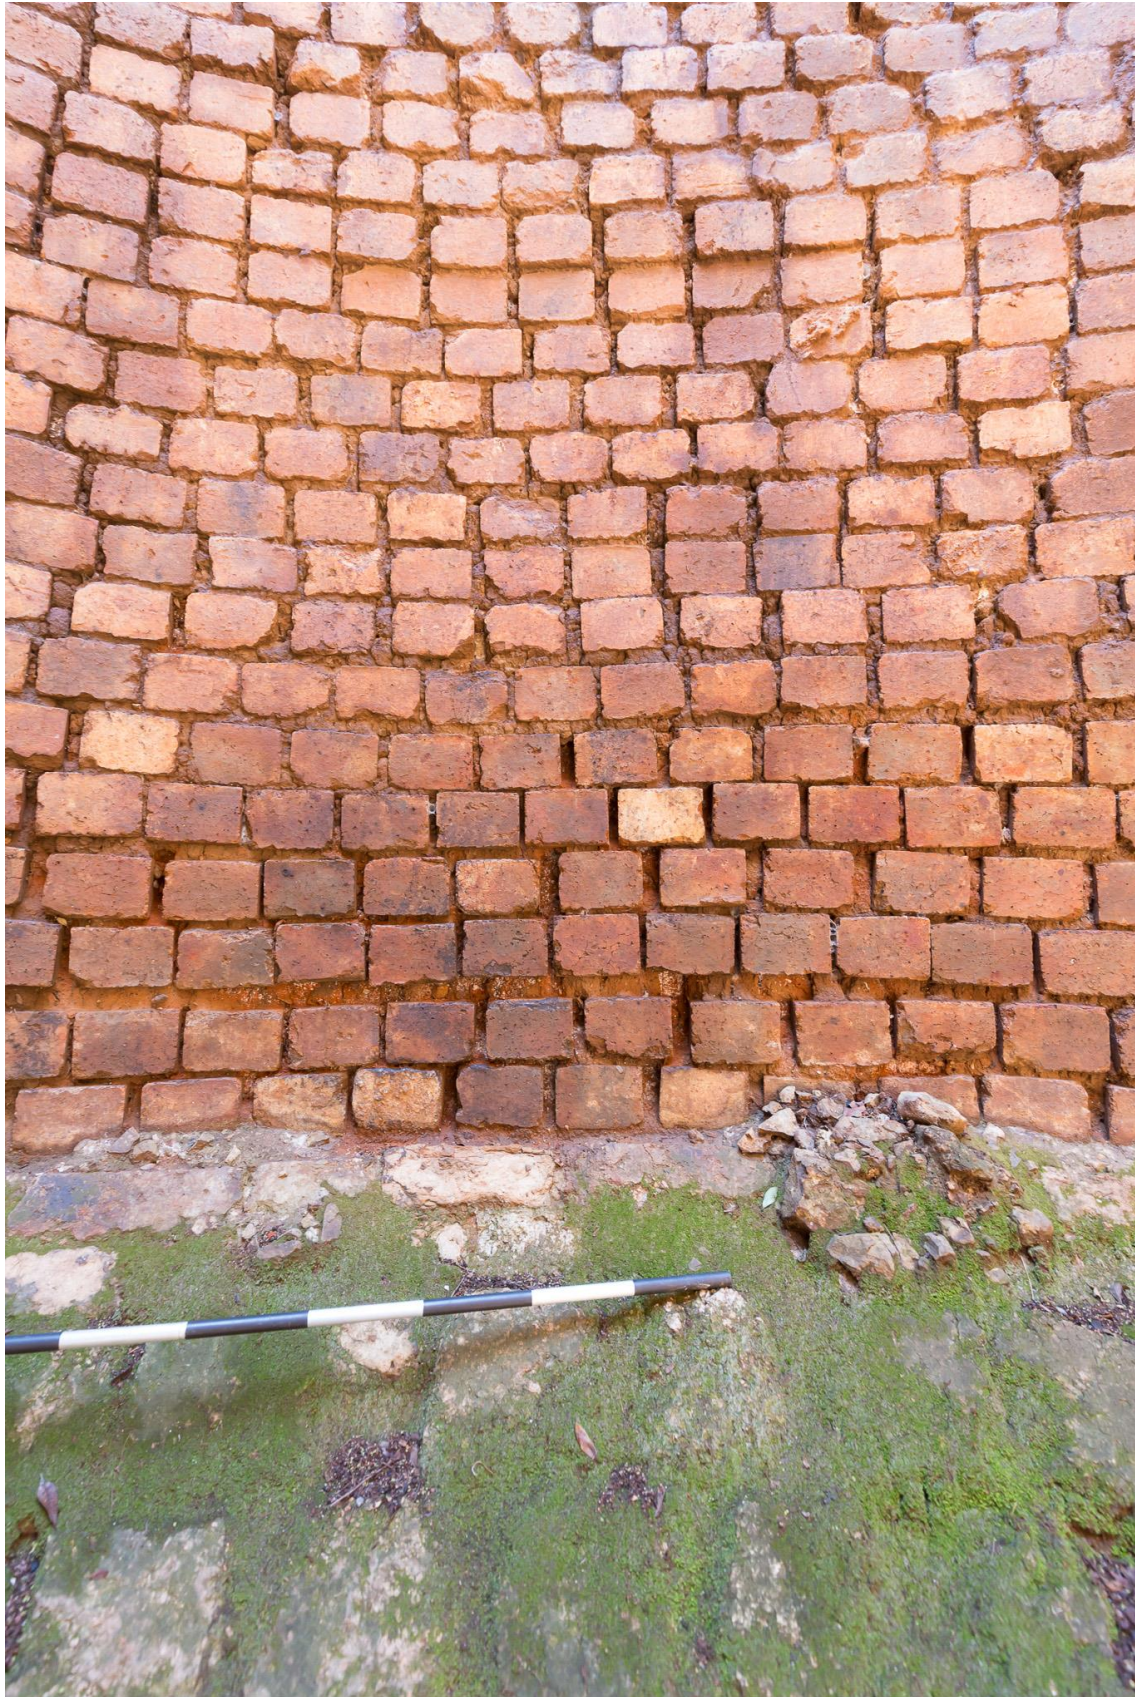
*Figure 41. Detail of the joint between the vertical kiln lining and the kiln base. Note the few lumps of unburnt limestone that remain on the kiln base.*

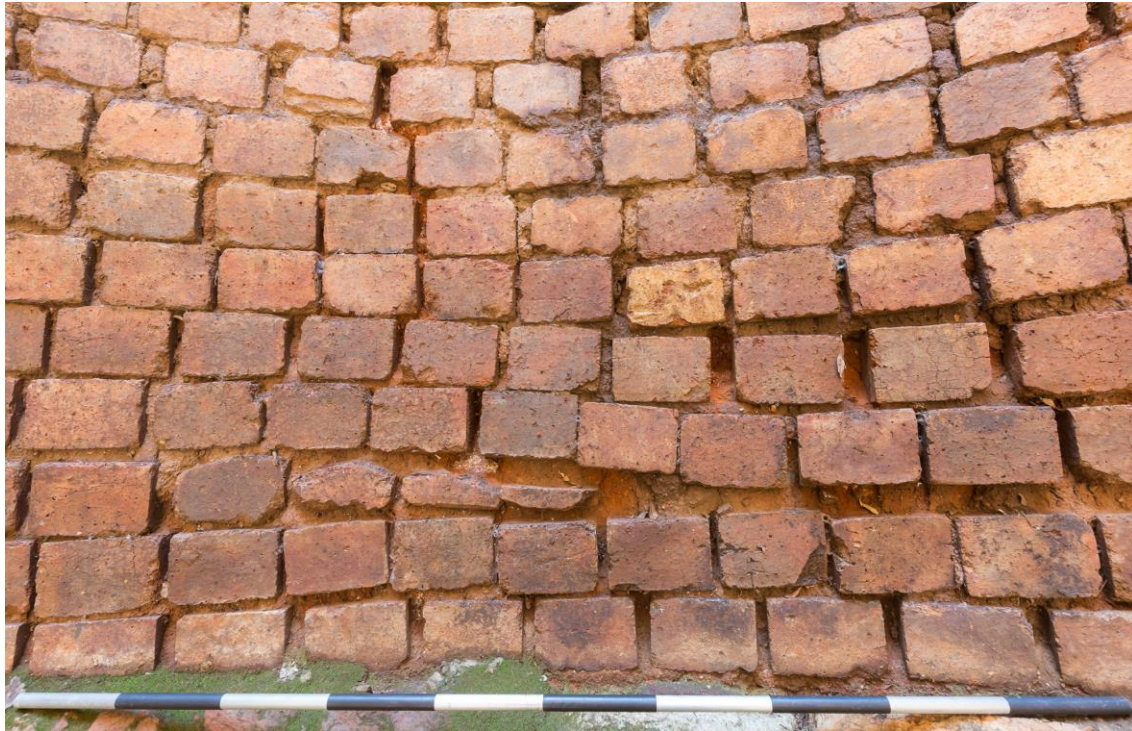
*Figure 42. Detail of the brick coursing of the vertical lining of the kiln.*

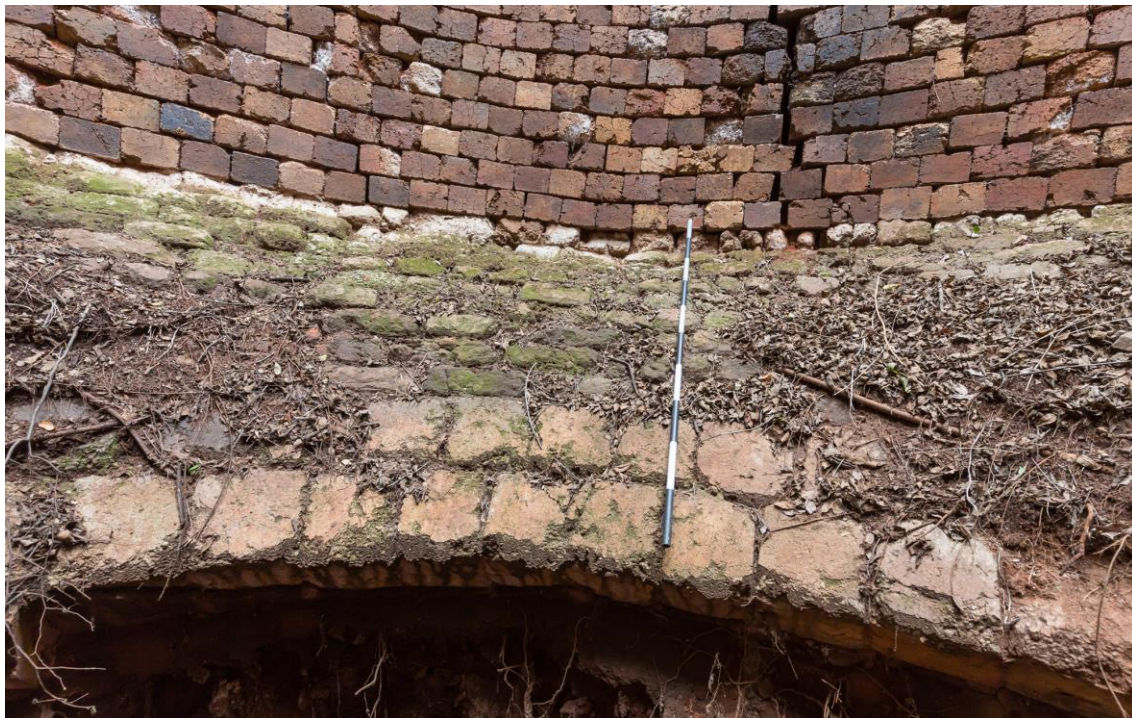
*Figure 43. Detail of the firebrick used at the centre of the kiln base. The first few rows were lined with ordinary fire bricks but the fire-bricks in the last two rows have different dimensions. The bricks are 160 x 140 x 200 mm in size.*

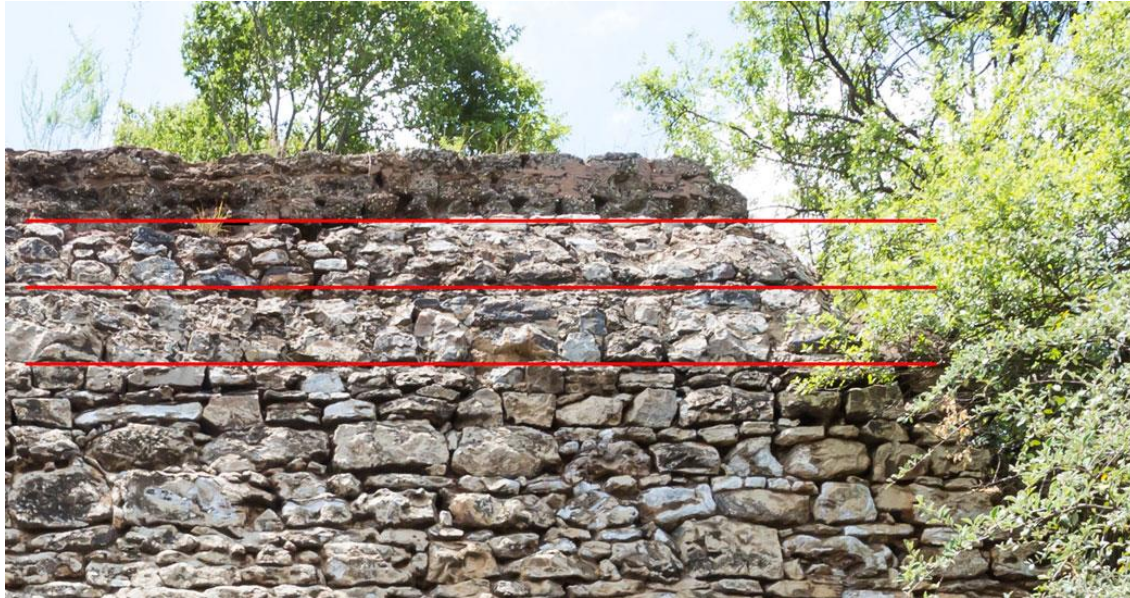
*Figure 44. Consecutive raising of the kiln height. Note the original stonework quality versus the two later additions and the lime bricks at the top.*
