**PHASE TWO ARCHAEOLOGICAL ASSESSMENT:  
THE REMAINDER OF PORTION 46 OF THE FARM  
OLIFANTSFONTEIN 410 JR  
CENTURION GAUTENG PROVINCE**

January 2018

**AFRICAN HERITAGE CONSULTANTS CC**

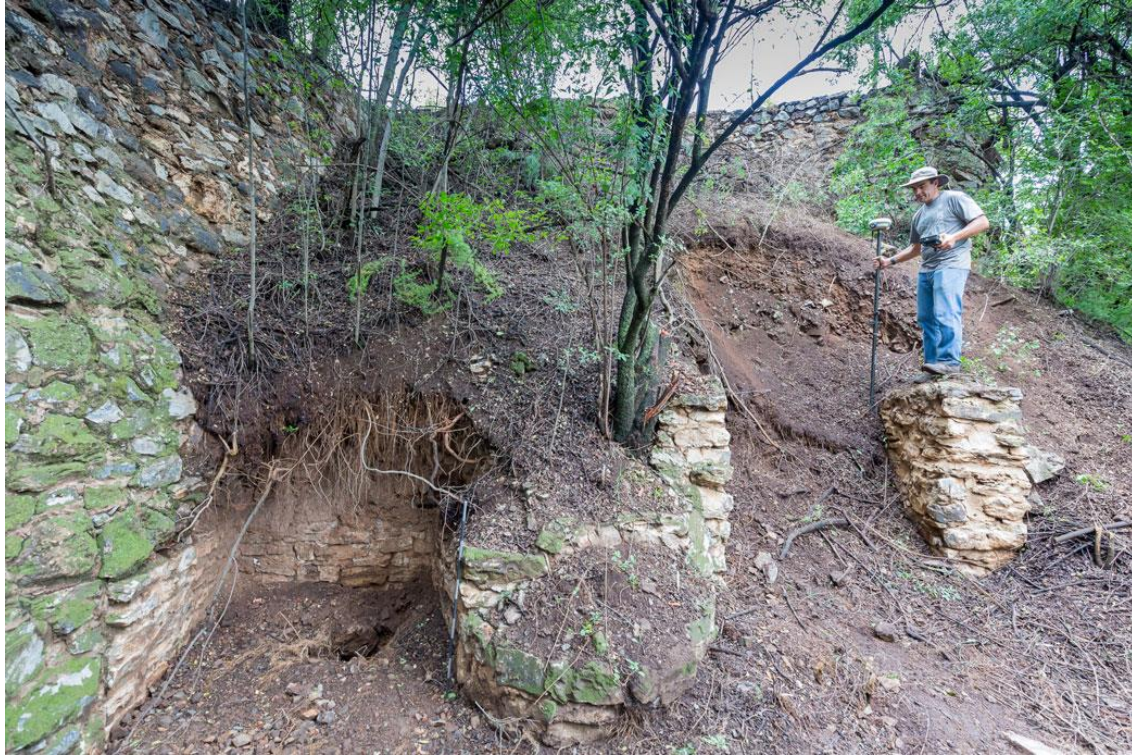
Figure 45. Additional draw holes likely constructed at a later stage.

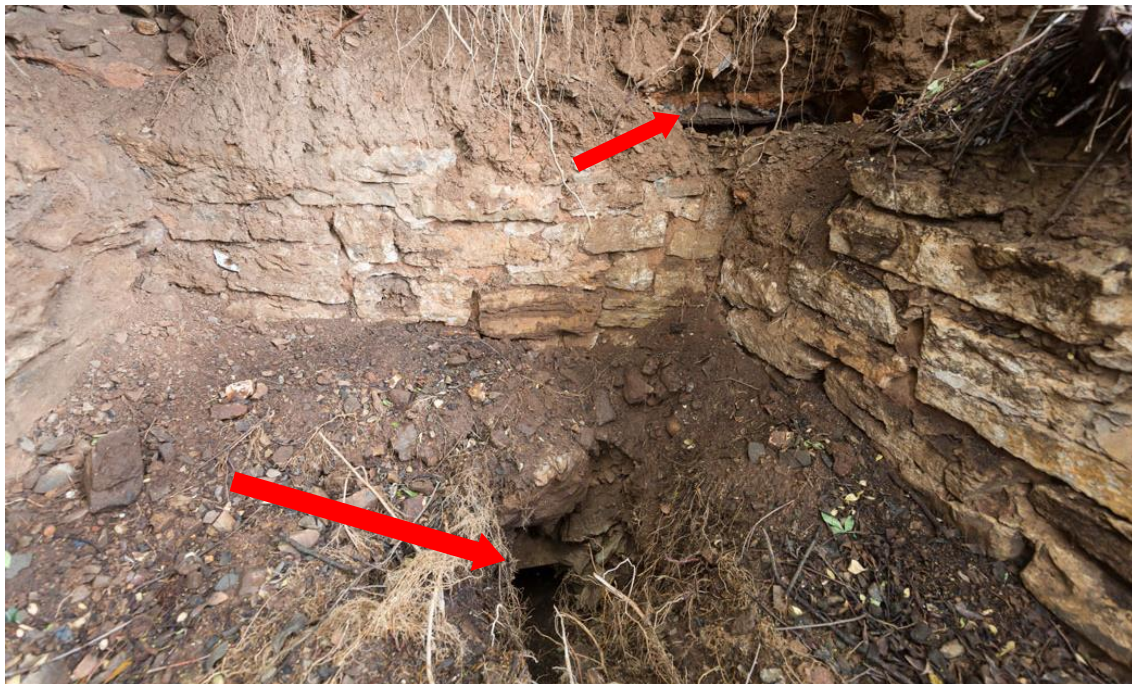
Figure 46. Note the remains of steel railway sleepers in the draw holes.

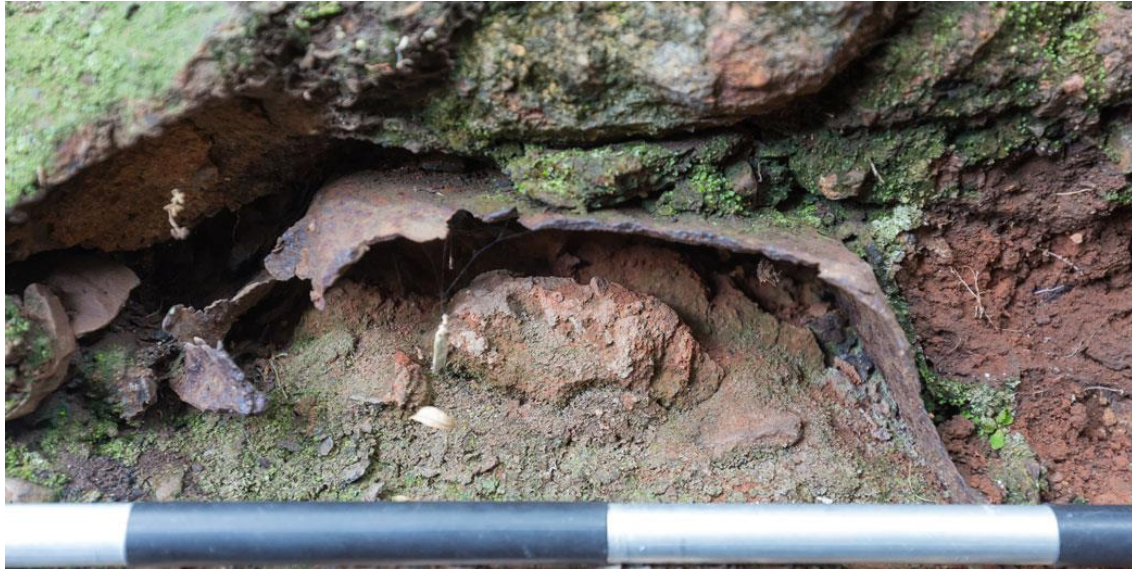
*Figure 47. Remains of a steel railway sleeper used as a lintel.*

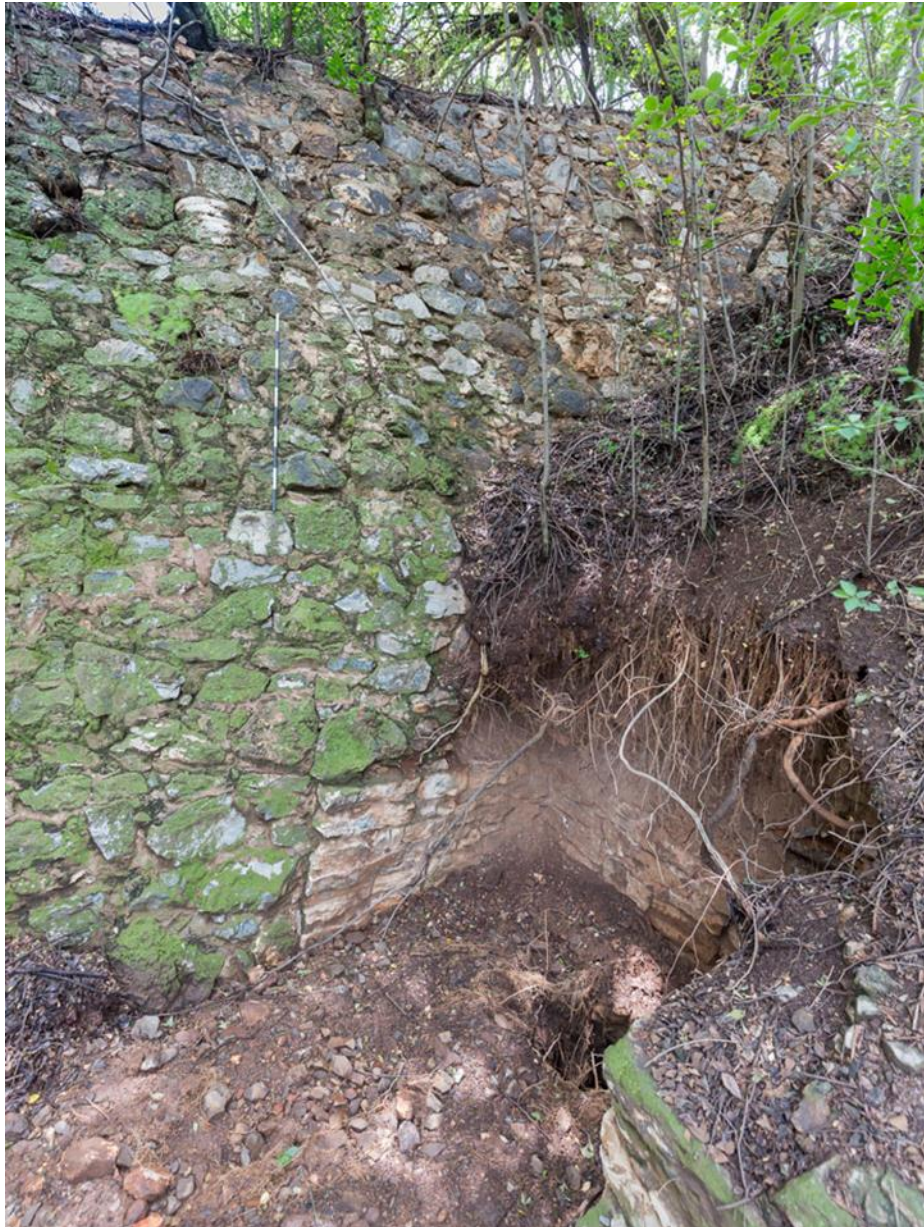
*Figure 48. Retaining ramp constructed over the second draw hole.*

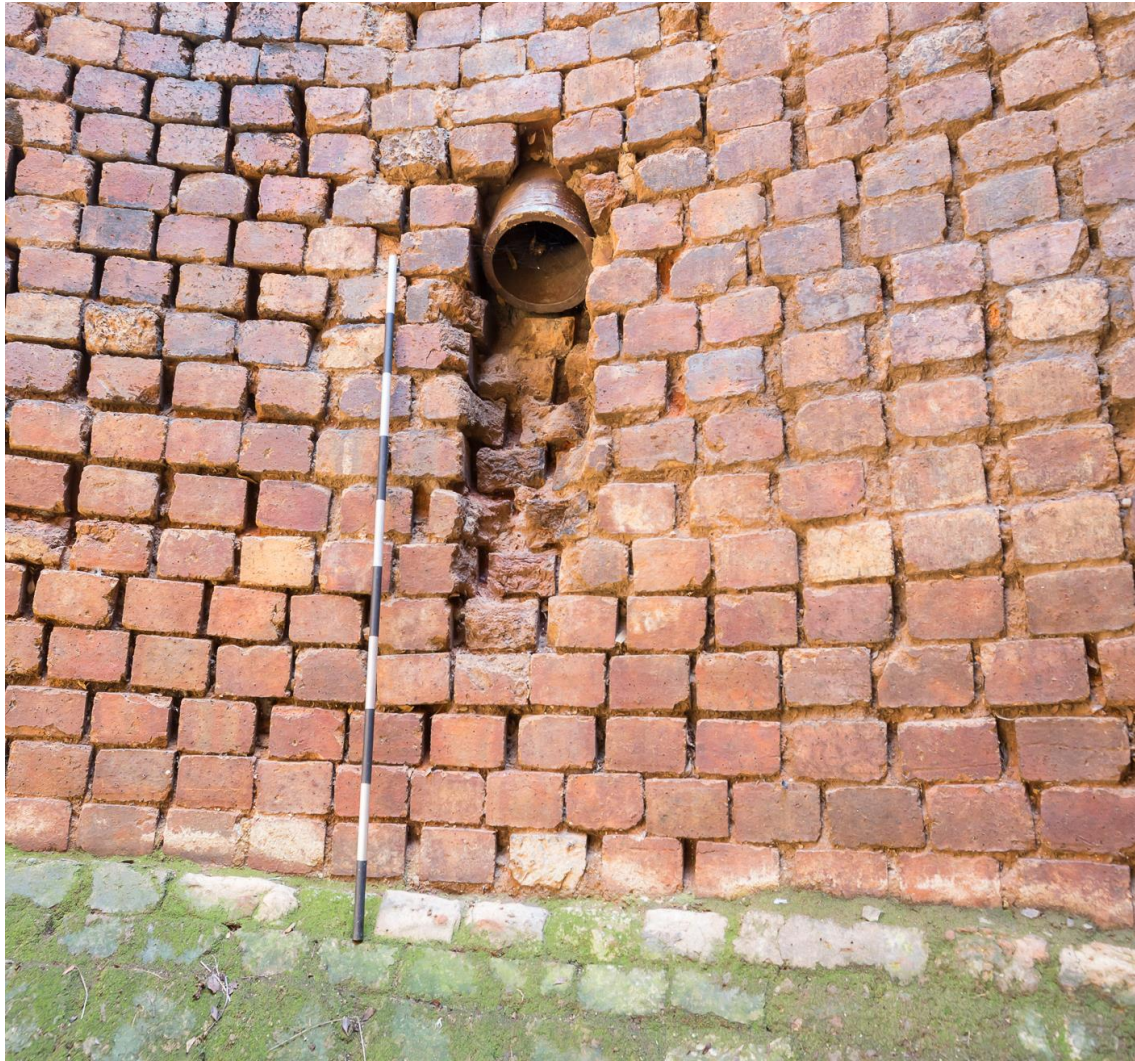
*Figure 49. Modification of the kiln by introduction of a coal chute. There is no vitrification of the brickwork or pipe and it is unlikely that the intervention ever worked.*

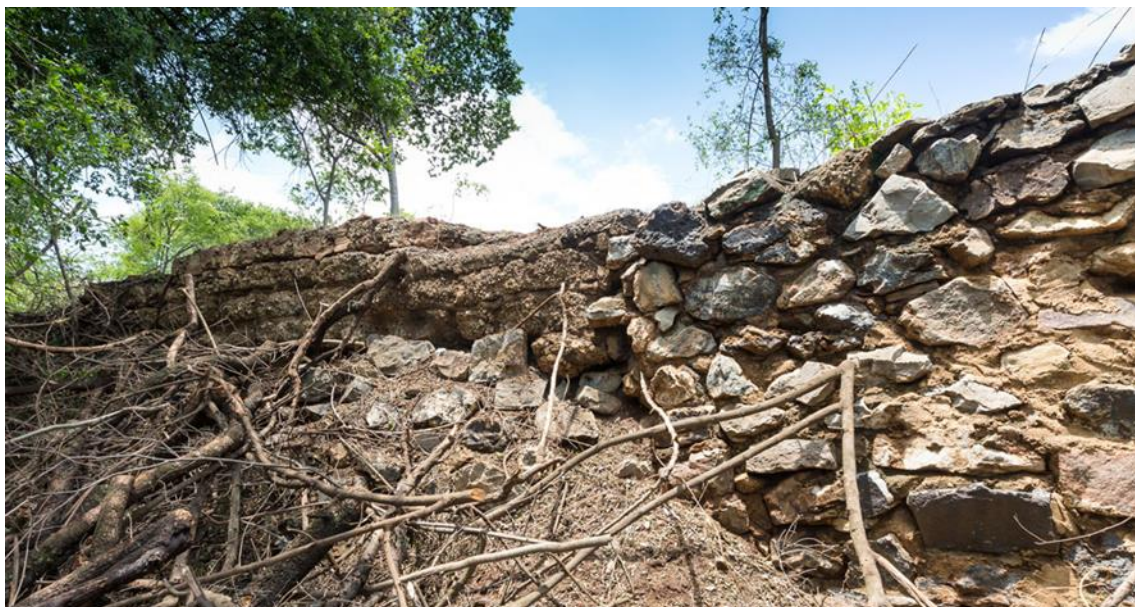
*Figure 50. Note the poor quality walling on the west section of the kiln close to where the coal chute was installed.*

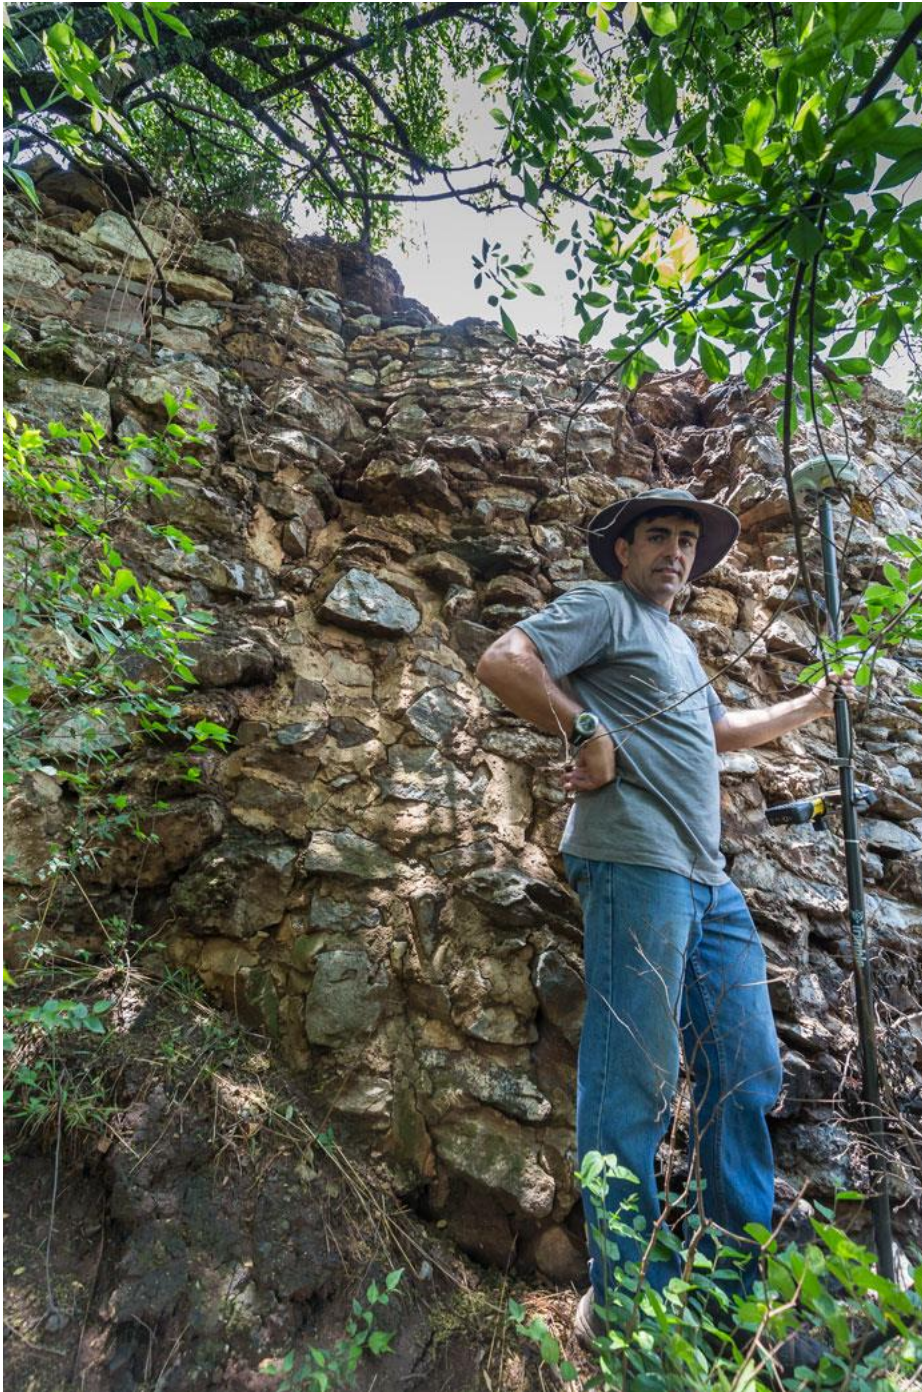
*Figure 51. Due to thermal expansion, distortion and the installation of the coal chute the southern wall of the kiln buckled and broke in several places. Note the large section behind the surveyor that was subsequently repaired.*

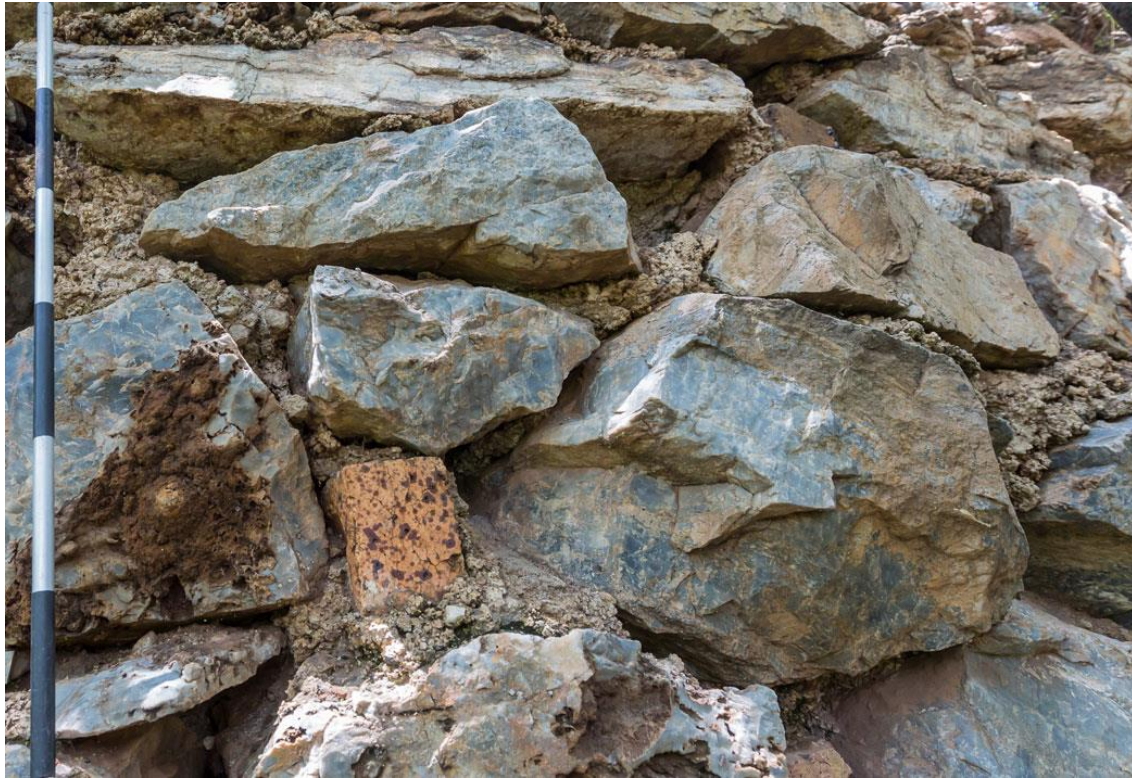
*Figure 52. Another example where repairs were undertaken on the south-western corner of the kiln. Note the Cullinan brick in the wall.*

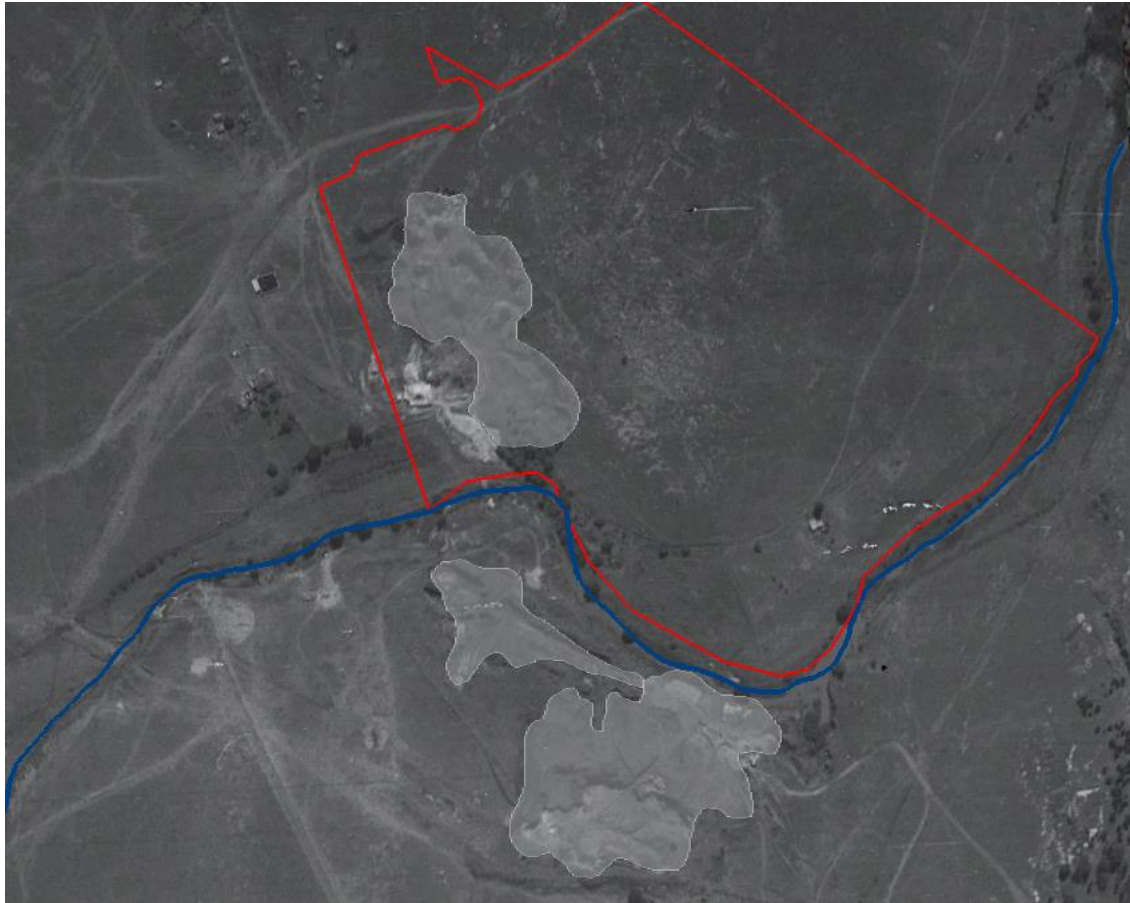
*Figure 53. Historical limestone quarries at Olifantsfontein. The red line demarcates the study area, the blue indicates the Kaalspruit. The aerial image was extracted from the 1937 regional aerial photograph.*

Apart from isolated walls, machine foundations, building outlines and discards piles, very little evidence of the lime processing remains. The study area contains several limestone deposits. Over and above the three quarries on the remainder of Portion 46, an extensive lime quarry was in existence on the eastern side of the Kaalspruit not included in the area of survey. However, it is unclear whether lime burning actually occurred at or around the latter locality as there is currently no evidence for a lime kiln or associated infrastructure in the vicinity of this quarry. The lime extracted from the quarry on the opposite side of the Kaalspruit may have been transported to the existing kilns on Portion 46 for burning. Scrutiny of the 1937 aerial photograph reveals that there is only one area on Olifantsfontein where lime works were present, namely on the remainder of Portion 46 where the extant double kilns are located. The situation of the processing plant in this particular locality may be on account of the availability of water from the furrow since water is critical in the manufacturing of hydrated lime. See figure below.

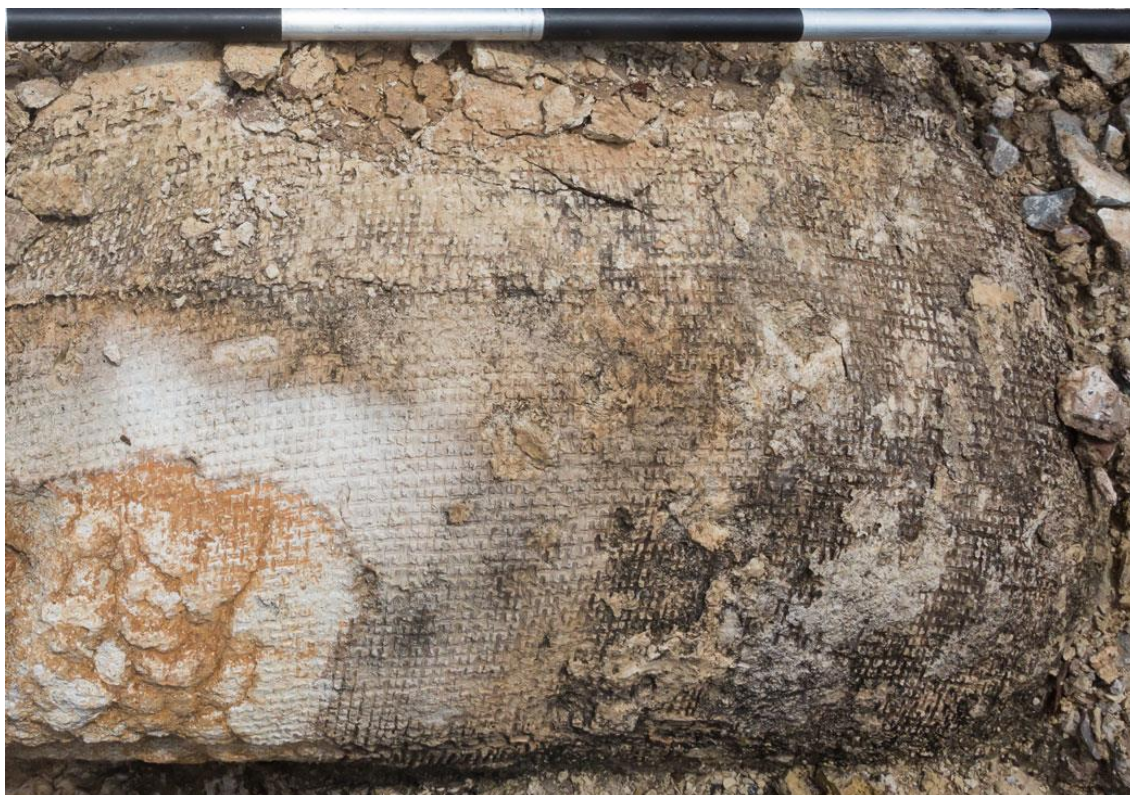
*Figure 54. Imprints left by hessian bags.*

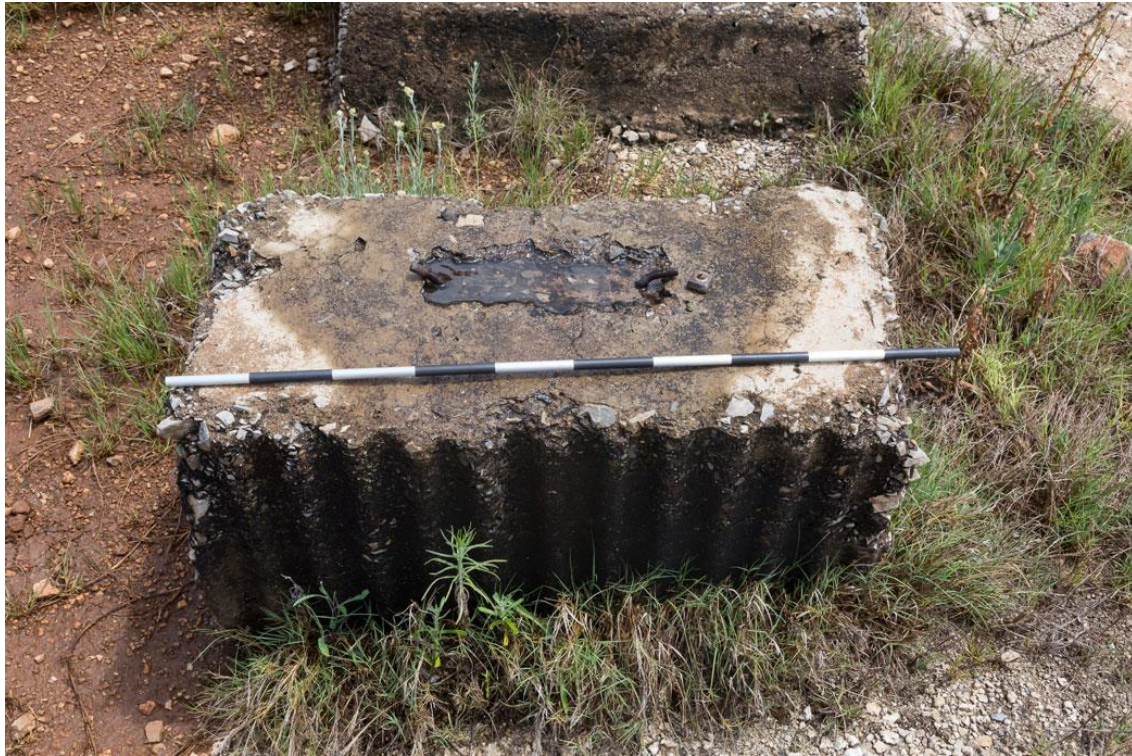
*Figure 55. Remains of a mounting block in plant area.*

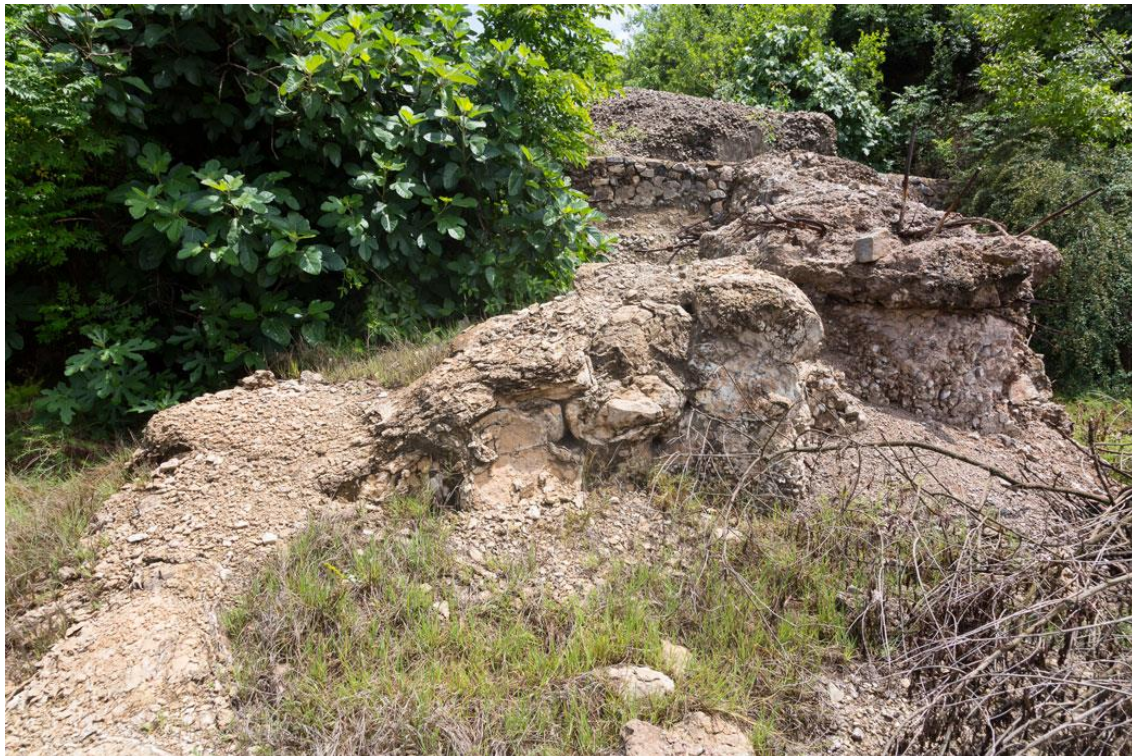
*Figure 56. Unidentified structure in the lime production area. This could have been part of an aerial cable way that connected the quarry on the other side of the river (pers. Comm. D Cullinan).*

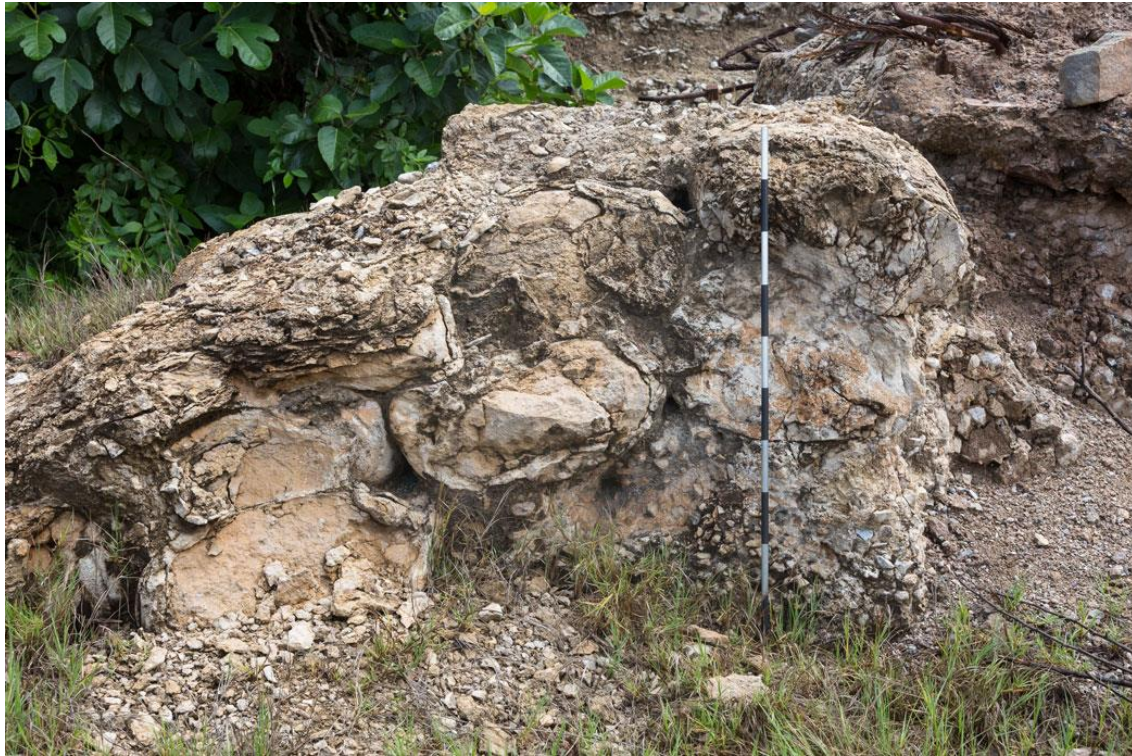
*Figure 57. Ramp-like structure made of lime-filled hessian bags. Note the cables imbedded in the structure on the right.*

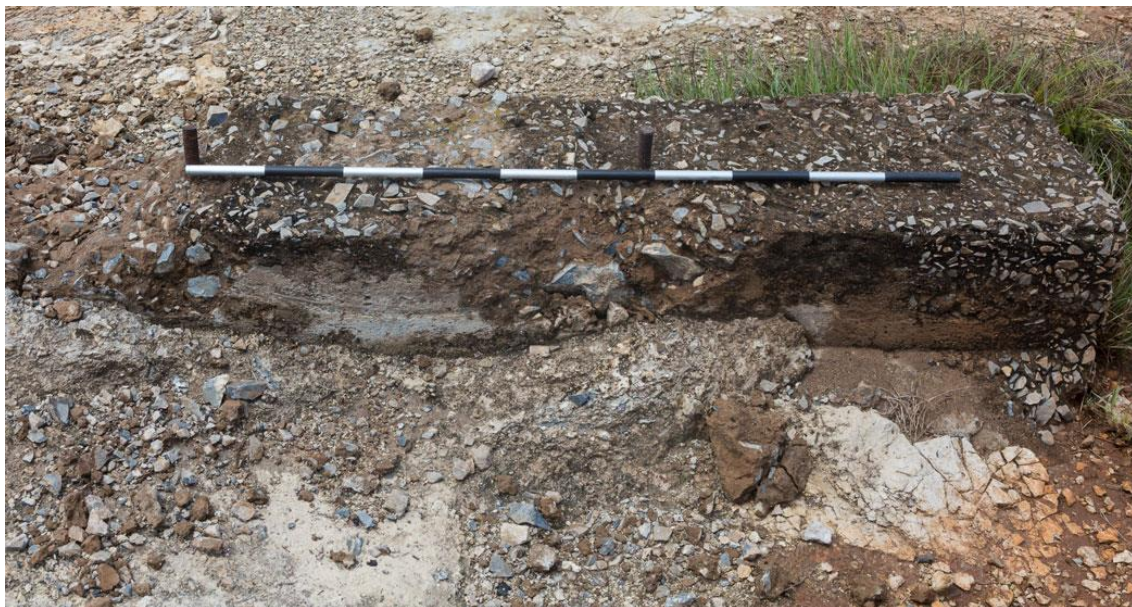
*Figure 58. Mounting block for machine showing a flywheel imprint and hydrated lime residue. This was presumably a mechanical screen with an offset flywheel to vibrate the screens.*

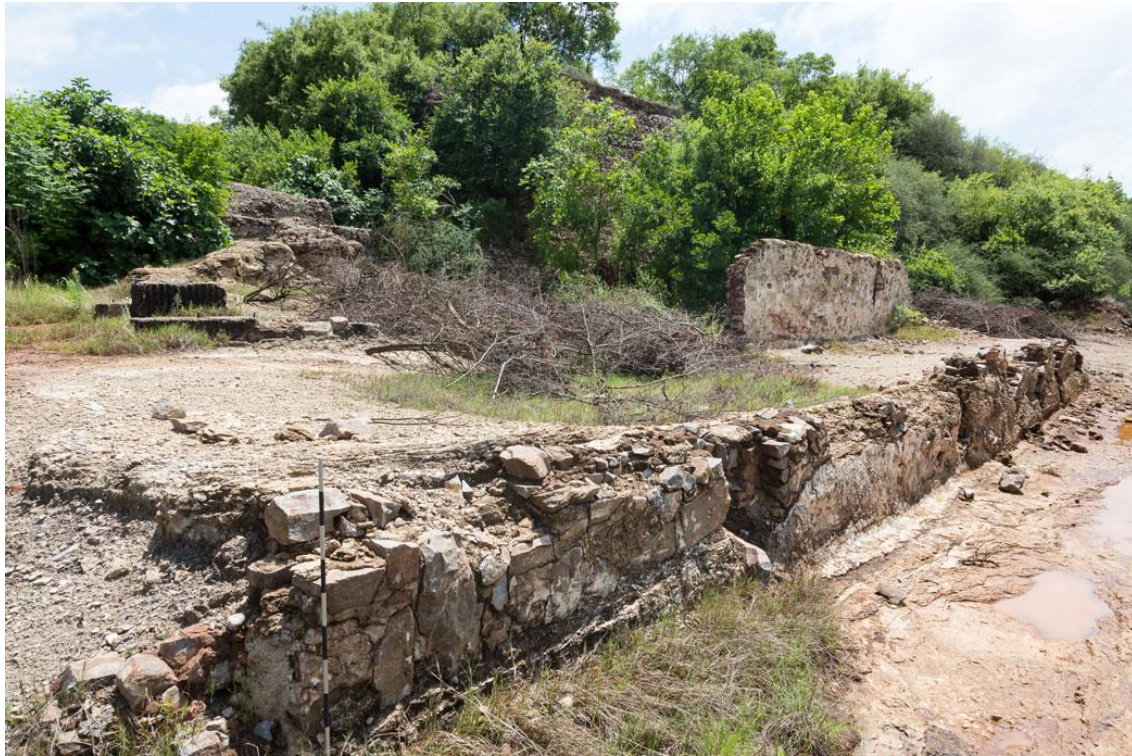
*Figure 59. General view of the lime stacking and loading area with the kilns in the background. This area was probably covered with a roof structure.*

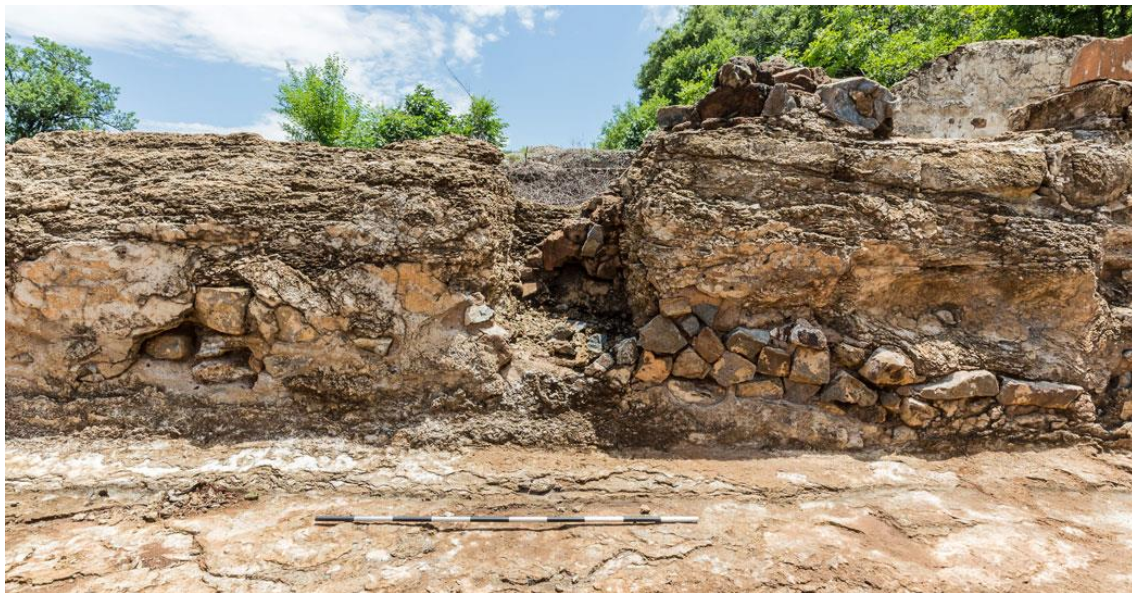
*Figure 60. Detail of lime residue that accrued next to the loading area. Note the horizontal accumulation of lime on top of the floor level. There is also a clear vehicle track imprint next to the photographic scale.*

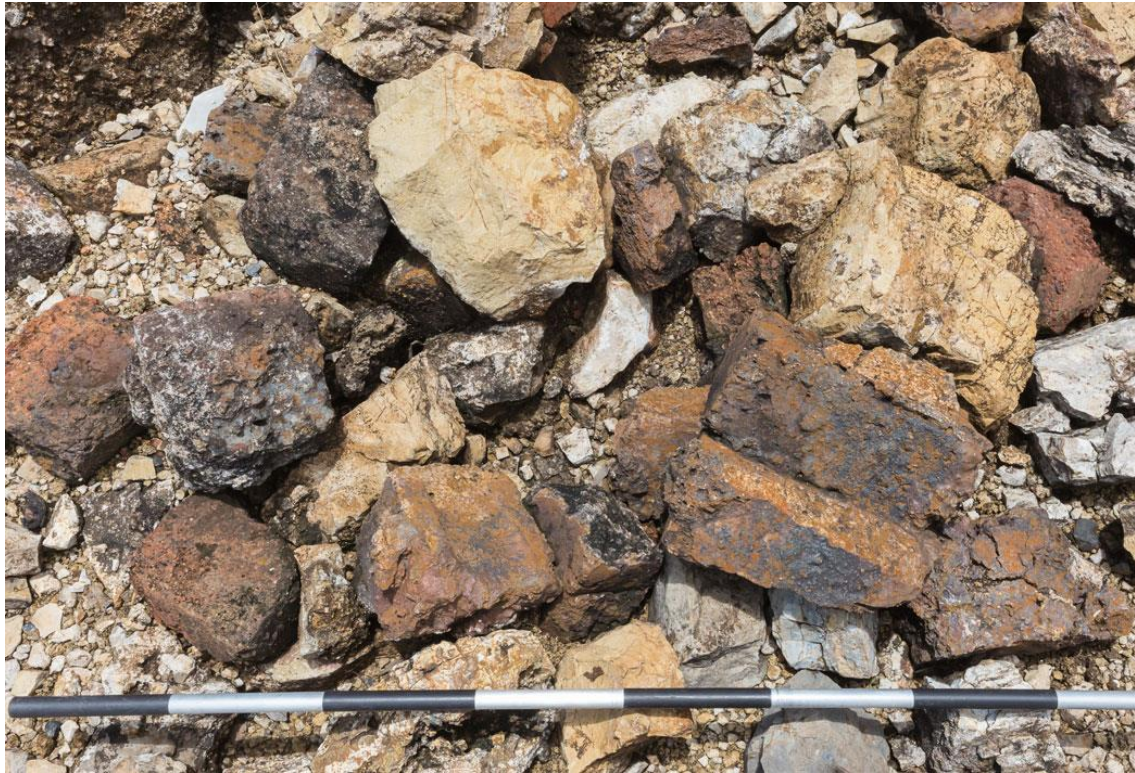
*Figure 62. Vitrified bricks from the kiln lining dumped in a discard area*

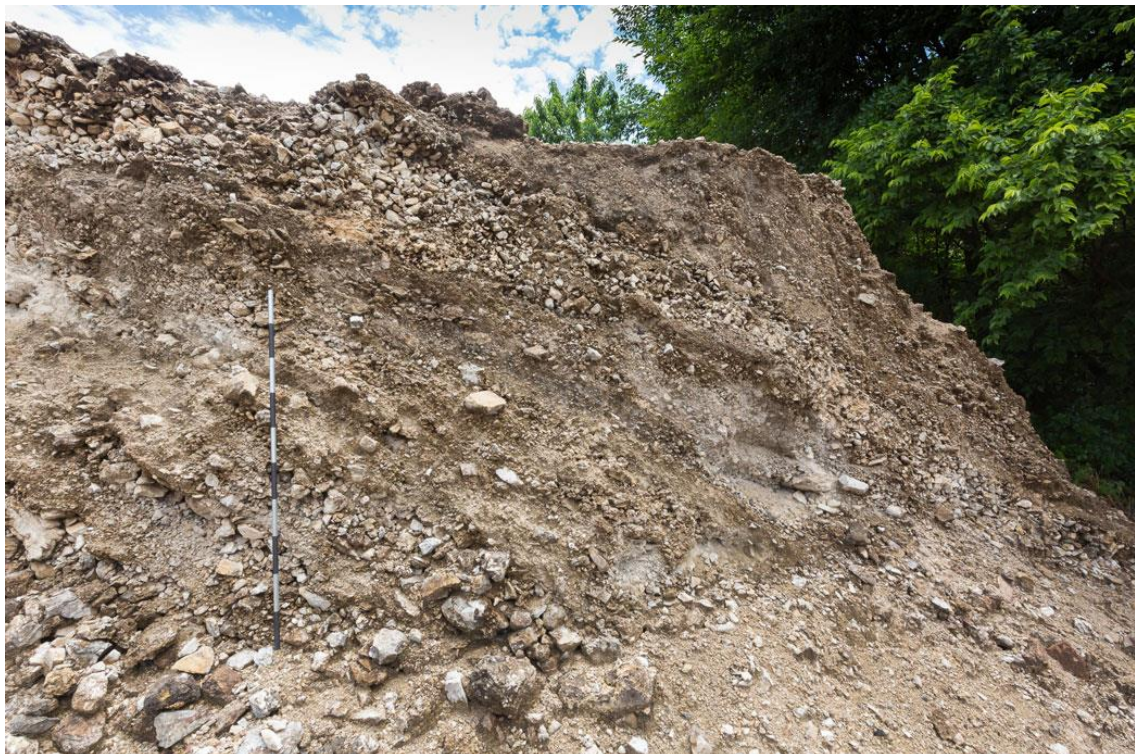
*Figure 63. General view of the discard pile to the east of the furrow. Note the alternating diagonal layers of dumped material.*

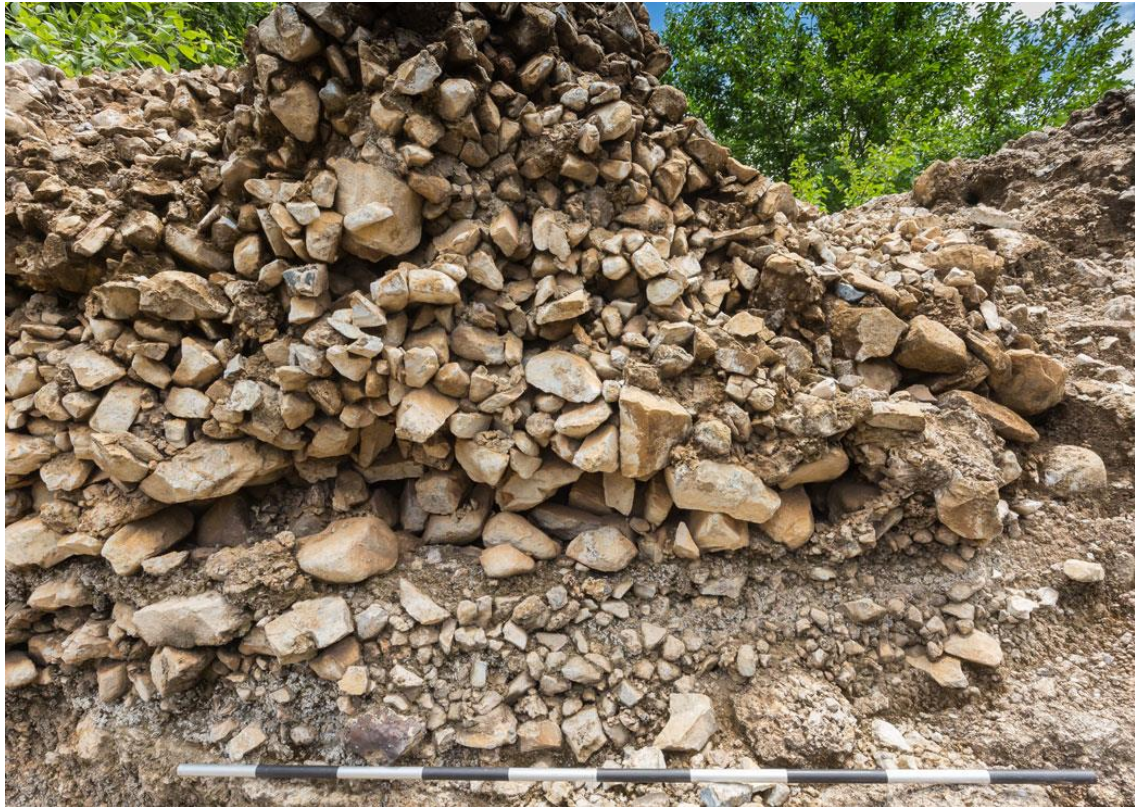
*Figure 64. Coarse screened material ranging in size from 150 mm, 75 mm, 50 mm and 20 mm.*

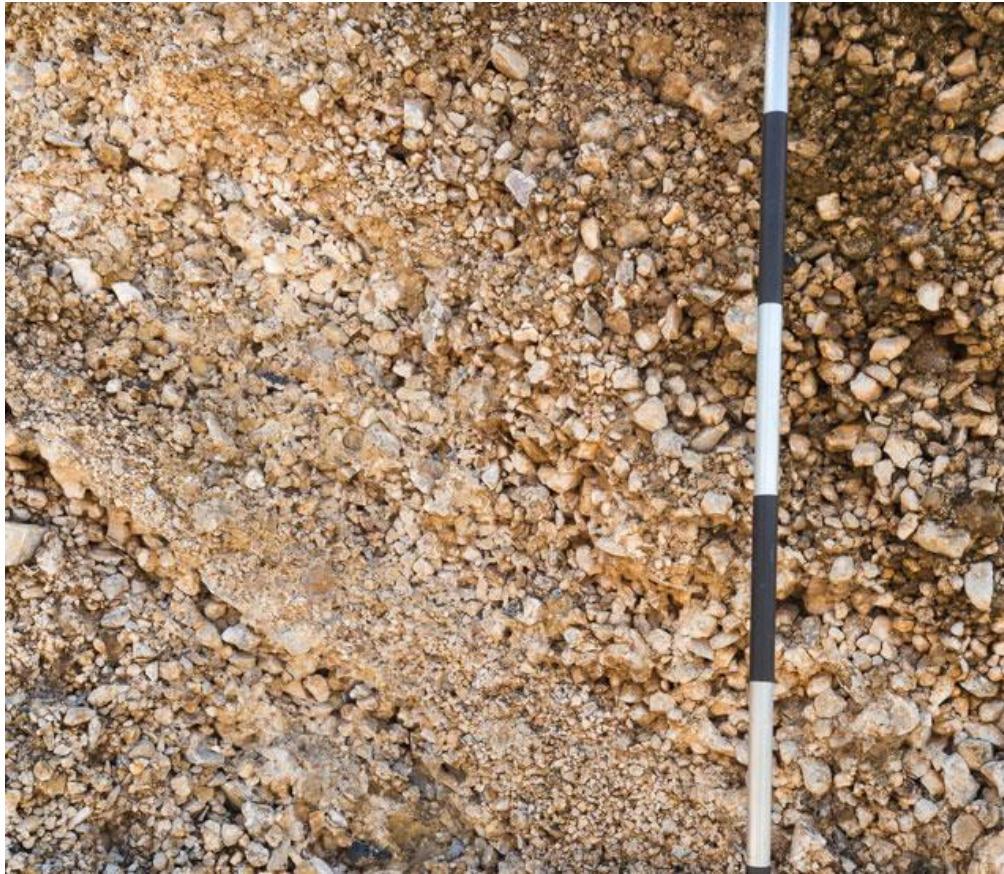
*Figure 65. Fine screened material ranging in size from 5 mm to 20 mm.*

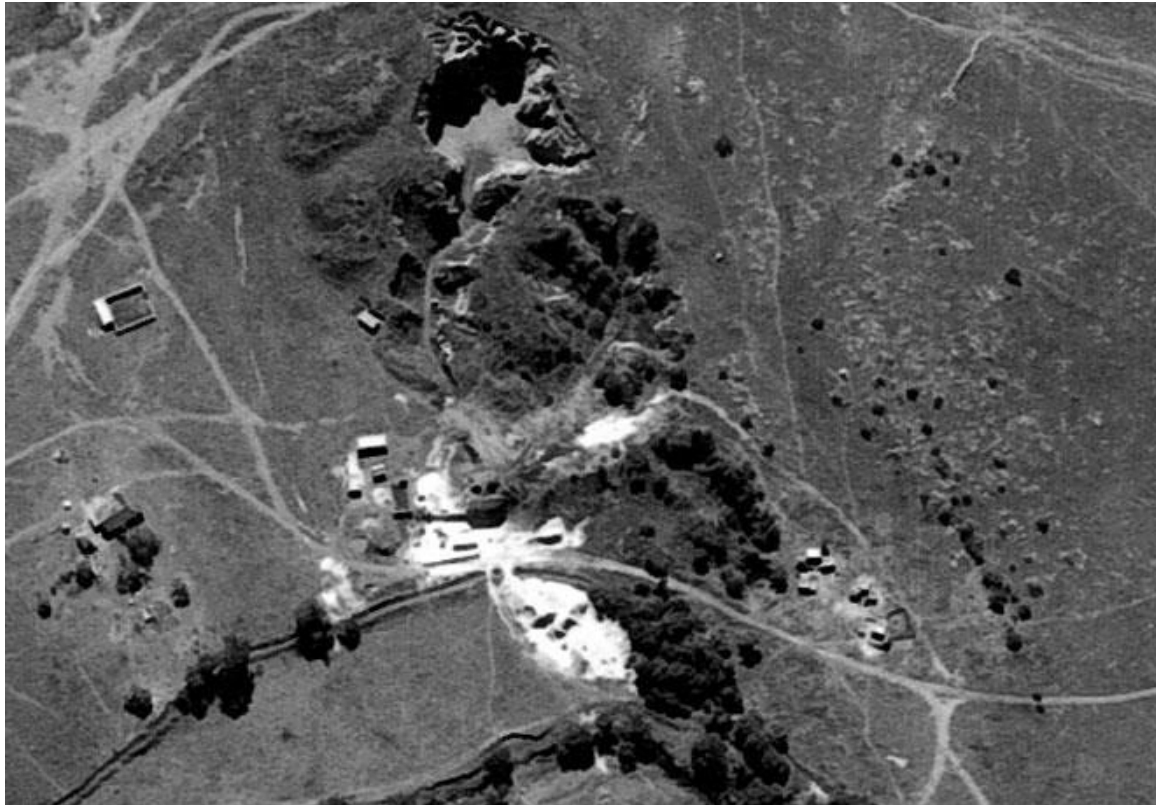
*Figure 66. Detail of the plant area on the 1958 aerial photograph.*

From the 1958 aerial photograph it is evident that significant changes and addition to the plant area has been made and that there are several new buildings and structures at the Olifantsfontein lime works. The location of slacking ponds for the eastern draw holes remains unknown. The presence of a discard pile at these draw holes indicates that processing likely occurred in close proximity. One of the buildings in this locality may have contained a mechanized hydrator such as the Kritzer hydrator that was generally used in South Africa.

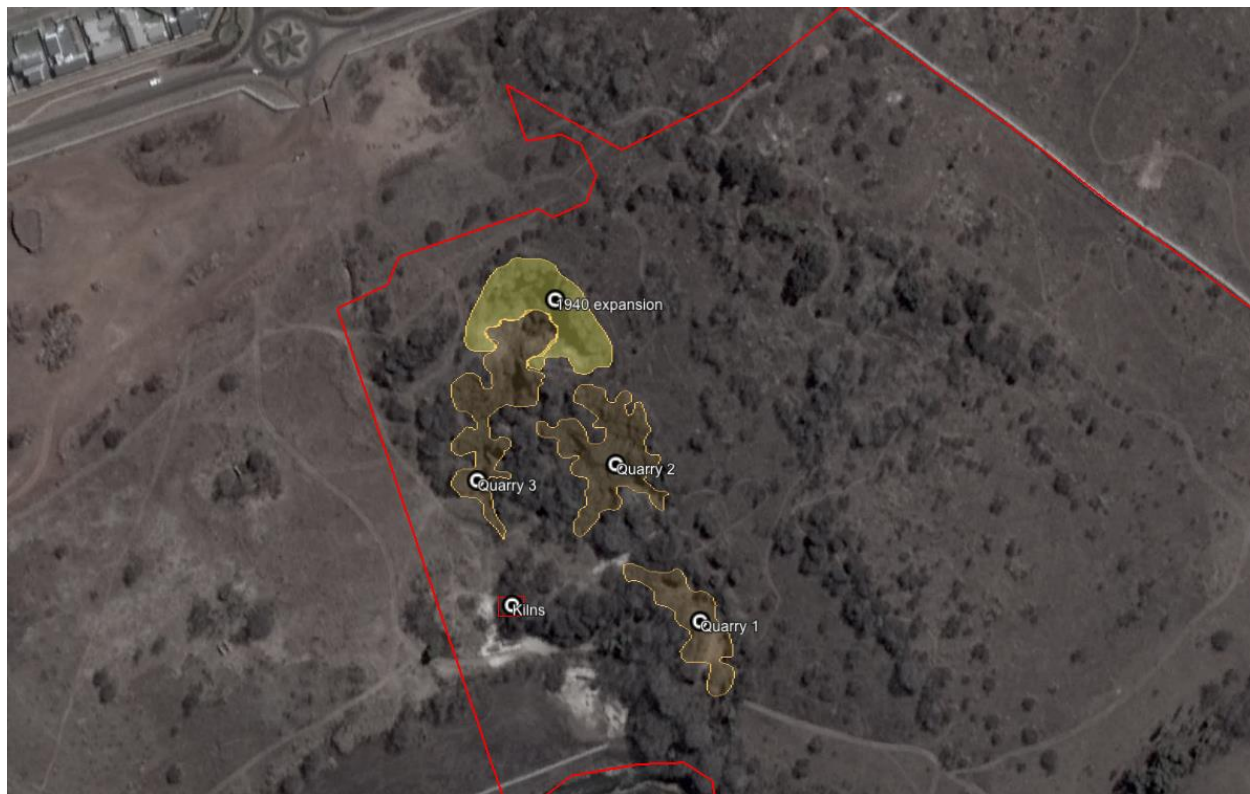
Figure 69. Quarry expansions in the final phase.

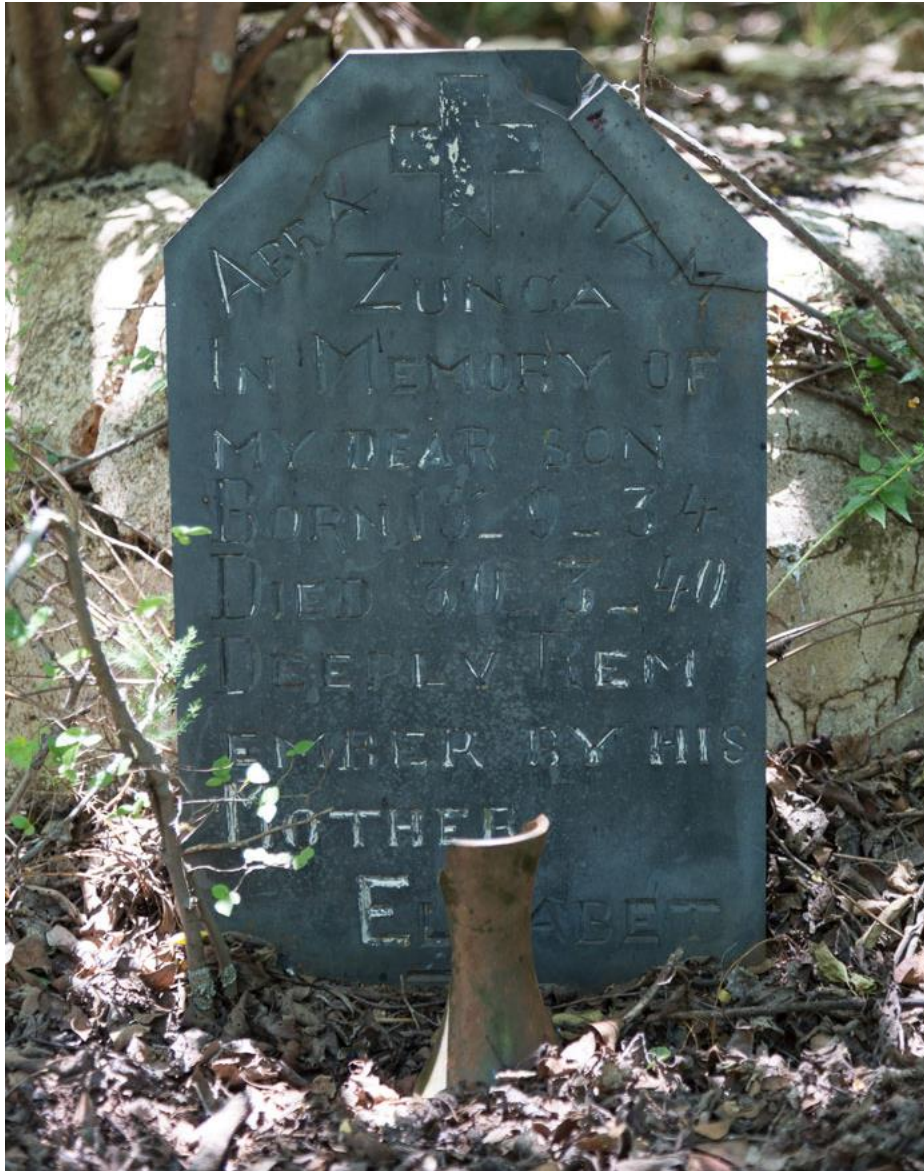
Figure 73. One of the earliest grave stones in the larger of the two cemeteries

The two cemeteries that have been recorded on the remainder of Olifantsfontein Portion 46 are also clearly visible on the 1958 aerial photograph. Collectively the two cemeteries contain more than 400 graves. Most of the graves are unmarked. The oldest grave with a headstone dates to 1940. The most recent burial dates to 1958, which is also the date of the aerial photograph. A new township, Tembisa, was established in 1957 when people were resettled from Midrand, Alexandra, Kempton Park and Germiston. Ceramics that can be linked to the Olifantsfontein industries have been placed on several of the graves. Some of the graves show evidence of having been recently cleaned and are clearly attended to by relatives and/or close friends.

Note that the cemeteries will have to be incorporated into the proposed development.

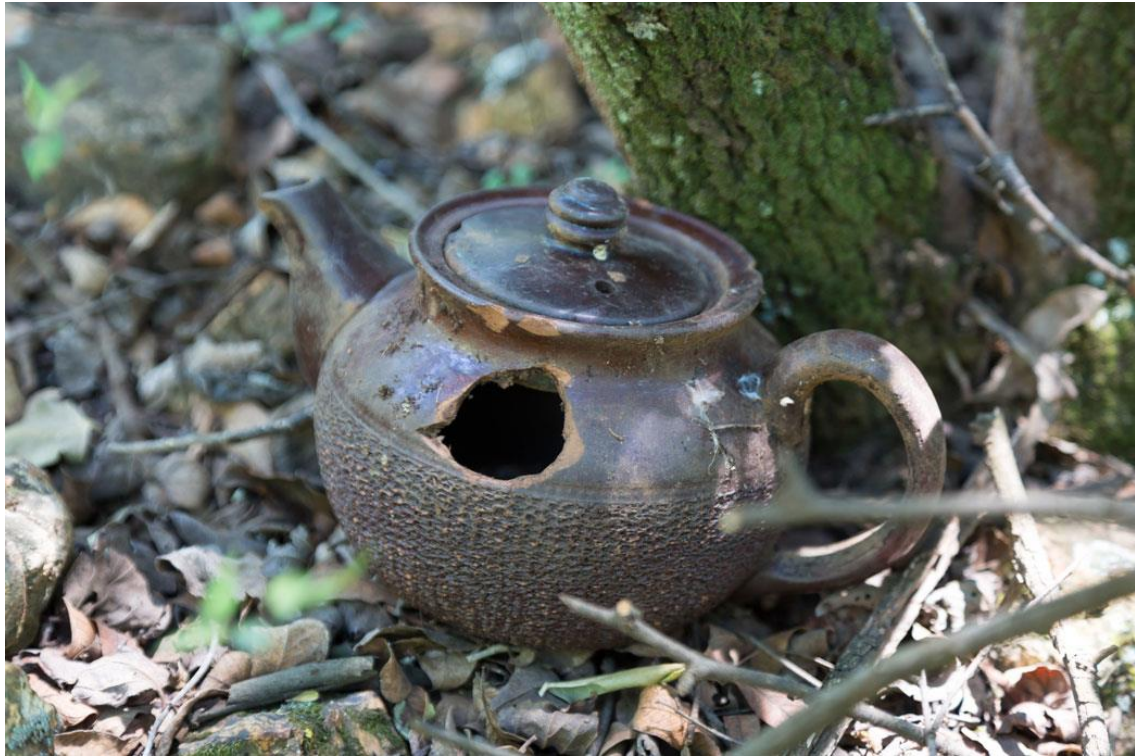
*Figure 74. Example of grave goods.*
