**PHASE TWO ARCHAEOLOGICAL ASSESSMENT:  
THE REMAINDER OF PORTION 46 OF THE FARM  
OLIFANTSFONTEIN 410 JR  
CENTURION GAUTENG PROVINCE**

January 2018

**AFRICAN HERITAGE CONSULTANTS CC**

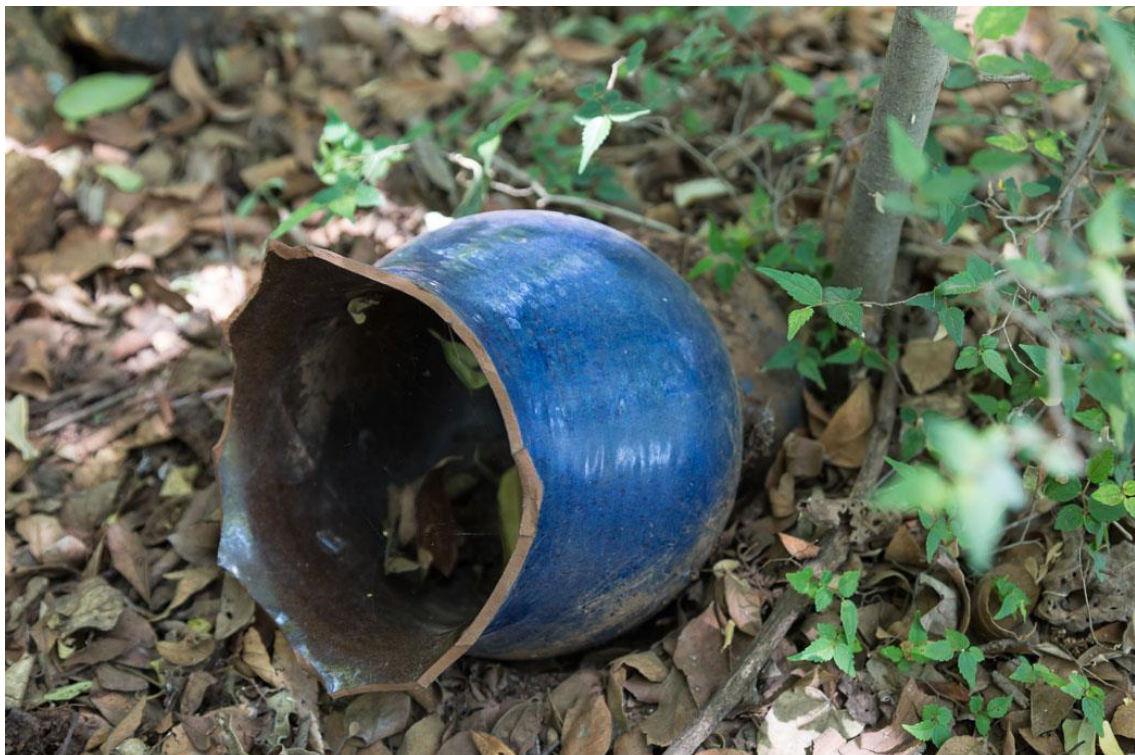
*Figure 75. Earthenware vessel on grave.*

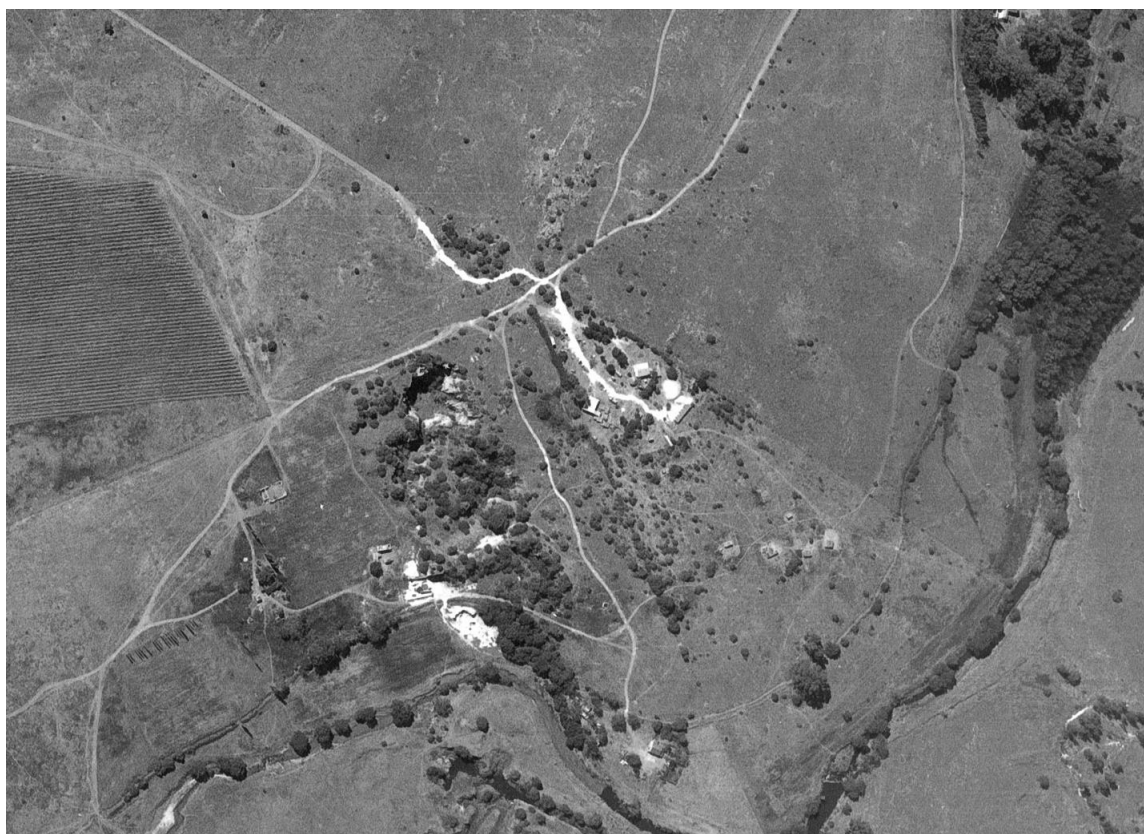
*Figure 76. Detail from the 1980 aerial photograph. Note the farm infrastructure that has developed to the north and east of the quarries during the 1970s.*

The 1980 aerial photograph documents extensive rural residential and farm-related infrastructure on a major portion of the land. These structures fall outside the ambit of the Heritage Act. No significant building remains, burials or other heritage artefacts are associated with these and subsequently no further recording has been undertaken. These do not have legislative protection and do not require a permit issued by SAHRA before demolition is undertaken.
