**HERITAGE SURVEY OF THE THREE BORROW PITS
FOR ROAD UPGRADES, UMTATHA, EASTERN
CAPE.**

FOR EOH COSTAL ENVIRONMENTAL SERVICES

DATE: 20 JULY 2016

**Umlando: Archaeological Surveys and Heritage
Management**

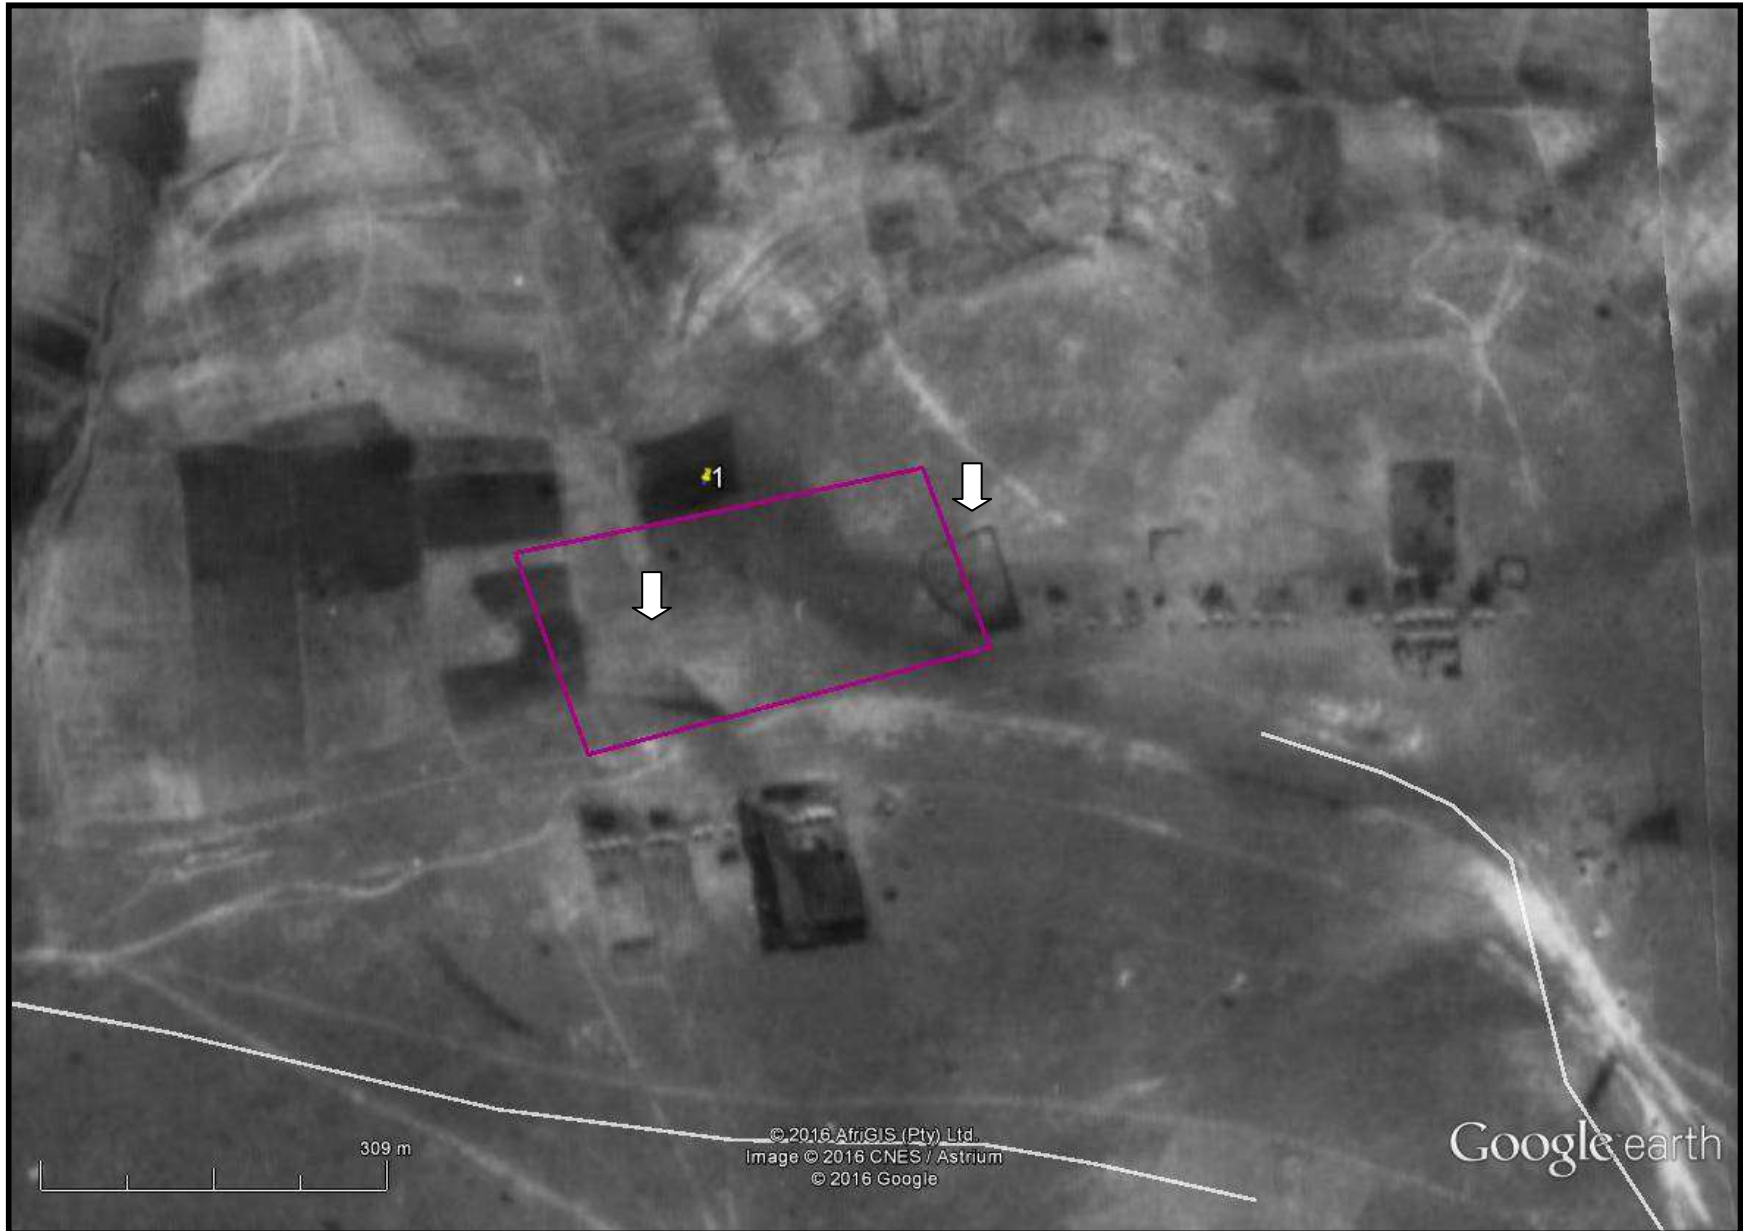
FIG. 8: AERIAL PHOTOGRAPH OF BORROW PIT 1 IN 1954

The 1954 aerial photographs of the borrow pits indicate that Borrow Pit 1 was mostly under cultivated land with an agricultural field and houses along the eastern side (fig. 8). Human graves related to this site are visible on the Google Earth Imagery. Google Earth imagery also shows another settlement in the middle of the study area. Borrow Pit 2 is surrounded by five settlements and one settlement inside the southern end of the study area (fig. 9). Borrow Pit 3 does not have any settlements near it (fig. 10).

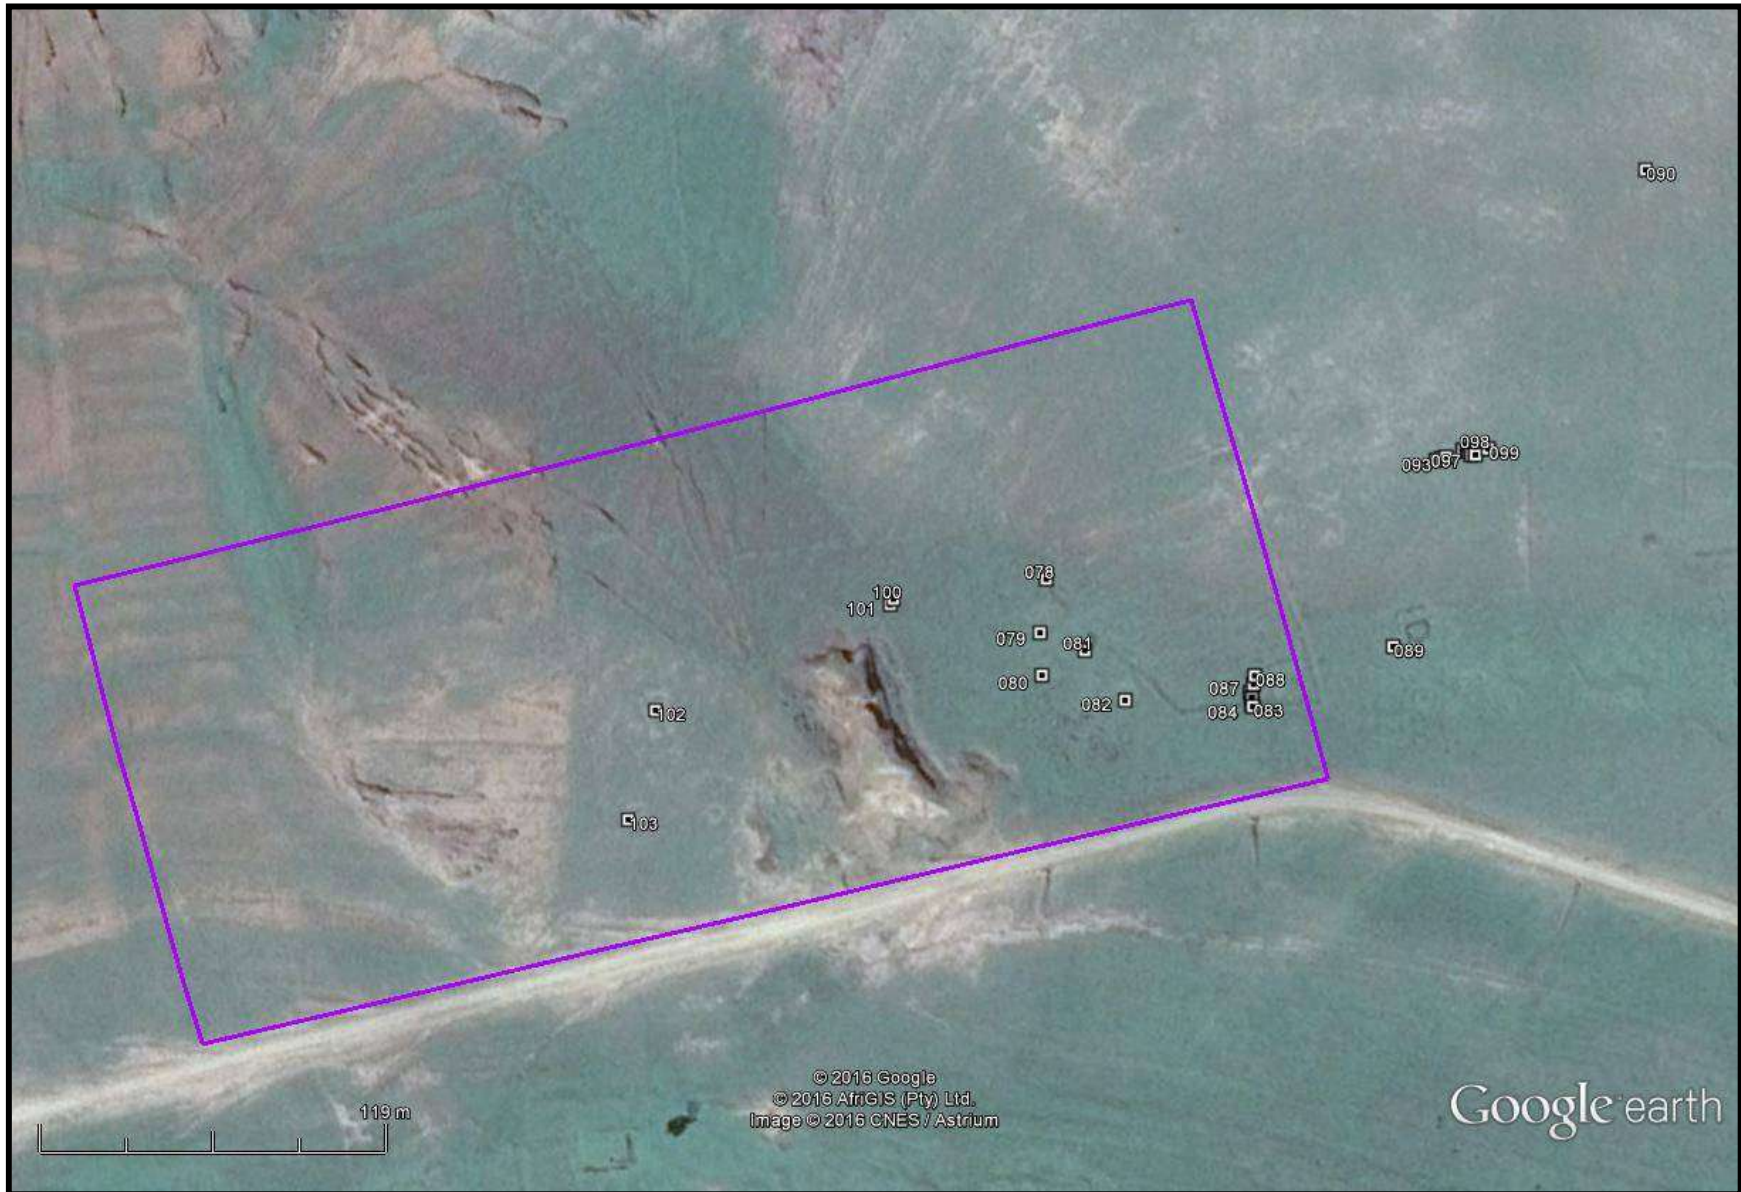
FIG. 13: LOCATION OF RECORDED FEATURES AT BORROW PIT 1

Borrow Pit 1 is located at the top of a hill besides a gravel road. The proposed Borrow Pit is approximately 370m x 170m in size. The upper part of the study area consist of several features that include graves, houses foundations and cattle byres, while the middle consist of three features (fig. 13). These latter features may contain graves. There is one cemetery of six graves within the study area, while a further nine graves occur ~70m to the east. There are two possible graves to the north of the existing borrow pit: these have headstones and footstones. Table 2 lists the locations of the features at the borrow pits.

- Group of 6 graves (fig. 14)
- Group of 9 graves (fig. 15)
- House floors (fig. 16)
- House walls (fig. 17)
- Cattle byre foundations (fig. 18)
- General foundations (fig. 19)
- Possible graves with headstone/footstone (fig. 20)

Significance: The graves are of high significance, while the foundations are of low significance.

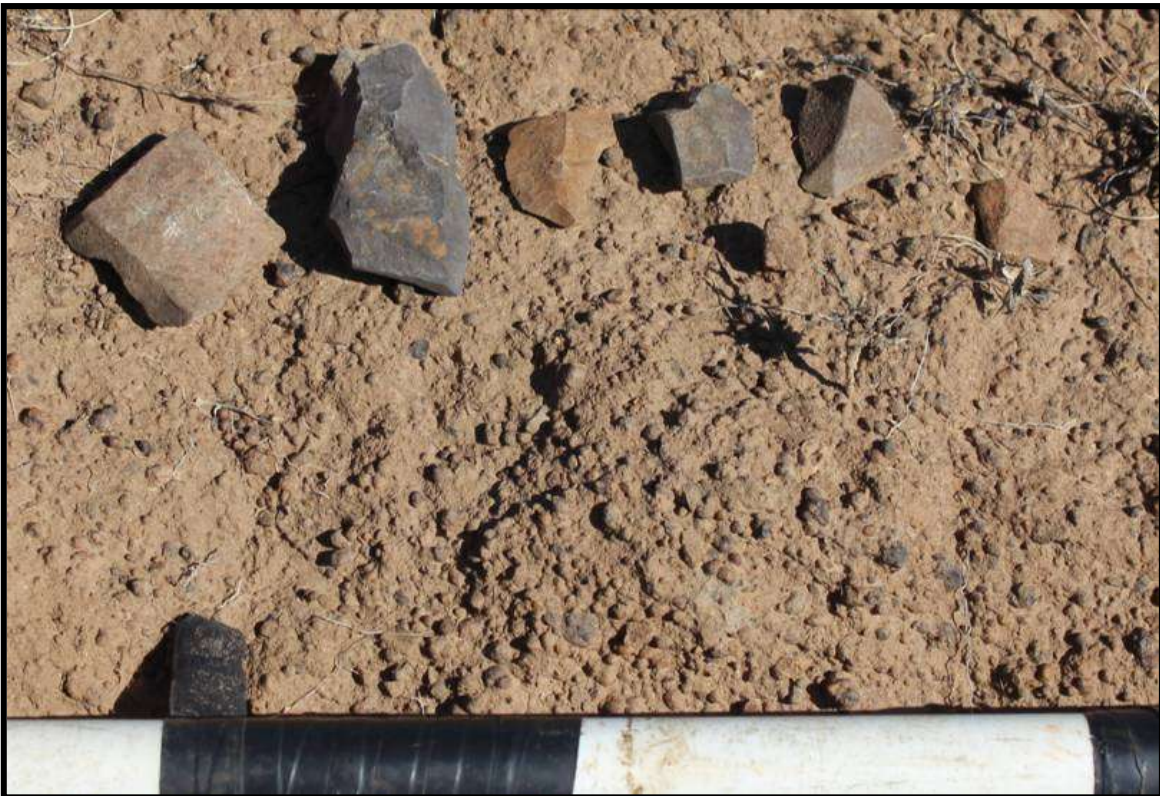
FIG. 21: STONE TOOLS

Stone tools occur throughout the site as a general scatter of artefacts. The tools date to the MSA and LSA (fig. 21).

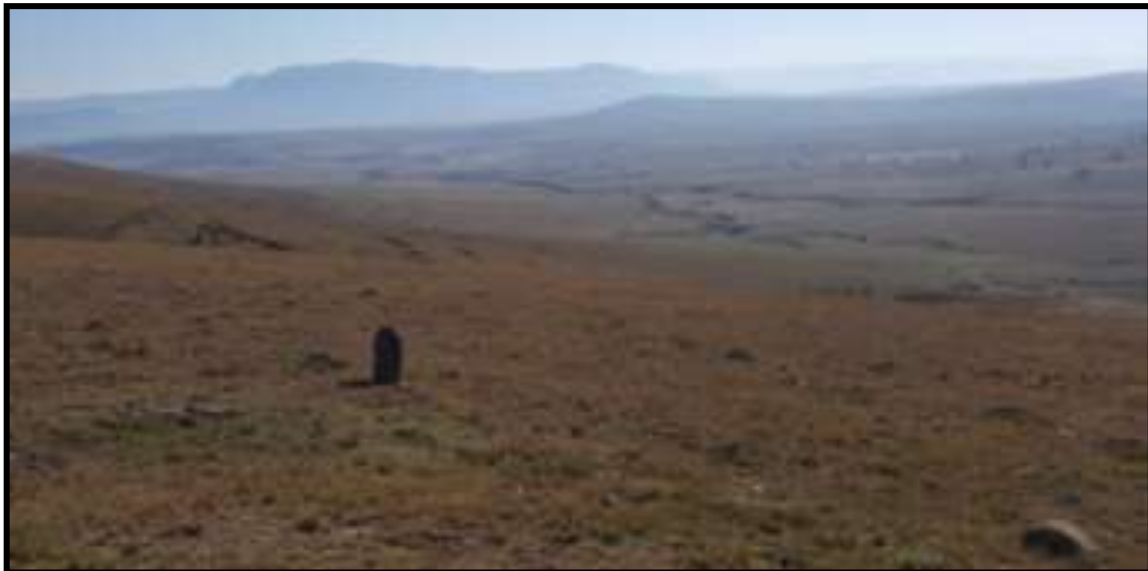
FIG. 22: POSSIBLE HEADSTONES AT BORROW PIT 2

The cattle byre and houses noted in the 1954 aerial photo was not visible at the time of the survey. However, two possible headstones were noted (fig. 22). The headstones appear to be in the correct location for them to be graves. The agricultural fields from these photos were visible. Two Late Stone Age stone tools were observed in an eroded area (fig. 23). The one is an irregular core, while the other appears to be a single platform core. The tools do not constitute a site. Fig. 24 shows the locations of these features.

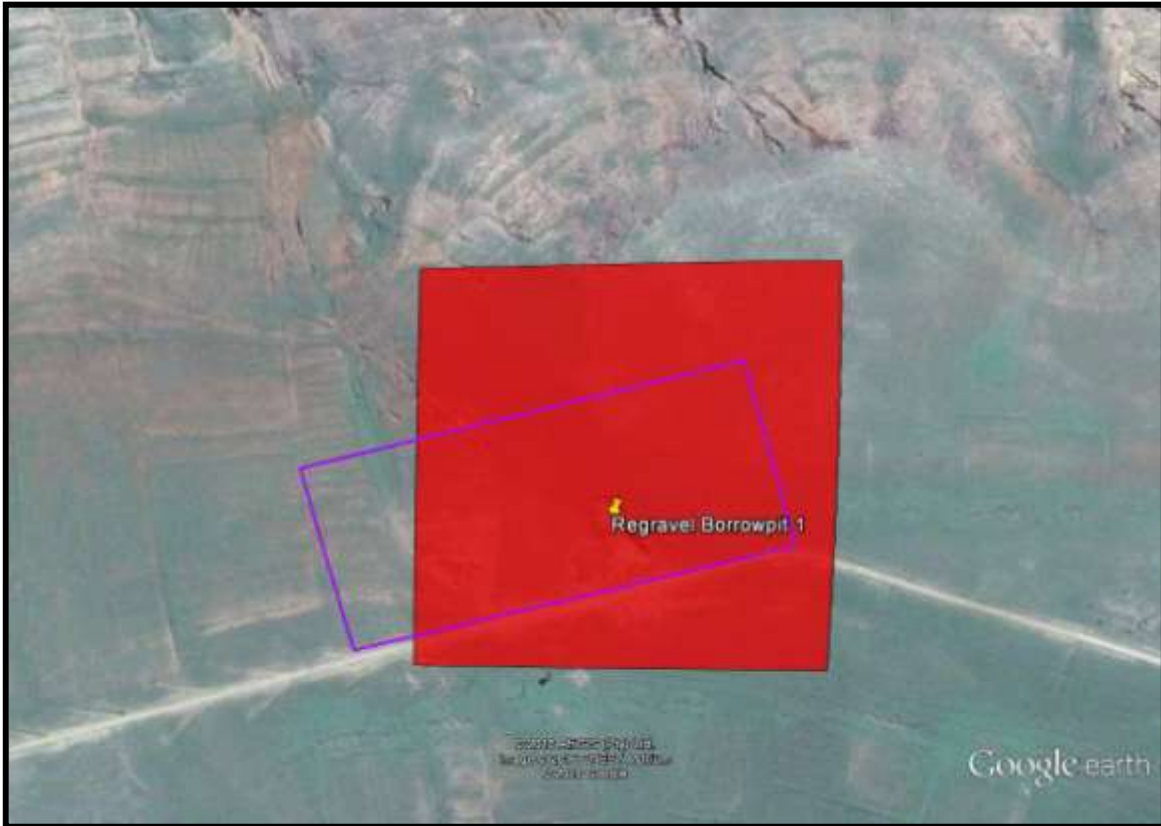
FIG. 25: PALAEOANTHROPOLOGICAL SENSITIVE AREAS AT BORROW PIT 1

The most of Borrow Pit 1 will be effected by excavations (fig 25). The southeastern section Borrow Pit 2 will be effected by excavations (fig. 26). Only the upper eastern part of Borrow pit 3 will be effected by excavations (fig. 27).

- Mitigation: The EAP and ECO must be informed of the fact that a Very High Palaeontological Sensitivity was allocated to all three the proposed sites for the development and due to highly weathered state of the rocks, no fossils were recorded during the Phase 1 field investigation.
- A suitably qualified palaeontologist must be appointed to inspect all areas where excavation of deeper than 1,5m is made into sediments of the Burgersdorp Formation. A protocol for the chance find of fossils must be developed and discussed with the contractor on site.
- These recommendations must be included in the EMP of this project.

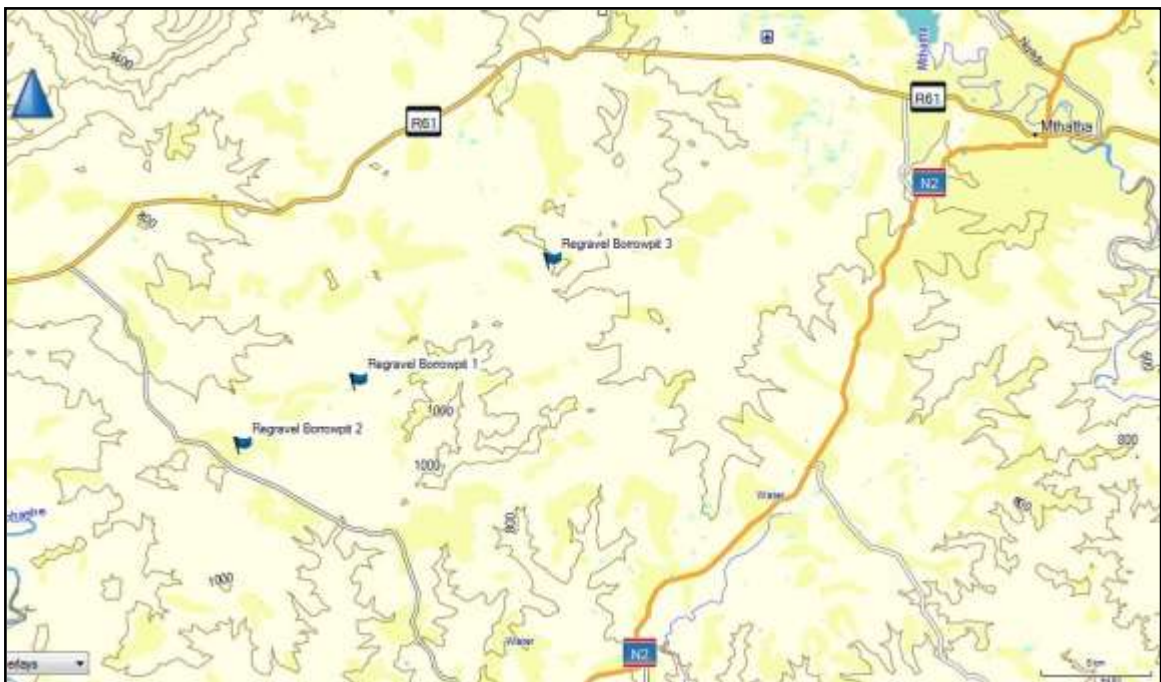
Figure 3 Observations for Palaeontological heritage

Observations were recorded at different GPS stations (Figure 3 and Table 2).

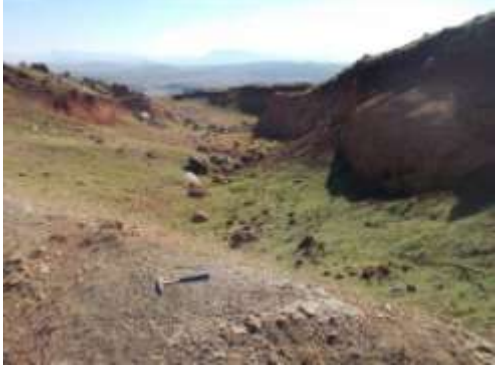
| Photo | (GPS station) Coordinates | Comments | Photographic Record |
|---|---|---|---|
| 1 | (Regravel 1) -31° 41' 16.4" 28° 29' 45.8" | Excavation onto upper part of Burgersdorp Formation and weathered dolerite at quarry site 1. Deeply weathered mudstone on contact with dolerite, no fossils observed | |

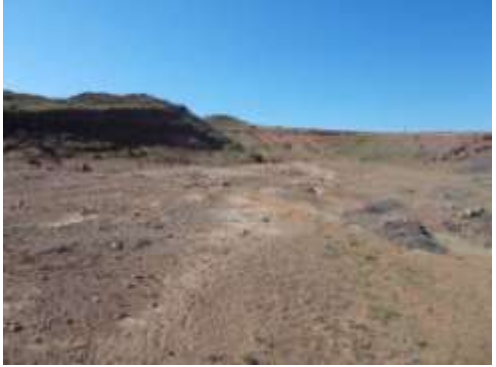
| Photo | (GPS station) Coordinates | Comments | Photographic Record |
|---|---|---|---|
| 2 | (Regravel 1) -31° 41' 16.4" 28° 29' 45.8" | Deeply weathered Burgersdorp Formation mudstone – no fossils observed | |

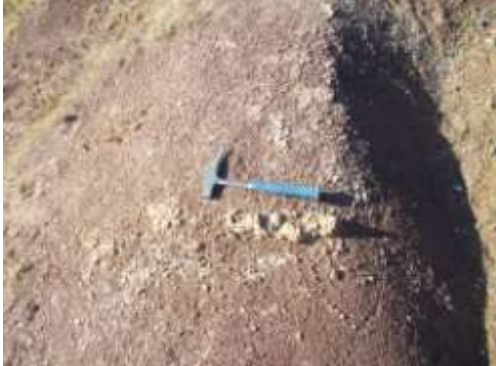
| Photo | (GPS station) Coordinates | Comments | Photographic Record |
|---|---|---|---|
| 3 | (Regravel 1) -31° 41' 16.4" 28° 29' 45.8" | Red coloured mudstone of the Burgersdorp Formation with calcareous concretions and pseudo bone fragments. Highly likely that more vertebrate fossils will be exposed during development | |

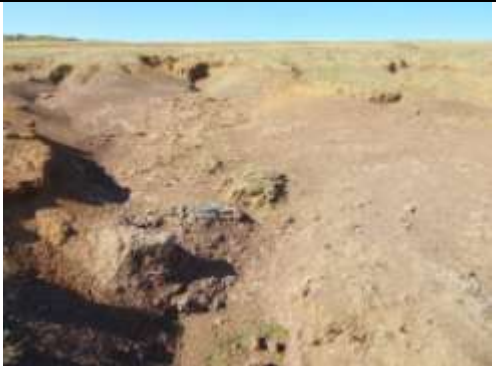
| Photo | (GPS station) Coordinates | Comments | Photographic Record |
|---|---|---|---|
| 4 | (Regravel 1) -31° 41' 16.4" 28° 29' 45.8" | Red coloured mudstone of the Burgersdorp Formation with calcareous concretions and pseudo bone fragments. Highly likely that more vertebrate fossils will be exposed during development | |

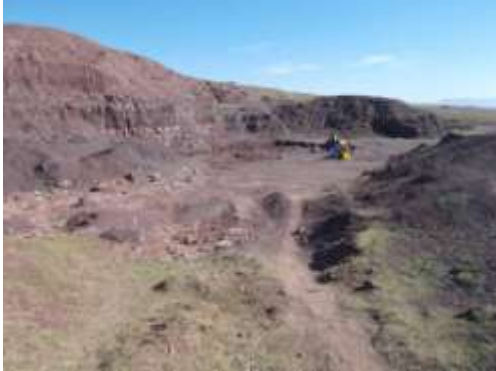
| 5 | (Regravel 2) -31° 42' 48.9" 28° 26' 47.7" | Red and maroon coloured mudstone of the Burgersdorp Formation. Very high possibility of exposing fossils. No fossils were however recorded during this site visit. | |

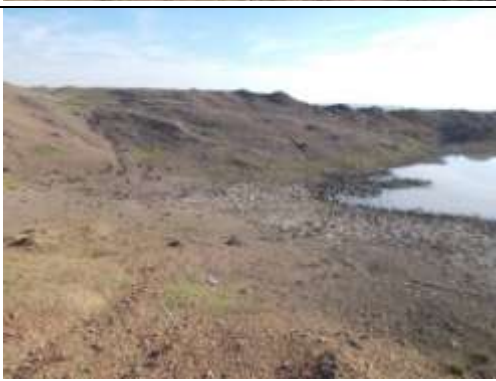
| 6 | (Regravel 3) -31° 38' 20.9" 28° 34' 44.5" | Deeply weathered red mudstone of the Burgersdorp Formation on dolerite. Very high potential for fossils however no fossils observed during this field visit. | |

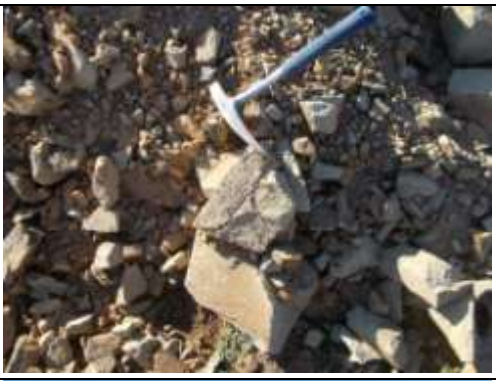
| 7 | (Regravel 3) -31° 38' 20.9" 28° 34' 44.5" | Rock samples out of situ with small scale trace fossils, indicating potential fossils in sandstone on site of development | |

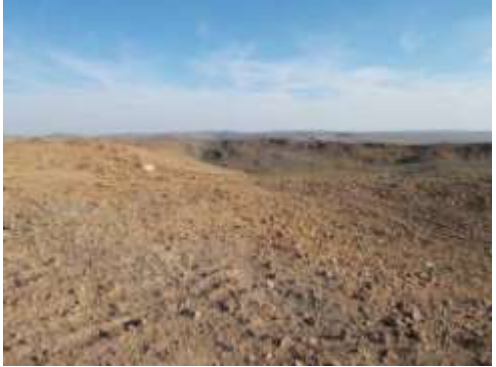
| 8 | (Regravel 3) -31° 38' 20.9" 28° 34' 44.5" | Variable sandstone mudstone and dolerite at Burrow Pit 3 site | |

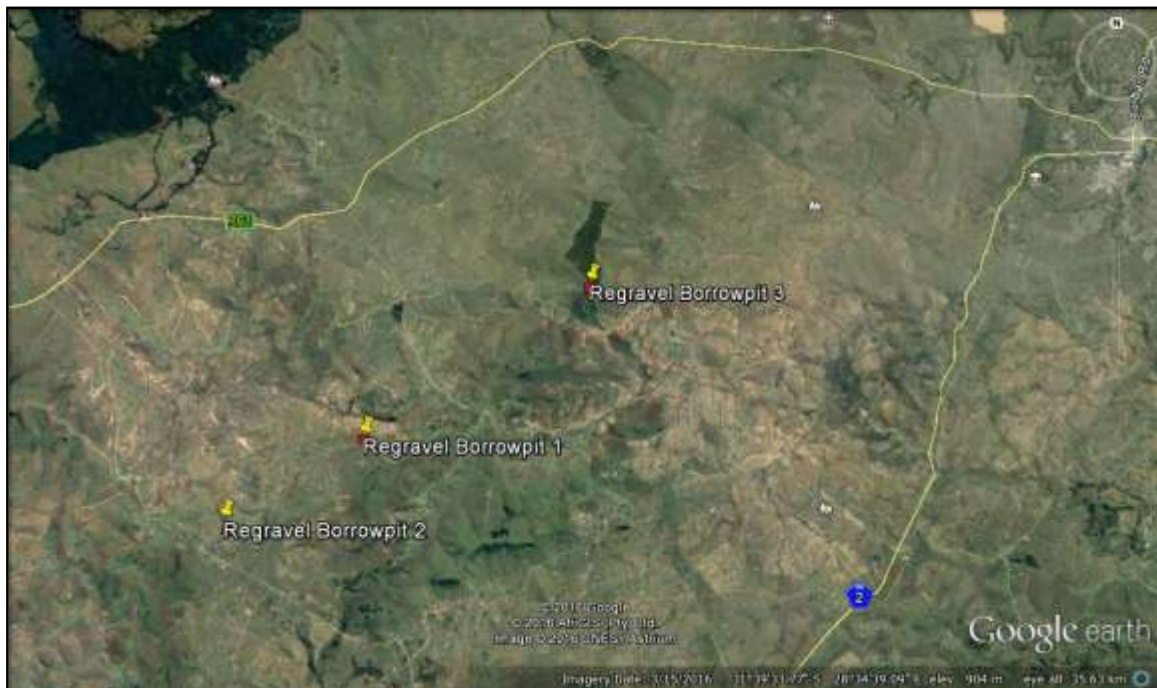
Figure 4. All three potential borrow pit sites are allocated Very High Palaeontological sensitivity. For explanation of colour code see Table 1

The excavation of the three borrow pits for this development will expose some sediments of the Burgersdorp Formation. Due to weathering, no well-preserved fossils were observed during the field investigation. Exposure of bedrock during excavation might however result in the exposure of significant plant, trace and possibly vertebrate fossils and the Very High palaeontological sensitivity of the sites are restricted to areas underlain by Burgersdorp mudstone and fine-grained sandstone or siltstone (Figure 4). Areas underlain by dolerite has no significant impact on palaeontological heritage.
