PROJECT 2011/1

SPECIALIST STUDY: HERITAGE IMPACT ASSESSMENT FOR THE INSTALLATION OF THE SIRIUS FIBRE OPTIC CABLE BETWEEN JOHANNESBURG AND YZERFONTEIN, GAUTENG, FREE STATE, EASTERN AND WESTERN CAPE PROVINCES

DATE: 8 March 2011

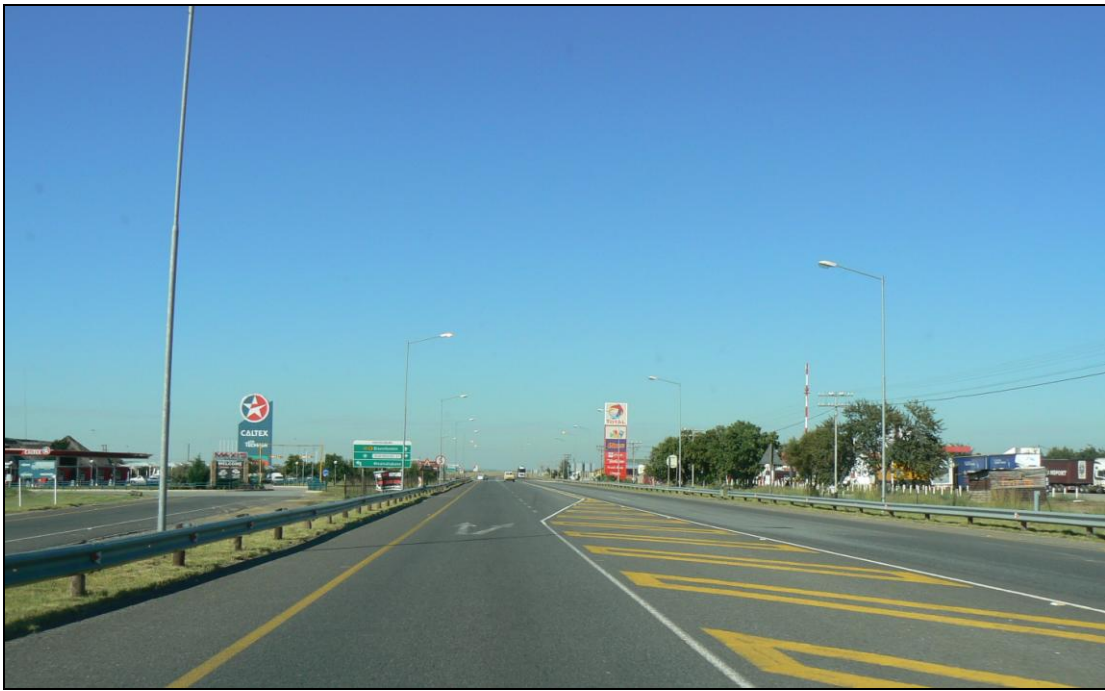
FIGURE 6: Ventersburg streetscape (lacking any historic buildings and structures) along the N 1

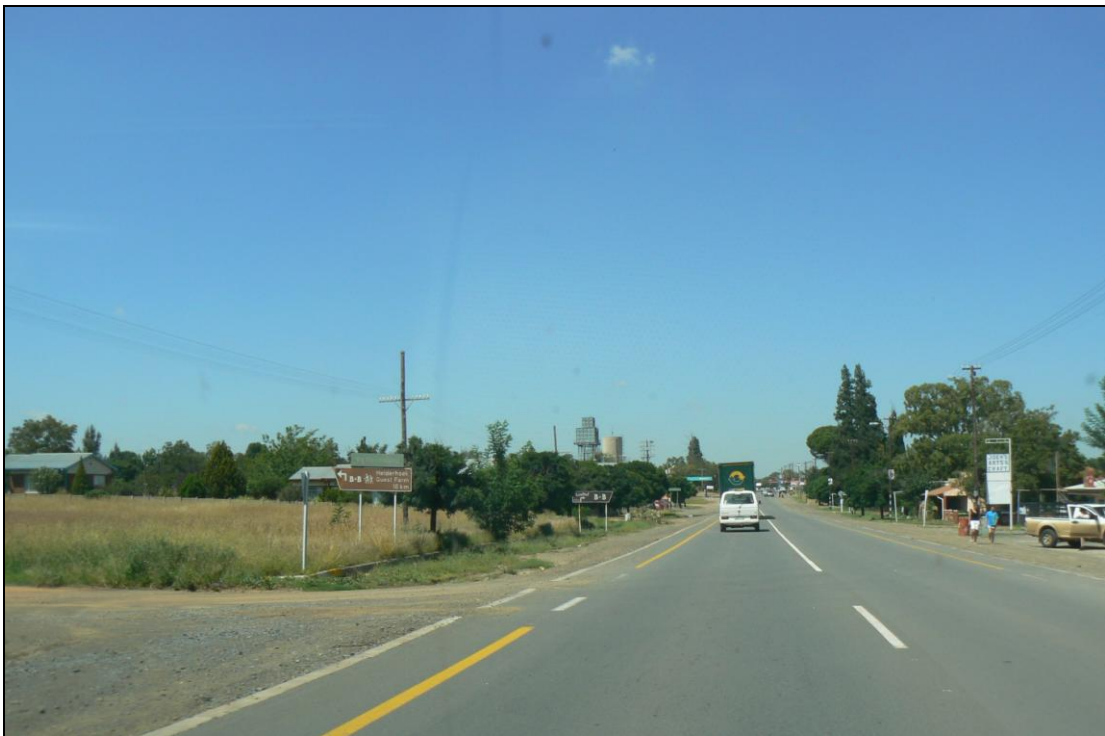
FIGURE 11: N 6 through Reddersburg' along this section no buildings and structures of heritage significance occur

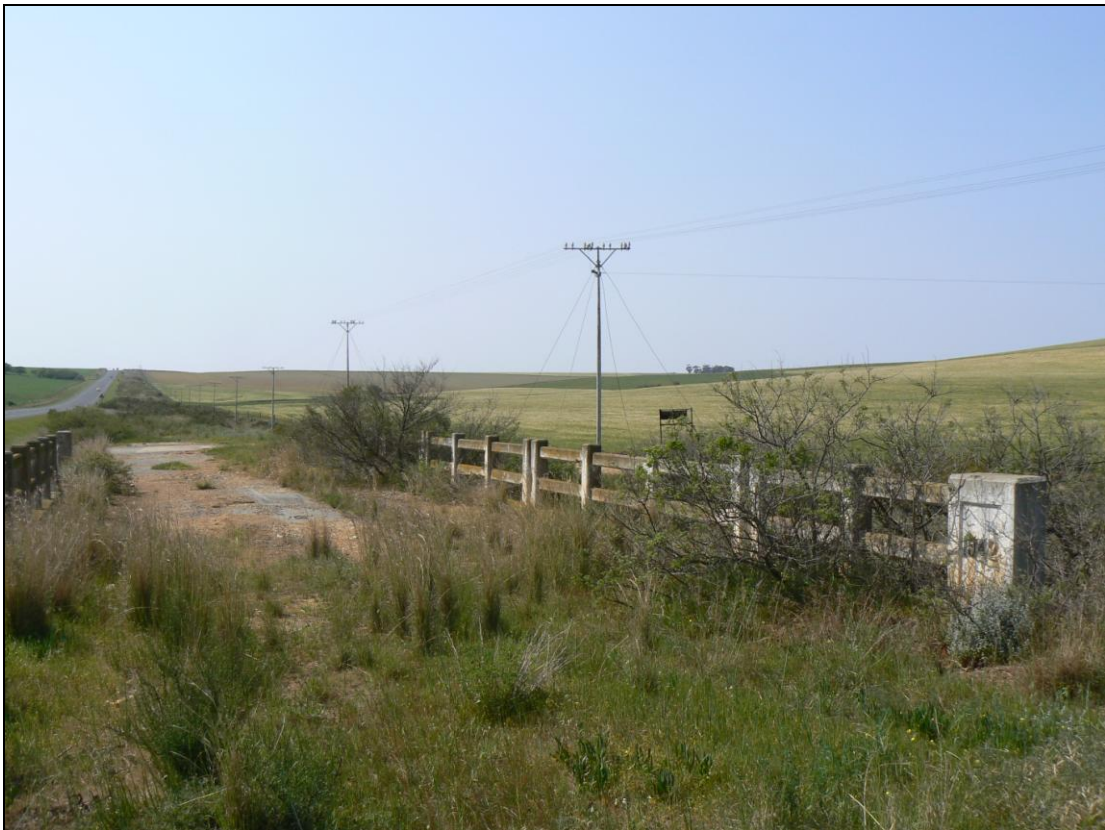
FIGURE 30: Old N 2 alignment between Riviersonderend and Heidelberg with bridges constructed in the mid-1940s

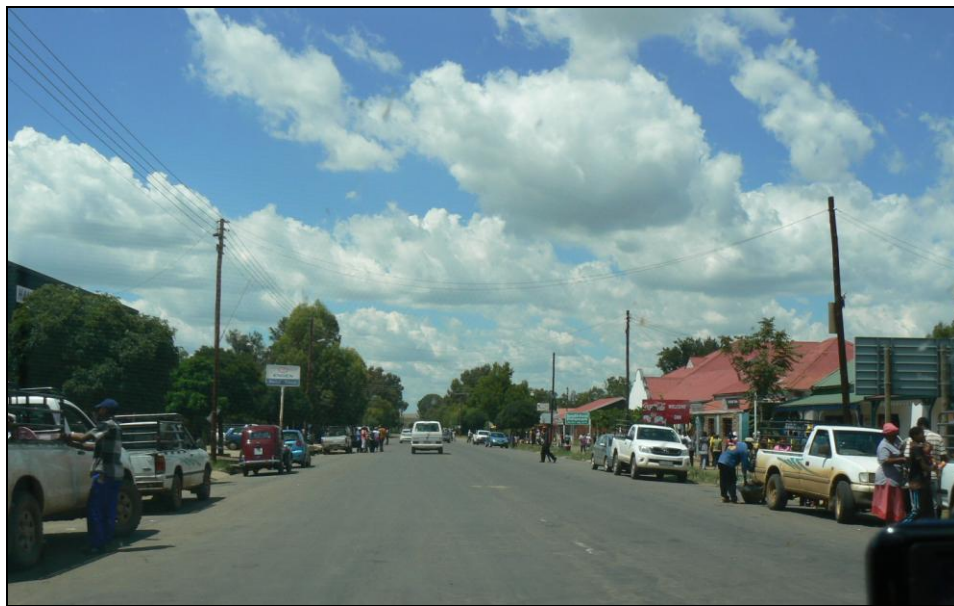
S 3(2) NHRA heritage resource	(a) Identification		(b) Significance	(c) Impact		(d) Recommended impact management, alternatives
	Site	GPS		Road section	Impact type, certainty and significance	
Buildings, structures, places and equipment of cultural significance	Historic buildings Smithfield (various)	-	High local	Smithfield (Kerk Street)	Damage during installation possible – low negative to neutral	Avoid and mitigation: Photograph and document current situation before trenching. Monitor damage to structures and buildings during trenching, installation and surface rehabilitation.

FIGURE 39: Various shops, houses and other historic buildings border on Smithfield’s main thoroughfare (Kerk Street)

4. Where other historic buildings and structures could be affected, the current situation must be documented (photographed) to create a benchmark for monitoring damage to the structures (e.g. by vibrations, dust, flying debris) during trenching, installation and rehabilitation. Should any significant damage take place, the provincial heritage resources authority should be contacted.

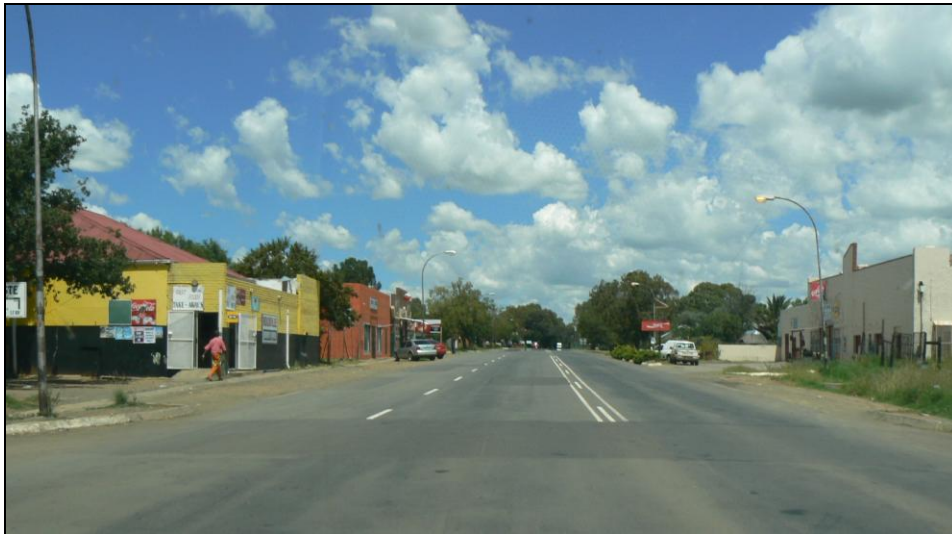
FIGURE 40: A few historic buildings front on the N 6 in Rouxville

S 3(2) NHRA heritage resource	(a) Identification		(b) Significance	(c) Impact		(d) Recommended impact management, alternatives
	Site	GPS		Road section	Impact type, certainty and significance	
Buildings, structures, places and equipment of cultural significance	Historic buildings Rouxville (few)	-	High local	Rouxville (Damage during installation possible – low negative to neutral	Avoid and mitigation: Photograph and document current situation before trenching. Monitor damage to structures and buildings during trenching, installation and surface rehabilitation.

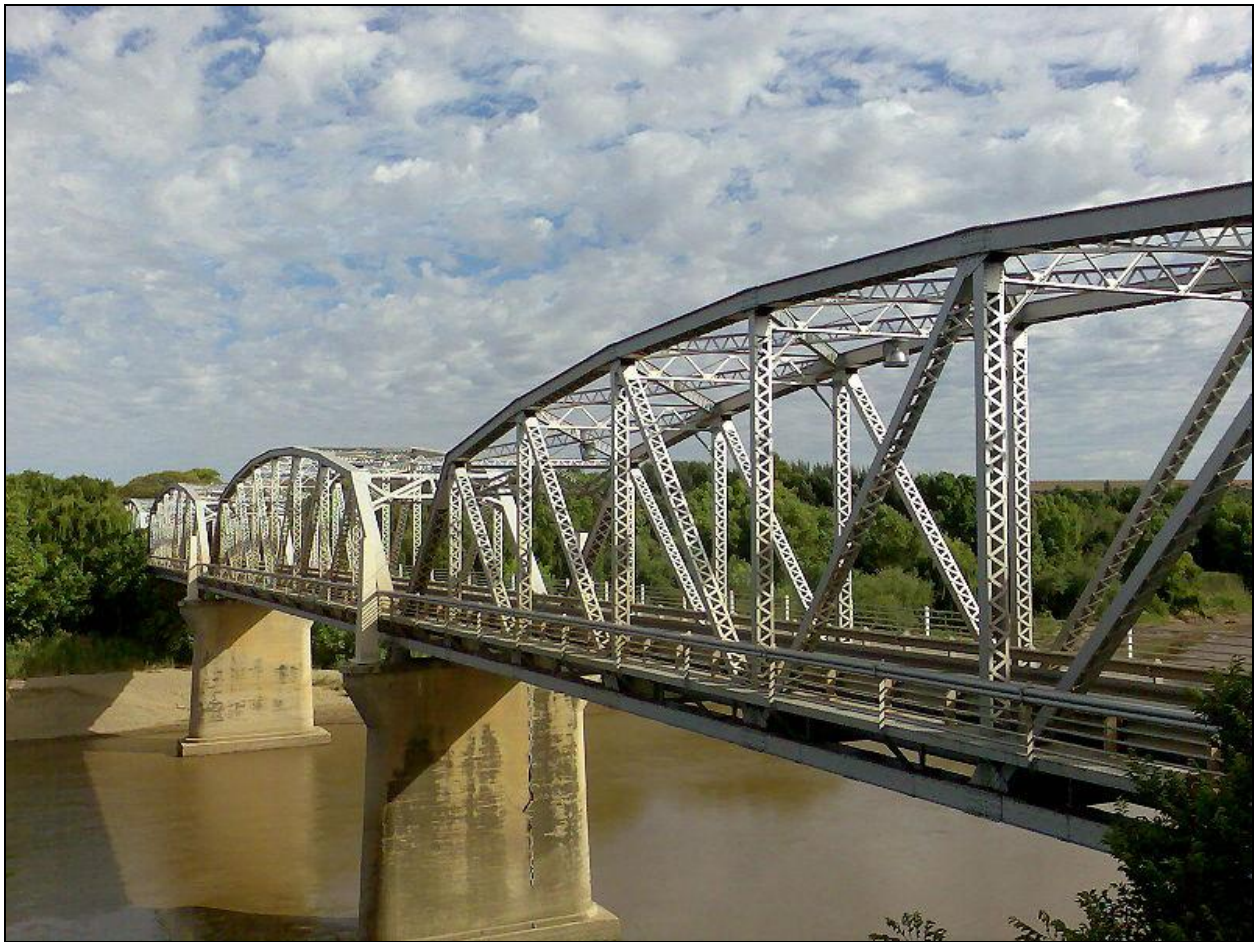
S 3(2) NHRA heritage resource	(a) Identification		(b) Significance	(c) Impact		(d) Recommended impact management, alternatives
	Site	GPS		Road section	Impact type, certainty and significance	
Buildings, structures, places and equipment of cultural significance	Hertzog Bridge across Orange River, Aliwal North (1937)	30°41'9.01"S 26°42'19.64"E	High local	Aliwal North	Medium	Mitigation: Cable installation should be invisible, reversible and not seriously damage the bridge. Document (photograph) bridge sections before installation and photograph installation process. Prepare detailed design drawings that explain the cable installation method for purposes of authorisation by heritage authorities.

FIGURE 41: Opened in 1937, the Hertzog Bridge across the Orange River at Aliwal North is a landmark protected in terms of Section 34 (older than 60 years) of the NHRA

3. Where the identified two historic bridges (Hertzog Bridge and Doring River Bridge), and any other bridges older than 60 years, are affected, the cable installation should be invisible, reversible and not seriously damage the bridge. Bridge sections should be documented (photographed) before installation and the installation process should be photographed. The heritage authority may request more detailed design drawings that explain the cable installation method.

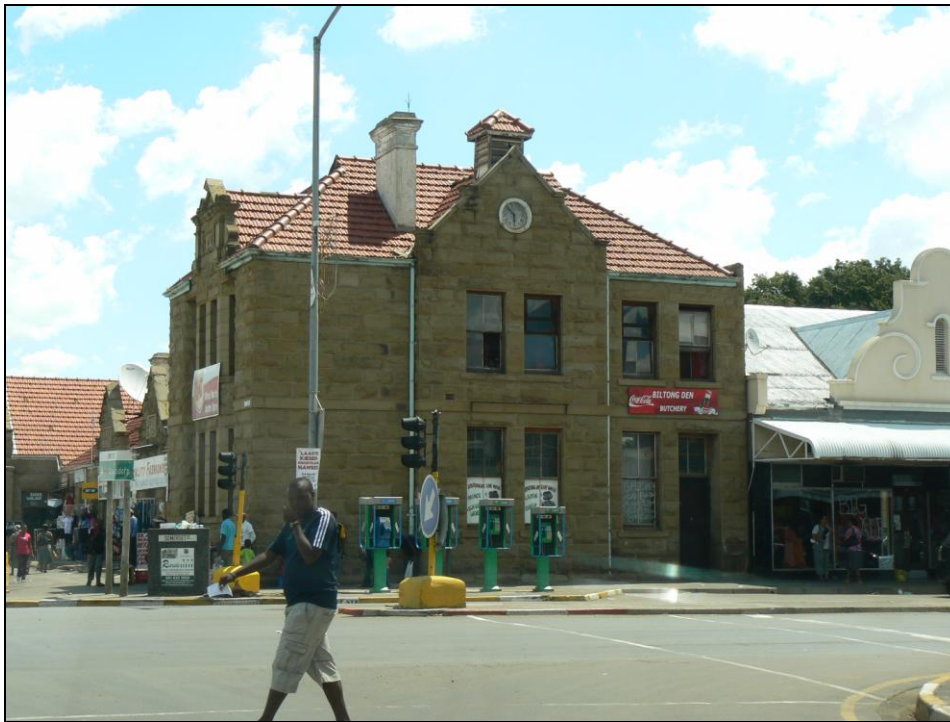
S 3(2) NHRA heritage resource	(a) Identification		(b) Significance	(c) Impact		(d) Recommended impact management, alternatives
	Site	GPS		Road section	Impact type, certainty and significance	
Buildings, structures, places and equipment of cultural significance	Historic buildings Aliwal North (various)	-	High local	Smith and Grey streets	Damage during installation possible – low negative to neutral	Avoid and mitigation: Photograph and document current situation before trenching. Monitor damage to structures and buildings during trenching, installation and surface rehabilitation.

FIGURE 42: The former magistrate's and post office (1896) on the corner of Grey and Smith streets is one of Aliwal North's most important historical buildings

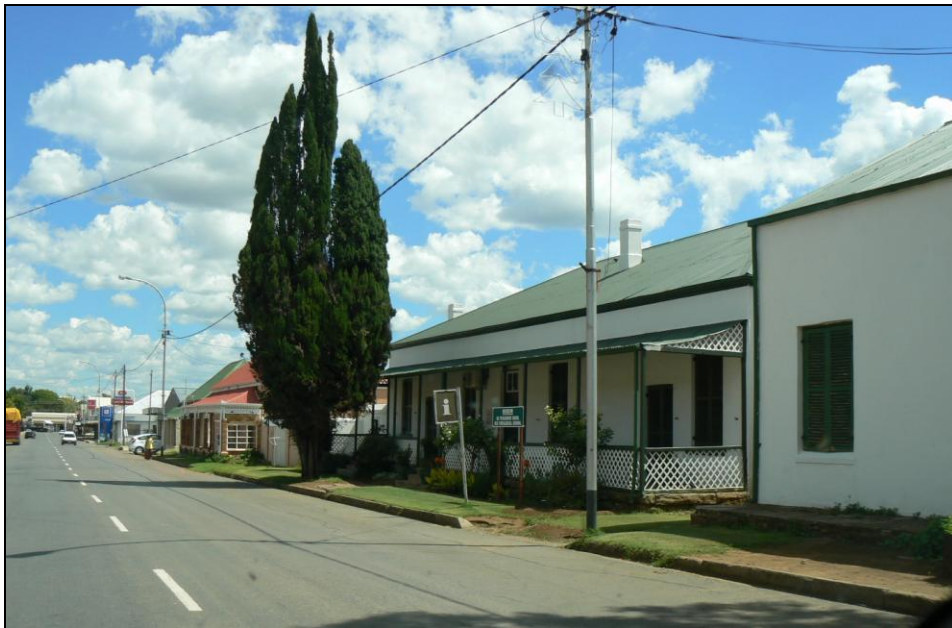
FIGURE 43: Various historic buildings front on Piet Retief and other streets in Burgersdorp

S 3(2) NHRA heritage resource	(a) Identification		(b) Significance	(c) Impact		(d) Recommended impact management, alternatives
	Site	GPS		Road section	Impact type, certainty and significance	
Buildings, structures, places and equipment of cultural significance	Historic buildings Burgersdorp (various)	-	High local	Piet Retief, Taylor, Van der Walt, Coligny streets)	Damage during installation possible – low negative to neutral	Avoid and mitigation: Photograph and document current situation before trenching. Monitor damage to structures and buildings during trenching, installation and surface rehabilitation.

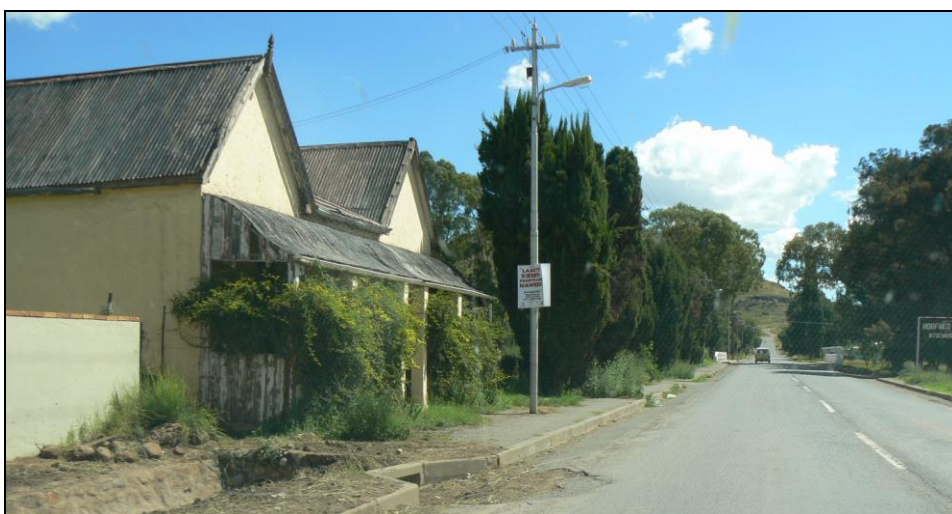
FIGURE 44: Historic buildings along Venter Street in Steynsburg

Historic buildings Steynsburg (various)	-	Low local	Venter Street	Damage during installation possible – low negative to neutral	Avoid and mitigation: Photograph and document current situation before trenching. Monitor damage to structures and buildings during trenching, installation and surface rehabilitation.
	Historic buildings Middelburg (various)	-	High local	Du Plessis and Meintjies streets	Damage during installation possible – low negative to neutral	Avoid and mitigation: Photograph and document current situation before trenching. Monitor damage to structures and buildings during trenching, installation and surface rehabilitation.
	Andries Pretorius Monument Graaff-Reinet	32°13'51.47"S 24°32'8.72"E	High local	50 m west of road reserve	Probably no impact (outside road reserve)	Avoid and mitigation: Monitor for any damage during installation etc.
	1938 Trek monument, Graaff-Reinet	32°14'15.08"S 24°32'9.80"E	High local	30 m west of road reserve	Probably no impact (outside road reserve)	Avoid and mitigation: Monitor for any damage during installation etc.

S 3(2) NHRA heritage resource	(a) Identification		(b) Significance	(c) Impact		(d) Recommended impact management, alternatives
	Site	GPS		Road section	Impact type, certainty and significance	
Buildings, structures, places and equipment of cultural significance	Historic buildings Steynsburg (various)	-	Low local	Venter Street	Damage during installation possible – low negative to neutral	Avoid and mitigation: Photograph and document current situation before trenching. Monitor damage to structures and buildings during trenching, installation and surface rehabilitation.

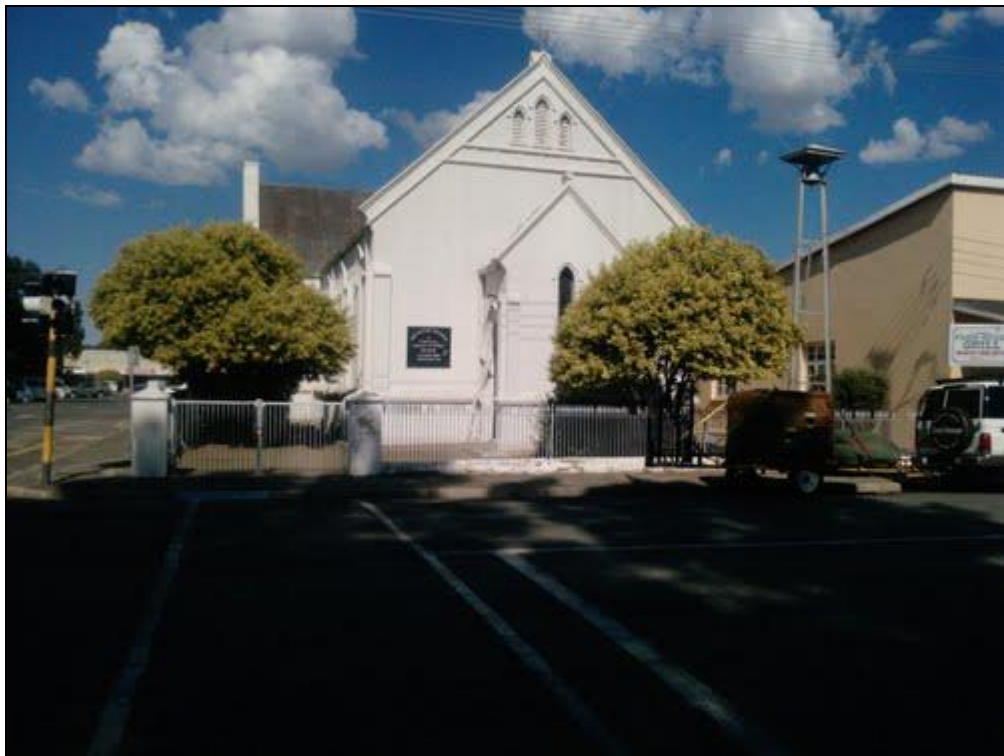
FIGURE 45: The Methodist Church on the corner of Meintjies and Loop streets is one of the many historic buildings in Middelburg

S 3(2) NHRA heritage resource	(a) Identification		(b) Significance	(c) Impact		(d) Recommended impact management, alternatives
	Site	GPS		Road section	Impact type, certainty and significance	
Buildings, structures, places and equipment of cultural significance	Historic buildings Middelburg (various)	-	High local	Du Plessis and Meintjies streets	Damage during installation possible – low negative to neutral	Avoid and mitigation: Photograph and document current situation before trenching. Monitor damage to structures and buildings during trenching, installation and surface rehabilitation.

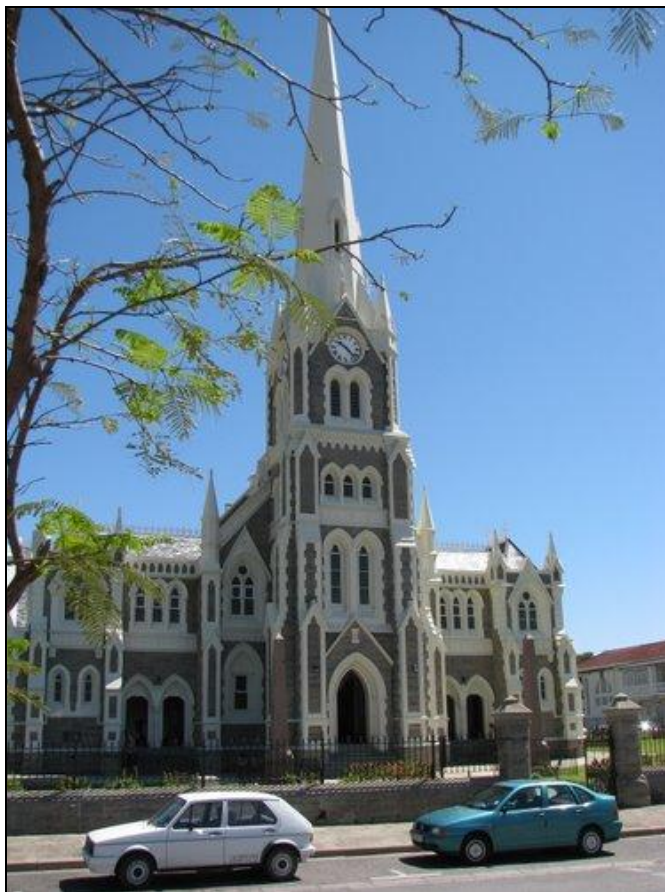
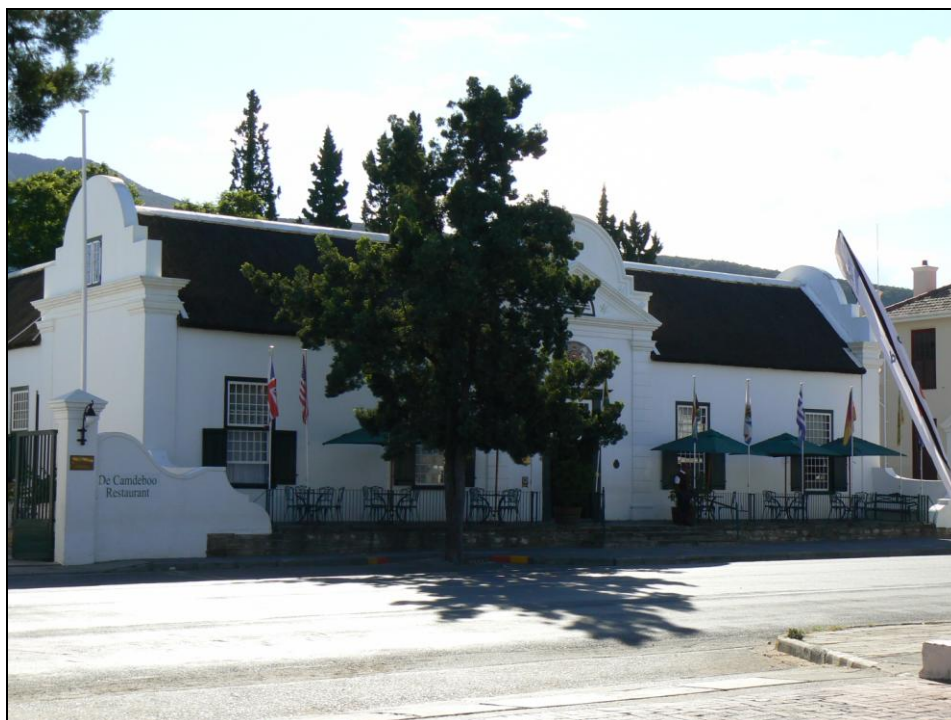
FIGURE 46: The Dutch Reformed Church (top) and the Drostdy Hotel (bottom), both declared heritage sites, are amongst the many historic buildings lining the streets of Graaff-Reinet

S 3(2) NHRA heritage resource	(a) Identification		(b) Significance	(c) Impact		(d) Recommended impact management, alternatives
	Site	GPS		Road section	Impact type, certainty and significance	
Buildings, structures, places and equipment of cultural significance	Historic buildings Graaff-Reinet (numerous, some of them declared heritage sites)	-	High local and regional	Caledon and Kerk streets	Damage during installation possible – medium/high negative to neutral	Avoid and mitigation: Photograph and document current situation before trenching. Monitor damage to structures and buildings during trenching, installation and surface rehabilitation.

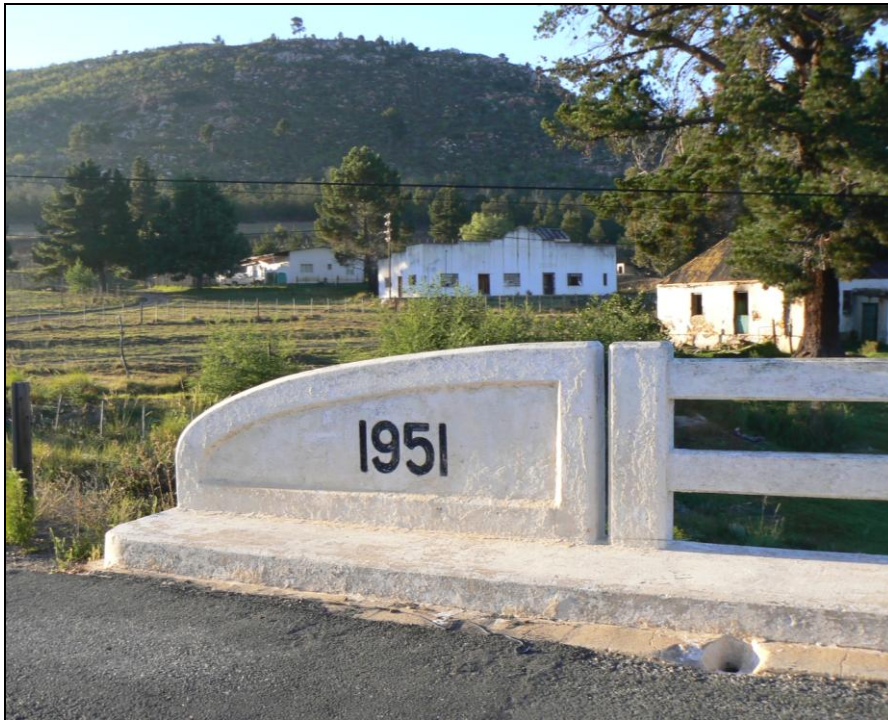
S 3(2) NHRA heritage resource	(a) Identification		(b) Significance	(c) Impact		(d) Recommended impact management, alternatives
	Site	GPS		Road section	Impact type, certainty and significance	
Buildings, structures, places and equipment of cultural significance	Doring River Bridge (1951)	33°50'3.13"S 22°26'41.29"E	Low local	N 9 Uniondale-George	Low	Mitigation: Cable installation should be invisible, reversible and not seriously damage the bridge. Document (photograph) bridge sections before installation and photograph installation process. Prepare detailed design drawings that explain the cable installation method for purposes of authorisation by heritage authorities.

FIGURE 47: Doring River Bridge with date inscription

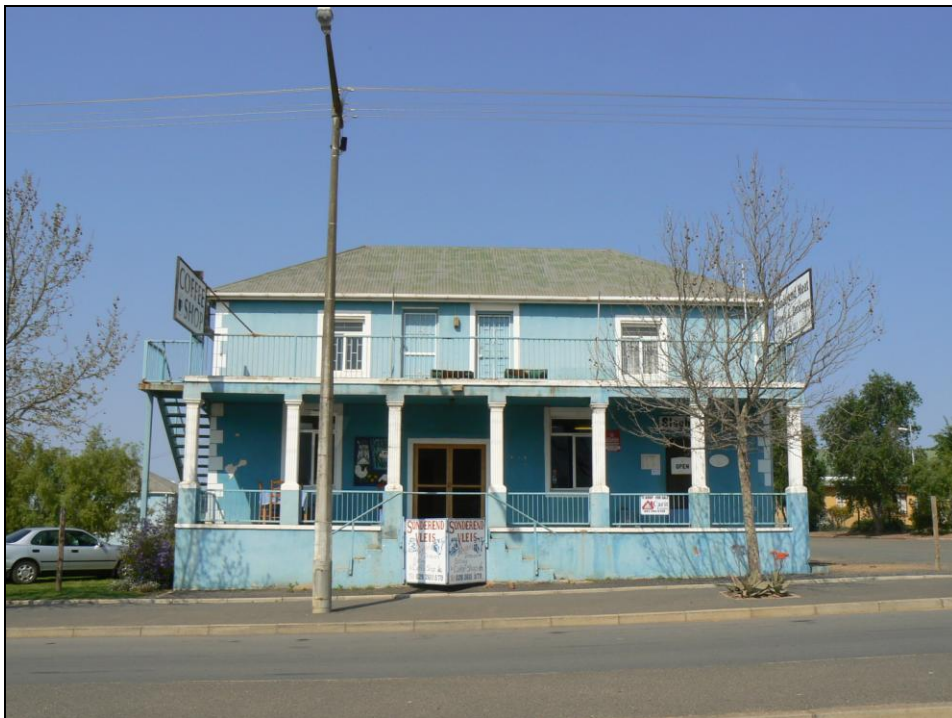
FIGURE 48: One of the historic buildings along the N 2's western approach to Riviersonderend

S 3(2) NHRA heritage resource	(a) Identification		(b) Significance	(c) Impact		(d) Recommended impact management, alternatives
	Site	GPS		Road section	Impact type, certainty and significance	
Buildings, structures, places and equipment of cultural significance	Historic Buildings, Riviersonderend (few)	-	Low local	Main Road	Damage during installation possible – low negative to neutral	Avoid and mitigation: Photograph and document current situation before trenching. Monitor damage to structures and buildings during trenching, installation and surface rehabilitation.

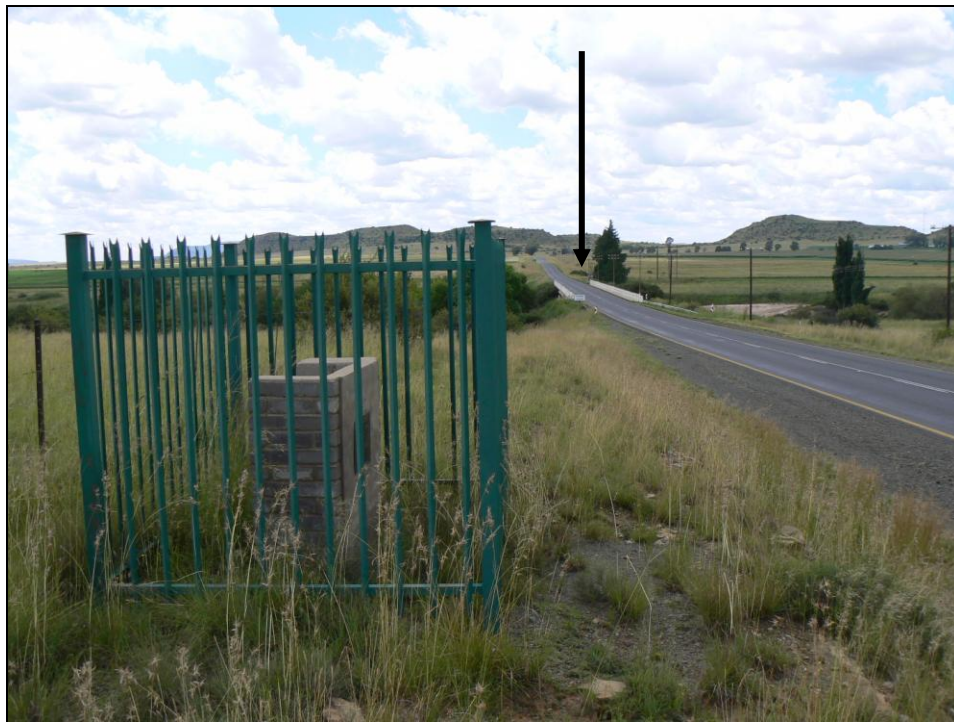
FIGURE 49: Inaugurated in 2005 next to the N 6 at the Caledon River (arrow), this monument commemorates a healing and praying ceremony held on 24 and 25 September in connection with fatal accidents on the N 6

Commissiedrift Prayer Monument	30°16'46.68"S 26°39'6.07"E	High regional	N 6 Smithfield-Rouxville at Caledon River Bridge	Damage during installation possible – low negative (depending on location of cable)	Avoid and monitor for any damage caused by dust, vibrations etc.
	Kleinspruit Cross	30°21'42.82"S 26°45'53.78"E	Low local	N 6 Smithfield-Rouxville, against fence	No impact (against fence)	No action
	Historic buildings Rouxville (few)	-	High local	Rouxville	Damage during installation possible – low negative to neutral	Avoid and mitigation: Photograph and document current situation before trenching. Monitor damage to structures and buildings during trenching, installation and surface rehabilitation.
	Hertzog Bridge across Orange River, Aliwal North (1937)	30°41'9.01"S 26°42'19.64"E	High local	Aliwal North	Medium	Mitigation: Cable installation should be invisible, reversible and not seriously damage the bridge. Document (photograph) bridge sections before installation and photograph installation process. Prepare detailed design drawings that explain the cable installation method for purposes of authorisation by heritage authorities.

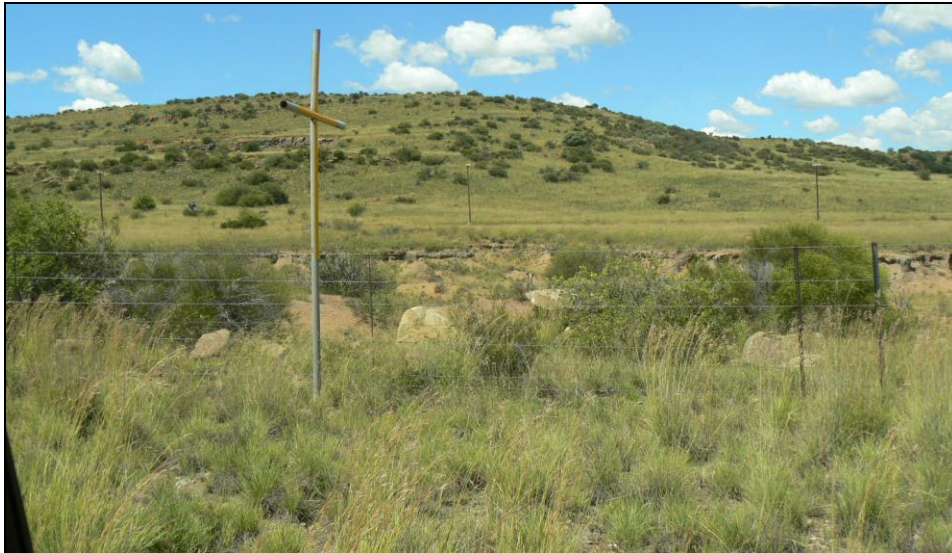
Stormberg crosses (two metal crosses on poles)	30°51'15.21"S 26°25'9.61"E	Low local	R 58 Aliwal North-Burgersdorp, south road reserve	Damage or destruction during installation possible – low negative	Photograph current situation, then remove memorial before trenching and installation and replace afterwards during surface rehabilitation.

FIGURE 50: One of the two metal roadside crosses on the farm Stormberg along the R 58

2. Where roadside memorials (crosses) could be affected, the current situation must be photographed, then removal of memorial (and any plaques etc) before trenching and installation and replacement afterwards during site rehabilitation.

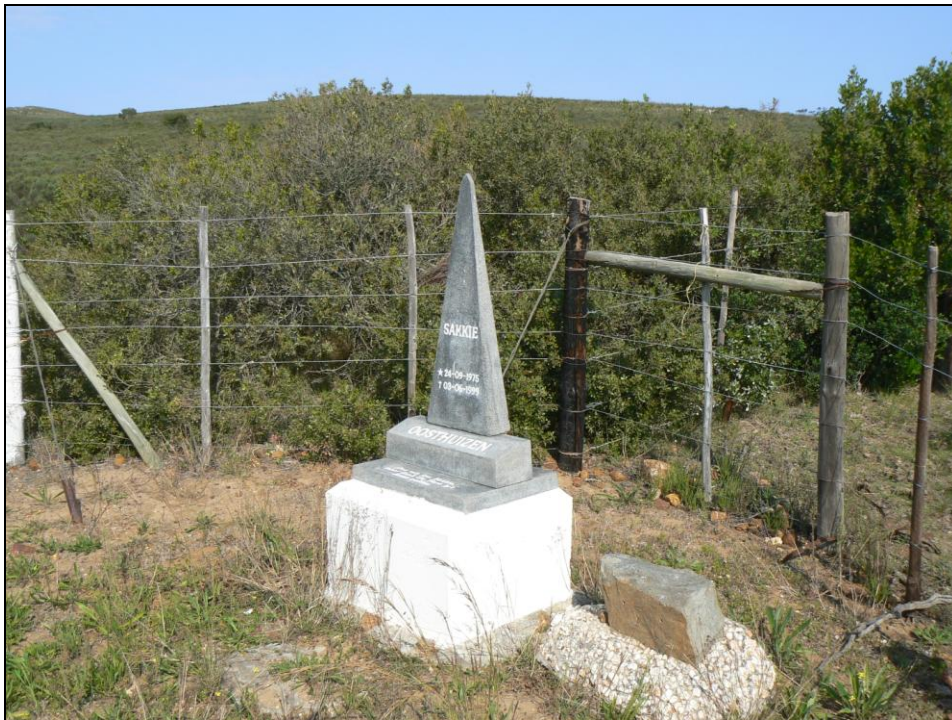
FIGURE 51: The Sakkie Oosthuizen memorial commemorates a tragic road accident that took place in 1999

S 3(2) NHRA heritage resource	(a) Identification		(b) Significance	(c) Impact		(d) Recommended impact management, alternatives
	Site	GPS		Road section	Impact type, certainty and significance	
Buildings,						
	Sakkie Oosthuizen Memorial	34°11'40.24"S 21°47'20.30"E	Low local	N 2 East of Gouritz River, south side	Low to neutral (depends on cable location)	Mitigation: Photograph current situation, then remove memorial before trenching and installation and replace afterwards during surface rehabilitation. Consult local farmer Christiaan Pienaar (044) 697-7044 about family members.
	Rietvlei cross	33°50'49.41"S 18°29'29.24"E	Low local	R 27 Cross mounted against eastern road reserve fence	Probably no impact	Avoid

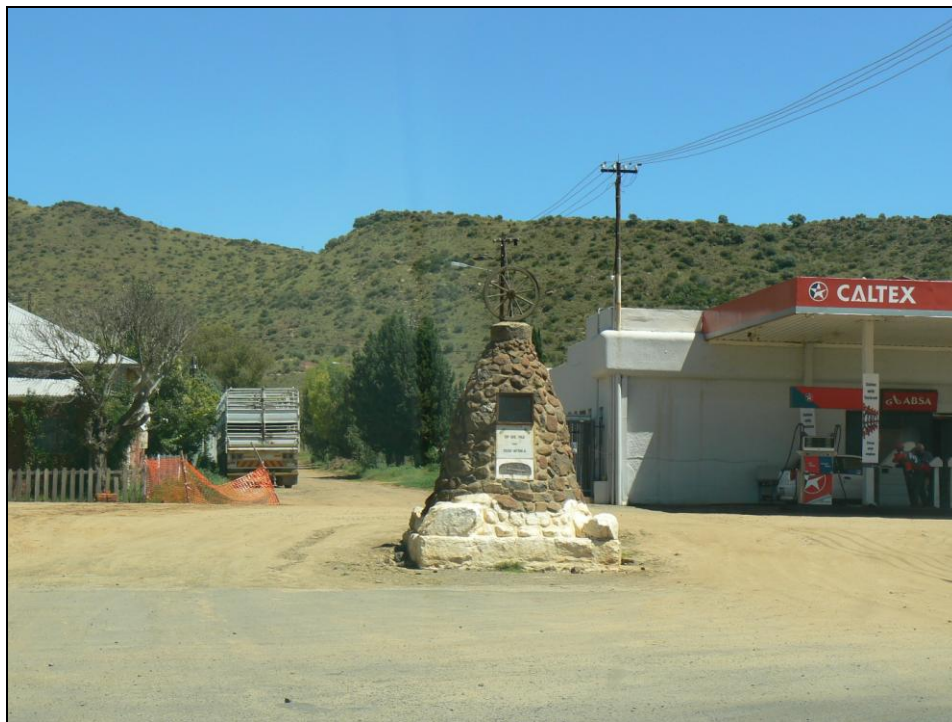
FIGURE 52: 1938 Great Trek commemoration memorial, Smithfield

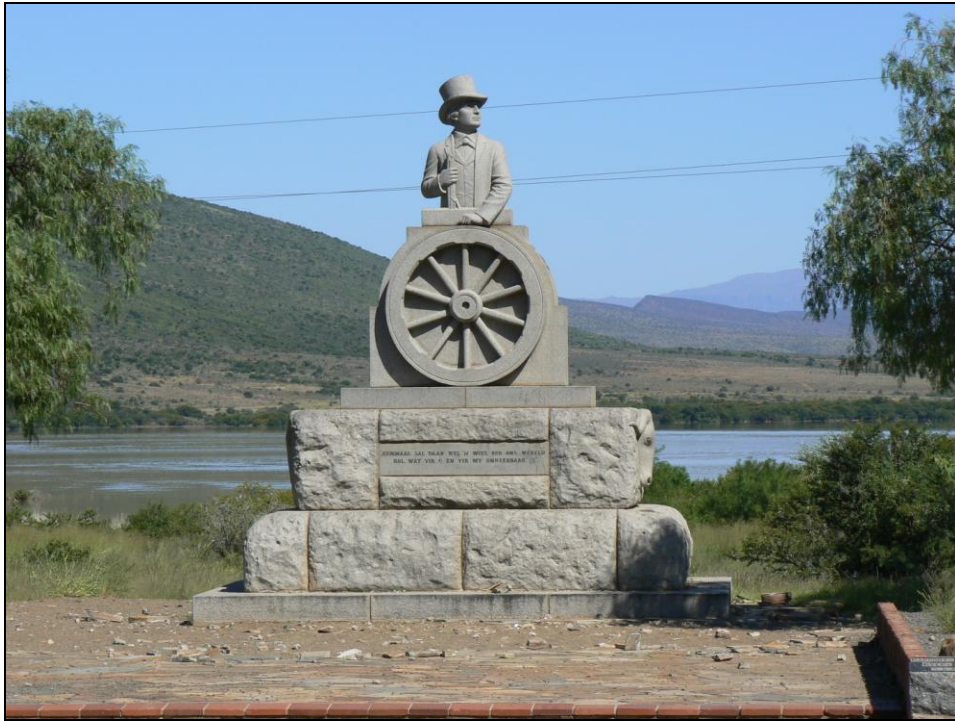
FIGURE 53: Andries Pretorius memorial (1943) just north of Graaff-Reinet

S 3(2) NHRA heritage resource	(a) Identification		(b) Significance	(c) Impact		(d) Recommended impact management, alternatives
	Site	GPS		Road section	Impact type, certainty and significance	
Buildings,	Andries Pretorius Monument Graaff-Reinet	32°13'51.47"S 24°32'8.72"E	High local	50 m west of road reserve	Probably no impact (outside road reserve)	Avoid and mitigation: Monitor for any damage during installation etc.
	1938 Trek monument, Graaff-Reinet	32°14'15.08"S 24°32'9.80"E	High local	30 m west of road reserve	Probably no impact (outside road reserve)	Avoid and mitigation: Monitor for any damage during installation etc.
	Camdeboo Heroes Monument (2006), Graaff-Reinet	32°14'46.90"S 24°32'15.83"E	High regional	Adjacent to western road edge of northern entrance to town	Damage during installation possible – low negative to neutral	Avoid and mitigation: Photograph and document current situation before trenching. Monitor damage to structure during trenching, installation and surface rehabilitation.

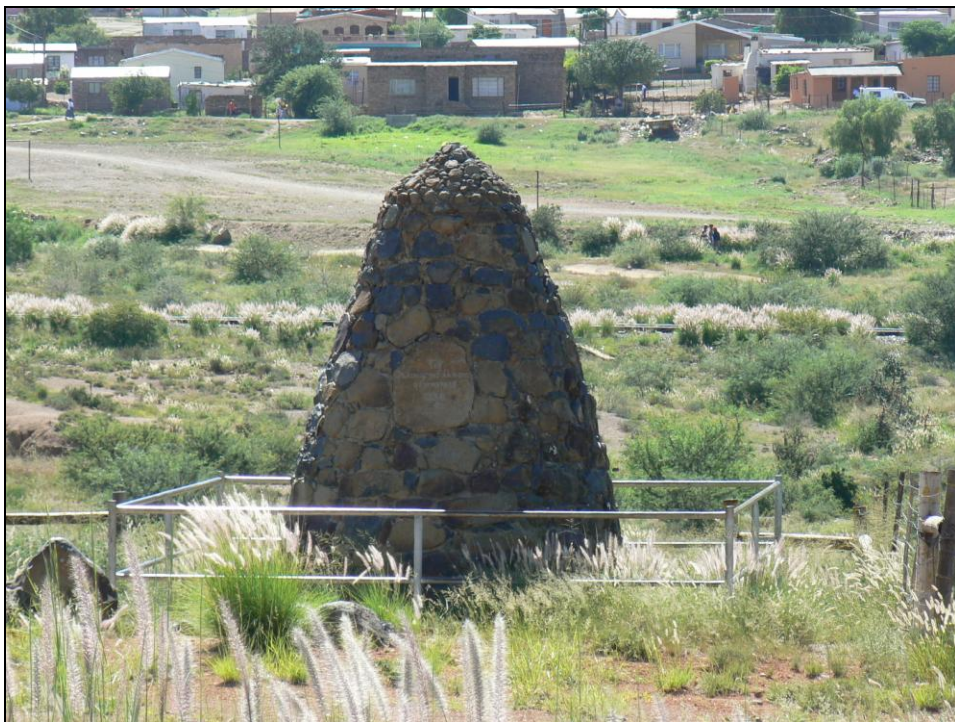
FIGURE 54: 1938 Great Trek commemoration memorial, Graaff-Reinet

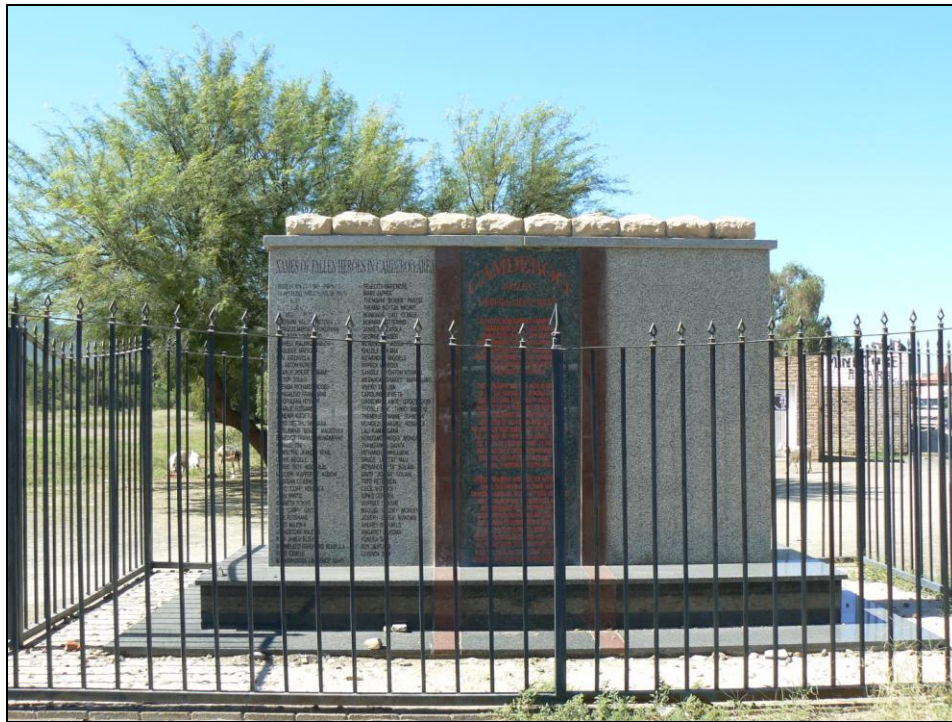
FIGURE 55: Inaugurated in 2006, this memorial at the northern entrance to Graaff-Reinet commemorates the “fallen heroes” of the Camdeboo region

Camdeboo Heroes	32°14'46.90"S 24°32'15.83"E	High regional	Adjacent to western road	Damage during installation possible	Avoid and mitigation:

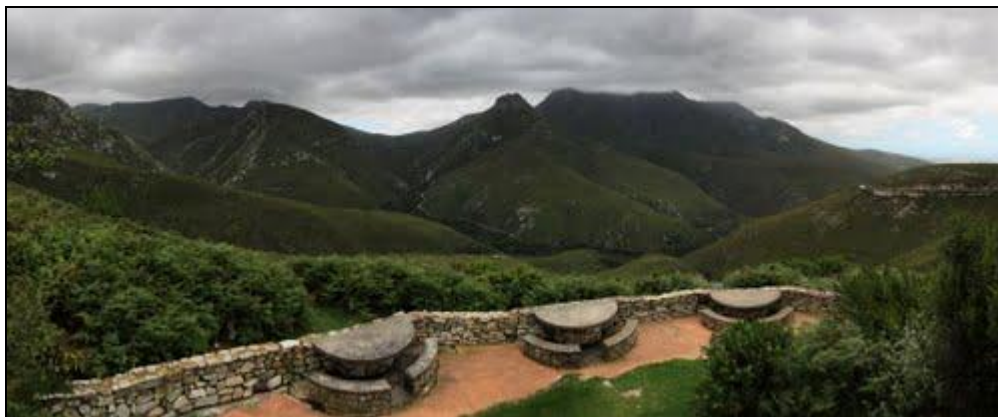
Four Passes Monument and Viewpoint	33°54'21.38"S 22°24'22.59"E	High local	N 9 Outeniqua Pass	Probably no impact (outside eastern road reserve)	Avoid and mitigation: Monitor for any damage during installation etc.

FIGURE 56: Four Passes monument and viewpoint, Outeniqua Pass

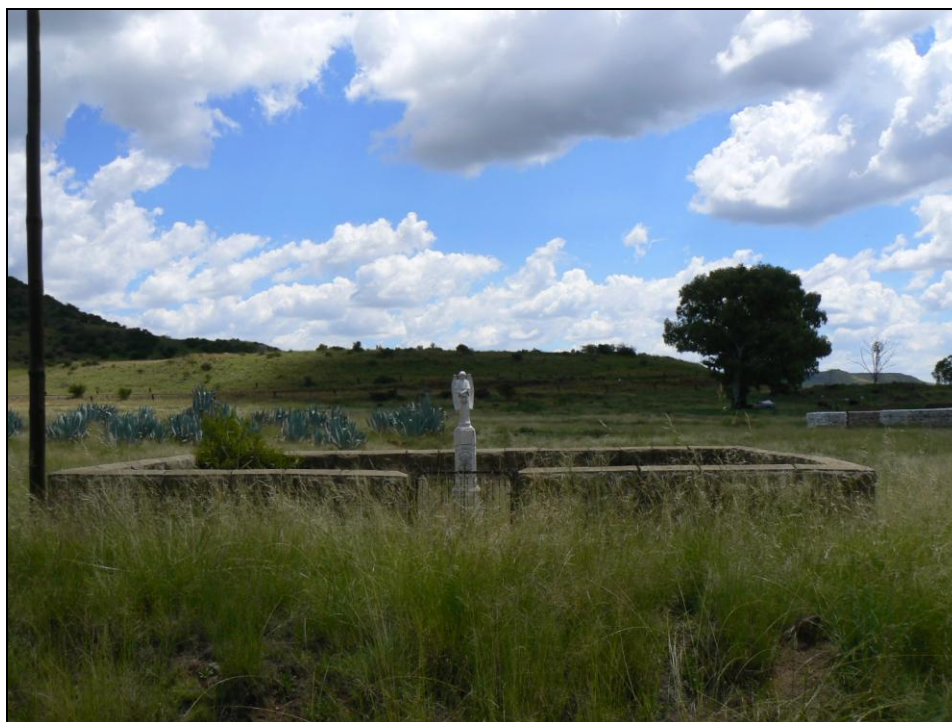
FIGURE 57: Cemetery on the farm Beestekraal adjacent to the N 6 road reserve

S 3(2) NHRA heritage resource	(a) Identification		(b) Significance	(c) Impact		(d) Recommended impact management, alternatives
	Site	GPS		Road section	Impact type, certainty and significance	
Graves and burial sites	Beestekraal cemetery	30°33'25.39"S 26°47'19.57"E	Medium local	N 6 Rouxville-Aliwal North, adjacent to northern road reserve	Probably no impact (outside road reserve)	Avoid and mitigation: Monitor for any damage during installation etc.
	Bultfontein cemetery	31°33'50.30"S 25° 0'18.83"E	Medium local	N 9 Middelburg-Graaff-Reinet	Probably no impact (outside road reserve)	Avoid and mitigation: Monitor for any damage during installation etc.
