**A REPORT ON A HERITAGE IMPACT ASSESSMENT FOR THE UPGRADE OF
VARIOUS BUILDINGS AT VHEMBE FURTHER EDUCATION AND TRAINING
COLLEGE/ CAMPUSES, LIMPOPO PROVINCE**

REPORT: AE01552V

December 2015

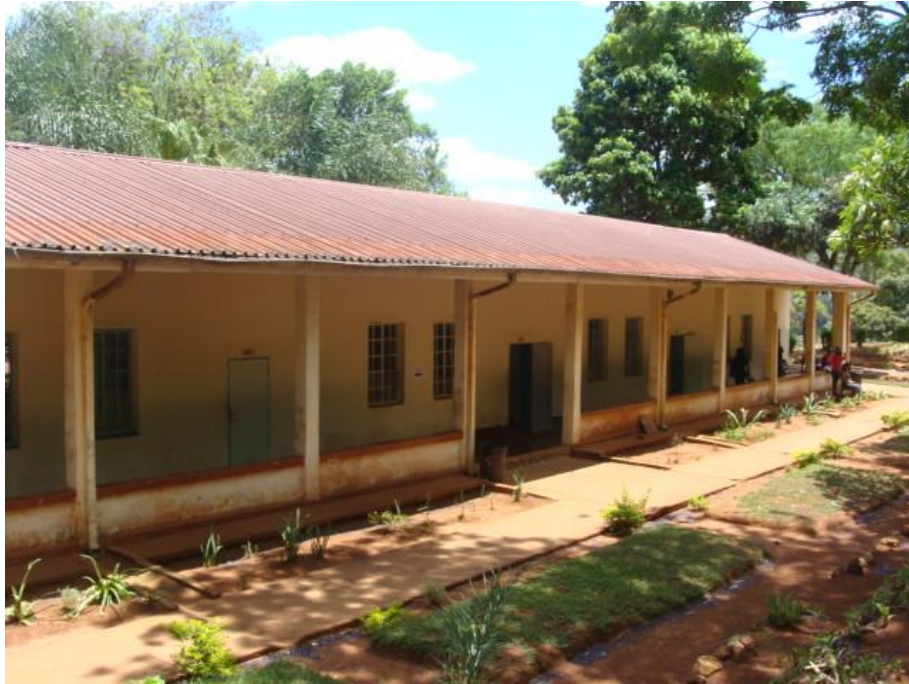
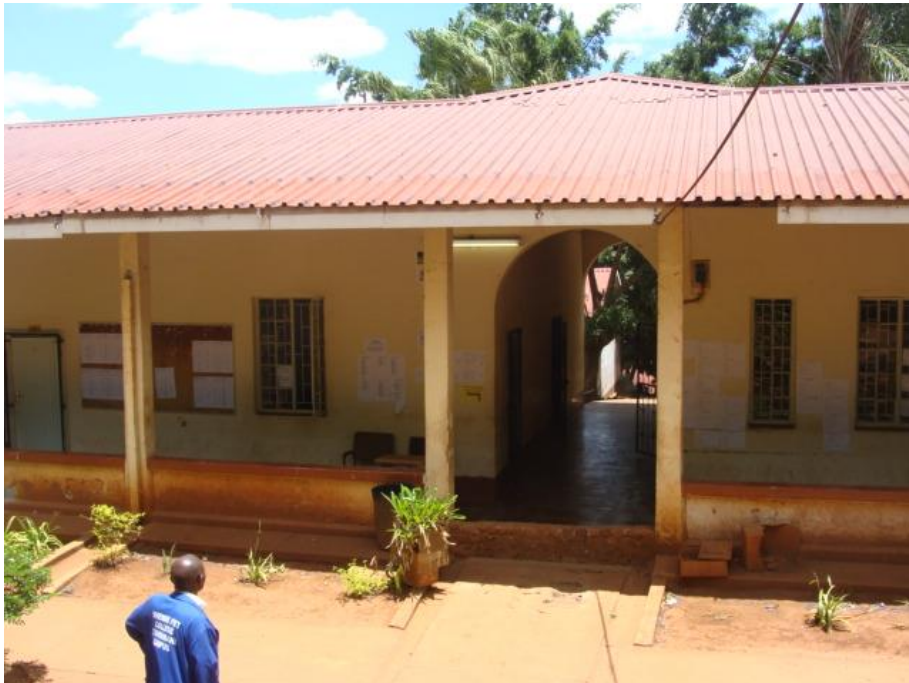
Classroom 1-8 and Offices (6) – Figure 33-34

As indicated it is not always possible to determine the exact age of buildings. The ones in this category was likely built just before the 1960's, and are therefore presumed to be older than 60 years of age. Although the age thereof gives it heritage significance, none of these buildings are in a good condition and it also has been changed many times since it has been built. The buildings also are not very unique and have no specific architectural features of note.

Figure 33: Classroom 1-8 and Offices.

Figure 34: Entrance to Classroom 1-8 and Offices.

- Therefore it receives a rating of low cultural significance. The proposed upgrade of these buildings may continue, but a permit for this purpose should be obtained from the Provincial Heritage Authority of the Limpopo Province (LHRA).

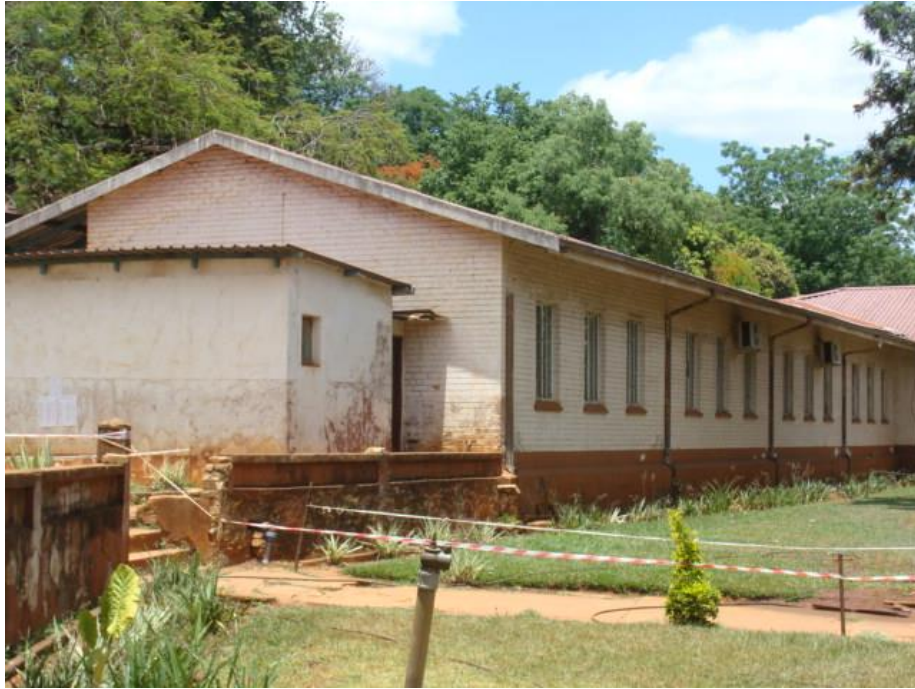
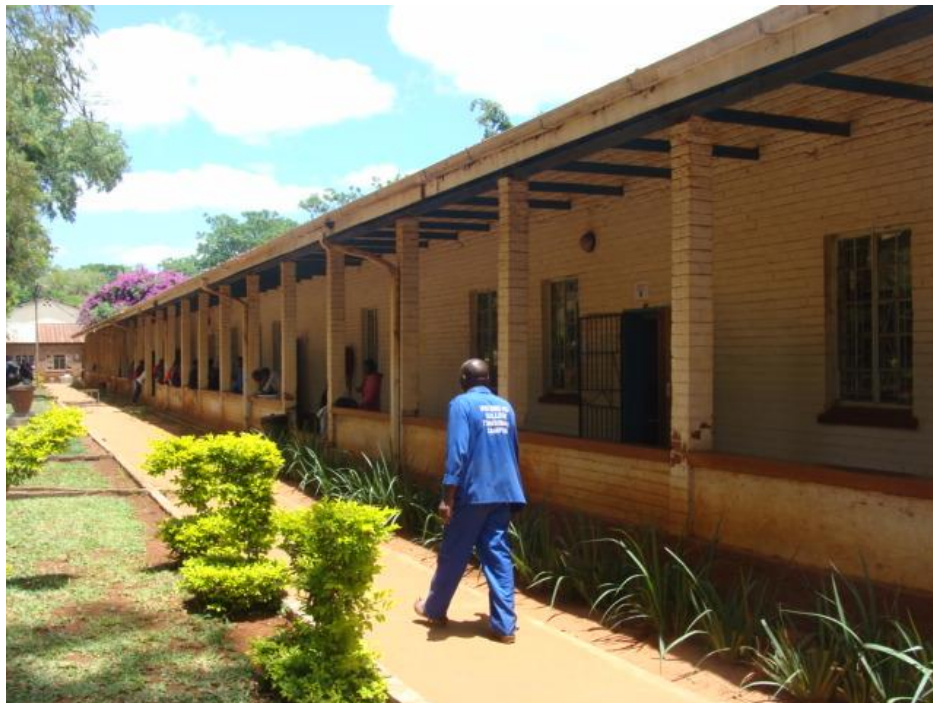
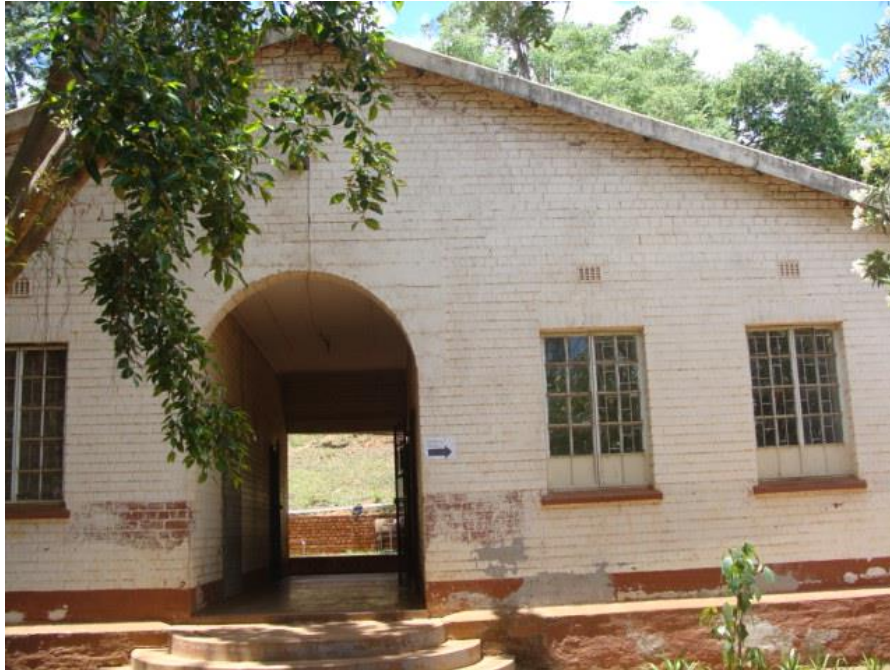
Classroom (7) - Figure 35-37

Figure 35: Classroom.

Figure 36: Another view of the Classroom.

Figure 37: Front façade of the Classroom.

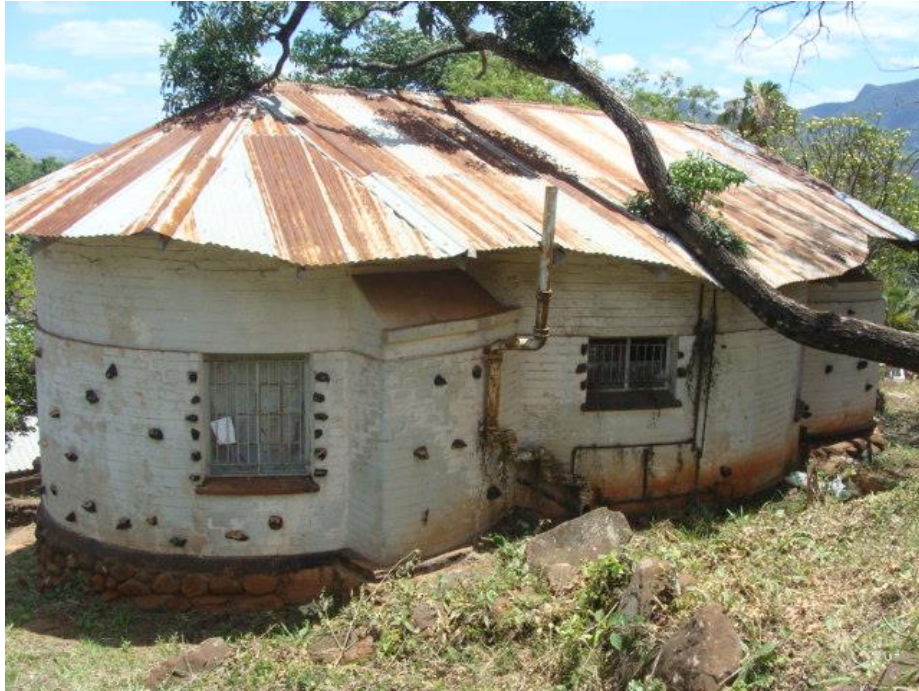
As indicated it is not always possible to determine the exact age of buildings. The ones in this category was likely built just before the 1960's, and are therefore presumed to be older than 60 years of age. Although the age thereof gives it heritage significance, none of these buildings are in a good condition and it also has been changed many times since it has been built. The buildings also are not very unique and have no specific architectural features of note.

Figure 62: Staff Residence.

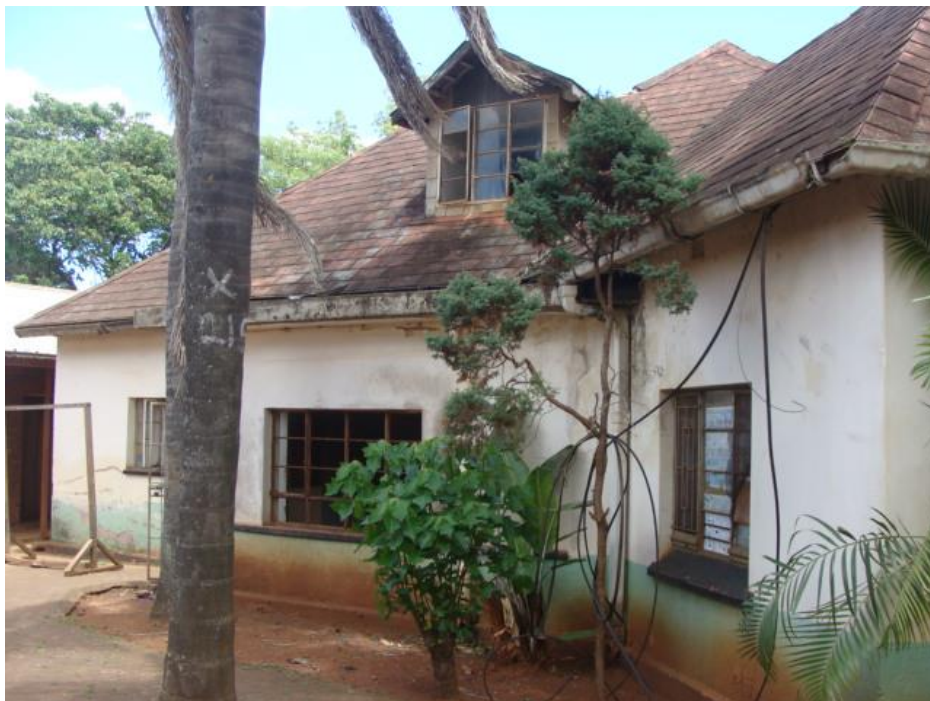
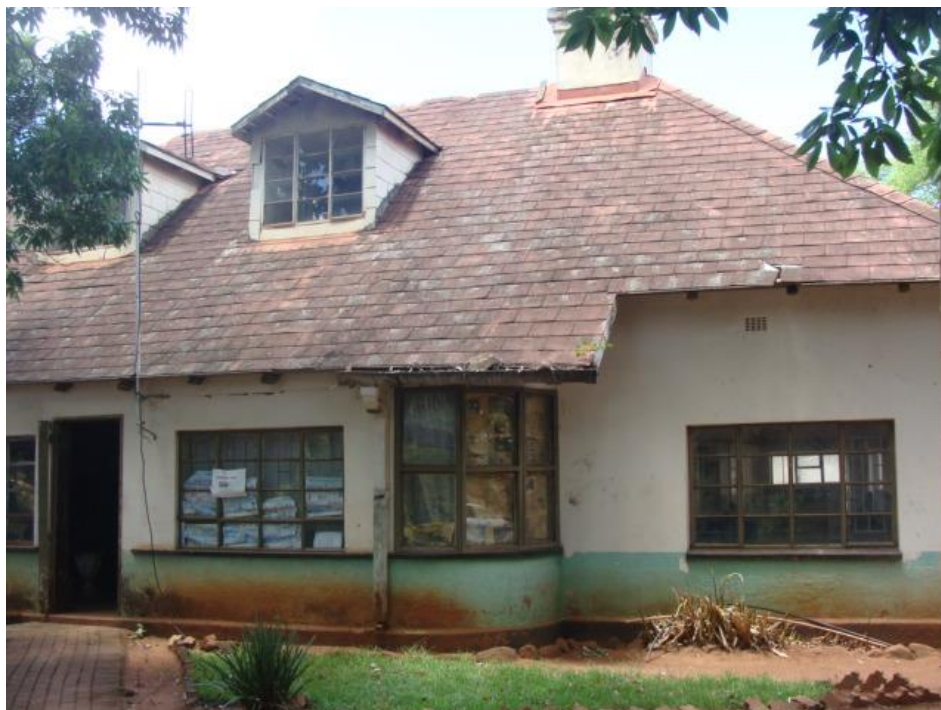
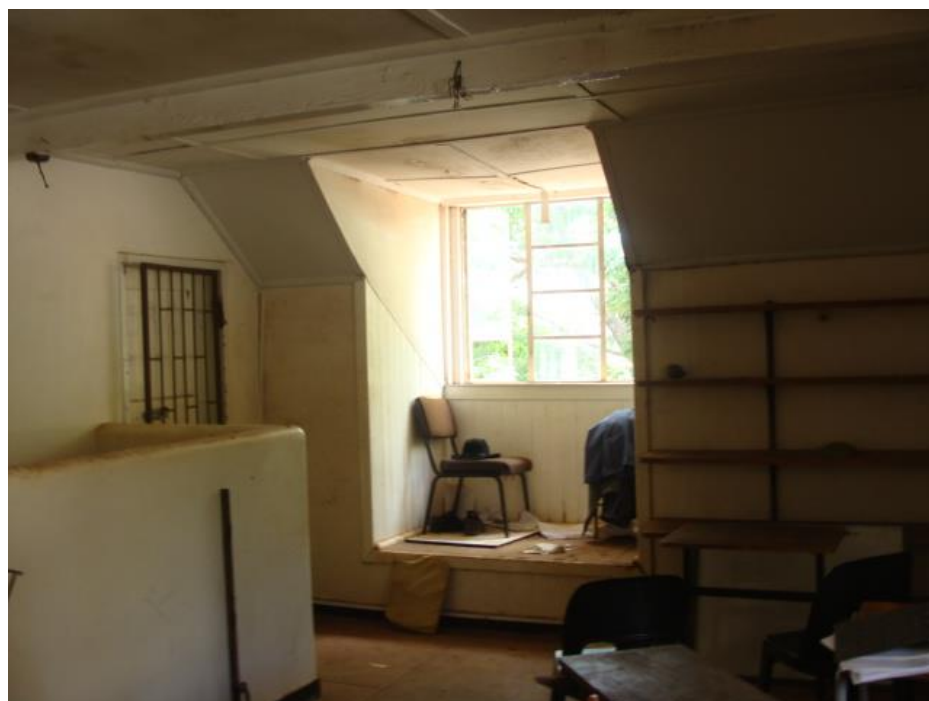
Figure 63: GRC Office.

Figure 64: Front façade of the GRC Office.

Figure 65: Inside view of the GRC Office.

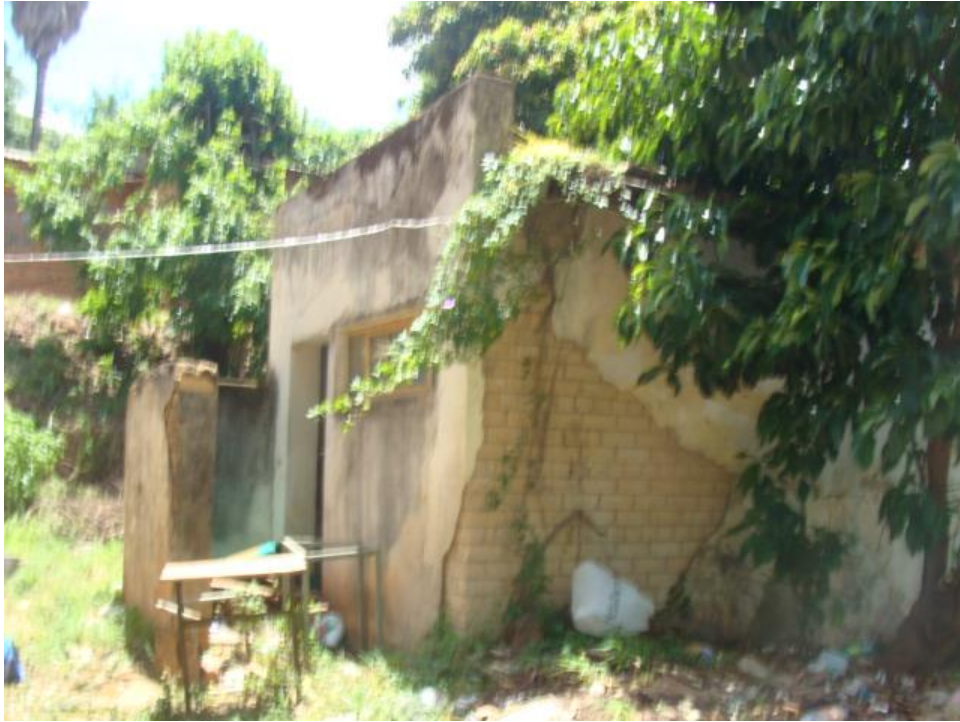
Figure 66: Storage.

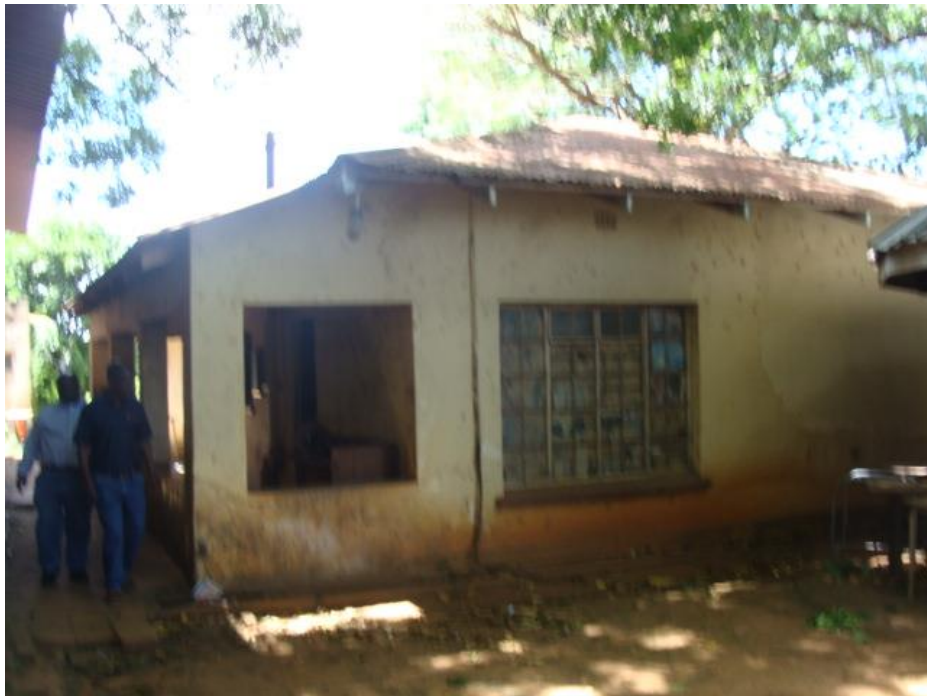
Staff Residence (51) – The house it typical of the Late Edwardian architecture, dating to roundabout the 1920's-1930's. It is very common and in a bad state and therefore has a low cultural significance – Figure 67-68

Figure 67: Staff Residence. Late Edwardian characteristics.

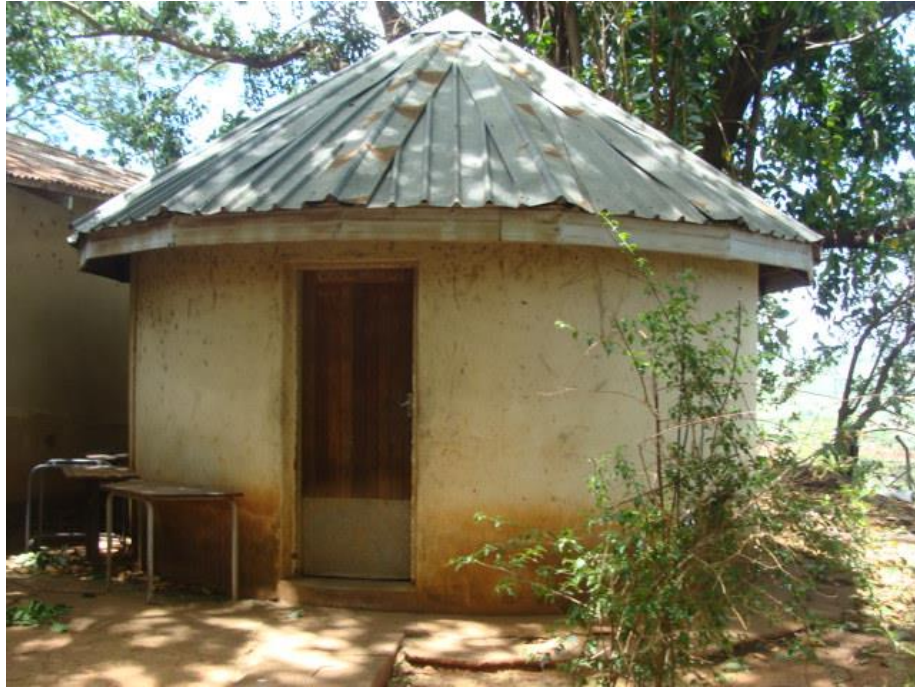
Figure 68: Rondavel adjacent to the above building.

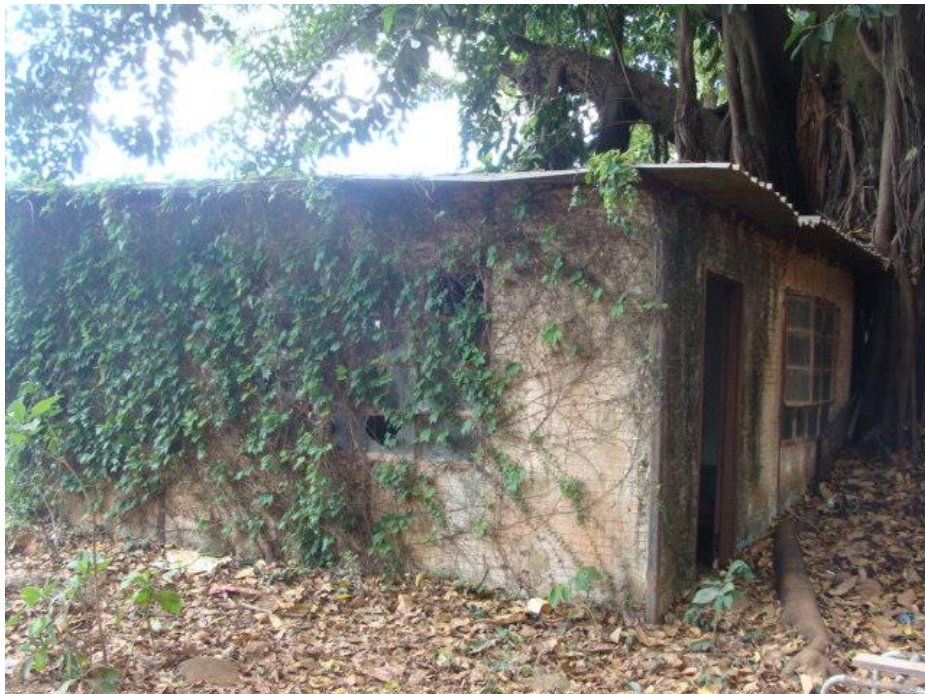
Stores (53) – Figure 69

Figure 69: Stores.
