**FIRST PHASE ARCHAEOLOGICAL AND HERITAGE
ASSESSMENT OF THE BORROW PIT DEVELOPMENTS NEAR
CAMPBELL, NORTHERN CAPE**

A borrow pit for the supply of road building material is planned at Campbell in the Northern Cape.

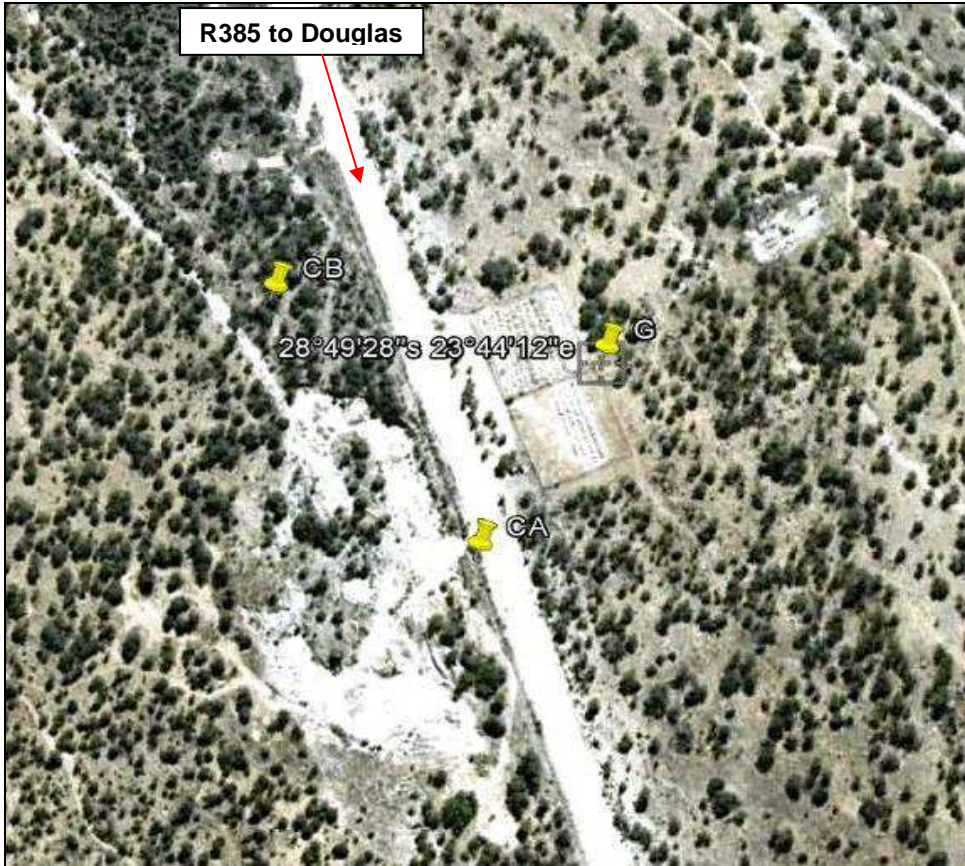
Map 3 Proposed borrow pit site at Campbell. Position of GPS coordinates indicated.

A borrow pit for the supply of road building material is planned at Campbell in the Northern Cape. The application is done on behalf of the Siyancuma Local Municipality, P.O. Box 27, Douglas. The area is part of the existing borrow pit and is heavily disturbed (Map 3).

The following GPS coordinates (Cape scale) were taken (Map 3) (2923).

CA	29°49'30"S 023°44'11"E	Altitude 1153m (Figs.1&2)
CB	29°49'26"S 023°44'06"E	Altitude 1154m (Figs.3-5)
G	29°49'28"S 023°44'12"E	Altitude 1149m (Fig.6)

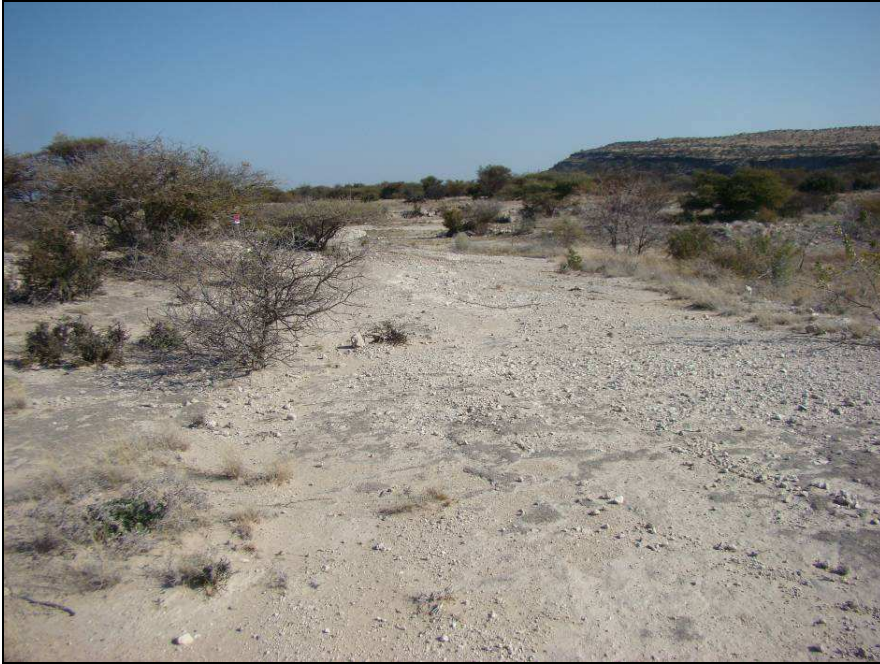
Fig.1 Point CA at Campbell borrow pit.

The area proposed for the new quarry developments (Map 3) is part of an existing borrow pit (Figs.1&2). Extensive soil excavations resulted in a serious disturbance of the land (Fig.2).

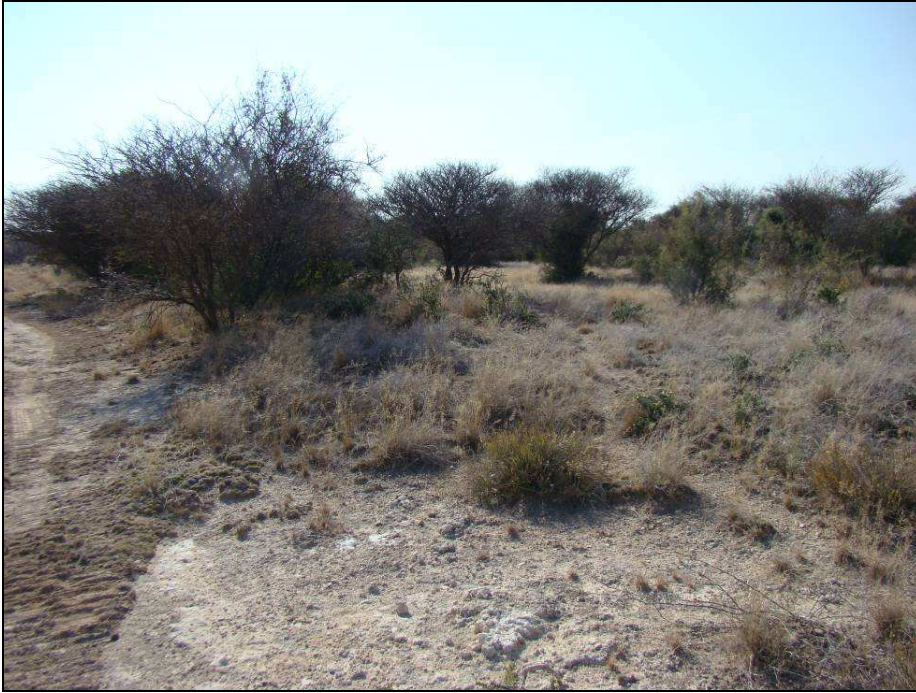
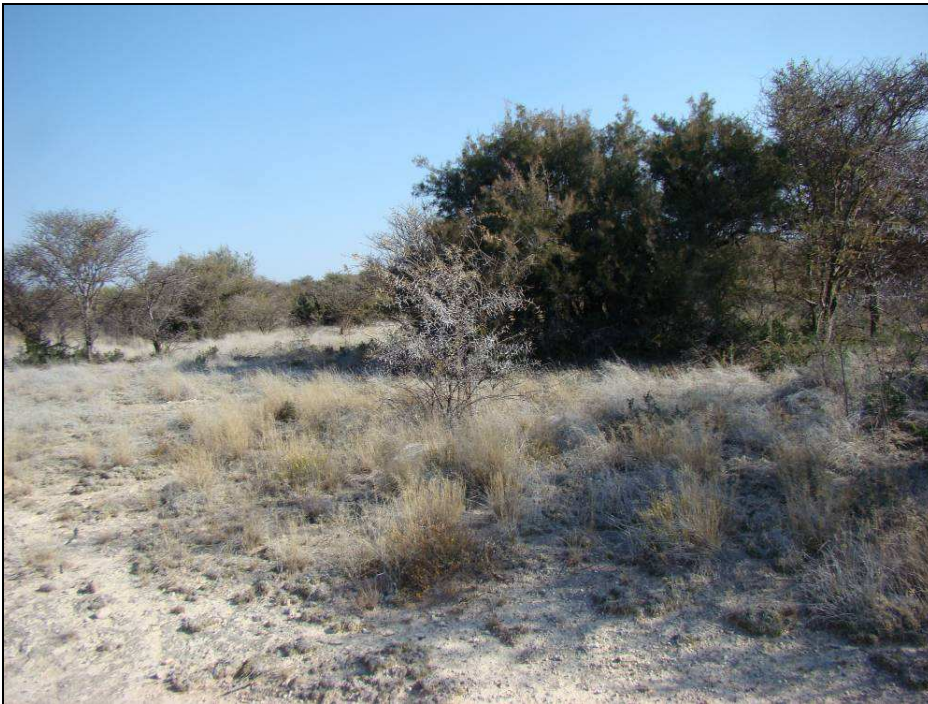
Vegetation cover consists mainly of Haak-en-Steek or Umbrella Thorn (*Acacia tortillis*) and Swarthaak or Black Thorn (*Acacia mellifera*) trees (Figs.3-5).

Fig.3 Point CB at Campbell borrow pit.

Fig.4 Point CB at Campbell borrow pit.

Fig.5 Point CB at Campbell borrow pit.

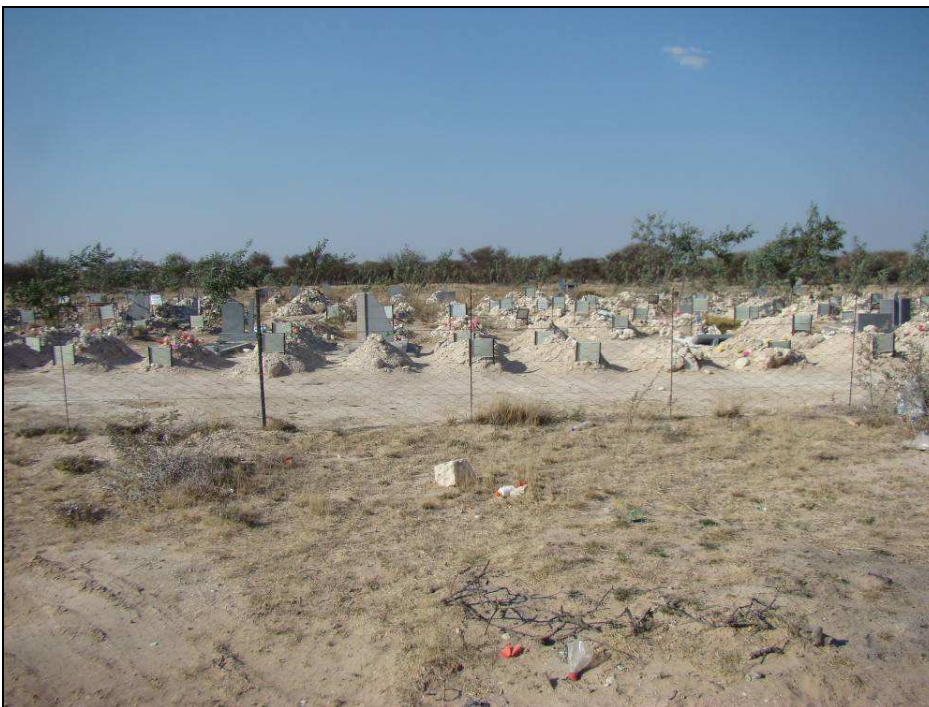
Fig.6 Graves at Point G near Campbell borrow pit.

A large graveyard with many graves (Map 3) is located right across the road from the proposed borrow pit site (Fig.6). These graves will not be affected in any way by the developments at the quarry.

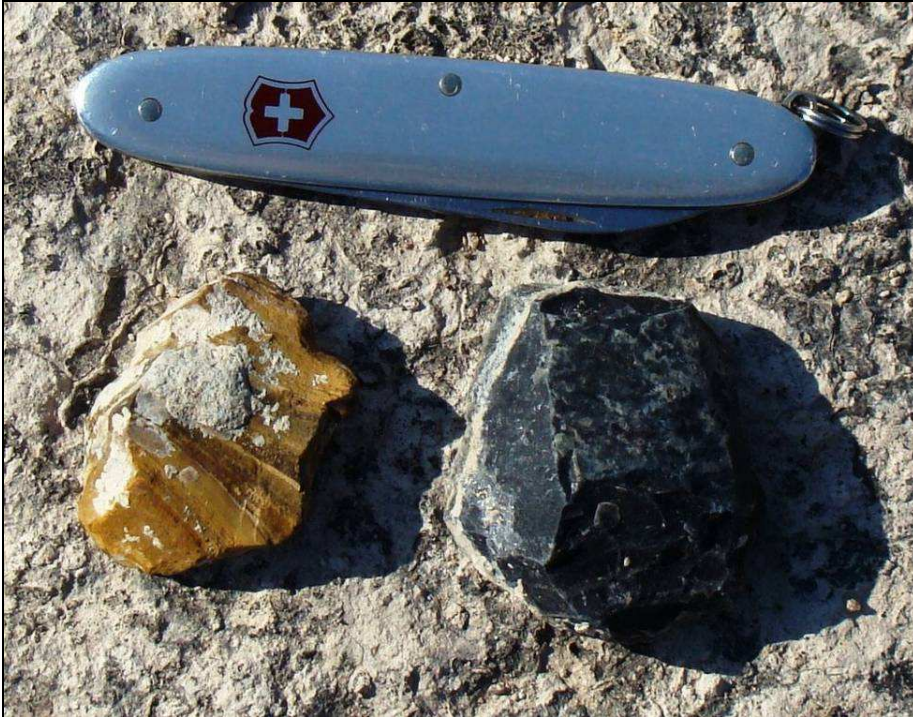
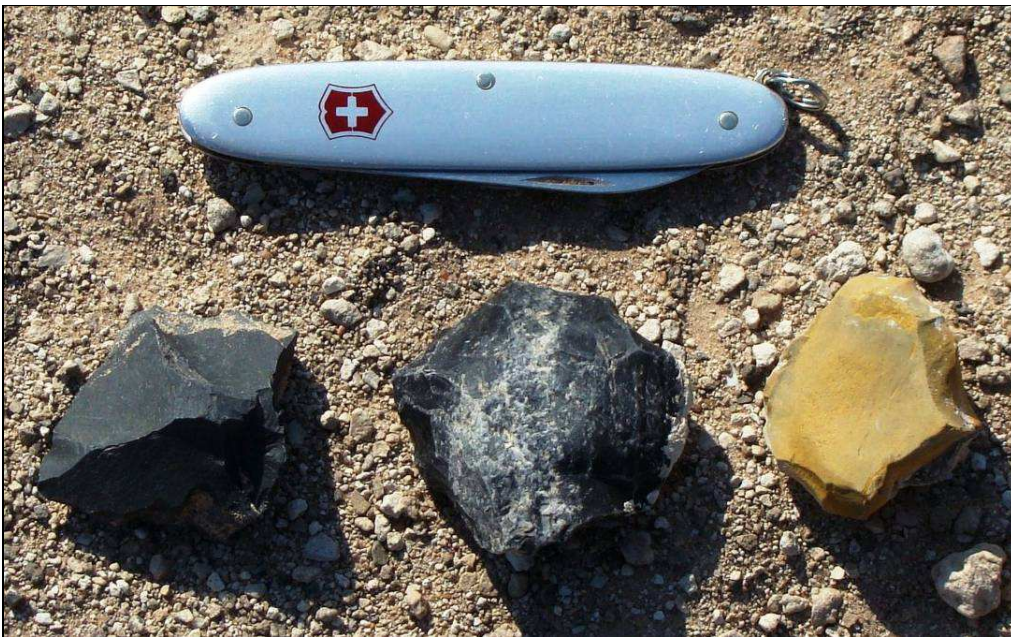
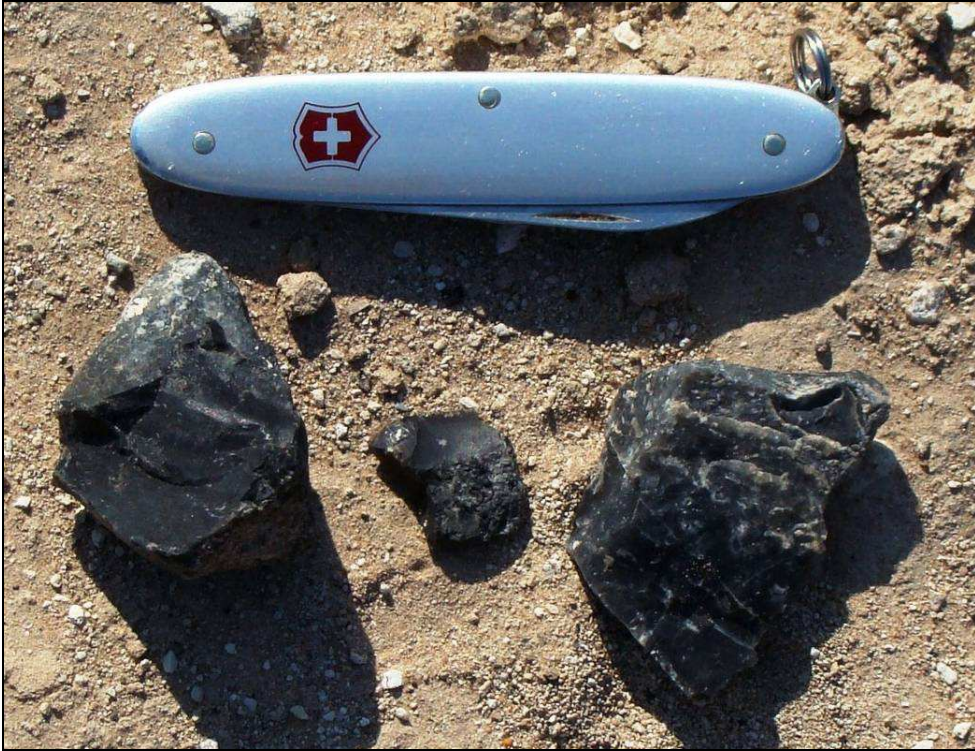
A few stone flakes were collected on the floor of the existing borrow pit (Figs.7-9). The stone flakes and cores are primarily made of Chert and have no secondary trimming. Percussion bulbs are prominent in most cases and prepared platforms are narrow and level. From standard tool typology and basic characteristics, the material could arbitrarily be classified as Later Stone Age.

The few scattered stone flakes are of minor significance. I anticipate that the borrow pit excavations will have no impact on any cultural or historical remains.

Fig.7 Stone flakes at Campbell borrow pit (Pocket knife=84mm).

Fig.8 Stone flakes at Campbell borrow pit (Pocket knife=84mm).

Fig.9 Stone flakes at Campbell borrow pit (Pocketknife=84mm).

There are no obvious reasons to delay the commencement of further planning of the borrow pit and I recommend that the work may proceed.

No mitigation measures will be required.
