REPORT ON SITE VISIT TO WEENEN NATURE RESERVE

Date: 5th and 6th of August 2013

Compiled by: Celeste Rossouw

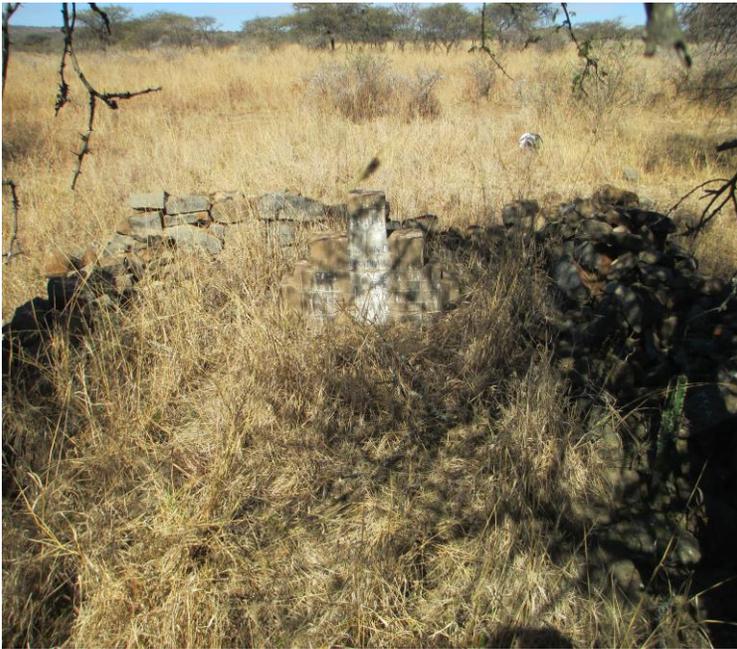
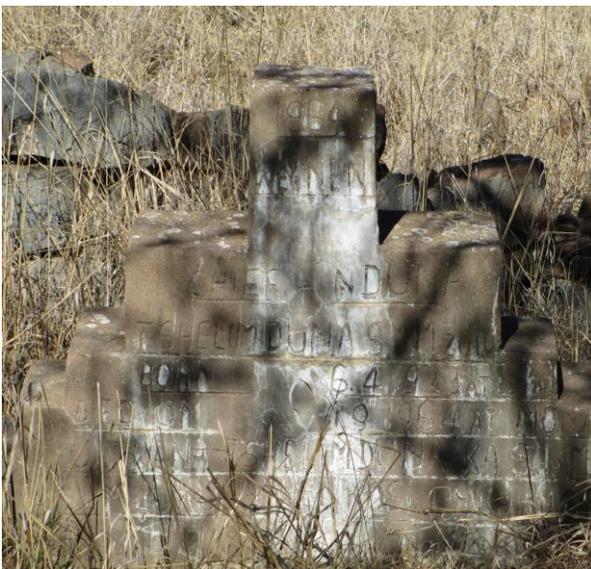
(i) Nkosi's grave

Content: 1964

The grave faces east

Condition: Fair

Material: Fence made of dolerite rock and headstone of bricks and cement, plastered and painted

- Any alteration or repair to the graves (including their head stone, random rubble, and the periphery wall) can only be executed, once the owners of the graves have obtained a permit from Amafa. Since this will include direct intervention and informal graves are protected.

- No excavation or stabilization of the graves if subsidence occurs can be carried out without a permit been issued by Amafa, since the latter also embodies direct intervention.

- General maintenance: this will be allowed and includes trimming the grasses inside the wall and washing of the headstone with water and Sunlight-liquid (the softest soap on the market).

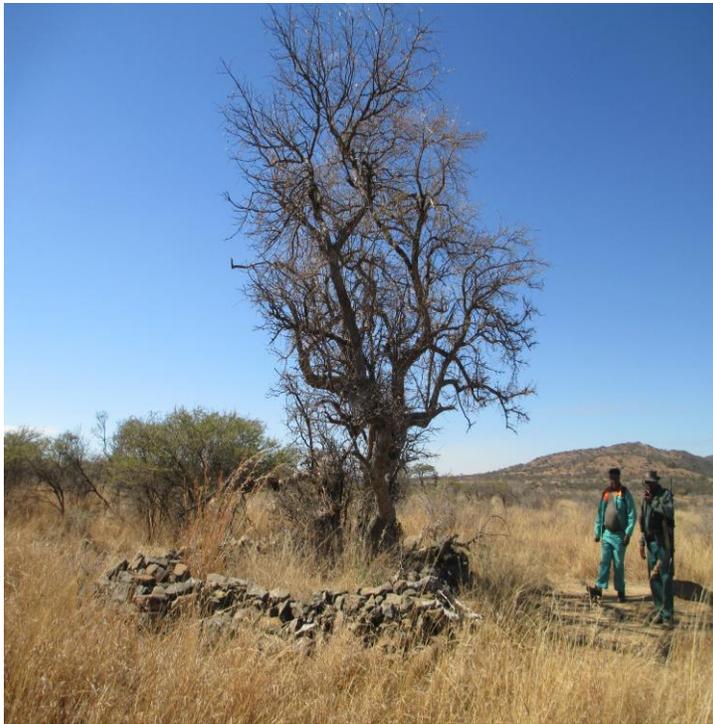
(ii) **Daughter's grave:**

Content: Contains no headstone, ledger or curbing, only a packed wall measuring 5m by 2m.

Material: wall is built of shale; a buffalo thorn-tree adorns the middle of the grave

Condition: Fair

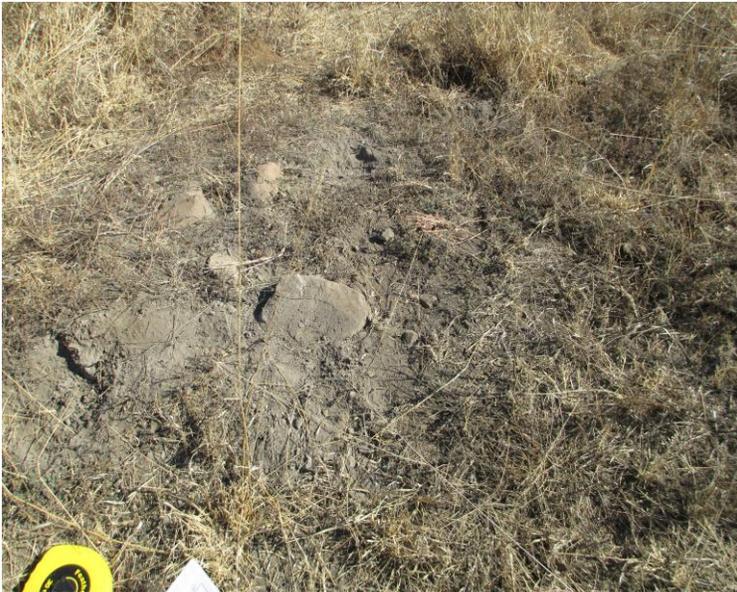
Ash-heap (see photo below):

I am not certain if the ash-pit is of more recent or older age, but subsidence is not evident and accordingly it could be of a recent age.

Management recommendations: No one may alter, remove, destroy or excavate this site without a permit being obtained from Amafa and Ezemvelo KwaZulu-Natal Wildlife, taking into consideration that it is located within a protected area.

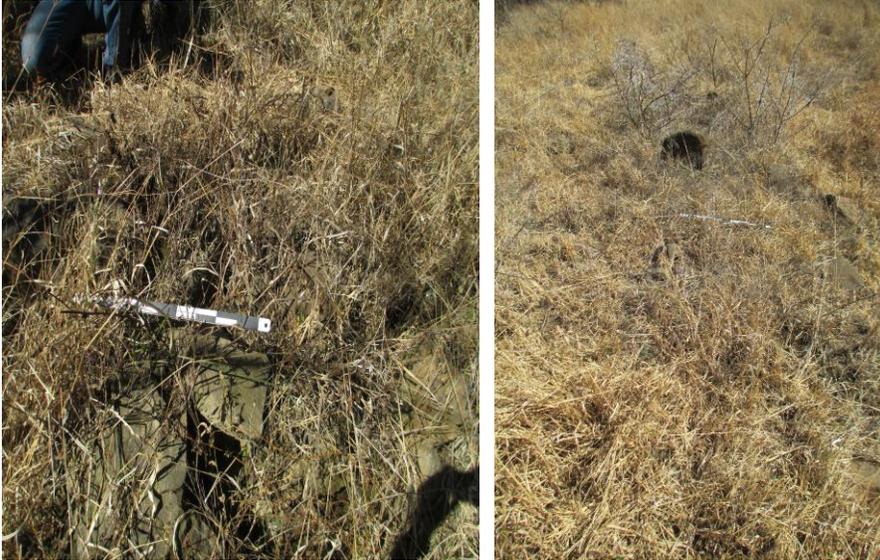
Grave (photo below)::

Faces: grave head stone faces to a south-eastern direction

Contextual locality: grave is situated 10,2m from the ash-heap in a south-eastern direction

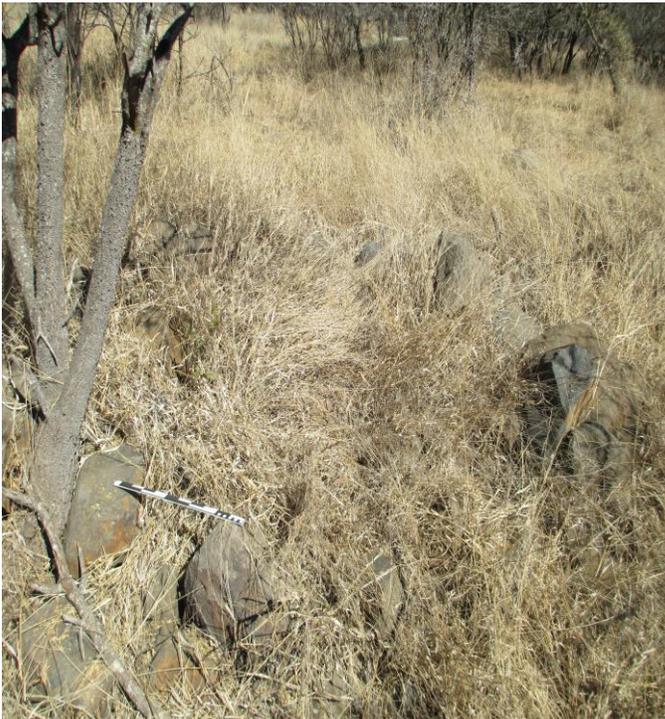
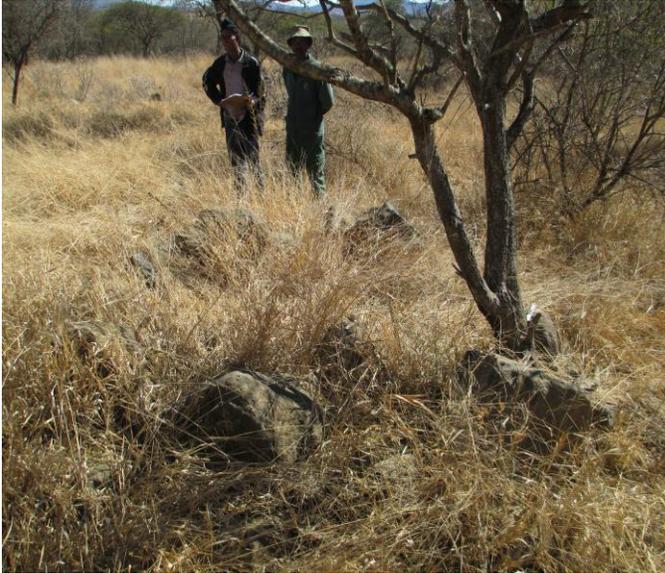
Milking cow-pen (very small enclosure) or low stone wall to support a grain-bin? View photo below:

Measurement: 2m by 1m large

Contextual locality: this structure is situated approximately 12m south-east from the grave and 10m east of the 2nd house floor terrace.

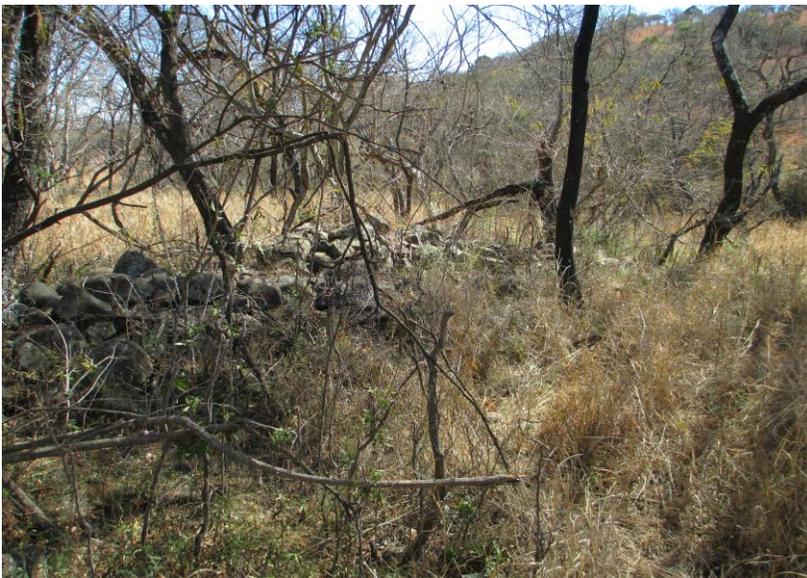
Kraal (view photo below): only 2 and a third of the walls of the original square kraal structure is left

State of conservation: only two walls are left forming a 90° corner with one another. A small section of the 3rd wall is left. Maximum height of the wall is 1m.

Measurement: 16m by 9, 6m by 1m.

The Officer-in-Charge to inform the Field Rangers and any employees of EKZNW not to remove any of the random rubble and boulders from the walled areas, to use it as building material or to limit soil erosion.

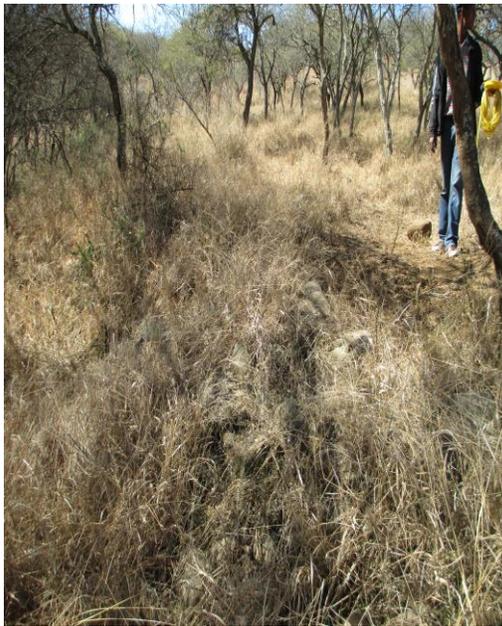
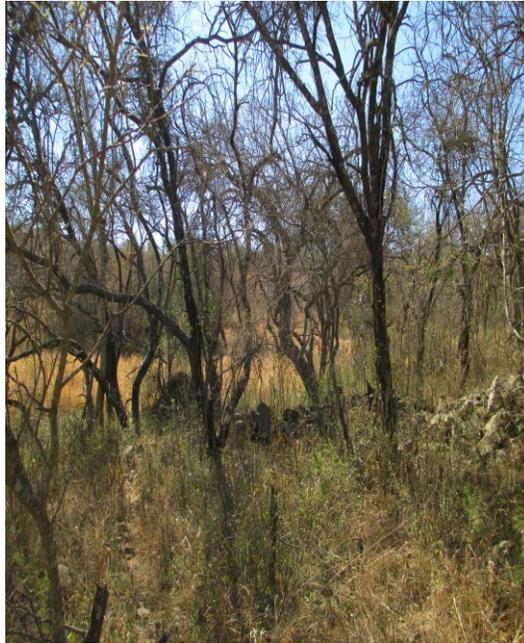
1st terrace wall (view photo below):

Measuring: Approximately 56m in a straight line, maximum height about 1m.

Locality: 26m south-east from the kraal structure, discussed above.

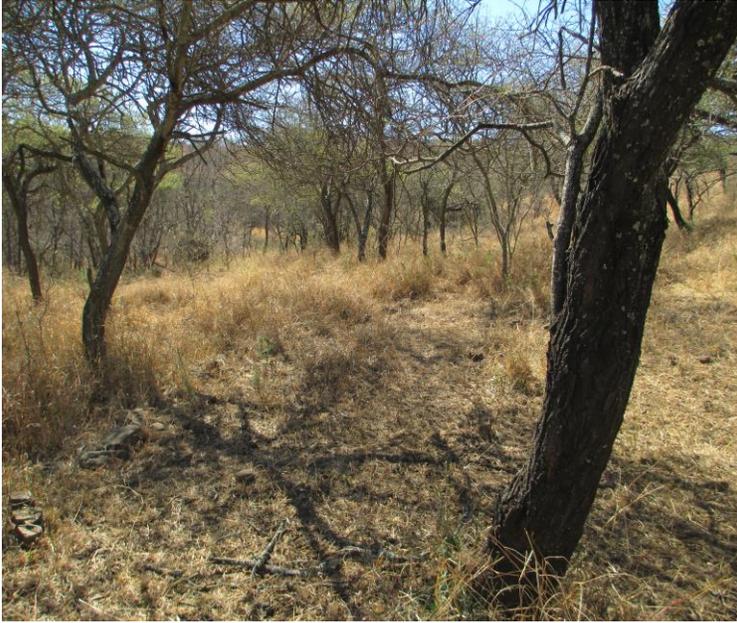
2nd terrace wall (see photo below):

Measurement: 10m terrace in a straight line with a maximum height of ½m

Locality: Approximately 12m southeast of the first terrace wall

House floor behind the 2nd terrace? (Not validated) – also view photo above, the house floor is behind the terrace wall.

The area constitutes a flat and “clean” space of approximately 8m by 6m square. This might be a house floor?

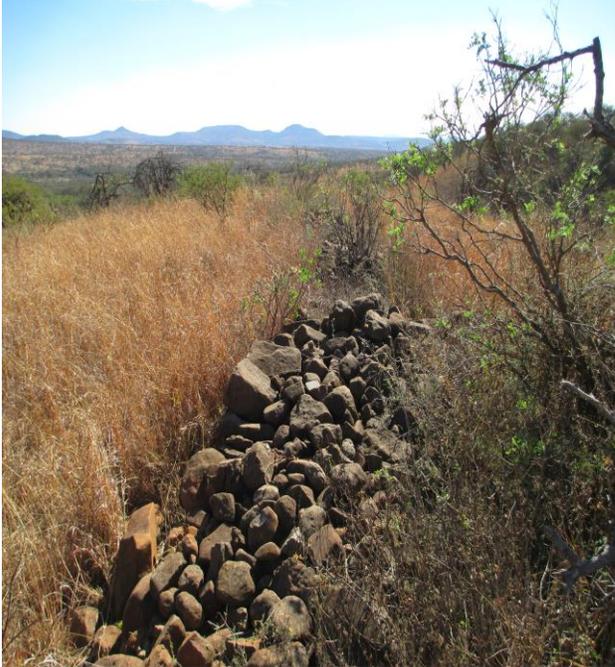
GPS c)

Sections marked on the map link with the following locational data (see photo below):

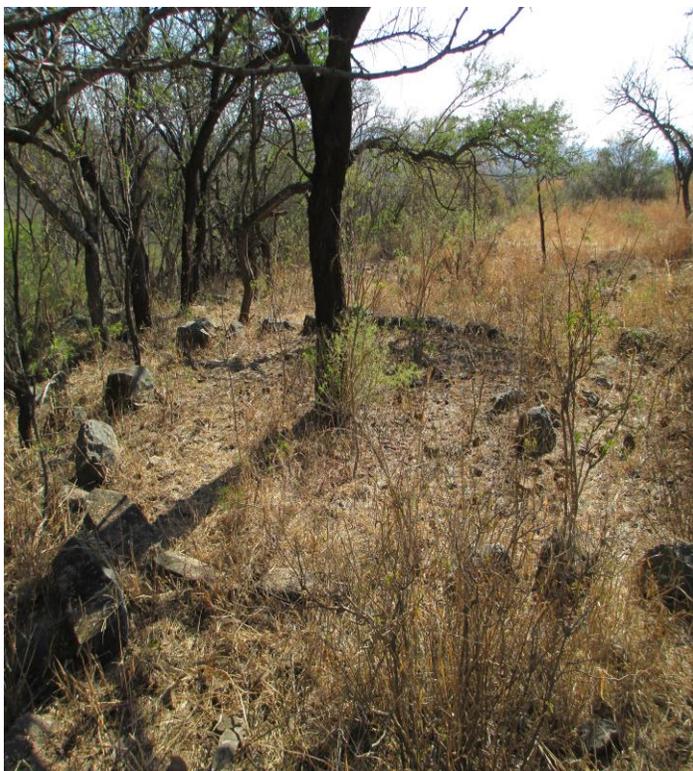
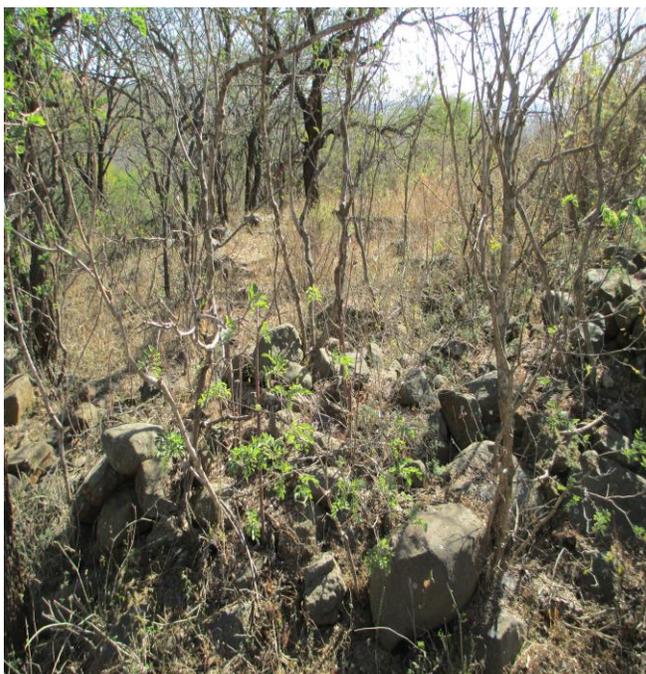
GPS d) View photos below

Feature: Two circles, the one within the other. The larger circle measures 13, 9m diameter and the smaller circle measures 5, 5m diameter.

Locality: These two circles are located approximately 16m in a western direction from the entrance of the larger and complex kraal structure.

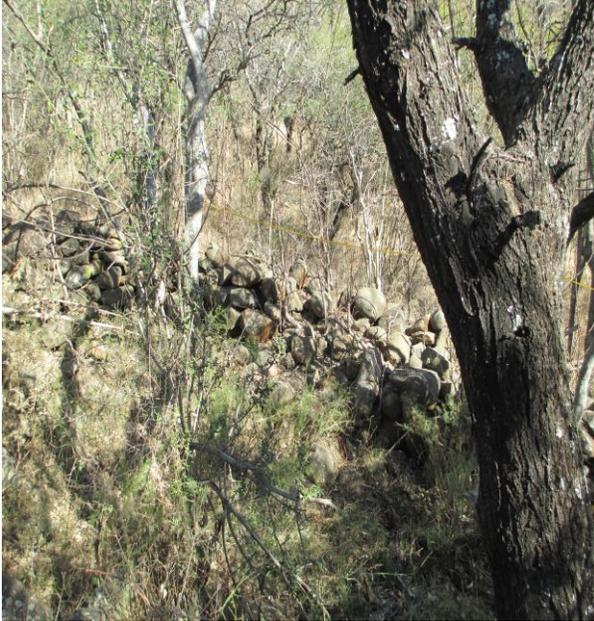
GPS e) View photo below

Feature: a rectangular kraal, neighbouring a semi circle or quarter circle kraal on the south-eastern side and another wall on the northwestern side, which links this feature with the complex kraal structure, see map no: 2.

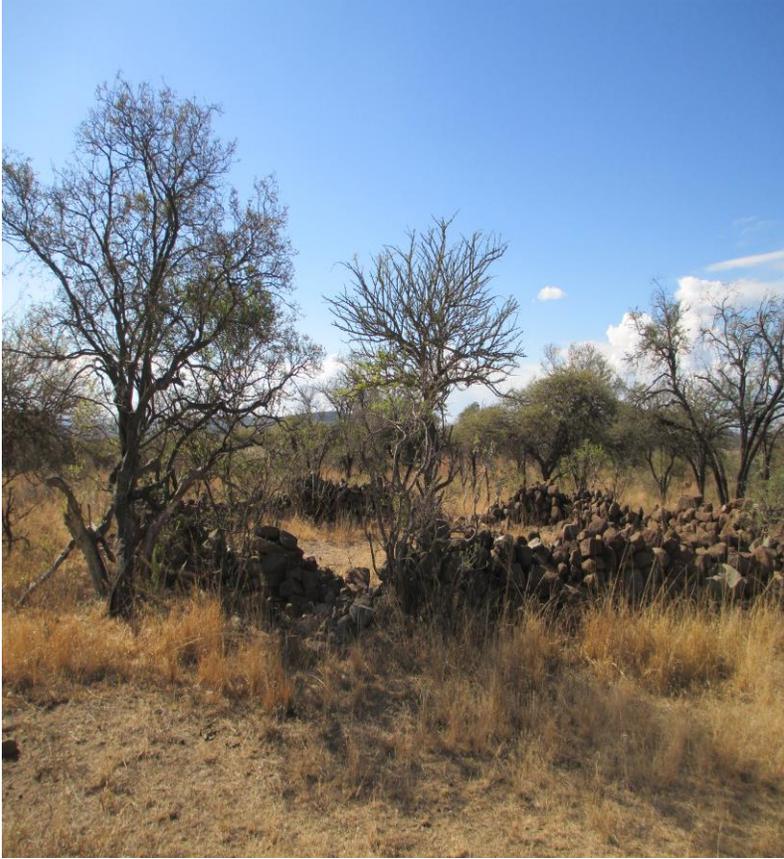
6 Iii) Indunas Kraal

Feature: a large square structure

State of Conservation: well preserved, maximum height is 1m

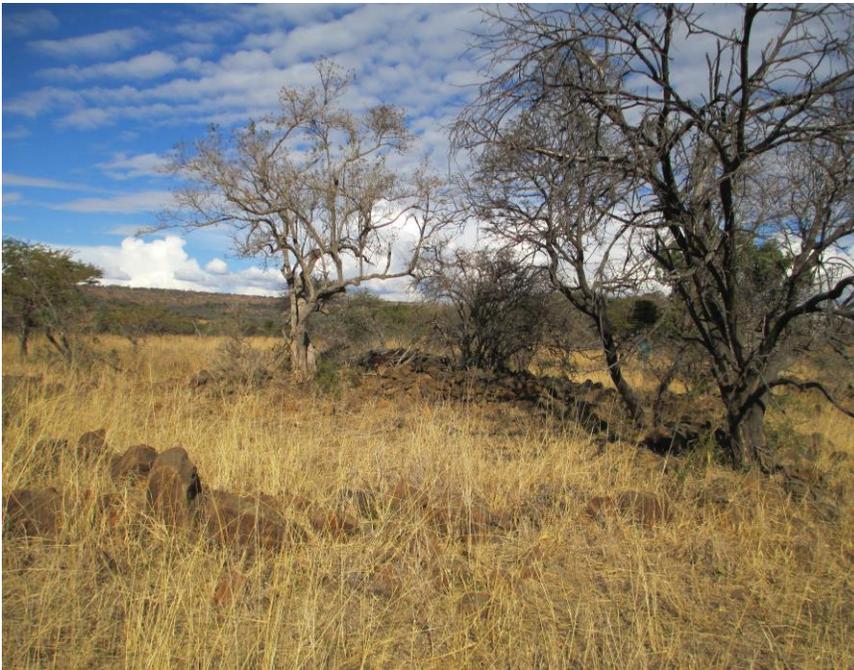
6v) Chief's Kraal II (See map no: 3, appendix iii)

This kraal structure is also a complicated integration of 4 features linked to one another” two circles, the most northern circle, measuring 8m in diameter, bordering in a southern direction on square kraal structure, measuring 13, 20m by 11, 8m, bordering, again in a more southern direction on another circle, measuring 12, 5m in diameter. The latter circle (or most southern circle) links with a wall, measuring 7m east and then again 27, 9, north. Refer to map no: 3, appendix no: iii. The entrance of the most northern circle points south-west.

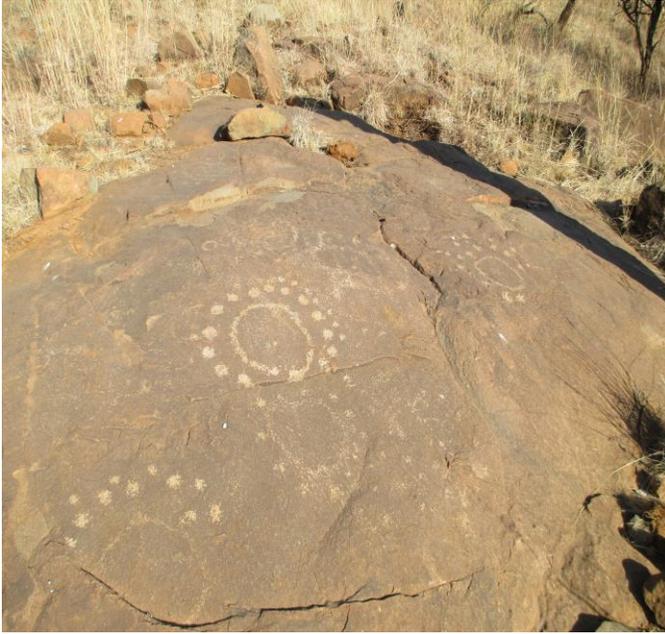
(i) Onverwacht 911 Engraving site:

| Natural damage to paintings (water, lichen, animals, etc) | Only natural weathering, the site is very well-preserved |
| Approximate number of engravings: | 7 engraved homesteads featuring the central-kraal motive with many homesteads surrounding the kraal. 2 small circles might depict grain bins, although the documenter is not sure of this. 1 engraving in the centre of the images, are unclear. See photo below. |

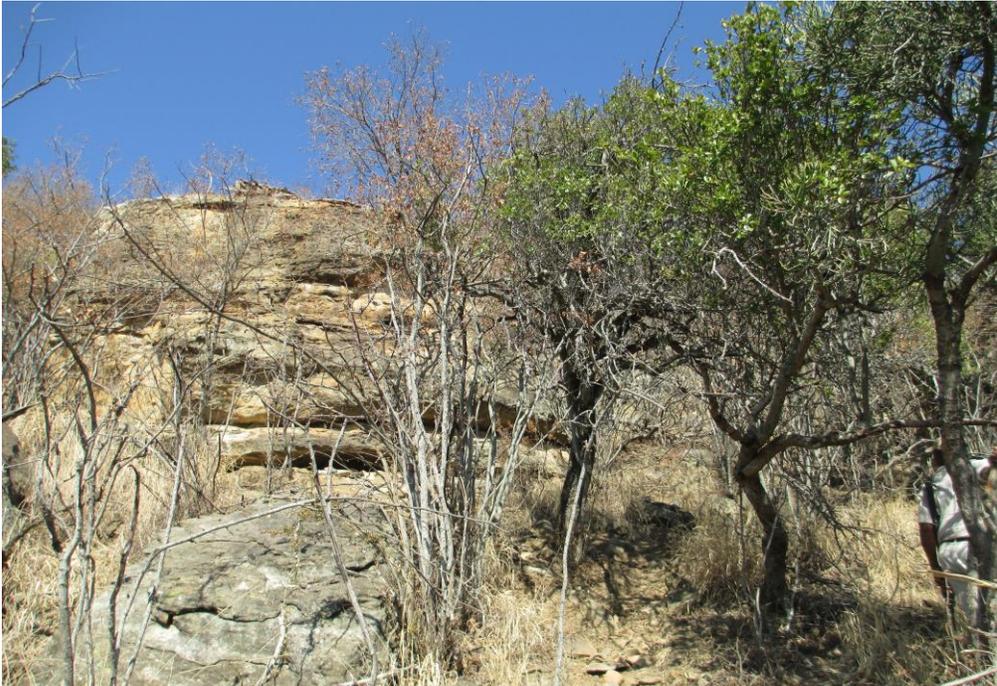
Shelter

| Natural damage to paintings (water, lichen, animals, etc) | Dust accretion and a water run-off area causing silica, salt and lime to cover the parent rock and the paintings. Swallows' nests are also present |
| Have the paintings or rock shelter walls been damaged by graffiti? Over what area? | The site is pristine, and no graffiti occurs |

Recommendations for management of the site: Since this site is not officially open for tourism purposes, no one may access the site.

When and if the Field Rangers access the site for monitoring purposes annually, no one must touch the paintings, stir dust (as the dust collects over the paintings and causes chemical weathering), never throw water or any other liquid over the paintings and be careful not to accidentally abrade (rub against the paintings with back-packs) the rock art.

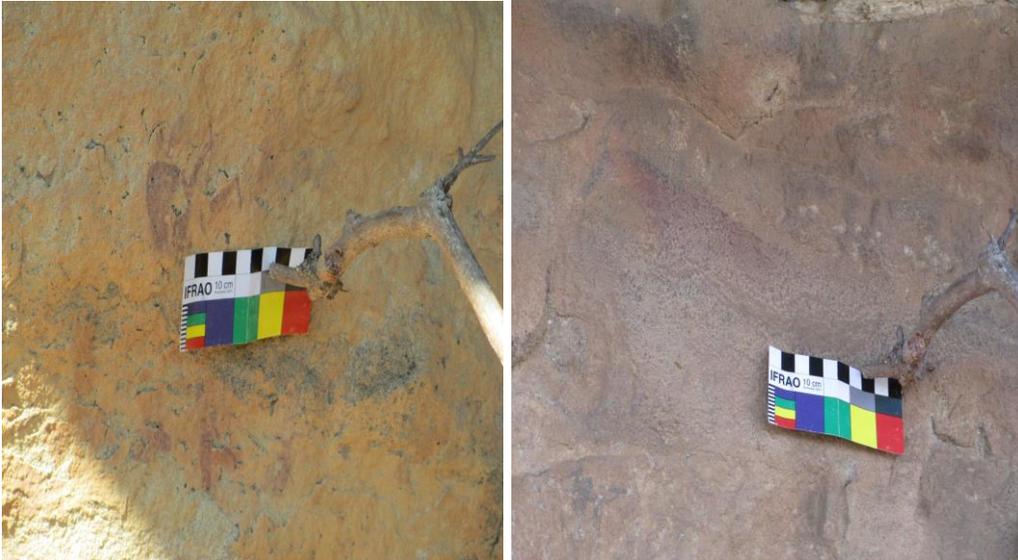
Photos from left to right: Kaross clad individual carrying a bow and arrows, bichrome roan atelope

Statement of significance: This site is of a high significance, taking into consideration that a roan sable antelope was depicted here and this is the first time I have seen one, since being employed 7 and a half years at Amafa. This image is very rare, also because generally sable roan antelopes can only be found in Northern KwaZulu-Natal, as this area is not a suitable habitat for the animal.
