**A REPORT ON A HERITAGE IMPACT ASSESSMENT FOR THE STEYNOL
UMTHOMBO PROJECT NEAR SPRINGS IN THE GAUTENG PROVINCE**

GCS project no.: 11-537

REPORT: AE01223V

April 2012

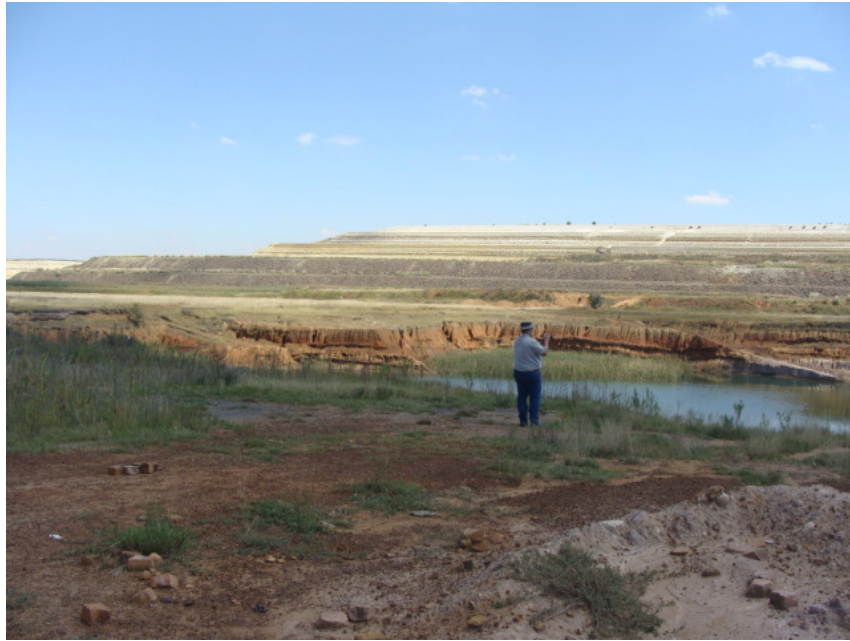
Figure 2 General view of the surveyed area showing a quarry and slimes dam just outside of the property.

The environment of the area is mostly disturbed. In fact the only areas with natural vegetation only include pioneer species. The disturbance were mainly caused by past mining activities and include quarries, mine heaps and dumping areas (Figure 2-4). During the survey the grass cover was reasonably long, making archaeological visibility difficult.

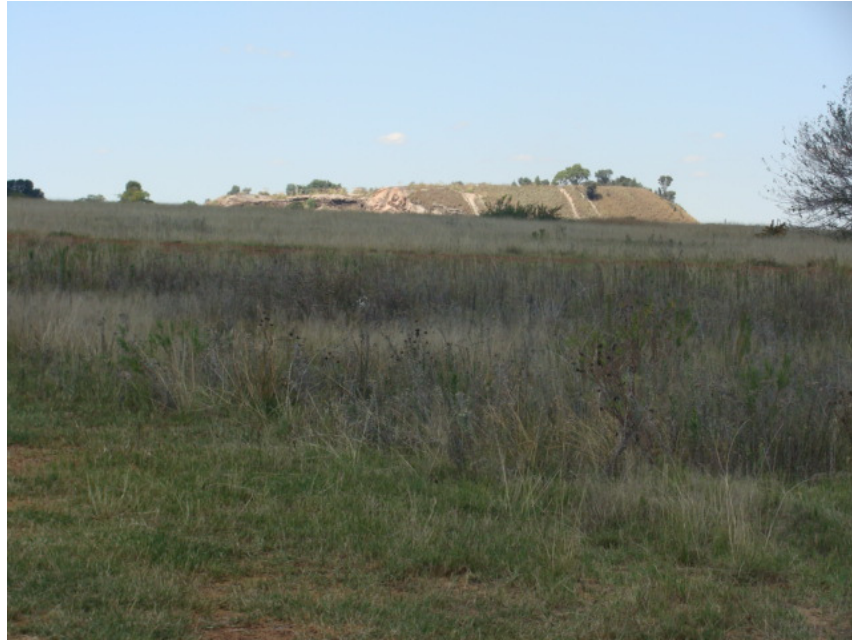
Figure 3 Another view of the surveyed area showing a mine heap and pioneer plant species.

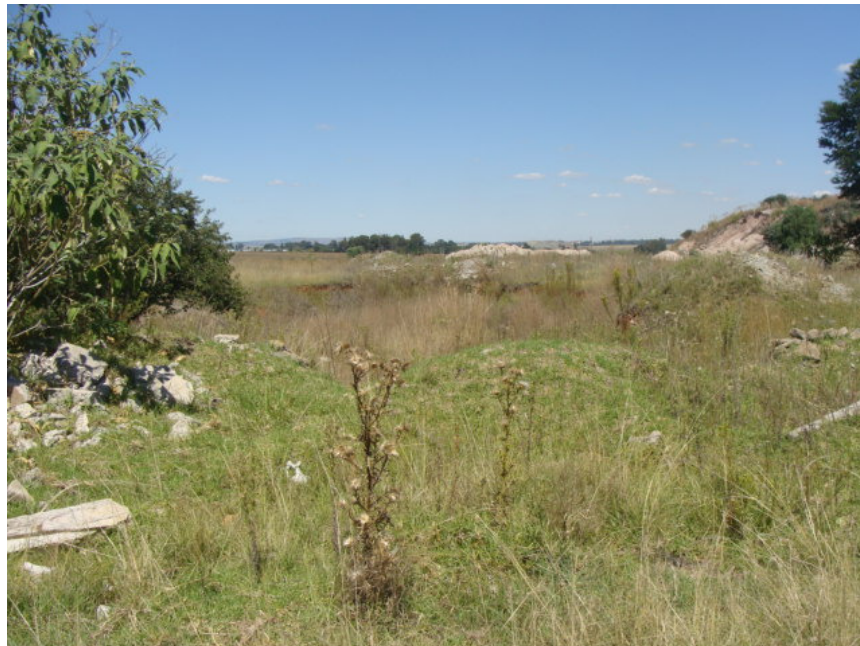
Figure 4 View of dumping within the surveyed area.

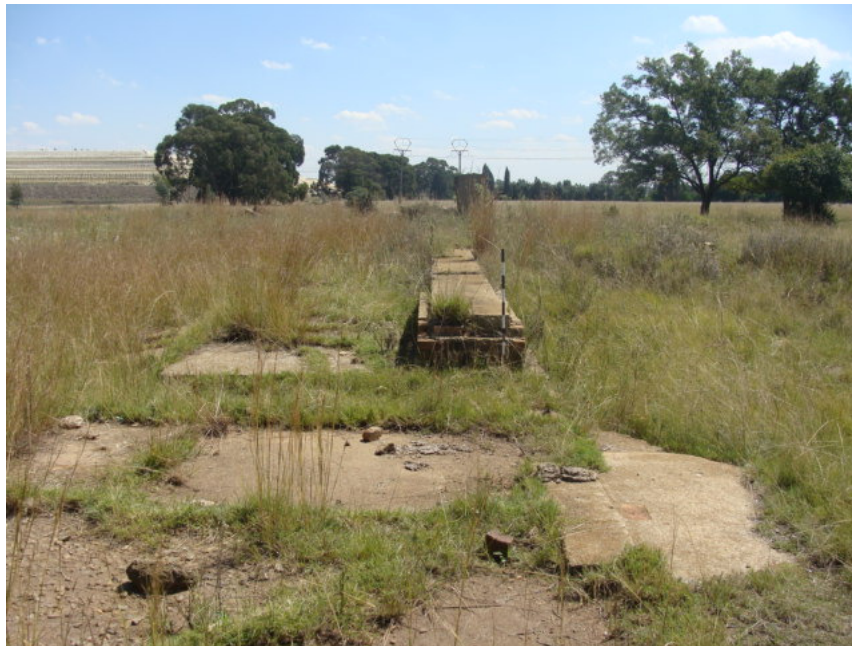
The site has a **low** cultural significance based on its historic and scientific value. It has a general local significance and is therefore given a rating of Grade C (IVC). This report is seen as ample mitigation and it may therefore be demolished during site development.

Figure 5 Industrial structure at site no. 1.

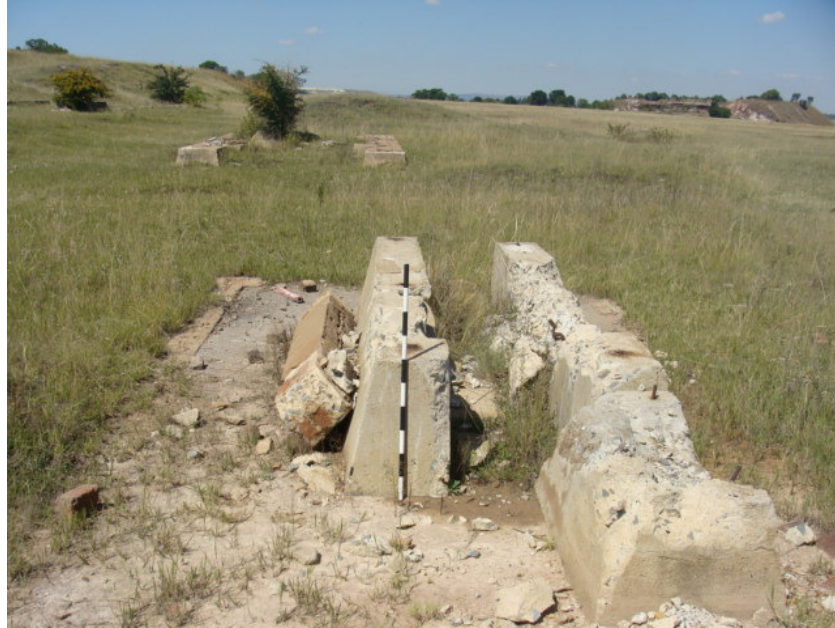
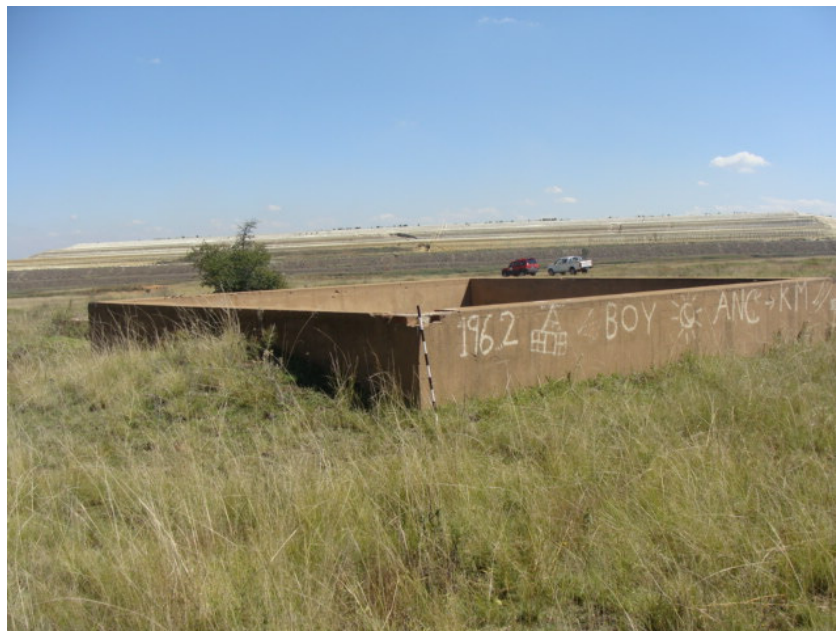
The site has a **medium** cultural significance based on its historic value. It is more than likely not older than 60 years and definitely is not very unique. Therefore it is of local significance only and is given a rating of Grade C (IVC). This report is seen as ample mitigation and it may therefore be demolished during future developments.

Figure 6 One of the structures at site no. 2.

Figure 7 The structure at site no. 2 showing political graffiti from 1972. It has no important historical message.

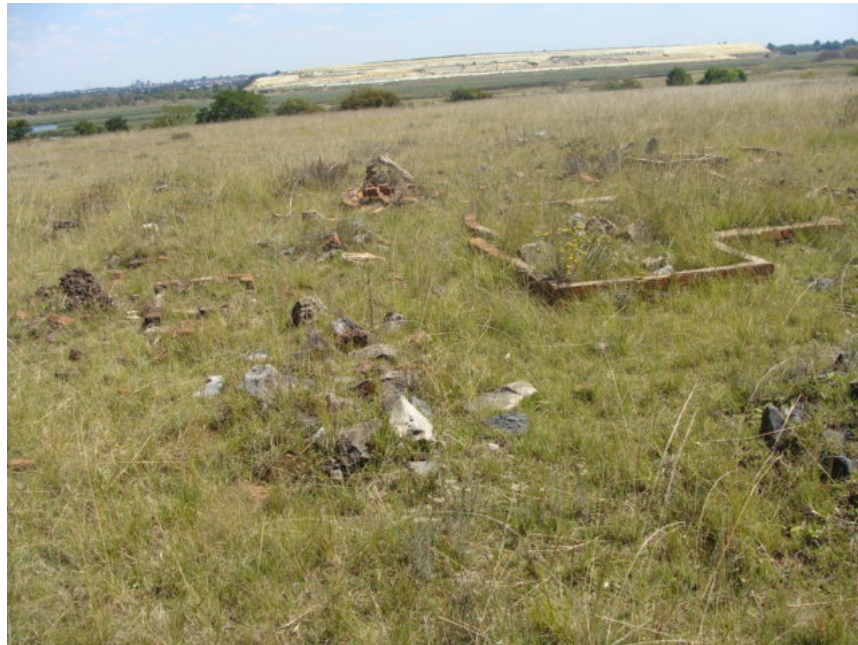
Most of the graves have no information meaning that it has an unknown date of death. Those with dates seem to range between 1950 and 1970. Some of the surnames identified include Phati, Mbulelwa, Masina and Maseke.

Figure 8 Some of the graves at site no. 3.

Graves always are regarded as having a **high** cultural significance. In this case there are three categories of graves being those older than 60 years, those younger than 60 years and those of an unknown date. These graves are of a local significance and are therefore given a rating of Grade IIIB. It may therefore be mitigated.

- Sites number 3 and 4 (graves) have a high cultural significance. Should it be directly impacted on by the mine the graves may be exhumed and the human remains reburied. Before this may happen the necessary advertising, possible social consultation and permitting applications should be implemented. The mine will also have to motivate for the exhumation by indicating that this would be the only option, since the graves are directly in the way of infrastructure that cannot be moved.
- Should the graves however not be impacted on directly, there will definitely be a secondary impact. The graves should then be fenced in a management plan for the preservation and maintenance thereof be written.
- Table 1 gives a risk assessment for graves.

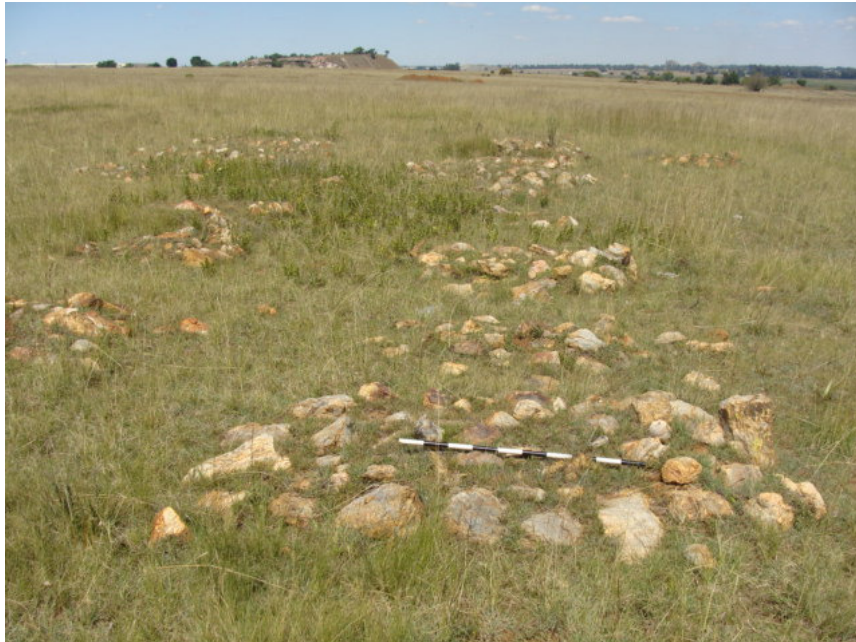
This is also site no. 4 of the previous survey. It is a grave yard consisting of at least 37 graves (Figure 9). All the graves have stone dressing and some also have stone headstones. None of these have any information. Therefore they all have an unknown date of death making it unknown graves.

Figure 9 Some of the graves at site no. 4.

Graves always are regarded as having a **high** cultural significance. In this case there is only one category of graves being those of an unknown date. These graves are of a local significance and are therefore given a rating of Grade IIIB. It may therefore be mitigated.

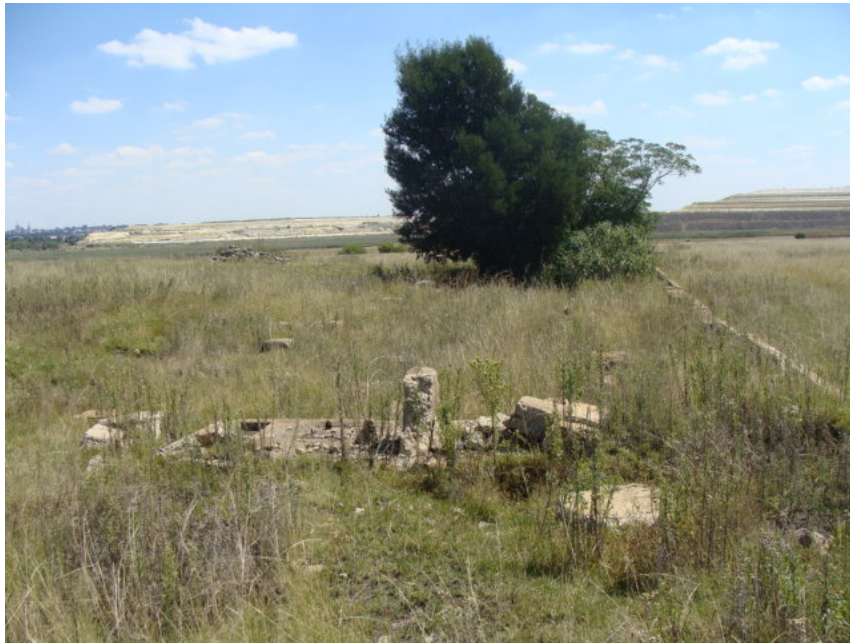
The site has a **low** cultural significance based on its historic and scientific value. It also is in a bad state of deterioration. The site has a general local significance and is therefore given a rating of Grade C (IVC). This report is seen as ample mitigation and it may therefore be demolished during site development.

Figure 10 Site no. 5.

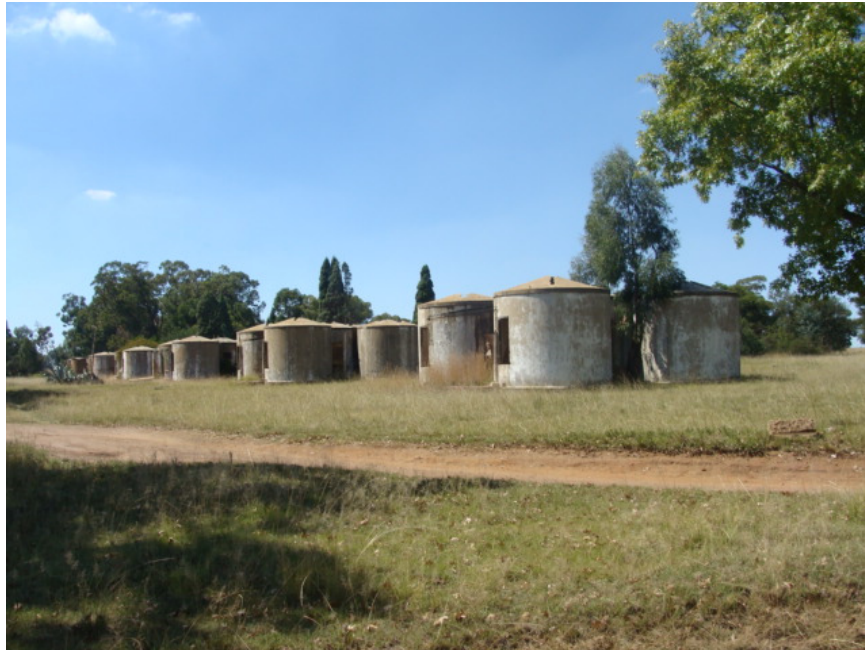
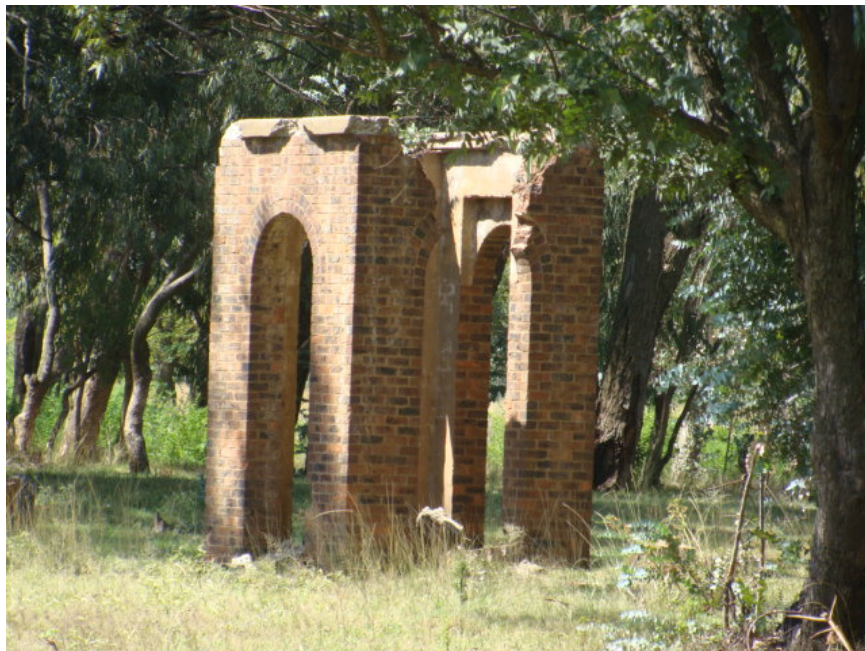
Site no. 6 is also site no. 6 from the previous survey report. It is a large site consisting of residential structures. This was the compound for mine workers (Figure 11-12). Most of the buildings are quite unique rondavel like structures. Other structures are built from face-brick, but the function thereof could not be determined.

Figure 11 Some of the residential units at site no. 6.

Figure 12 Face brick structure at site no. 6.

The site has a **high** cultural significance based on its uniqueness and historic and social value. It has a general local significance. It however is difficult to determine the rating of the site – it would either be IIIA, IIIB or A (IVA). The different possibilities have the following implications:

The phase II should be used to determine which of these is the correct rating. Therefore a phase II study is recommended, aimed at the full documentation of the site.

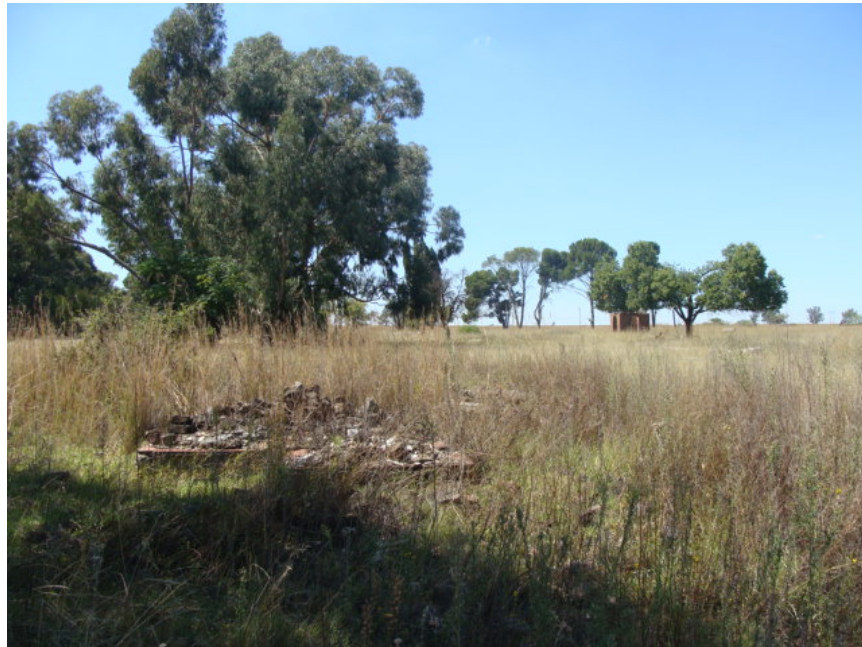
The site has a **low** cultural significance based on its historic value. It is not unique and is in a bad state of repair. It has a general local significance and is therefore given a rating of Grade C (IVC). This report is seen as ample mitigation and it may therefore be demolished during site development.

Figure 13 Ruins of mine house at site no. 7.

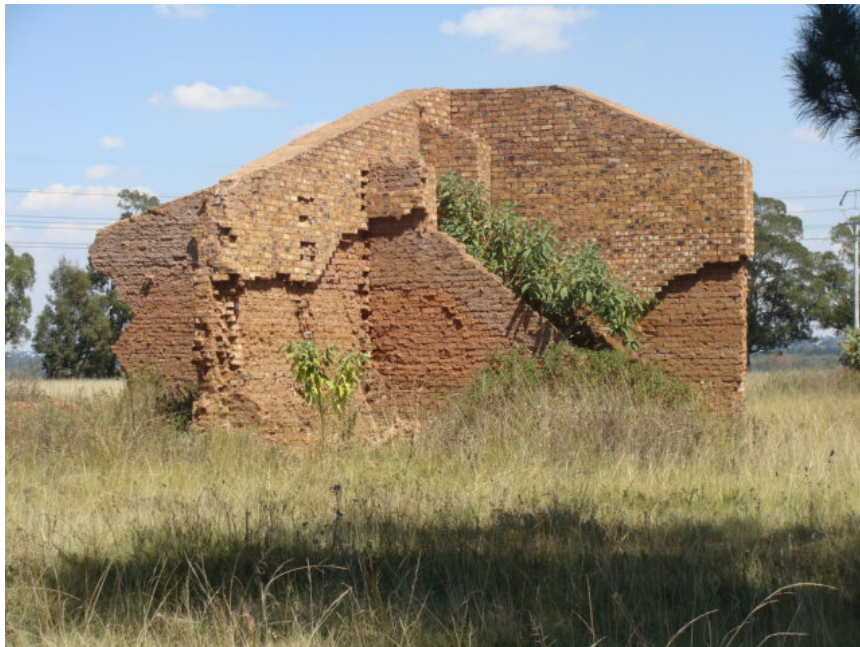
The site has a **low** cultural significance based on its historic and social value. It has a general local significance and is therefore given a rating of Grade C (IVC). This report is seen as ample mitigation and it may therefore be demolished during site development.

Figure 14 Industrial building at site no. 8.

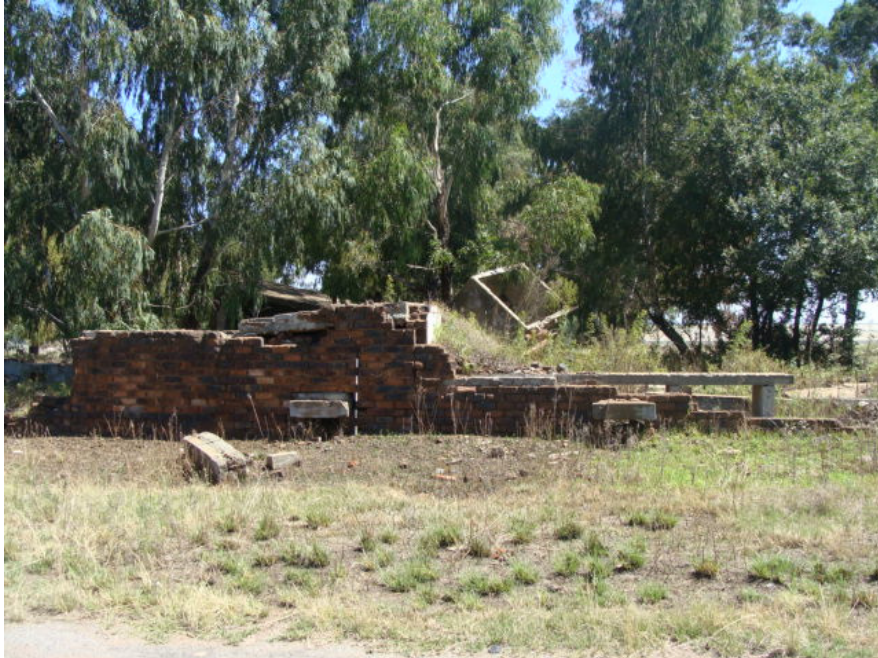
This is another industrial building linked to the mining history. It seems to be part of the processing plant. It may be just older than 60 years of age (Figure 15).

Figure 15 One of the graves at site no. 15.

The site has a **low** cultural significance. It is of a local significance based on its historical and scientific value. Therefore it is given a rating of Grade C (IVC). It may therefore be demolished during development activities on site.

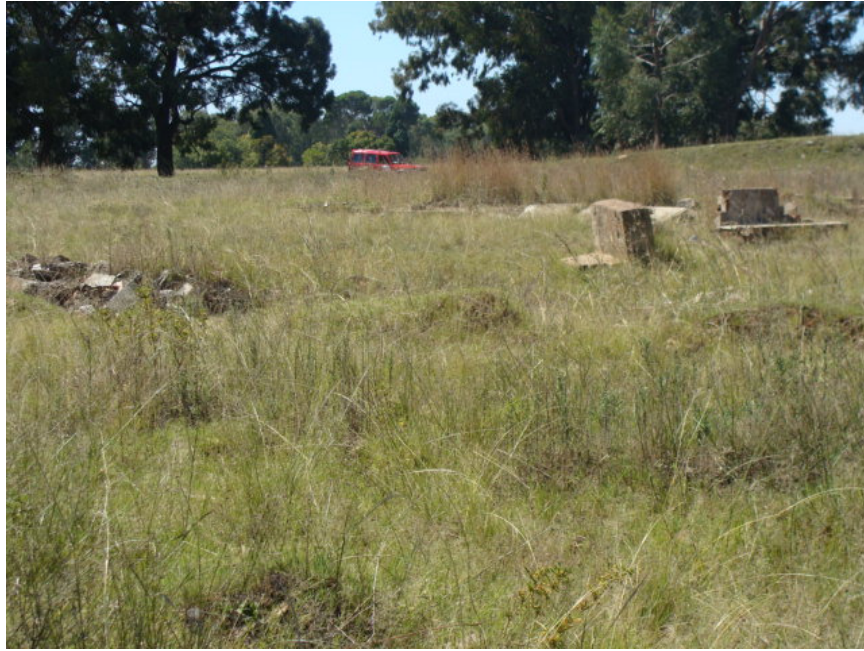
This is the ruin of yet another industrial building linked to the mining history. It is in an extremely deteriorated state (Figure 16).

The site has a **low** cultural significance. It is of a local significance based on its historical and scientific value as well as its bad state. Therefore it is given a rating of Grade C (IVC). It may therefore be demolished during development activities on site.

Figure 16 Remains of building at site no. 10.

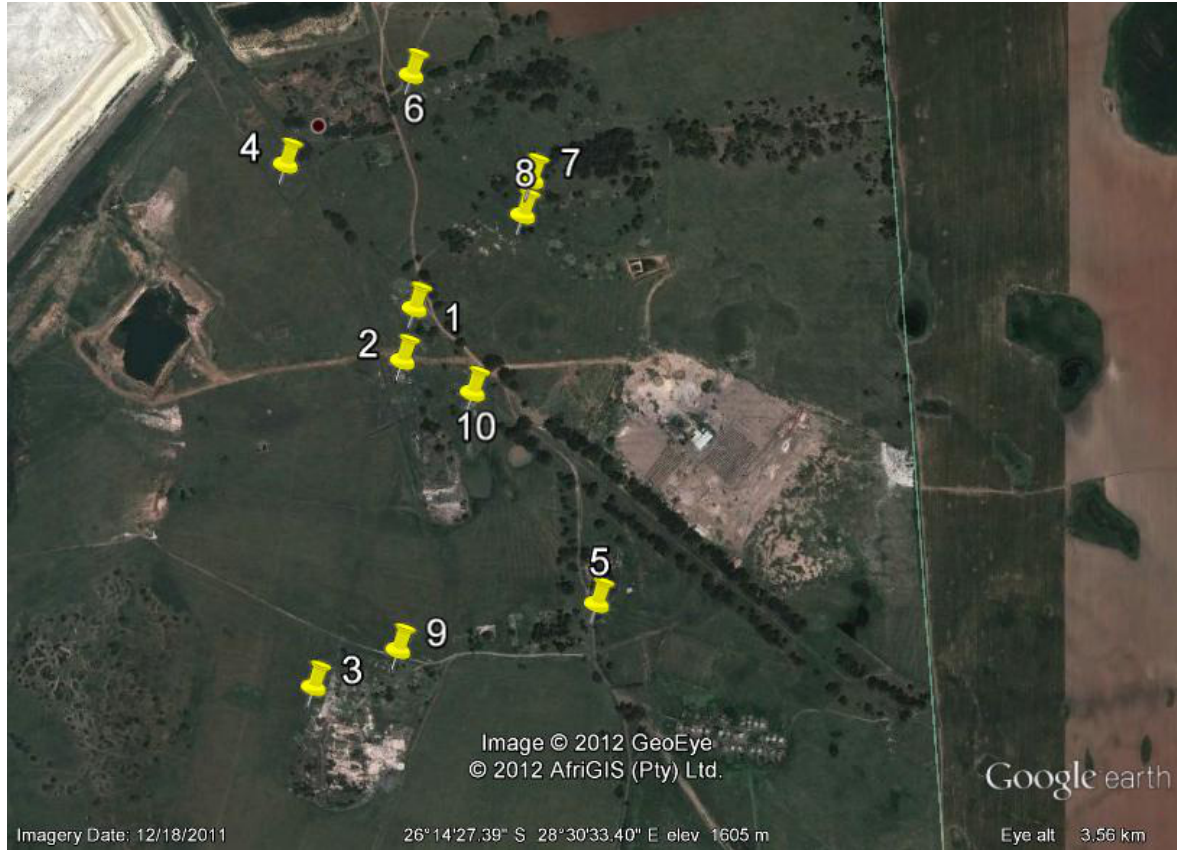
It is concluded that the assessment of the area was conducted successfully. In the surveyed area 10 sites (Figure 17) of cultural significance have been found.

Figure 17 Google image indicating the location of sites found during the survey.
