**REPORT ON A WATCHING BRIEF DURING THE DEMOLITION OF AN ANGLO-
BOER WAR (1899-1902) BLOCHOUSE AT PAMPOENNEK, NORTHWEST PROVINCE**

September 2017

Report no.: AE01745

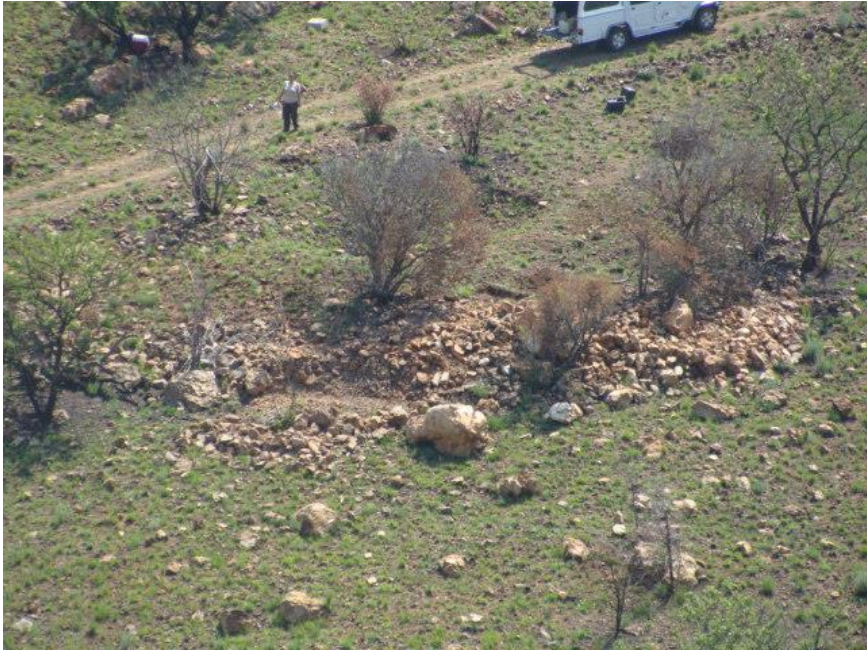
Figure 4: View of the remains of blockhouse no. 2.

The blockhouse that was excavated and now demolished (no. 2) most likely used to be a circular Rice pattern (corrugated iron) blockhouse. Very little remains of the corrugated iron, but the circular form of the defensive wall around it, still are well defined (Figure 4-5). The diameter of the blockhouse is 10 m and the mule path is about a further 10 m away.

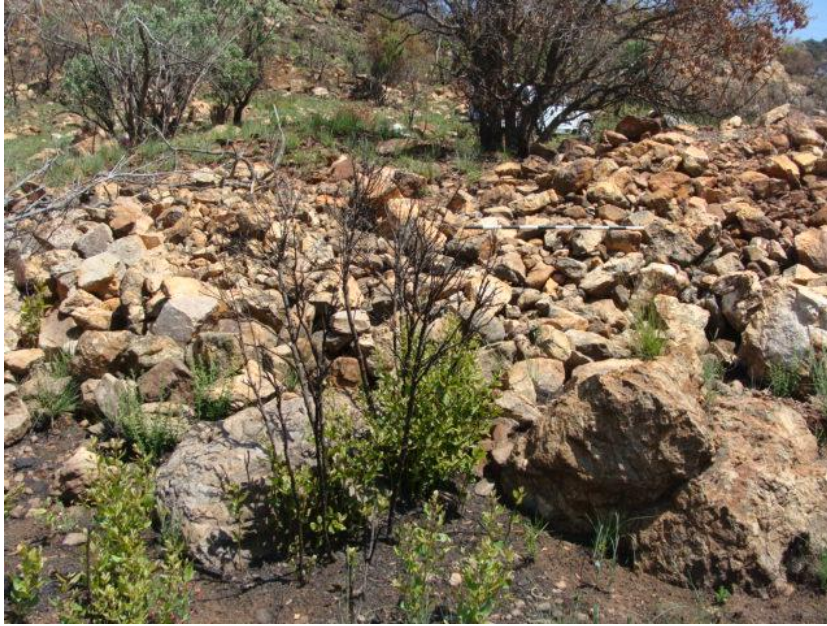
Figure 5: Collapsed defensive wall around blockhouse no. 2.

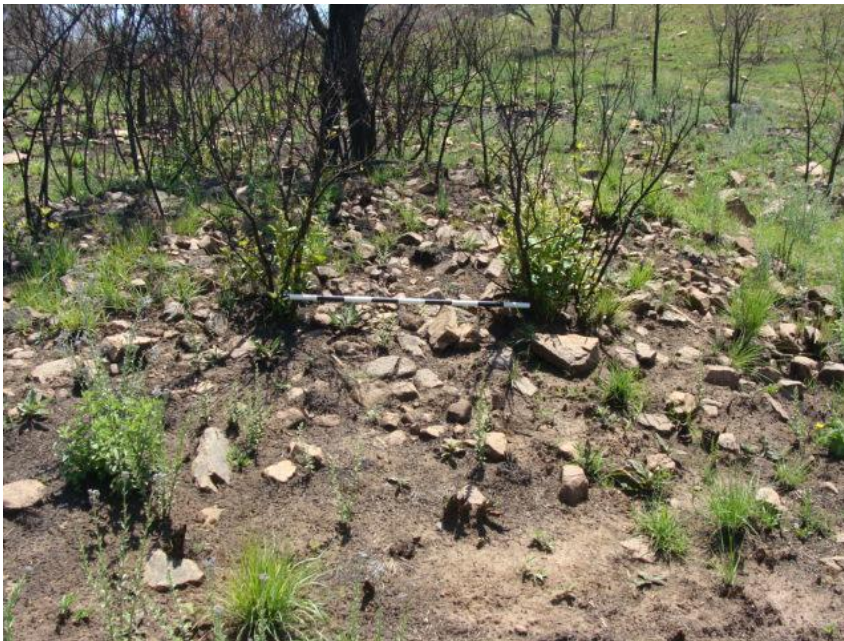
Figure 6: Heap of stones that may have been used as a loading bay.

The mule path starts to the east of the blockhouse from where it criss-crosses up the hill to end at blockhouse no. 1. A heap of stones are found at the start of the mule path and may be some kind of a platform used as a loading bay (Figure 6). Mule paths were used to carry equipment and supplies, either on mule back or by carts pulled by mules. A similar heap is found further to the north, but this one is too far from the mule path to have been used for this purpose.

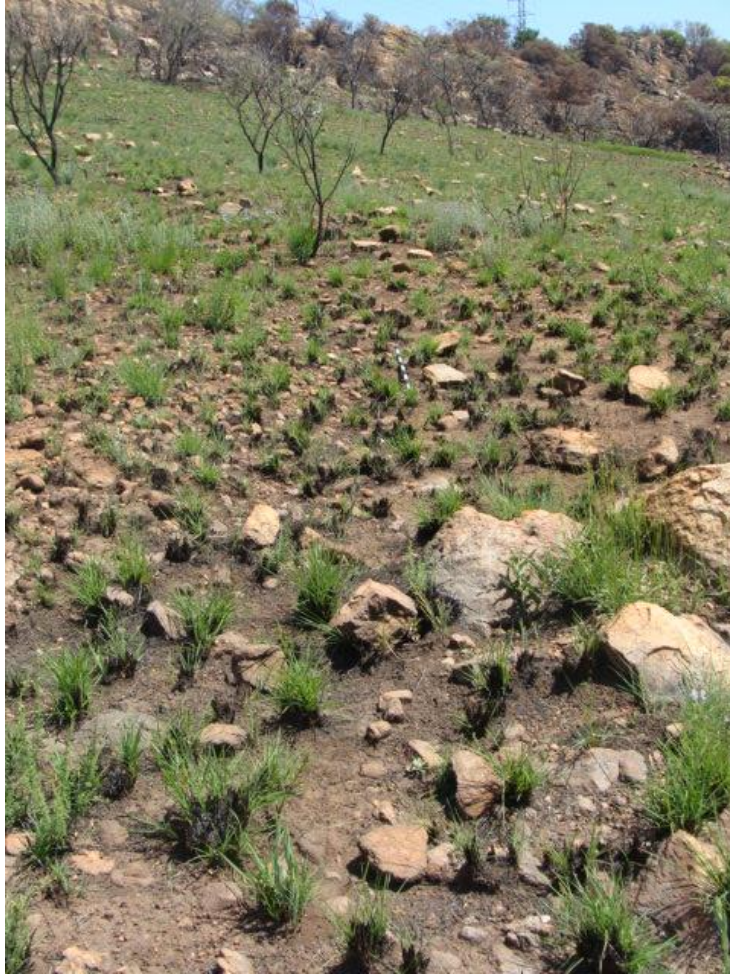
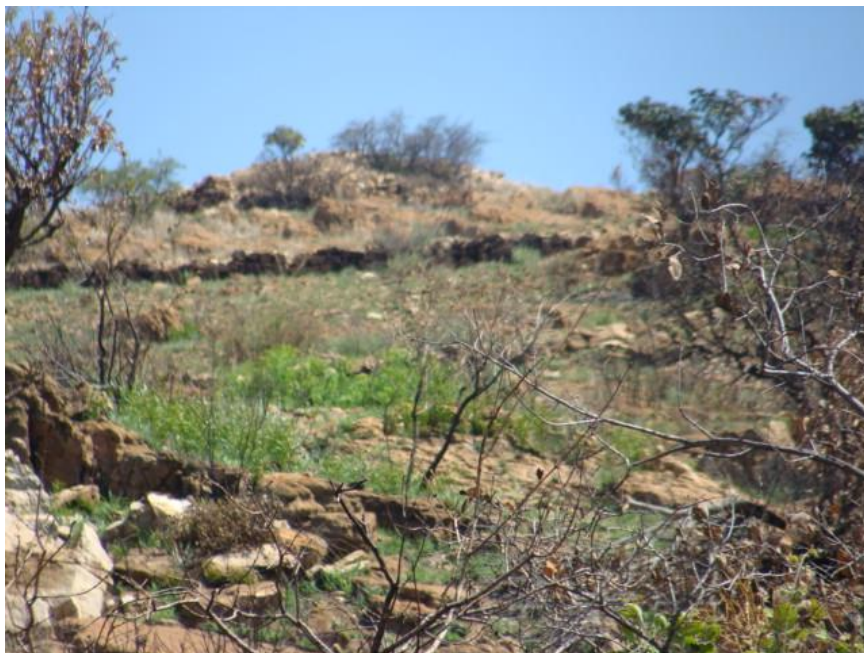
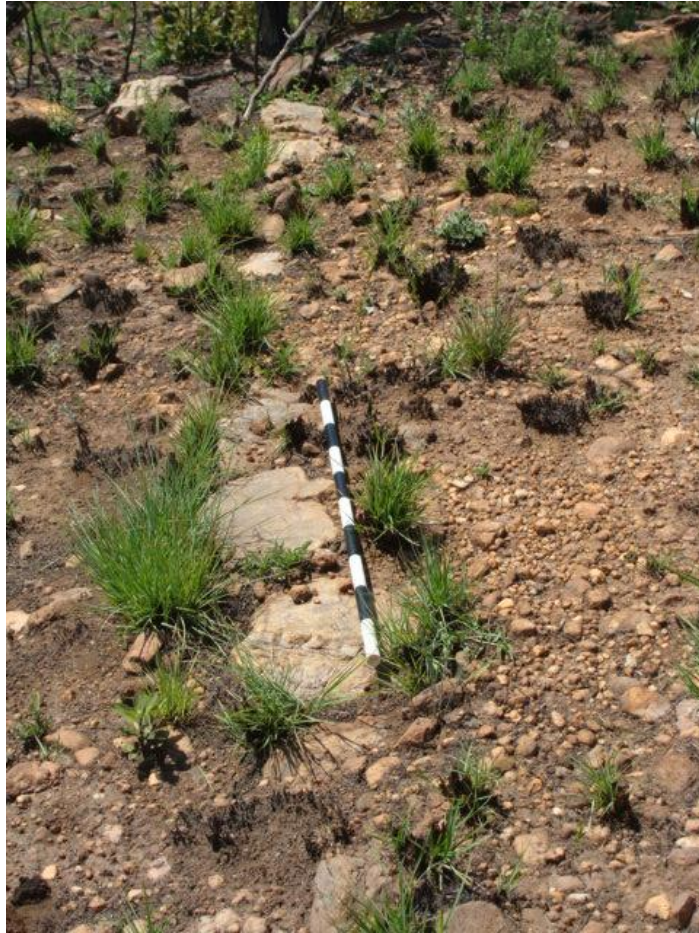
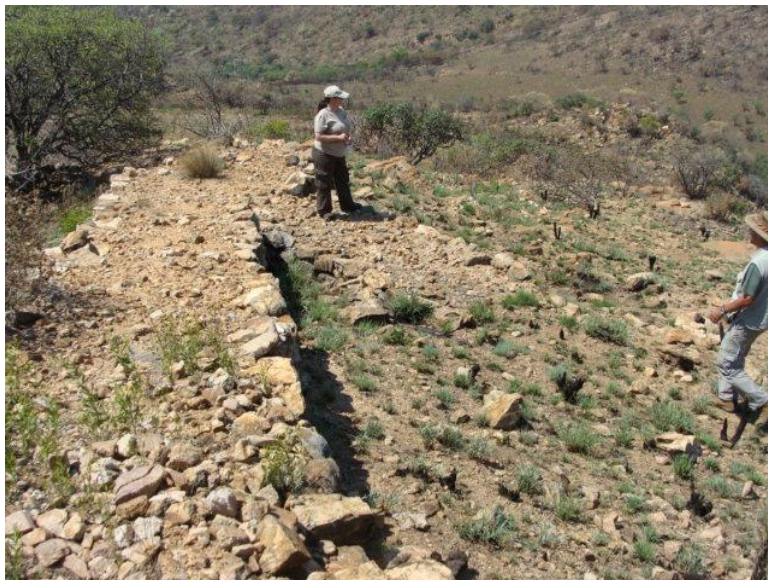
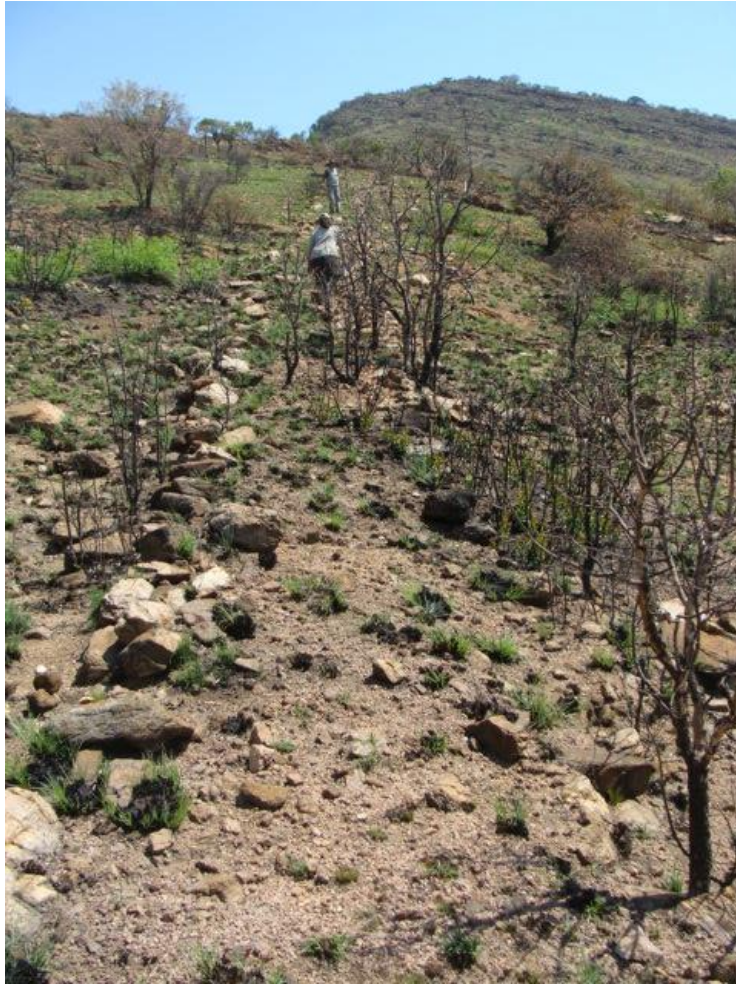
Figure 7: Remains of the mule path close to the ‘nek’.

Figure 8: View of the mule path against the slope of the mountain.

Figure 9: Well-defined side wall of the mule path.

Figure 10: Mule path at the top of the mountain. Note the ramp on the side, where the people are standing.

Figure 11: The mule path almost halfway up the mountain.

The mule path is more or less 1,5 m wide and built with stones (Figure 7-11). Where it turns, it is wider and even built in a square shape in order to create space for the carts to turn. Where necessary it was built up with a wall on one side to create a level surface. Close to the top a ramp is found. This is probably the area where the carts were stored and the ramp was used to give access to the path. This area also leads to a structure believed to have been an enclosure to keep the mules.

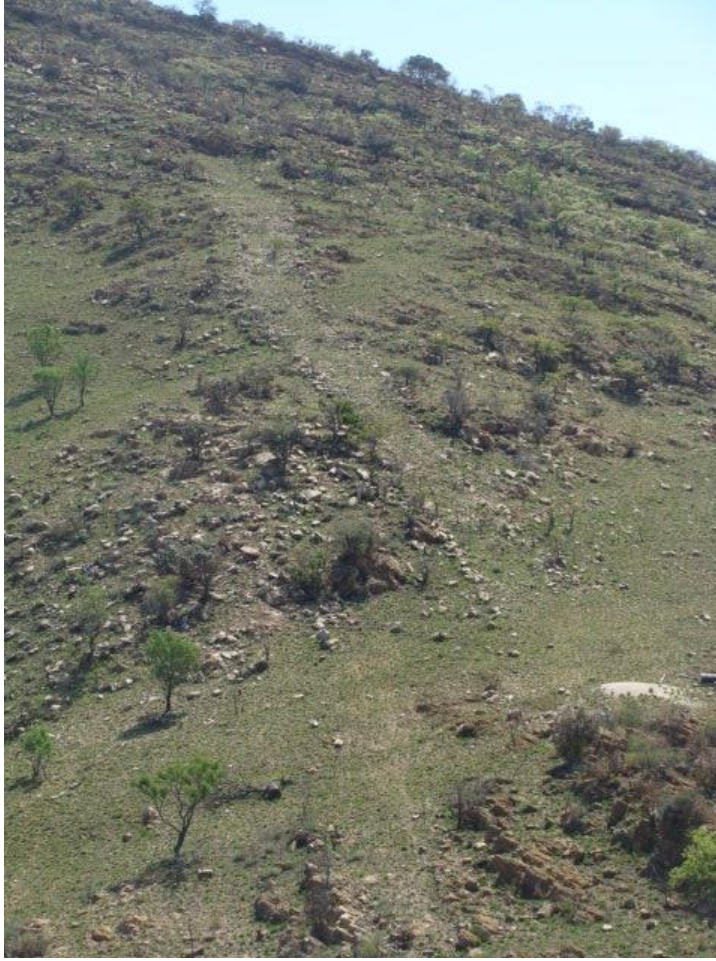
Figure 12: Another mule path running to another blockhouse further to the west.

Another mule path, running to a third blockhouse further to the west of blockhouse no. 1, can also be seen in a distance (Figure 12). On the eastern side a similar mule path, most likely running to a blockhouse on that side is also visible (Figure 13).

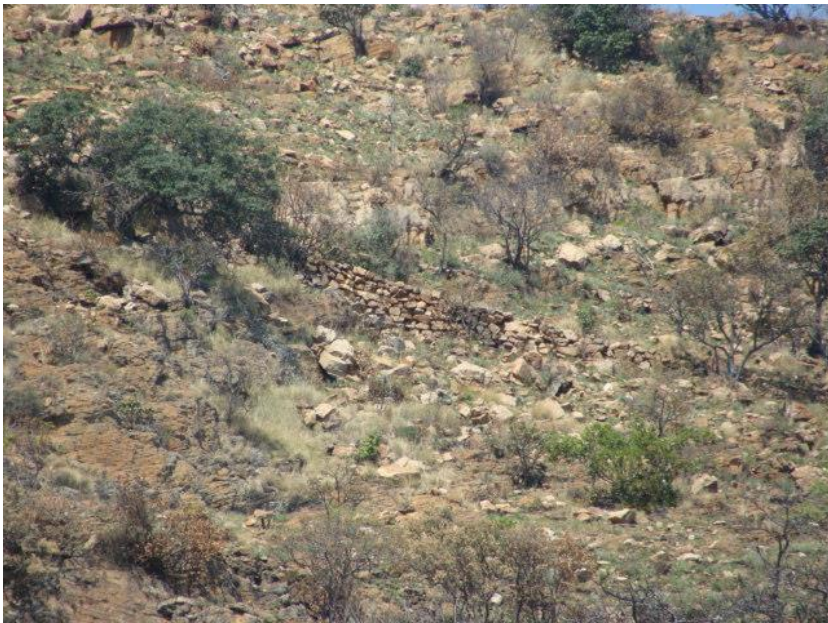
Figure 13: Mule path against the eastern slope.

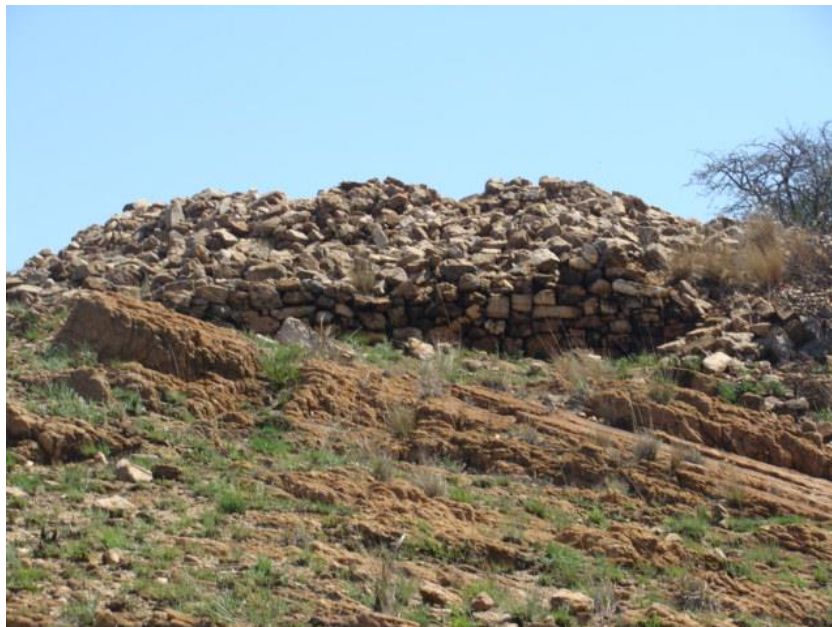
Figure 14: Blockhouse no. 1.

The other blockhouse, called blockhouse no. 1, is situated on top of the hill and the mule path goes up to right next to it. The remains consist of a heap of stones which formed the platform on which the corrugated iron Rice pattern blockhouse was placed (Figure 14). The platform has two areas where the stones were removed, but it is not certain whether this was deliberately done during the building thereof or whether it was a recent occurrence. It also has a defensive wall on its north-eastern side.

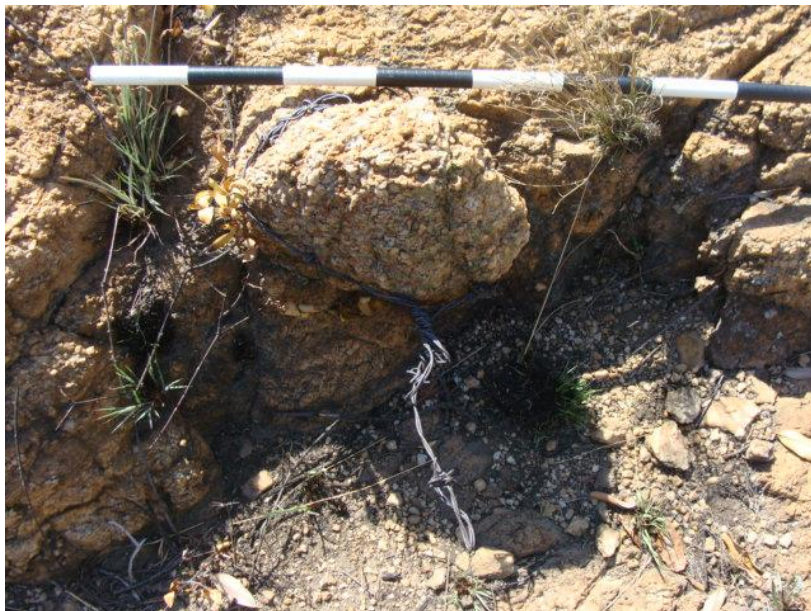
Figure 16: Piece of barbed wire fixed to a rock.

Barbed wire was sometimes used to make it difficult for the Boers to move in between the blockhouses. A piece of such wire was found tightened to a rock (Figure 16). Other cultural material, including a piece of corrugated iron (Figure 17) was also identified on site.

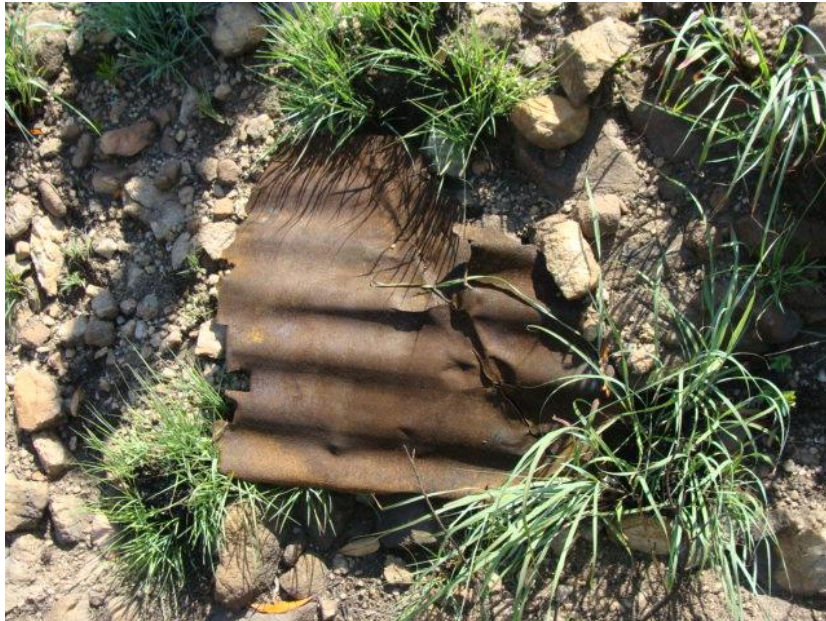
Figure 17: Corrugated iron found close to blockhouse no. 1.

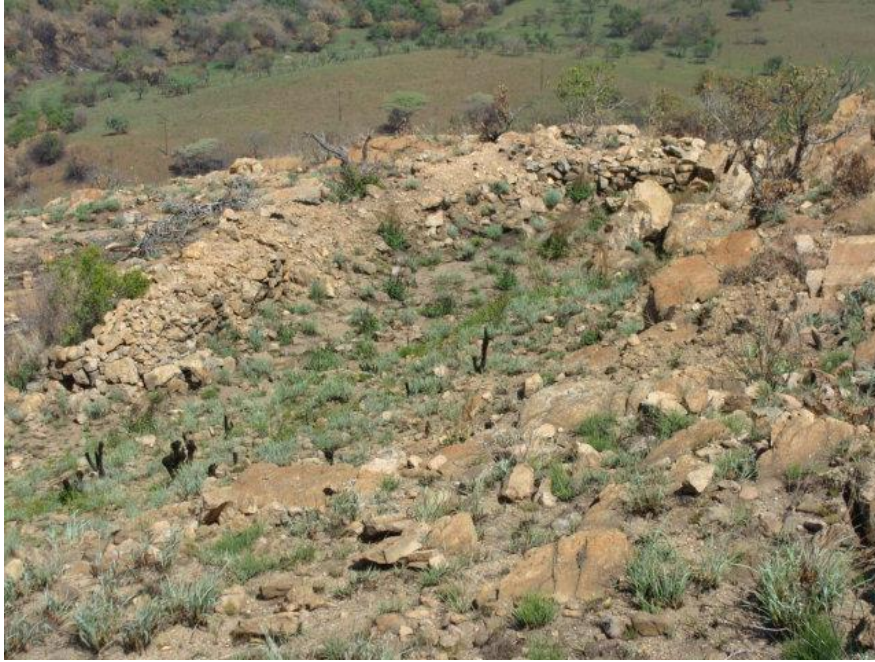
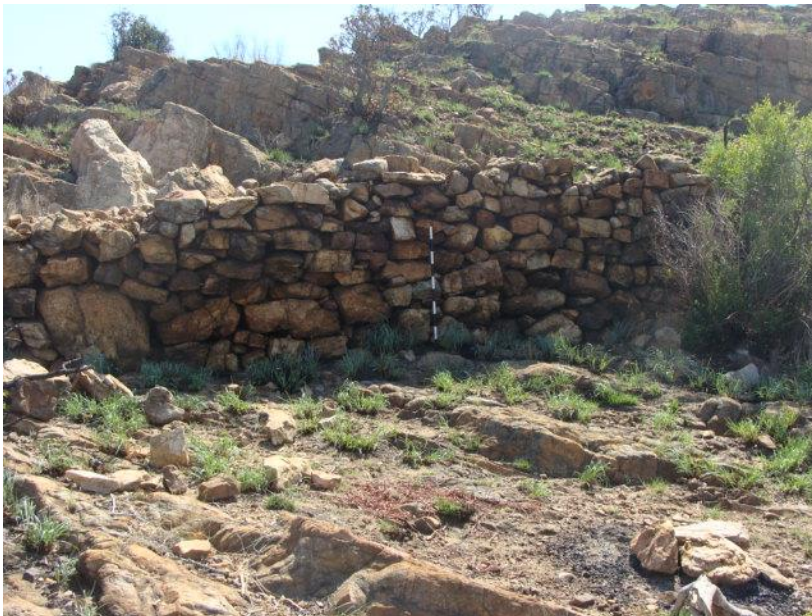
Figure 19: The enclosure where mules were most likely kept.

Figure 20: Eastern wall of the mule enclosure. Natural rock was used for the western wall.

To the south-west and about 40 m further other structures built from stone were also identified (Figure 18). The first looks like it could have been an enclosure for keeping the mules (Figure 19-20). The entrance of this kraal, is to the north and directly opposite the ramp where the mules and carts had access to the mule path.

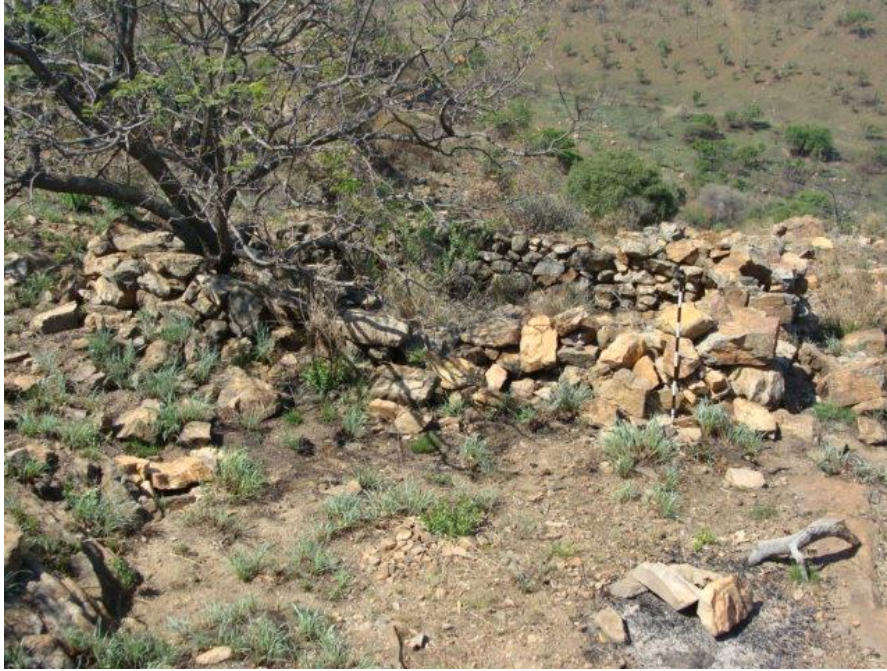
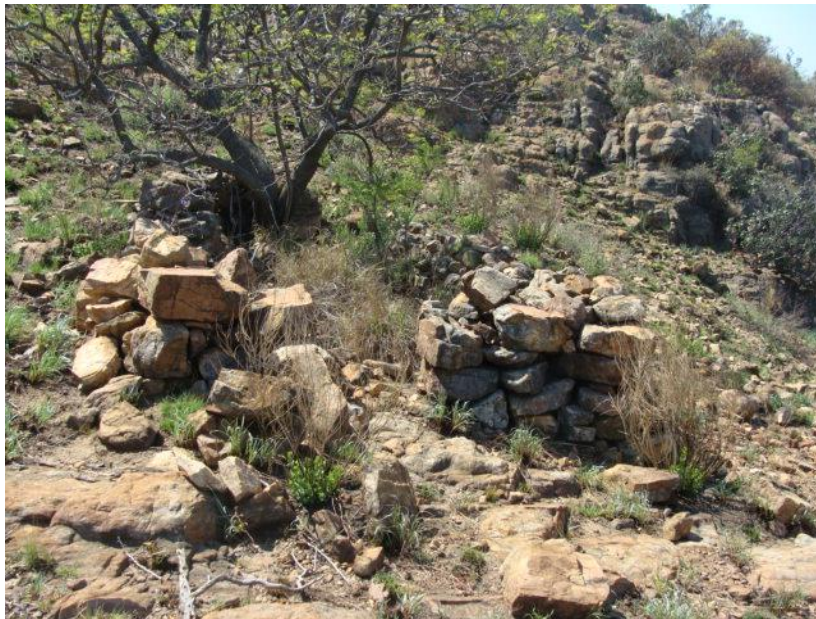
Figure 21: Possible guard house.

Figure 22: Entrance to the guard house.

To the east of the kraal another rectangular structure was identified. This one is built much better and has its entrance to the south (Figure 21-22). This most likely was a guard house.

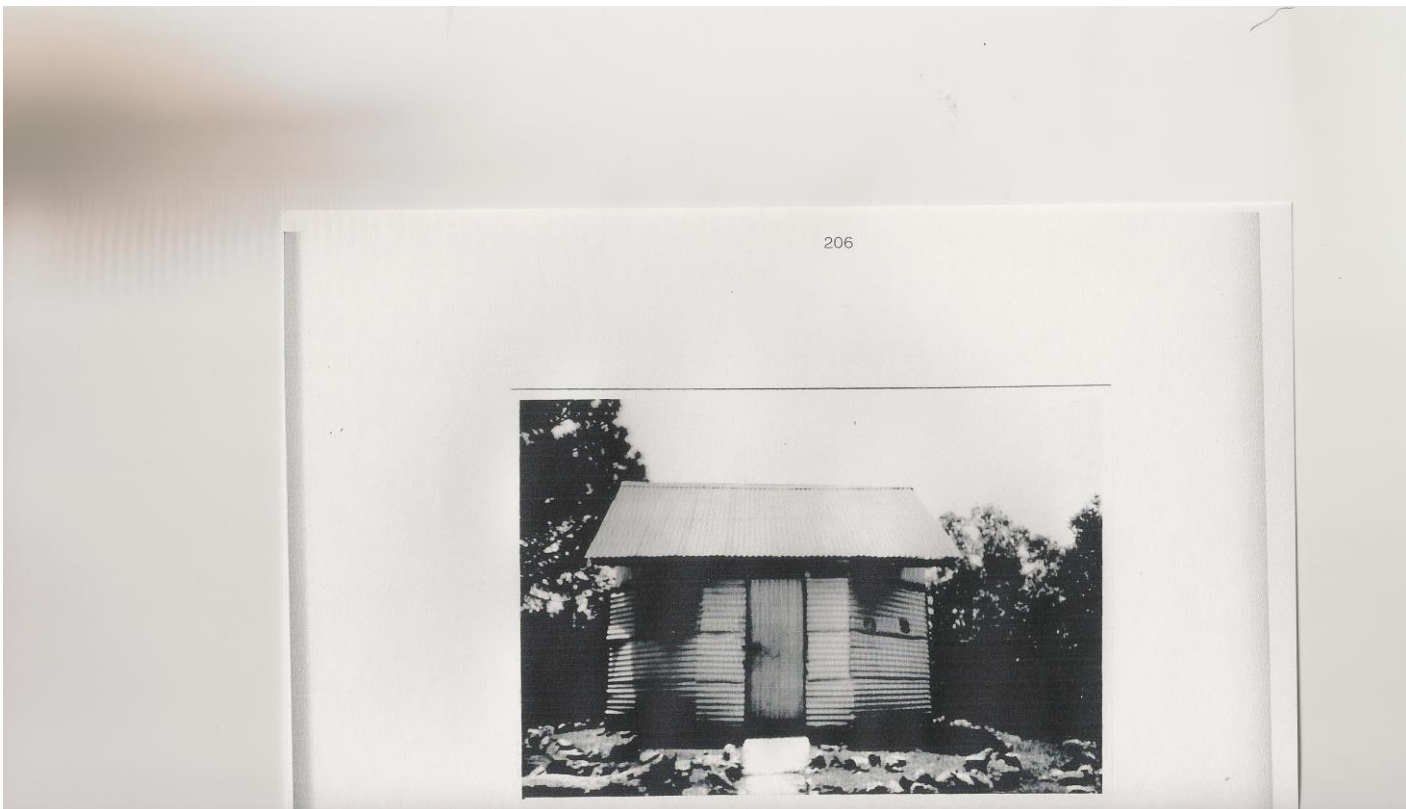
Figure 23: Example of a Rice pattern blockhouse in Pretoria (Van Vollenhoven 1992: 206).

By January 1901 the large scale erection of blockhouses along railway lines was at the order of the day. These were corrugated iron structures, called Rice-pattern blockhouses (Figure 23). These had different shapes and were much smaller than those built from stone and could therefore be build much quicker. From March 1901 these blockhouses were also erected at other strategic positions such as roads. It was used to prevent the Boers from moving around freely. By January 1902 the blockhouse lines were completed. Blockhouses were placed more or less three quarters to one and a half mile apart (1,20 - 2,40km). As much as 8 000 blockhouses were eventually build over a distance of 6 000 kilometres (Van Vollenhoven 1999: 81). These were manned by about 50 000 troops and 16 000 black scouts and guards (Pakenham 1986: 215).

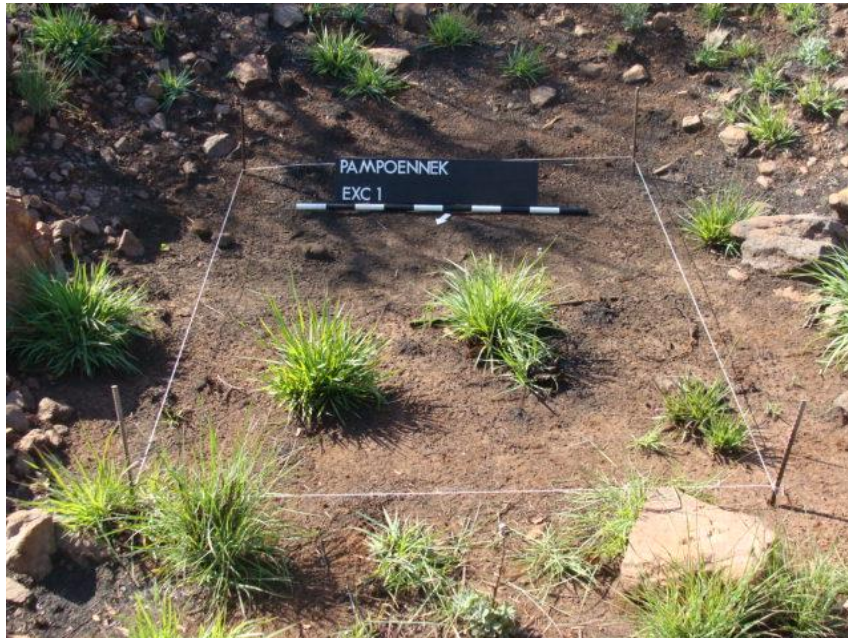
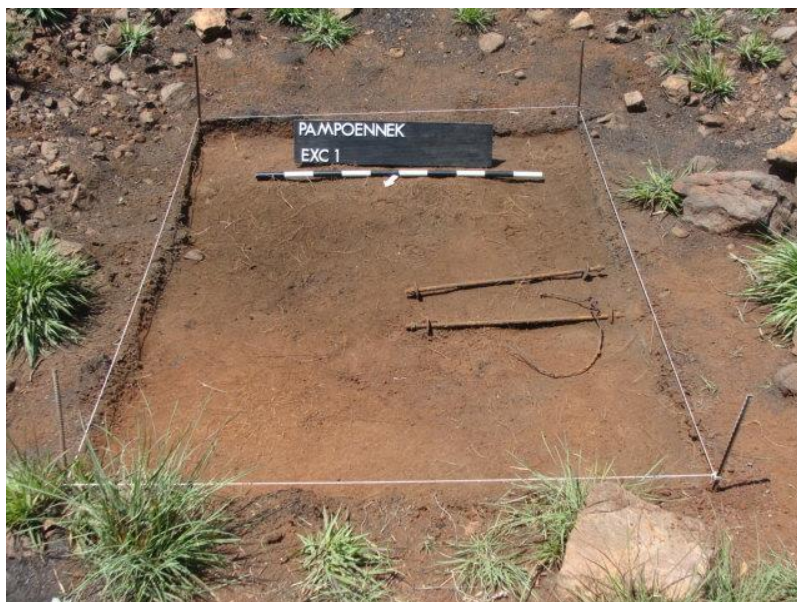
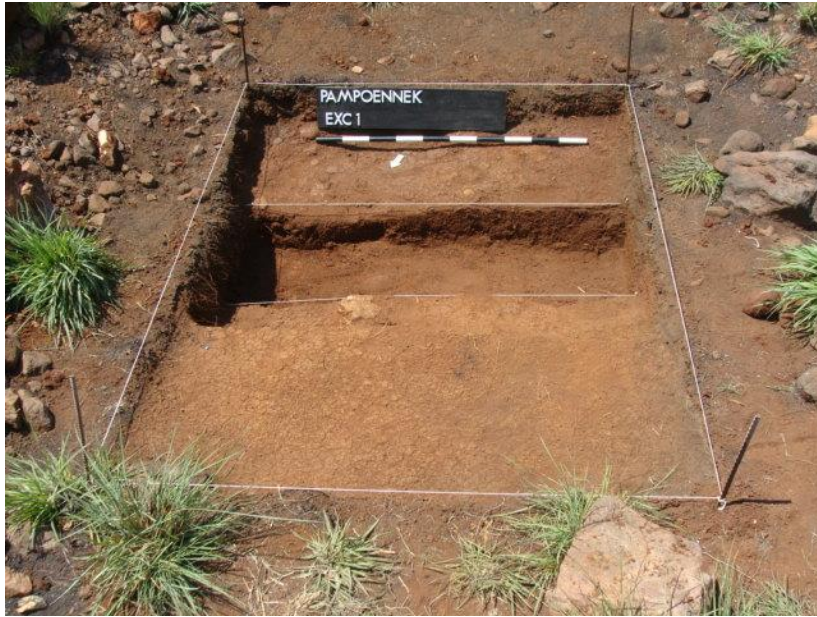
Figure 24: Excavation 1 before excavation.

Figure 25: Unearthing artefacts at Excavation 1.

Figure 26: The completed Excavation 1. The test trench in the centre was done to test the depth of the deposit.

In summary (details to be found in Van Vollenhoven & Pelsler 2011) two excavations were done. The first was on an area next to the outer wall of the structure in an area believed to be

a refuse midden (Figure 24-26). Excavation 2 was measured out inside of the blockhouse (Figure 27-29).

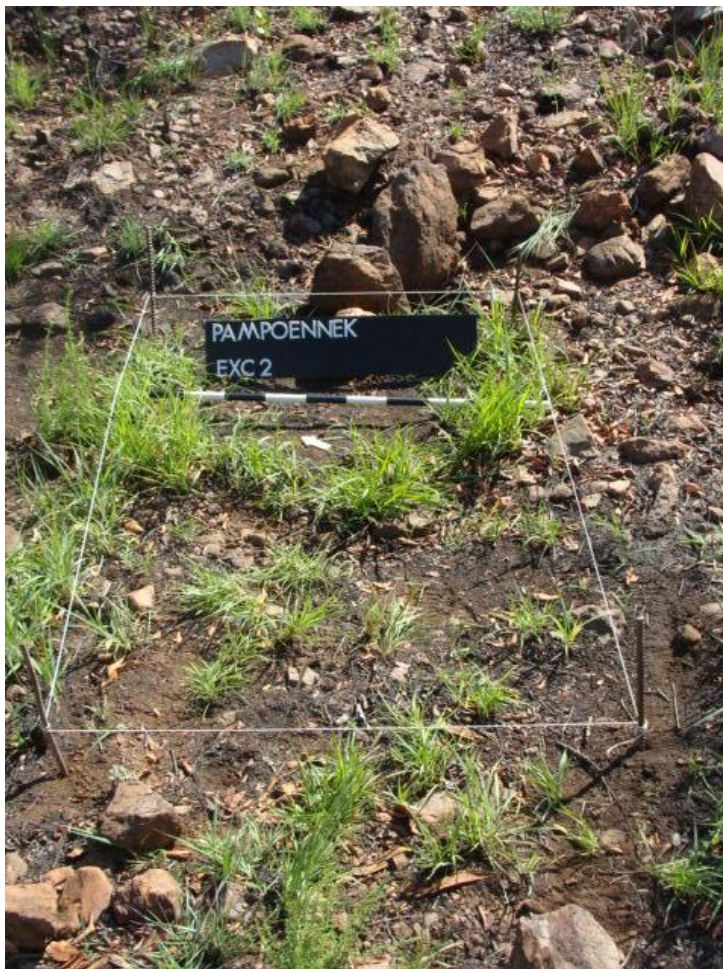
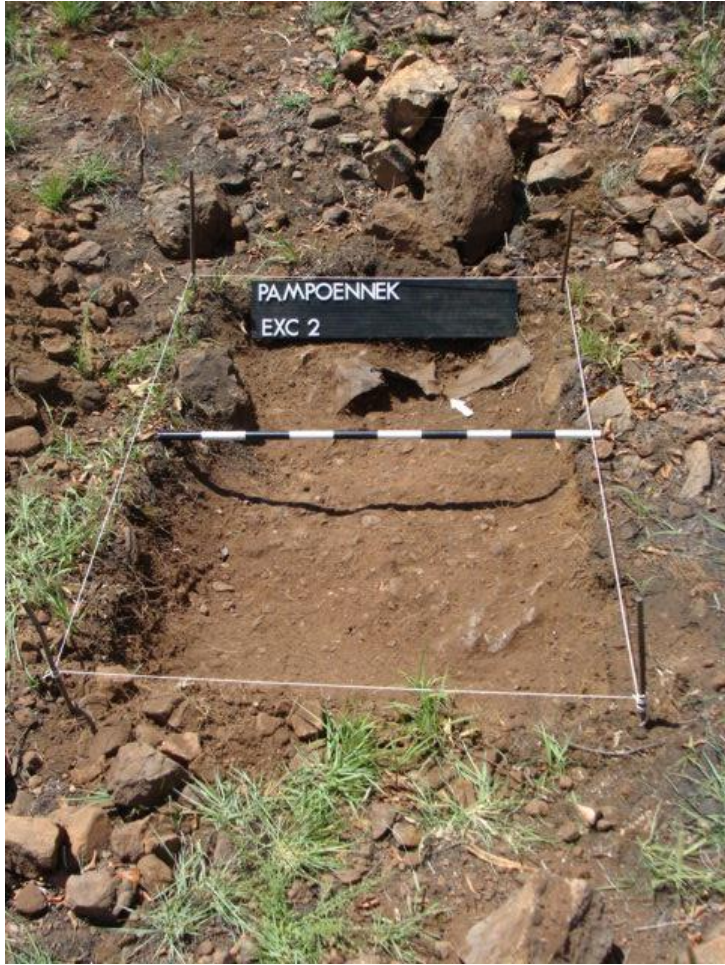
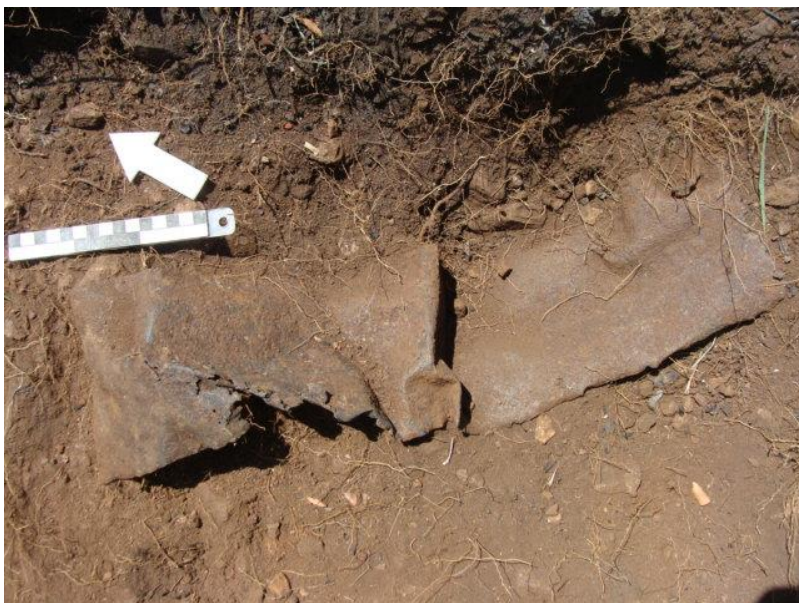
Figure 27: Excavation 2 before excavation.

Figure 28: The completed Excavation 2.

Figure 29: Detail of corrugated iron in Excavation 2.

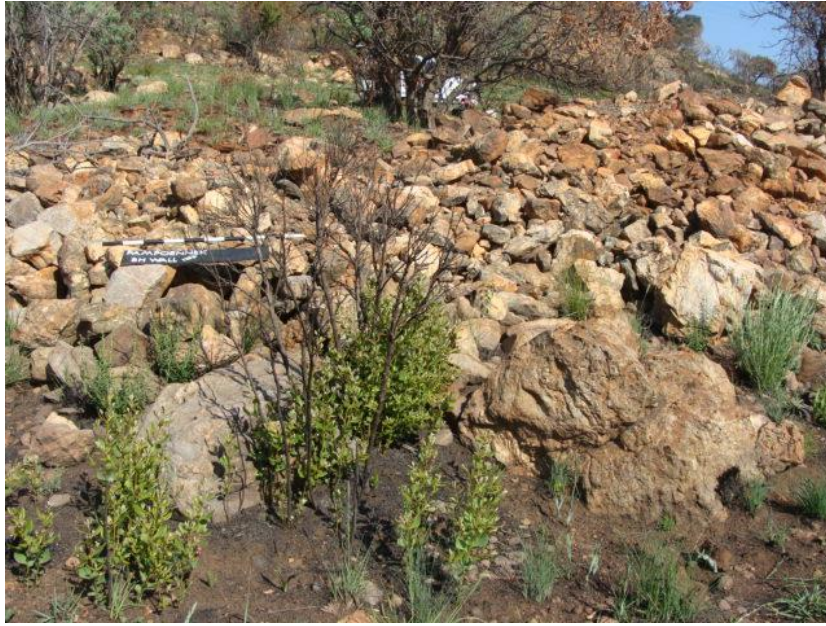
Figure 30: The defensive wall around the blockhouse.

The defensive wall around the blockhouse was also investigated by unpacking some of the loose stones (Figure 30). This was also done to learn more about the construction and building materials used.

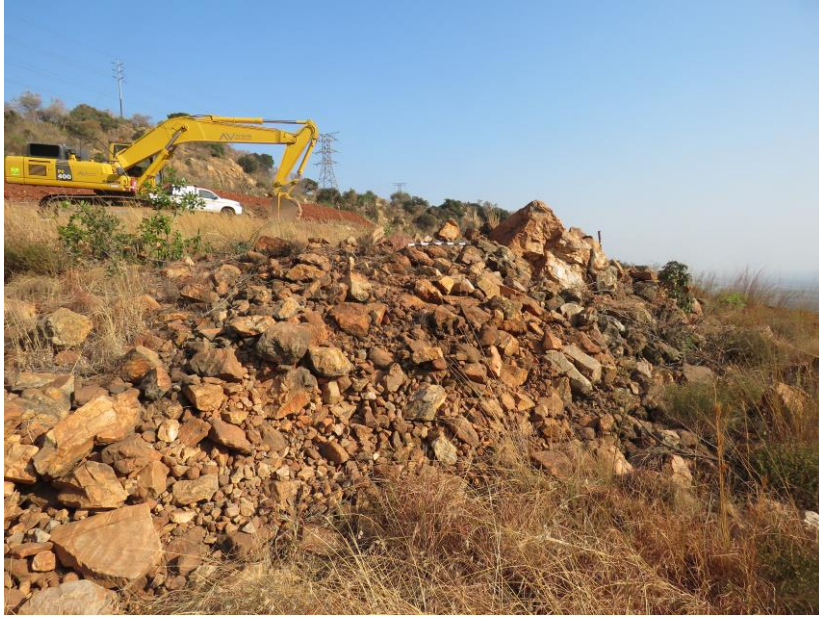
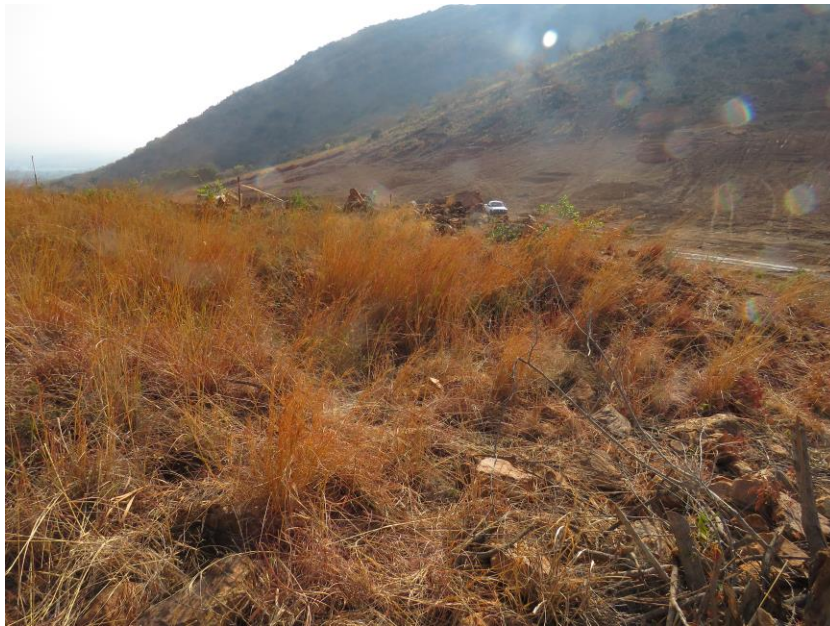
Figure 31: View of remains of the blockhouse, photographed from the east.

Figure 32: View of the blockhouse, photographed from the south.

The methodology consisted of documenting as much as possible of the site before and during demolition. Before the demolition of the structure started, a few site photographs were taken (Figure 31-32). These indicate the site before destruction.

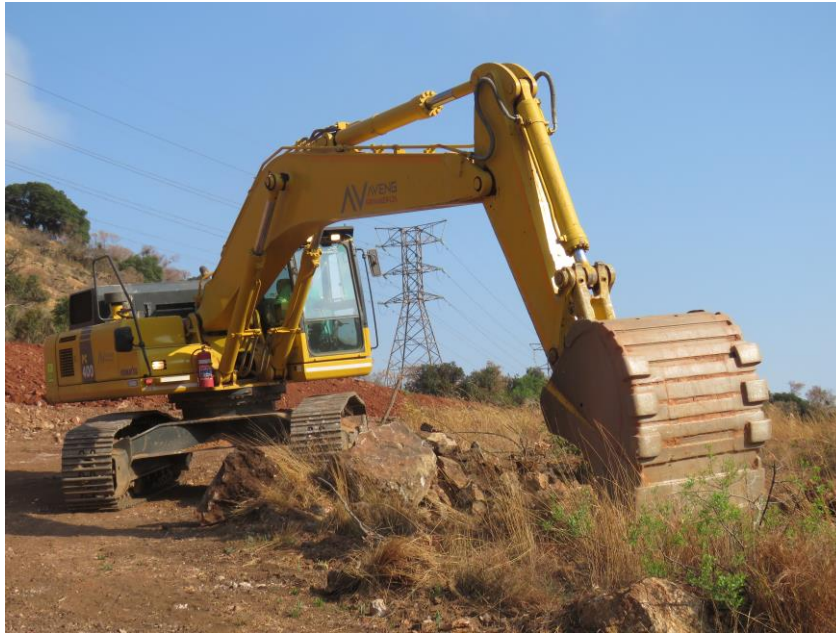
Figure 33: The excavator that was used in the demolition of the site.

The destruction was done by using a 40 ton excavator (Figure 33). The bucket of the excavator is 1,25 m wide. Each bucket load were carefully monitored for artefacts, as was the area after each scrape of the bucket. Lastly the heaps of soil from the site were also checked for possible artefacts.

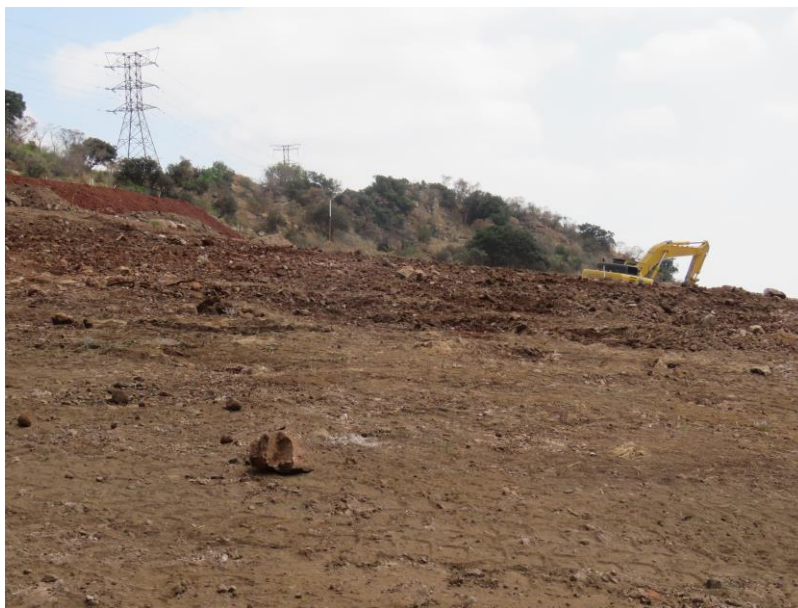
Figure 34: The site after the demolition of the blockhouse.

The site was made level with the ground (Figure 34). The stones and soil were removed and dumped with other material from the broader site, in order to prepare it for road construction.

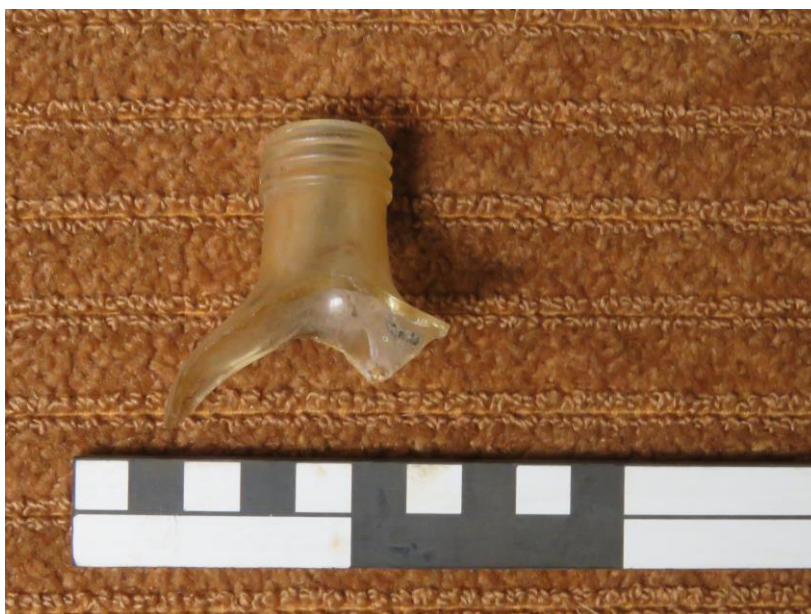
- 1 x fragment from a glass bottle (Figure 35). It is the shoulder, neck and mouth part of a clear bottle with screw top. Although screw-top bottles were known since 1885 (Lastovica & Lastovica 1990: 41), this one is very delicate and therefore likely post-dates the blockhouse. It likely was a medicine bottle.

Figure 35: Medicine bottle fragment.

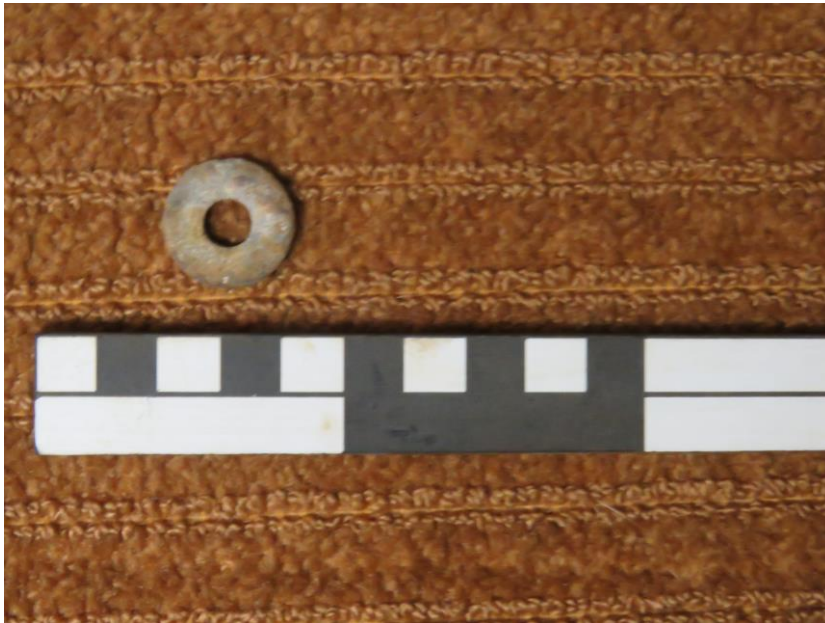
- 1 x washer, likely from typical screws used in corrugated iron (Figure 36). Such examples were found at various other fortification sites from this time period (see for instance Van Vollenhoven 2017: 69) and it therefore can be regarded as being contemporary with the blockhouse.

Figure 36: Washer from the site.

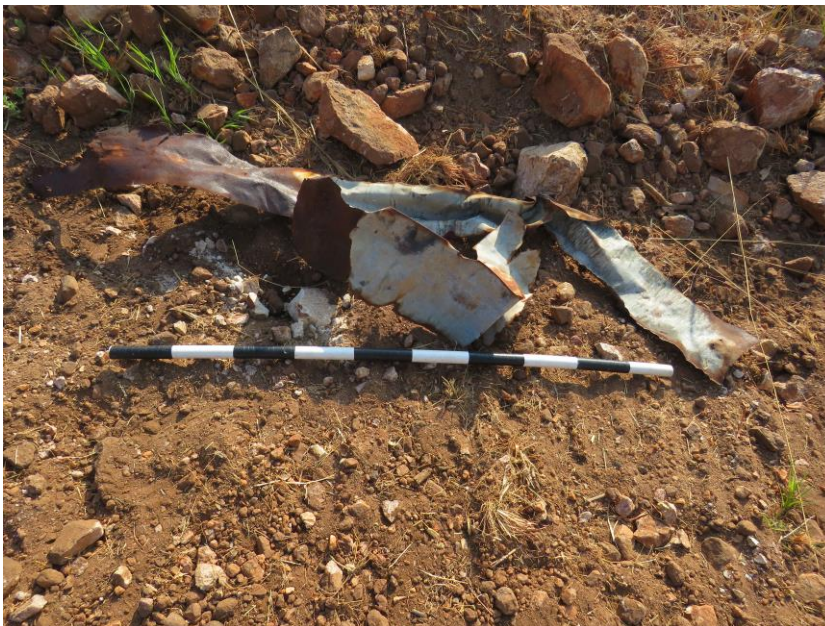
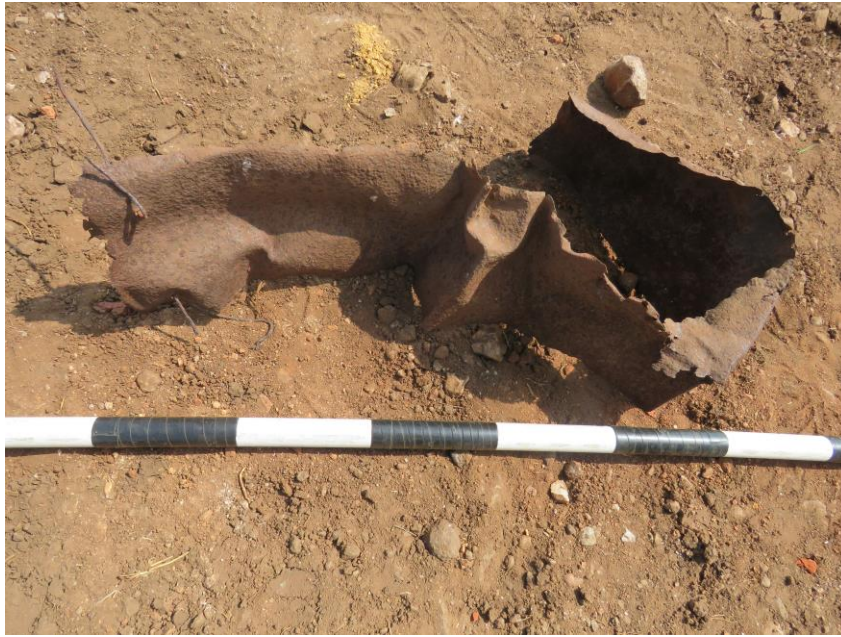
- 3 x pieces of corrugated iron (Figure 37-38). All of these likely are contemporary with the fort. One of the pieces have wire attached thereto. This may indicate that it was used in the defensive system around the blockhouse as wire was frequently used for this purpose (Van Vollenhoven 2017:69).

Figure 37: Two pieces of corrugated iron from the site.

Figure 38: Piece of corrugated iron with wire attached thereto.

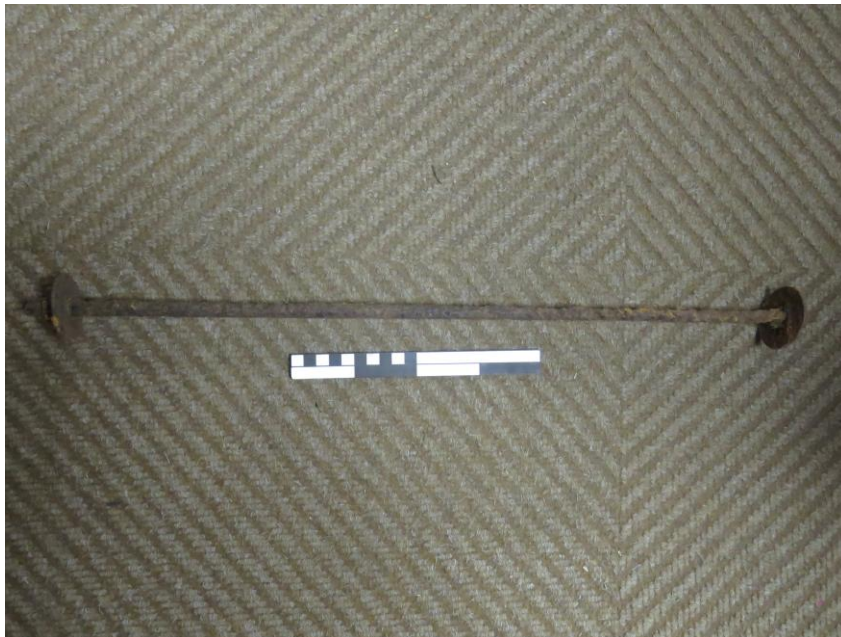
- 1 x metal rod with nuts and washer on both sides (Figure 39). It is similar to ones that were found during the excavations on site and may therefore not be contemporary with the site (see Van Vollenhoven & Pelsler 2011).

Figure 39: Metal rod from the site.

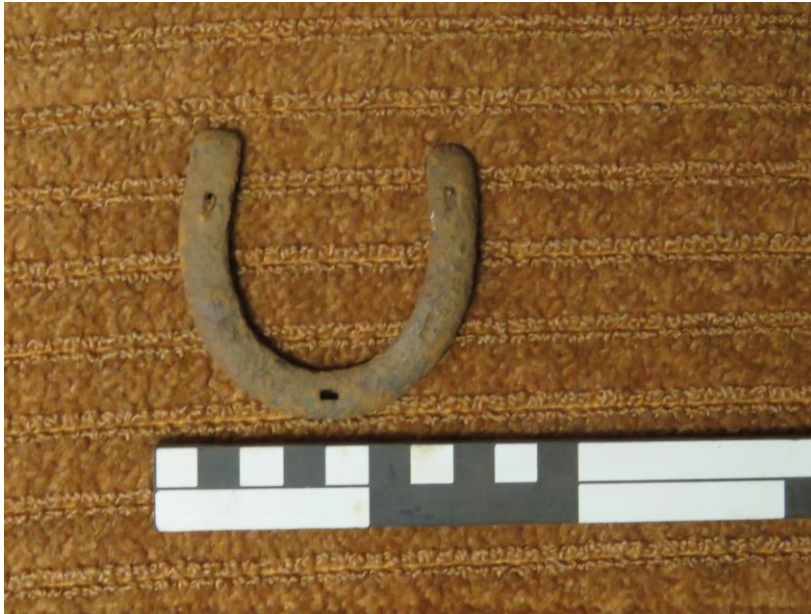
- 1 x heel iron from a military boot (Figure 40). This indeed is contemporary to the blockhouse and belonged to a soldier's boot. Similar items are found frequently on other fortification sites (see for instance Van Vollenhoven 2010: 126).

Figure 40: Heel iron from a military boot.

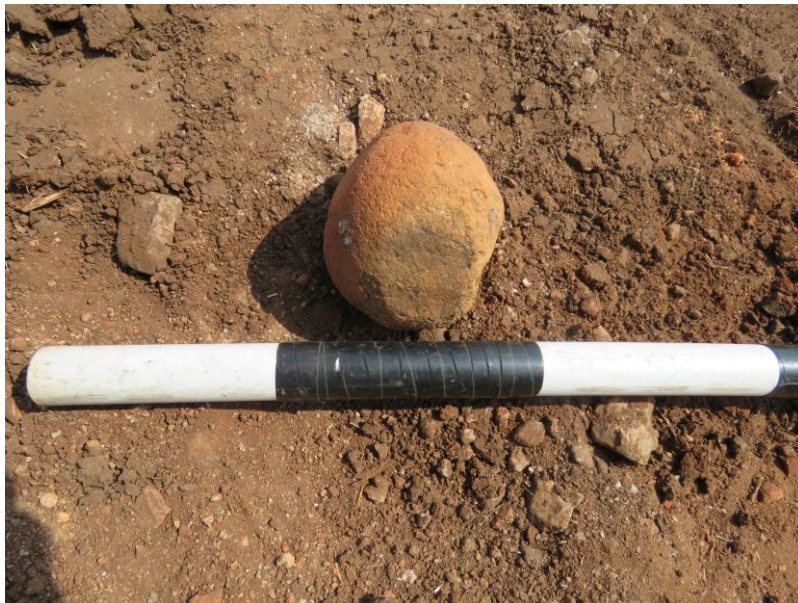
- 1 x hammer stone (Figure 41). This is just a rock with markings indicating that it was used as a hammer. Such hammer stones were used frequently during the Iron Age, but since this one is similar to the stones used in the construction of the blockhouse, it is believed to be contemporary therewith.

Figure 41: Hammer stone from the site. Note the hammering marks.
