**REPORT ON A WATCHING BRIEF DURING THE DEMOLITION OF AN ANGLO-
BOER WAR (1899-1902) BLOCHOUSE AT PAMPOENNEK, NORTHWEST PROVINCE**

September 2017

Report no.: AE01745

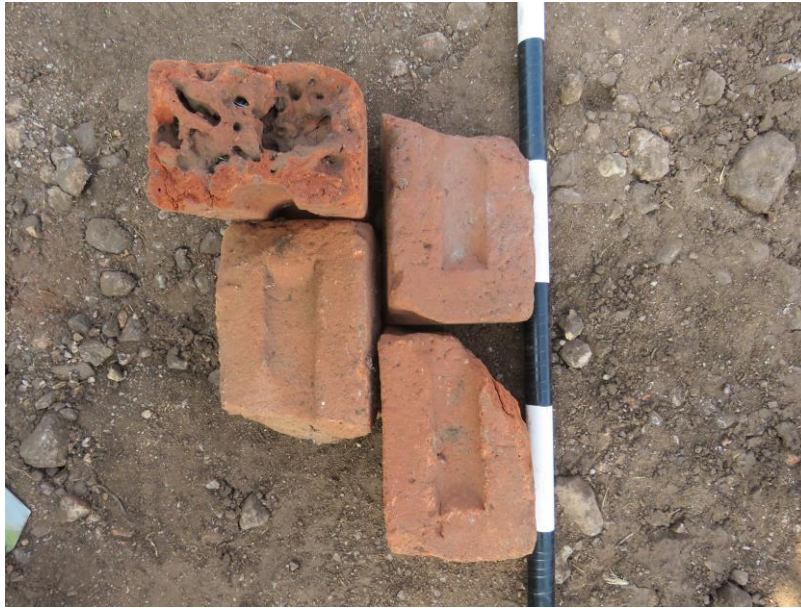
- 4 x clay bricks (Figure 42). The brick seems to be hand-made, but it was done by a skilled craftsman. They are not formed perfectly with the sides being somewhat skew. The clay was well-prepared and the bricks baked at a low temperature (personal communication: M Naudé). These bricks are too few to have been used in the construction of the blockhouse and there also is no evidence of such bricks ever been used for this purpose. It therefore probably is an intrusion – the bricks were likely left there during the dumping of building material on site. In fact, one of the contractors indicated that they had removed much dumped material from the broader site during construction of the new road.

Figure 42: Handmade clay bricks found at the site.

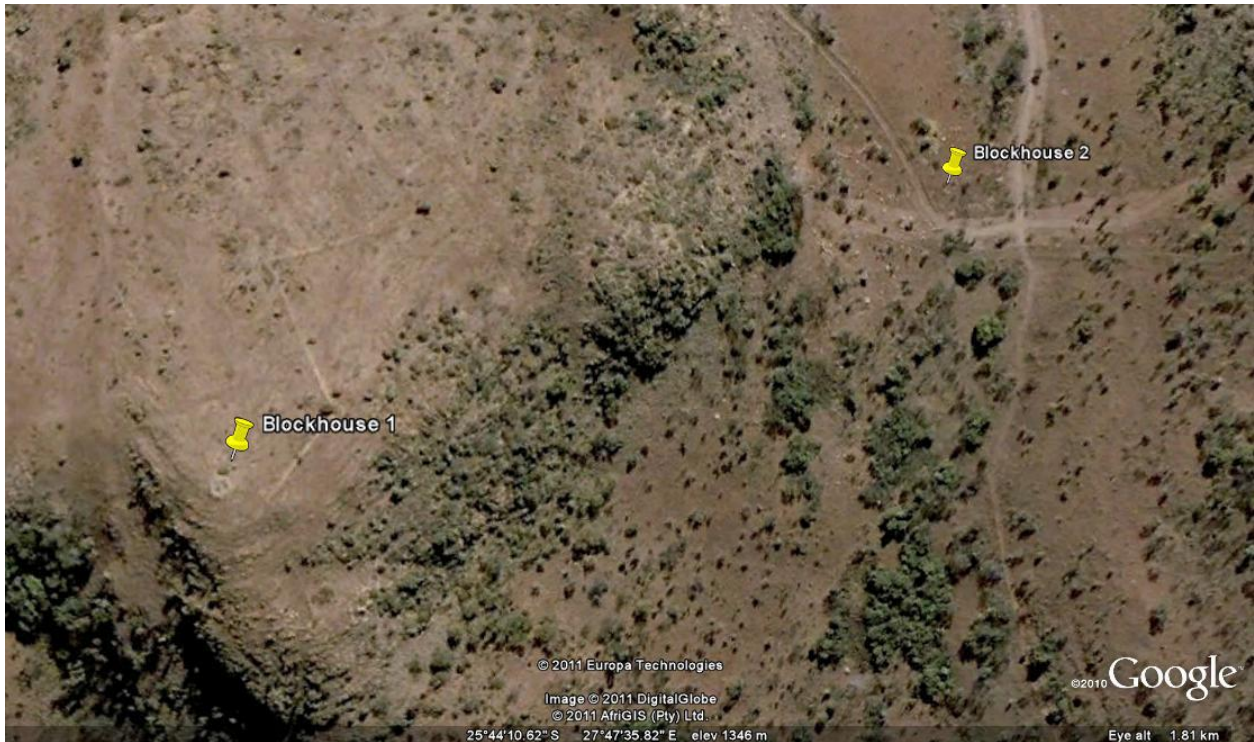
Figure 44: Google image indicating the two blockhouses. Note the mule path close to the upper one.

The detailed phase II investigation and documentation of the blockhouse was done during 2011 in accordance with the issued SAHRA permit. Detailed site maps (see earlier) and a map of the demolished blockhouse were also done (Figure 43). The documentation on site was completed and no further work is necessary. The relation between the two blockhouses and the mule path is clearly indicated on a Google image of the site (Figure 44).
