**A REPORT ON A CULTURAL HERITAGE IMPACT ASSESSMENT FOR THE
PROPOSED PROSPECTING OF THE GLOSAM MINE CLOSE TO
POSTMASBURG, NORTHERN CAPE PROVINCE**

REPORT NO.: AE01802V

19 January 2018

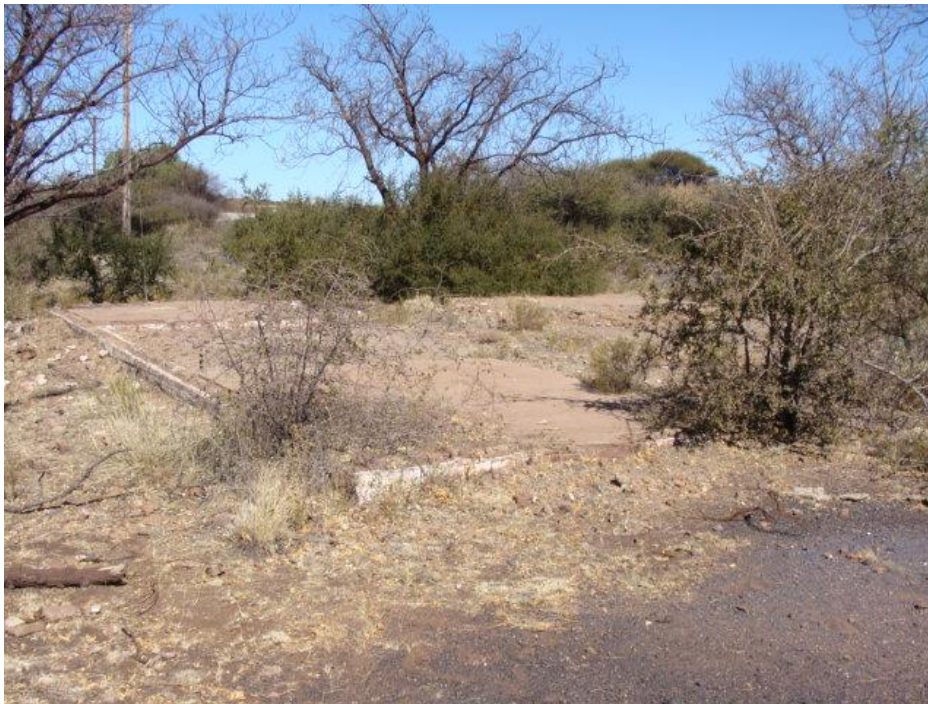
Foundation - Site no 5:

This is the foundation of a house or office building (Figure 34). Nothing of the walls or roof remained, but it probably is older than 60 years.

Figure 34: Foundation of a building less than 60 years old.

- The foundation (site 5), concrete building remains (site 16) and metal framework of an industrial building (site 21) has no cultural heritage value and may therefore be demolished. Since it is older than 60 years, a permit would be required from the SAHRA.

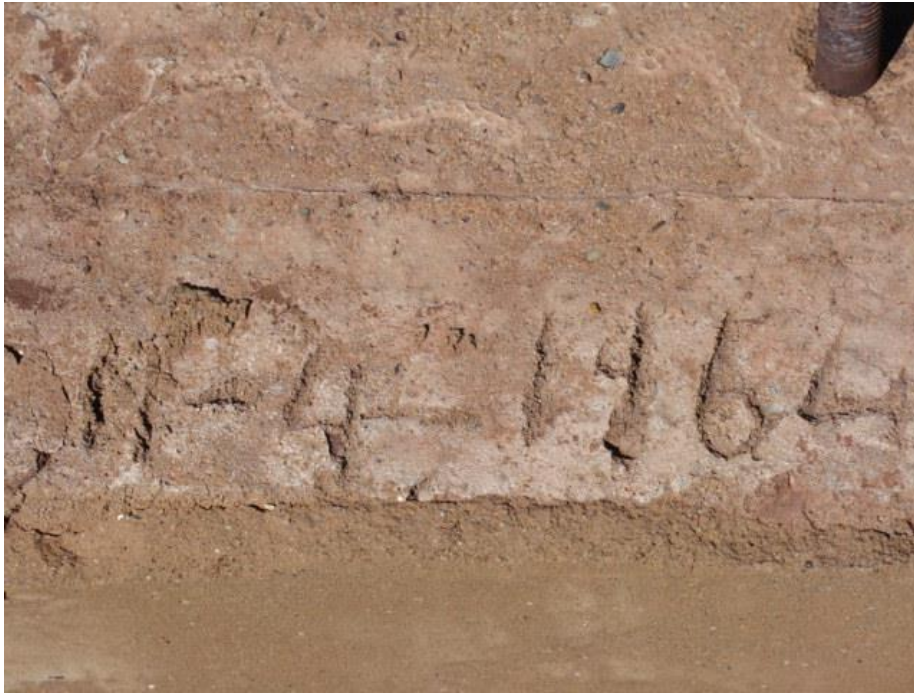
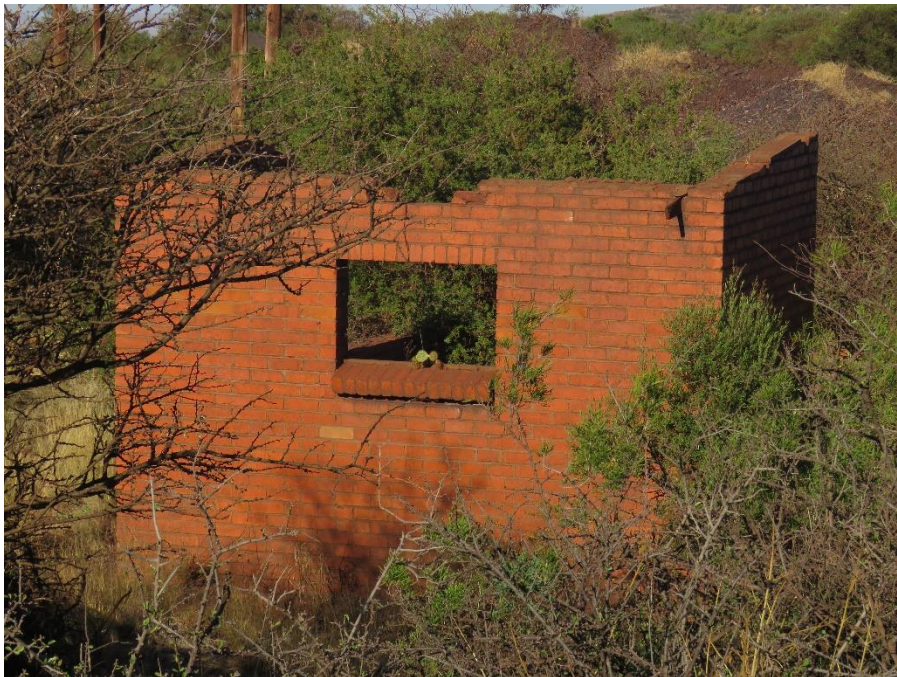
This is the remains of two associated industrial buildings within the mining area. The first has dimensions of 6 x 4 m and have concrete 9 pillars, approximately 2 m high. The second is a small brick building with walls of about 3 x 3 m and 2 m high. It was built in 1964, as indicated in an inscription in the cement (Figure 35-37).

FIGURE 35: REMAINS OF AN INDUSTRIAL BUILDING IN THE MINING AREA.

FIGURE 36: (11-4-1964) INDICATED ON THE BUILDING.

FIGURE 37: SECOND BUILDING ASSOCIATED WITH THE FIRST.

- The remains of industrial building (site 6), the base of a water reservoir (site 9), the office complex remains (site 10), various remains of brick buildings (site 11) and the farm yard (site 18) has no cultural heritage value. This report is seen as ample mitigation. The structures are younger than 60 years and in a very poor condition. It may be demolished without a permit from SAHRA.

The site has no cultural heritage value and may therefore be demolished. This report is seen as ample mitigation. The structure is younger than 60 years and in a very poor condition. It may be demolished without a permit from SAHRA.

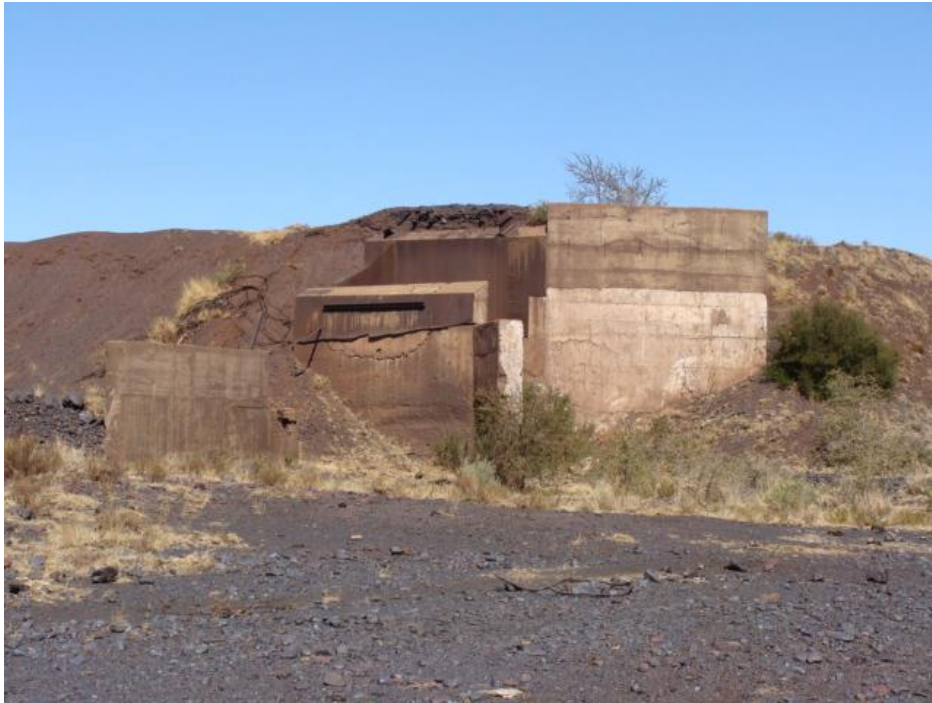
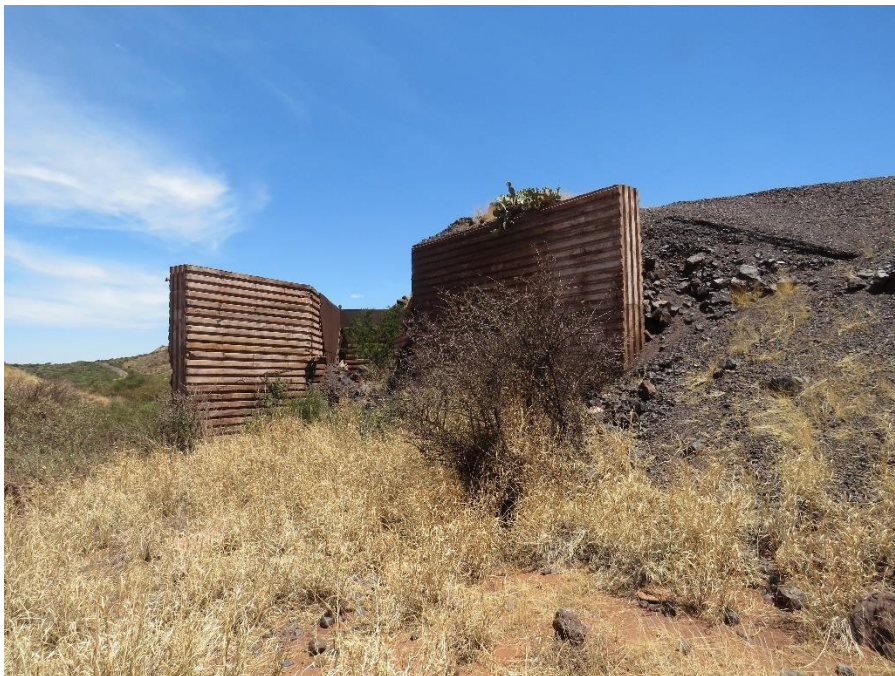
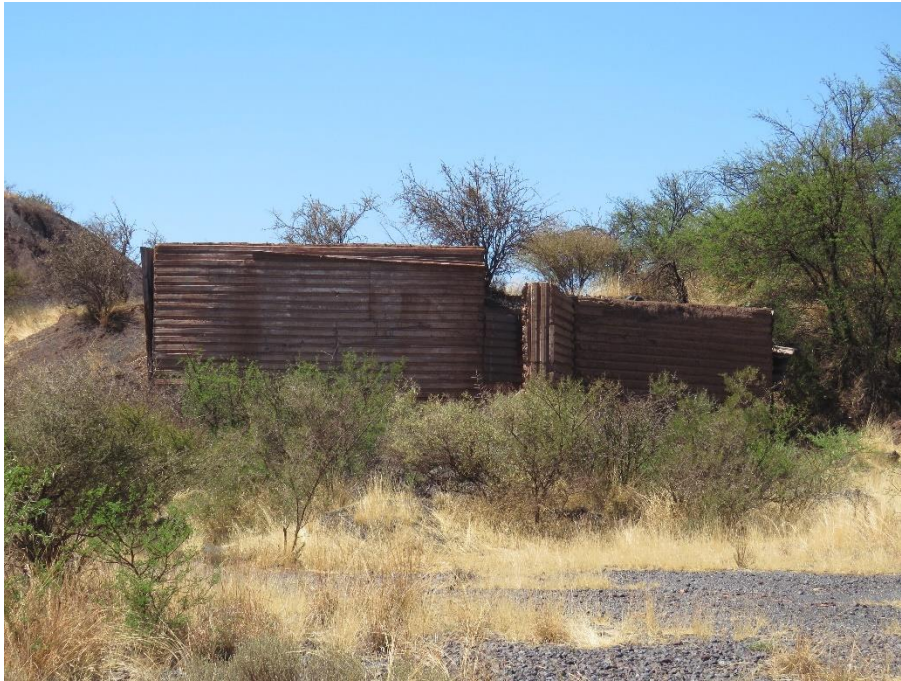
FIGURE 38: REMAINS OF AN ORE LOADING BAY, SITE NO. 7.

FIGURE 39: REMAINS OF AN ORE LOADING BAY, SITE NO. 14.

FIGURE 40: REMAINS OF AN ORE LOADING BAY, SITE NO. 19.

- The field rating for the ore loading bays (site 7, 14 and 19) Local Grade IIIC. The description in the phase 1 heritage report is seen as sufficient recording and it may be granted destruction. Since these sites are all younger than 60 years and in a very poor condition, it may be demolished without a permit from SAHRA.

The field rating for these sites are Local Grade IIIC. The description in the phase 1 heritage report is seen as sufficient recording (low significance) and it may be granted destruction. Since these sites are all younger than 60 years and in a very poor condition, it may be demolished without a permit from SAHRA.

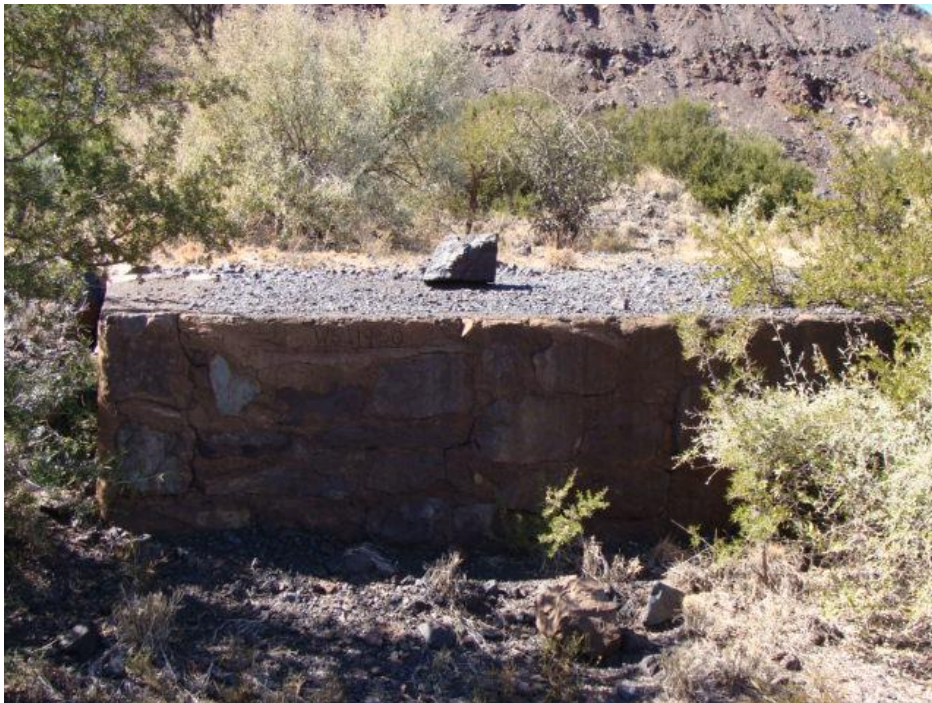
This is a loading platform, built from stone and cement from where ore was loaded onto trucks or carriages. The date, 1950, is scratched into the cement (Figure 41-42). The structure therefore is older than 60 years old.

FIGURE 41: DATE (1950) SCRATCHED INTO THE CEMENT OF THE LOADING PLATFORM.

FIGURE 42: THE LOADING PLATFORM.

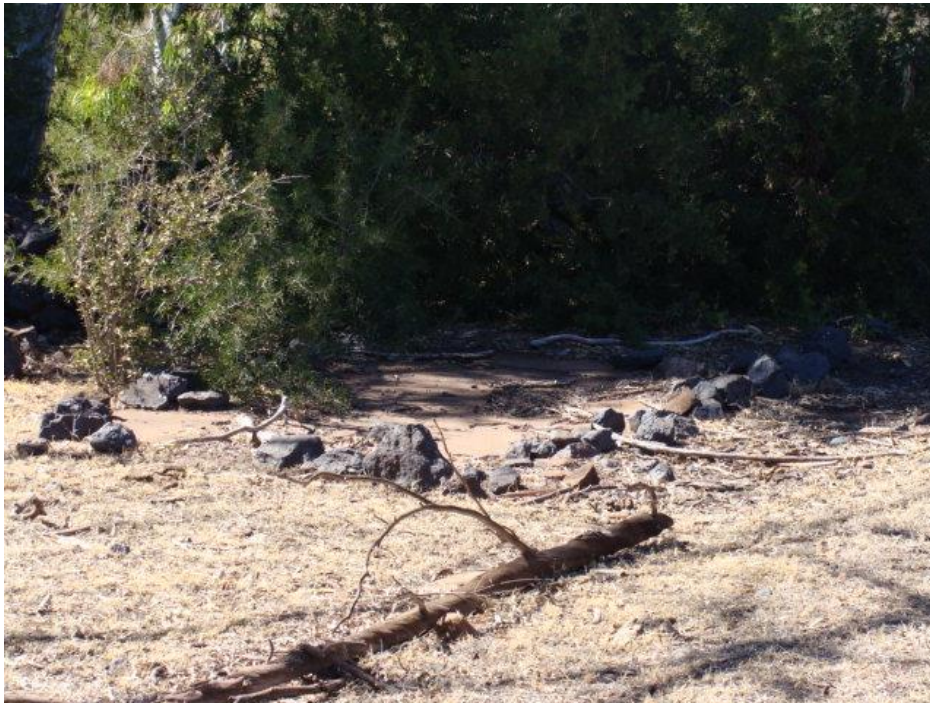
From the bad state of the site it seems it was deliberately demolished.

FIGURE 46: REMAINS OF THE TOILET BUILDING.

FIGURE 47: PART OF THE ROW OF TOILETS INSIDE OF THE BUILDING.

FIGURE 48: REMAINS OF ONE OF THE OTHER BUILDINGS IN THE AREA.

FIGURE 49: STONE WALL IN THE AREA.

FIGURE 50: FOUNDATION OF ANOTHER BUILDING IN THE AREA.

FIGURE 51: ANOTHER ASSOCIATED BUILDING.

The site has no cultural heritage value and may therefore be demolished. This report is seen as ample mitigation. The structures are younger than 60 years and in a very poor condition. It may be demolished without a permit from SAHRA.

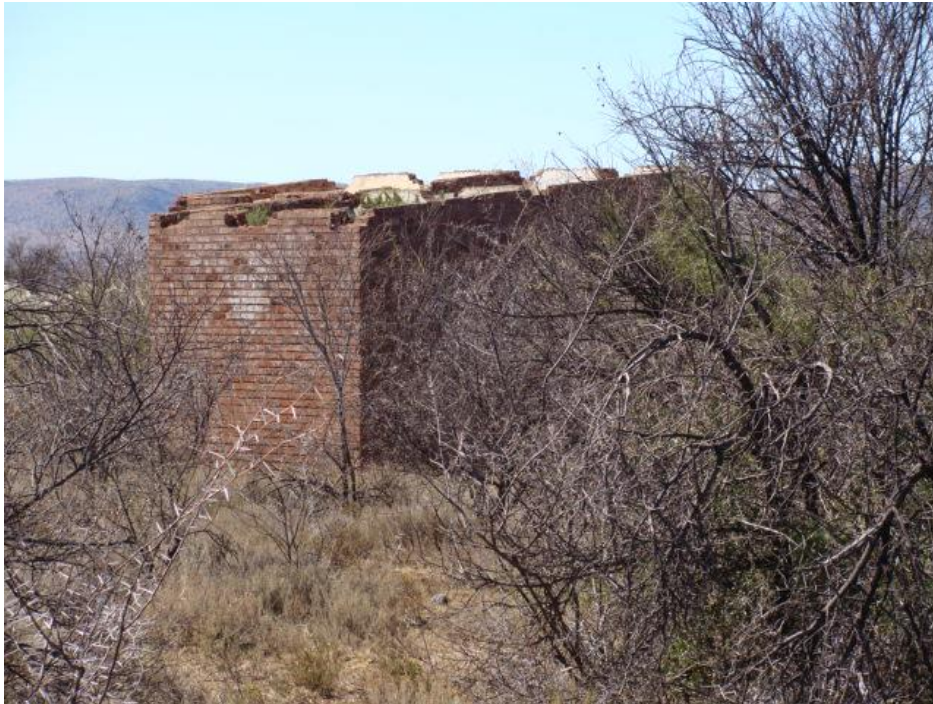
It probably also was part of the industrial or office setup at the mine, or it may have been residential. It is younger than 60 years.

FIGURE 52: REMAINS OF ONE OF THE BUILDINGS AT SITE NUMBER 11.

FIGURE 53: REMAINS OF ANOTHER BUILDING IN THE AREA.

The site has no cultural heritage value and may therefore be demolished. This report is seen as ample mitigation. The structures are younger than 60 years and in a very poor condition. It may be demolished without a permit from SAHRA.

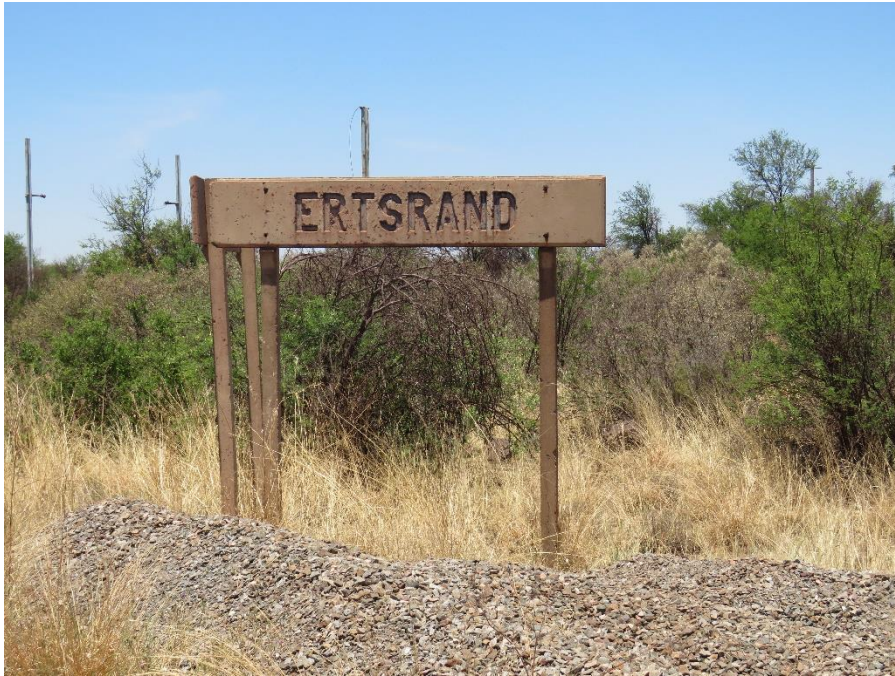
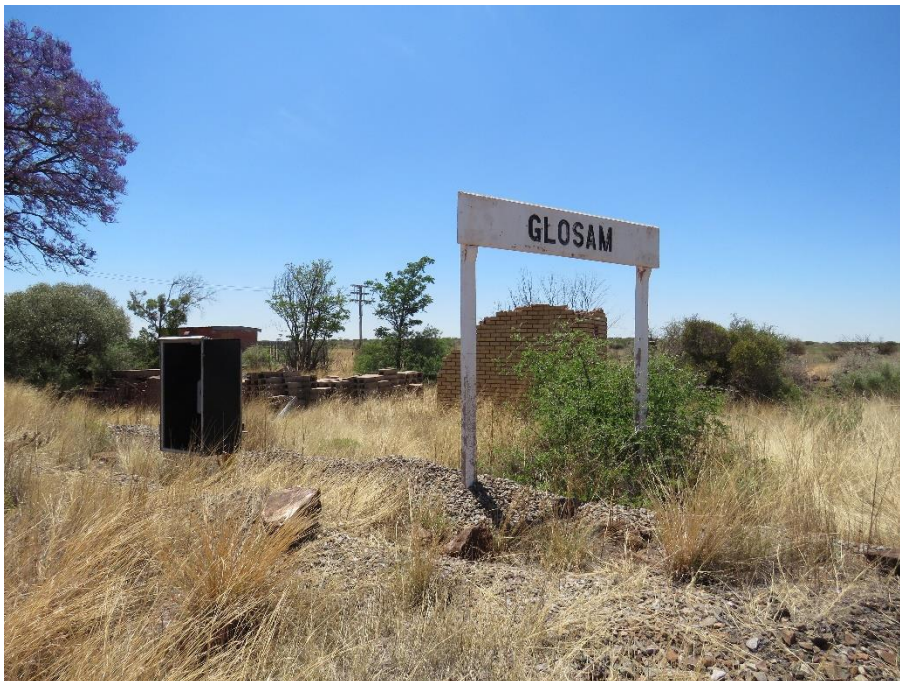
At Ertsrand siding there are no building remains left and one can only see the signage. At Glosam siding the ruins of some buildings are visible. These are however in a very bad state of decay. It seems everything may be just older than 60 years.

FIGURE 55: THE ERTSRAND SIDING.

FIGURE 56: THE GLOSAM SIDING.

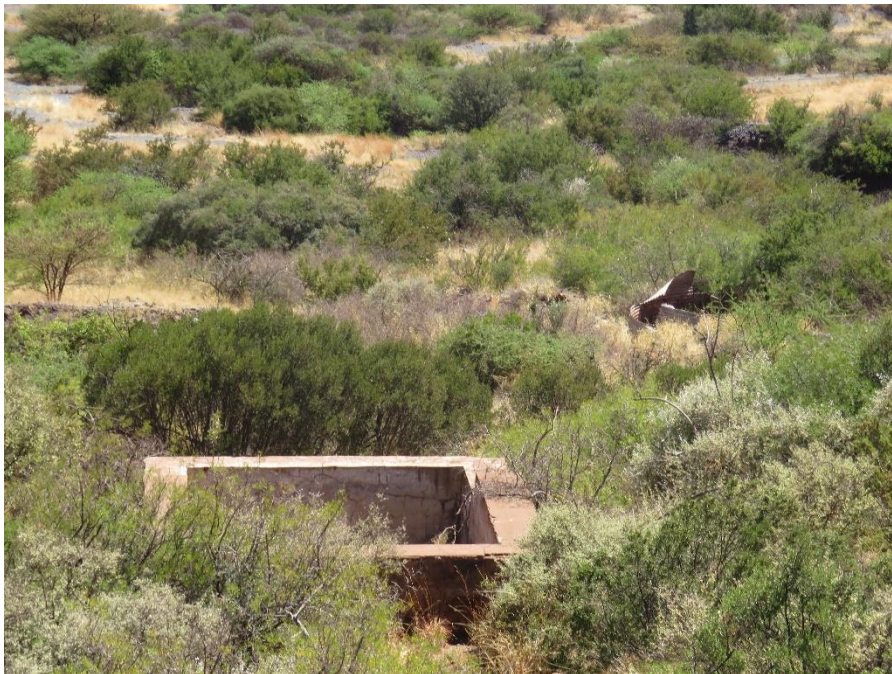
This is a building, likely associated to the loading platform (site 8). It is built with stone and concrete, with sizes of approximately 3 x 4 m as well as some loosely packed stone walling (Figure 57).

FIGURE 57: BUILDING ASSOCIATED WITH LOADING PLATFORM.

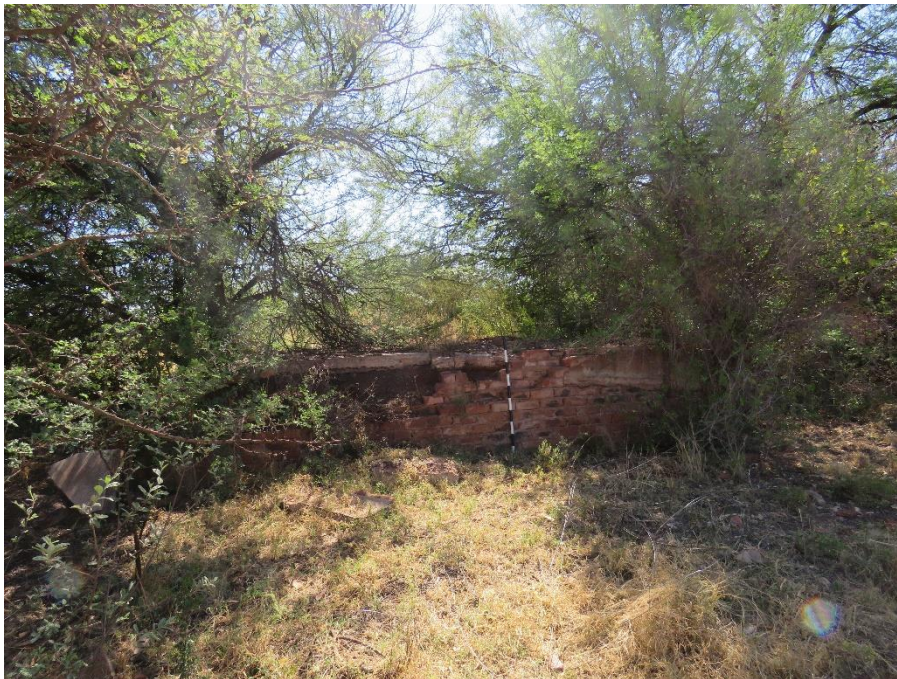
This is an abandoned farm yard consisting of the remains of a house (without walling), other concrete floors, a dam, fences etc. The house floor has a size of 18 x 11 m (Figure 58). It likely dates to the 1960's.

FIGURE 58: HOUSE REMAINS AT FARM YARD.

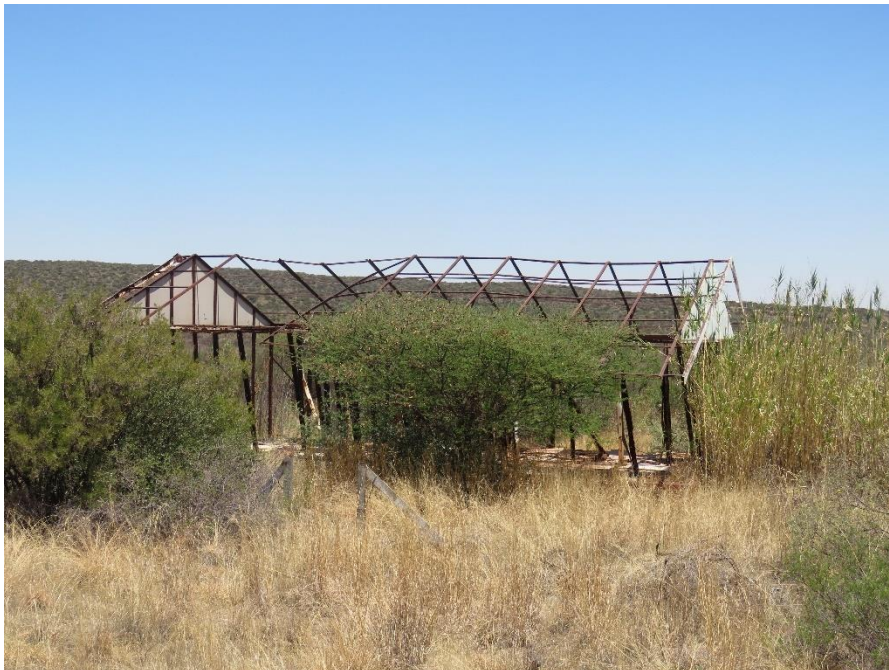
The building is probably related to the railways as it is located directly adjacent to the railway track. It consists of steel poles forming a frame and a concrete floor (Figure 59).

FIGURE 59: STEEL FRAME OF A RAILWAY BUILDING.
