Heritage Scoping Report

Development of 2.0 km and upgrading of 2.0 km gravel road in Chachacha Village

Gxobanyawo, Msinga LM, Mzinyathi District DM, KwaZulu-Natal.

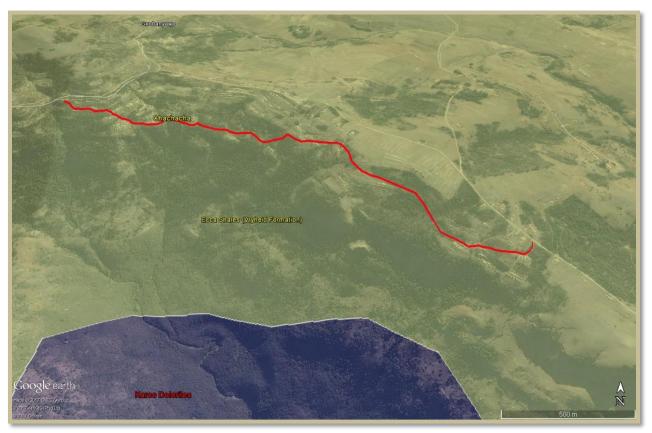
Figure 1 Locality map of the proposed Chachacha Village access-road alignment and attendant lithostratigraphy

eThembeni staff inspected the study area on 31 August 2017 (See Figure 1). The proposed road follows the alignment of existing rudimentary sledge and donkey tracks that have been hand excavated in places to allow access for light vehicular traffic to some imizi. (See Figure 2). Much of the alignment traverses along a steep south-west facing scarp slope, infested with thick stands of feral black wattle (*Acacia mearnsii*).

The proposed alignment is underlain with Vryheid Formation sandstones and shales that are intruded by dolerite. However, the entire road alignment traverses over shallow sandy clay colluvial soils derived from extensive decomposition of the underlying shales and sandstones; observed to be 1-2 m deep in manually cut access routes to various *imizi*. Road construction is unlikely to exceed vertical depths of 1,5m and consequently no impact on the underlying hard rock is anticipated.

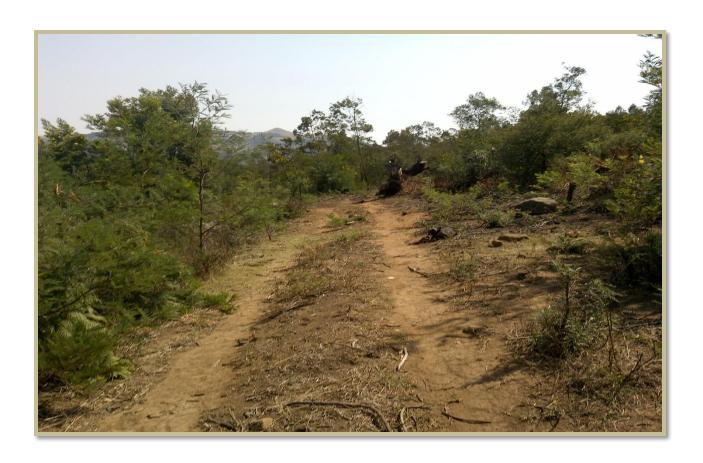
Figure 2 Existing servitude from which the Chachacha Village access-road will be constructed (Note intrusive dolerite)

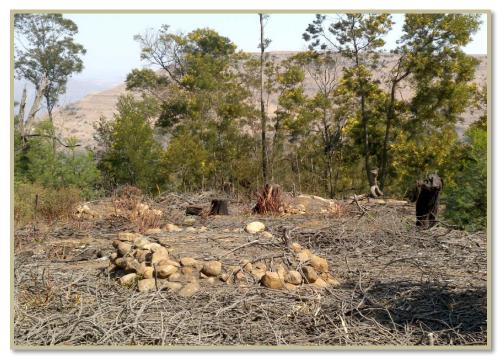
No road construction had been incepted along existing roads and track alignments into the village, although these were obviously manually maintained periodically. The only graves observed within 20m of the route alignment are clearly apparent (Figure 3). Their locations are tabled below:

<sup>2</sup> Graves of Ngubane family who currently reside some 250m away from the burial ground. Are aware of and welcome the proposed road upgrade (pers.com. LvS. 31.08.2017).

Figure 3 Cluster of six graves in cleared feral wattle plantation (S28° 43.068'; E30° 33.005')

It is recommended that these graves<sup>2</sup> be barriered with ski netting during the construction phase.

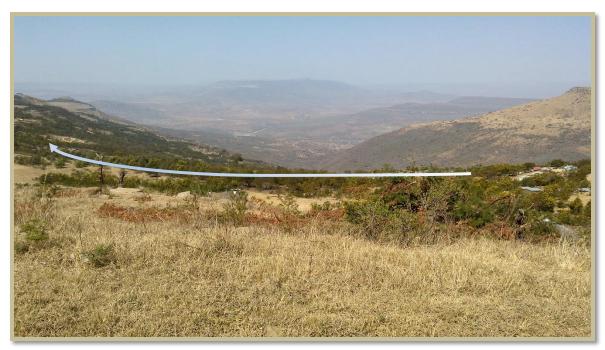
Figure 4 Alignment along SSW facing scarp through feral wattle stands and between existing *imizi*. The Thukela Valley is due South.
