**HERITAGE SURVEY OF THE PROPOSED EXPANSION  
TO THE TRANSNET NATIONAL PORTS  
AUTHORITY, RICHARDS BAY**

**FOR MSA ENVIRONMENTAL, LEGAL & MINING  
SERVICES**

**DATE: June 2009**

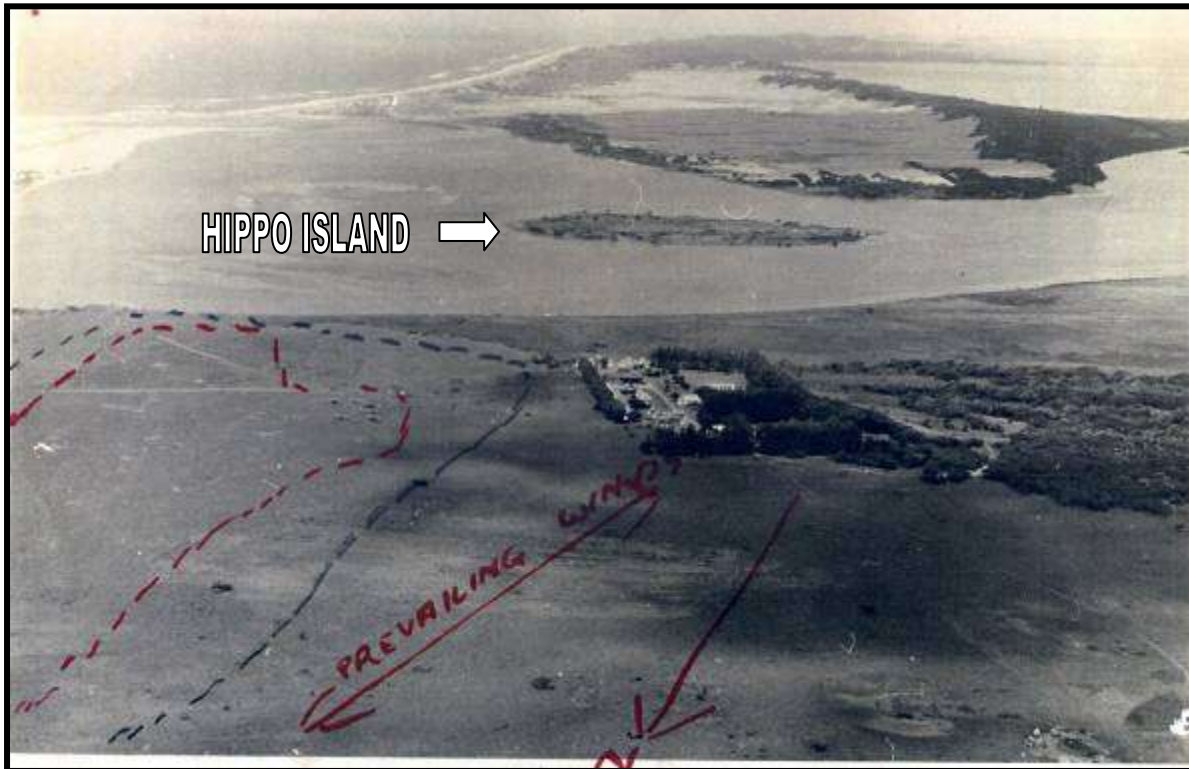
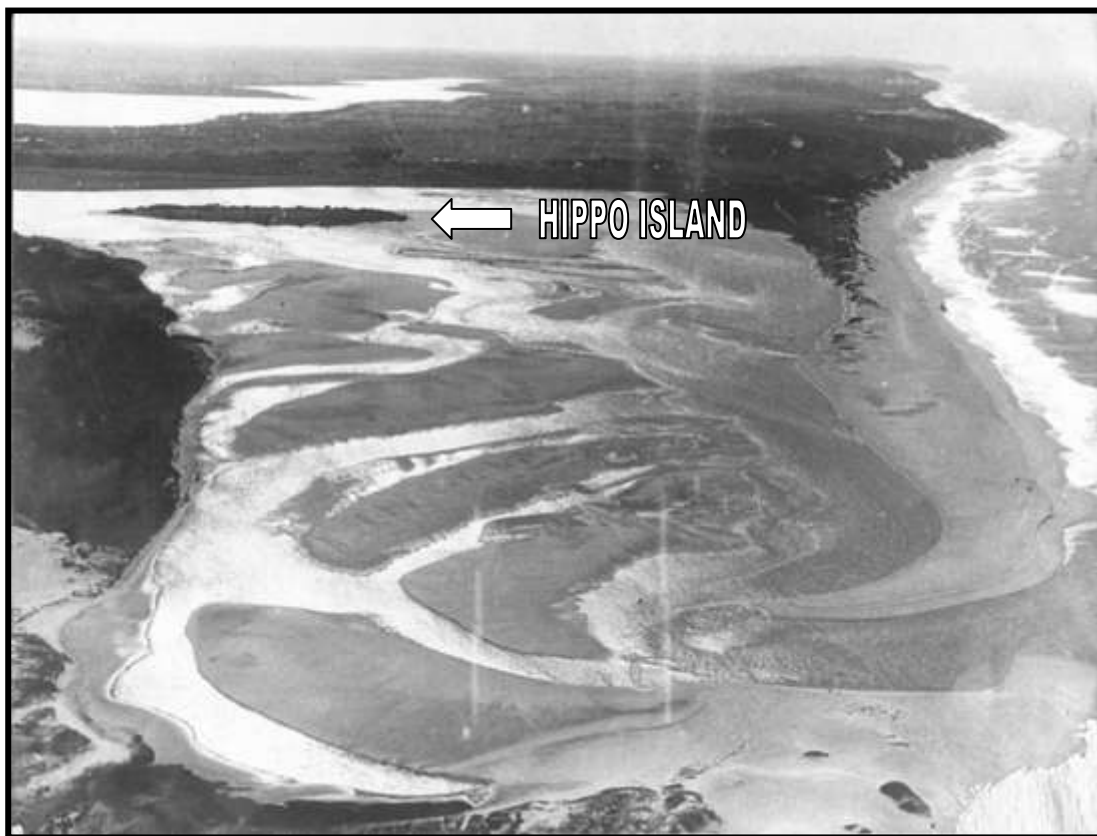
FIG. 4a: THE RIVER MOUTH FROM THE NORTH (TOP) AND SOUTH (BOTTOM)<sup>3</sup>

The photographs in figure 4a clearly show that the area to the east of the lake was mostly open dune with some grassland. There is no evidence, from the photographs, for human occupation in the area between the Lake and the coast. There is a possibility that Stone Age sites may occur in the deflation hollows, as we found tentative evidence for this – see below. However, much of this area would be tidal related and the deflation hollows tend to be very wet at the base, as we observed during our survey of this area. Much of this area has been damaged by the harbour development. The only strip that appears to be undamaged is the 5km stretch of coastal dunes (fig. 4b). This stretch is only 300m – 500m wide and most of it is now under dense Casuarinas forest and wetland.

The historical photos also show how certain marshes and/or wetlands have been reclaimed for agricultural activity, e.g. between Lake Cubhu and the John Ross Parkway. The retaining walls and canals draining these wetlands are secondary evidence. These areas are thus unlikely to yield archaeological sites and this is supported by the archaeological finds that occur on small hills overlooking these original wetlands. These low-lying areas were also affected by the deposition of alluvial sands from Cyclone Demoina.

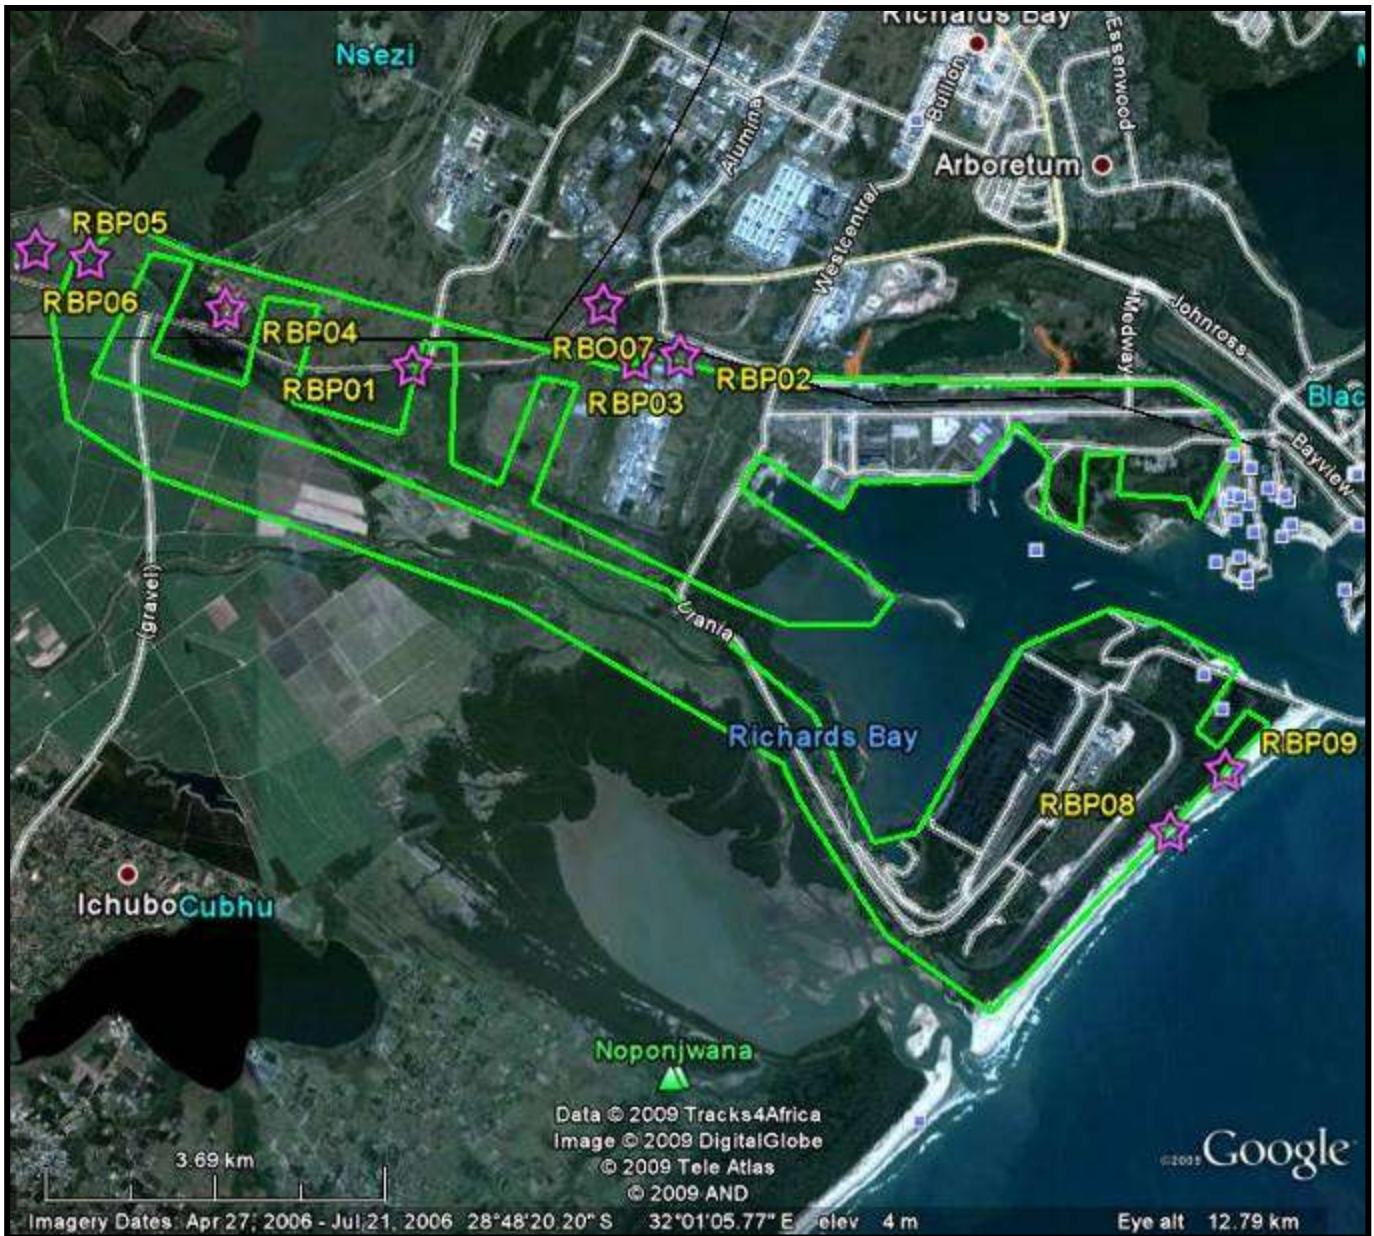
FIG. 5: LOCATION OF RECORDED SITES IN THE STUDY AREA

The construction of the John Ross Parkway, and its current widening has affected potential archaeological sites, as well as the construction of the transmission lines, substation and industrial buildings. Thus, we were not expecting to find many sites in a primary context. Figure 5 indicates the locations of the various sites.

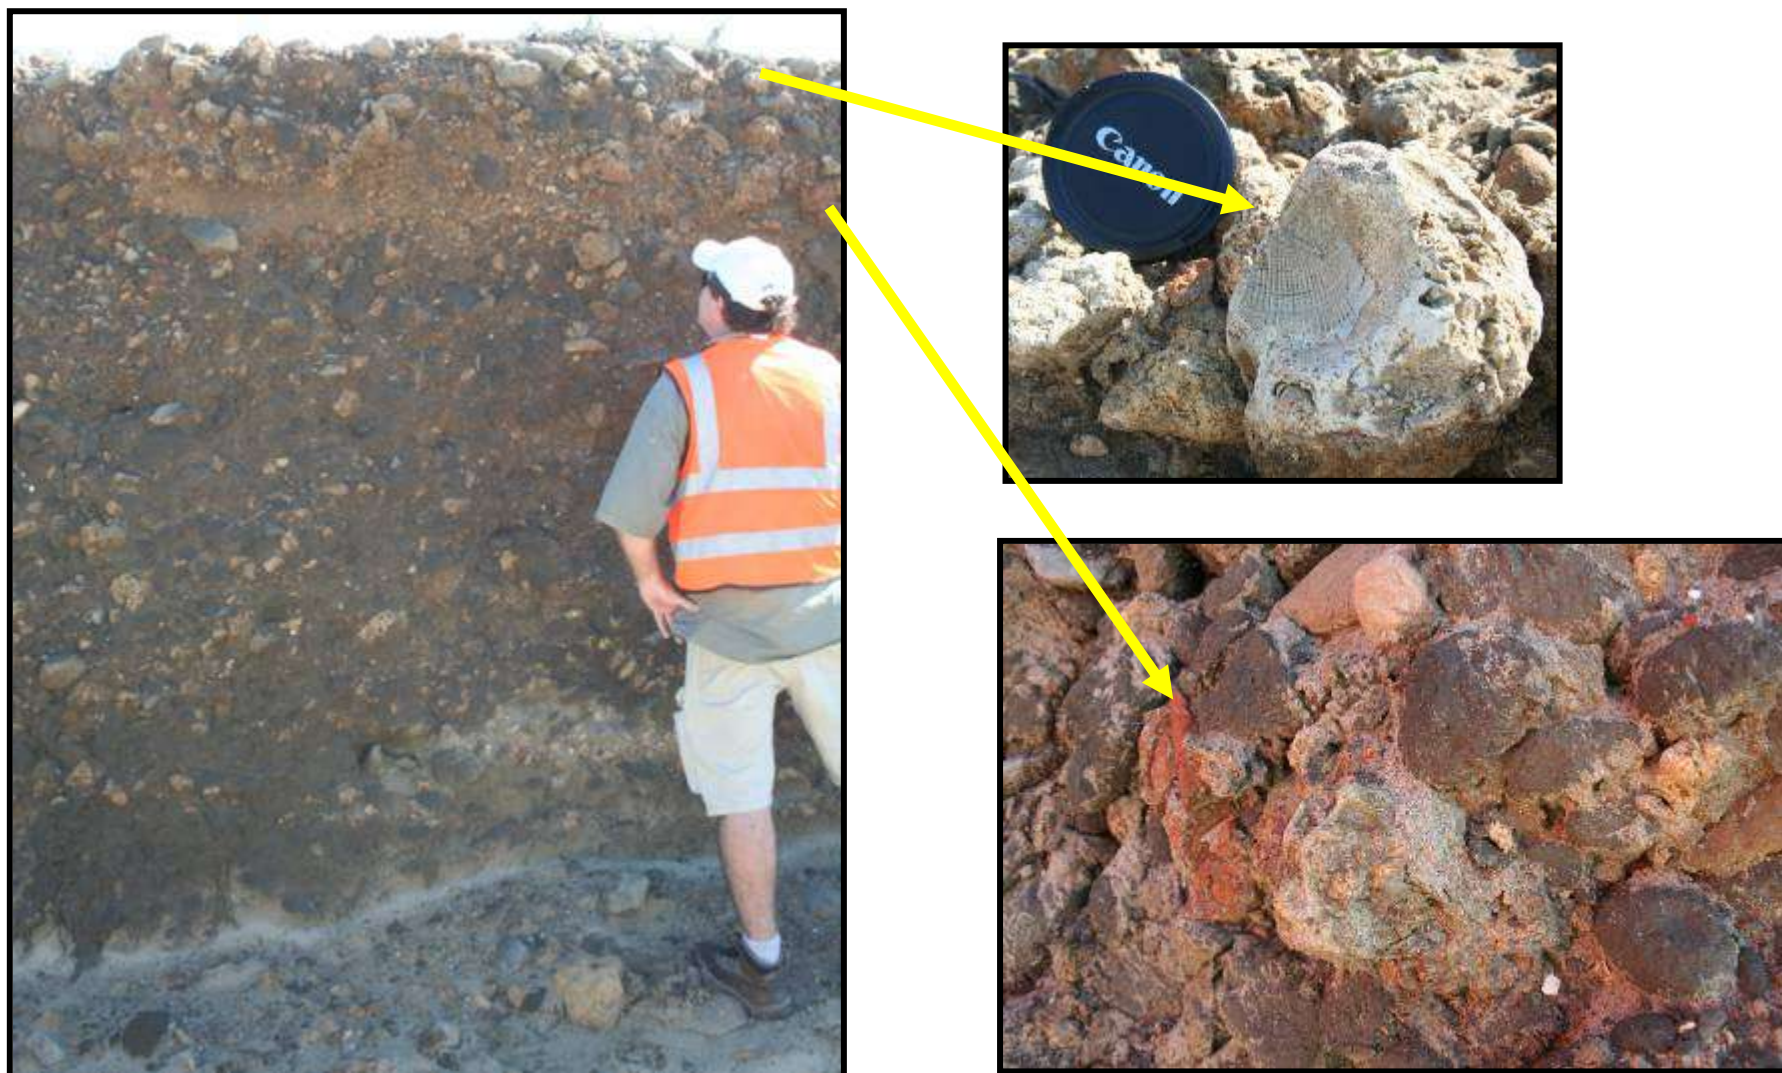
**FIG. 6: VIEW OF A CRETACEOUS LAYER OUTCROP ALONG THE BEACH**

RBP08 is located along the coastline and just above the high water mark. It is about 2.5km south of the southern breakwater. The site consists of a geological formation that has formed a shelf protruding from the sand dunes, as the dunes are eroded (fig. 6). The formation appears to be that of a Cretaceous layer (Dr. G. Groenwald pers. comm.) and consists of many fossilised remains. The layer is relatively thick and either thins out towards the interior, or it dips below the sand dunes – see Fig. 7 where the same material is scattered along the surface.

Significance: The site is of high significance.

Mitigation: The area will need to be monitored and sampled.

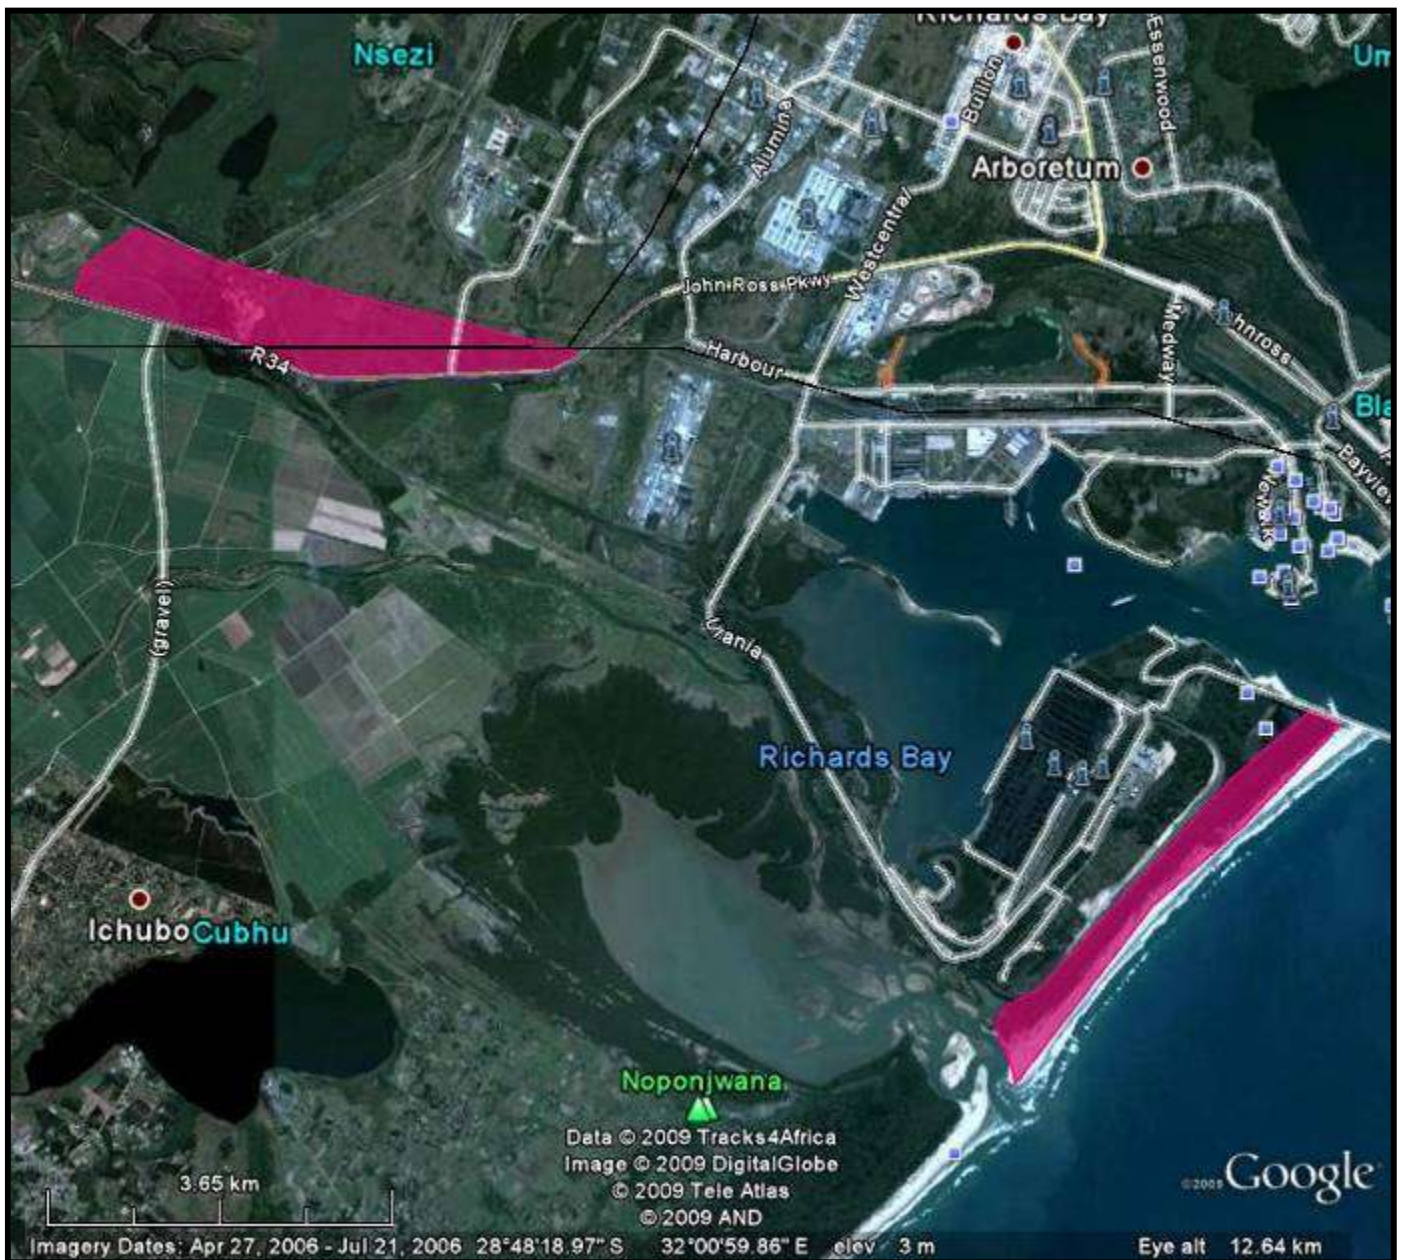
FIG. 8: LOCATION OF SENSITIVE ARCHAEOLOGICAL AREAS THAT REQUIRE MONITORING, SAMPLING AND/OR EXCAVATION<sup>5</sup>

There are two areas of archaeological sensitivity that will require further investigation if they are to be affected. The first area is mostly north of the John Ross Parkway. Several ESA and MSA sites were observed in the area, and those around RBP06 appear to be more significant than the other areas. Few ESA sites have been recorded in this area and a sample of these tools should be taken. The area will need to be monitored during any earthmoving activity and samples of various types of stone tools may be taken. The area has been (and still is) damaged by a quad-bike track and a sand borrow pit. The former damage is minimal, while the borrow pit damage is permanent and negative.

The second area is located between the harbour's easternmost railway and the coast. There are possible remains of archaeological sites: RBP09 is such a site, and this may extend under the dense Casuarinas trees. We did not survey under these trees due to poor visibility and a safety issue. Any type of earth moving, rehabilitation, or development should be monitored by an archaeologist with the possibility of excavations.

Figure 8 outlines these two sensitive areas.

<sup>5</sup> Sensitive areas demarcated in cerise pink
