**HERITAGE SURVEY OF THE PROPOSED EXPANSION
TO THE TRANSNET NATIONAL PORTS
AUTHORITY, RICHARDS BAY**

**FOR MSA ENVIRONMENTAL, LEGAL & MINING
SERVICES**

DATE: June 2009

**By Gavin Anderson & Louise Anderson
Umlando: Archaeological Tourism and Resource
Management**

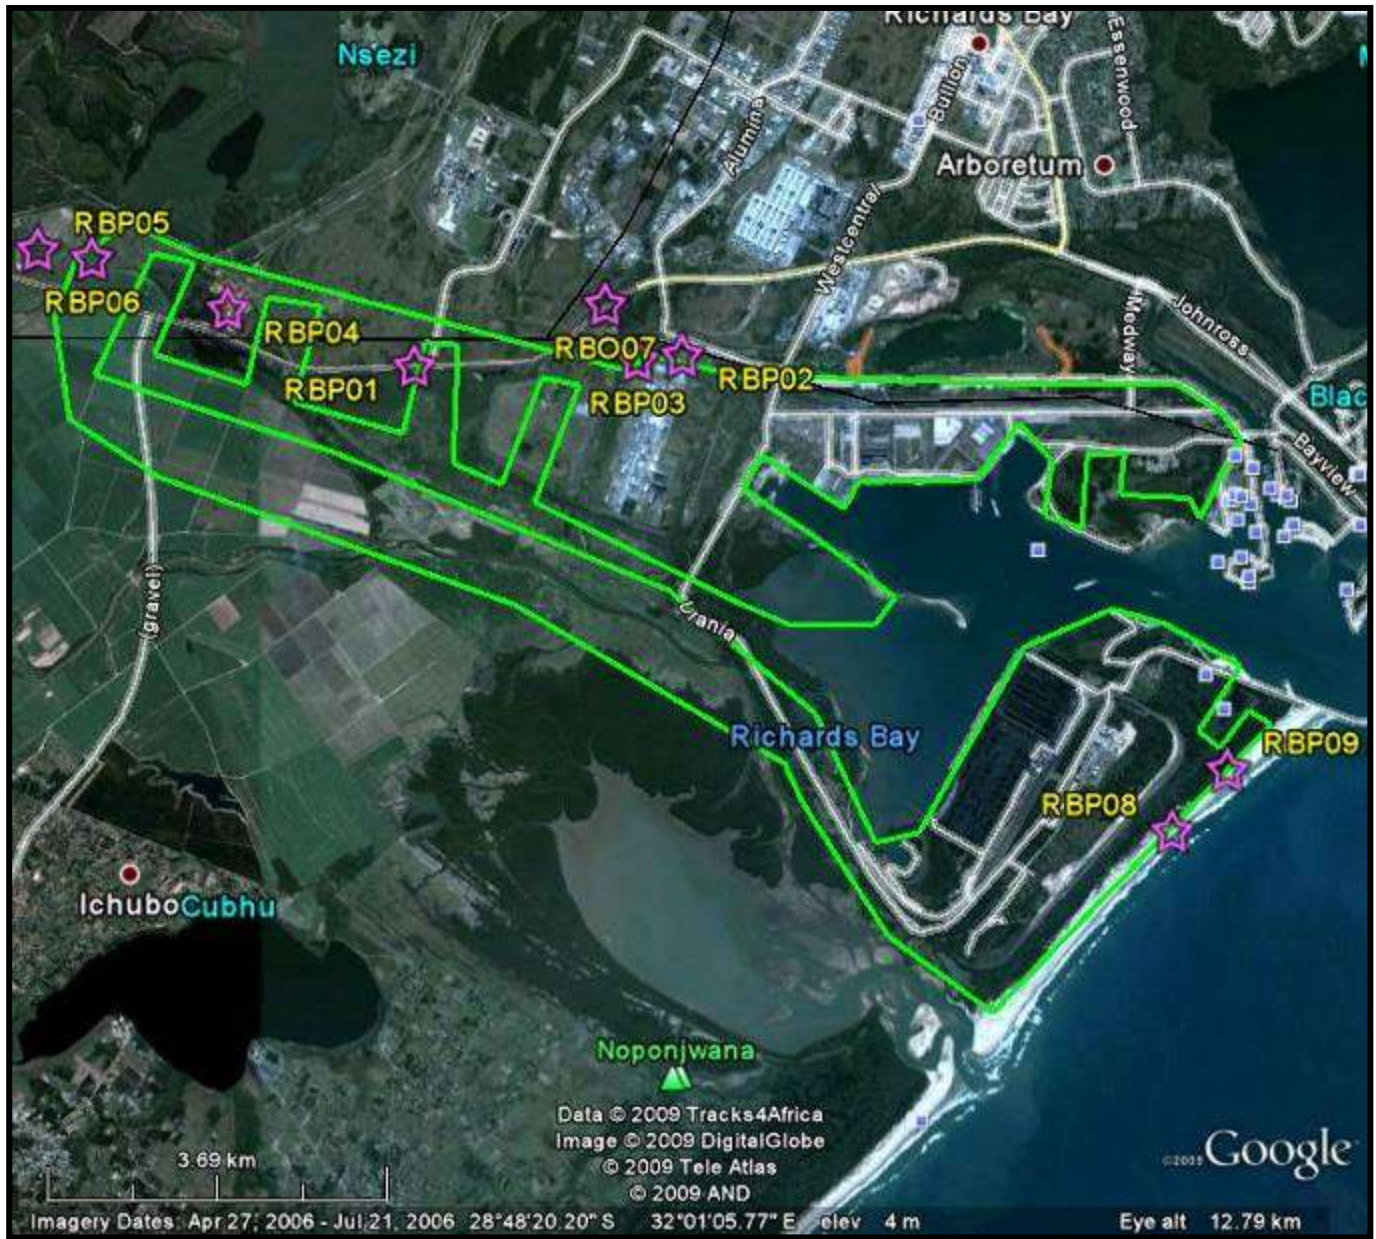
FIG. 5: LOCATION OF RECORDED SITES IN THE STUDY AREA

The construction of the John Ross Parkway, and its current widening has affected potential archaeological sites, as well as the construction of the transmission lines, substation and industrial buildings. Thus, we were not expecting to find many sites in a primary context. Figure 5 indicates the locations of the various sites.
