Heritage Impact Assessment for the old bridge on Krysfontein and Weltevreden 826, near Richmond

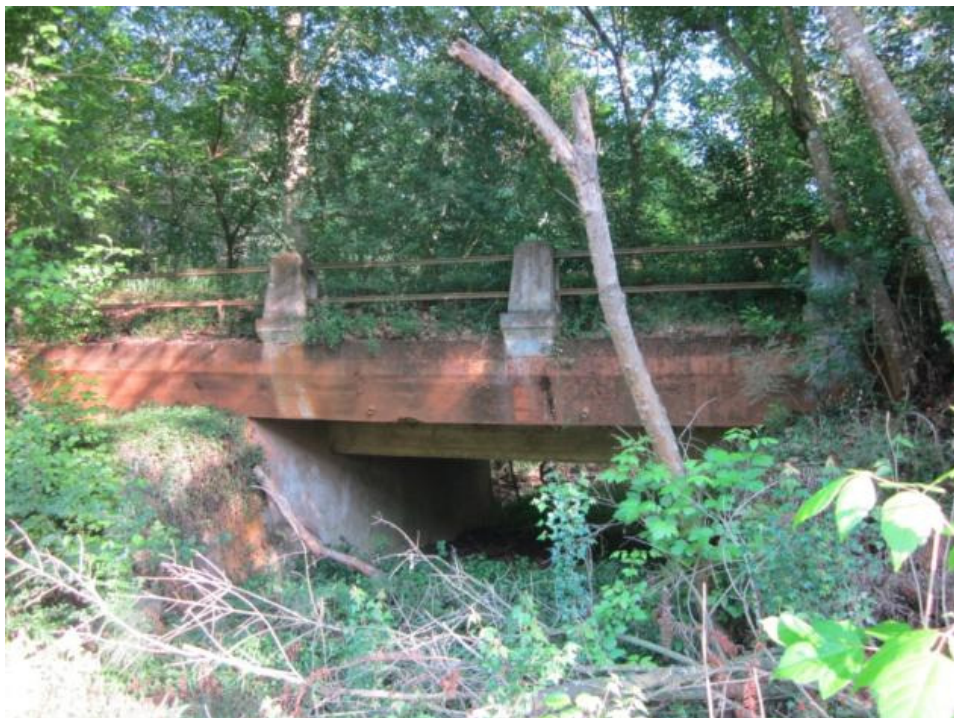
Fig 1: Showing old bridge from the R56

The bridge is a modest structure that crosses the Mkhuzane River close to the contemporary road bridge on the R56 which leads from Pietermaritzburg to Richmond at GPS co-ordinates S 29°48'28.5" and 30°20'8.5"E. The track crossing the bridge is dirt and it travels parallel with it for some distance. It is visible on the 1937 aerial photographs suggesting that the bridge was extant at the time.

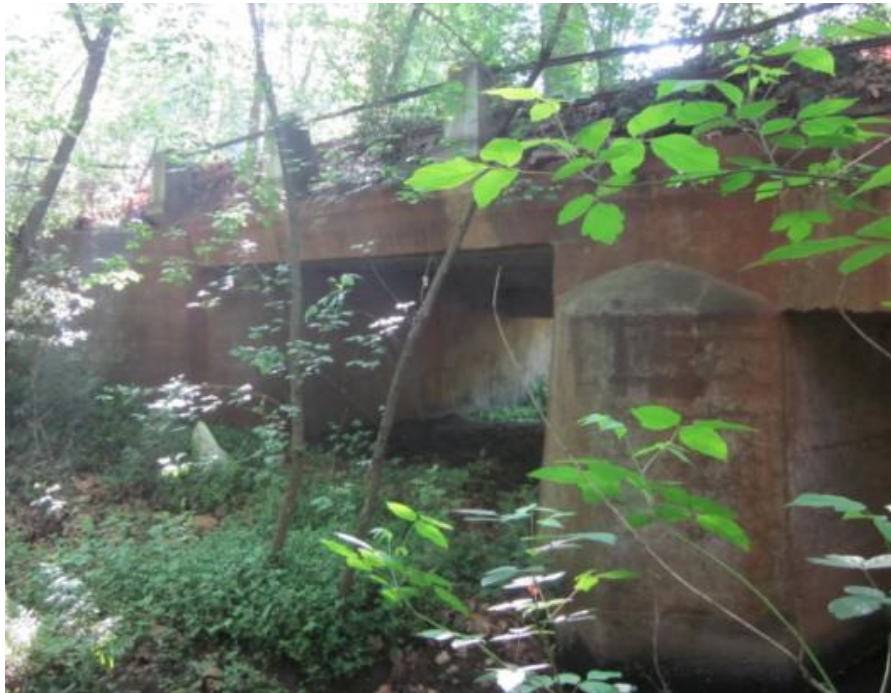
Fig 2: Showing shaped bridge piers (western edge)

The bridge is constructed of off - shutter concrete spanning the river by means of two substantial concrete piers which project beyond the sides of the bridge (see Fig 2 below). A protective railing consisting of two rails of railway iron spans a series of shaped bollards (see Fig 3 below) some of which are unstable, and out of line possibly due to being hit by traffic in the past, or ground movement.

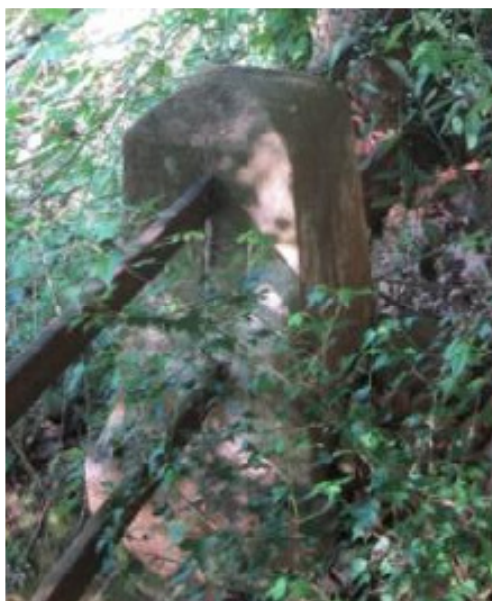
Fig 3 (left): Showing shaped bollard intersected with railway iron railings
Fig 4 (above) Dislocated bollard

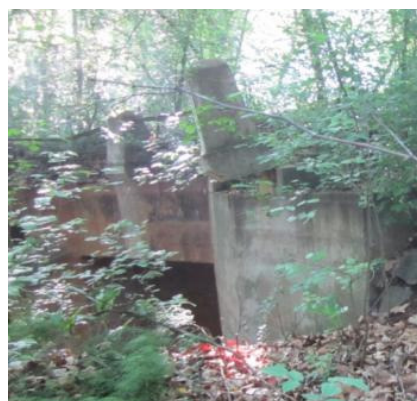
In plan, the alignment of the railings to both sides of the bridge is similarly distorted, with any symmetry in the past obliterated (see Fig 11). As noted, this could also be due to ground movement or traffic impact (see Fig 4)
