# Visual Study

*for the Proposed Photovoltaic Project on Robben Island, Western  
Cape*

Visual Study  
for the Proposed Photovoltaic Project on  
Robben Island, Western Cape

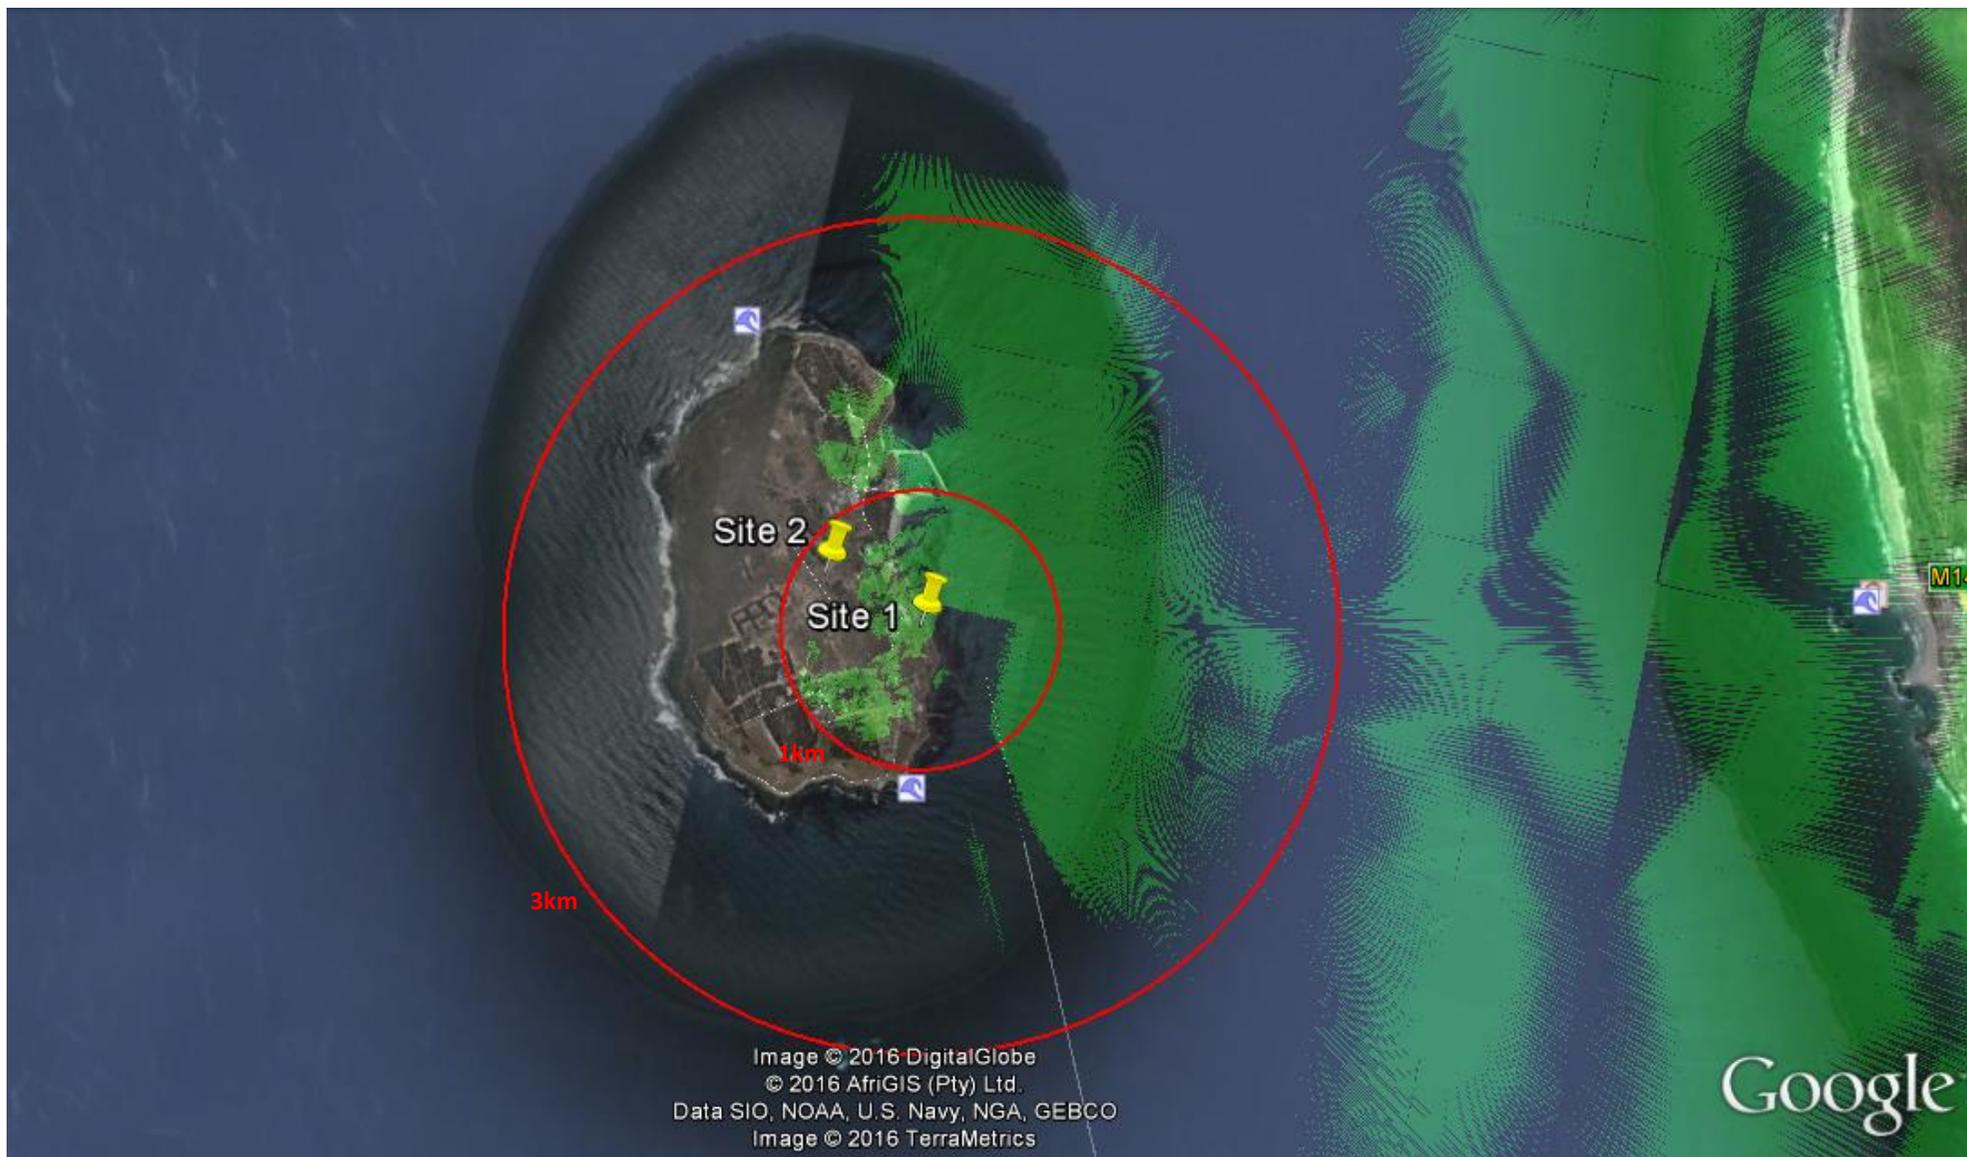
Figure 5: Viewshed for Site 1

**Site 1:** The viewshed area for Site 1 lies predominantly to the eastern side of the site, stretching across the sea to the mainland and also includes the area immediately surrounding the site. The harbour falls within the viewshed area, but from most viewpoints visibility is partially or completely obscured by the harbour walls and buildings.

When assessing the viewsheds as depicted in Figure 4 and 5 the distance of a viewer from an object is an important determinant of the visibility, often referred to as the visual exposure. This is due to the visual impact of an object diminishing/attenuating as the distance between the viewer and the object increases, at an exponential rate. Thus the visual impact at 1 000m would, nominally, be 25% of the impact as viewed from 500m. At 2 000m it would be 10% of the impact at 500m (Hull and Bishop 1988).

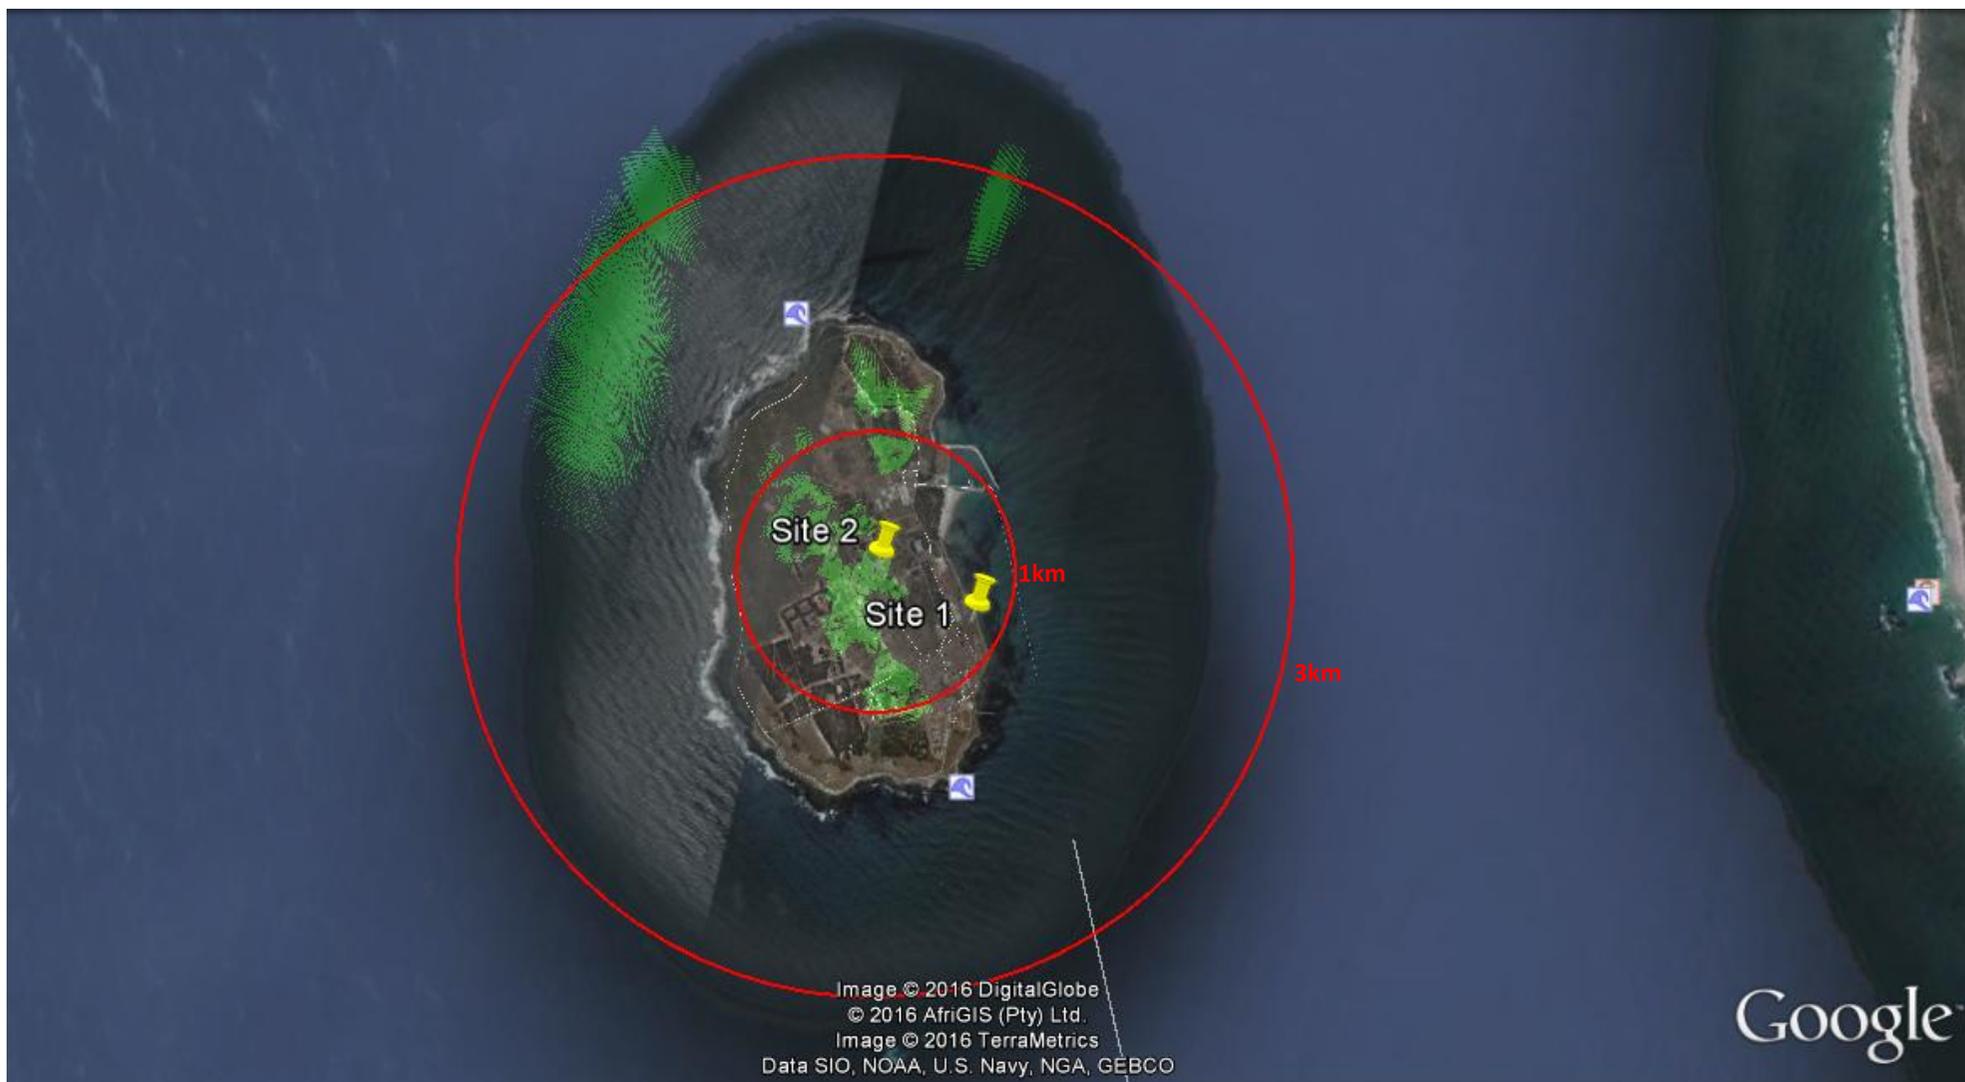
Figure 6: Viewshed for Site 2

**Site 2:** The viewshed area for Site 2 is very limited and is restricted to a short section of Boundary Road and the highest points of elevation in a band to the west of the site (middle of the Island). The viewshed does not extend across the sea to the east or the mainland.

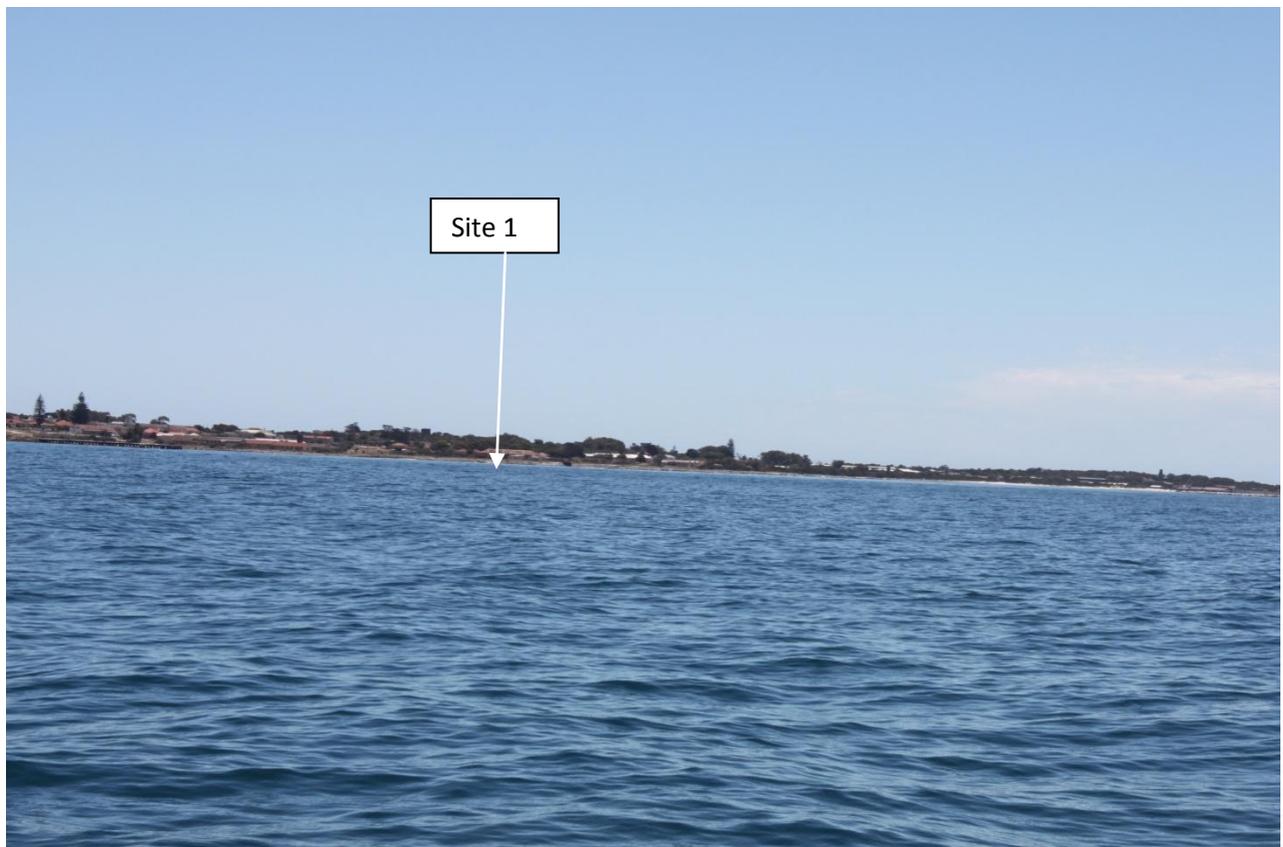
**Plate vi: VP1: From the boat about 2,7km from site (marginally visible)**

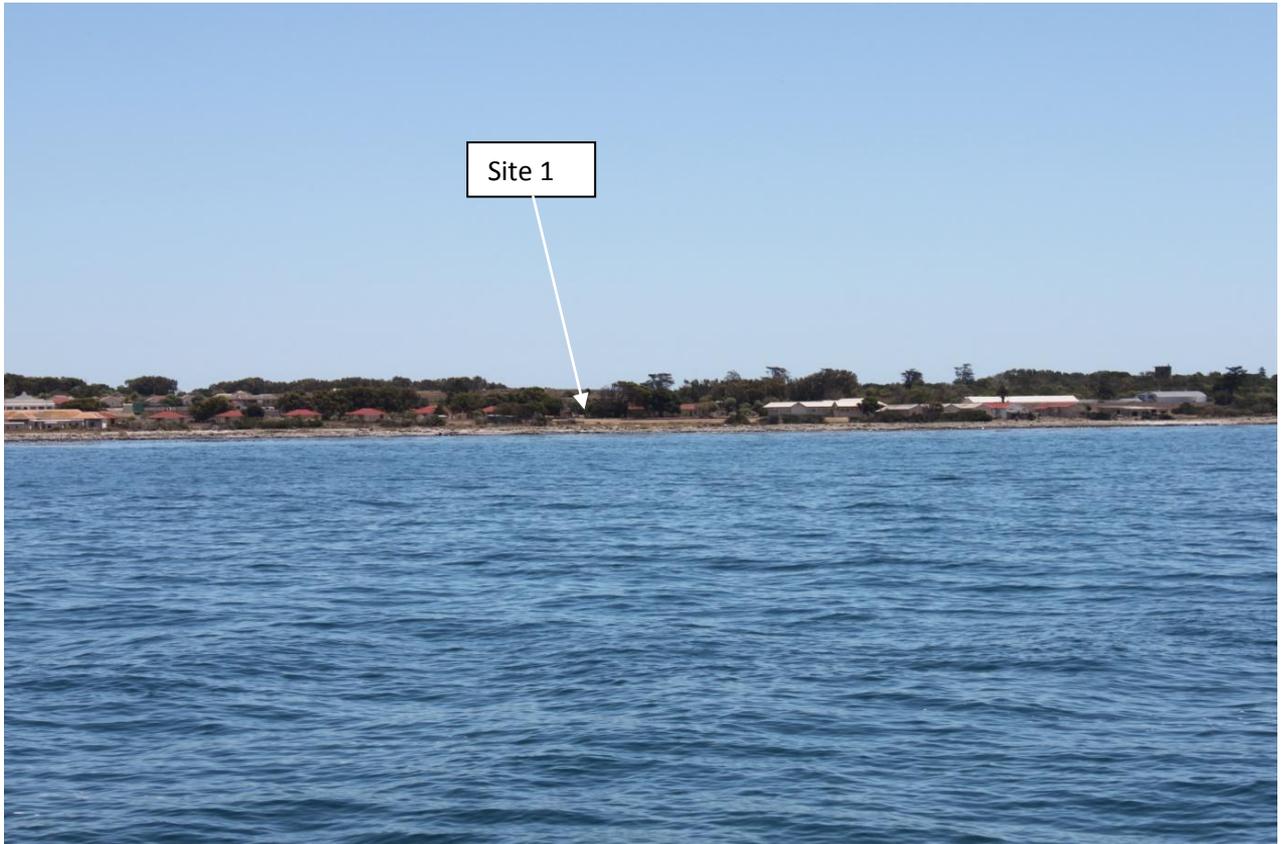
Plate vii: VP 2: From boat directly opposite site (highly visible)

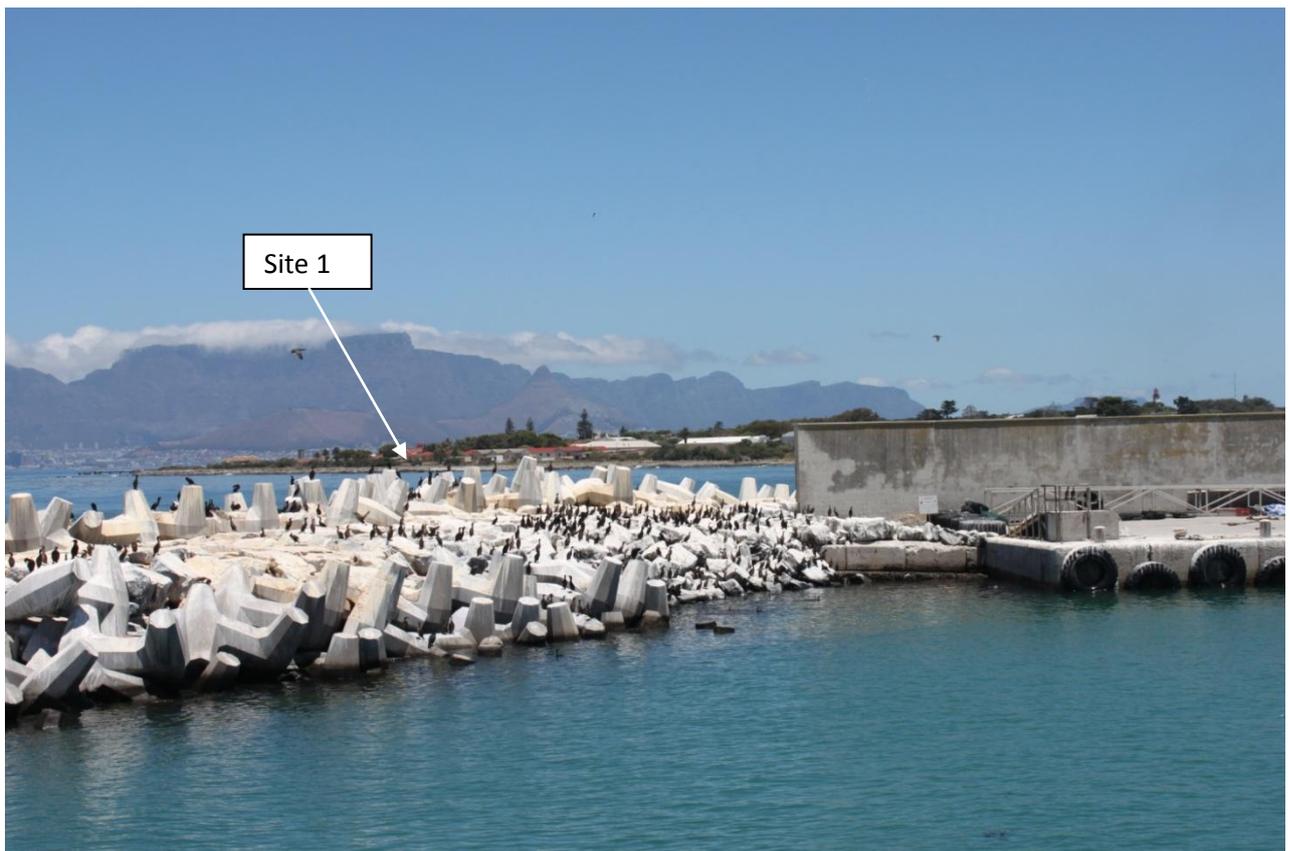
Plate viii: VP 3: From Harbour (site visible – from most other locations in harbour, site is obscured by harbour wall)

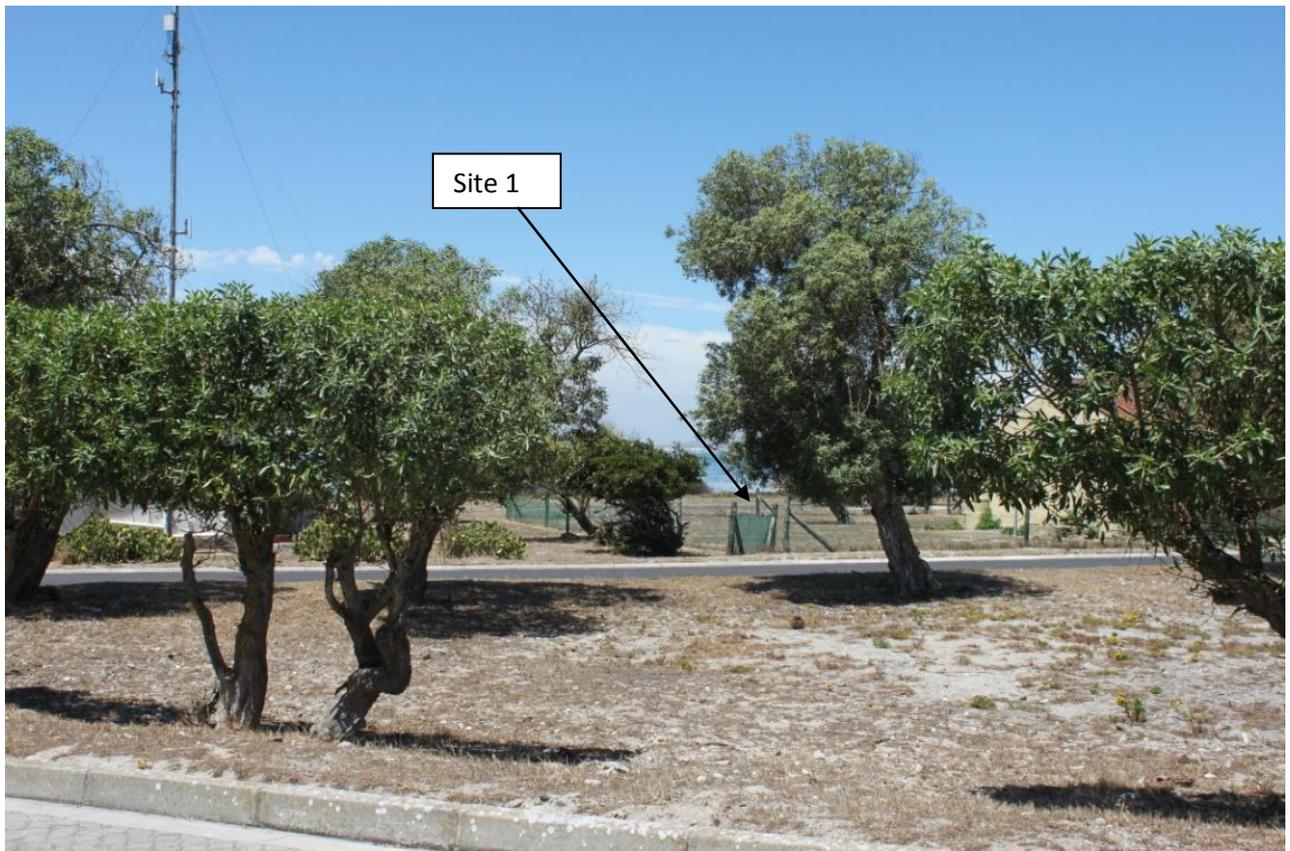
Plate ix: VP 4: Just off access road from harbour looking east (visible/marginally visible, site partially obscured)

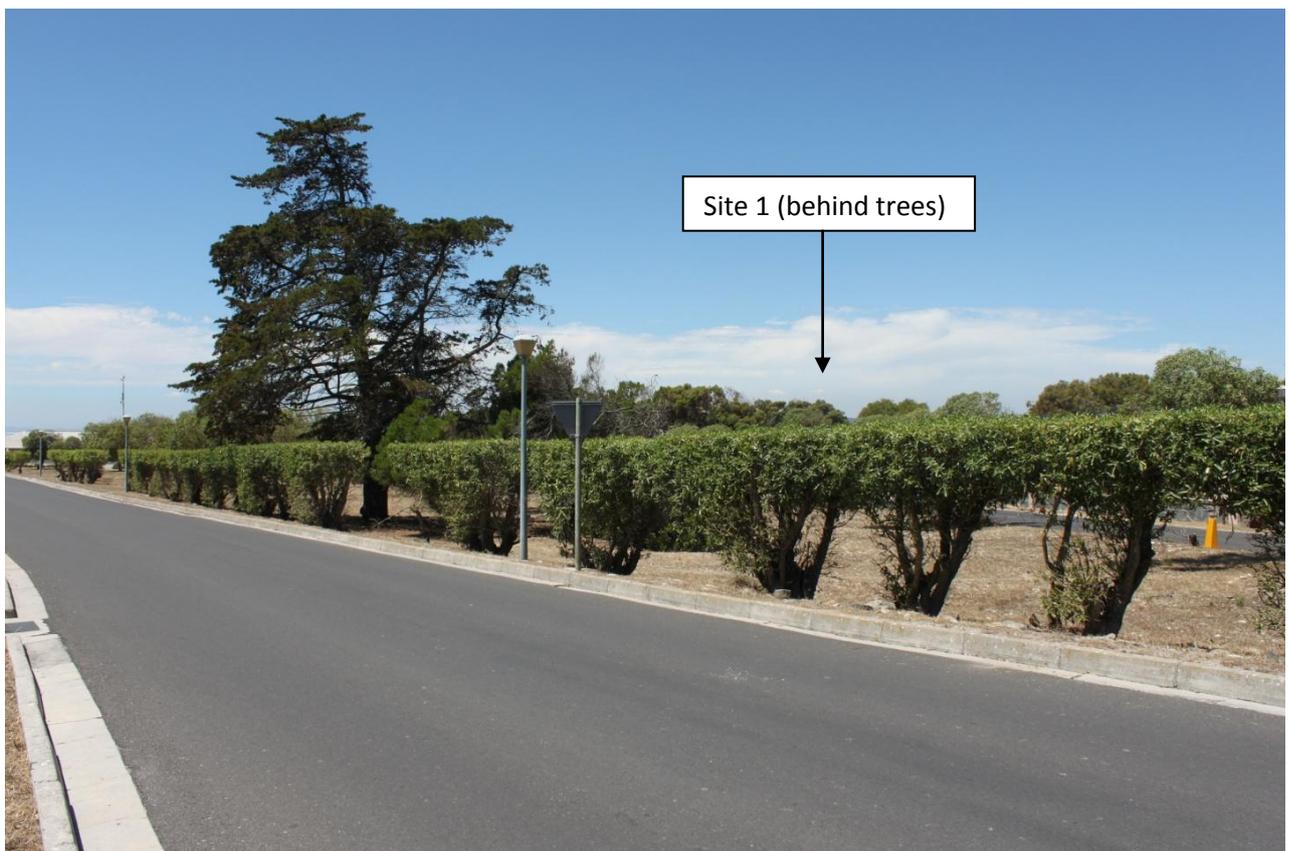
Plate x: VP5: From road linking the access road from harbour with the road to Rifle Range site looking south-east (not visible behind trees)

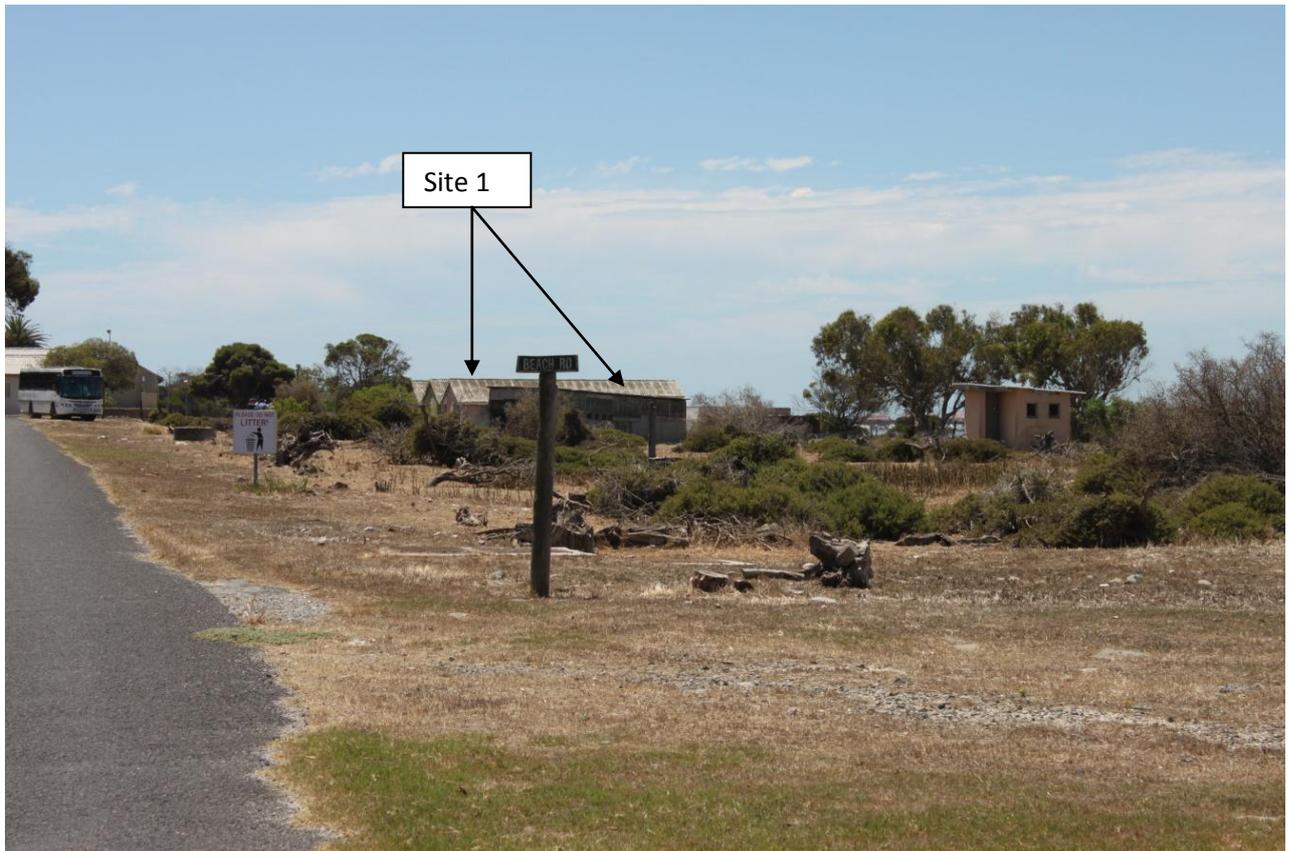
Plate xi: VP 6: From Beach Road looking north (marginally visible)

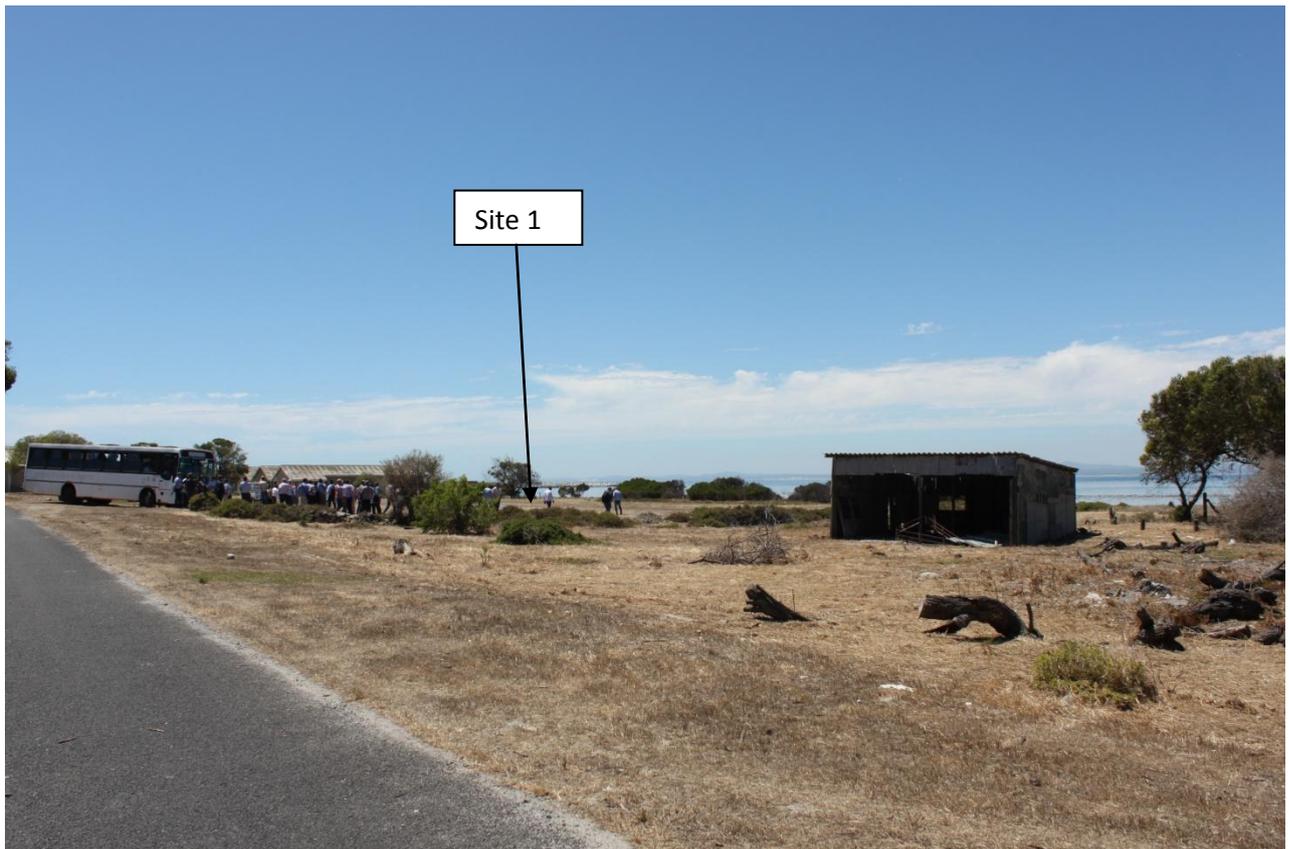
Plate xii: VP 7: From Beach Road looking north (highly visible)

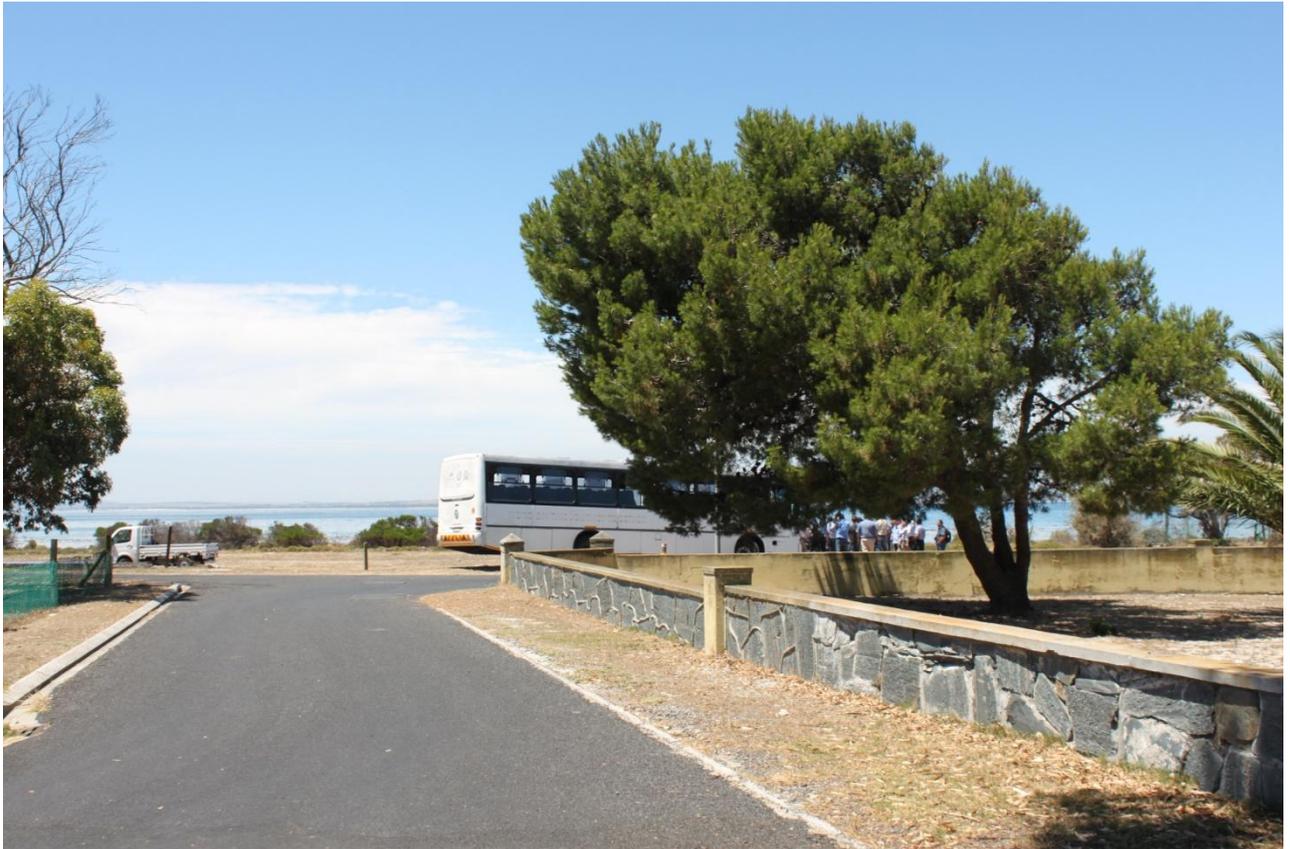
**Plate xiii: VP 8: From road running NW towards Rifle Range site looking east (highly visible from intersection and corner property)**

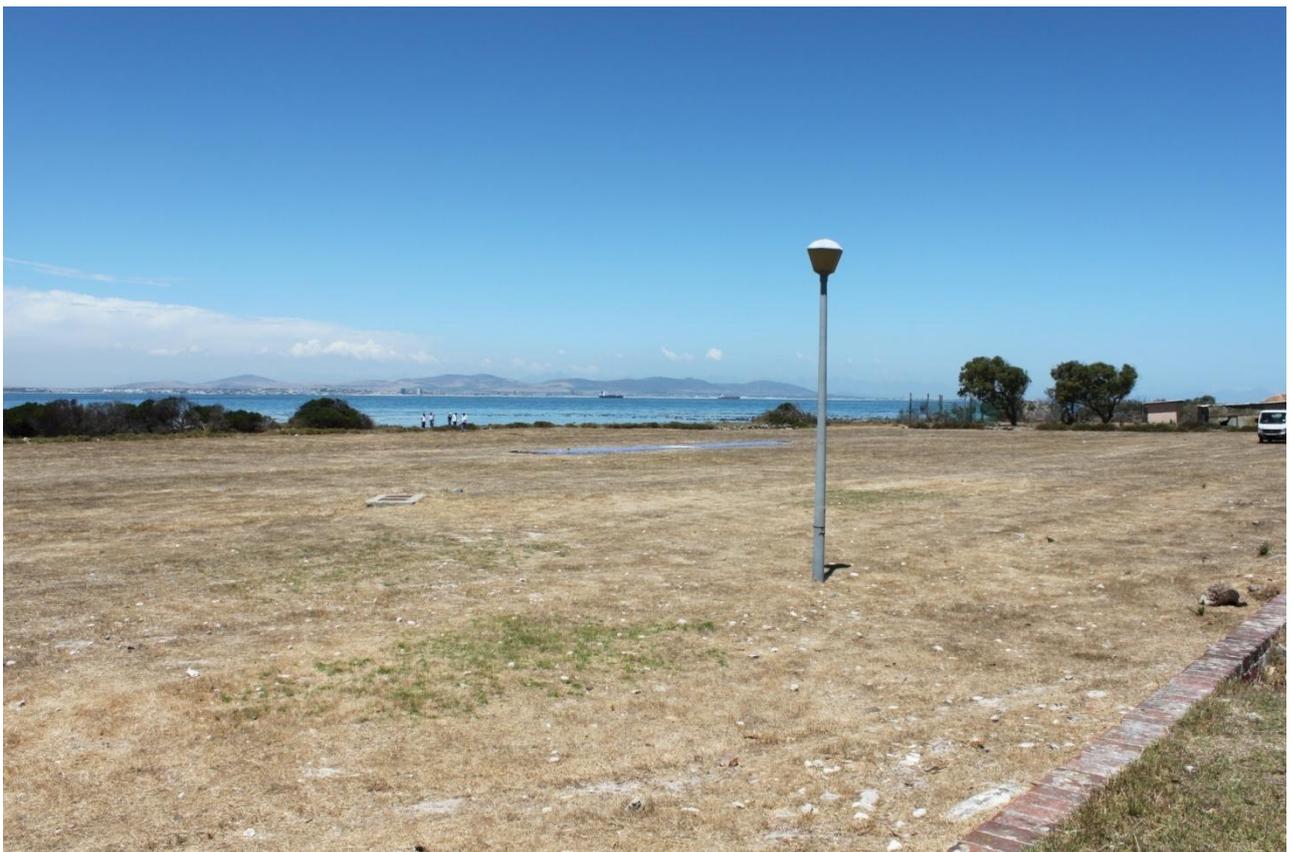
**Plate xiv: VP 9: From front of Education and Research Centre (highly visible from front of building)**

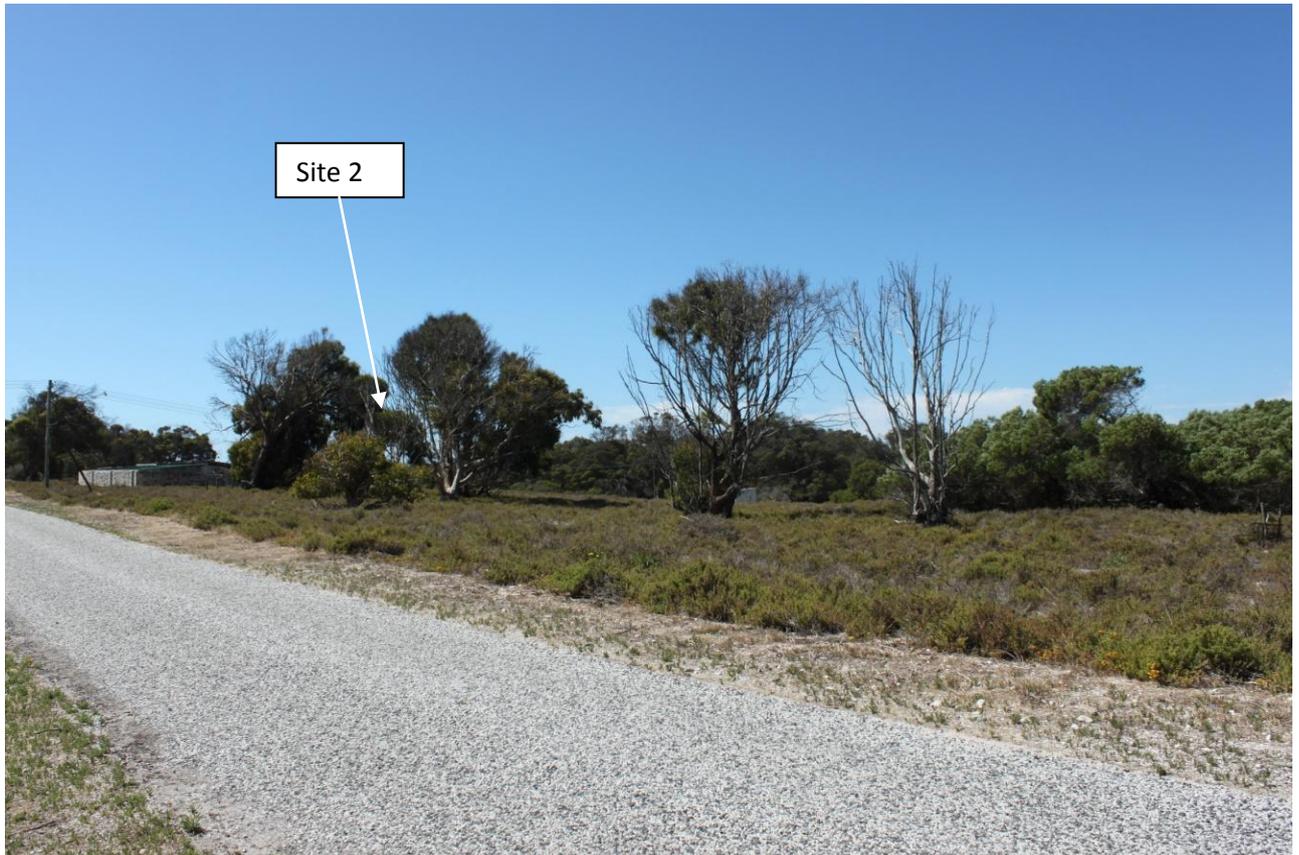
Plate xxi: VP 15: From Boundary Road looking north (may be marginally visible)

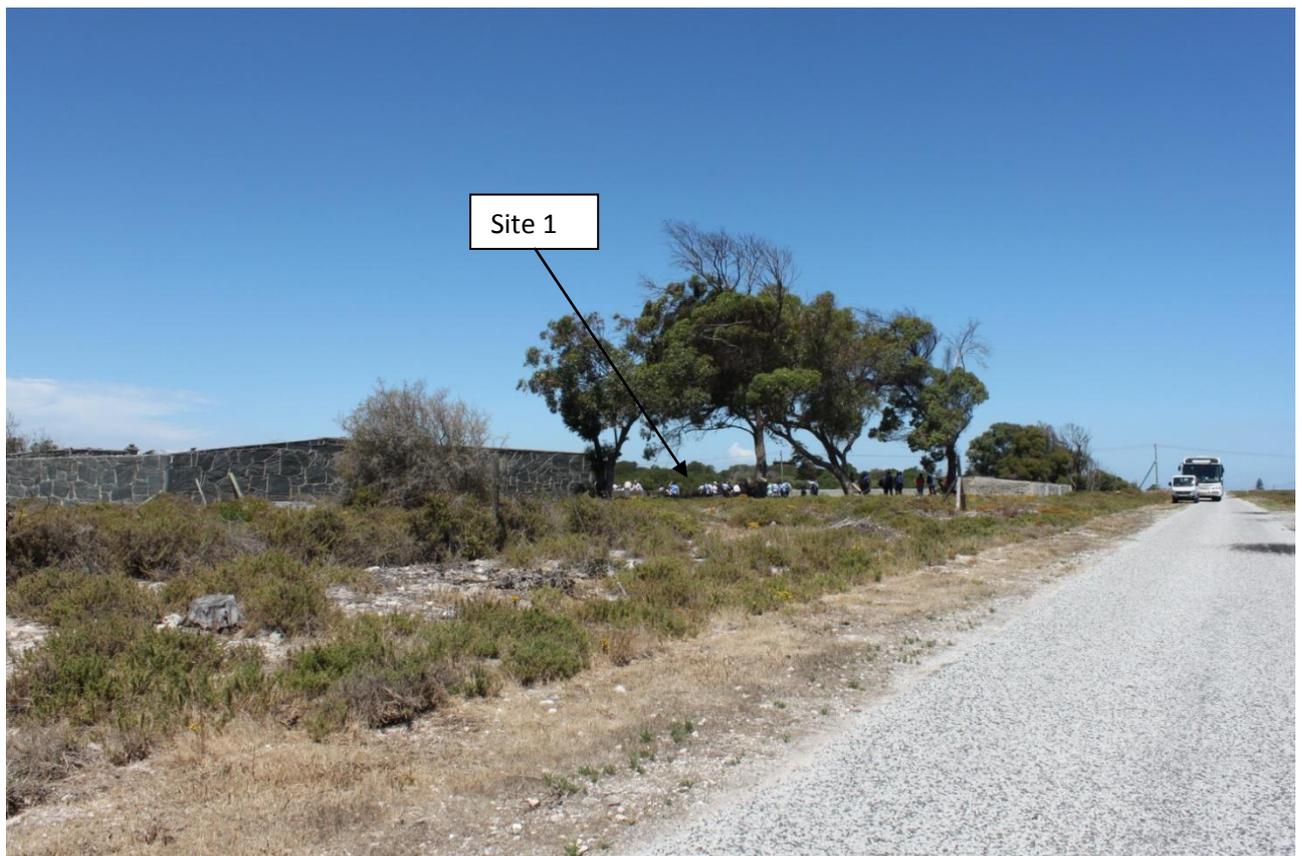
Plate xxii: VP 16: From Boundary Road looking south-east (visible)
