STORM DAMAGE REPAIR AND RESTORATION OF RUSSEL HIGH SCHOOL PIETERMARITZBURG, KZN

HERITAGE ASSESSMENT

15 February 2021

PREPARED FOR:
VNA Consulting

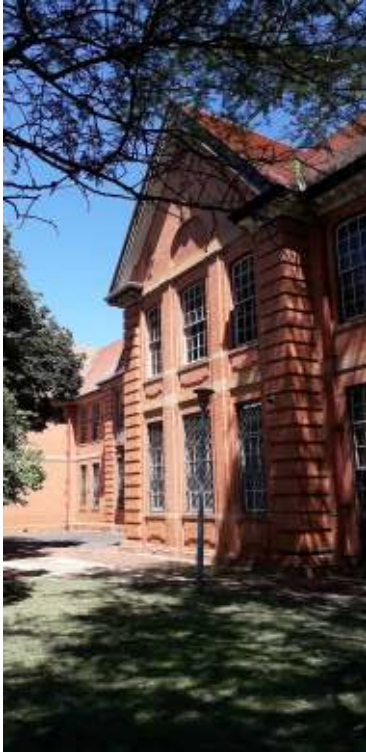
*Classroom block 1910
Neo-Classical Edwardian*

In 1910 a new block was added to this three-storey block between it and Berg (Hoosen Hafejee) street. It had a new entrance hall, the principals office and more classrooms. It was built in the Edwardian period, but had added Neo-classical detail to the facades.

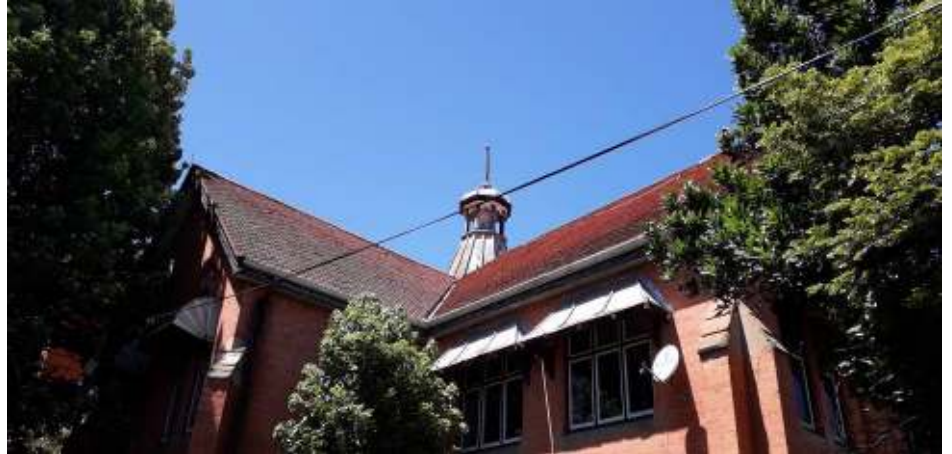
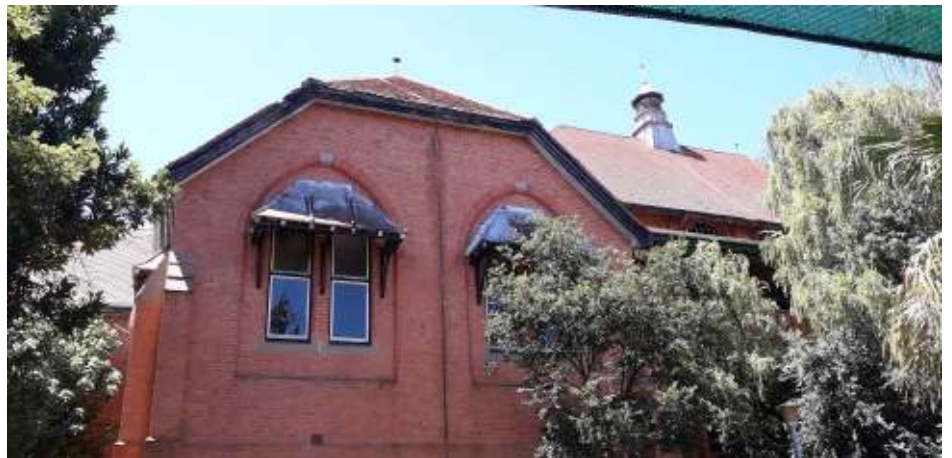
The library building estimated late 1890's

Russell High School was established in 1878 as the Girls Model School in Berg street. The school was renamed in 1941 in honour of Robert Russell, the former superintendent of Education in the Colony of Natal. The earliest buildings that still exist are the (current) hospitality classrooms and library above them, it is assumed that the original Model Girls School building was replaced by the 1910 extension. The Library current building was built in the Victorian style of clay facebrick, large vertical proportioned windows and a steeply pitched roof with a lantern for ventilation. The high roof and lantern were for prominence and landmark status in the early streets of Pietermaritzburg.

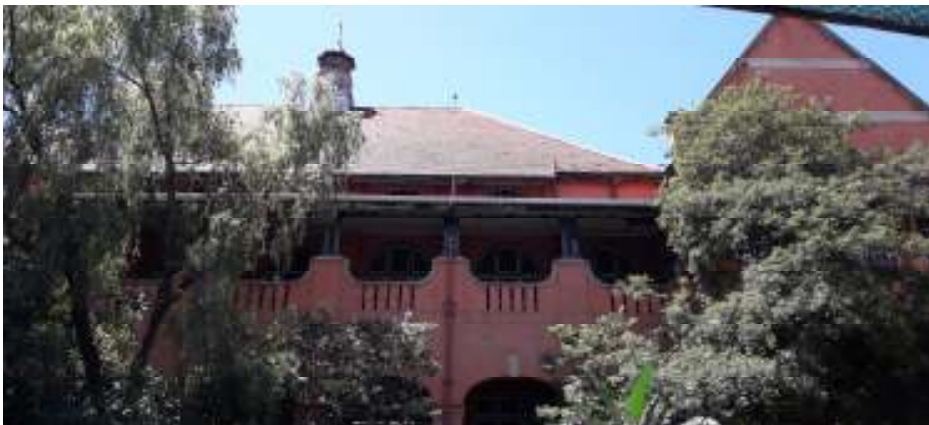
1905 Classroom block and assembly hall

In 1905 a new three-storey block of classrooms and an assembly hall was built in the Edwardian style, the fashion of the period.

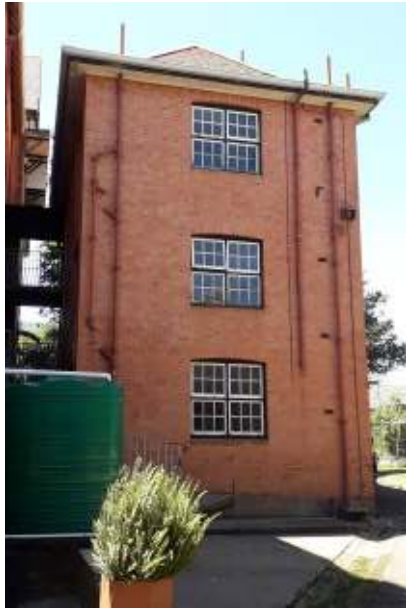
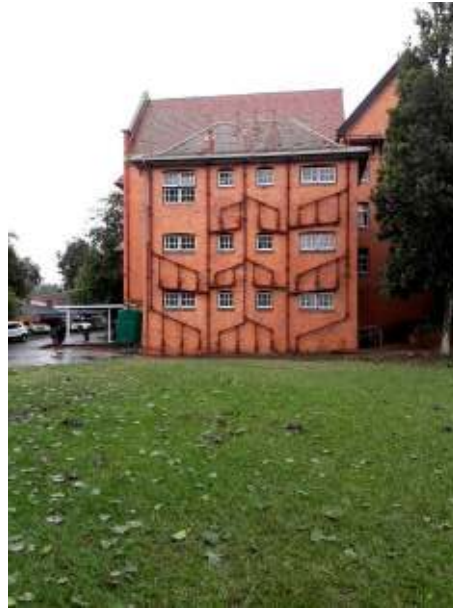
1912 Ablution block

In 1912 the ablution block was built on the West side of the classrooms as a stand-alone building.
