**TABLE MOUNTAIN NATIONAL PARK**  
**APOSTLE BATTERY HERITAGE REPORT & DEVELOPMENT GUIDELINES**  
COMPILED IN TERMS OF SECTION 27 OF THE NHRA (1999) FOR  
Erven 1432-RE and CA 902-1, The Apostle Battery, Victoria Avenue, Llandudno.

DRAFT V.4  
July 2017

Prepared by Rennie Scurr Adendorff, CTS and Square One

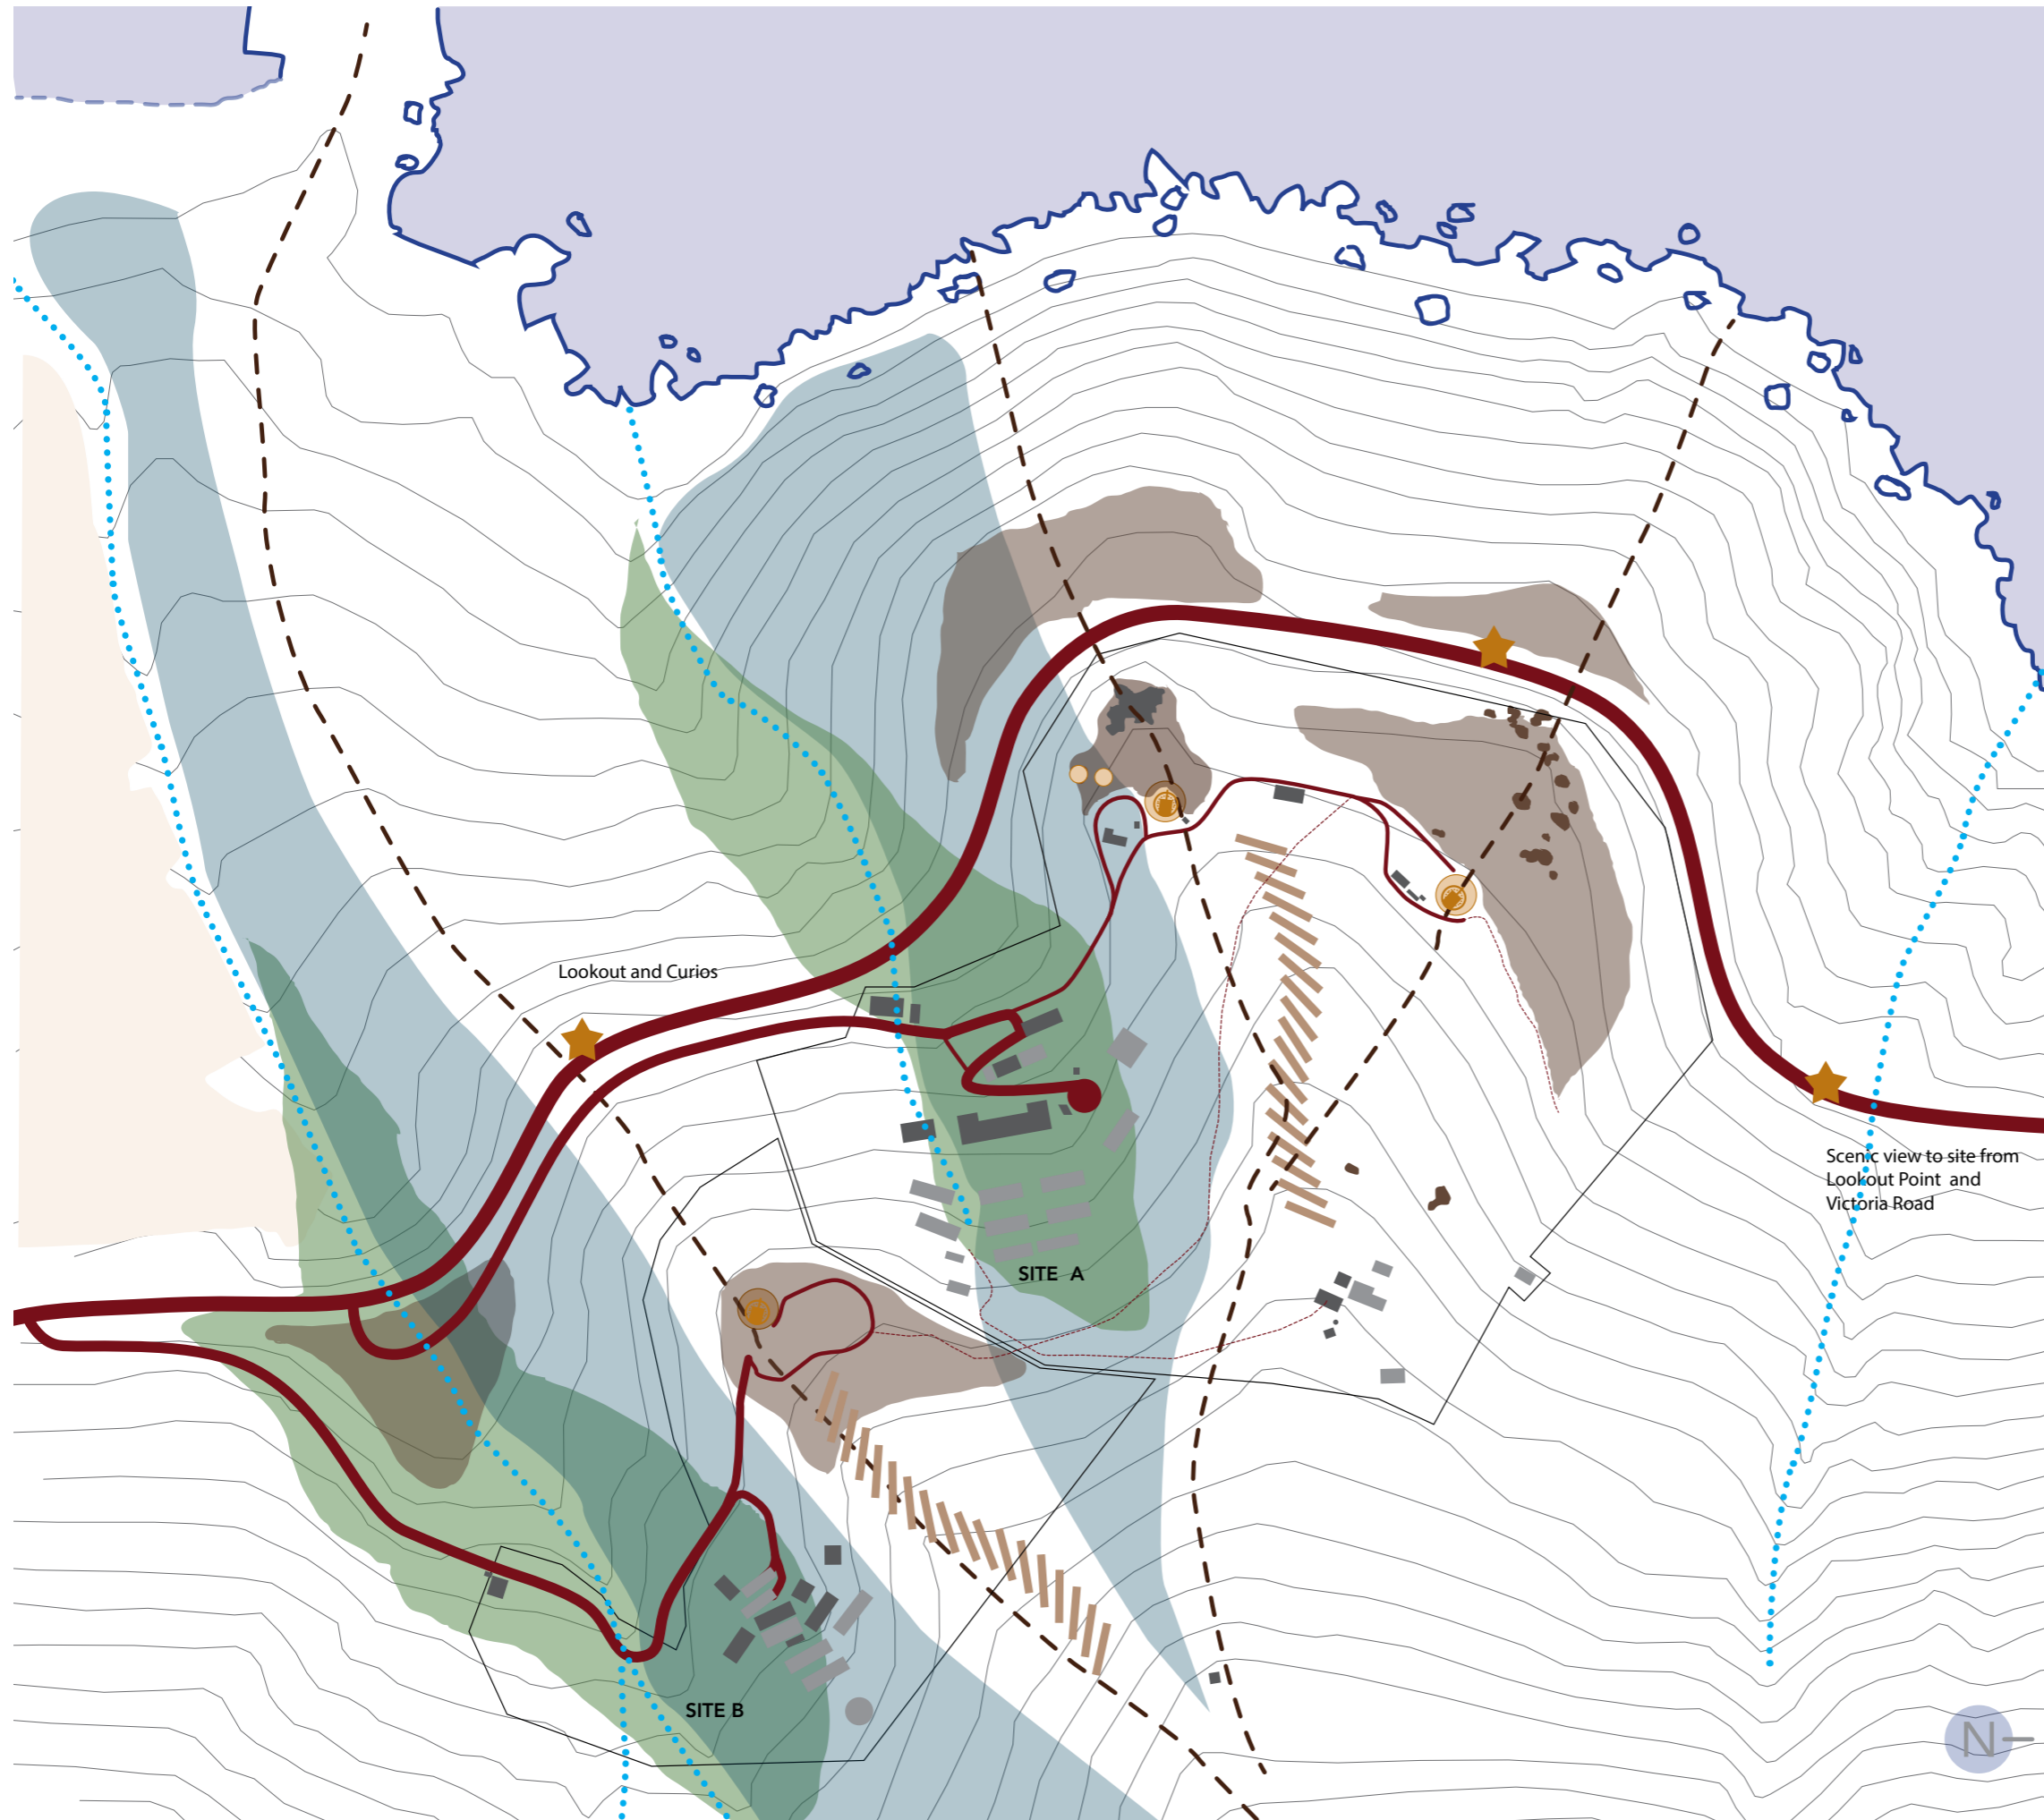
Map 13. Site Analysis: Spatial Features (Square One, 2017)

This map illustrates the location of gun emplacements on natural terraces associated with prominent ridgelines. The guns would have been placed in these areas to ensure that they could achieve prime trajectories towards enemy vessels. The location of the gun emplacements on prominently exposed areas also explains the historic need for increased vegetation density to provide suitable camouflage. The southern slopes are associated with sheltered valleys in which the barracks for both Battery A and Battery B are located. These areas, particularly the barracks associated with Battery B would have been less prominently visible to enemy vessels than the guns located on prominent ridgelines. The map also indicates the location of prominent granite boulders as unique geological features and the location of granite heaps that were used for construction and that may be re-harvested for future use.

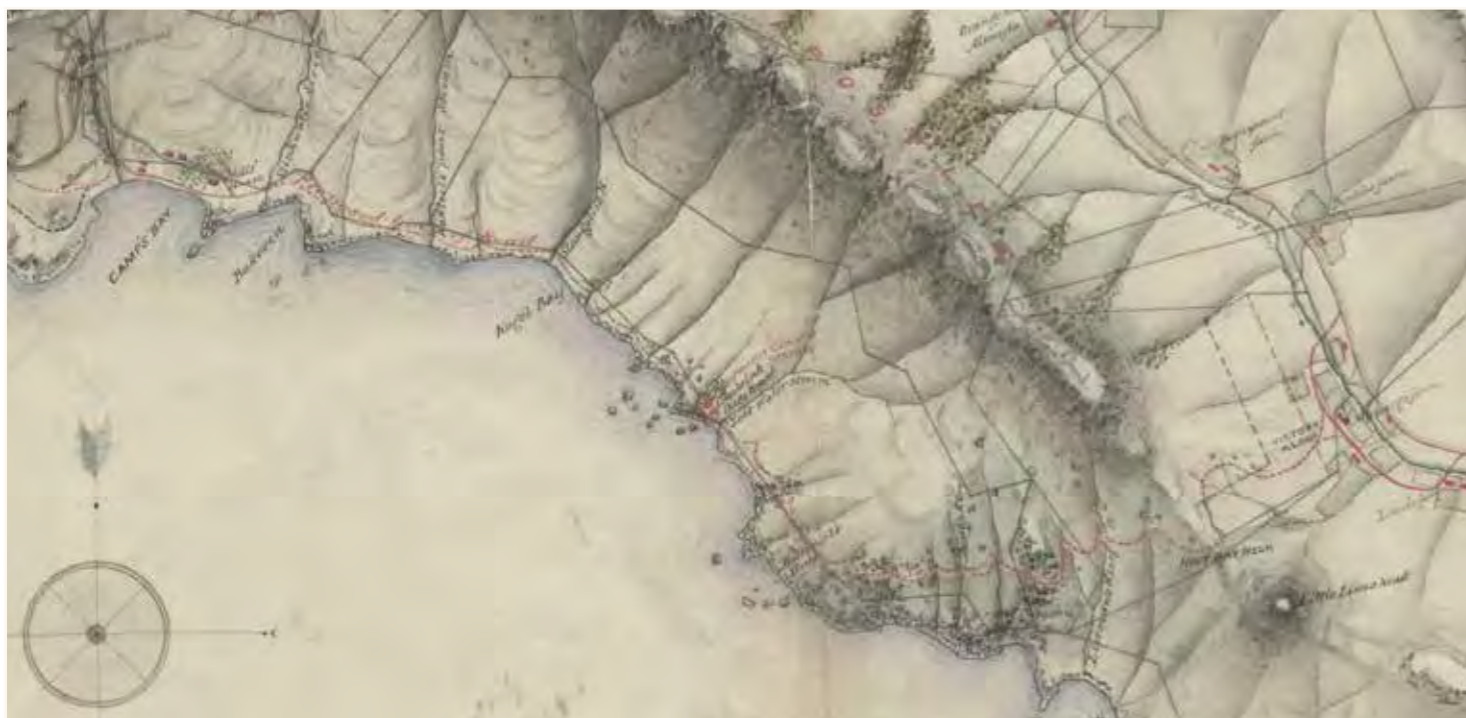
Figure 23. Extract from the Cape Archives map M3/536 signed by Thomas Bain 9/4/1884 which notes the dotted route near Bakoven as "Proposed line of Road."

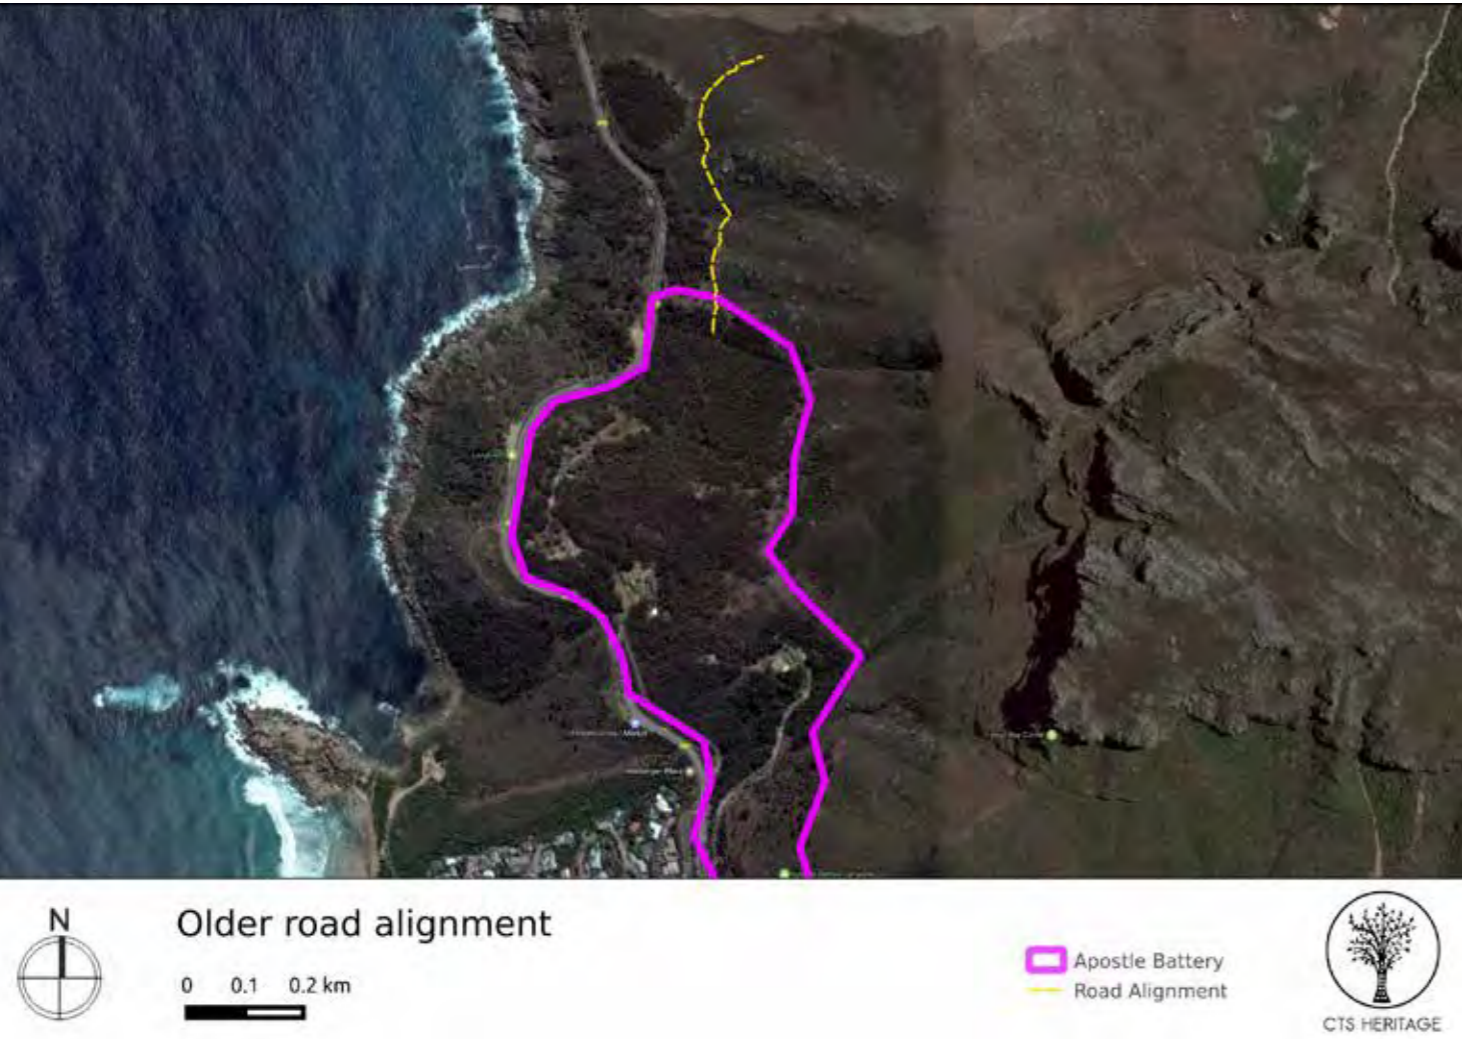
Figure 26. Aerial image indicating the alignment of the older road, thought to be the Bridal Path.

A matter of possible interest is the historical alignment of Victoria Road. While conducting a site visit, a possible older road alignment was identified (Figure 26), which was thought to be the remnants of an earlier alignment of Victoria Road. It is not entirely clear, but the 1866 SG Diagram of the study area indicates a bridle path (Figure 22) across the site that seems to align with this path. Other maps seem to indicate an early alignment for Victoria Road (Figure 27 and Figure 28) that correlates well with the existing Victoria Road. Unfortunately, the resolution of the historic maps mean that it is very difficult to determine whether or not the alignment of Victoria Road has changed over time. While it seems unlikely that the main thoroughfare from Cape Town to Hout Bay would have changed very much over time, it is not possible to rule that out, and, as such, the discovery of previous road alignments within the property should be considered.

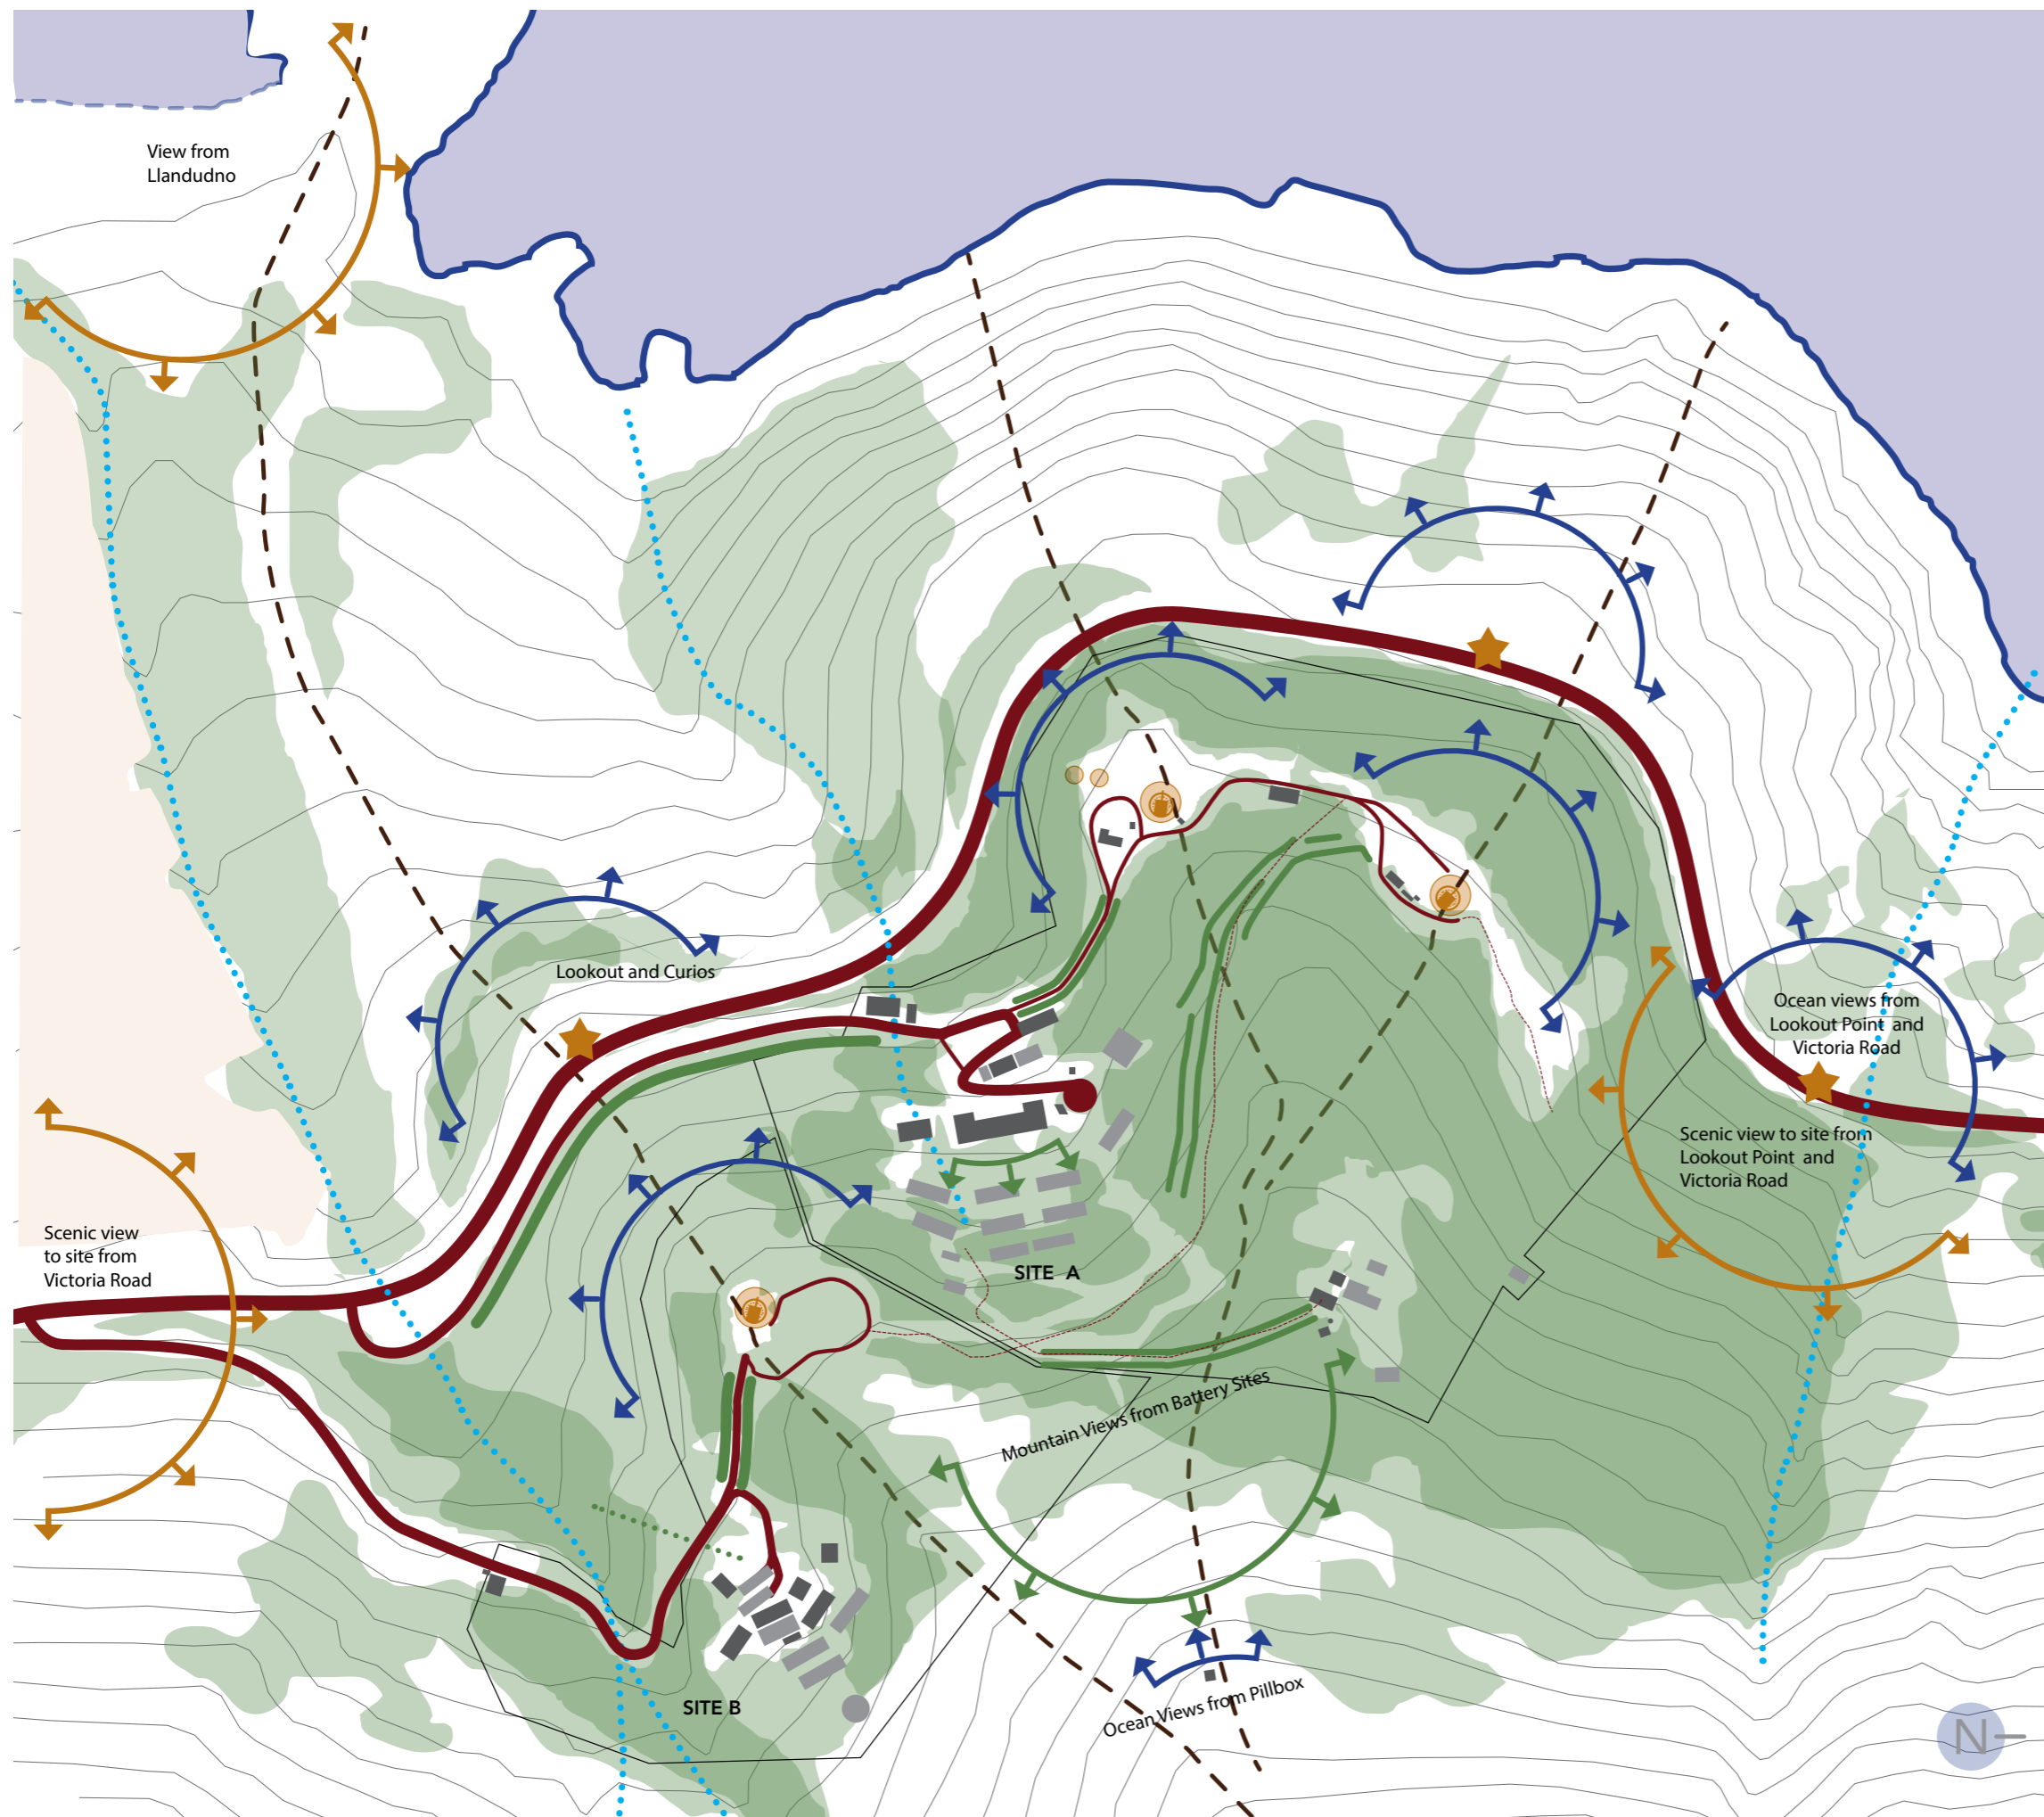
Map 14. Site Analysis: Visual Analysis (Square One, 2017)

Key views towards the site are located at Llundudno, and at lookout points along Victoria Road. Historic axes towards prominent topographical features such as Leeukoppie, the Twelve Apostles ridgeline and Karbonkelberg are also of visual significance. As the site is densely vegetated, trees form barriers along prominent routes, creating narrow view corridors in certain portions of the site. These endow a certain sense of place to the site and allow the prominent expression of views and vistas towards the ocean and the mountains when they are revealed.

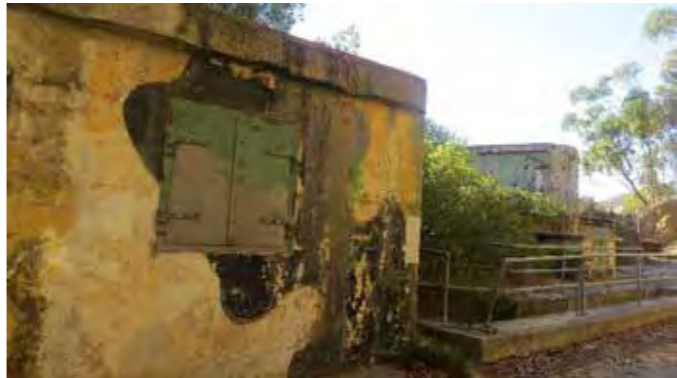
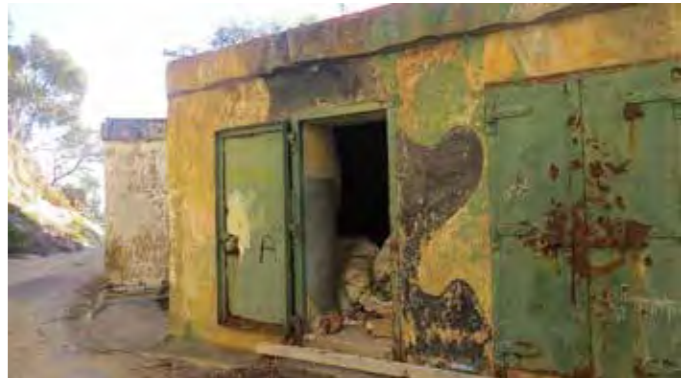
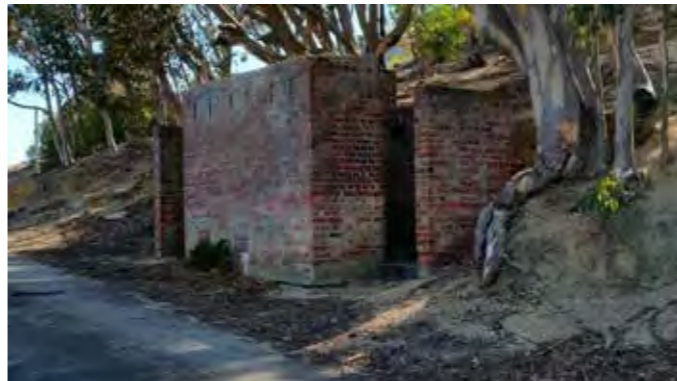
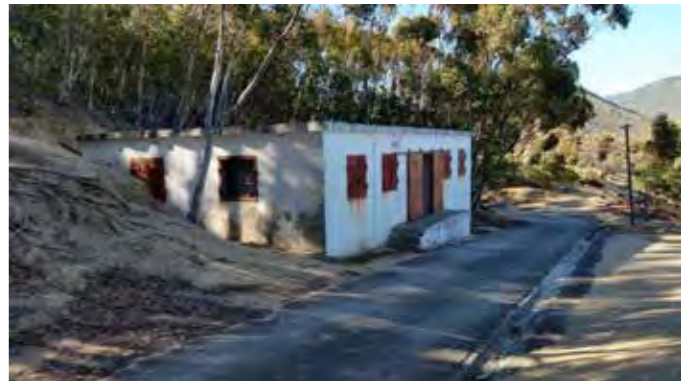
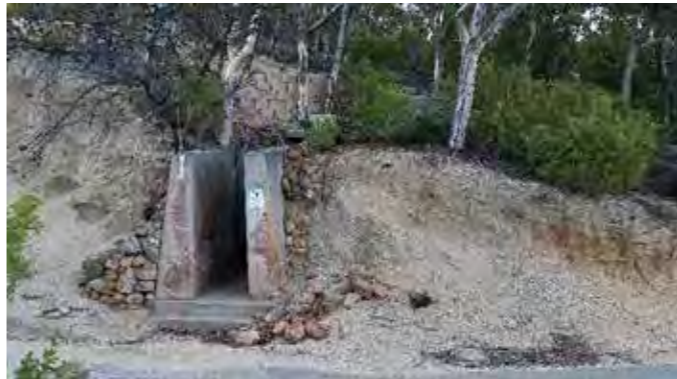
BUILDING NAME/S: No. 2 Gun Emplacement (15)

PHYSICAL CONDITION: Intact but rusted and eroded.

OPPORTUNITIES & THREATS: Threat of vandalism, graffiti and continual erosion, rusting and stripping of fabric. Opportunity for restoration and interpretation. In order to secure their protection, the guns will need to be subject to a formal assessment process through the SAHRA Heritage Objects Unit.

RECOMMENDATIONS & GUIDELINES: To be conserved to highest international military conservation standards and should form part of the interpreted Apostle Battery site and also in relation to overall Cape military history trail. Adaptive reuse in the area only to enable an interpretive role for military history visitors and managed public viewing.

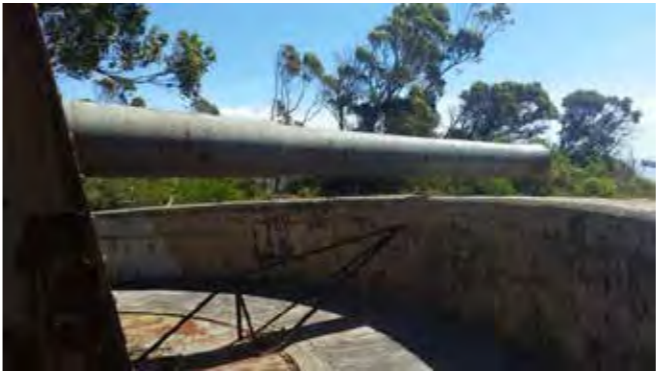
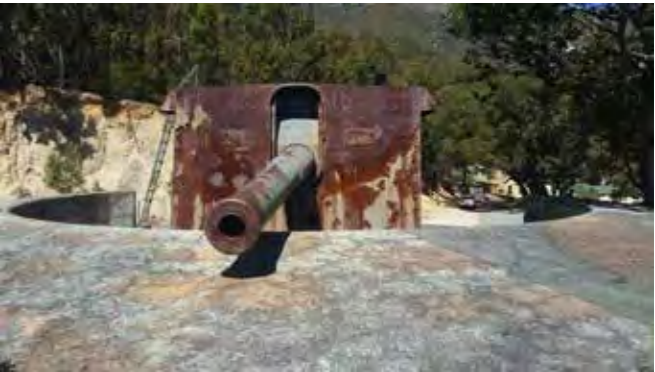
SITE & STRUCTURE DESCRIPTION Located between Gun 1 and Site A. Contains the two 6 inch MK XIX gun emplacements and gun number 2.

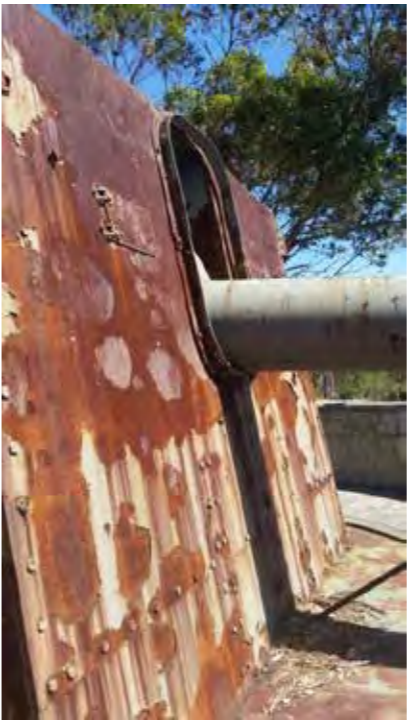
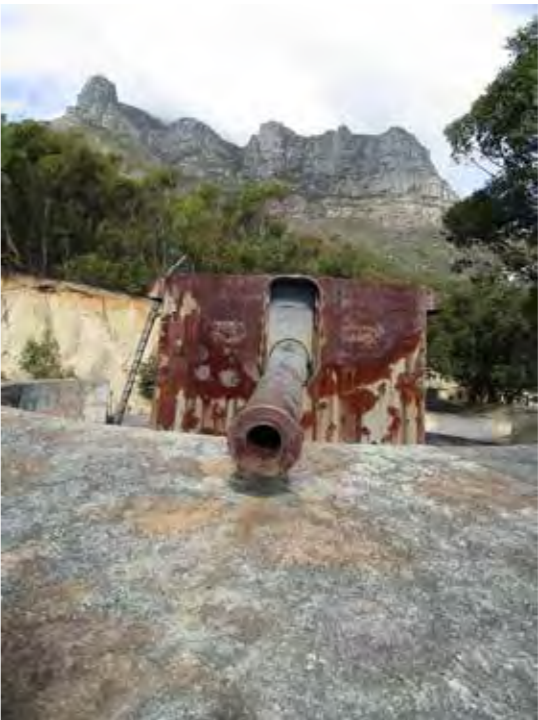
BUILDING NAME/S: Artillery Range (42), Artillery Range (43)

**PHYSICAL CONDITION:** Intact but rusted and eroded.

Threat of vandalism, graffiti and continual erosion, rusting and stripping of fabric. Opportunity for interpretation in conjunction with the adjacent Gun 2.

**RECOMMENDATIONS & GUIDELINES:** To be conserved to highest international military conservation standards and should form part of the interpreted Apostle Battery site and also in relation to overall Cape military history trail. Adaptive reuse in the area only to enable an interpretive role for military history visitors and managed public viewing.

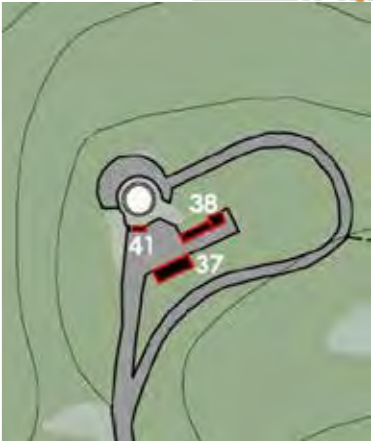
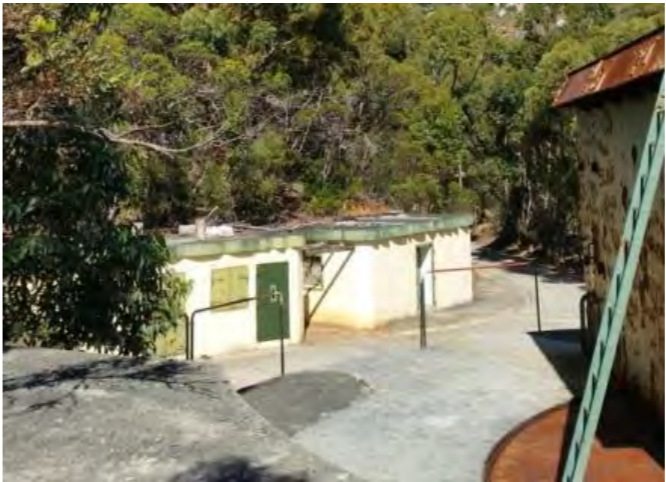
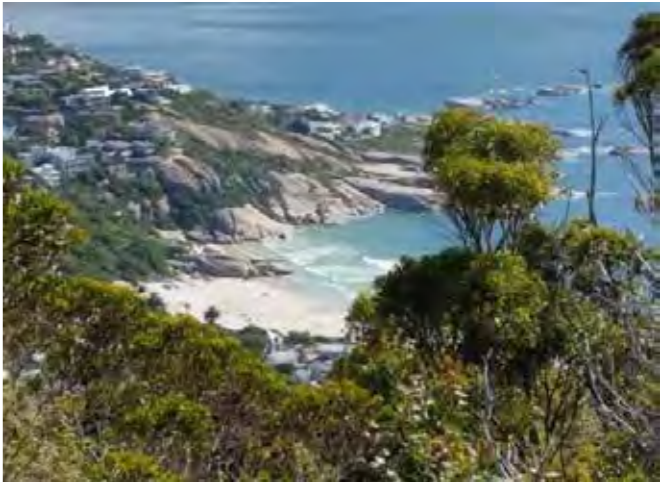
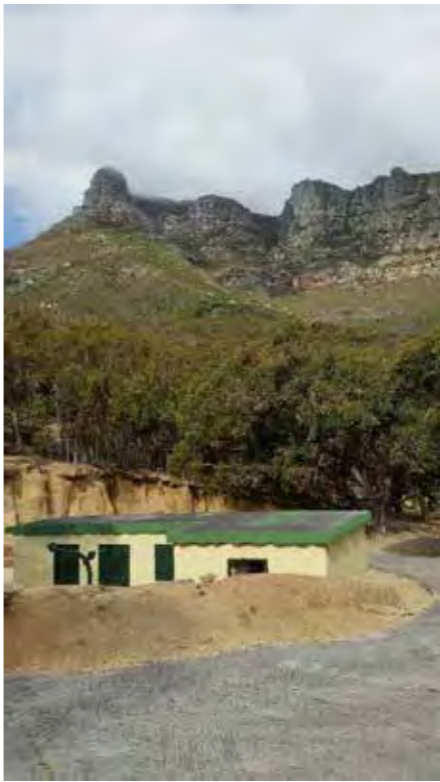
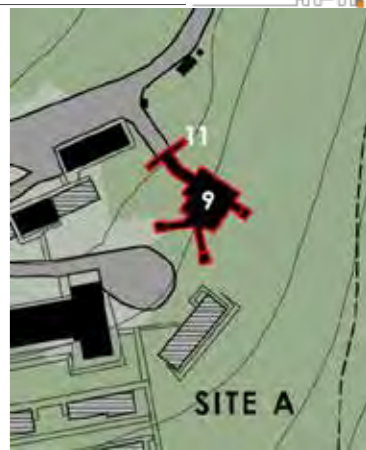
BUILDING NAME/S: Powerhouse (9), Transformer House (11)

SITE Site A, Apostle Battery, Victoria Avenue, Llandudno ERF 1432-RE  
ARCHITECT/S: South African National Defence Force DATE C.1940  
ORIGINAL USE: Transformer House CURRENT USE Used as gathering space/  
church etc.

PHYSICAL CONDITION: Good / Average

RECOMMENDATIONS & GUIDELINES: The building should be subject to a health and safety audit and a plan put in place which allows the building to be used safely, in conjunction with any proposed new overall usage. Buildings should be made available for appropriate adaptive re-use. The key military details and features are to be retained and conserved.

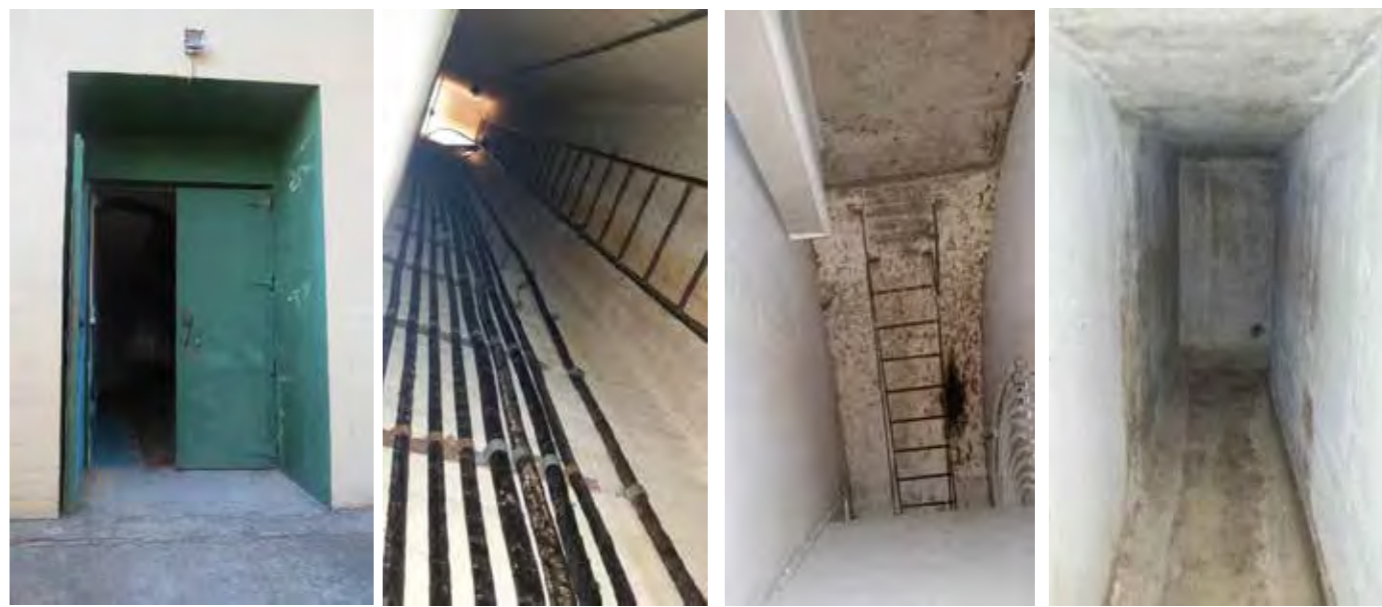
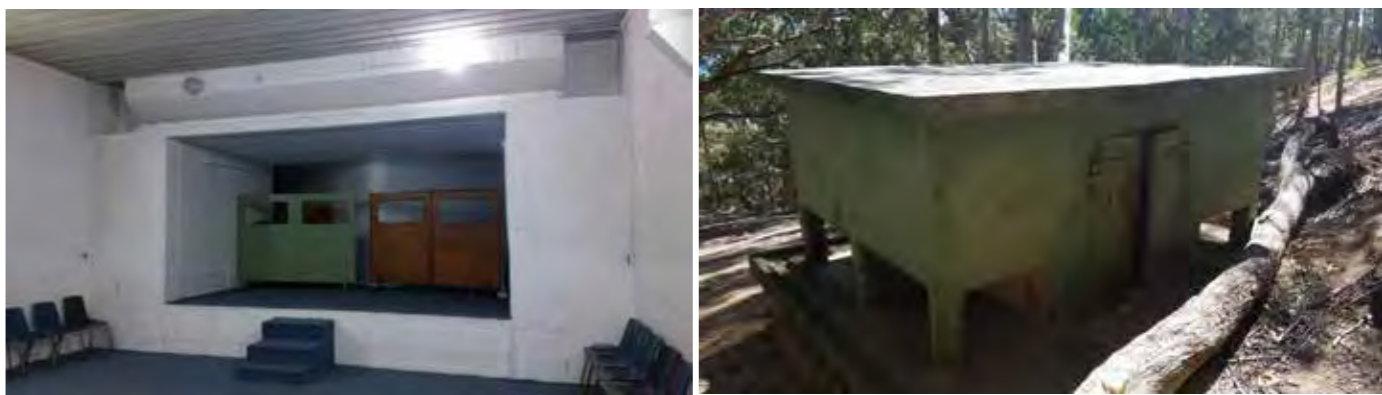
SITE & STRUCTURE DESCRIPTION The buried structure complete with ventilator shafts and perimeter tunnels and escape stair takes the form of a large underground concrete bunker beneath an earth hill.

MAJOR ALTERATION/S: Minor modern insertions and finishes. DATE/S: 1940

STATEMENT OF SIGNIFICANCE: This unique structure is a key component of the military installation on the site and retains its original spatial arrangement and many fittings include steel shutter doors, ladders, ventilator outlets etc.

PROPOSED GRADING Grade IIIA within the PHS  
OPPORTUNITIES & THREATS: The space is well suited to an interpretive centre, display, film screenings, functions and training sessions etc, however, health and safety requirements (fire, escape, ventilation) are challenges to be overcome.

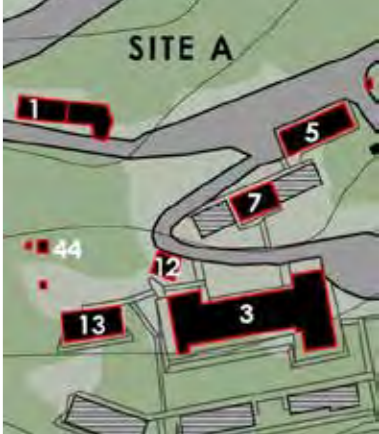
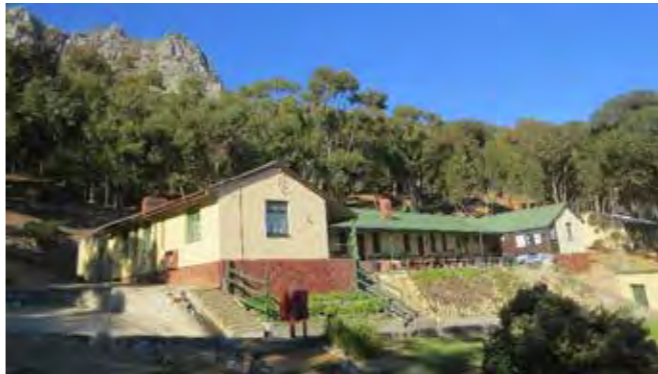
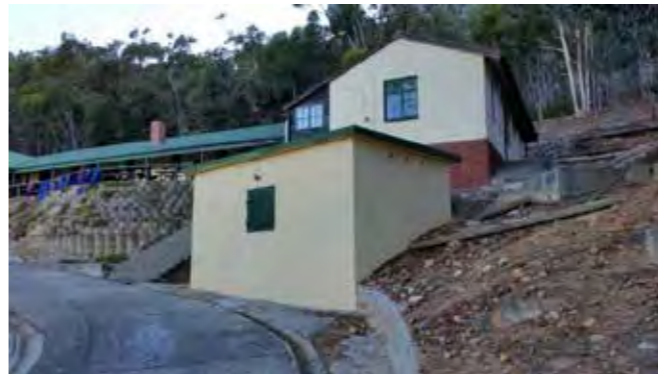
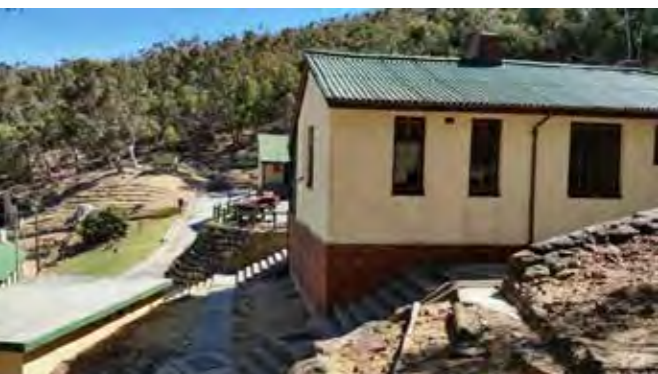
| BUILDING NAME/S: | Dormitory foundations (2), Officer’s Mess foundations (4), Orderly Room foundations (6), MI Room foundations (8) | | | | | | | | | | | | | |

| SITE & STRUCTURE DESCRIPTION | Extant foundations of the nine dormitories - the sleeping quarters of the WAAS. | | | | | | | | | | | | | |
| PHYSICAL CONDITION: | The women’s barracks were demolished after a mountain fire, and the demolished foundations remain visible. | | | | | | | | | | | | | |
| PROPOSED GRADING OPPORTUNITIES & THREATS: | Opportunities exist for new accommodation or other appropriate low-key use to be built on/over the remaining foundations on the existing footprints and alignments. Tree clearing/ fire protection to be carefully considered and integrated. | | | | | | | | | | | | | |

| RECOMMENDATIONS & GUIDELINES: | If no usage is required, the site is to be left undisturbed. However, if the area is to be utilised again, the footprints of the previous dormitories should inform the new layout. The units should touch the ground lightly and not visually intrude into the landscape and built environment. The pattern of paths and steps should tie the units together as previously. Simple architectural forms are suggested, but the architectural expression need not copy the 1940s dormitory architecture. | | | | | | | | | | | | | |

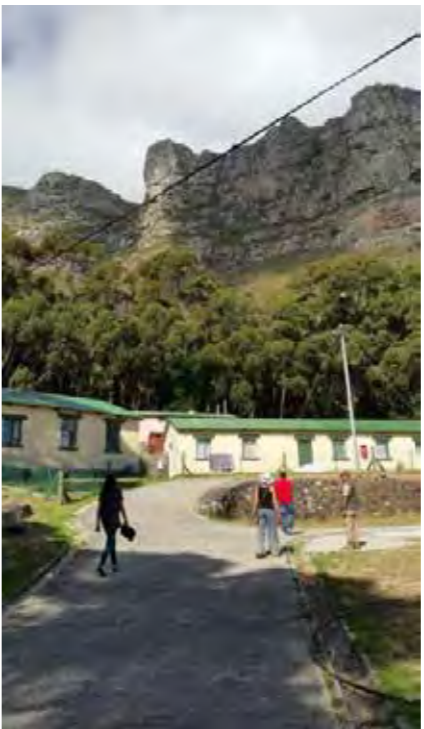
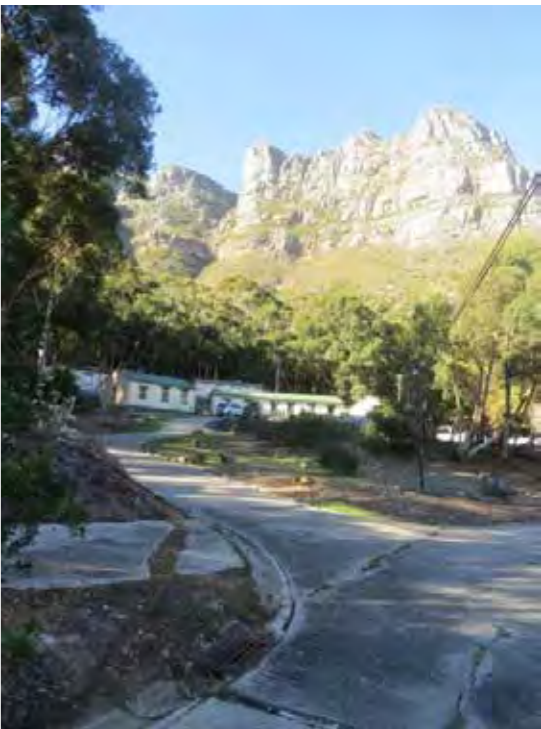
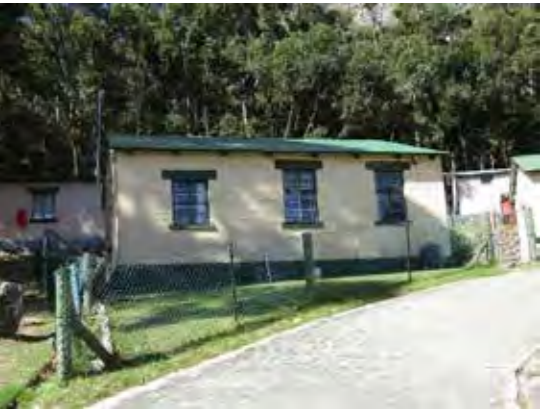
BUILDING NAME/S: Radio Room (23), Battery Turret (24), Generator Room (25), Store Room (26), Reservoir (27), Building 7 (45)

PHYSICAL CONDITION: Abandoned and dilapidated. Extensive rusting apparent, metal shutters remain in place.

Remoteness and exposure of the buildings to the elements leading to vandalism and continued decay are the main threats. The structures

RECOMMENDATIONS & GUIDELINES: Any repurposing or new usage must be low key and must not disturb the visual or intrinsic character of the buildings. A detailed fabric analysis and measured survey is to be undertaken as part of any proposal considered.

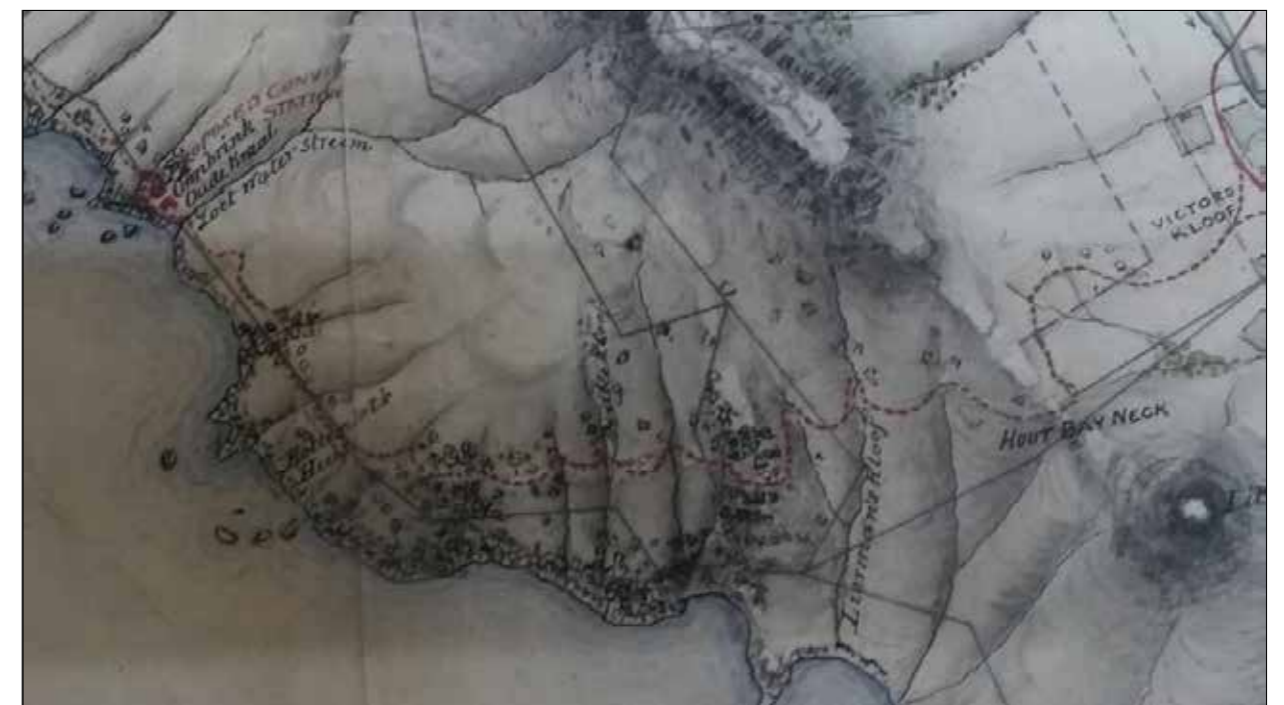
Figure 11: Extract from the Cape Archives map M3/536 signed by Thomas Bain 9/4/1884 which notes the dotted route near Bakoven as "Proposed line of Road"

While evidence of an additional road exists, it is impossible to determine if this road equates to the bridle path identified in Figure 8, or if this road is indeed the remnants of an earlier alignment for Victoria Road (Figure 11). In either scenario, the identified road has limited significance in terms of archaeology and is therefore not discussed further.

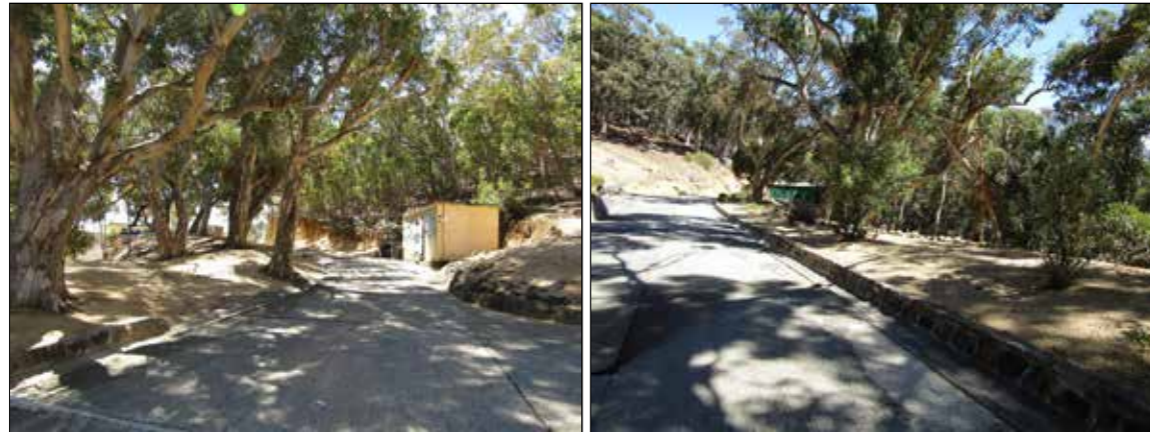
Figures 15 and 16: Contextual photographs of the lower levels of Site A

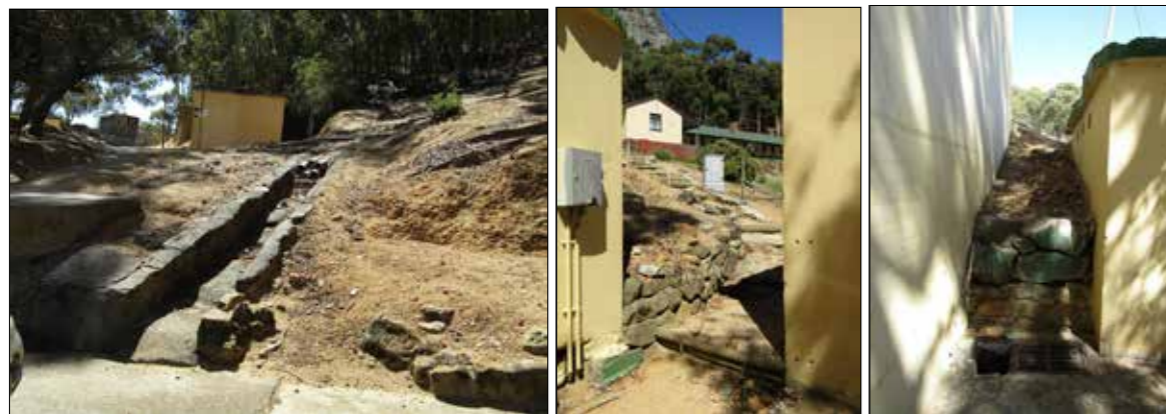
Figures 17, 18 and 19: Examples of infrastructure and strategies employed to manage the steep nature of the site at Site A

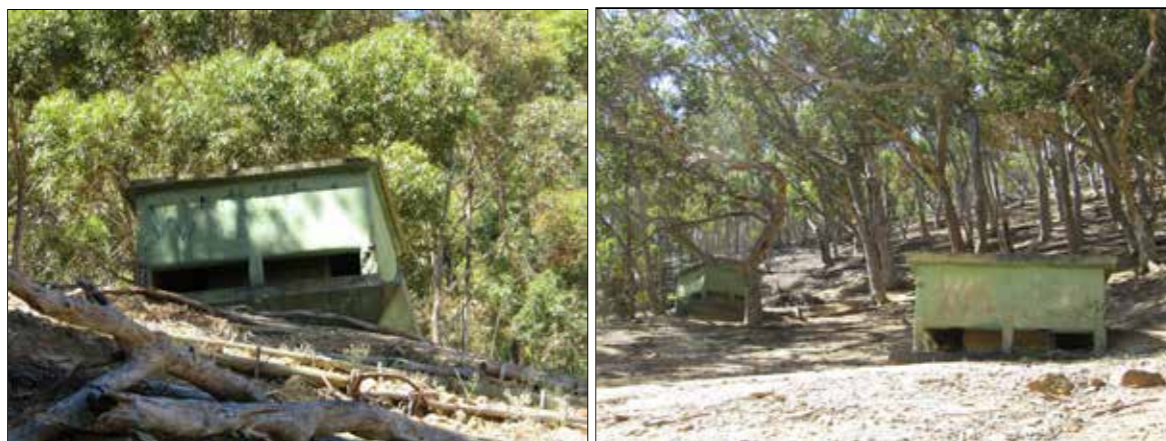
Figures 20 and 21: Air vents associated with the Generator Room at Site A

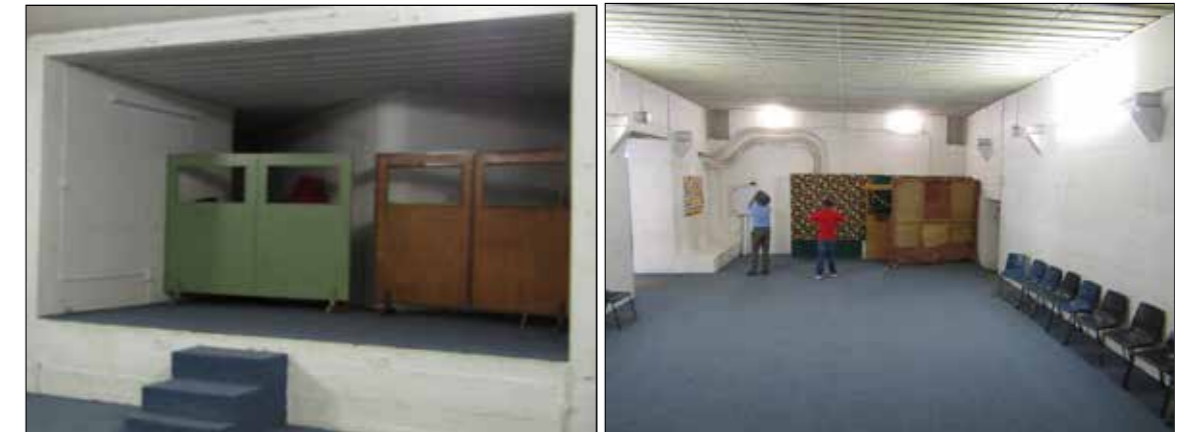
Figures 22 and 23: The Generator Room associated with the air vents, currently used as prayer space by the camp at Site A

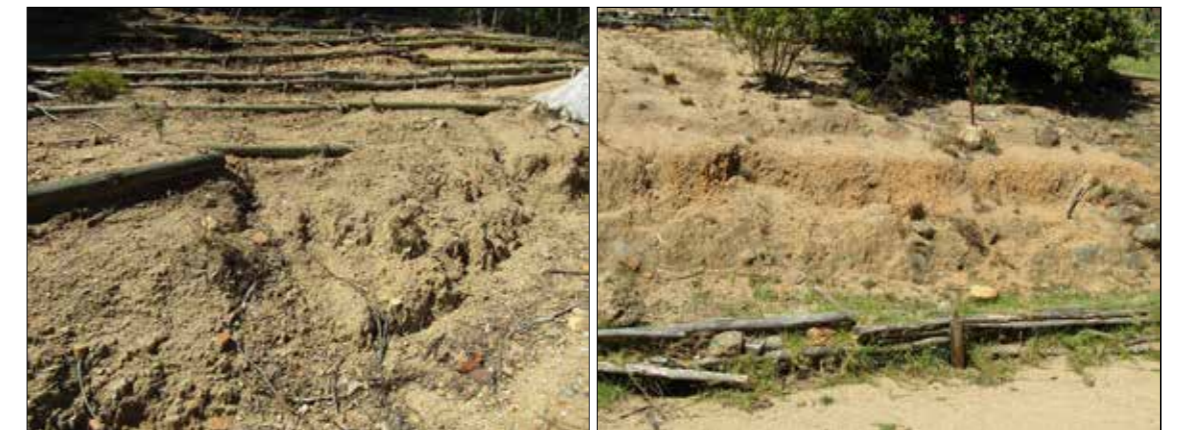
Figure 24 and 25: Terracing used to stabilise deposit covering the underground generator room. Material remains may be located within this deposit at Site A
