**TABLE MOUNTAIN NATIONAL PARK**  
**APOSTLE BATTERY HERITAGE REPORT & DEVELOPMENT GUIDELINES**  
COMPILED IN TERMS OF SECTION 27 OF THE NHRA (1999) FOR  
Erven 1432-RE and CA 902-1, The Apostle Battery, Victoria Avenue, Llandudno.

DRAFT V.4  
July 2017

Prepared by Rennie Scurr Adendorff, CTS and Square One

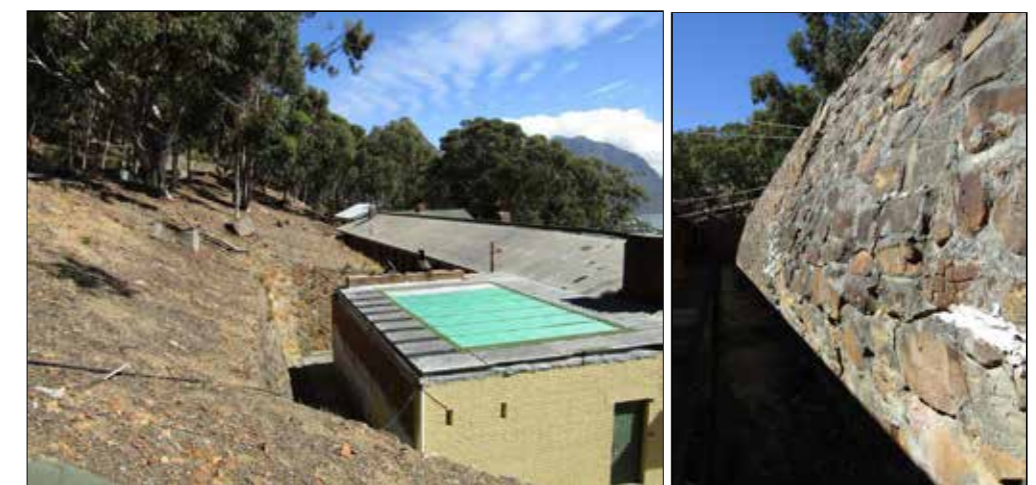
Figures 26 and 27: Terracing walls used to retain soil on steep mountain slope at Site A

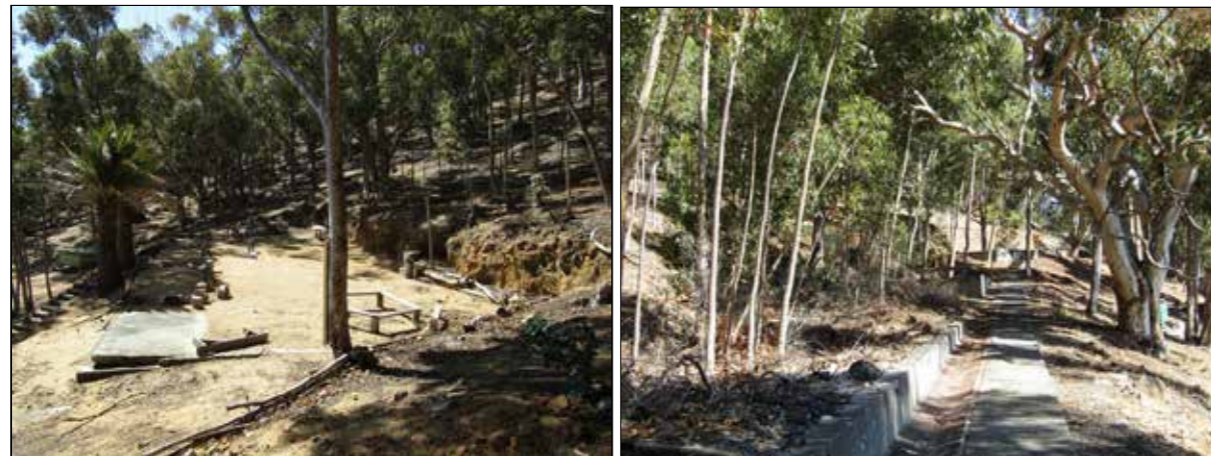
Figures 28 and 29: Remnant foundations of old military barracks that have subsequently burnt down. Material remains may be located within these foundations at Site A

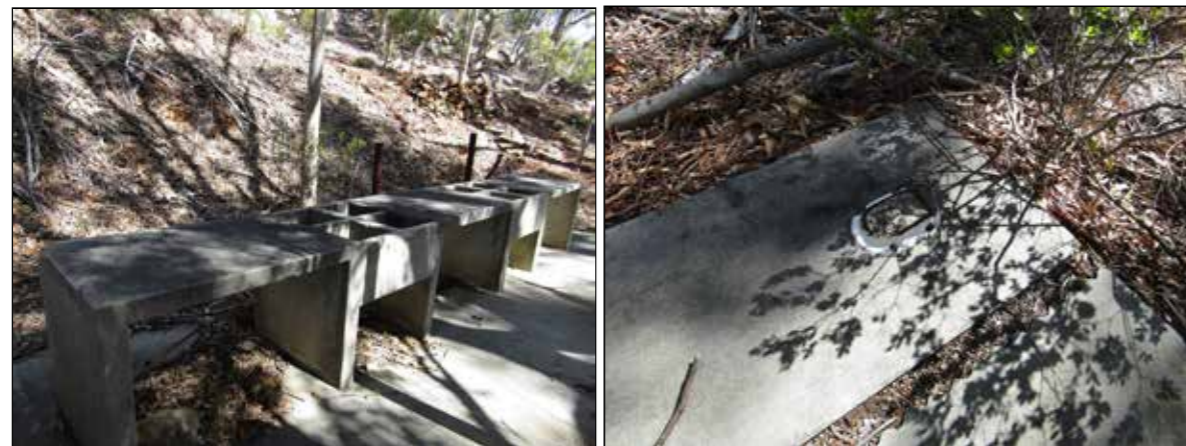
Figures 30 and 31: Remnant infrastructure from the laundry and ablution facilities at Site A

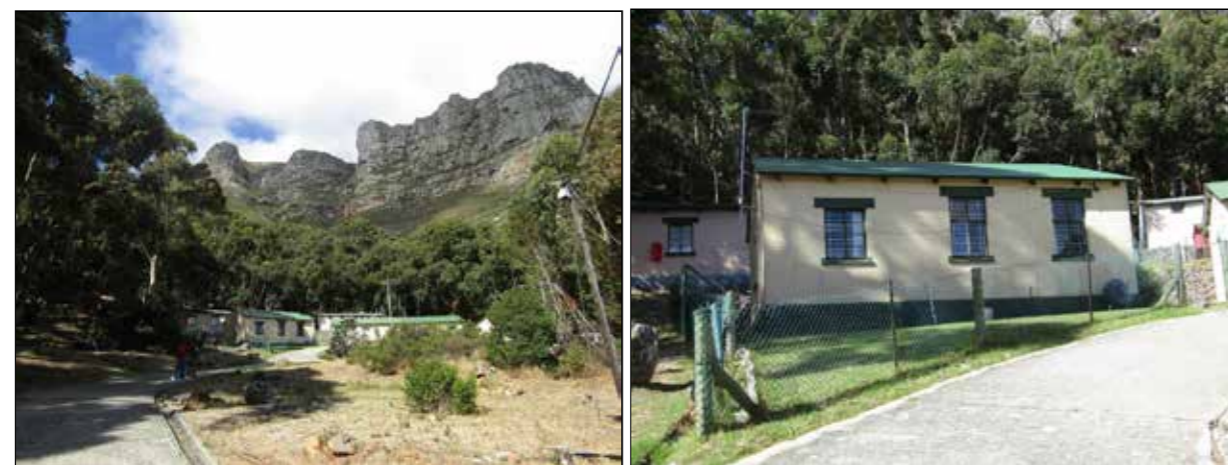
Figures 32 and 33: General Context of Site B

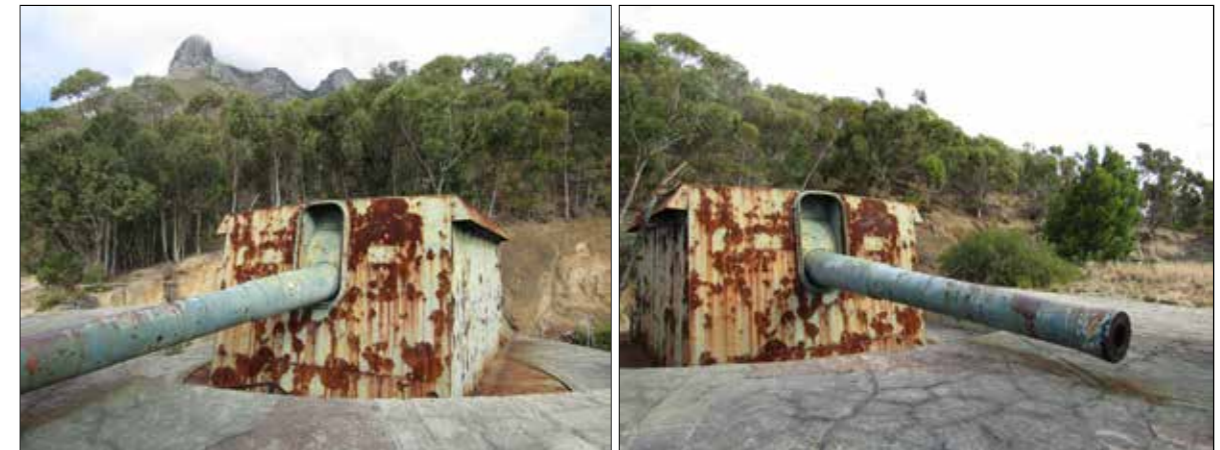
Figures 34 and 35: Gun 1 [SAHRIS Object ID 33857] at Site A

Currently, the guns are in a bad state of repair and have been subjected to stripping that has seen much of their brass and copper fittings removed, as well as graffiti that has contributed to significant rusting.

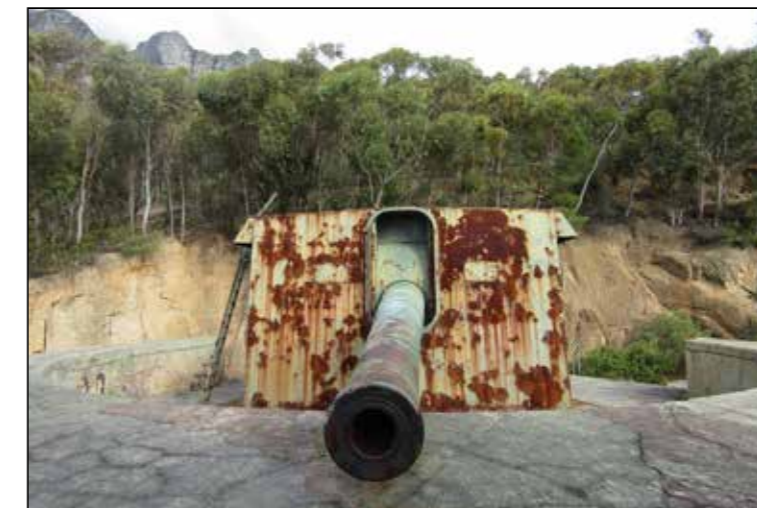
Figure 36: Gun 1 at Site A

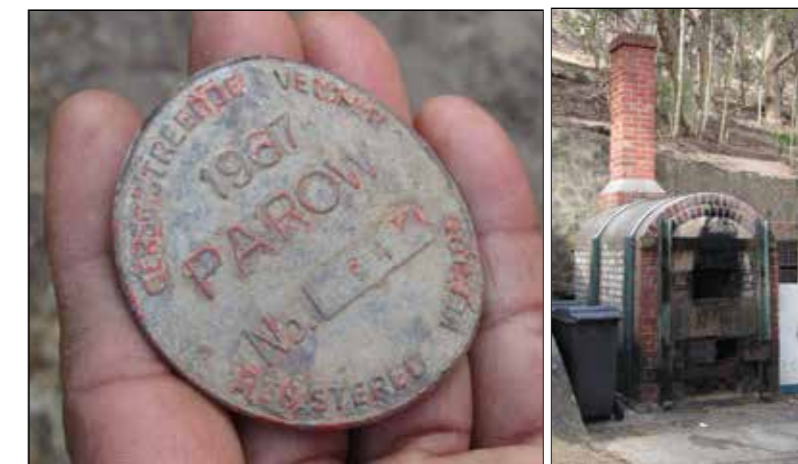
Figures 37 and 38: Material remains identified at Site A and B including a Vendor Tag

The area proposed for development was visited by Jenna Lavin on 1 February 2017. This site visit recorded no archaeological material, although a single metal vendor tag was recorded at Site B (see Figure 37 below). This tag would have been used as a form of identification for a vendor to obtain payment for the provision of services; interestingly, a similar one from the Gas Works was found at the Amsterdam Battery (pers. Comm. Tim Hart). The extant guns were documented, however.

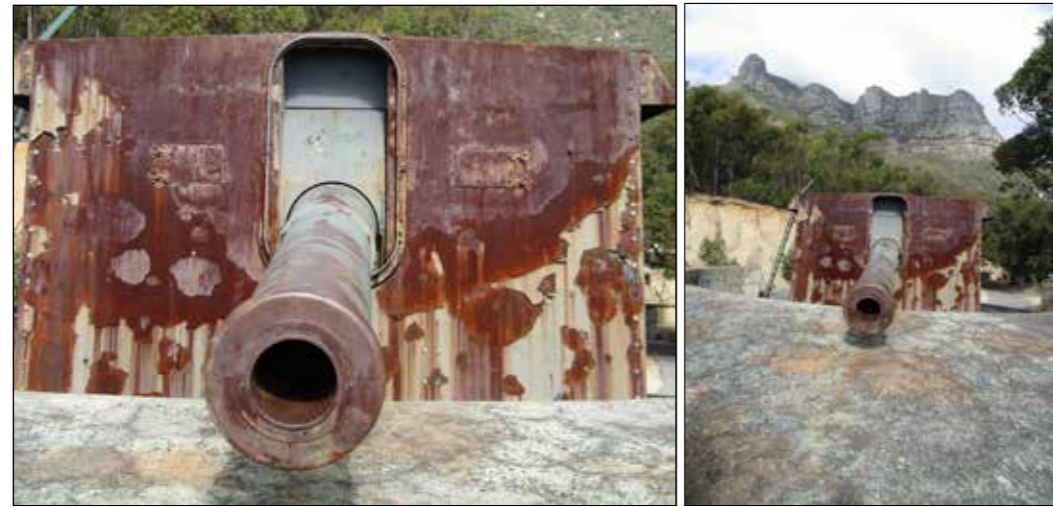
Figure 39 and 40: Gun 2 [SAHRIS Object ID 33858] located at Site A. Note the camouflage painted on the guns concrete plinth

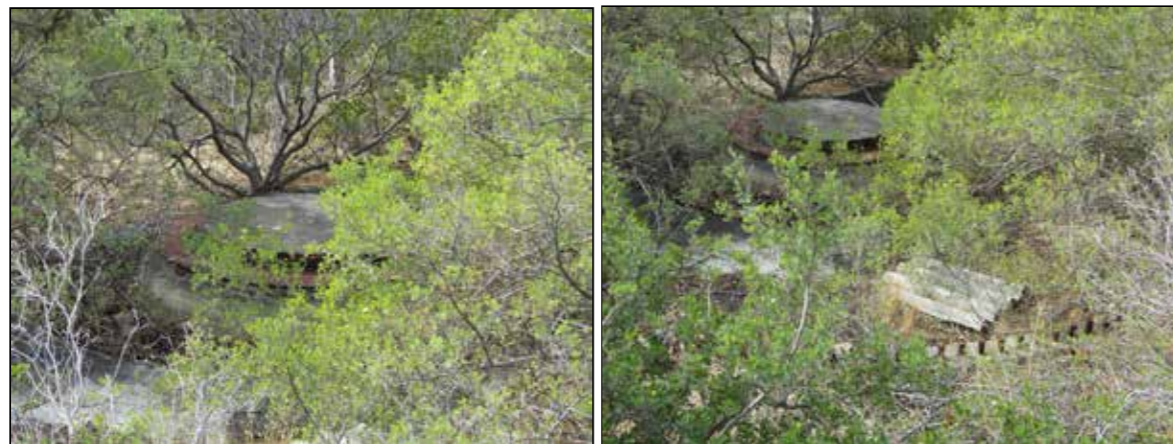
Figures 41 and 42: Anti-aircraft gun emplacements located on either side of Gun 2.

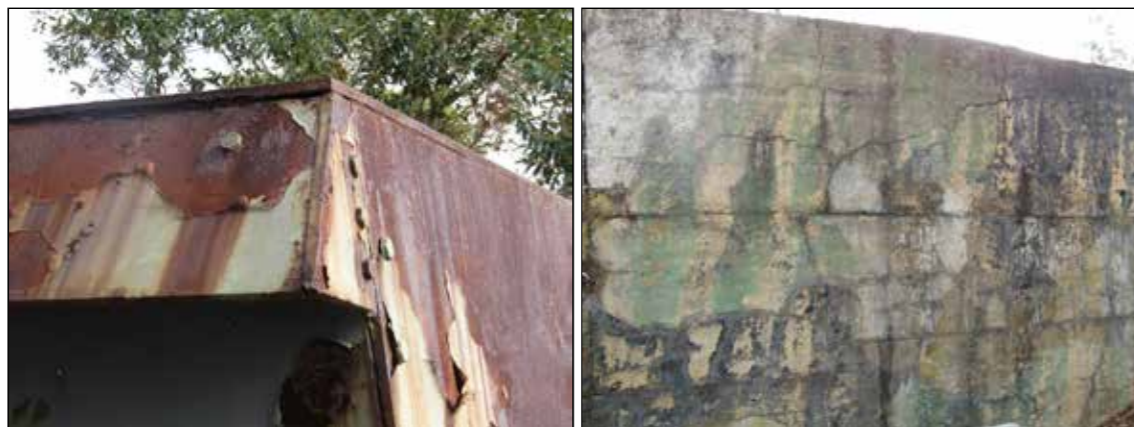
Figure 43: Rust damage to Gun 2 Figure 44: Camouflage paint evident on concrete plinth of Gun 2

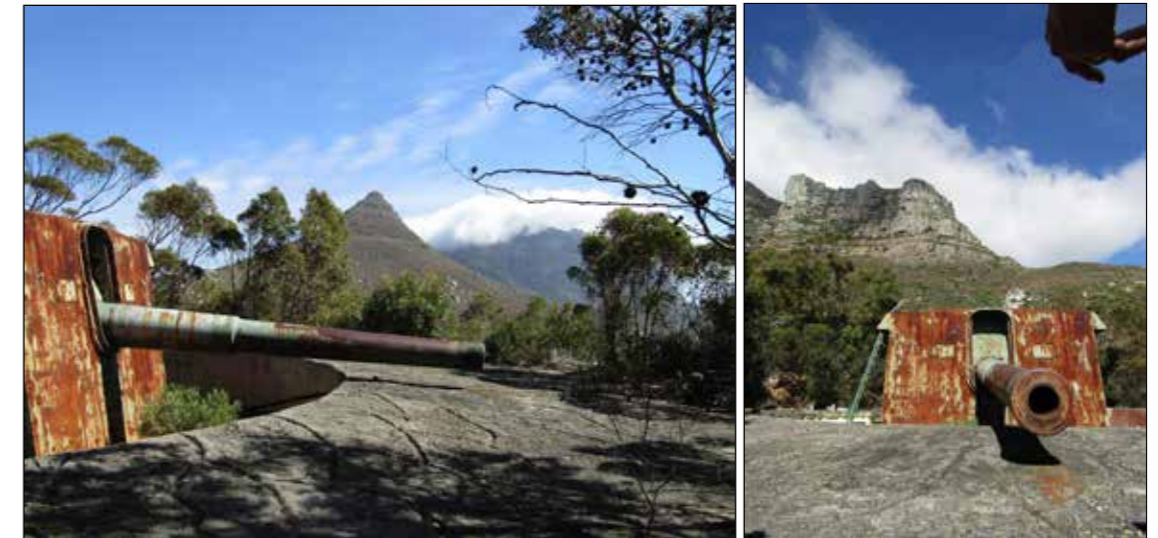
Figure 45 and 46: Gun 3 [SAHRIS Object ID: 33859] at Site B

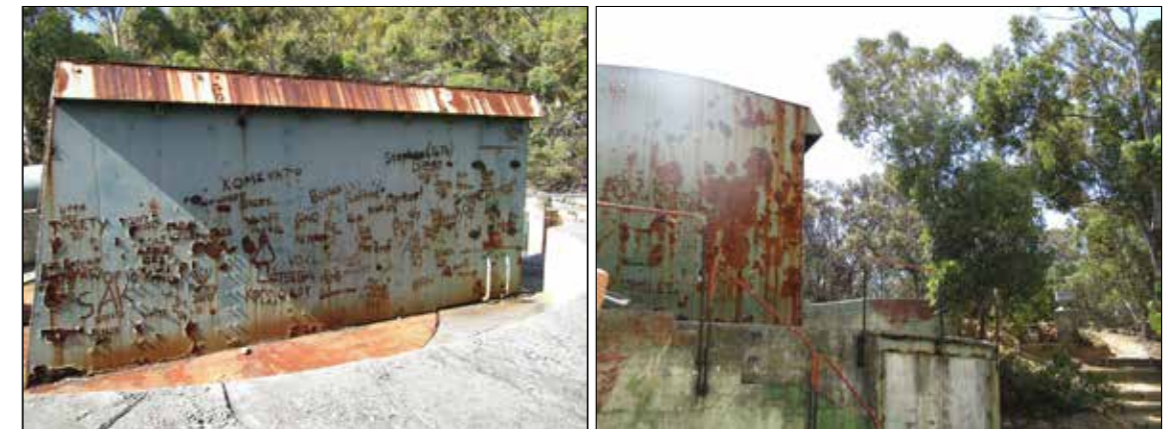
Figure 47 and 48: Evidence of vandalism and disrepair at Gun 3 at Site B

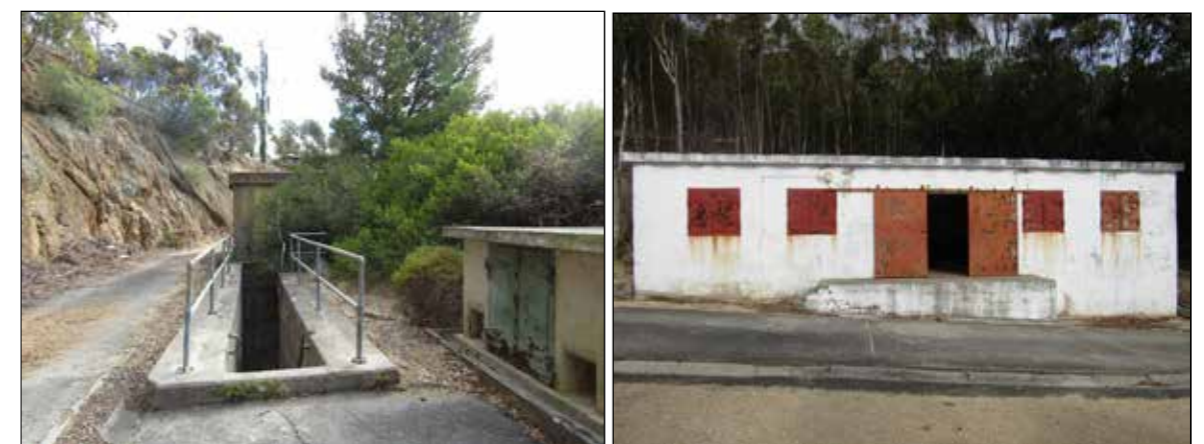
Figures 49 and 50: Examples of infrastructure associated with all the guns at the Apostle Battery

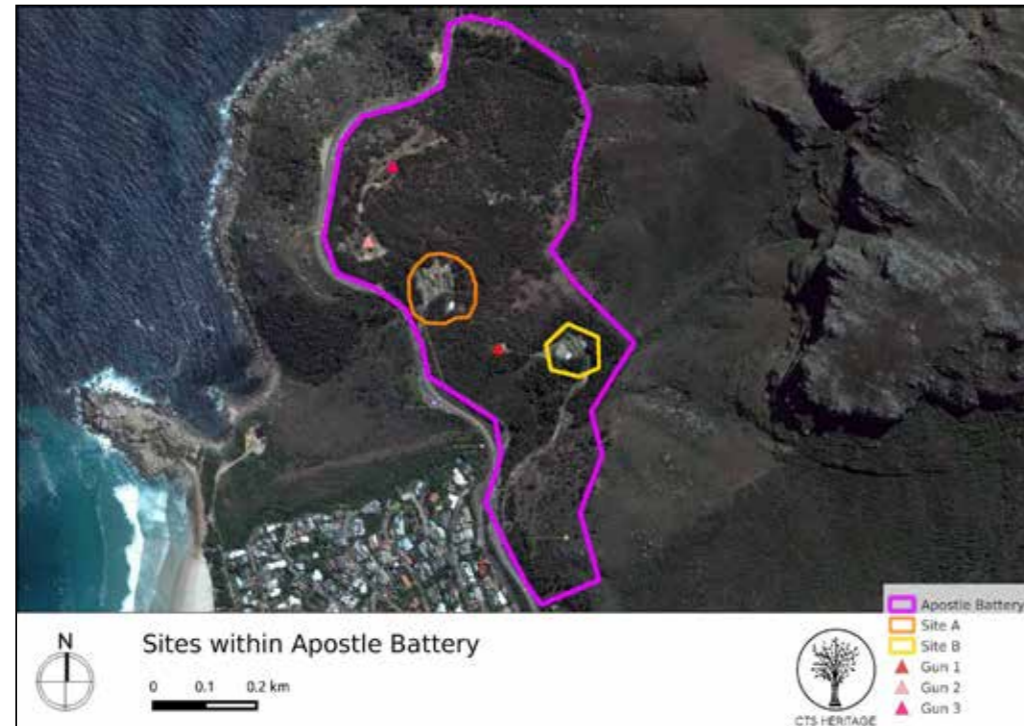
Figure 51: Spatial location of identified heritage resources within the study area

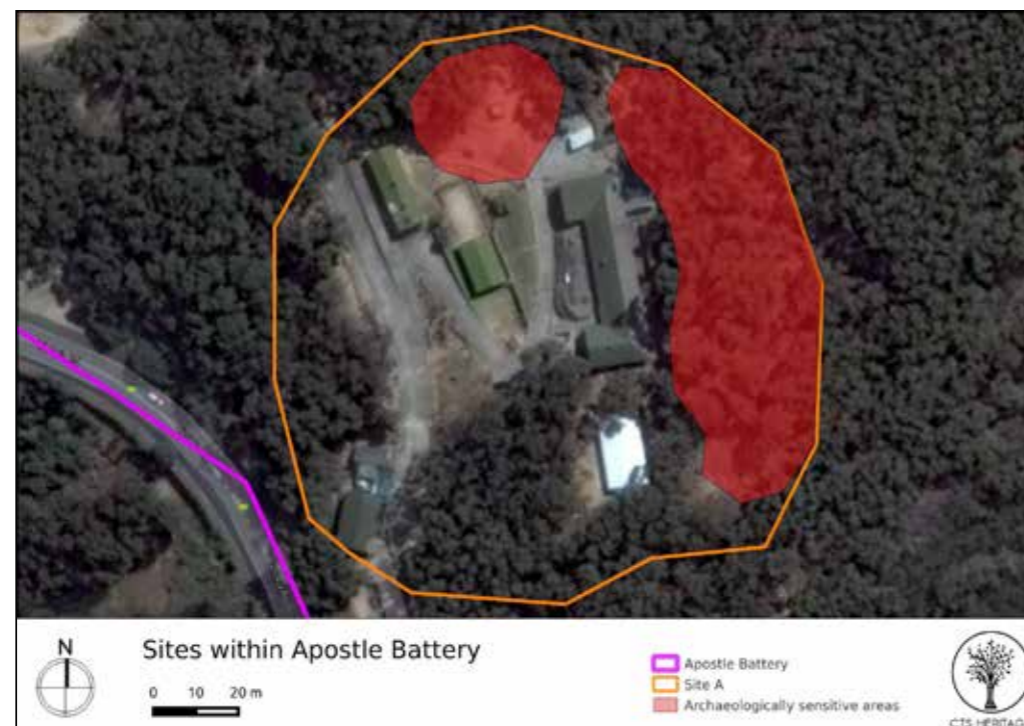
Figure 52: Zoomed in view of Site A with likely archaeologically sensitive areas highlighted in red

the buildings were demolished, they could either be obscuring historic ground surface levels with artefactual material present on them, or there could be artefactual material in the demolition rubble. The vicinity of these foundations, therefore, are the most likely places to find archaeological material.
