SAHRA PERMIT APPLICATION  
HOUSES OF PARLIAMENT  
ERF 95165

OLD ASSEMBLY BUILDING REFURBISHMENT OF BASEMENT  
INFRASTRUCTURE  
DRAINAGE OF BASEMENT

# Motivation for alterations with Parliamentary precinct, Cape Town: drainage issues.

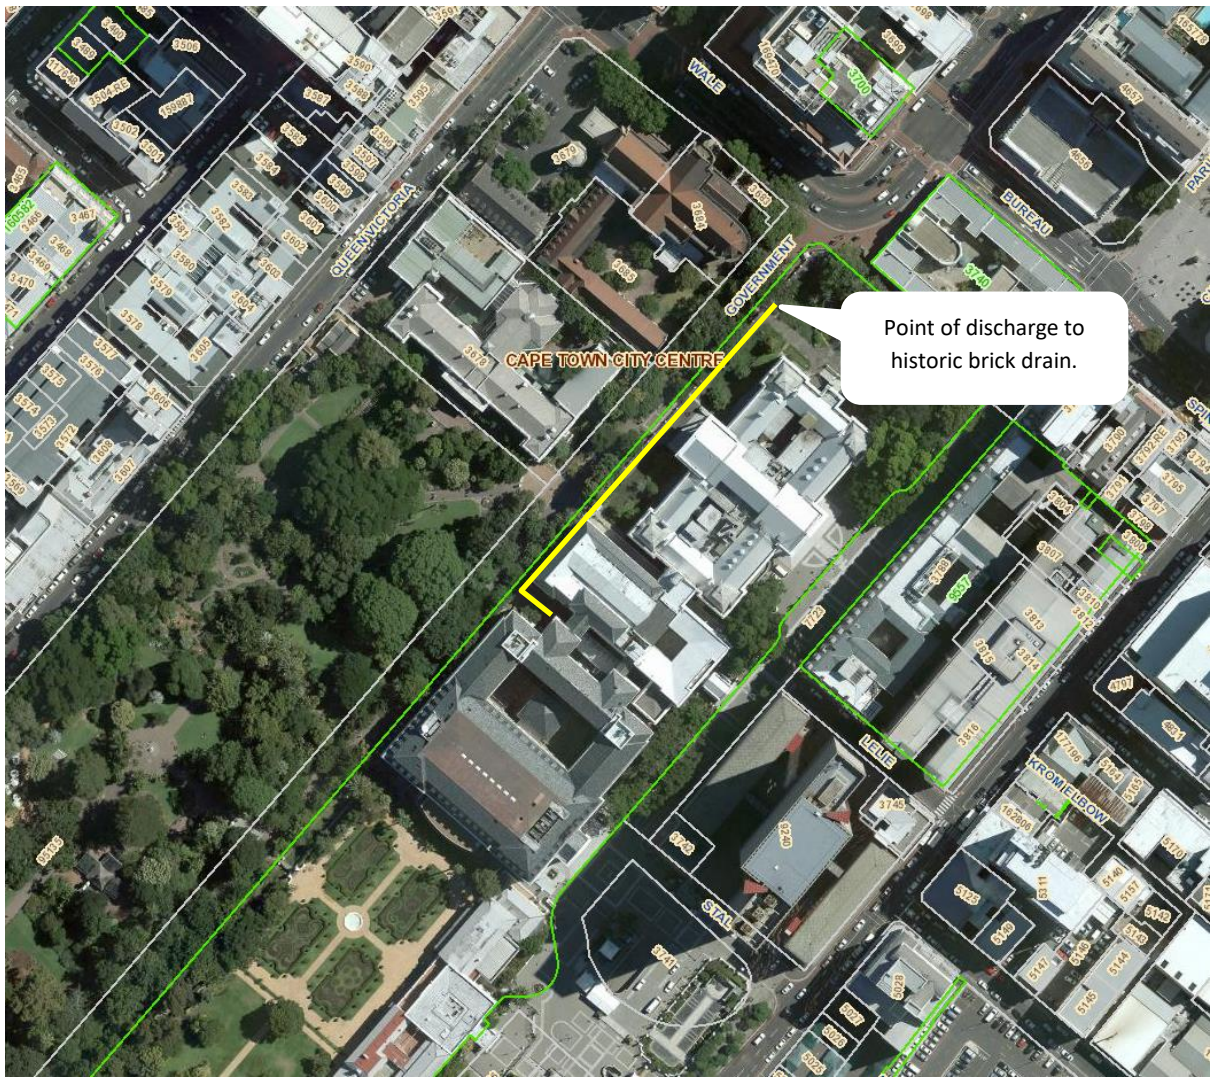
Figure 1 The yellow line indicates the proposed alignment of the drainage pipe.

The proposed activity is the installation of a drainage system and digging of a trench along the side of the old Assembly Building to the start of the Adderley Street brick drain. The groundwater will be pumped from the basement and discharged via a buried pipeline to the brick drain inspection chamber in the Parliament Gardens. Some alteration of fabric will be necessary in the Parliament basement and also at the point of discharge where alteration and breaking through of the inspection chamber is required.

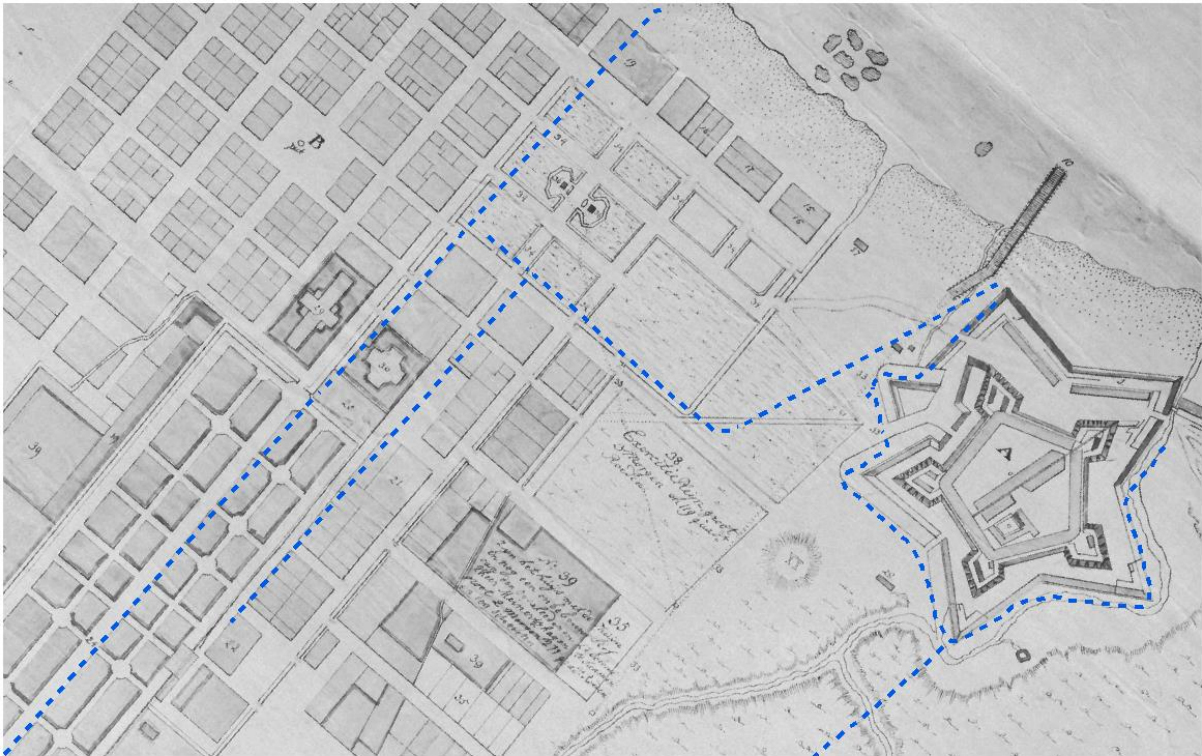
C1680?? With water courses marked on Snow (blue dashed line)

Figure 2 Alignment of Dutch canals in Cape Town 17th century.

The VOC were attracted to Table Bay because of the “Mountain Streams” – Platteklip, Devils Peak (Capel) and relevant to this project, the Varsche River. The VOC used these as the city’s water supply by at first building a canal to divert water to Waggenaar’s Dam followed by a formal canal building program that is reflected in the Street names – Heerengracht, Buitengracht, Kaisersgracht. Typically these canals were about 3 m deep and 4 m wide, stone lined and capable of accommodating flood water (see Hart and Dewar 2007: Report on archaeological investigation of the Canals at the grand Parade erf 4651 for the city of Cape Town and Cape Town partnership).

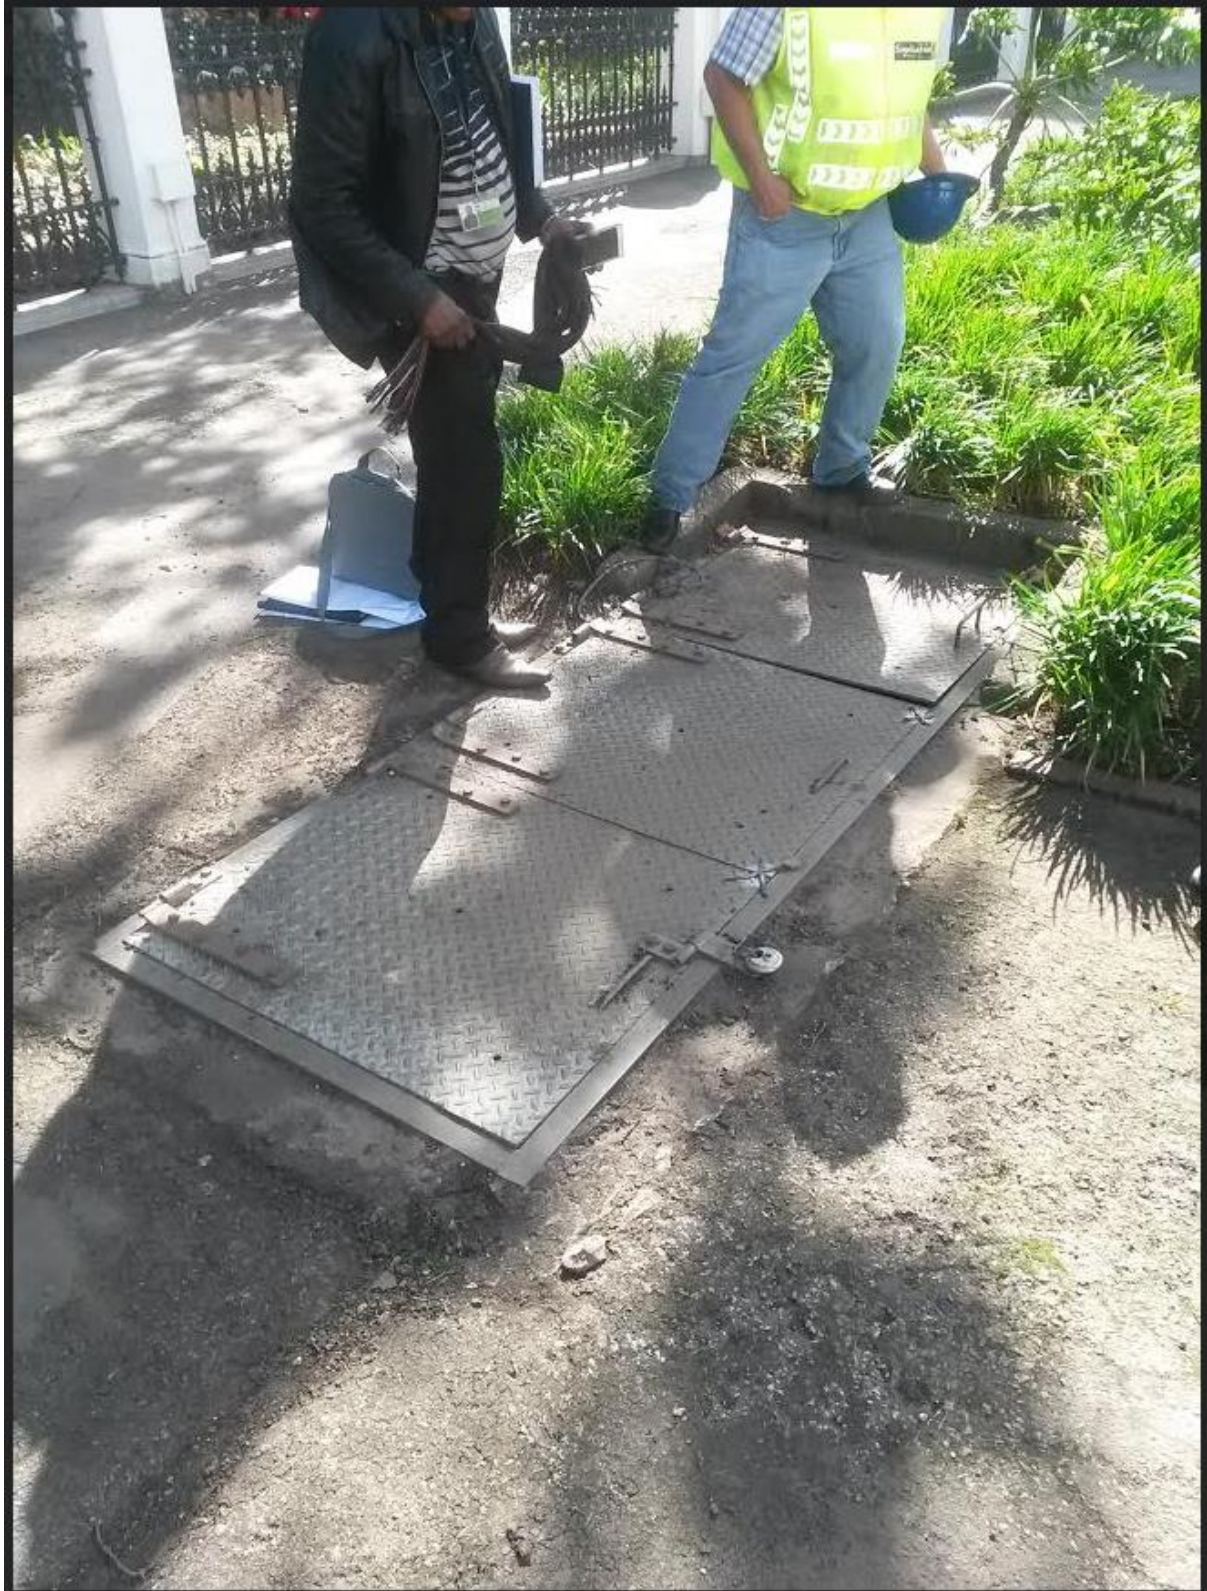
Figure 4 The manhole cover which gives access to the Heerengracht brick drain.

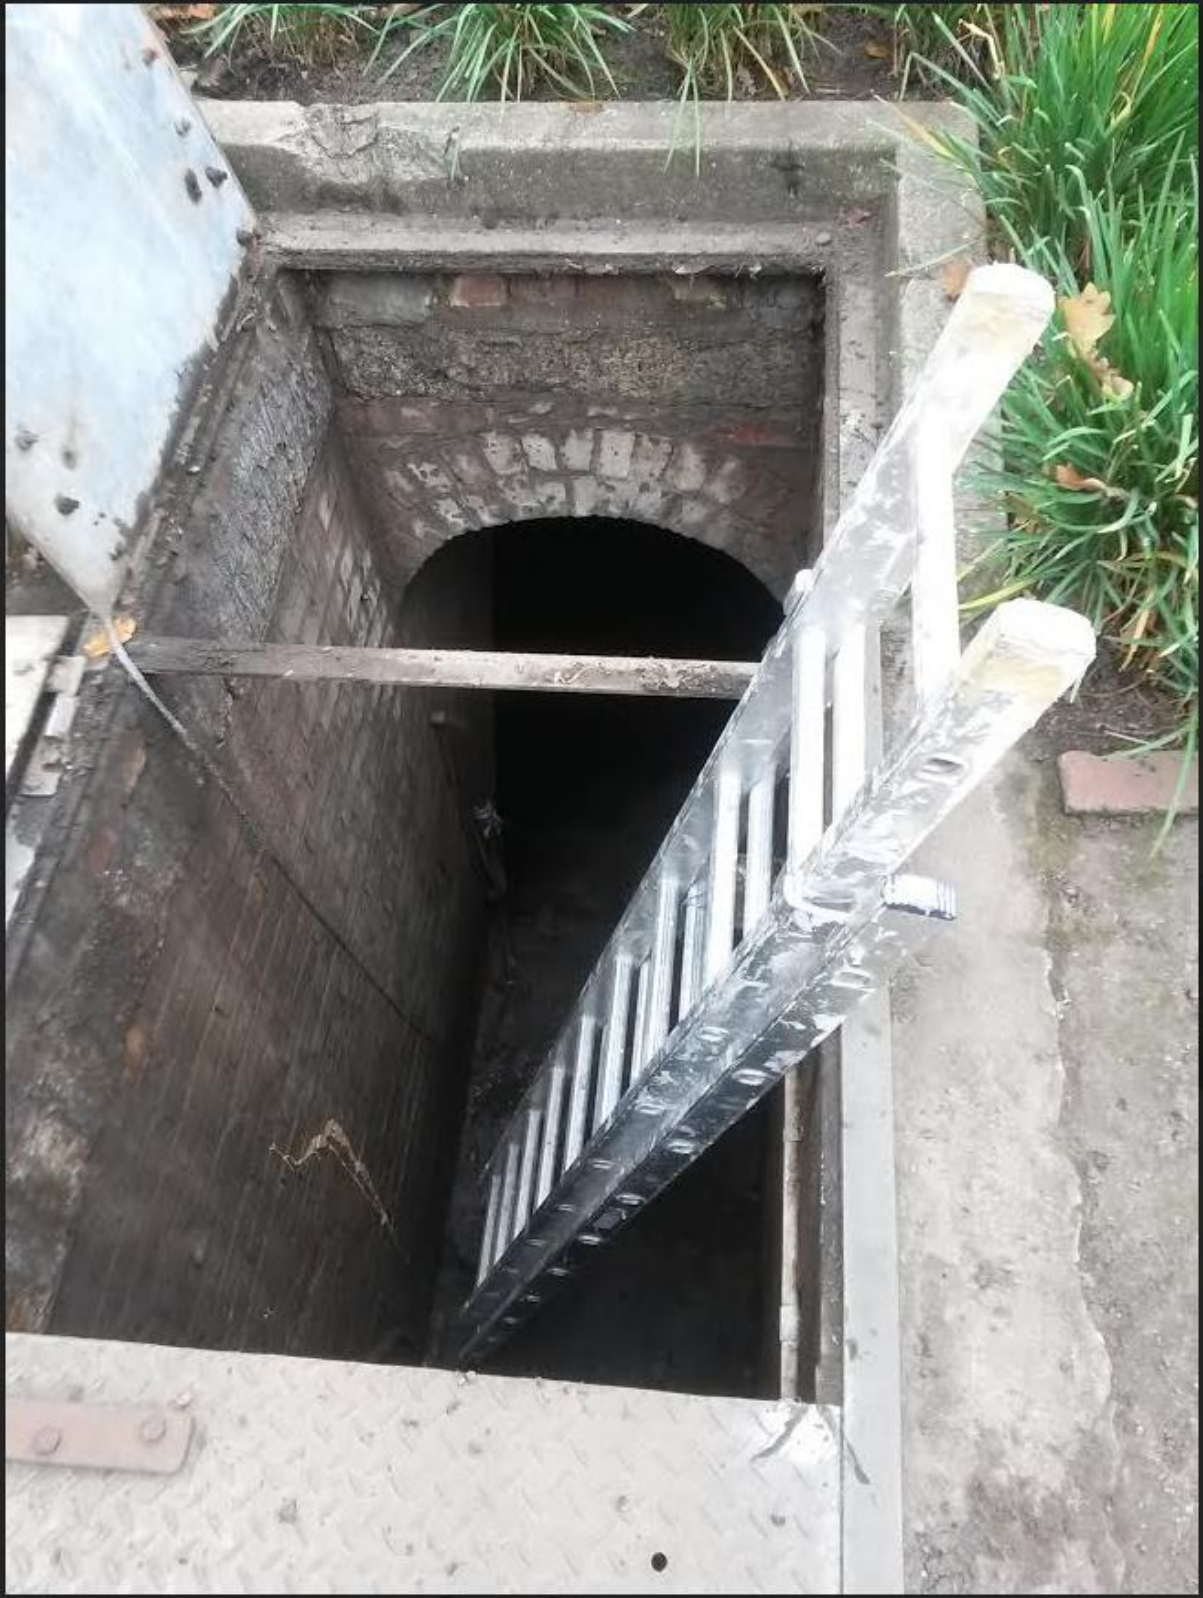
Figure 5 The brick drain.

These very large brick drains are engineering marvels in their own right and are now used for the conducting of formal tours under the city.
