**REHABILITATION OF ROCK ART SITES, SCHRODA, AND K2 AT THE  
MAPUNGUBWE CULTURAL LANDSCAPE**

**February 2021**

## INTRODUCTION

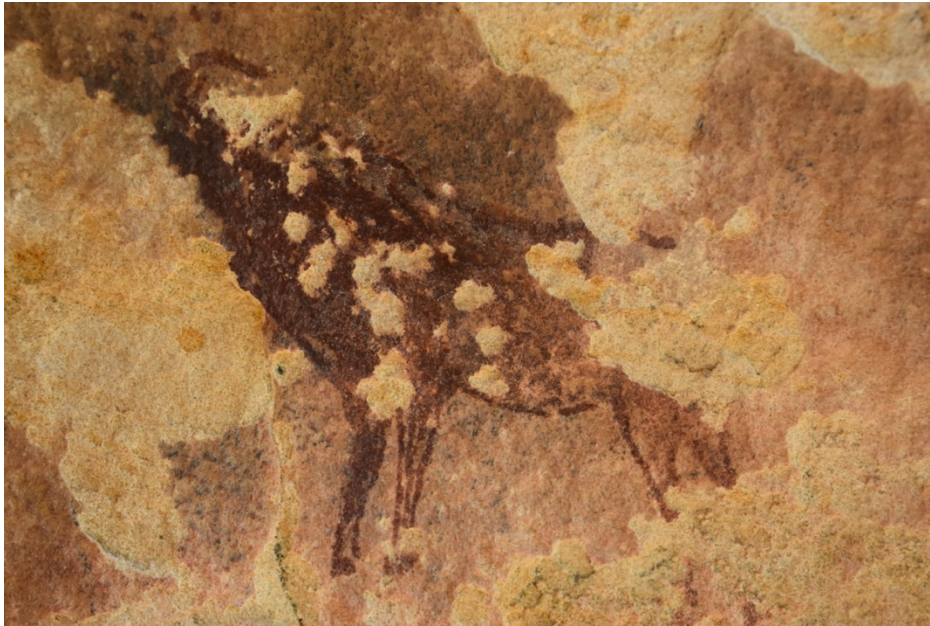
Named after the Venda name for a snake, this site has aprons, human figures, animals, and a big eland to the extreme right of the site (figure 3a, b). Dyambila (Jambila), which is about 23m long, 5m deep, and 6m high (figure 4a, b, c), has a clear evidence of elephant presence as per the dung found at the site. The major threat at this site is elephants rubbing against rock art and the dust element. Other evident threats are exfoliation, water run-off, and fading.

Figure 3a: The image of an eland from Dyambila (Jambila).

- i. To protect the archaeological deposit of the site, lay the geotextile and cover it with soil to protect lessen the dust factor. No change of an existing surface will be done prior to laying the geotextile. The geotextile and soil cover should cover the full area underneath the water dropline. In addition, it is recommended that polymer is applied on the 'new soil cover' to bind the particles together, thus further assisting in curbing erosion and significantly lowering dust levels (Teo *et al.* 2001; Yakupoglu *et al.* 2019).
- ii. Cobbling the surroundings of the site: it is recommended that cobble stones are used to curb the presence of elephants at the site. In cobbling the site with these stones, the natural shrubs of mopani is not to be interfered with.

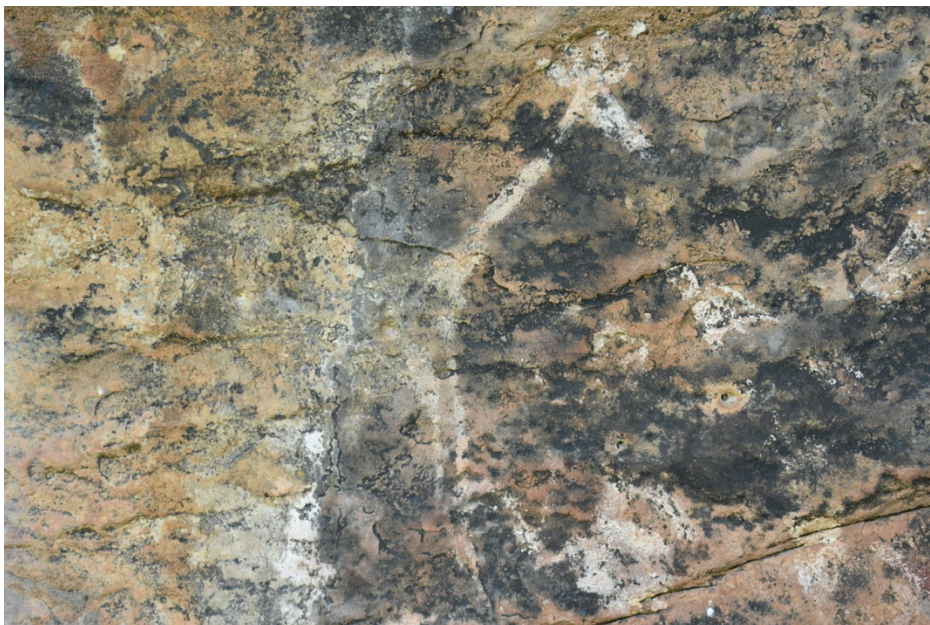
Figure 3b: The fading image of an antelope at Dyambila (Jambila).

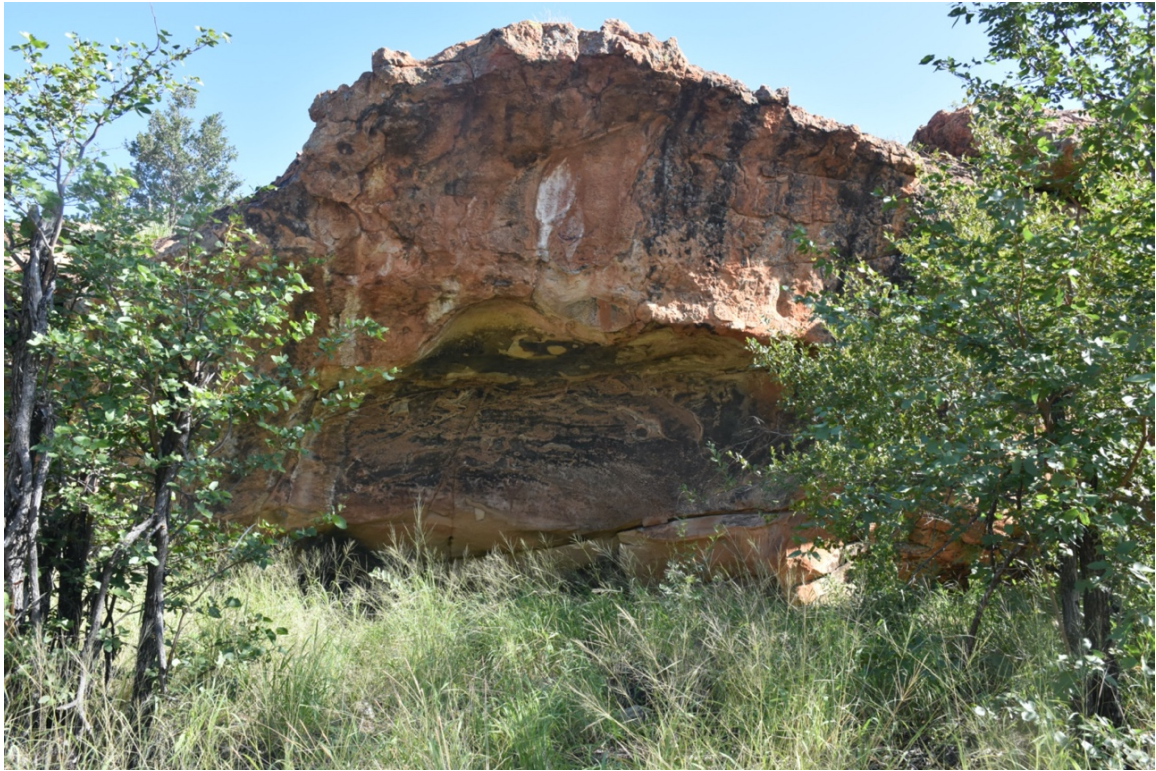
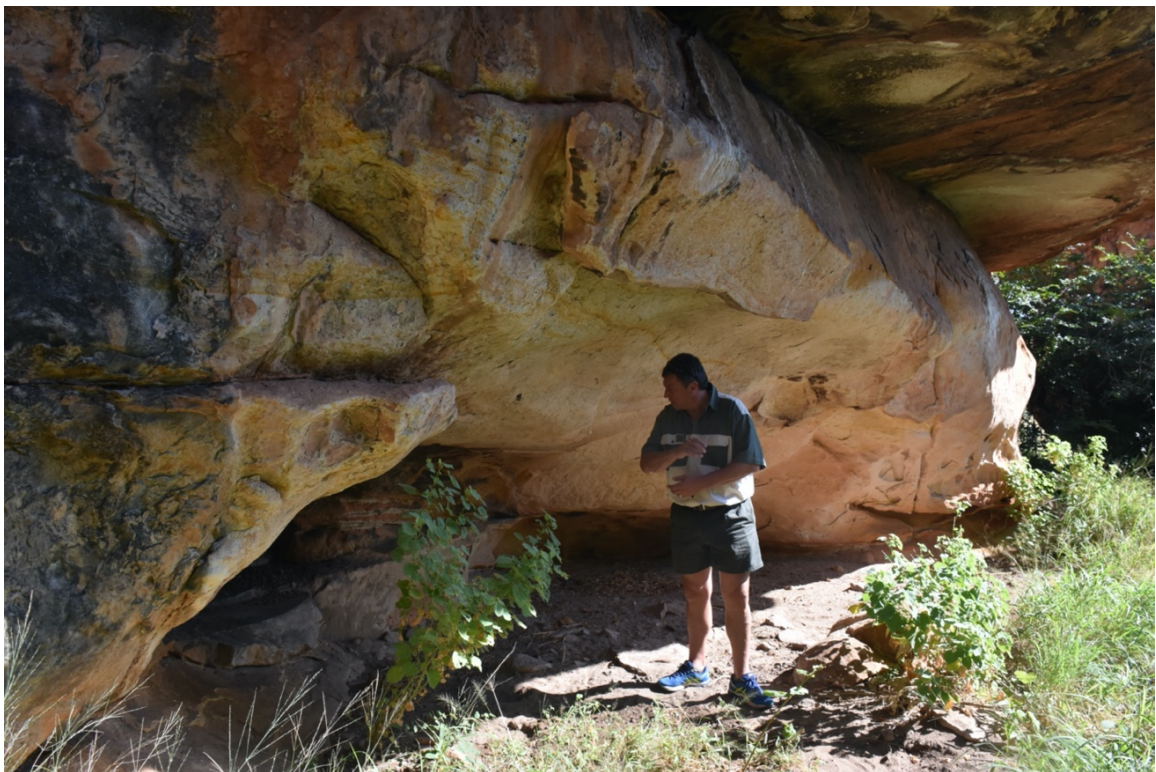
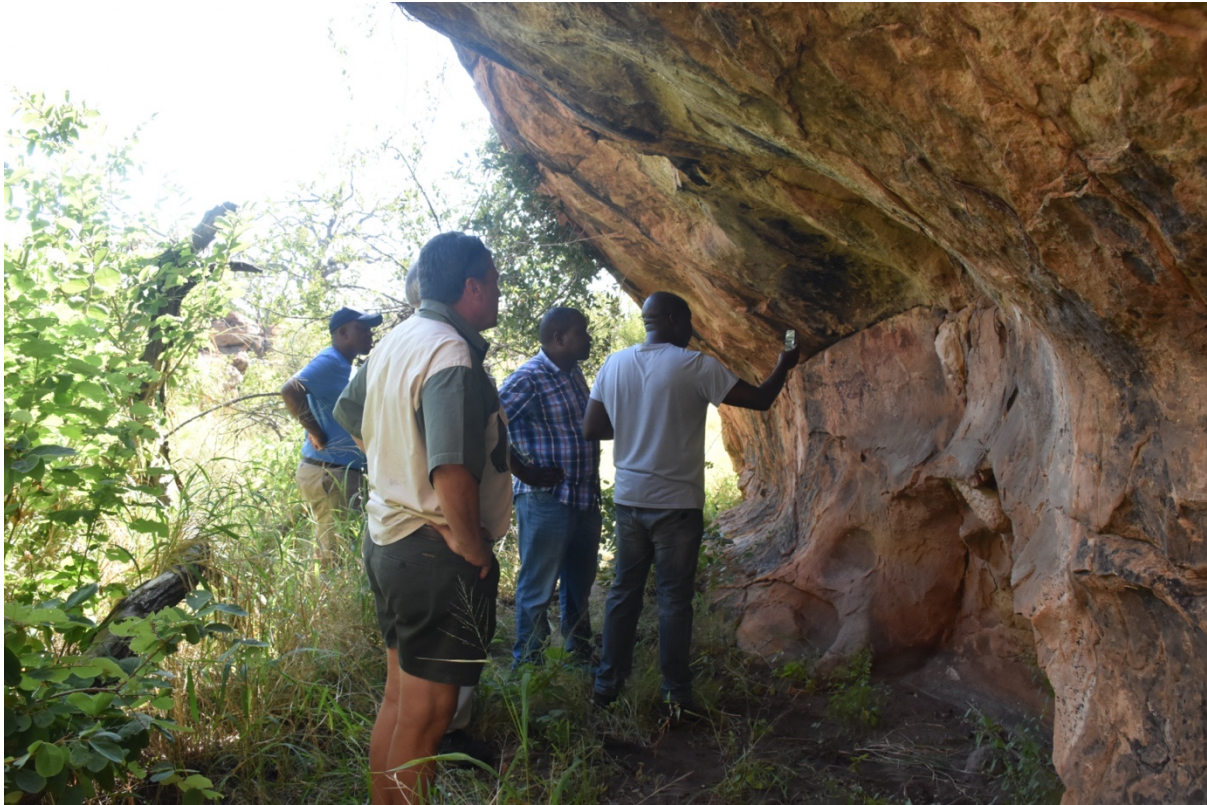
Figure 4a: The frontal view of Dyambila (Jambila).

Figure 4b: The view inside Dyambila (Jambila).

Figure 4c: The vegetation cover within and nearby the site of Dyambila (Jambila).

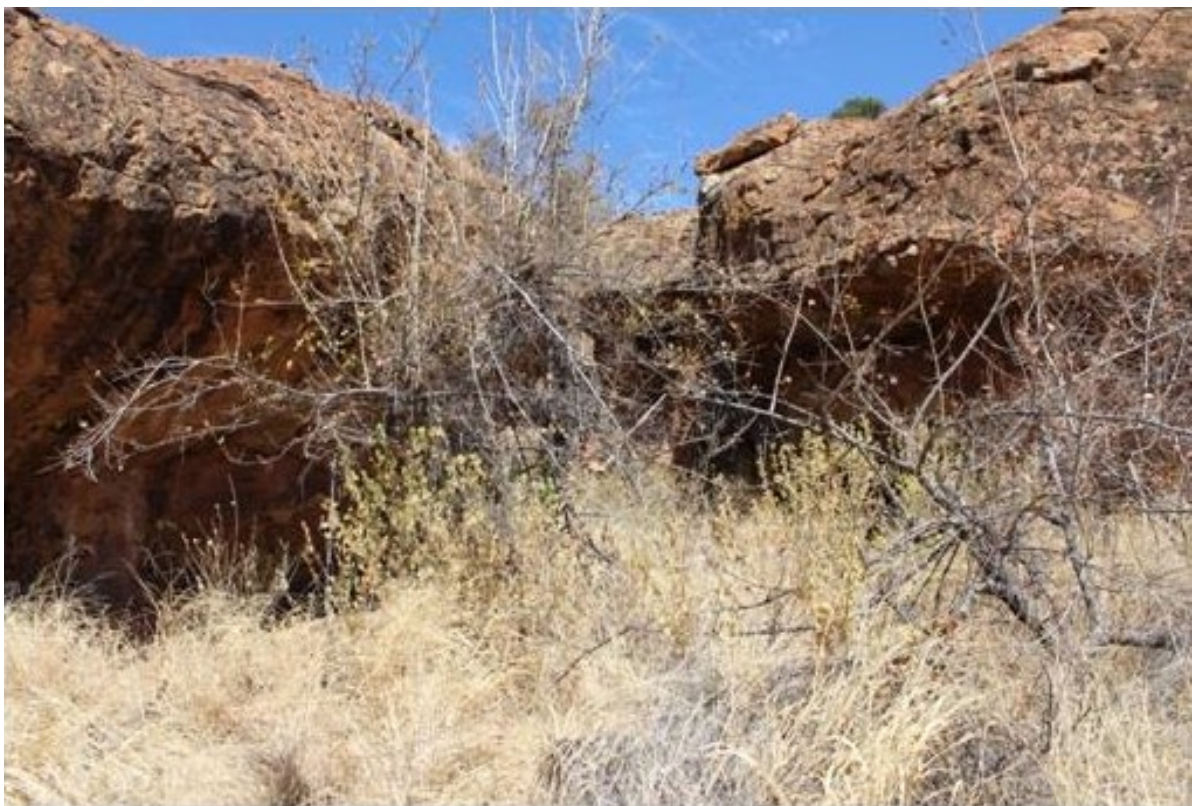
These two sites are geographically located nearby each other, separated by a space of about 3 metres, and face each other (Figure 5). Like Battis I, they are all named after Walter Whall Battiss (1906-1982). He was one of the most famous South African artists with a keen interest in southern African rock art. Both these sites have been affected by the challenge of elephants. Evidence of their presence was found from dung and sandy patches where elephants had been laying on the ground. There is a far greater threat from elephants at these two sites than was identified to be the case at Dyambila (Jambila). Noting the closeness of these sites to each other, the idea is to block elephants from both ends.

Figure 5: The two rock art sites, Battis II and Battis II faces each other.

- i. To protect the evident archaeological deposit of the site, lay the geotextile and soil covering the whole surface in front of both sites. This intervention will help to lessen the dust factor. No change of an existing surface will be done prior to laying the geotextile. The proposed geotextile and soil cover should cover the full area underneath the water dropline. In addition, it is recommended that polymer is applied on the ‘new

soil cover' to bind the particles together, thus further assisting in curbing erosion and significantly lowering dust levels (Teo *et al.* 2001; Yakupoglu *et al.* 2019).

- ii. There are two entrances, on either end of the sites, used by elephants to access them. It will be an important measure to block both these access routes. As a measure to deal with the elephant threat, it is recommended that the floor area between the sites is cobbled. In cobbling this specific area, it is important to note that the natural shrubs of mopani would not to be interfered with.
- iii. No plants should be up-rooted nor boulders moved. The natural look of the area in front of the sites and the surrounding landscape should thus stay as it currently is.

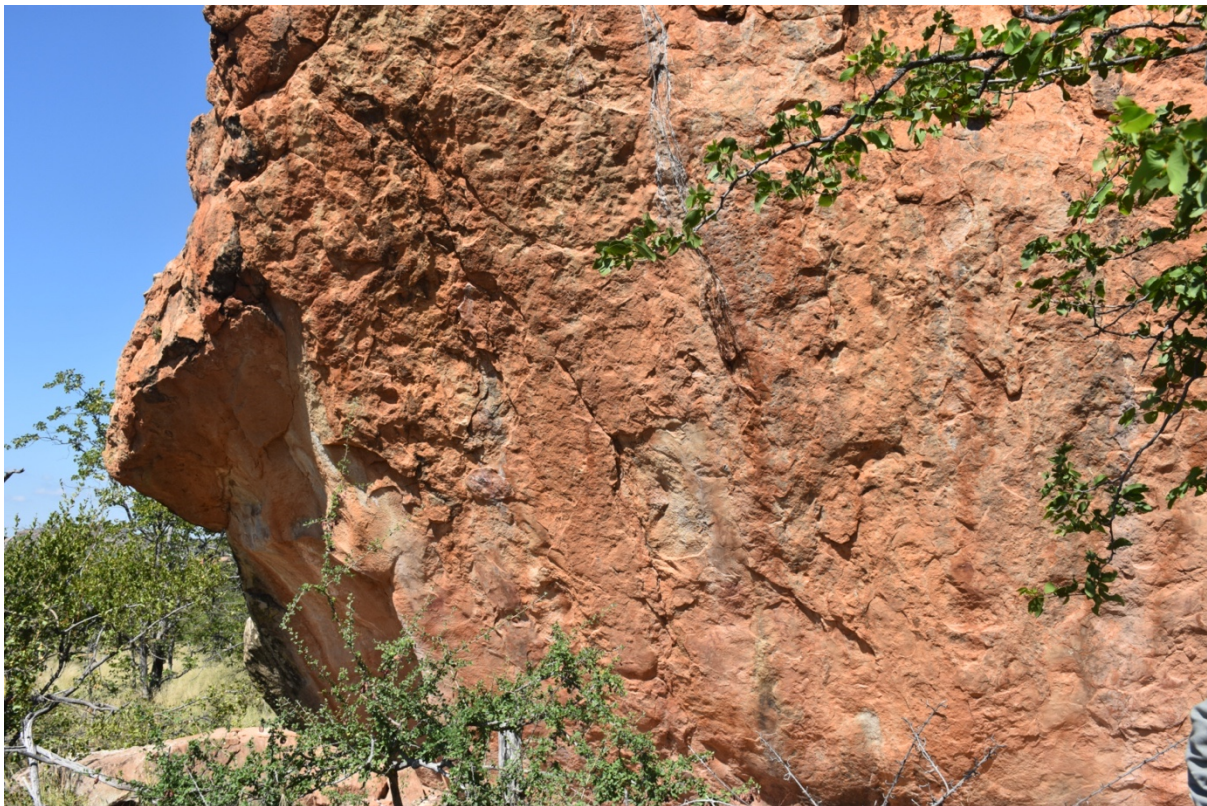
More an overhang rather than a rock shelter (figure 8), Aardvark Rock is about 13m long, 2.5m deep, and has a height of 5m. While the approved Mapungubwe Cultural Management Plan provides a list of a number of images at this specific site, not much rock art is clearly visible, particularly to the untrained eye. As a result, Aardvark Rock may not be among those sites that leaves significant impression to visitors. The aardvark, after which the site is named, is the biggest attraction (figure 9). It is not an animal that dominates the painted or engraved rock art imagery, whether in South Africa or other southern African countries with rock art.

Because of the nature of the site, being an overhang, rock art images at Aardvark Rock are not well protected from the water surface run-off. This may be one of the greatest natural threats to the images, leading to most of them fading as a result of their exposure to various elements. Elephants also visit the site, adding to the other potential threats to rock art. Other than animals, and from an anthropogenic point of view, there is evidence for human destruction of the site. This has led to the presence of one graffiti dated 1966 at the boulder which probably fell from the main one housing rock art images within this site (figure 10).

Figure 8: The boulders housing the paintings at Aardvark Rock.

- i. Besides rock art, the site is further defined by an archaeological deposit of the site. To protect this deposit, it is thus recommended that the geotextile and soil is used to cover the front of the site (about 3m from the back of the rockface with rock art). This intervention will help to lessen the dust factor. No change of an existing surface will be done prior to laying the geotextile. In addition, it is recommended that polymer is applied on the ‘new soil cover’ to bind the particles together, thus further assisting in curbing erosion and significantly lowering dust levels (Teo *et al.* 2001; Yakupoglu *et al.* 2019).

- ii. To address the issue of elephants, it is recommended that the floor area few metres away from the rockface with the paintings are cobbled. In cobbling the surrounding of the site with cobble stones, the natural shrubs of mopani and boulders to the extreme left of the site are not to be interfered with.

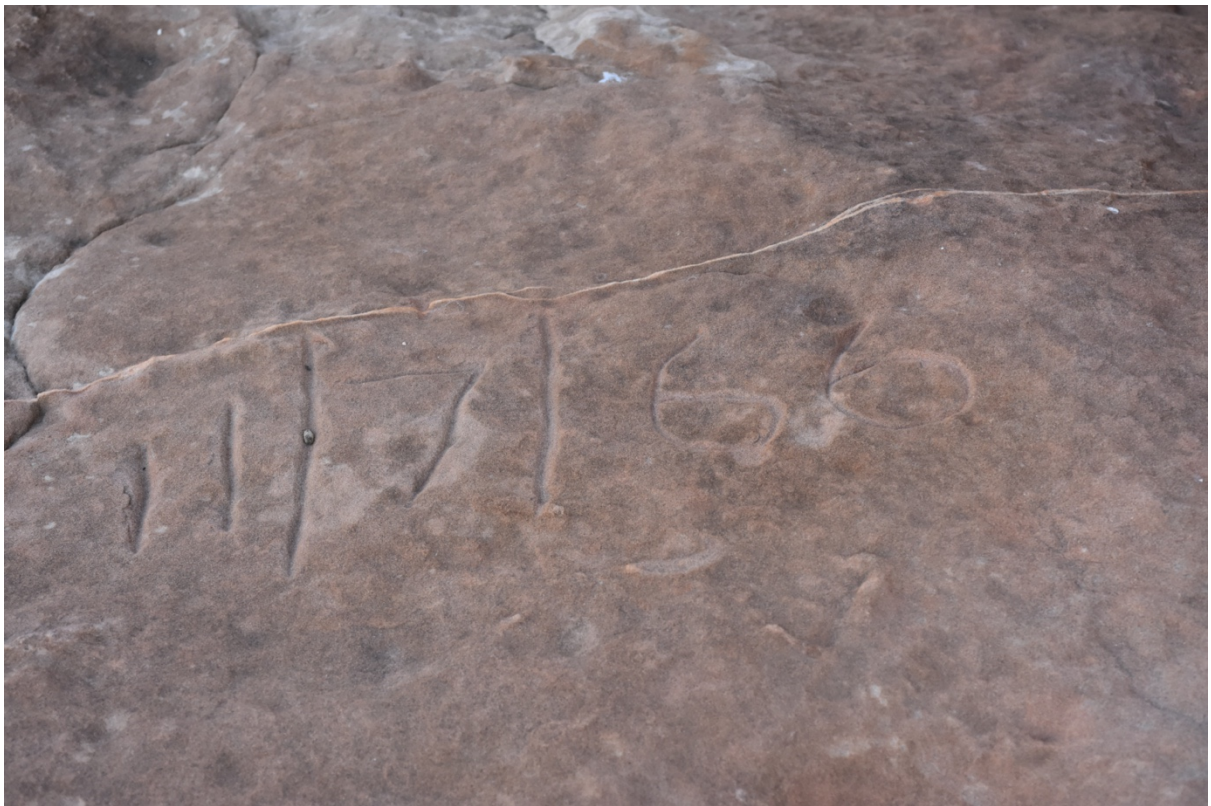
Figure 10: The one recorded graffiti, with a date of 11 July 1966.

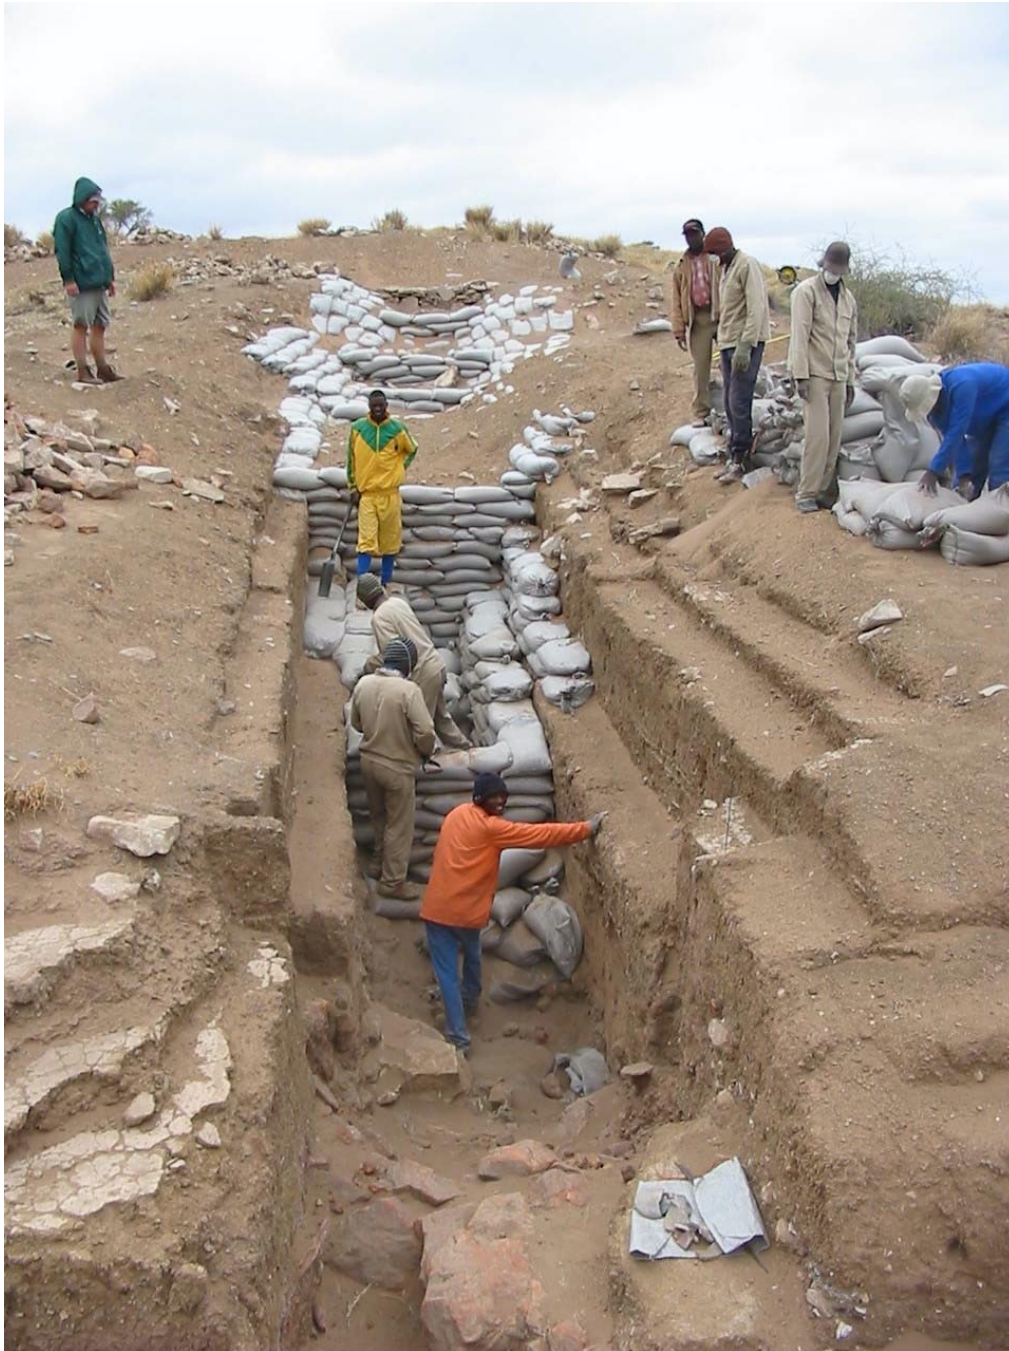
Various interventions undertaken to rehabilitate and stabilise the two important sites have made an important contribution to helping the management authority for the World Heritage Site to adequately safeguard the integrity and authenticity of the landscape. For example, a November 2005 report was authored by Coen Nienaber and titled “*Rehabilitation and stabilization of old excavation trenches and erosion damage at Mapungubwe, K2, Schroda and Little Much*”. It was after the review of this report by SAHRA (Case ID: 3260) that an archaeological permit (Permit ID: 586) for the necessary interventions were made (figure 11). This archaeological permit was for one calendar year (31 January 2006 to 01 February 2007).

Figure 11: The sandbags being used to stabilise excavated walls.

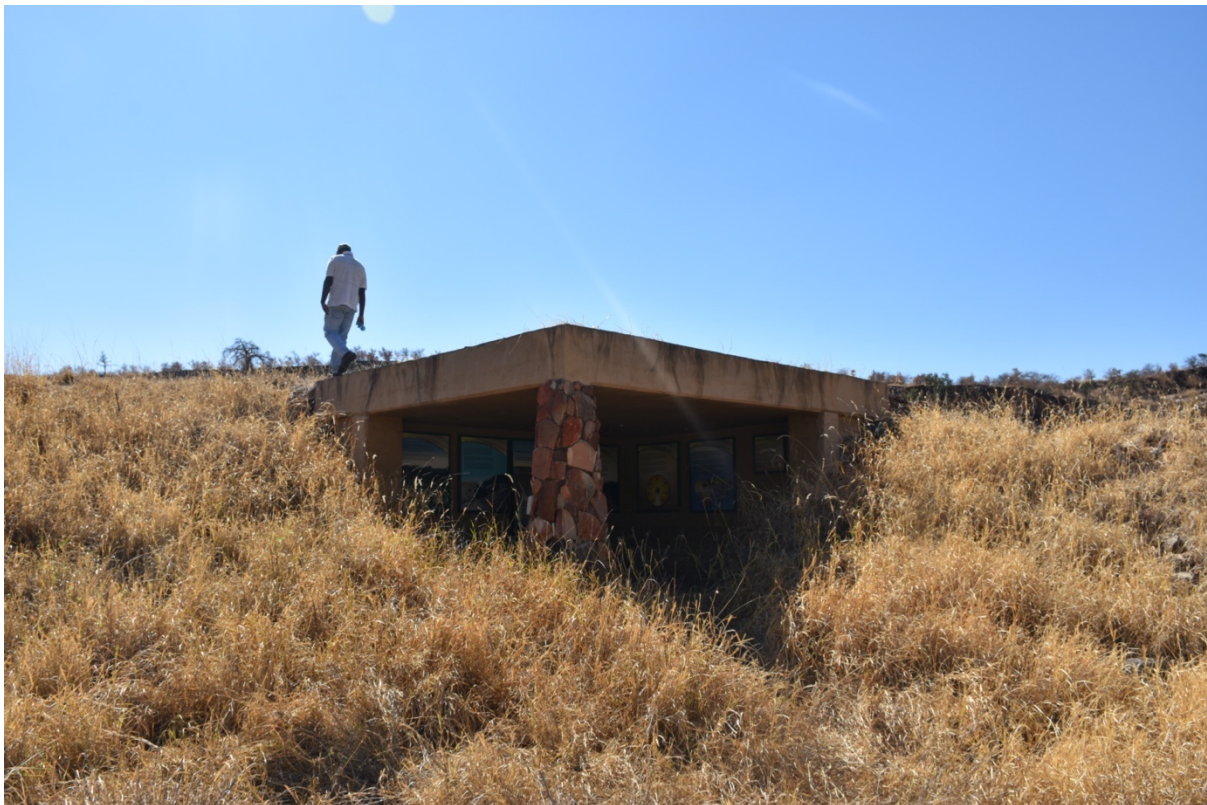
Figure 12: The view of the display at K2.

Early excavations at K2 dates back to the 1930s (see figures 12 and 13). Important insights into the occupation of the area during the Iron Age has been gained from the many excavations at K2 and other archaeological sites in the vicinity (Antonites 2016). At the time, these K2 excavations were left open, with the sites not properly stabilised nor were the sections properly recorded (Huffman & Murimbika 2001). To address these conservation challenges, and also per recommendations of the Archaeology Action Group that led efforts to have Mapungubwe inscribed into the World Heritage List, rehabilitation programme was undertaken between July and November 2001 (Permit ID: 80/01/01/002/51). After these rehabilitation interventions, the old excavations walls were exposed in order for them to be drawn, and thus properly recorded. These efforts did not address the large central midden. Following the process to properly record the walls that were previously unrecorded during the 1930s excavations, they had to be secured to ensure their conservation over a long term.

#### RECOMMENDED INTERVENTIONS

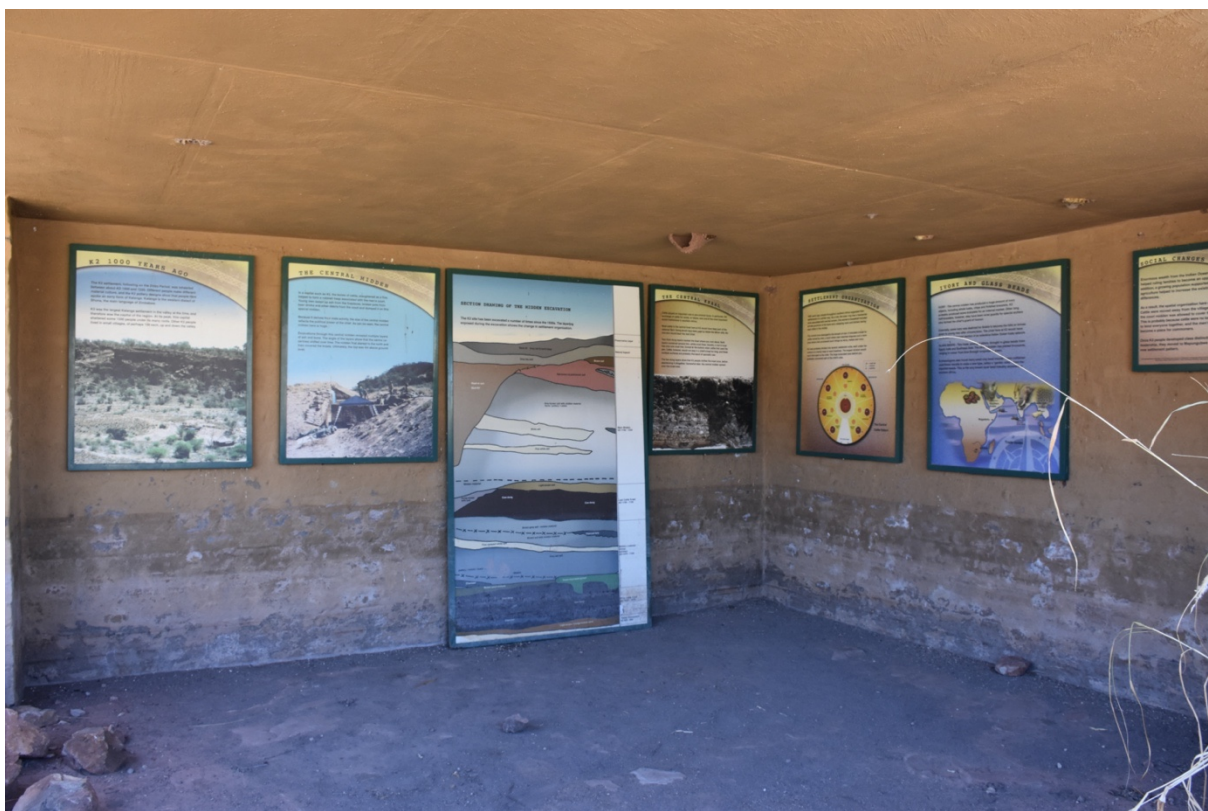
Figure 13: The display at K2, giving insightful details about social relations dating back to the Iron Age.

Sifted soil from the old archaeological dumps was placed in bio-degradable sandbags that were then used as a protective frame against the exposed walls. The use of these sandbags subsequently extended the excavation walls out a few metres to adequately safeguard them. As

a result, it should be known that none of the artefacts and bone evident in this area are in the appropriate archaeological context. As such, they are not *in situ*. The bio-degradable bags were thus meant to disintegrate over time, forming a base for grass seeds (palatable grass *Cenchrus ciliaris*) and succulent tree *Euphorbia cooperi* that were planted to help prevent soil erosion (see Gotze *et al.* 2008 on dominant plant species in the area). Some of the palatable grass grew in wet years, but the desired vegetation cover was not possible, presumably due to limited availability of water during the winter months. With the considerable failure of the grass, soil erosion has become intensified over the recent past and necessary interventions must be undertaken.
