**Heritage Impact Assessment of the SANBI KZN Herbarium,
Durban Botanic Gardens, 4 Problem Mkhize Road**

**Prepared for: Futureworks Sustainability Consulting (Pty.) Ltd
PO Box 2221
Everton
3625
KwaZulu-Natal
July 2014**

Heritage Impact Assessment of the SANBI KZN Herbarium, Durban Botanic Gardens, 4 Problem Mkhize Road

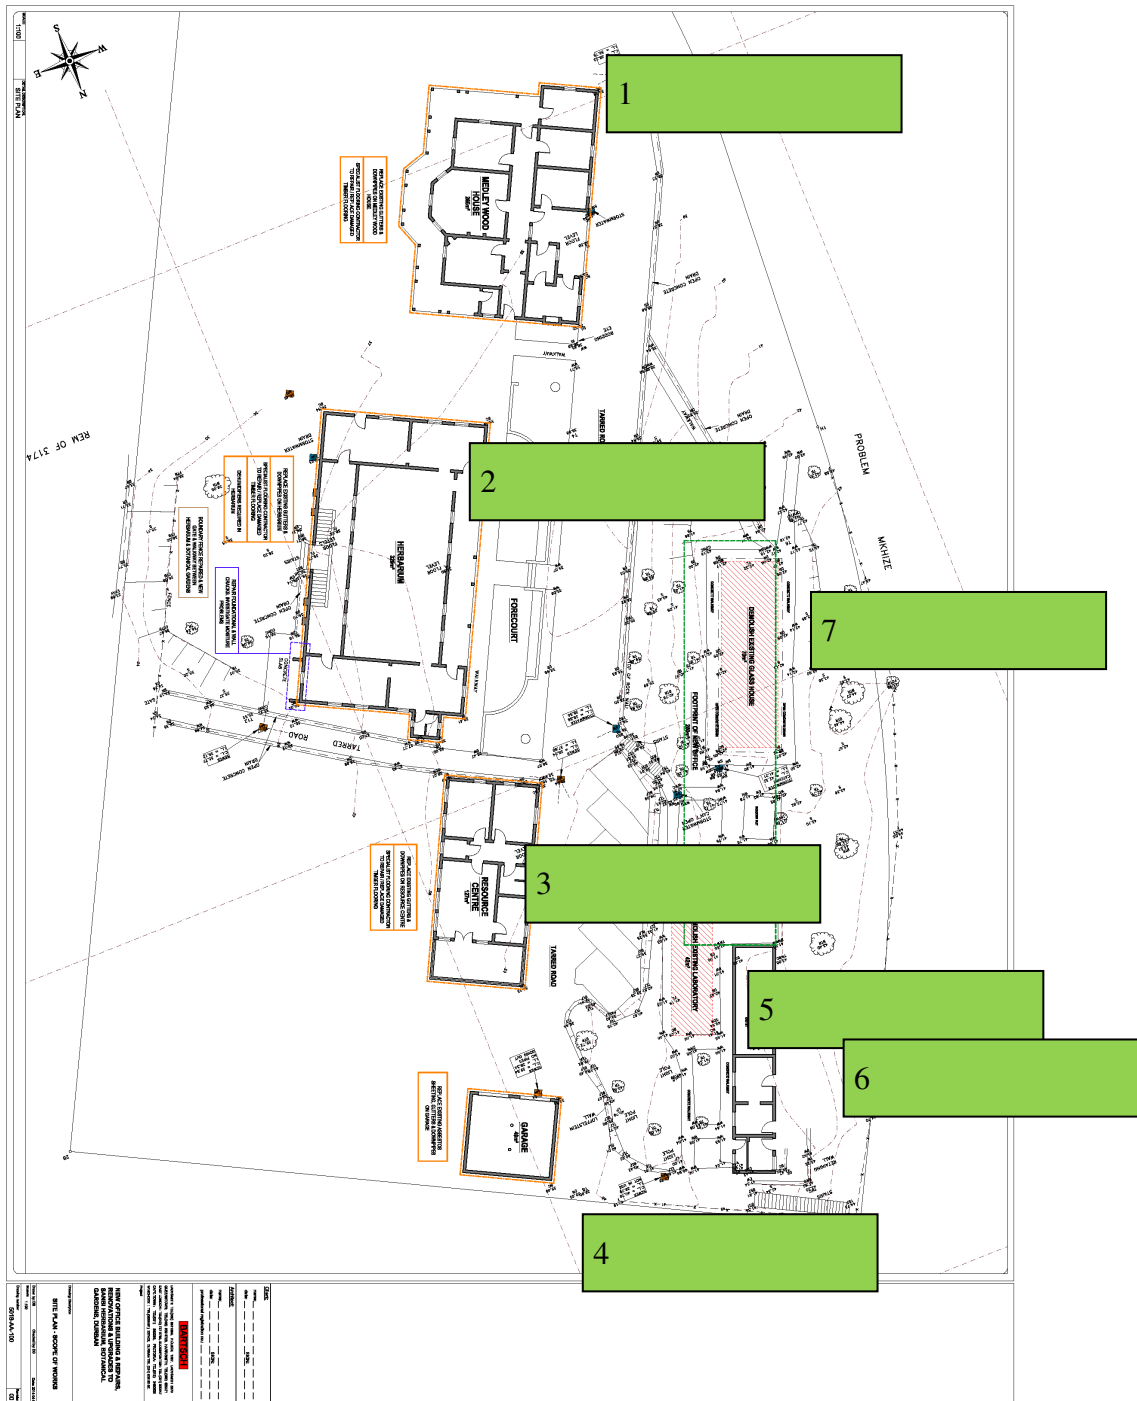
Fig 1: Schematic layout of the site illustrating Medley Wood House (1) the Herbarium (2), Resource Centre (3), Garage (4), Existing Laboratory (5), Umdoni Block (6), and the existing Glasshouse (7) all situated at the Durban Botanic Gardens.

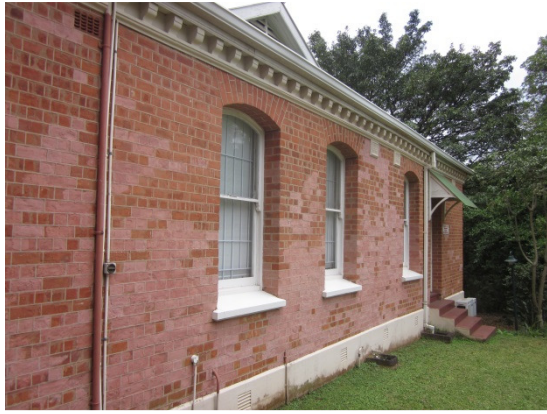
It is constructed of red face - brick in English Bond, many bricks of which have been badly repaired with which compromises the integrity of the building. The pointing is raised.

Fig 19: Southern elevation showing patched brick

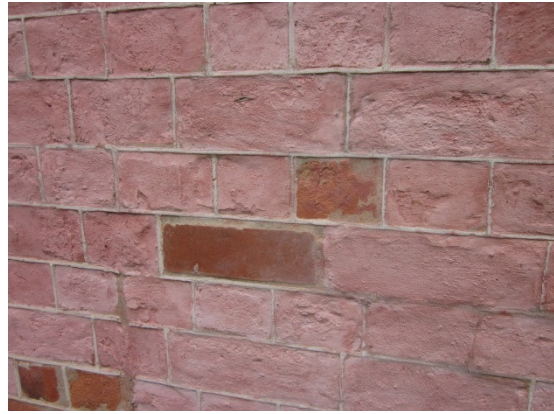
Fig 20: Badly patched brickwork

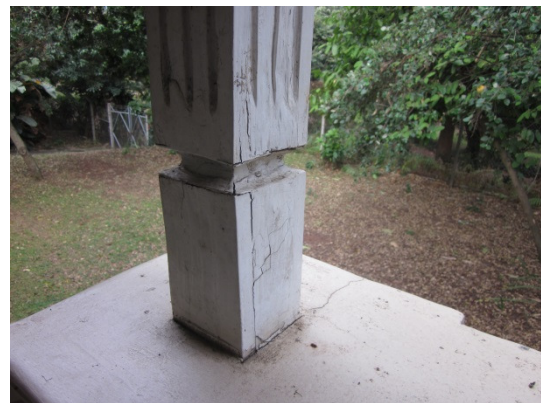
Fig 26: Water damage to timber posts

- Importantly, the very serious issue of the rotting timber posts to the eastern veranda wall will also have to be assertively addressed: the option of assessment of extent, replacement, splicing, contractors available are all issues that will have to be carefully detailed and be thoroughly investigated in liaison with professionals at Amafa.

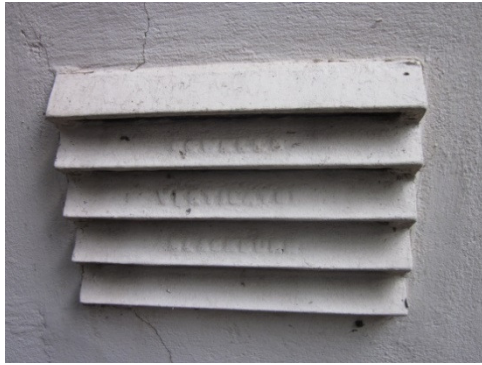
Fig 27: Cast iron ventilator

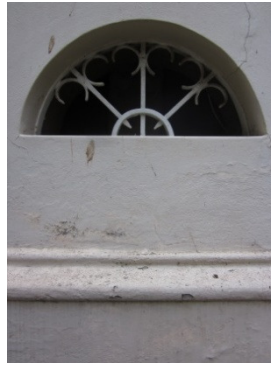
Fig 28: Detail of ventilation guard

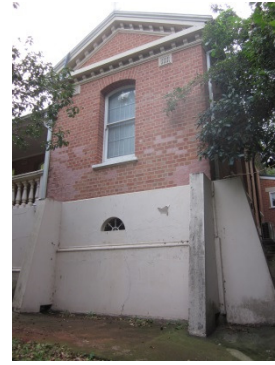
Fig 29: Buttresses

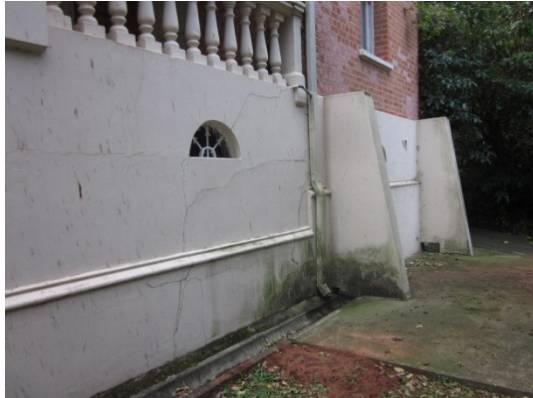
Fig 30: Eastern elevation showing water damage.

The document provided to Archaic Consulting notes briefly what the intentions are regarding repairs to the buildings on site. These generally tend to be 'replace gutters and downpipes' and 'specialist flooring contractor to repair floors'. There is also a note regarding sorting out the water problems on the eastern façade of the Herbarium.

- The replacement of gutters and downpipes has to be detailed and itemized: correct and appropriate materials have to be chosen, and these decisions submitted to Amafa for approval.
- The nature, extent and manner of timber floor repairs will also have to be detailed, itemised and assessed in liaison with professionals at Amafa.
- The process by which the water issues on the eastern façade of the Herbarium are to be addressed, ie stripping plaster, drying, excavating, installing correct slotted

drainage etc would also have to be thoroughly investigated and in liaison with professionals at Amafa.

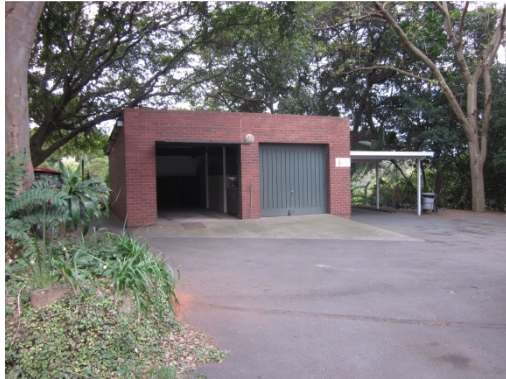
This building is a double carport situated on the extreme north of the site. It is a modest, utilitarian building constructed of facebrick under fibre cement sheeting with no architectural value, and no value from any other perspective. The building is in excellent condition.

Fig 37: The Garage

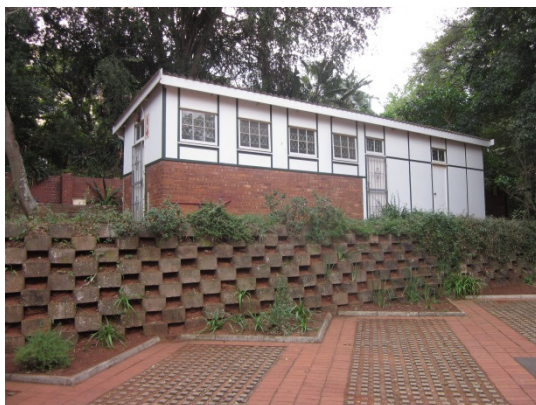
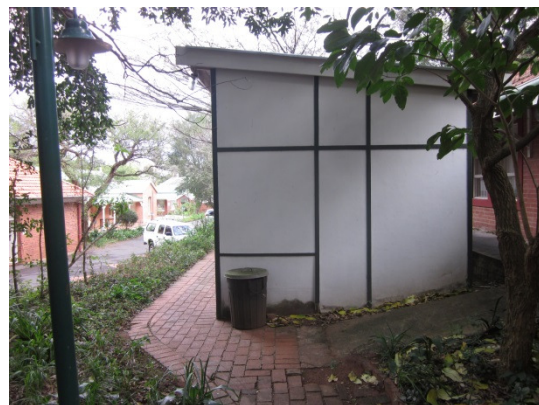
This is a small, prefabricated building of asbestos sheeting, of indeterminate age, situated on top of the higher terrace. It has little architectural value, and, certainly, given its material construction, its retention is problematic from the perspective of Health and Safety.

This Laboratory consists of a number of different materials in its construction. A one metre high stretcher - bond brickwork base exists to part of it, whilst the balance consists of panels of asbestos sheeting. The scale of the doors and windows is reduced and shows top-hung windows and a standard 900x2100mm timber door. It has little to no heritage value.

Fig 38: The laboratory from the east

Fig 39: The laboratory from the north

This building has no significance to support its retention and it is recommended that demolition, should it be sought, can be condoned.

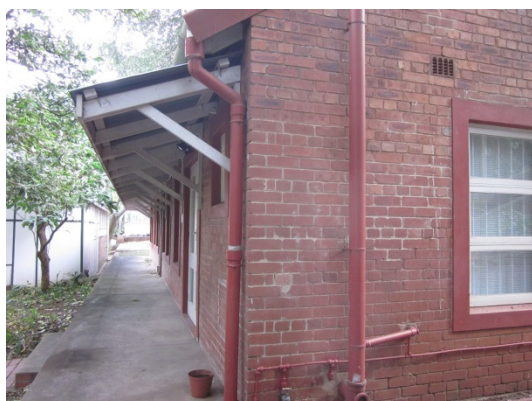
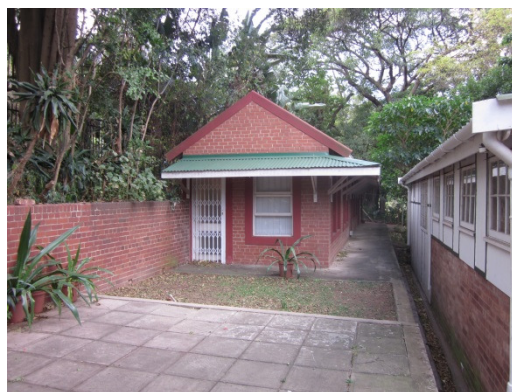
This is a long, narrow building on the top terrace. Its core section, to the northern end, is the older part, which has latterly been extended along the terrace with a structure of similar form and proportion. It is hidden right along the boundary and is not very visible from the main part of the site.

It has little architectural value, although the original section is potentially historic. However, given the scale and proportions of the space, this is dubitable, and the suspicion is that antiquated methods of brick construction were employed in a latter day building.

Fig 40: Building from the north

Fig 41: Umdoni Block from the south

This building has no significance to support its retention and it is recommended that demolition, should it be sought, can be condoned.

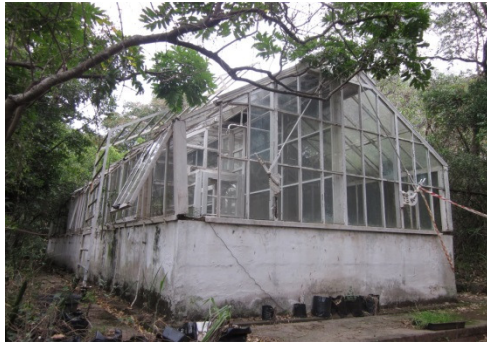
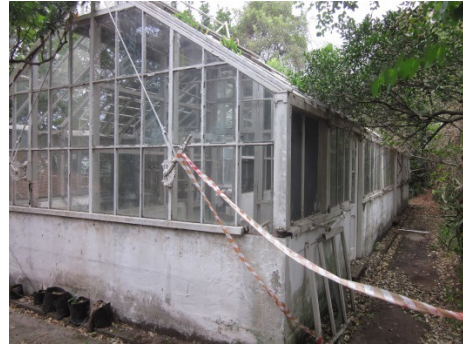
This structure is situated on the top terrace and as such is largely obscured from the main part of the site. It is a late Victorian structure, with a substantial lower section of plastered and painted masonry, then topped with a lighter weight structure of timber glazed sections, operated in places by cast iron prefabricated elements to open and close the glasshouse.

It is in bad condition, and demolition has been approved by Amafa, on condition that the Cast – iron sections be delivered to the Amafa Materials Bank after demolition for safe keeping.

Figs 42 & 43: The condemned glasshouse

- ***That, as per permit, the Glasshouse be demolished and the cast iron operating elements be lodged in the Amafa Built Environment Materials bank.***

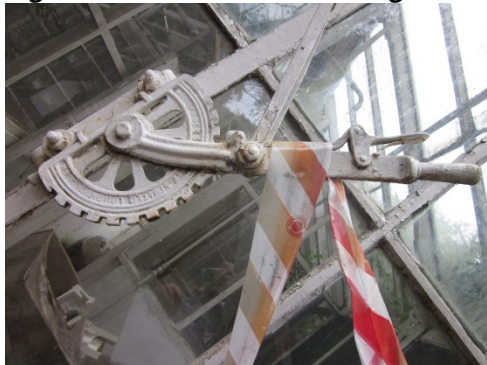
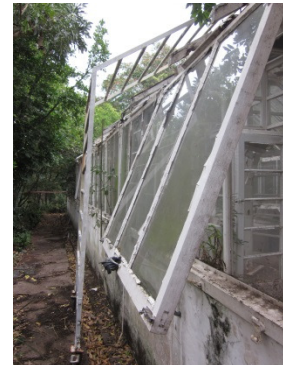
Figs 44 & 45: Industrial elements of the glasshouse

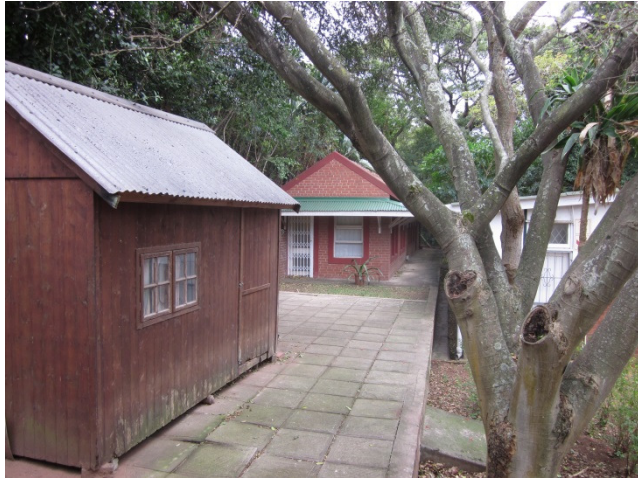
This is a commonplace 'Wendy House' constructed of timber. It has no heritage value.

Fig 46 : The Shed
