Sasol Sigma Mooikraal 7Me Pipeline

Heritage Watching Brief Report

Report Type:	Heritage Watching Brief Report
Project Name:	Sasol Sigma Mooikraal 7Mℓ Pipeline
Project Code:	SAS3432

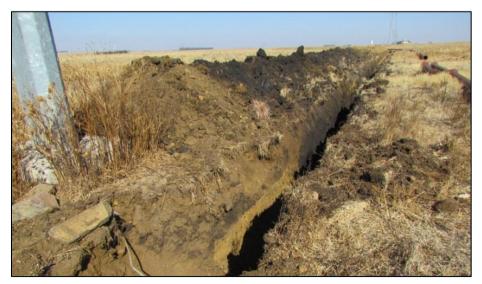
Figure 4-1: Section of dark clay

The top layer of soil excavated was dark brown black clay. At a depth of approximately 50 cm, the soil became a yellow brown colour (See Figure 4-1). At a few points along the excavated pipeline, the dark clay was deeper than 50 cm, and sometimes extended the full 1.2 m required depth. A small section of sandstone or sedimentary rock was excavated in the first week as shown in Figure 4-2. This sedimentary rock was inspected periodically for palaeontological material. No palaeontological resources were identified from this section of sandstone.

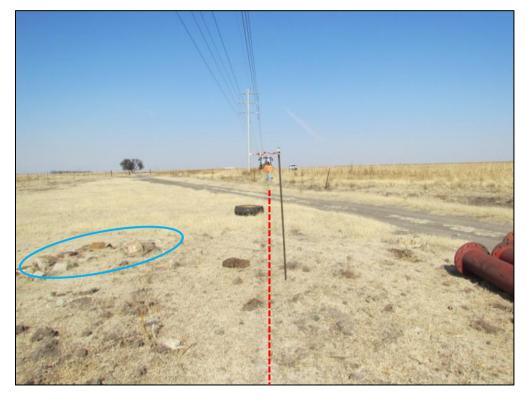
Figure 4-3: Sandstone foundation within pipeline route (red) before excavation. Note the location of the walls that will be temporarily buried (blue)

The first structure was a rectangular stone foundation measuring 9 m x 8 m. The pipeline route was excavated through the centre of the foundation on the northern end as shown in Figure 4-3 and Figure 4-4. The pipeline route exited the foundation near the north-western corner as shown in Figure 4-5 below.

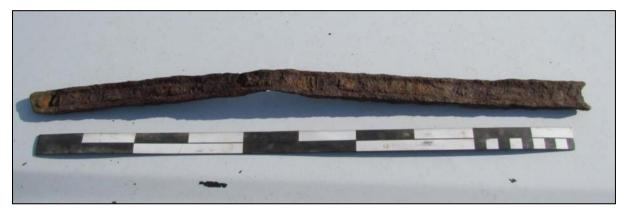
Figure 4-7: Metal fence dropper uncovered from the first foundation

Two metal items were uncovered at a depth of 20 cm within the first foundation. The first piece was a curved metal fragment, pointed at both ends, approximately5 mm thick (See Figure 4-6). This may have been part of a previous fence. The second metal artefact was a flat metal bar measuring 50 cm long with raised ridges on either side of the bar, and three holes along its length (See Figure 4-7). It appears to be a fence dropper. Both of these artefacts are of negligible significance. This significance rating was assigned using the cultural significance methodology in Appendix B and considering the negligible significance rating of the historical werf (See Section 5 below). The artefacts were rated against criteria such as historical and scientific significance.

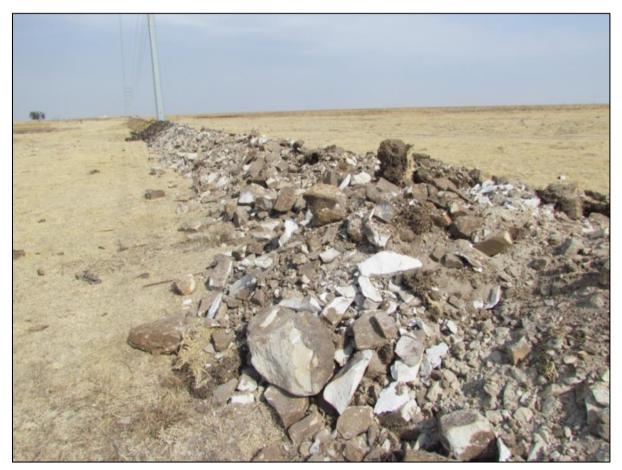
Figure 4-8: Sandstone inspected during the week

Sandstone was excavated from a section of the pipeline route measuring 20 m in length at a depth ranging between 20 cm and 1.2 m below the surface as shown in Figure 4-8. The sandstone was inspected periodically for palaeontological material. No palaeontological resources were identified from this section of sandstone.

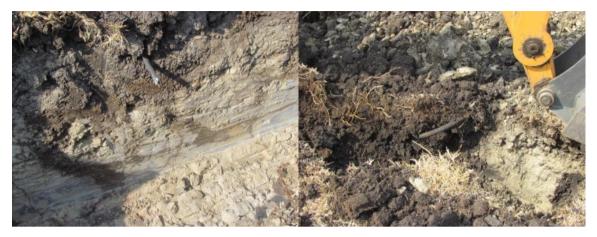
Figure 4-9: Electrical and plastic pipes uncovered by the excavator

The TLB uncovered several metal pipes, plastic pipes and electrical wirings that were connected to the historical werf as seen in Figure 4-9 below.

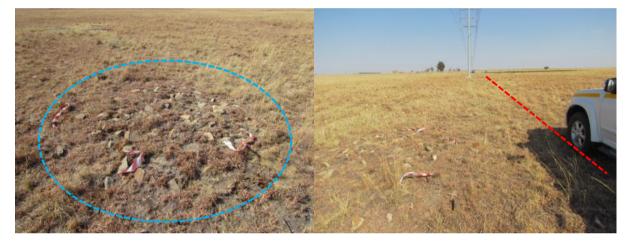
Figure 4-13: Circular stone foundation (blue) and location in relation to pipeline route (red)

A screening walk down was completed for the route to be covered during the second half of week 2 and the section to be covered in week 3. Approximately 500 m of the pipeline route would be excavated without on-site monitoring. This section of the pipeline route was located in unaltered grazing land, running along the existing power line servitude. A circular stone foundation was noted approximately 2 m from the pipeline route as shown in Figure 4-13 below. This foundation was marked with danger tape and the on-site contractors were been informed of its location. The foundation was not to be disturbed by the excavated material to minimise the potential of accidental damage during the backfilling process.

- When backfilling the excavated soil in the vicinity of the historical werf (Wf-001), the contractor must ensure that the TLB does not excavate deeper than the original surface to safeguard against additional impact to the werf;
- Additional care should be taken when backfilling soil around the circular stone foundation (Ste-002) to ensure it is not disturbed in any way.

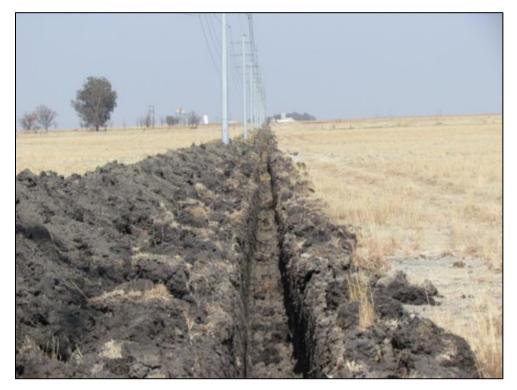
Figure 4-14: Dark clay soil excavated during week 3

The majority of the soil excavated during the third week was a dark grey colour (See Figure 4-14. It was noted that the colour of the soil around the power line pylons was an orange brown colour as shown in Figure 4-15. The soil used to stabilize the foundations of the pylons was sourced from an area to the north of the pipeline route as shown in Figure 4-16. No Chance Finds were identified during week 3.

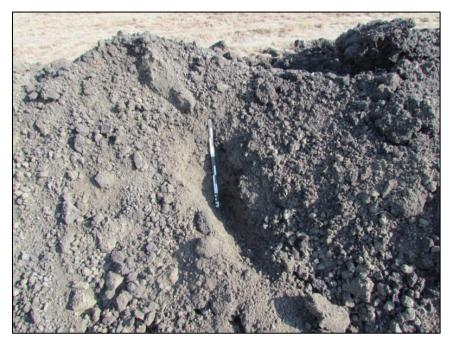
Figure 4-17: Example of the test pit in the spoil heap

The spoil heap of the section of pipeline excavated without on-site monitoring was inspected for deposit and chance finds. A test pit was dug every 100 m within the spoil heap and no chance finds or deposit was identified (See Figure 4-17).

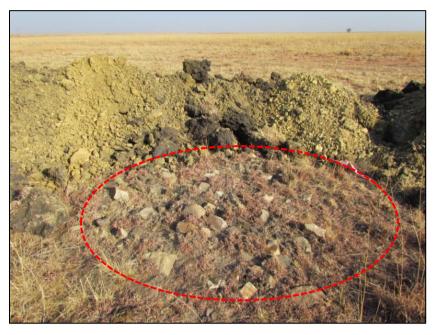
Figure 4-18: Circular stone foundation adjacent spoil heap

The circular stone foundation identified during week 2 screening walk-down was inspected to ensure it had not been disturbed. The foundation had been avoided during the excavation process and had not been covered by the excavated material as shown in Figure 4-18.

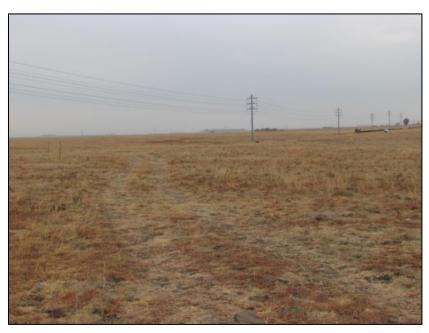
Figure 4-19: Final segment of the pipeline route through grazing land

A screening walk down was completed for the route to be covered during the second half of week 3. Approximately 400 m of the pipeline route would be excavated without on-site monitoring occurring. This section of the pipeline route is located in unaltered grazing land, running along the existing power line and into the mine property as shown in Figure 4-19 and Figure 4-20.
