HERITAGE IMPACT ASSESSMENT

Proposed development of SBPM solar PV and battery storage facility near Northam in the Limpopo and North West Provinces

Prepared by CTS Heritage

June 2021

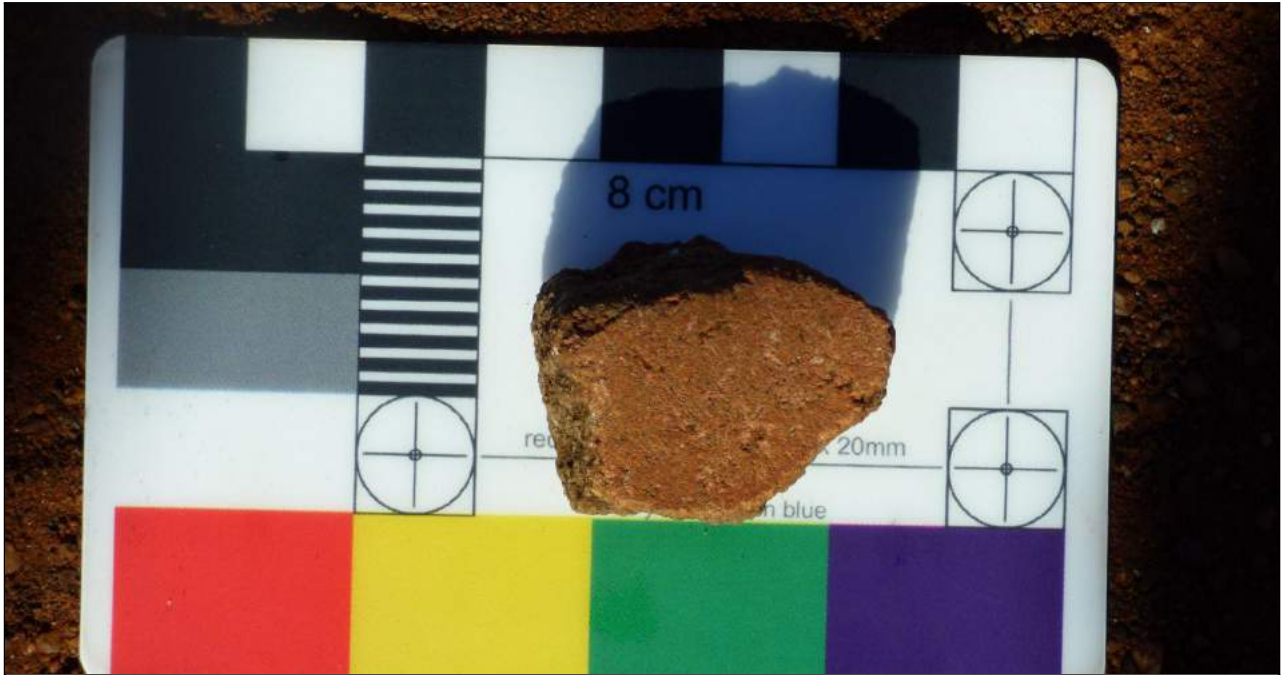
Figure 6.1: WP001

| Site No. | Project Name | Description | Co-ordinates | | Grading | Mitigation |
|---|---|--|---|---|---|---|
| WP001 | SCSC PV 1 | Isolated surface artefact. Low-fired ceramic undecorated sherd. This artefact was found in alluvial deposit with no archaeological context | 24°56'12.18"S | 27°12'46.12"E | NCW | NA |

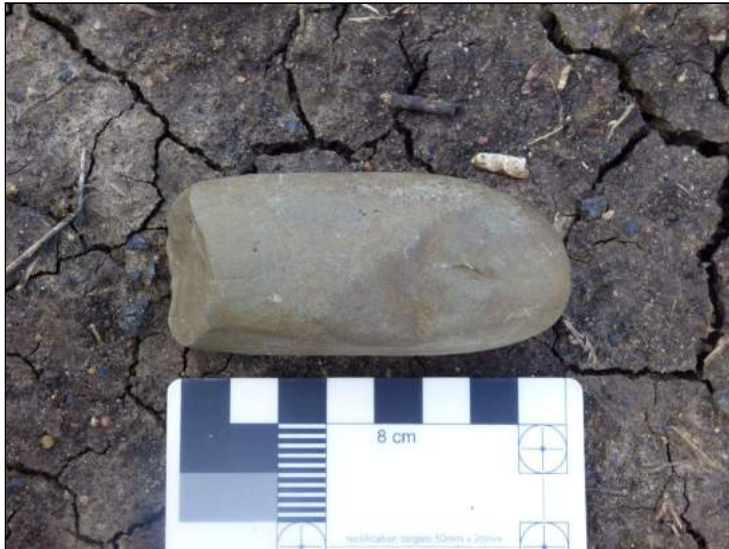
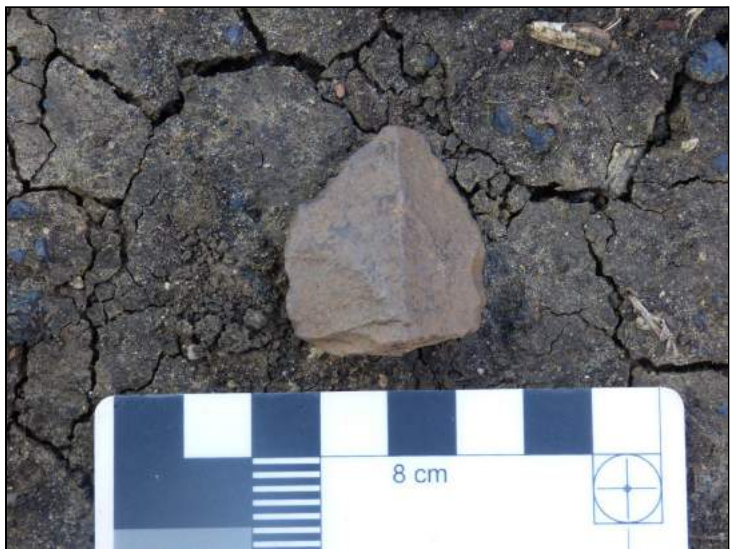
Figure 6.2: WP002

| POINT ID | Site Name | Description | Co-ordinates | | Grading | Mitigation |
|---|---|--|---|---|---|---|
| WP002 | SBPM PV 2 | Isolated surface scatter, no archaeological context. Dolerite early LSA scraper, and single upper grindstone. | 24°56'1.84"S | 27°11'25.66"E | NCW | NA |

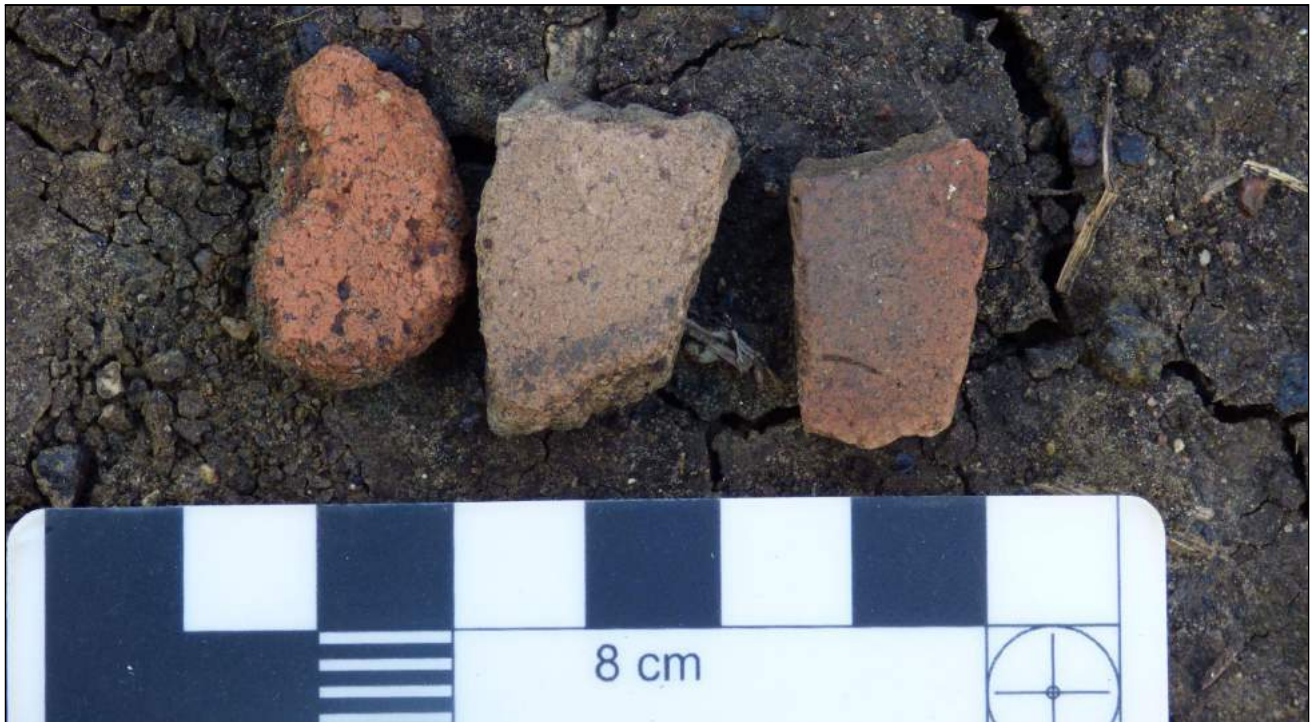
Figure 6.3: WP003

| POINT ID | Site Name | Description | Co-ordinates | | Grading | Mitigation |
|---|---|--|---|---|---|---|
| WP003 | SBPM PV 2 | Surface scatter of Low-fired ceramics, undecorated. No archaeological context. | 24°5'612.66"S | 27°11'36.36"E | NCW | NA |

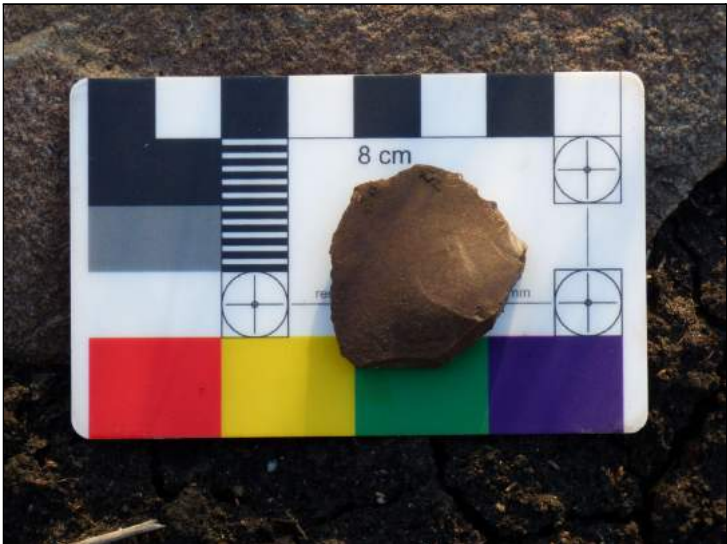
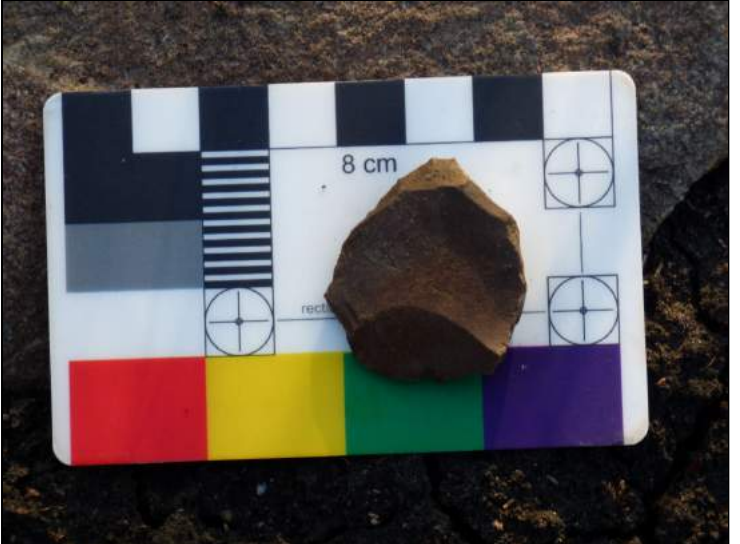
Figure 6.6 WP006

| Site No. | Project Name | Description | Co-ordinates | | Grading | Mitigation |
|---|---|--|---|---|---|---|
| WP006 | SBPM PV 2 | Dolerite MSA scraper and Low-fired ceramics, undecorated.. Isolated surface scatter. No archaeological context. Located in disturbed area next to the road with open, visible ground surface and loose stones on the surface. Stones have no noticeable pattern. | 24°56'19.63"S | 27°11'16.35"E | NCW | NA |

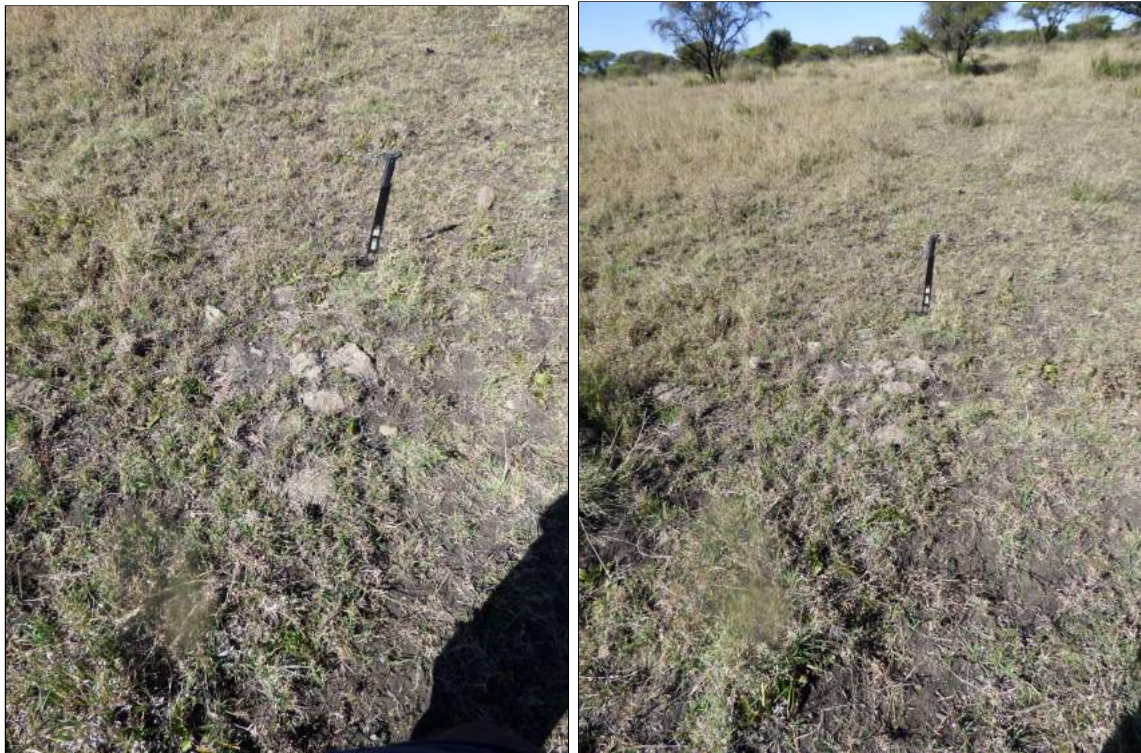
Figure 6.9 WP008

| Site No. | Project Name | Description | Co-ordinates | | Grading | Mitigation |
|---|---|--|---|---|---|---|
| WP008 | SBPM PV 2 | Few <i>in-situ</i> stones, possible fieldstone cairn, no head or footstones. Possible grave. Loose stones are scattered around these stones. With North-south orientation | 24°56'5.56"S | 27°10'55.78"E | IIIA | No development buffer of 50m |

| The area in which the possible graves are situated are highly sensitive. Ground-truthing with sub-surface survey or prospecting technology could establish whether these are indeed graves, whether unmarked graves are also present in the vicinity, and the extent of the graveyard. In the absence of sub-surface survey data, I recommend a NO-GO ZONE of at least a 50m radius from the graves. |

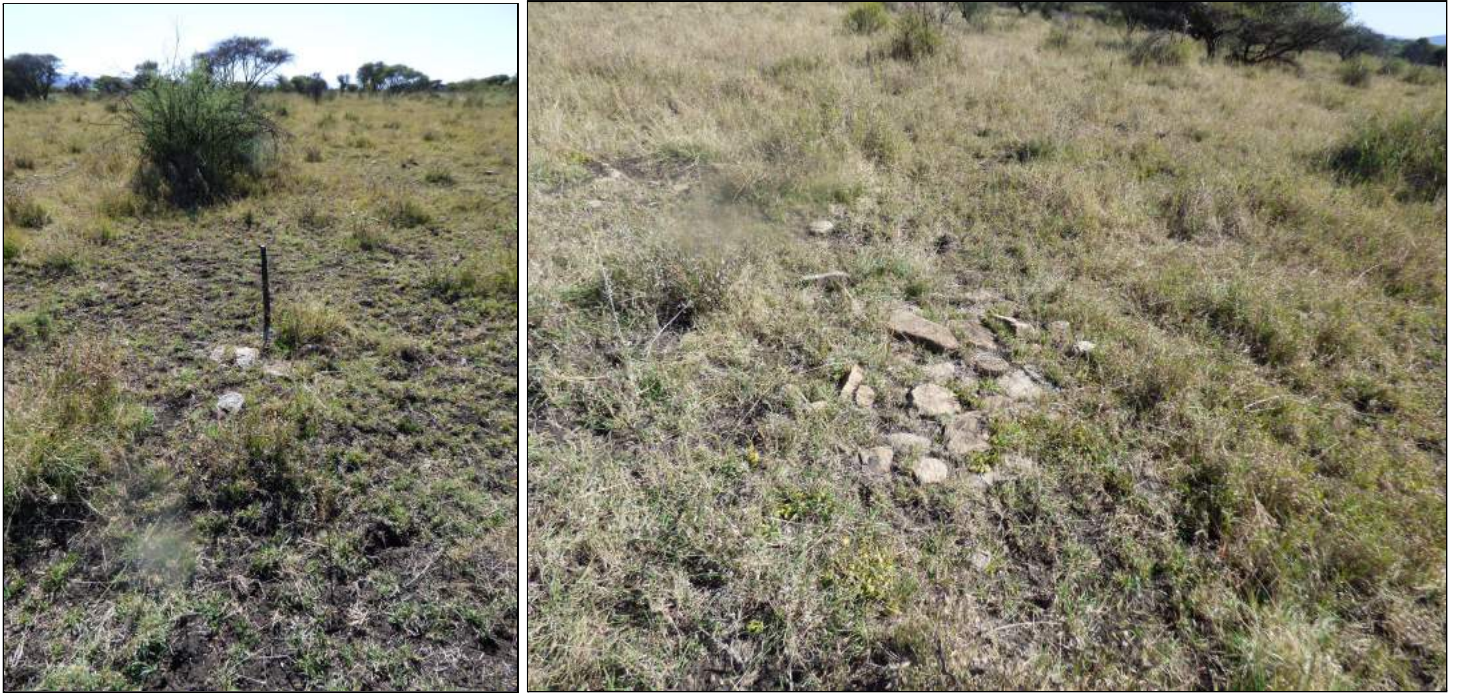
Figure 6.10 WP009

| Site No. | Project Name | Description | Co-ordinates | | Grading | Mitigation |
|---|---|--|---|---|---|---|
| WP009 | SBPM PV 2 | 2 Graves. Few <i>in-situ</i> stones, with a possible fieldstone cairn, no head or footstones. Possible graves. Loose stones are scattered around these stones Grave 1: 75cmx50cm Grave 2: 1x2m | 24°56'5.84"S | 27°10'55.61"E | IIIA | No development buffer of 50m |

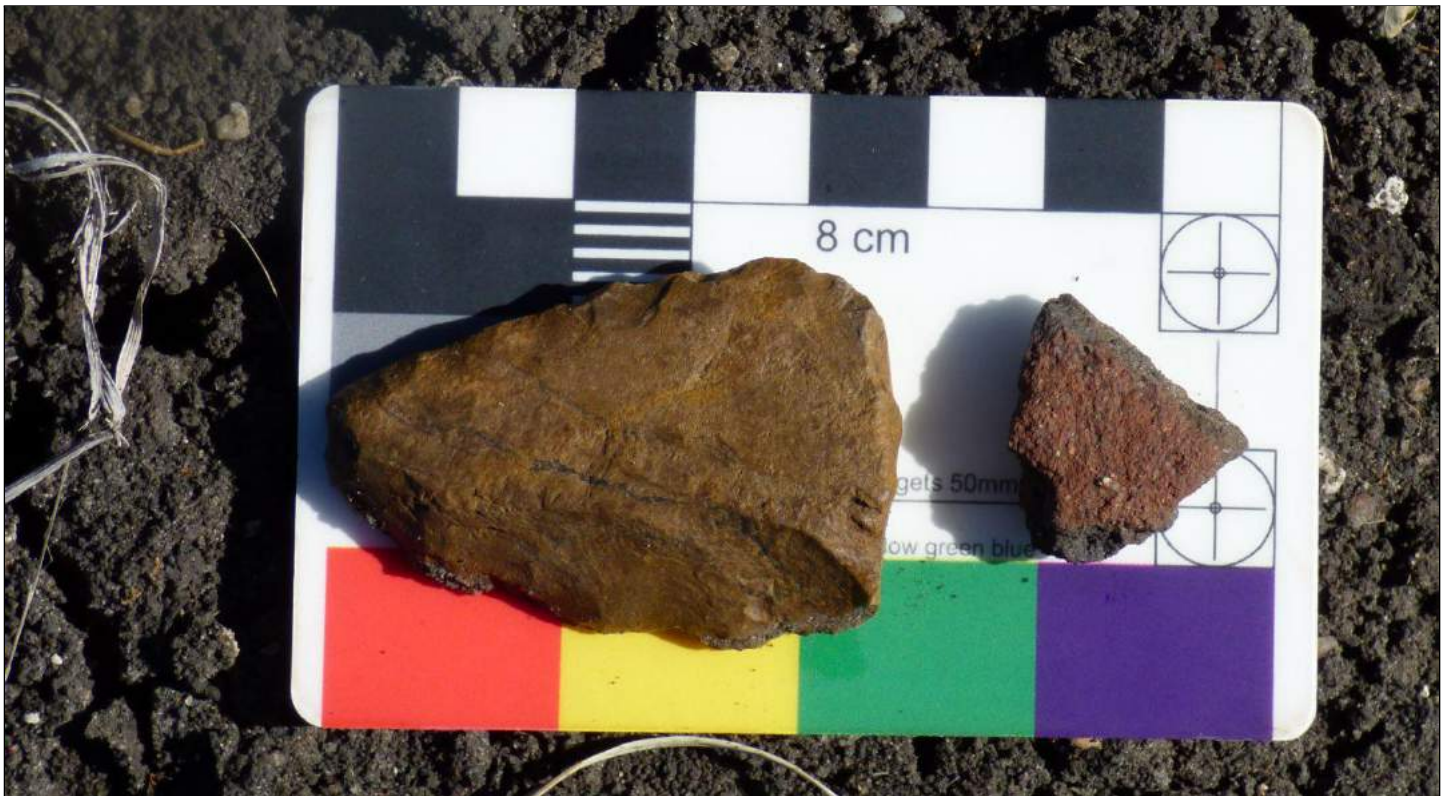
Figure 6.11 WP010

| POINT ID | Site Name | Description | Co-ordinates | | Grading | Mitigation |
|---|---|--|---|---|---|---|
| WP010 | SBPM PV 2 | Dolerite MSA scraper and Low-fired ceramics, undecorated. Isolated surface scatter. No archaeological context | 24°56'12.59"S | 27°10'53.24"E | NCW | NA |
