**Phase 1 Palaeontological Impact Assessment of Section 14
of the N1 National Road between the Trompsburg
interchange and Fonteintjie, Kapanong Local Municipality,
FS Province.**

Report prepared for:
SRK Consulting
Oakwood House, Palm Square,
Bonza Bay Rd, Beacon Bay,
East London
5241
eastlondon@srk.co.za

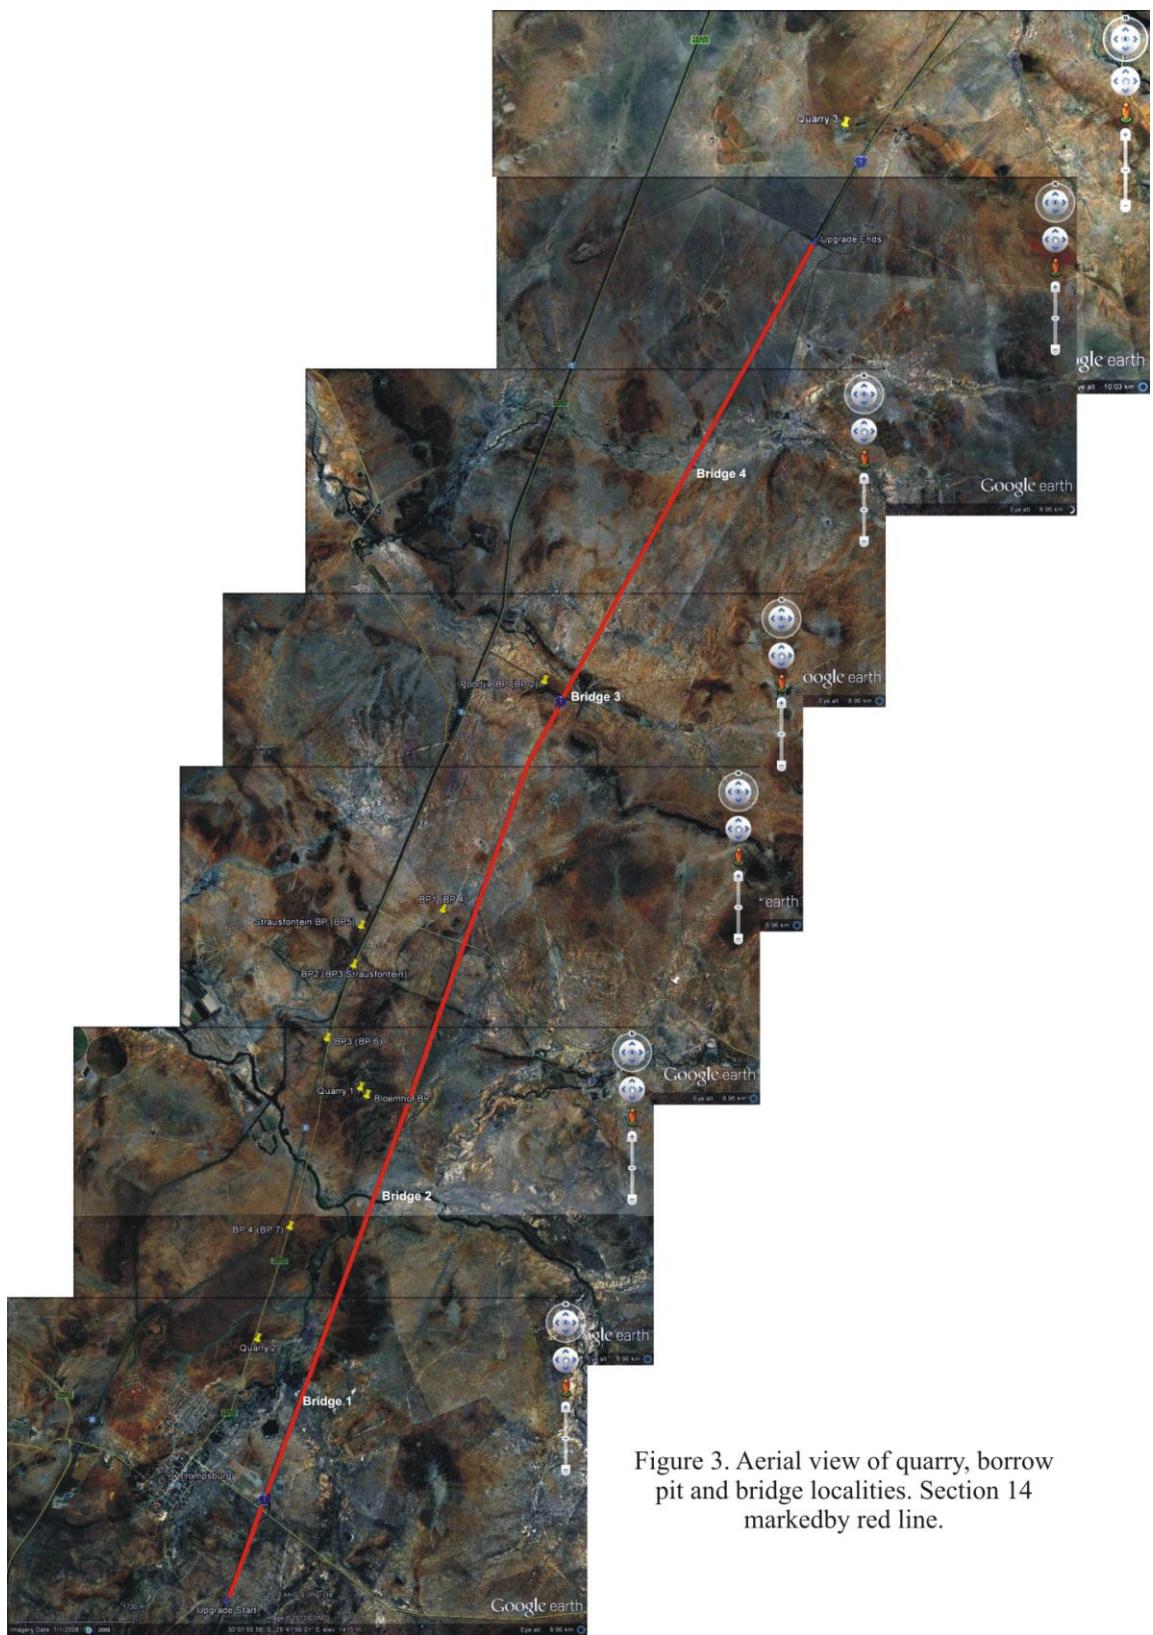
Figure 3. Aerial view of quarry, borrow pit and bridge localities. Section 14 marked by red line.

The project includes the proposed rehabilitation and widening of the N1 along the section (**Fig. 3**). The current road is a two-lane single carriageway with travel lanes of about 3.7m wide and 2.4m paved shoulders. The current carriageway is built on the right hand side of the road reserve which means that it will become the southbound carriageway in the future when the additional northbound carriageway lanes are built. The road section comprises 10 culverts and 4 bridges. **The main elements of the proposed development include replacement of the base and sub base layers as well as the seal of the road, widening of the road, widening, rehabilitation and/ or replacement of bridges and culverts, construction of a temporary detour alongside the entire section** to accommodate bi-directional traffic during construction, construction camp site and the **operation of several borrow pits and quarries**.

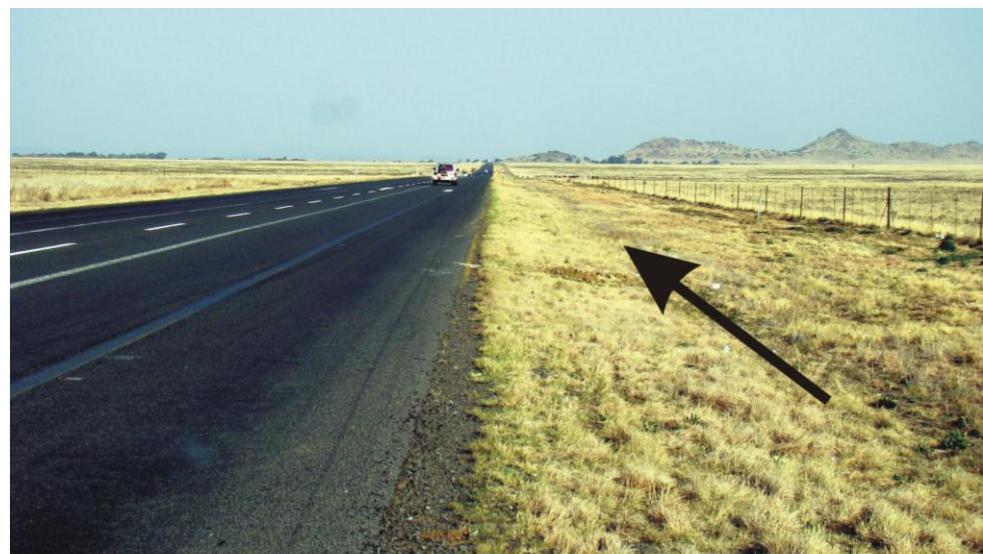
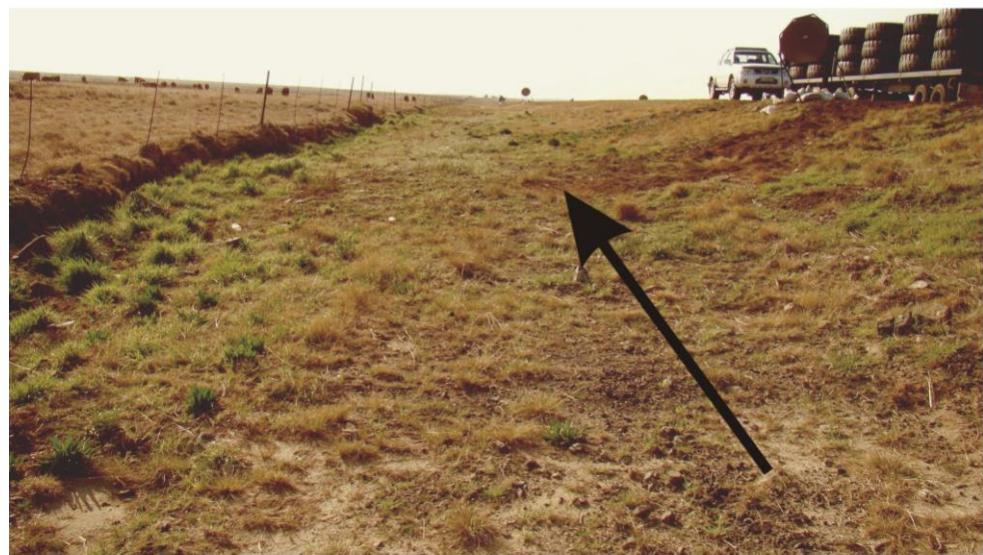
Intact Quaternary sediments are absent along the road reserve and superficial deposits are mostly disturbed as a result of previous road-building activities (**Fig 7**). This also includes road cuttings made into bedrock during the original construction of the road section. The Quaternary sediments in the demarcated area are not palaeontologically vulnerable and are of **low** palaeontological significance.

Figure 7. Intact Quaternary sediments are absent along the road reserve and superficial deposits are mostly disturbed as a result of previous road-building activities.

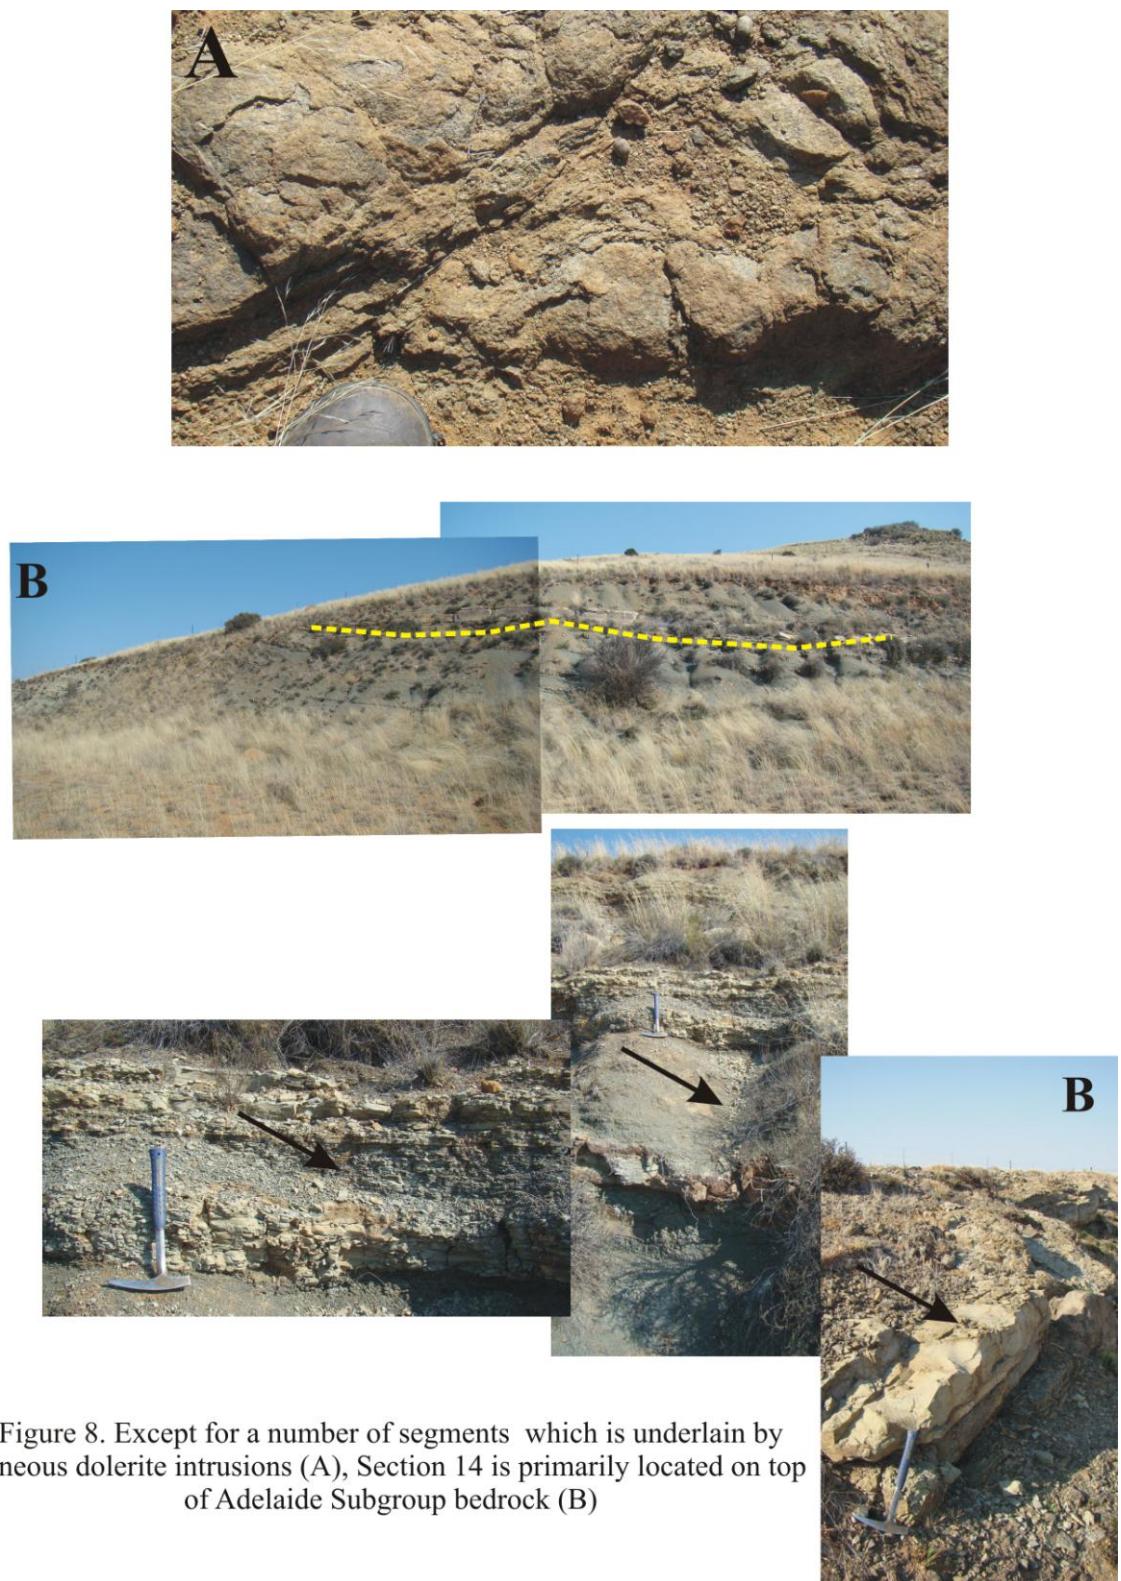
Except for the segment between coordinates 30° 1'13.63"S 25°48'1.84"E and 30° 0'8.97"S 25°48'28.51"E, which is underlain by igneous dolerite intrusions , Section 14 is mainly located on top of Adelaide Subgroup bedrock (*Pa*) (**Fig 8**). The igneous dolerites are not fossiliferous and are not considered palaeontologically significant. The demarcated area has been sufficiently recorded, mapped and documented in terms of conditions necessary for a Phase 1 palaeontological impact assessment and can be accessed for further development.

Figure 8. Except for a number of segments which is underlain by igneous dolerite intrusions (A), Section 14 is primarily located on top of Adelaide Subgroup bedrock (B)

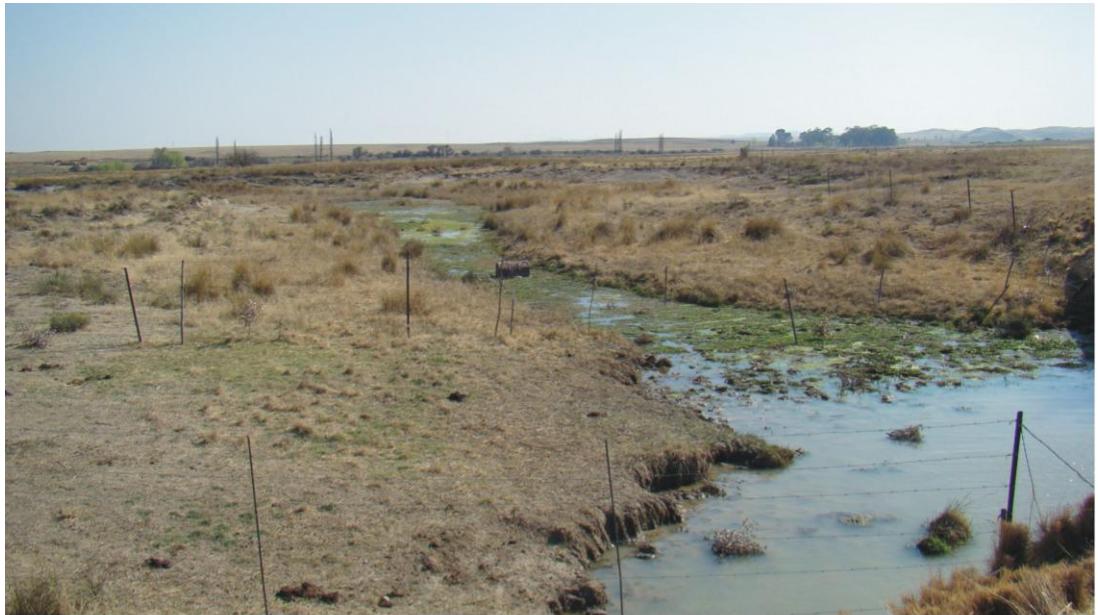
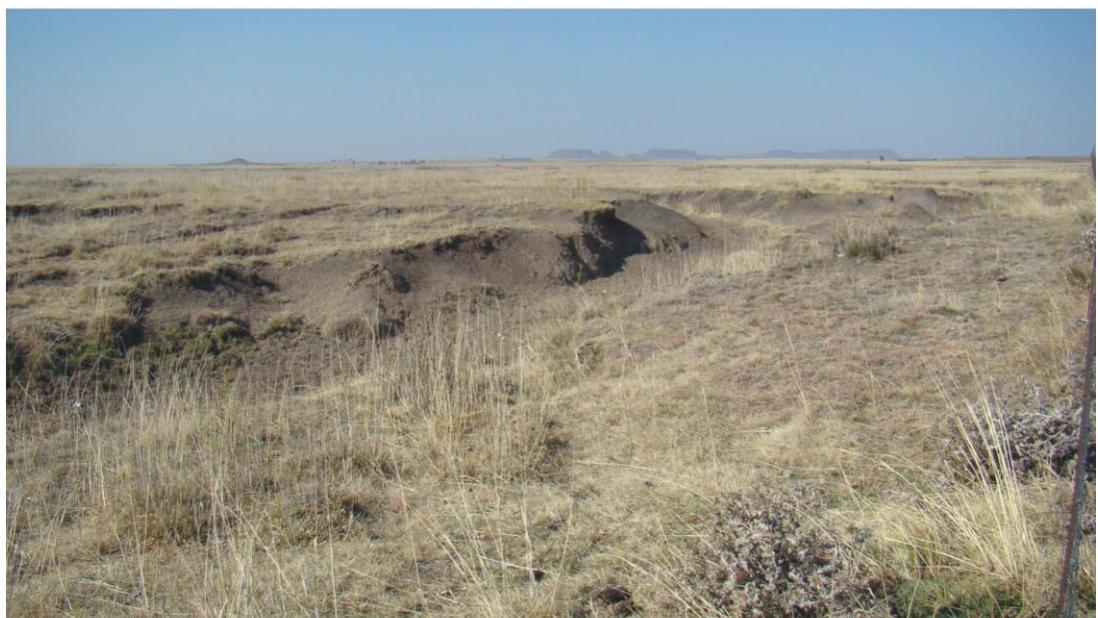
Rehabilitation of drains and culverts will impact mainly on previously disturbed building rubble and superficial deposits of Quaternary age (**Fig. 9**). These superficial deposits are already heavily disturbed as a result of previous road-building activities. The Quaternary sediments in the demarcated area are not palaeontologically vulnerable and are of **low** palaeontological significance. There is no evidence for the accumulation and preservation of intact fossil material within the Quaternary sediments.

Figure 9. Rehabilitation of culverts will impact mainly on previously disturbed residual deposits and superficial deposits of Quaternary age.

The culverts have been sufficiently recorded, mapped and documented in terms of conditions necessary for a Phase 1 palaeontological impact assessment and can be accessed for further development.

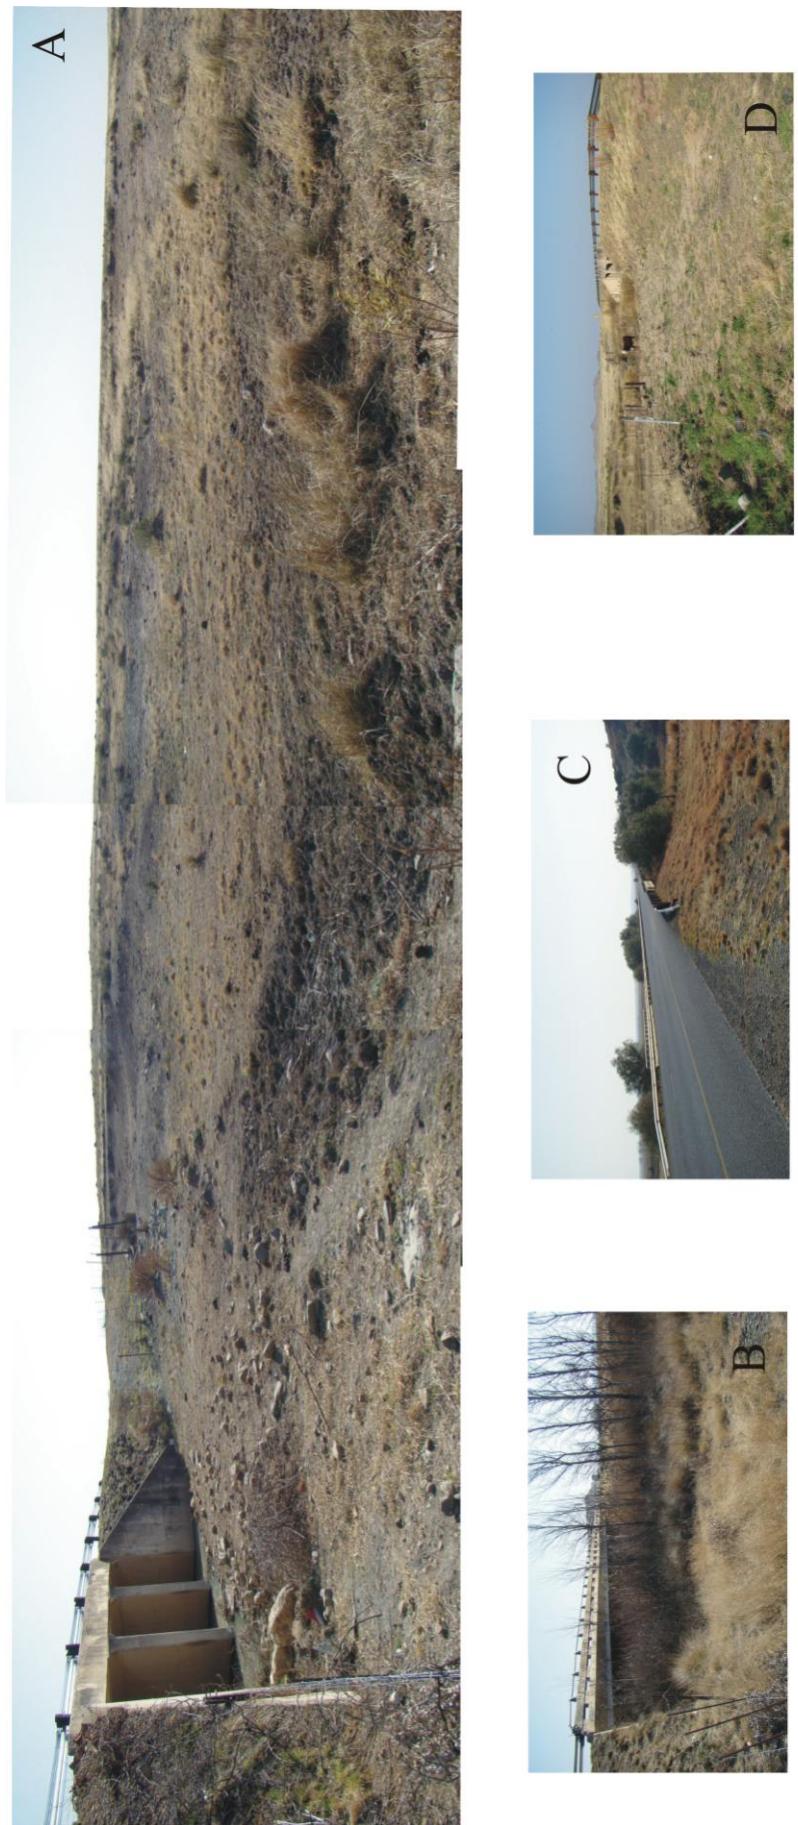
Bridge 1 (S30 01 14.7 E25 48 01.2) is underlain by sedimentary bedrock (*Pa*) covered by a foundation of building rubble (**Fig 10 A**) Quaternary-aged alluvial deposits are exposed along a shallow drainage. Quaternary profiles are sterile. There is no evidence for the accumulation and preservation of intact fossil material within the Quaternary sediments. The underlying sedimentary rocks (*Pa*) are moderately significant and potential fossil heritage may be affected if substantial bedrock excavations are to be conducted here.

The area around **Bridge 2** (S29 59 47.6 E25 48 37.9) is underlain by sedimentary bedrock (*Pa*), covered by a foundation of building rubble and Quaternary alluvial overbank deposits from the Van Zyls River (**Fig. 10 B**). There is no evidence for the accumulation and preservation of intact fossil material within the Quaternary sediments. This is especially indicated by sterile Quaternary profiles exposed along the riverbanks where the N1 crosses the Van Zyls River. Superficial deposits on both sides of the bridge are heavily disturbed as a result of previous road-building activities. The underlying sedimentary rocks (*Pa*) are moderately significant and potential fossil heritage may be affected if substantial bedrock excavations are to be conducted here.

Bridge 3 (S29 55 42.7 E25 50 24.6) is built over a farm road (**Fig. 10 C**). The structure rests on top of a foundation of building rubble which is underlain by sedimentary bedrock (*Pa*). Superficial sheet wash deposits cover the surrounding area. There is no evidence for the accumulation and preservation of intact fossil material within the Quaternary sediments in the vicinity of the bridge. The underlying sedimentary rocks (*Pa*) are moderately significant and potential fossil heritage may be affected if substantial bedrock excavations are to be conducted here.

Bridge 4 (S29 53 39.8 E25 51 44.8) is underlain by sedimentary bedrock (*Pa*) covered by a foundation of building rubble (**Fig 10 D**). Shallow, Quaternary-aged alluvial deposits are exposed along the river bed. Quaternary profiles are sterile. There is no evidence for the accumulation and preservation of intact fossil material within the

Quaternary sediments in the vicinity of the bridge. The underlying sedimentary rocks (*Pa*) are moderately significant and potential fossil heritage may be affected if substantial bedrock excavations are to be conducted here.

Figure 10. The bridge structures are underlain by sedimentary bedrock (*Pa*) that is covered by a foundation of building rubble. Associated Quaternary-aged alluvial deposits are sterile.

The bridges have been sufficiently recorded, mapped and documented in terms of conditions necessary for a Phase 1 palaeontological impact assessment and can be accessed for further development.

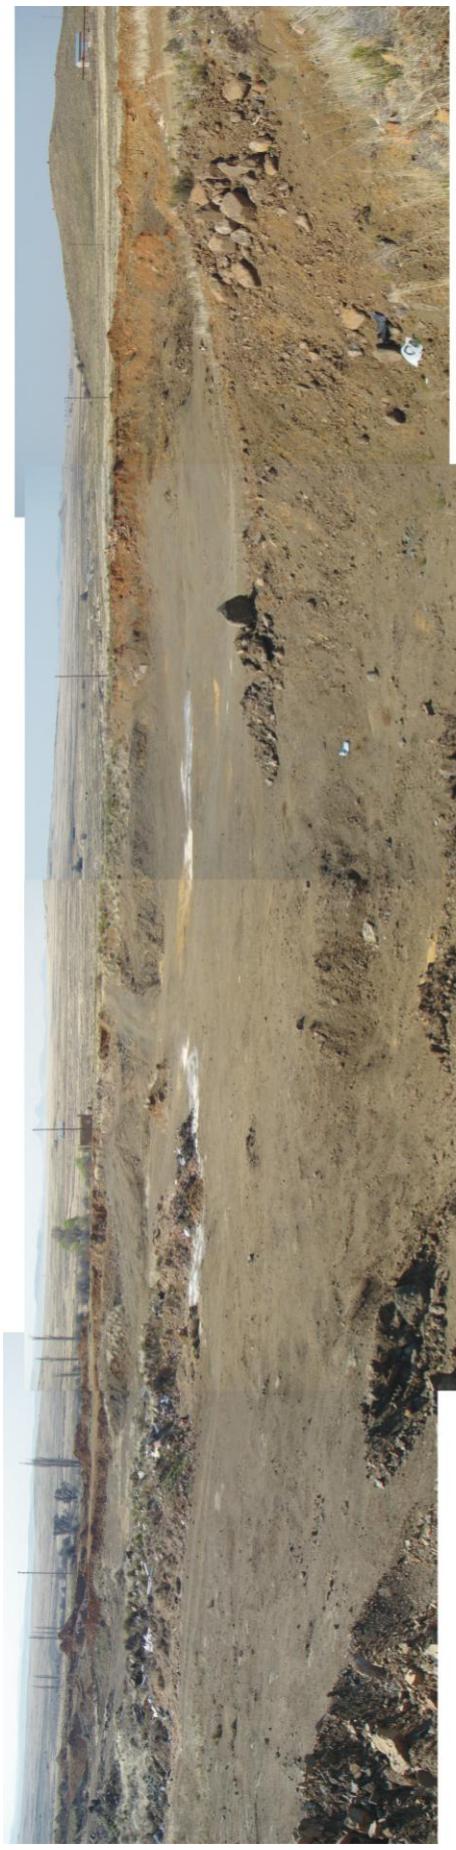
Figure 11. Quarry 2

Quarry 2 is located on intrusive dolerite bedrock, covered by superficial sheet wash deposits and a veneer of unconsolidated topsoil (**Fig. 11**). The igneous dolerites are not fossiliferous and not considered palaeontologically significant. A pedestrian survey of the borrow pit and its surroundings found no evidence for the accumulation and preservation of intact fossil material within the superficial sheet wash deposits. The footprint is not considered to be palaeontologically vulnerable and potential impact on palaeontological remains is unlikely. The demarcated area has been sufficiently recorded, mapped and documented in terms of conditions necessary for a Phase 1 palaeontological impact assessment and can be accessed for further development.

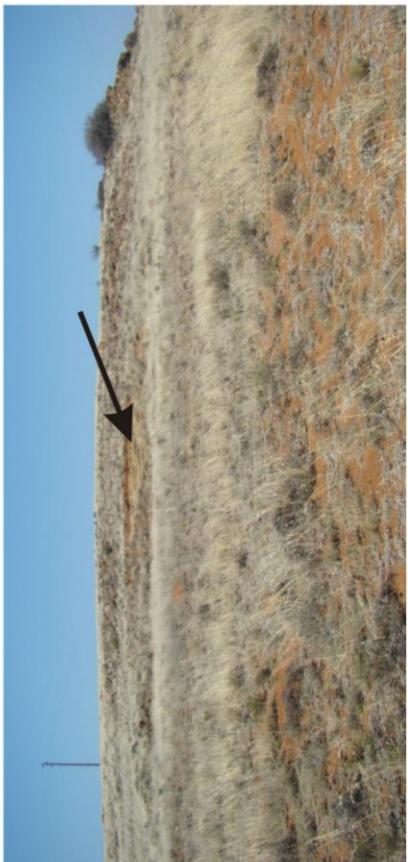
Figure 12. Borrow Pit 4

Borrow Pit 4 is located on intrusive dolerite bedrock, covered by superficial sheet wash deposits (**Fig. 12**). The igneous dolerites are not fossiliferous and are not considered palaeontologically significant. A pedestrian survey of the borrow pit and its surroundings found no evidence for the accumulation and preservation of intact fossil material within the superficial sheet wash deposits. The footprint is not considered to be palaeontologically vulnerable and potential impact on palaeontological remains is unlikely. The demarcated area has been sufficiently recorded, mapped and documented in terms of conditions necessary for a Phase 1 palaeontological impact assessment and can be accessed for further development.

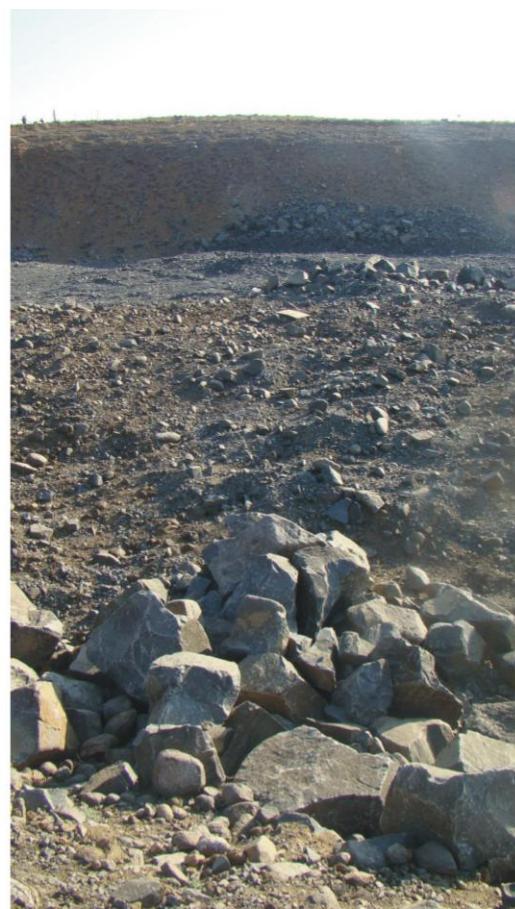
Figure 13. Quarry 1

Situated less than 100 m from each other, the **Quarry 1** and **Bloemhof Borrow Pit** sites are located on intrusive dolerite bedrock and covered by superficial sheet wash deposits. The igneous dolerites are not fossiliferous and are not considered palaeontologically significant. A pedestrian survey of the borrow pit and its surroundings found no evidence for the accumulation and preservation of intact fossil material within the

superficial sheet wash deposits. The footprints of these two sites are not considered to be palaeontologically vulnerable. Potential impact on palaeontological remains is unlikely. The demarcated area has been sufficiently recorded, mapped and documented in terms of conditions necessary for a Phase 1 palaeontological impact assessment and can be accessed for further development.

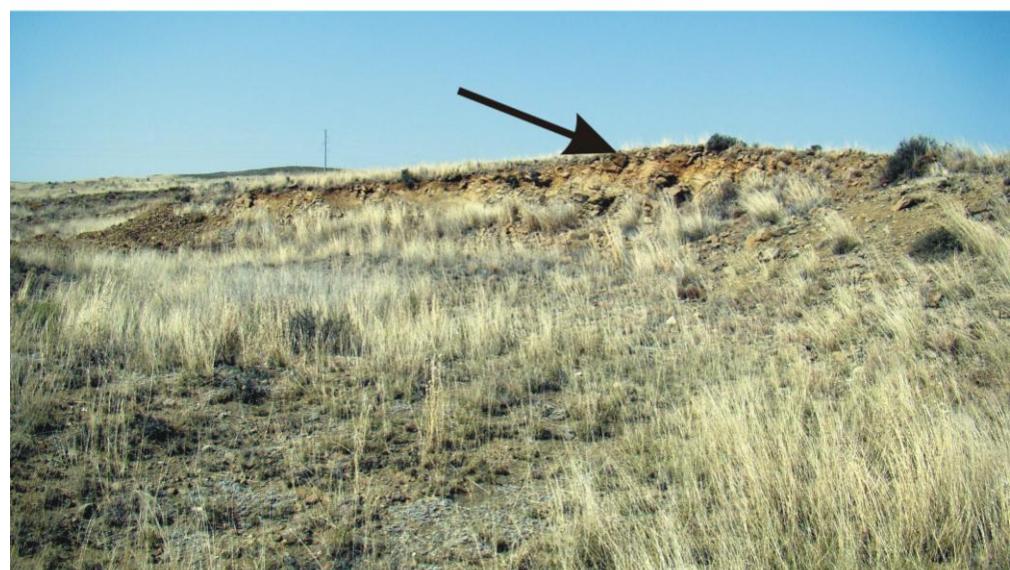
Figure 14. Borrow Pit 3.

Borrow Pit 3 is located on intrusive dolerite bedrock, covered by superficial sheet wash deposits (**Fig. 13**). The igneous dolerites are not fossiliferous and are not considered palaeontologically significant. A pedestrian survey of the borrow pit and its surroundings found no evidence for the accumulation and preservation of intact fossil material within the superficial sheet wash deposits. The footprint is not considered to be palaeontologically vulnerable and potential impact on palaeontological remains is unlikely. The demarcated area has been sufficiently recorded, mapped and documented in terms of conditions necessary for a Phase 1 palaeontological impact assessment and can be accessed for further development.

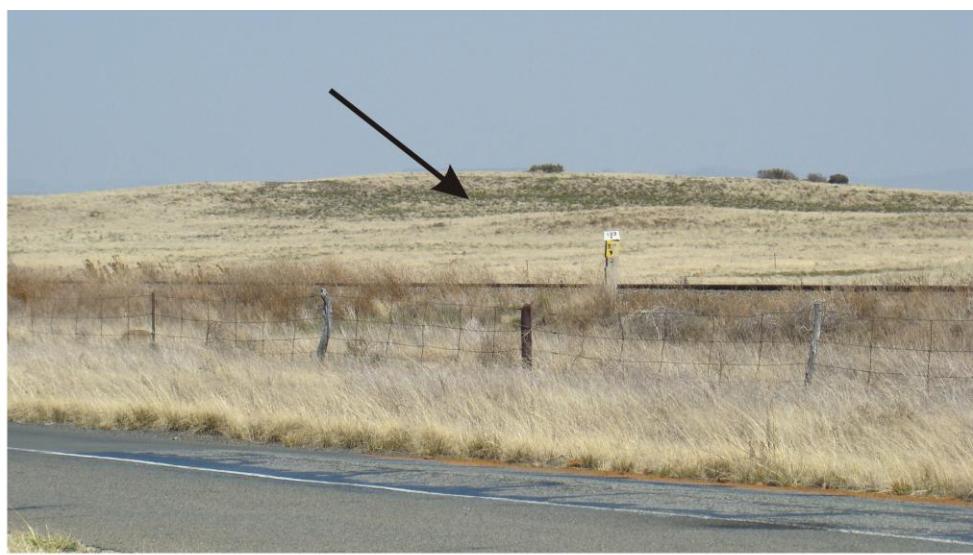
Figure 15. Straussfontein Borrow Pit

The **Straussfontein Borrow Pit** locality is located on intrusive dolerite bedrock and superficial sheet wash deposits (**Fig. 14**). The igneous dolerites are not fossiliferous and are not considered palaeontologically significant. A pedestrian survey of the affected area and its surroundings found no evidence for the accumulation and preservation of intact fossil material within the superficial sheet wash deposits. The footprint is not considered to be palaeontologically vulnerable. Potential impact on palaeontological remains is considered unlikely. The demarcated area has been sufficiently recorded,

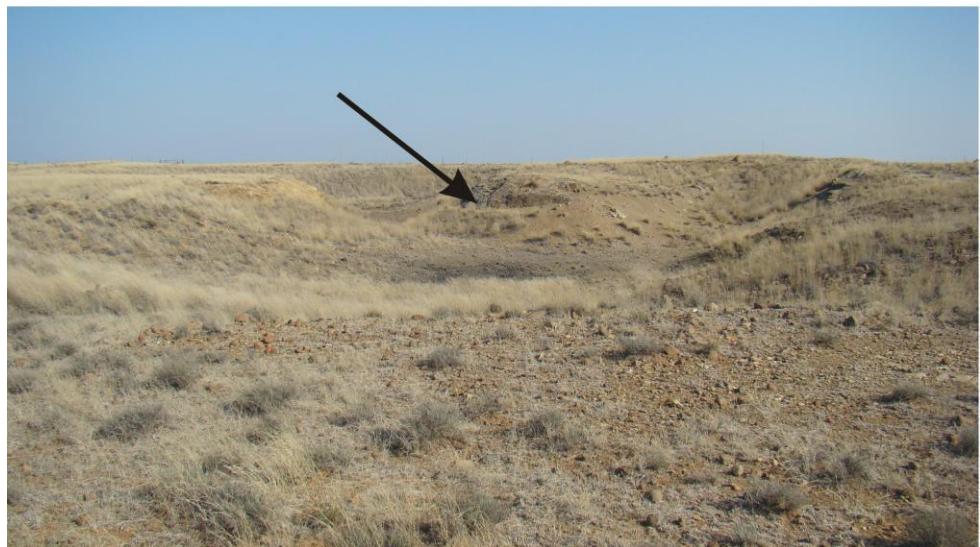
Figure 16. Borrow Pit 1.

Borrow Pit 1 is located on intrusive dolerite bedrock, covered by superficial sheet wash deposits (**Fig. 15**). The igneous dolerites are not fossiliferous and are not considered palaeontologically significant. A pedestrian survey of the affected area and its surroundings found no evidence for the accumulation and preservation of intact fossil material within the superficial sheet wash deposits. The footprint is not considered to be palaeontologically vulnerable and potential impact on palaeontological remains is unlikely. The demarcated area has been sufficiently recorded, mapped and documented in terms of conditions necessary for a Phase 1 palaeontological impact assessment and can be accessed for further development.

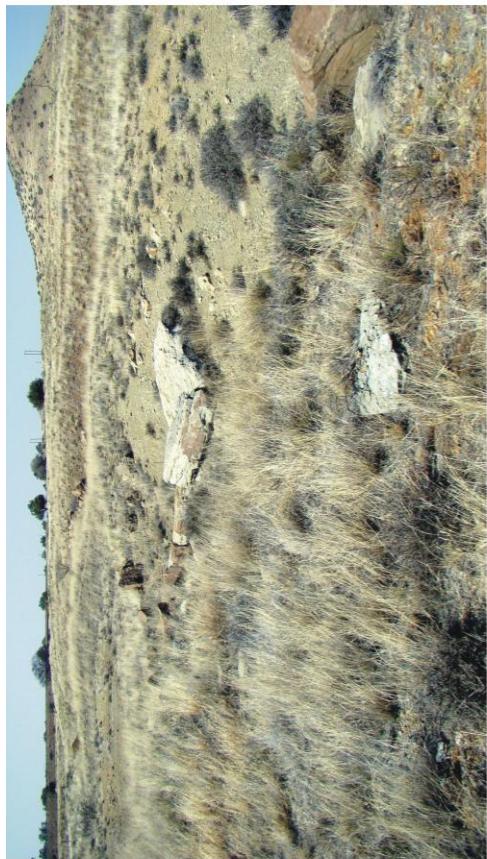
Figure 17. Poortjie Borrow Pit.

Poortjie Borrow Pit is partially located on Balfour Frm. sandstone and mudstone that are intruded by dolerite bedrock, and covered by superficial sheet wash deposits (**Fig. 16**). The igneous dolerites are not fossiliferous, but fossils may well be preserved near the contact metamorphic zones. A pedestrian survey of the borrow pit and its surroundings found no evidence for the accumulation and preservation of intact fossil material within Balfour Frm. outcrop and the superficial sheet wash deposits. The sedimentary bedrock is considered to be of moderate palaeontological significance. The demarcated area has been sufficiently recorded, mapped and documented in terms of conditions necessary for a Phase 1 palaeontological impact assessment and can be accessed for further development, provided that fresh excavations will be sufficiently monitored during the site's operational phase. It is advised that newly uncovered palaeontological material found during the course of excavation activities into sedimentary bedrock must be reported to SAHRHA, that excavations into *in situ* sediments should allow for inspection by a specialist at the appropriate time and that possible intact finds may require a Phase 2 rescue operation at the cost of the developer.

Except for one, all the Borrow Pits and all the Quarries are underlain by intrusive igneous dolerites. Dolerites are not fossiliferous and can be excluded from further consideration in the present assessment. There is a possibility of finding fossils in the contact metamorphic zones adjacent to the dolerite intrusions at the Poortjie BP, but palaeontological impact is, on the whole, considered to be low. There is no major palaeontological reason to suspend development at the Poortjie BP, provided that fresh excavations will be sufficiently monitored during the site's operational phase.

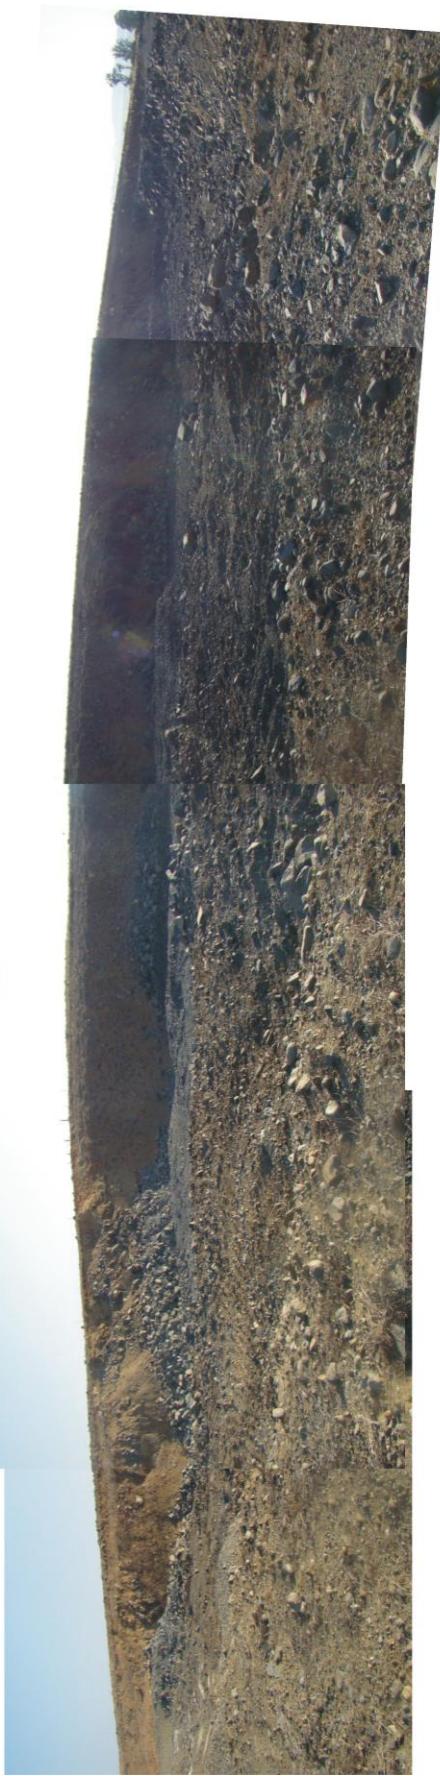
Figure 18. Quarry 3.

Quarry 3 is located on intrusive dolerite bedrock, covered by superficial sheet wash deposits that have been extensively (**Fig. 17**). The igneous dolerites are not fossiliferous and are therefore not considered palaeontologically significant. A pedestrian survey of the borrow pit and its surroundings found no evidence for the accumulation and preservation of intact fossil material within the superficial sheet wash deposits. The footprint is not considered to be palaeontologically vulnerable.
