**A PHASE 1 ARCHAEOLOGICAL IMPACT ASSESSMENT (AIA) FOR THE PROPOSED ROAD UPGRADE OF THE DR 08376 FROM THE R61 AT ST MARKS TO SABALELE VILLAGE AND ASSOCIATED BORROW PITS, NEAR COFIMVABA, INTSIKA YETHU LOCAL MUNICIPALITY, EASTERN CAPE PROVINCE.**

**Date:** September 2014

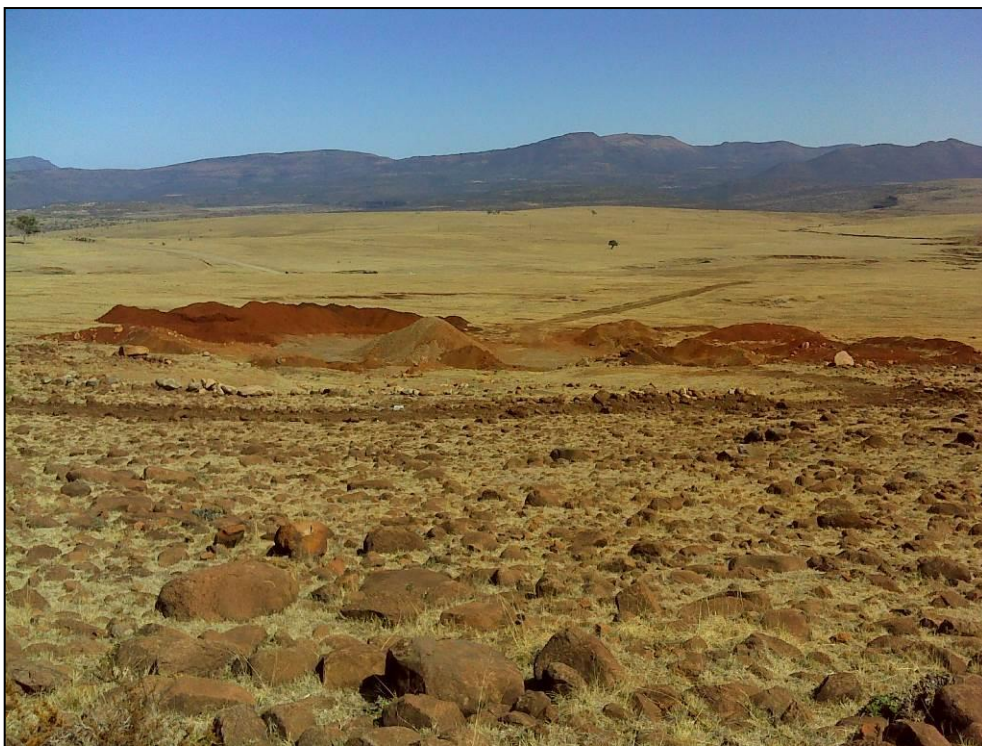
**Figure 5. View of the existing Borrow Pit 171 (BP171).**

The intention is to expand the existing borrow pit area. The existing borrow pit area is approximately 115 m x 85 m in extent (Figure 5). The proposed borrow pit area including the existing borrow pit is approximately 575 m x 450 m in extent.

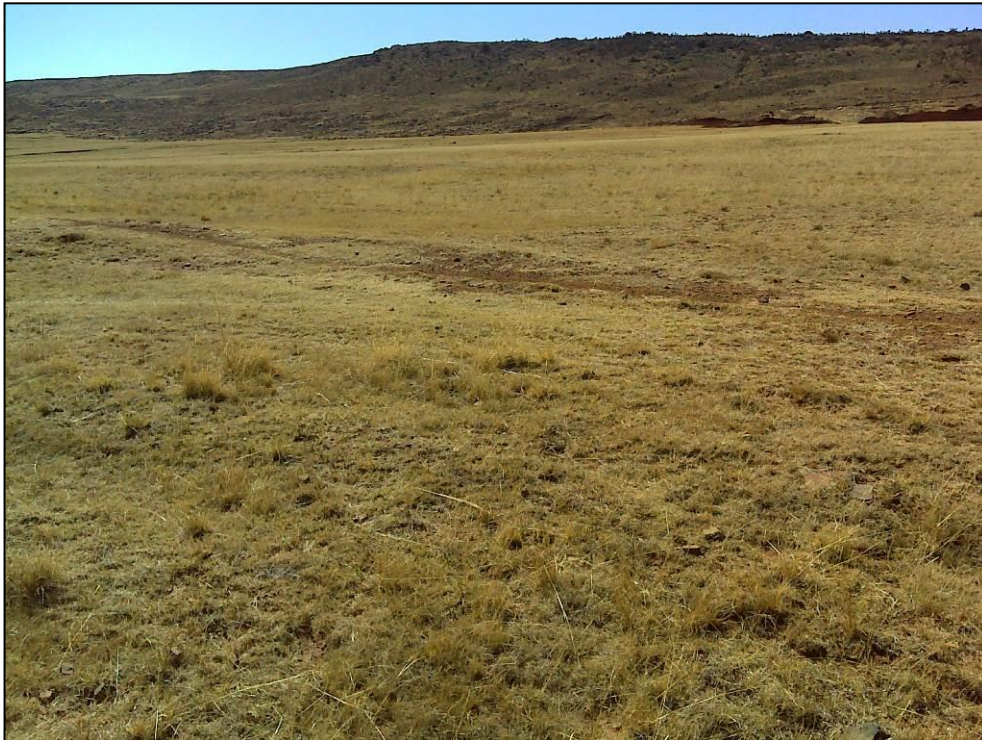
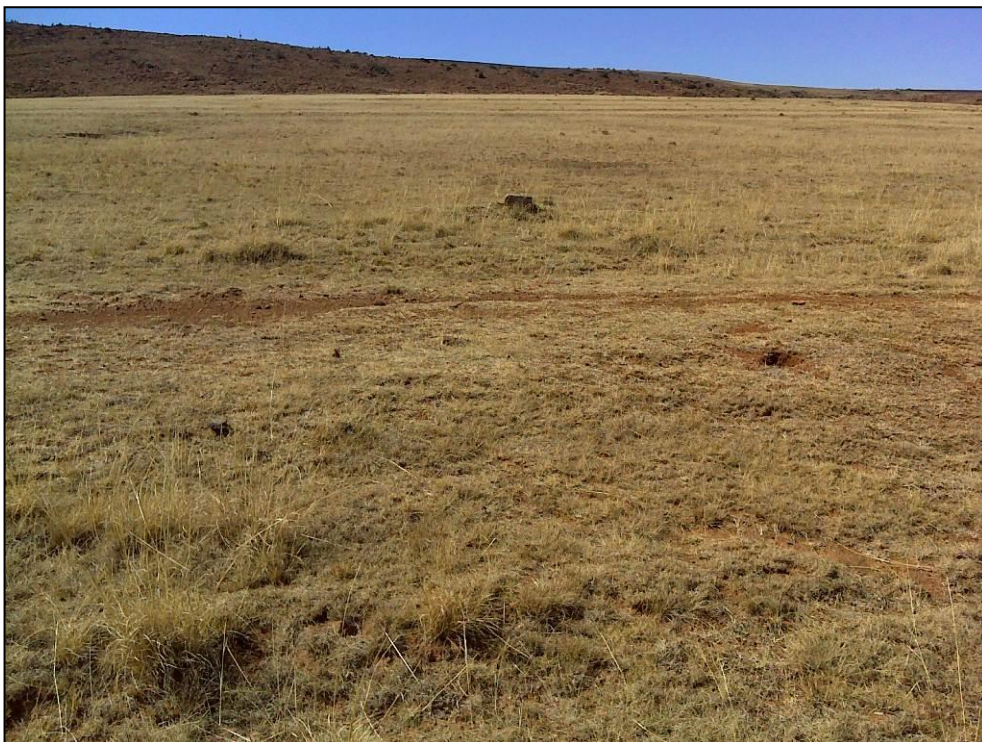
The vegetation cover is mainly low grass cover that allowed for relatively good archaeological visibility (Figures 6-7). The exposed and disturbed surface and soil eroded areas were investigated for the possibility of encountering archaeological heritage remains.

**Figure 6. View of the general landscape of the area proposed for the extension of Borrow Pit 171 (BP171) facing east.**

**Figure 7. View of the general landscape of the area proposed for the extension of Borrow Pit 171 (BP171) facing south east.**

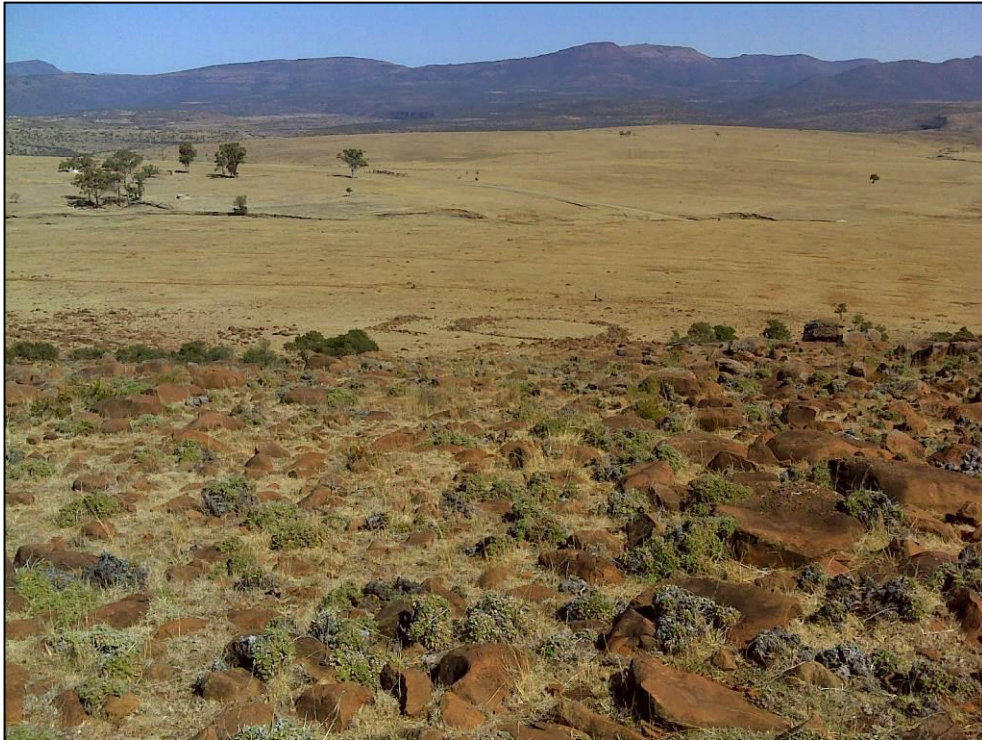
The remains of two dry packed stone walling features situated at the base of a hill on the boundary of the proposed mining area in the south-eastern corner were recorded. The features included a relatively large circular enclosure and a smaller rectangular enclosure that may have been adjoined (Figures 8-10).

**Figure 8. View of the dry packed stone walling complex situated at the base of the hill on the boundary of the proposed borrow pit development area.**

It is unlikely that the dry packed stone walling complex at SVR SW1 would be negatively impacted by the proposed development. The dry packed stone walling complexes BP171 SW1 and BP190 SW1 are situated within the proposed quarrying area and would probably be negatively affected by the proposed development. Therefore, the appropriate recommended mitigation measures must be considered before development may proceed. However, if it is deemed necessary that these structures be demolished for the proposed development to proceed, it is recommended that a specialist oral historian be appointed to assess the significance of the dry packed stone walling complexes.

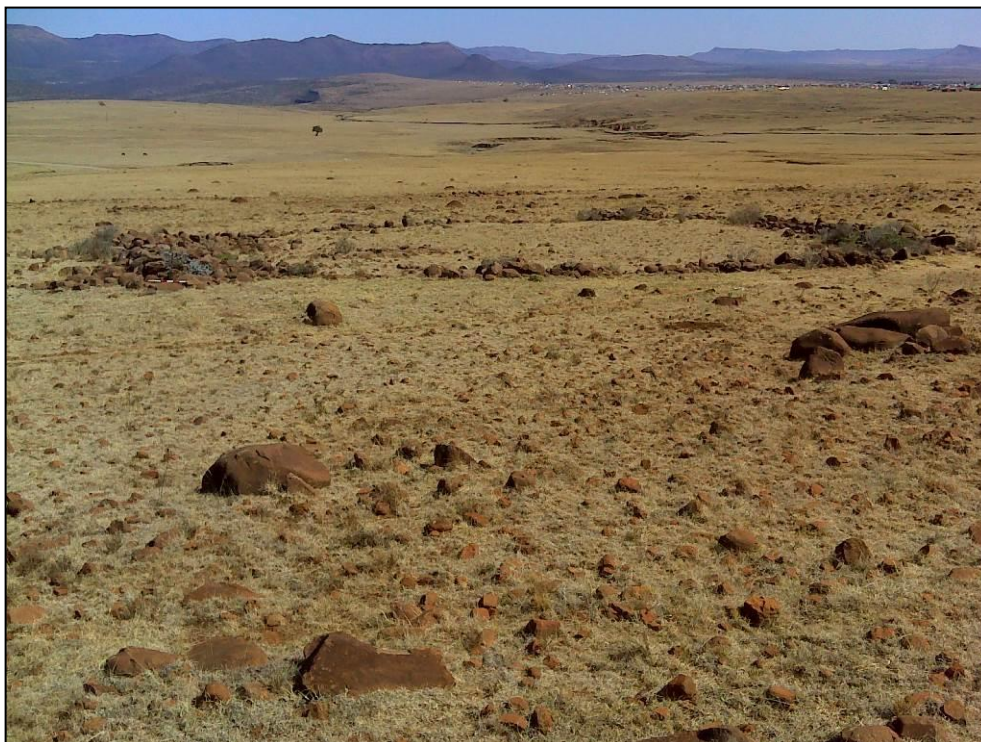
**Figure 9. Close-up view of the remains of the circular dry packed stone walling feature.**

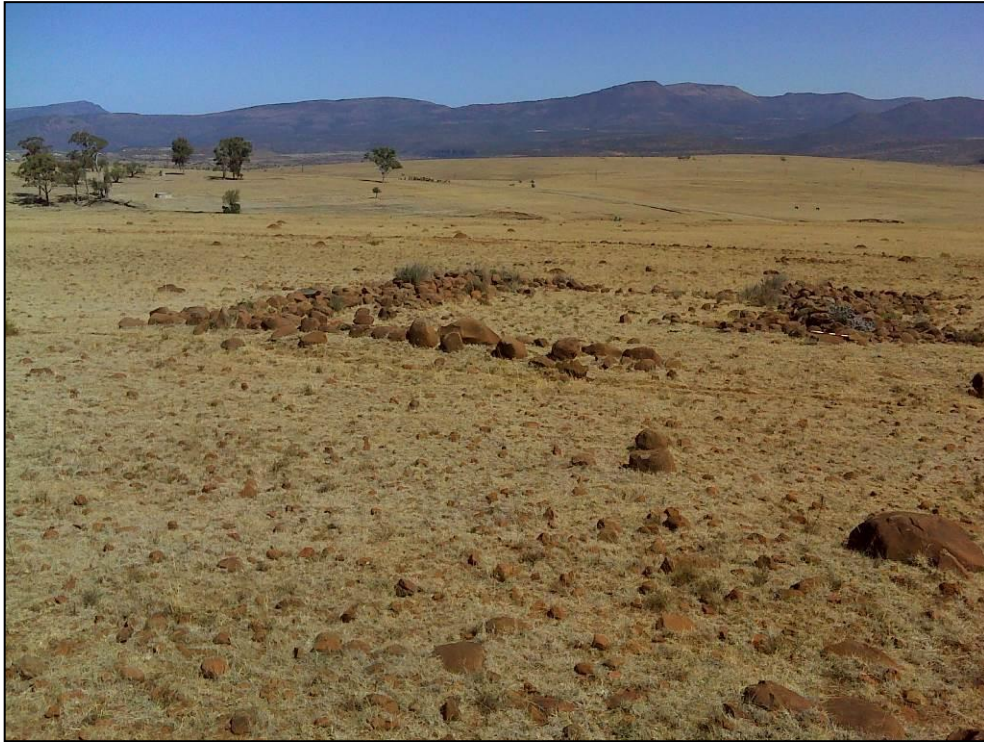
**Figure 10. Close-up view of the remains of the adjacent rectangular dry packed stone walling feature.**

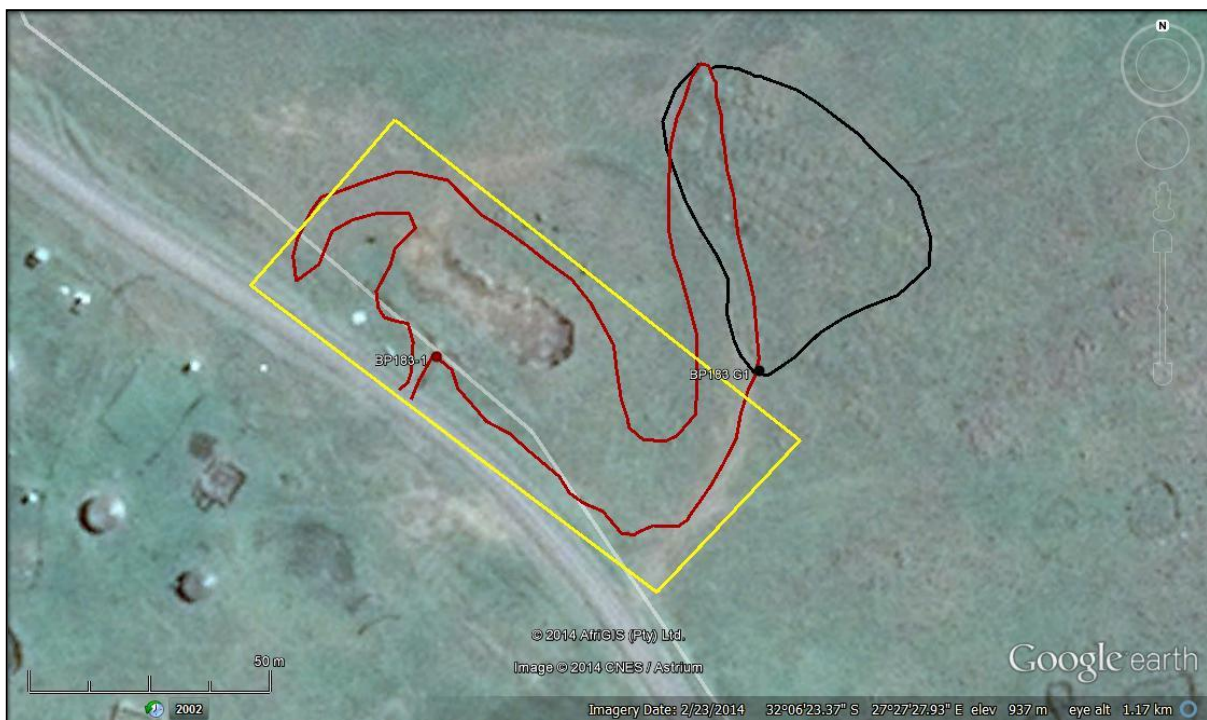
**Figure 11. Close-up aerial view of the area proposed for Borrow Pit 183 (BP183) showing the extent of the proposed borrow pit and area surveyed.**

Borrow Pit 183 (BP183) is located about 6 km along the proposed route for the DR 08376 road upgrade from the area proposed for Borrow Pit 171 (BP171) on the Farm Sabalele No 119 (Figure 11). The site is situated on the eastern side of the road just south of Lower Sabalele Village and north of Kwanakaya Village.

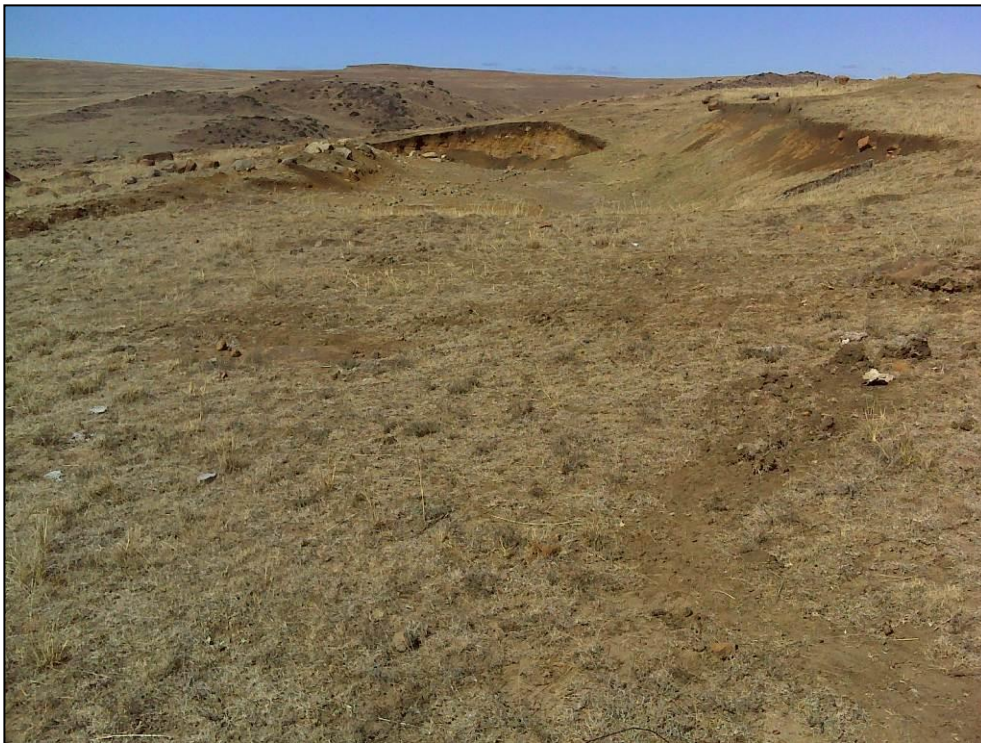
**Figure 12. View of the existing Borrow Pit 183 (BP183).**

The intention is to expand the existing borrow pit area. The existing borrow pit area is approximately 45 m x 15 m in extent (Figure 12). The proposed borrow pit area including the existing borrow pit is approximately 115 m x 50 m in extent.

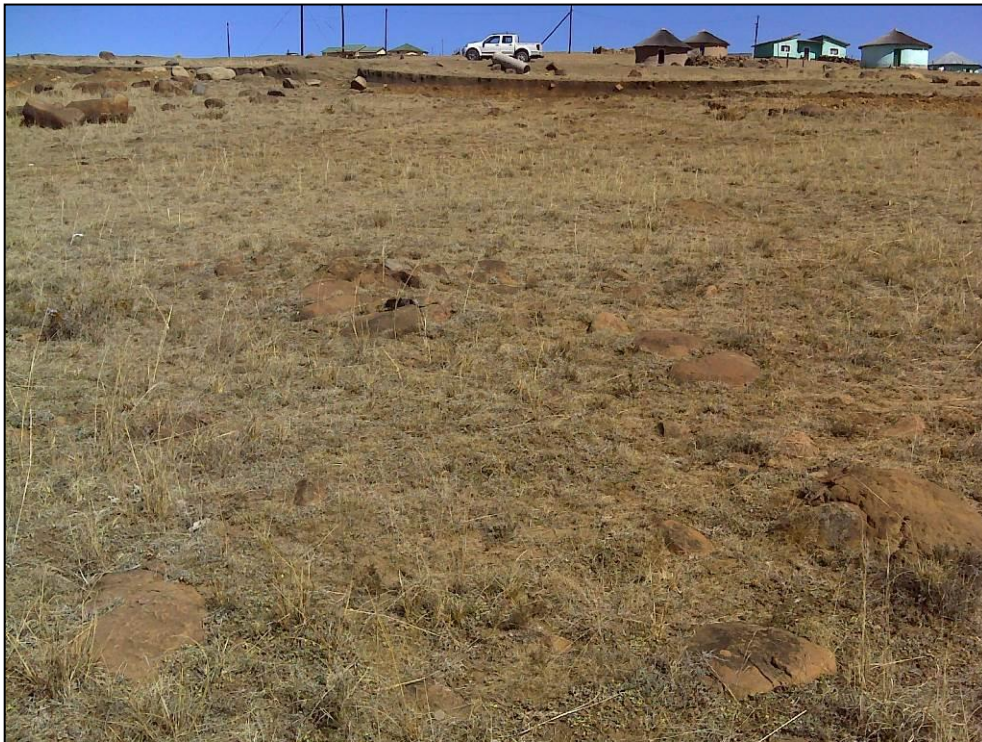
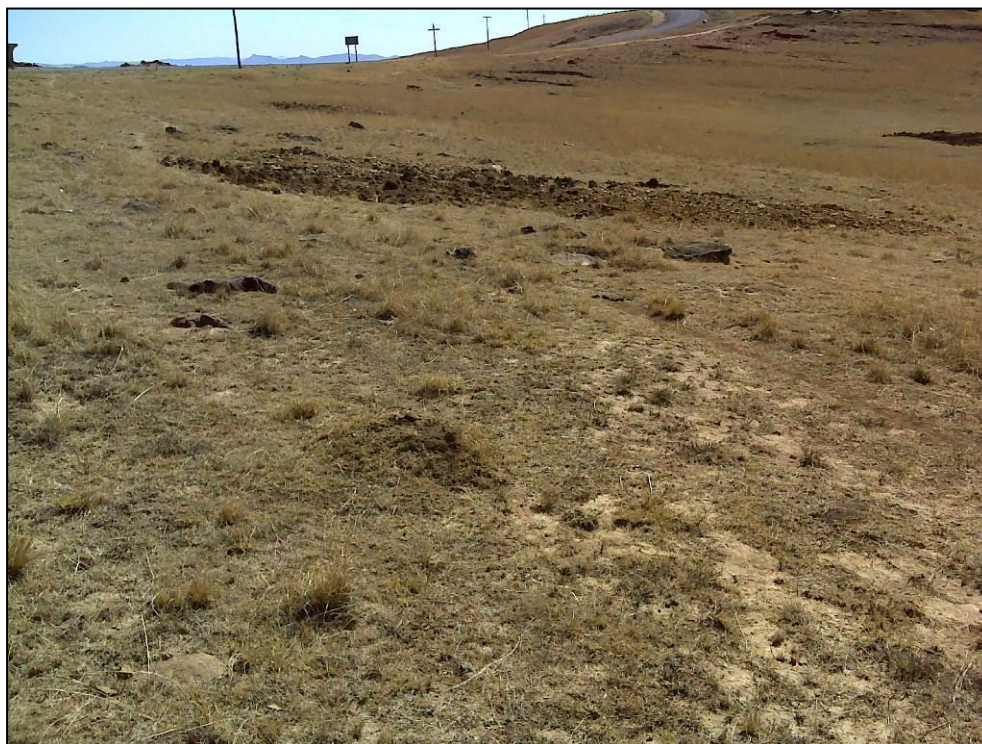
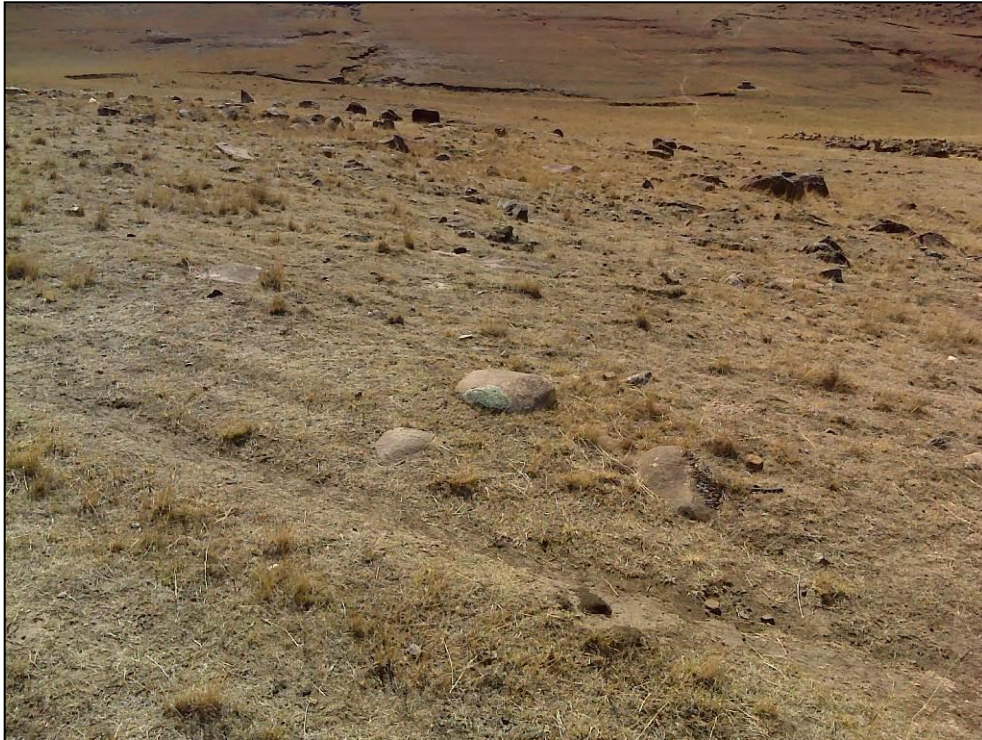
The vegetation cover is mainly low grass cover that allowed for relatively good archaeological visibility (Figures 13-15). The exposed and disturbed surface and soil eroded areas were investigated for the possibility of encountering archaeological heritage remains.

**Figure 13. View of the general landscape of Borrow Pit 183 (BP183) and surrounding area facing south-west.**

**Figure 14. View of the general landscape of the area proposed for the extension of Borrow Pit 183 (BP183) facing north-west.**

**Figure 15. View of the general landscape of the area proposed for the extension of Borrow Pit 183 (BP183) facing north-east.**

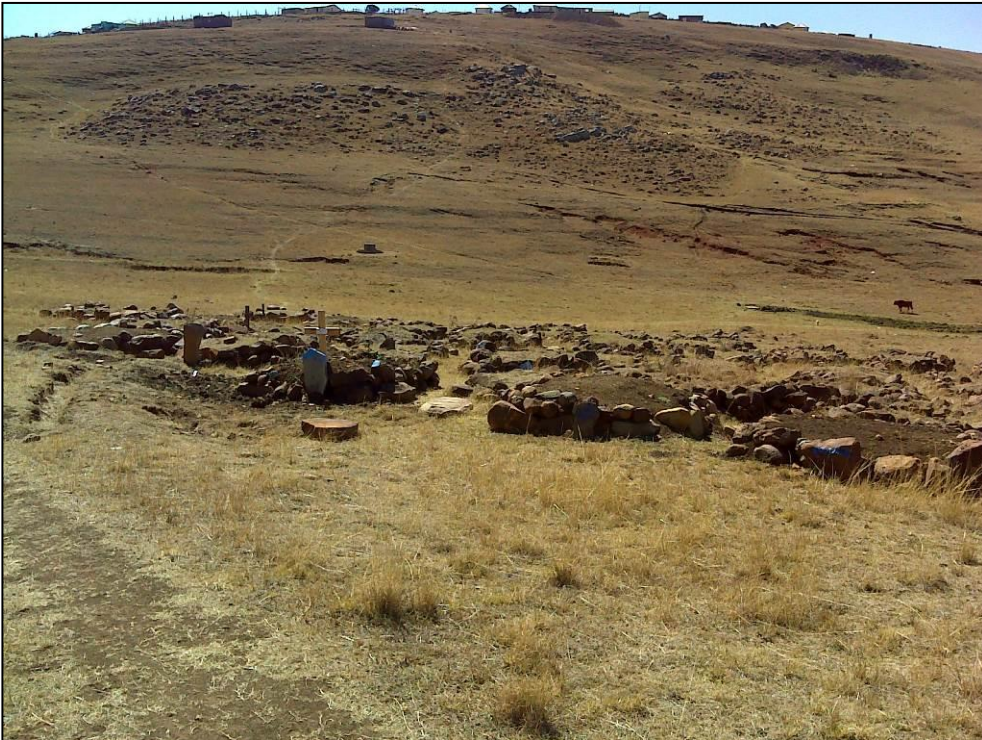
An established burial ground housing traditional graves occurs immediately next to an informal gravel access road that would presumably be used for the proposed mining activities and that leads to the neighbouring village (Figures 16-17). The burial ground can be regarded as informal and is therefore protected under the National Heritage Resources Act 25 of 1999 (NHRA).

**Figure 16. View of the burial ground situated near Borrow Pit 183 (BP183) facing north.**

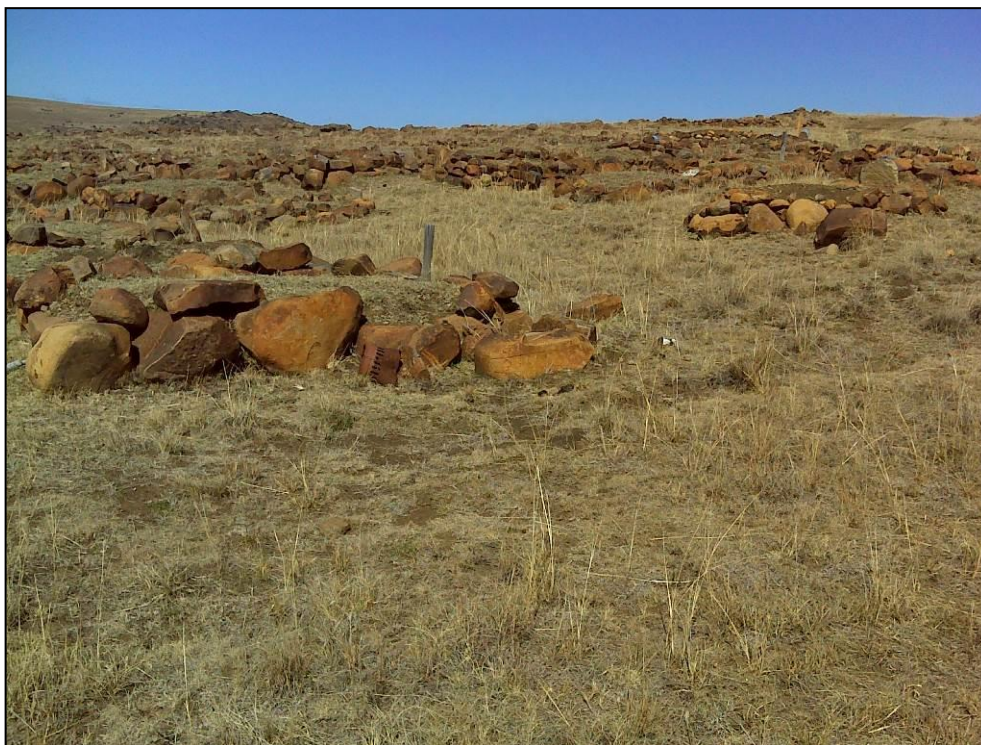
**Figure 17. View of the burial ground situated near Borrow Pit 183 (BP183) facing south-east.**

**BP183 G1:** The burial area is situated immediately east of the access road to the borrow pit and to the neighbouring village. The area is not fenced and it is possible that the burials closest to the road may be negatively affected during the quarrying activities. The appropriate recommended mitigation measures must be considered before development may proceed.

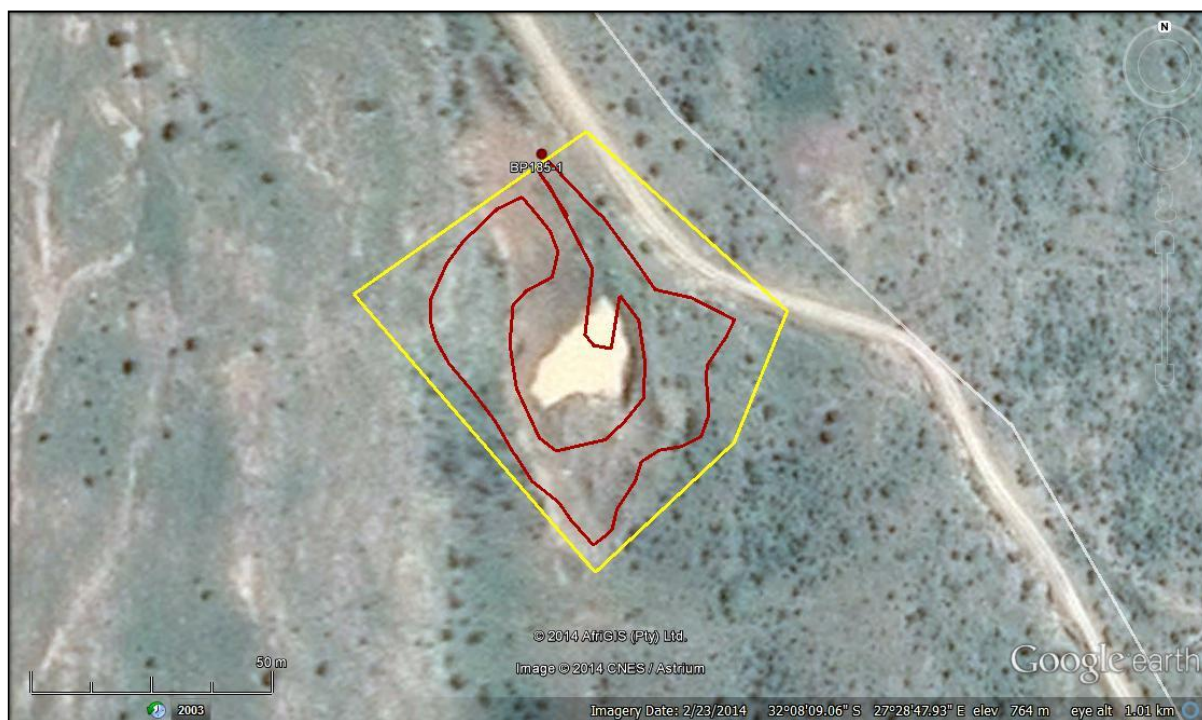
**Figure 18. Close-up aerial view of the area proposed for Borrow Pit 185 (BP185) showing the extent of the proposed borrow pit and area surveyed.**

Borrow Pit 185 (BP185) is located about 5 km along the DR 08375 road that connects with the R61 near Cofimvaba on the Farm Hohita No. 117 (Figure 18). The site is situated on the southern near the Village of Lower Cardif.

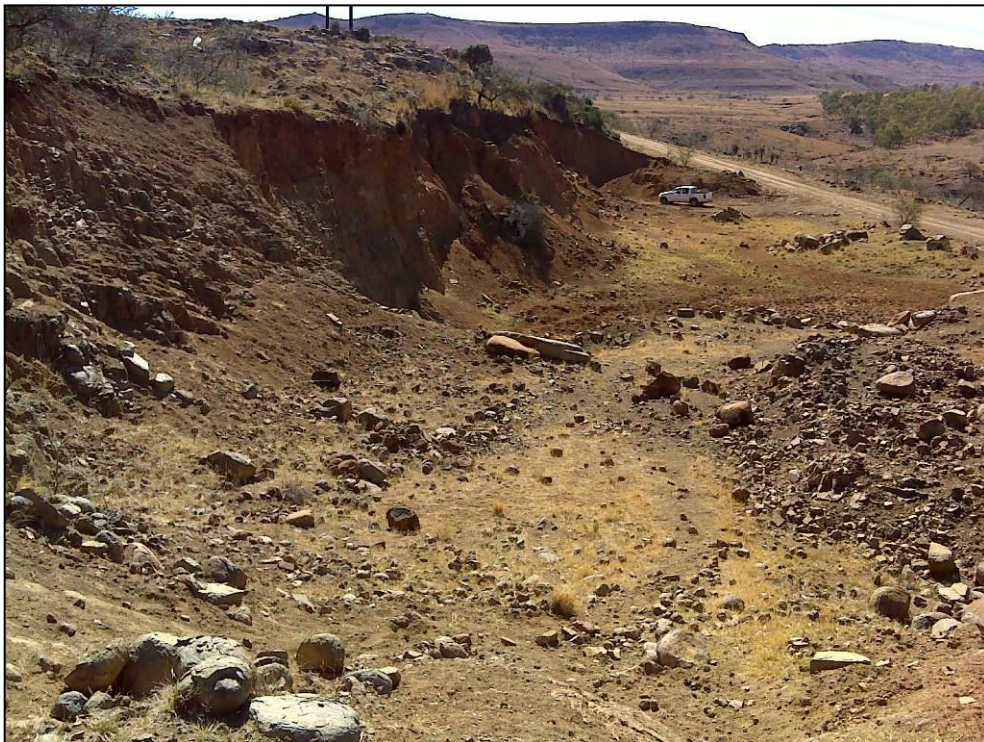
**Figure 19. View of the existing Borrow Pit 185 (BP185).**

The intention is to expand the existing borrow pit area. The existing borrow pit area is approximately 25 m x 20 m in extent (Figure 19). The proposed borrow pit area including the existing borrow pit is approximately 80 m x 75 m in extent.

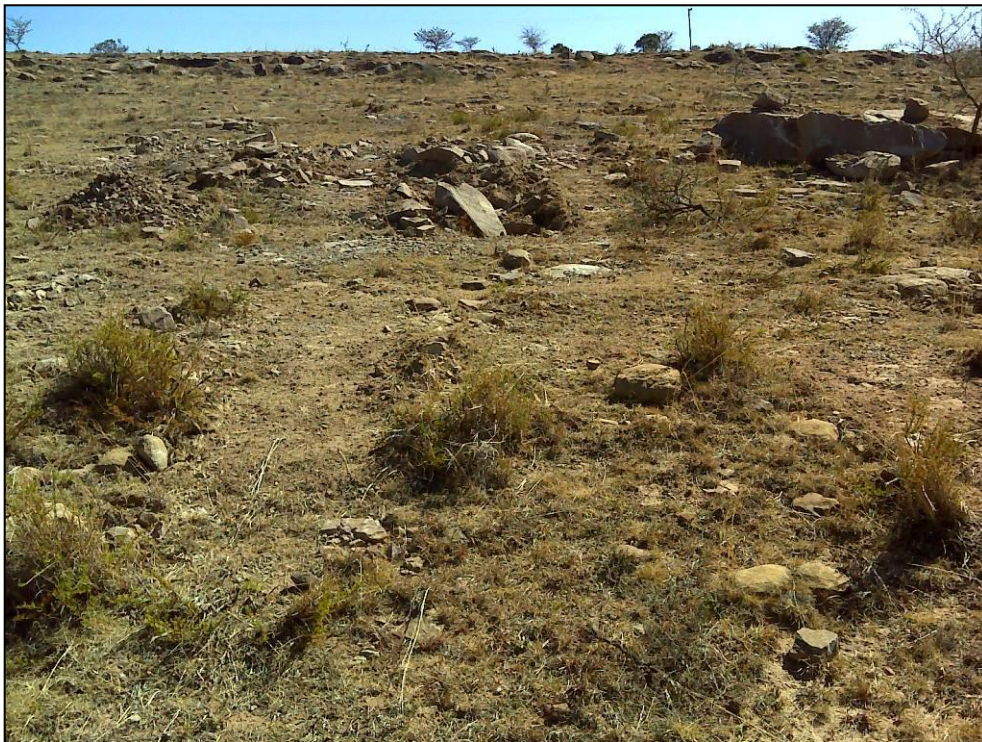
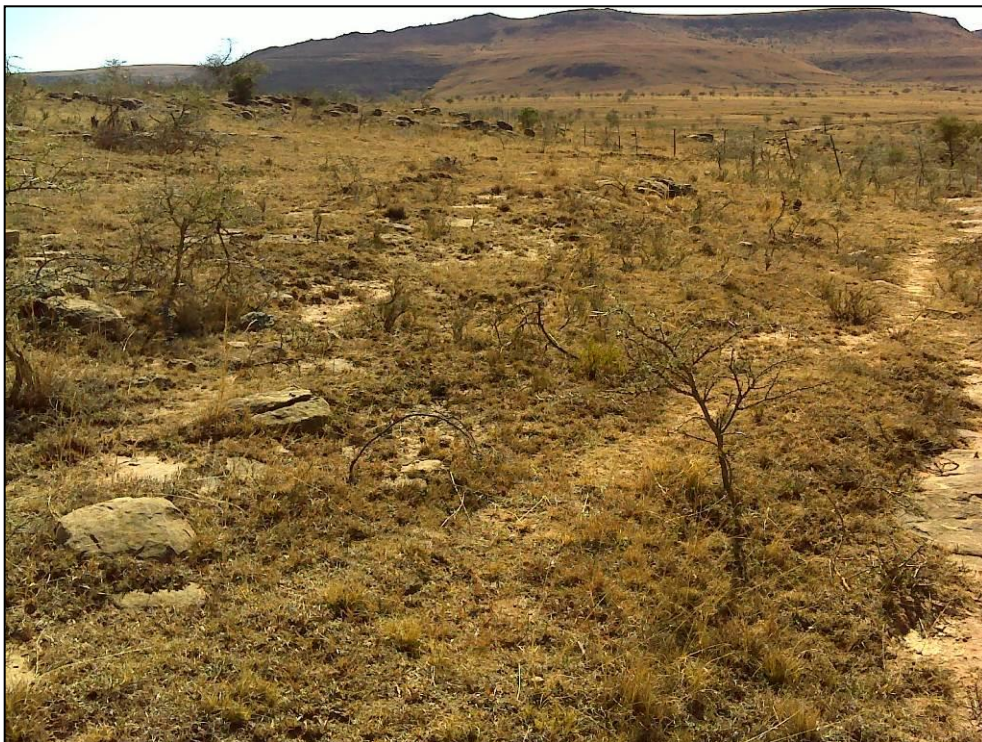
The vegetation cover is mainly low grass cover that allowed for relatively good archaeological visibility (Figures 20-21). The exposed and disturbed surface and soil eroded areas were investigated for the possibility of encountering archaeological heritage remains.

No archaeological or other heritage resources were documented within the exposed areas. However, it is possible that stone artefacts may occur in primary context (*in situ*) 50 cm – 80 cm underneath the dense vegetation.

**Figure 20. View of the general landscape of the area proposed for the extension of Borrow Pit 185 (BP185) facing south-west.**

**Figure 21. View of the general landscape of the area proposed for the extension of Borrow Pit 185 (BP185) facing north-west.**

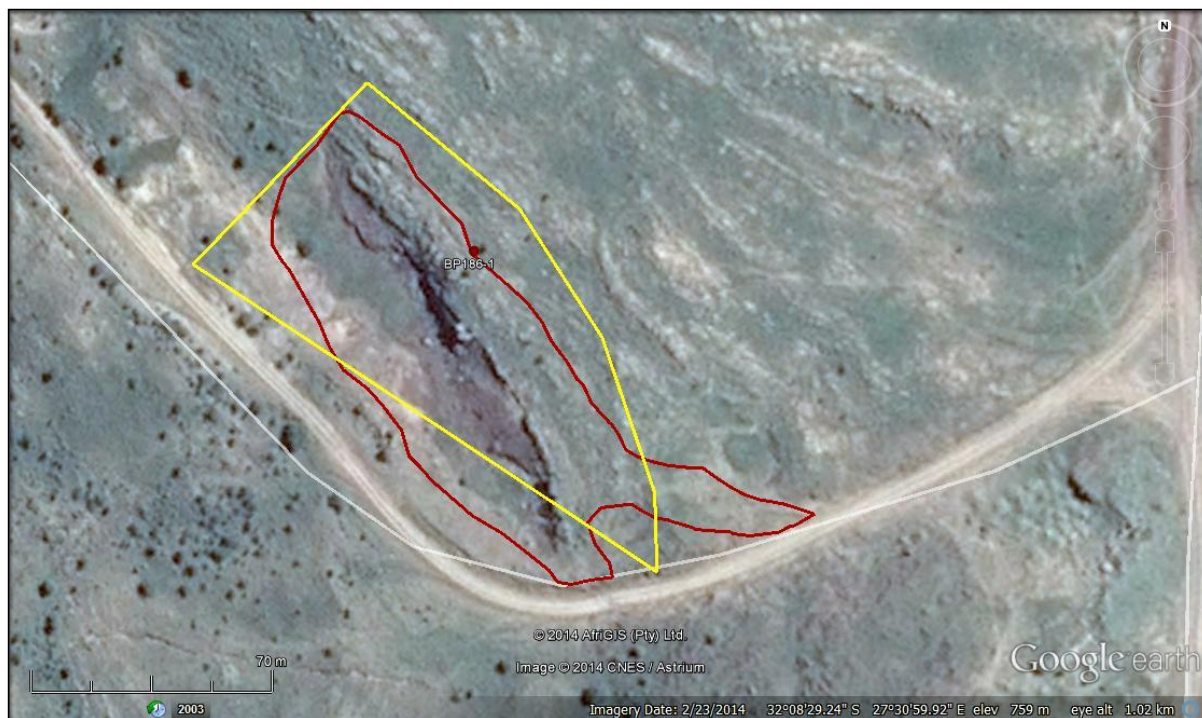
**Figure 22. Close-up aerial view of the area proposed for Borrow Pit 186 (BP186) showing the extent of the proposed borrow pit and area surveyed.**

Borrow Pit 186 (BP186) is located about 4 km from Borrow Pit 185 (BP185) along the DR 08375 on the Farm Hohita No. 117 (Figure 22). The site is situated on the northern side of the road between the villages of Ntshinsthi and Banzi.

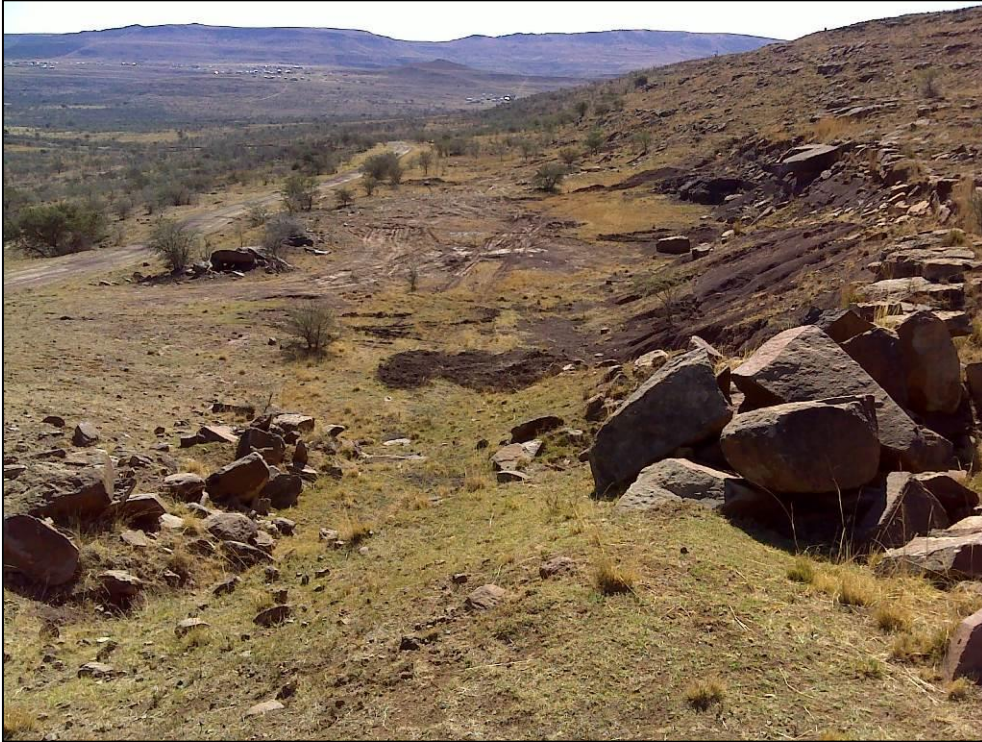
**Figure 23. View of the existing Borrow Pit 186 (BP186).**

The intention is to expand the existing borrow pit area. The existing borrow pit area is approximately 120 m x 50 m in extent (Figure 23). The proposed borrow pit area including the existing borrow pit is approximately 145 m x 70 m in extent.

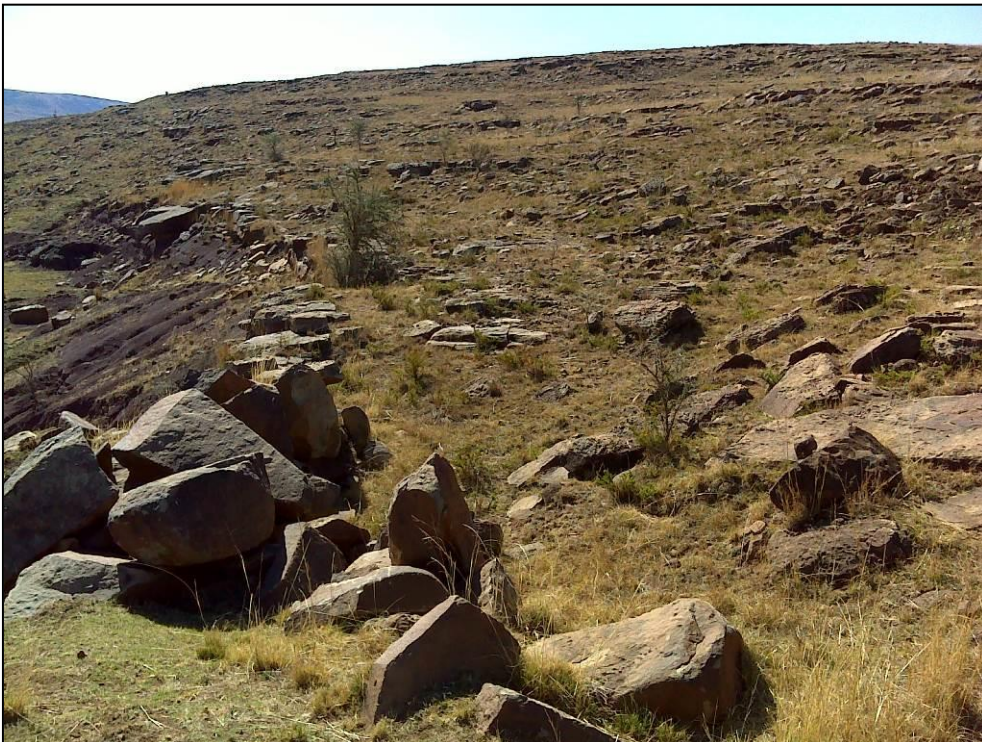
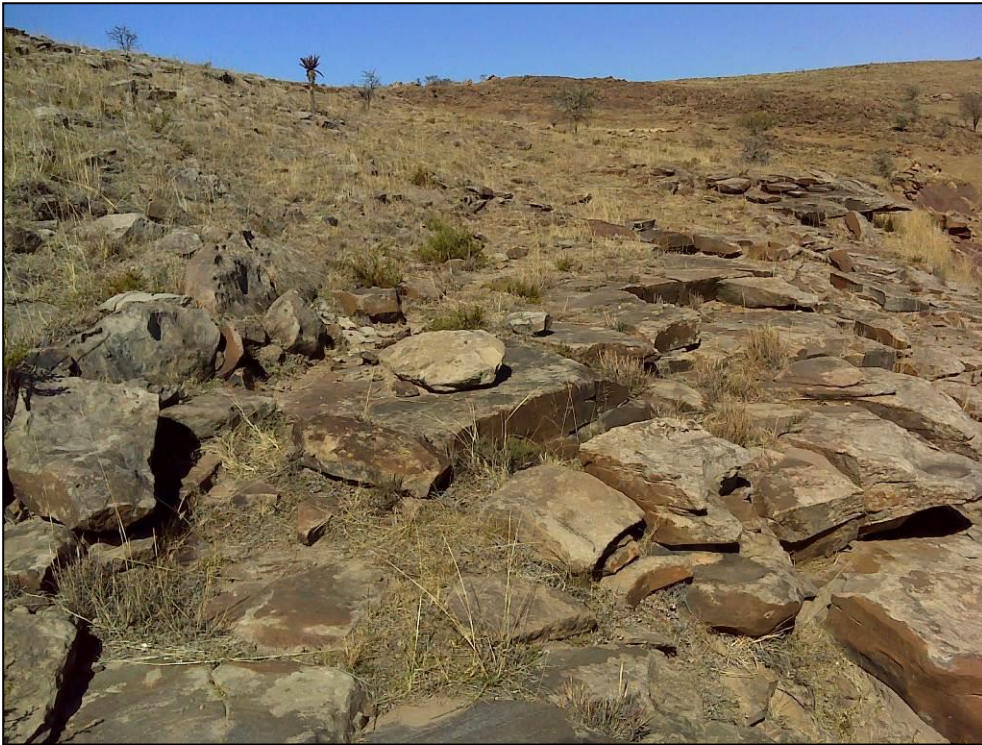
The vegetation cover is mainly low grass cover that allowed for relatively good archaeological visibility (Figures 24-25). The exposed and disturbed surface and soil eroded areas were investigated for the possibility of encountering archaeological heritage remains.

No archaeological or other heritage resources were documented within the exposed areas. However, it is possible that stone artefacts may occur in primary context (*in situ*) 50 cm – 80 cm underneath the dense vegetation.

**Figure 24. View of the general landscape of the area proposed for the extension of Borrow Pit 186 (BP186) facing north.**

**Figure 25. View of the general landscape of the area proposed for the extension of Borrow Pit 186 (BP186) facing south.**

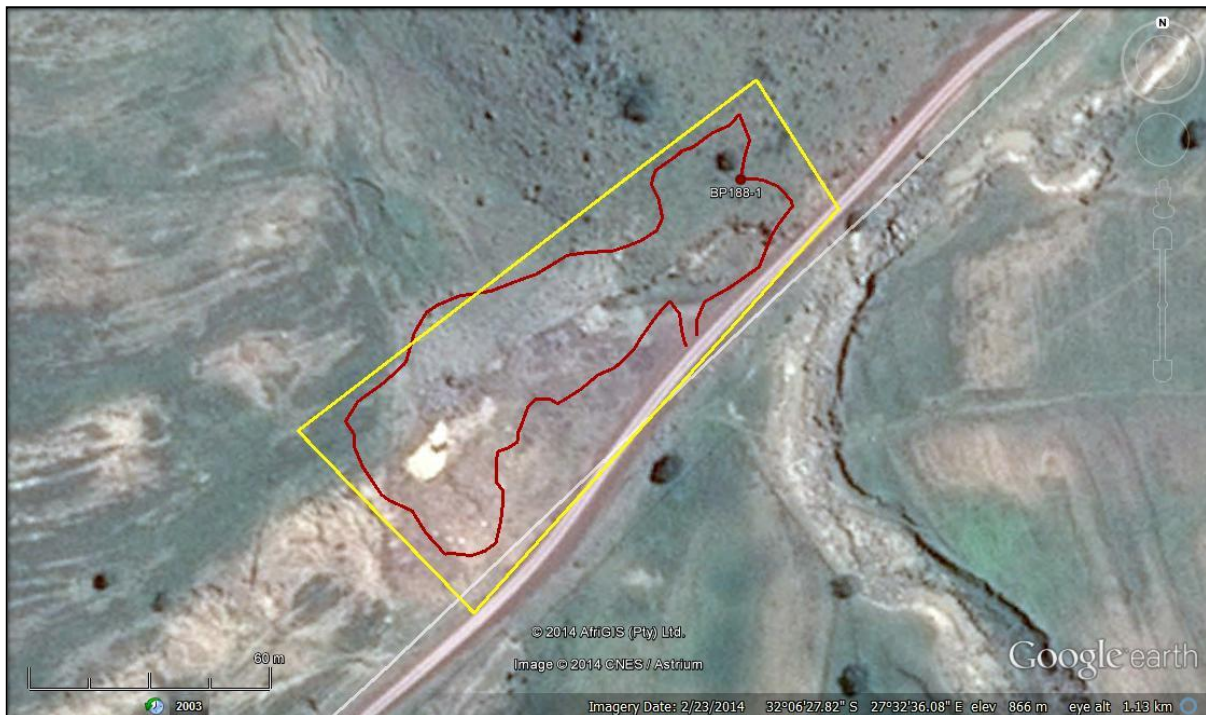
**Figure 26. Close-up aerial view of the area proposed for Borrow Pit 188 (BP188) showing the extent of the proposed borrow pit and area surveyed.**

Borrow Pit 188 (BP188) is located about 5 km from Borrow Pit 186 (BP186) along the DR 08375 on the Farm Banzi No. 114 (Figure 26). The site is situated on the northern side of the road between the villages of Thunzini and Luxeni Villages.

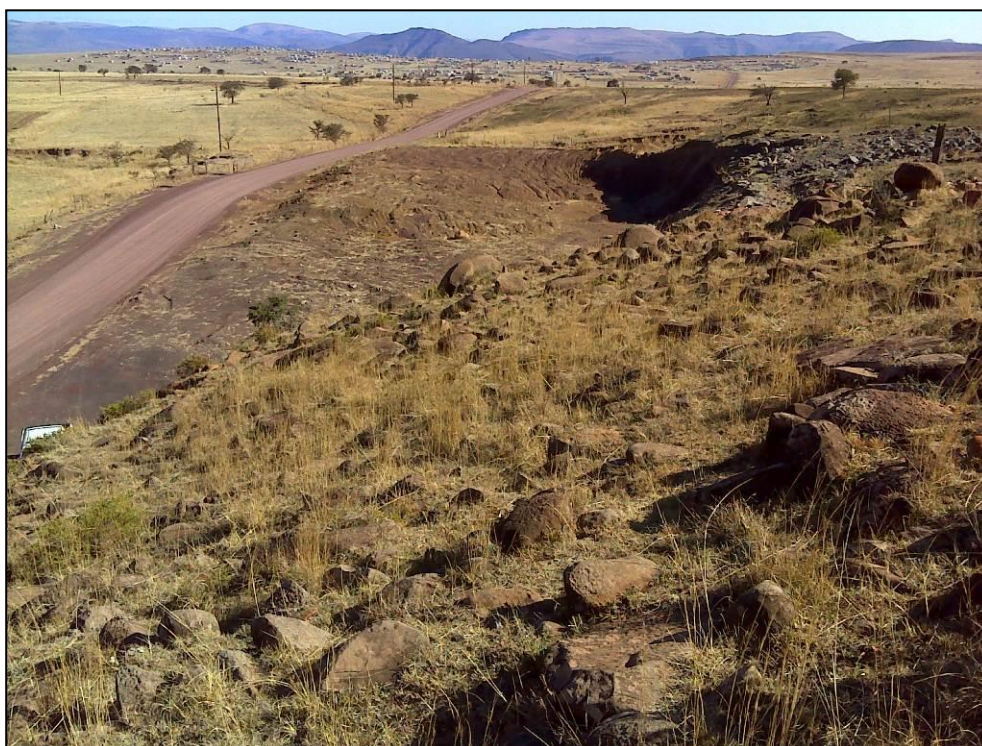
**Figure 27. View of the existing Borrow Pit 186 (BP186).**

The intention is to expand the existing borrow pit area. The existing borrow pit area is approximately 105 m x 20 m in extent (Figure 27). The proposed borrow pit area including the existing borrow pit is approximately 145 m x 65 m in extent.

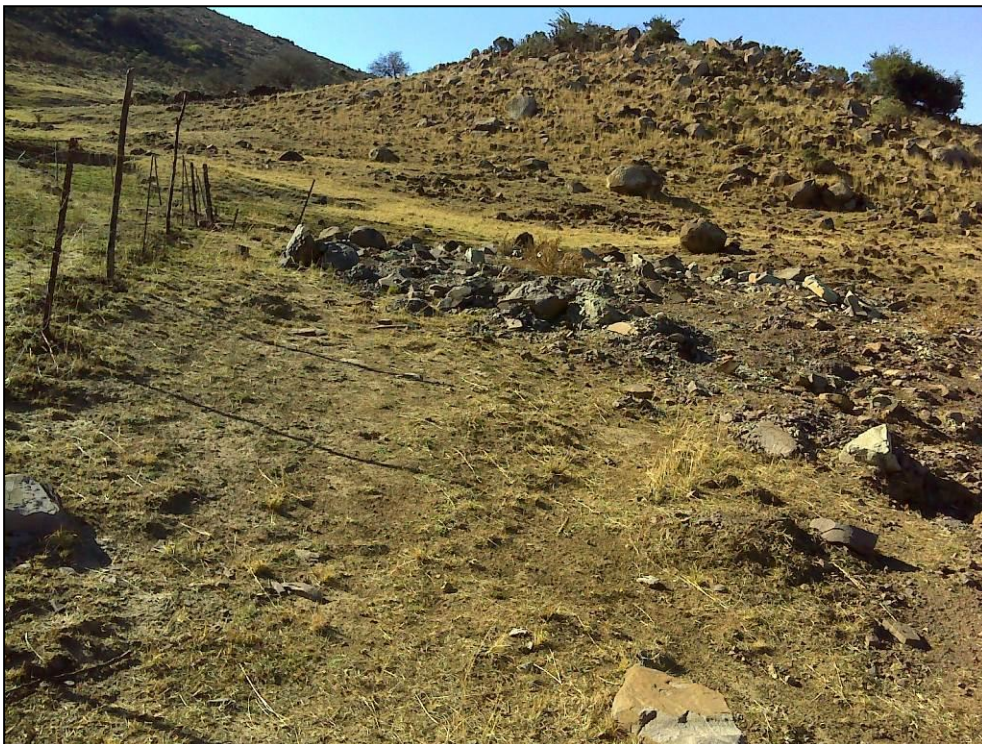
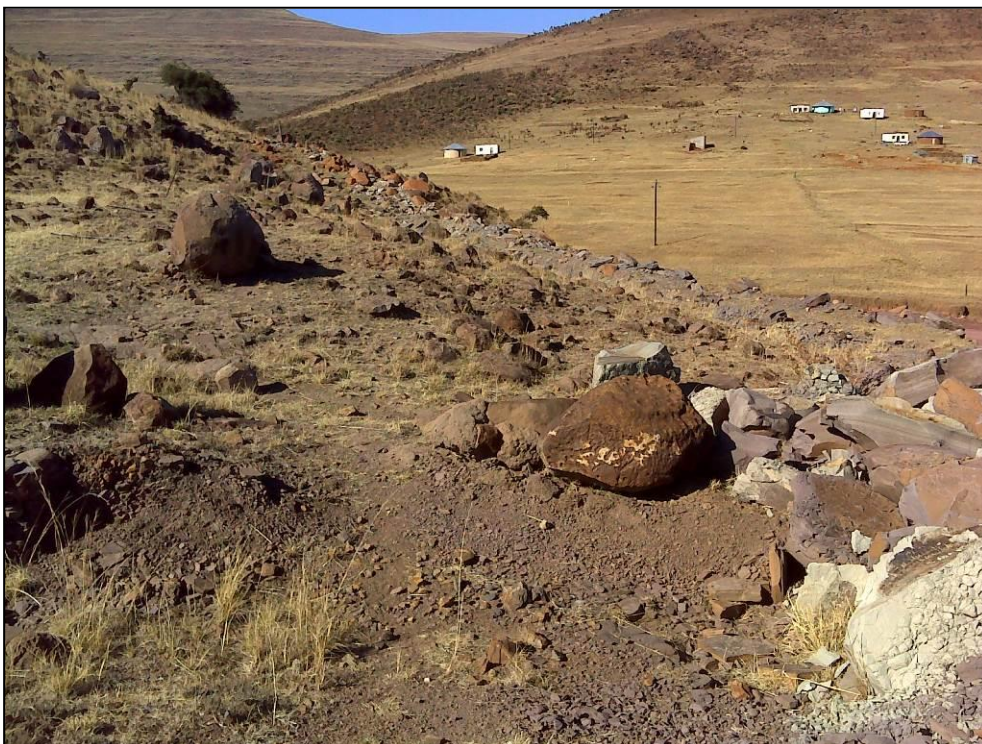
The vegetation cover is mainly low grass cover that allowed for relatively good archaeological visibility (Figures 28-29). The exposed and disturbed surface and soil eroded areas were investigated for the possibility of encountering archaeological heritage remains.

No archaeological or other heritage resources were documented within the exposed areas. However, it is possible that stone artefacts may occur in primary context (*in situ*) 50 cm – 80 cm underneath the dense vegetation.

**Figure 28. View of the general landscape of the area proposed for the extension of Borrow Pit 188 (BP188) facing north-east.**

**Figure 29. View of the general landscape of the area proposed for the extension of Borrow Pit 188 (BP188) facing east.**

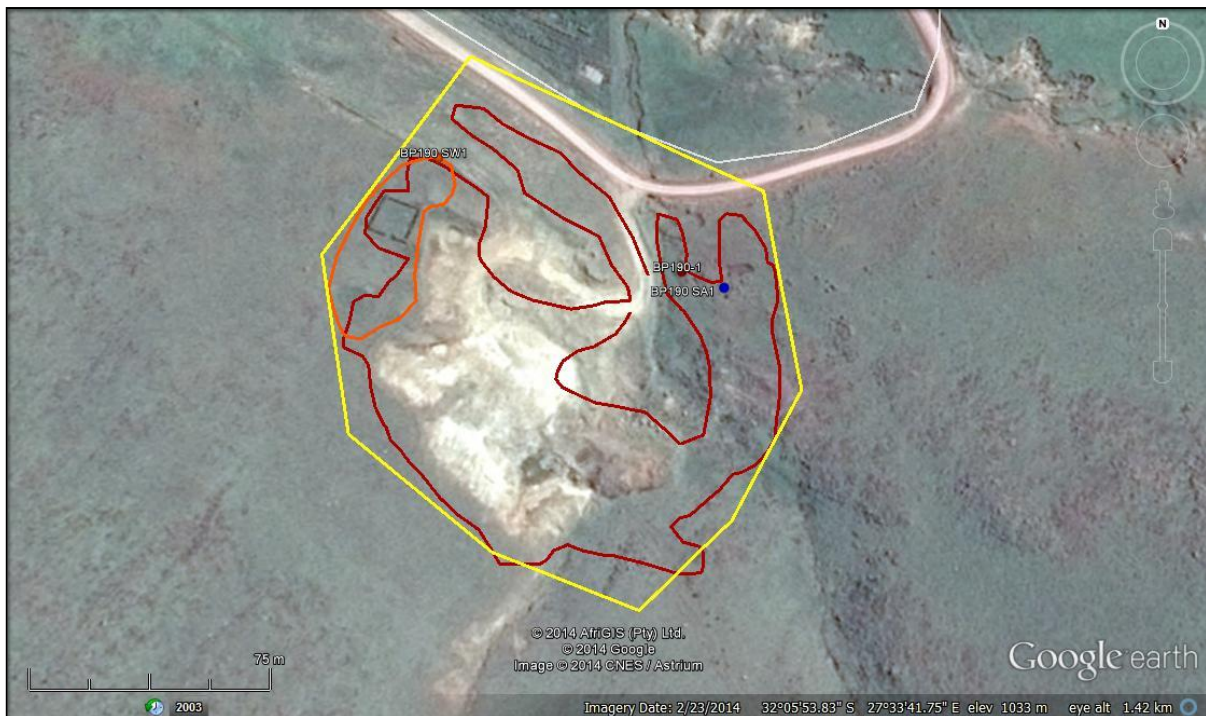
**Figure 30. Close-up aerial view of the area proposed for Borrow Pit 190 (BP190) showing the extent of the proposed borrow pit and area surveyed.**

Borrow Pit 190 (BP190) is located about 3 km from Borrow Pit 188 (BP188) along the DR 08375 on the Farm Qutsa No. 113 (Figure 30). The site is situated on the southern side of the road in close proximity to Ngxingweni Village.

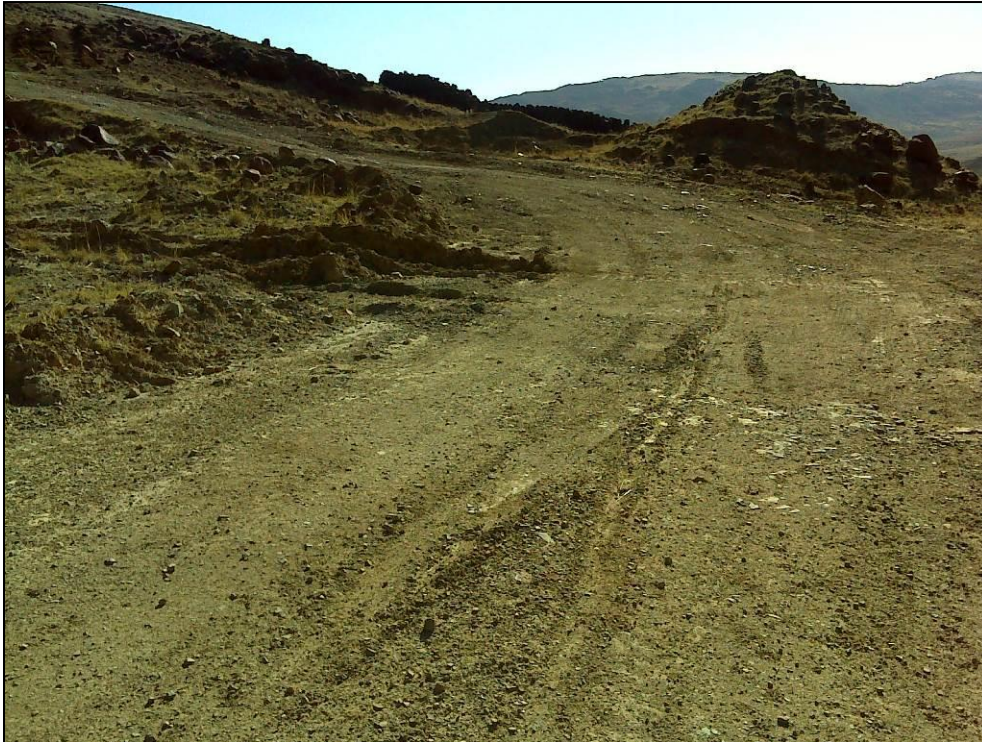
**Figure 31. View of the existing Borrow Pit 190 (BP190).**

The intention is to expand the existing borrow pit area. The existing borrow pit area is approximately 110 m x 100 m in extent (Figure 31). The proposed borrow pit area including the existing borrow pit is approximately 175 m x 160 m in extent.
