**A PHASE 1 ARCHAEOLOGICAL IMPACT ASSESSMENT (AIA) FOR THE PROPOSED ROAD UPGRADE OF THE DR 08376 FROM THE R61 AT ST MARKS TO SABALELE VILLAGE AND ASSOCIATED BORROW PITS, NEAR COFIMVABA, INTSIKA YETHU LOCAL MUNICIPALITY, EASTERN CAPE PROVINCE.**

**Date:** September 2014

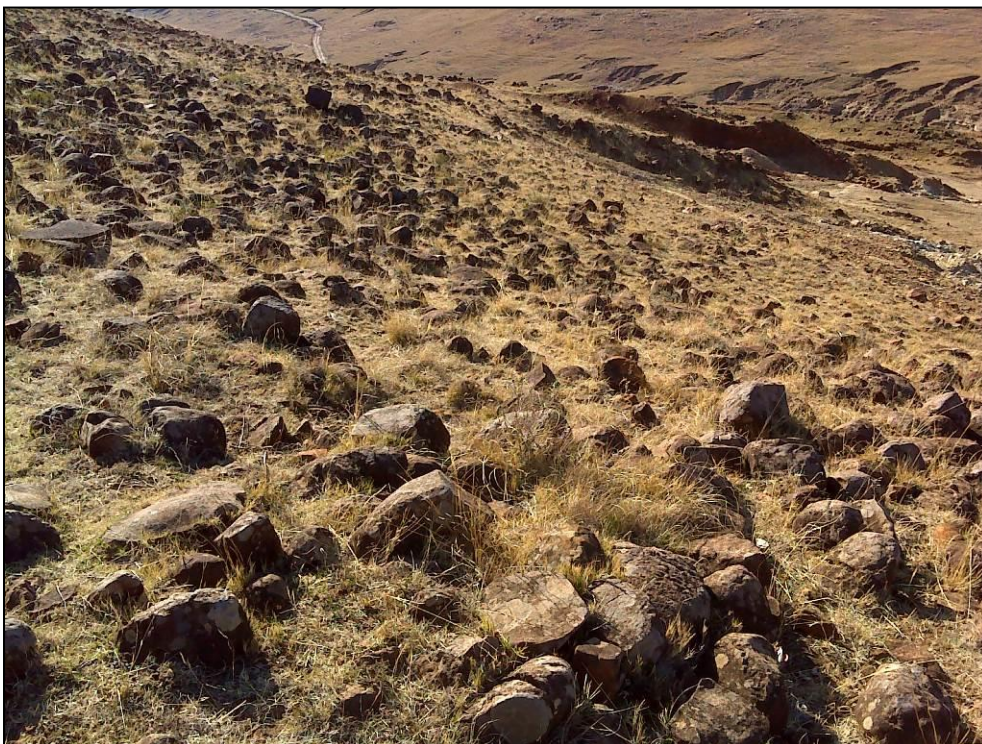
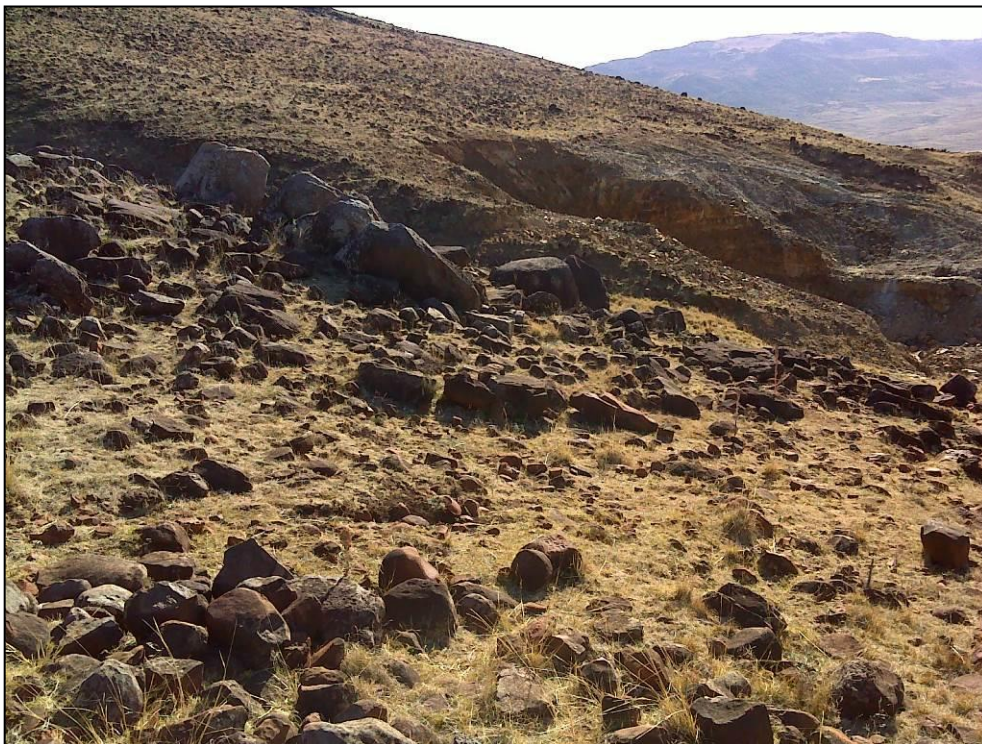
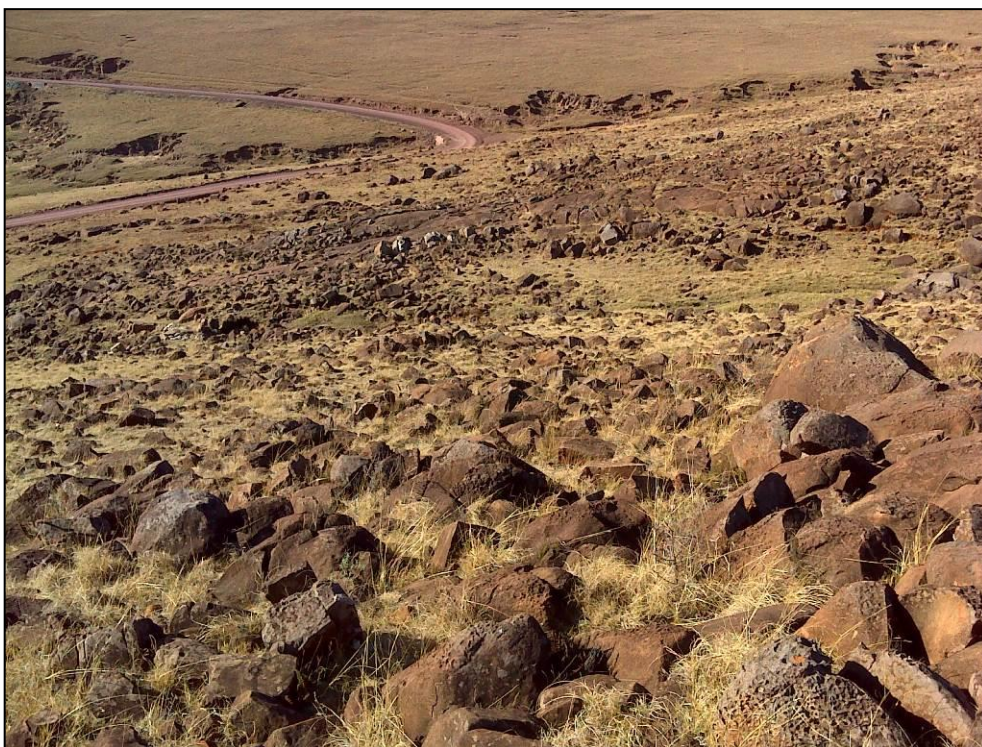
**Figure 32. View of the general landscape of the area proposed for the extension of Borrow Pit 190 (BP190) facing north-west.**

**Figure 33. View of the general landscape of the area proposed for the extension of Borrow Pit 190 (BP190) facing west.**

**Figure 34. View of the general landscape of the area proposed for the extension of Borrow Pit 190 (BP190) facing north.**

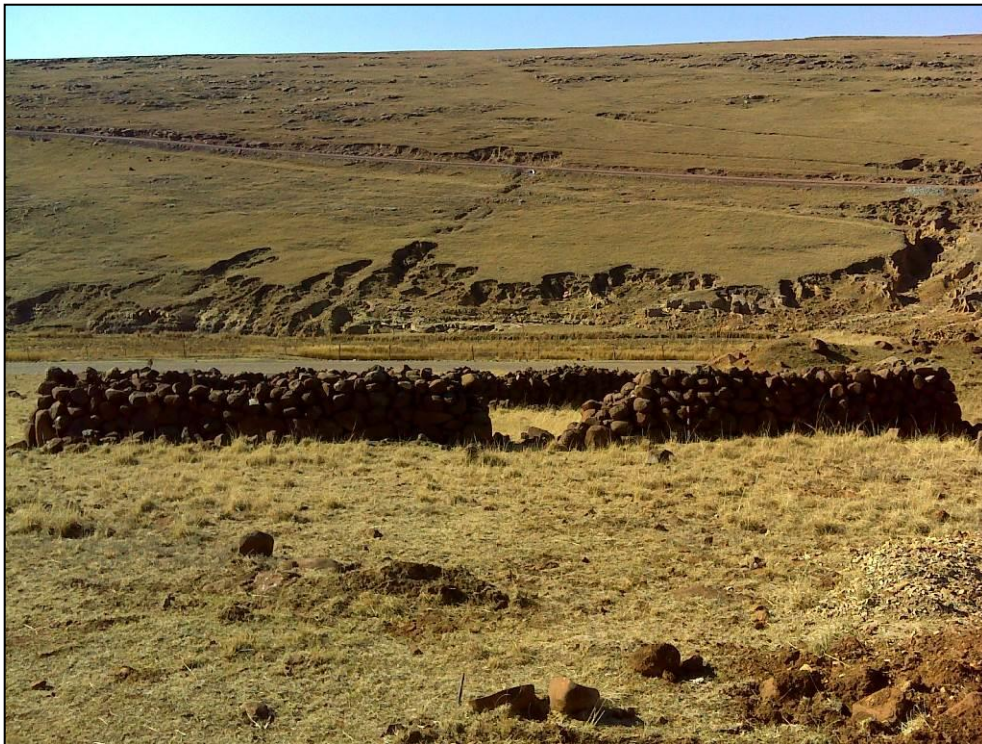
A dry packed stone walling complex occurs within the north-western boundary of the proposed extended mining area (Figures 35-37). The complex comprises one rectangular structure, the foundations (floor) remains of what may have been a hut floor, and a low possibly erosion wall.

**Figure 35. View of one of the dry packed stone walling features situated within the area proposed for the extension of Borrow Pit 190 (BP190).**

**BP190 SW1:** A dry packed stone walling complex comprising of one relatively intact rectangular enclosure, one smaller circular enclosure, the possible remains of the foundation of a hut floor.

It is unlikely that the dry packed stone walling complex at SVR SW1 would be negatively impacted by the proposed development. The dry packed stone walling complexes BP171 SW1 and BP190 SW1 are situated within the proposed quarrying area and would probably be negatively affected by the proposed development. Therefore, the appropriate recommended mitigation measures must be considered before development may proceed. However, if it is deemed necessary that these structures be demolished for the proposed development to proceed, it is recommended that a specialist oral historian be appointed to assess the significance of the dry packed stone walling complexes.

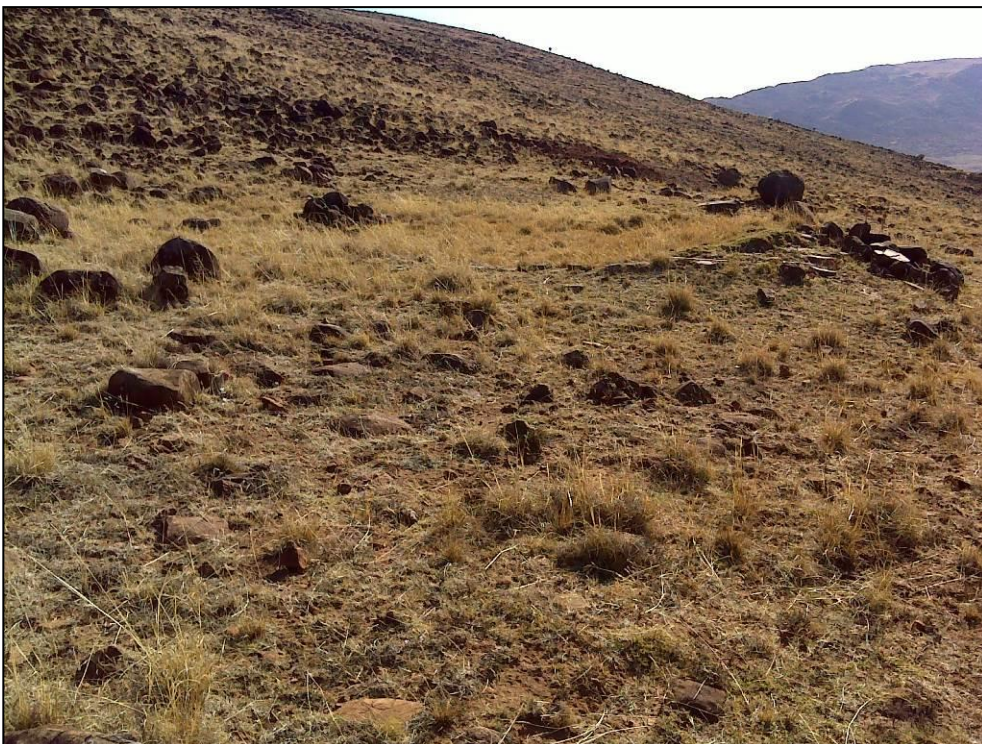
**Figure 36. View of one of the dry packed stone walling features situated within the area proposed for the extension of Borrow Pit 190 (BP190).**

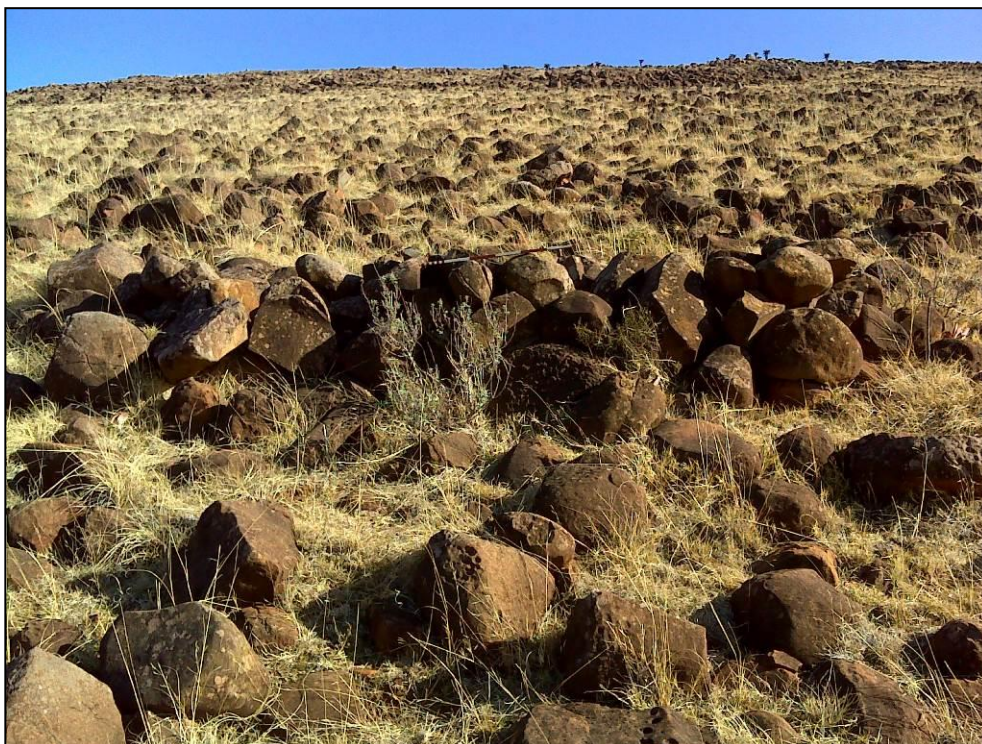
**Figure 37. View of one of the dry packed stone walling features situated within the area proposed for the extension of Borrow Pit 190 (BP190).**

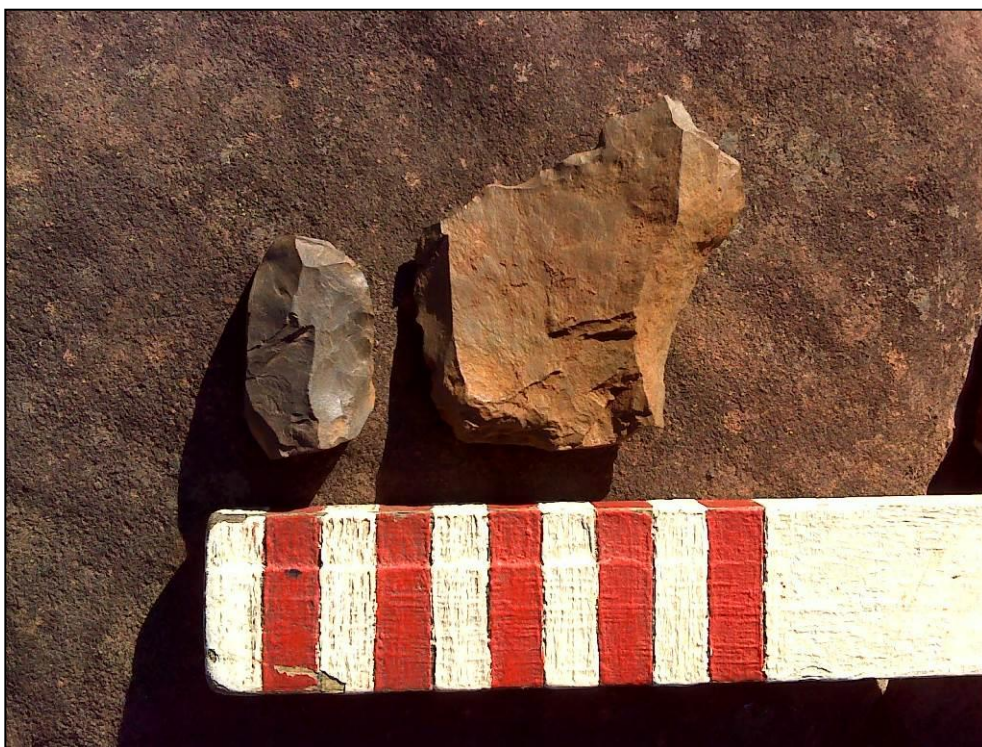
Two stone artefacts were documented within the north-eastern boundary of the proposed extended mining area (Figure 38).

**Figure 38. Examples of stone artefacts documented within the area proposed for the extension of Borrow Pit 190 (BP190).**

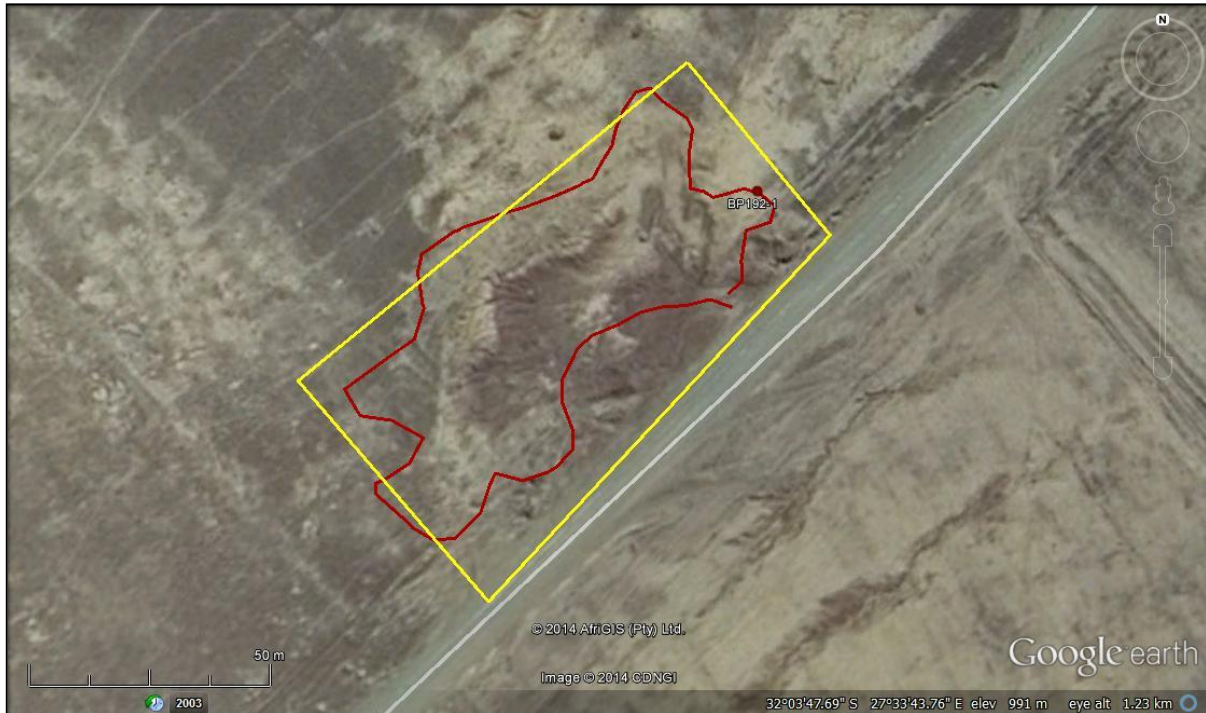
**Figure 39. Close-up aerial view of the area proposed for Borrow Pit 192 (BP192) showing the extent of the proposed borrow pit and area surveyed.**

Borrow Pit 192 (BP192) is located about 4.5 km from Borrow Pit 190 (BP190) along the DR 08375 on the Farm Camama No.112 (Figure 39). The site is situated on the northern side of the road in south of Camama and Mkoba Villages.

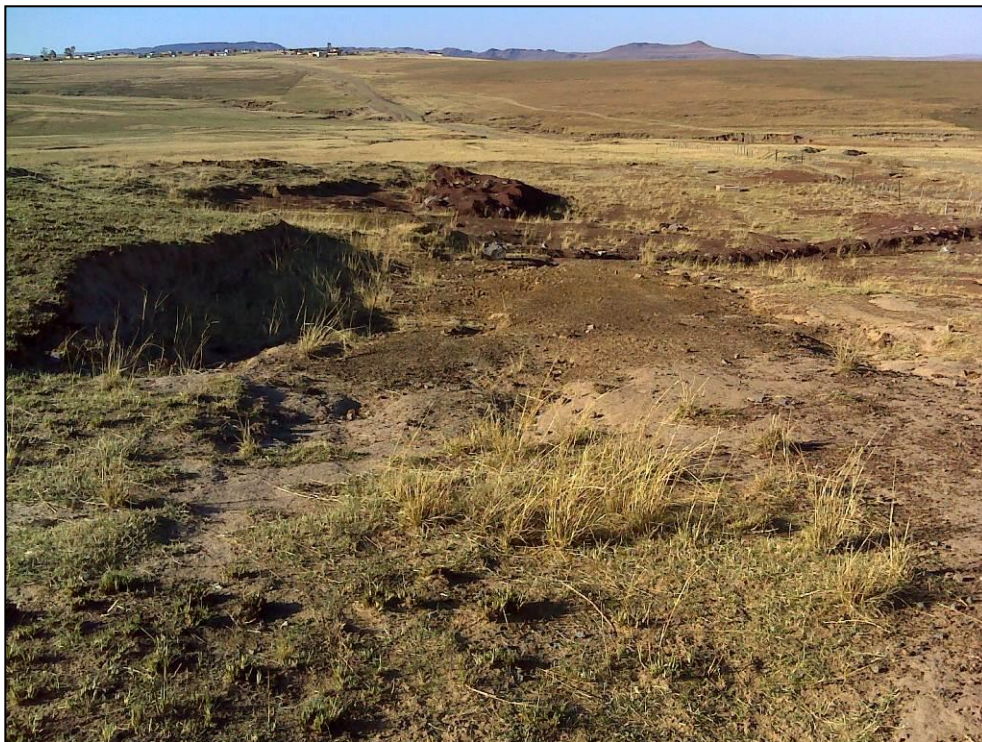
**Figure 40. View of the existing Borrow Pit 192 (BP192).**

The intention is to expand the existing borrow pit area. The existing borrow pit area is approximately 60 m x 20 m in extent (Figure 40). The proposed borrow pit area including the existing borrow pit is approximately 115 m x 66 m in extent.

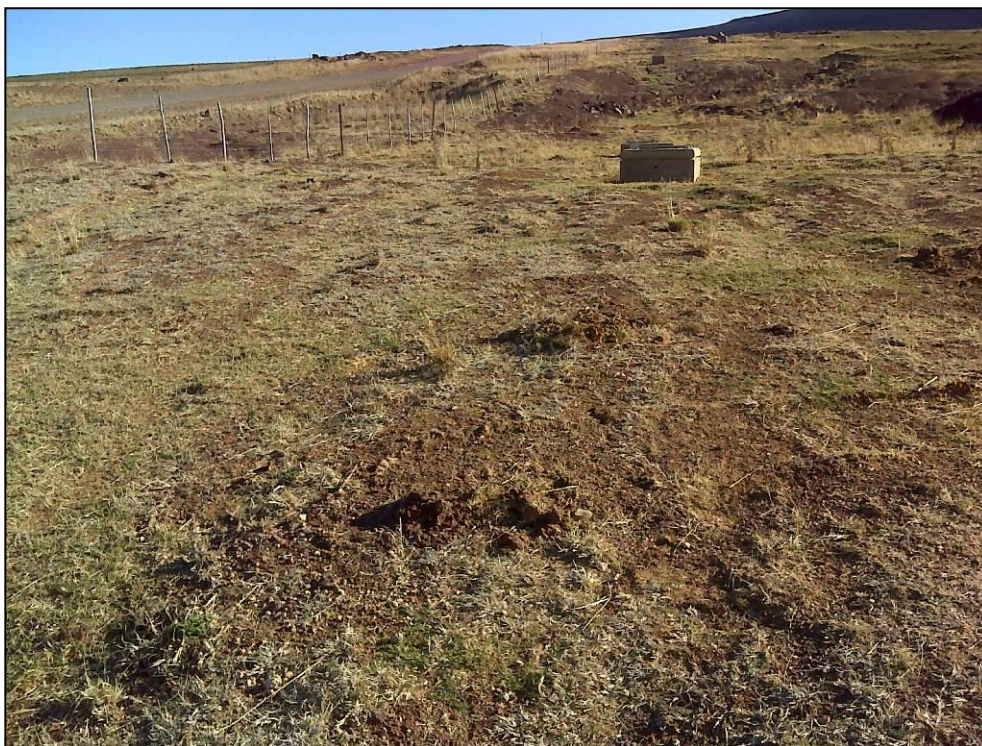
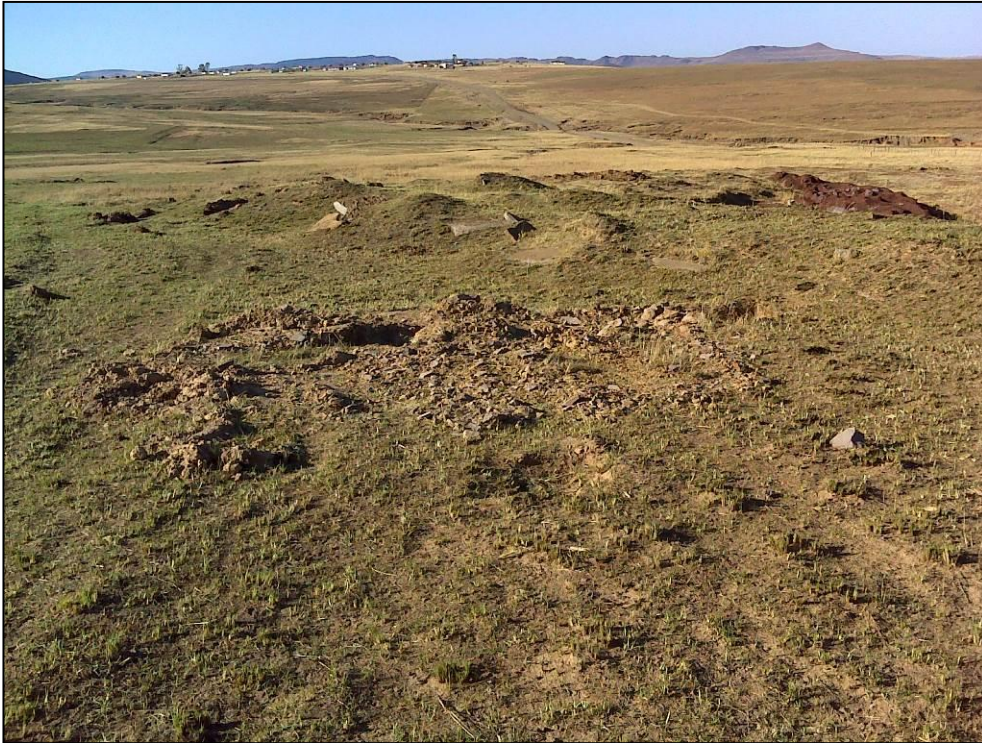
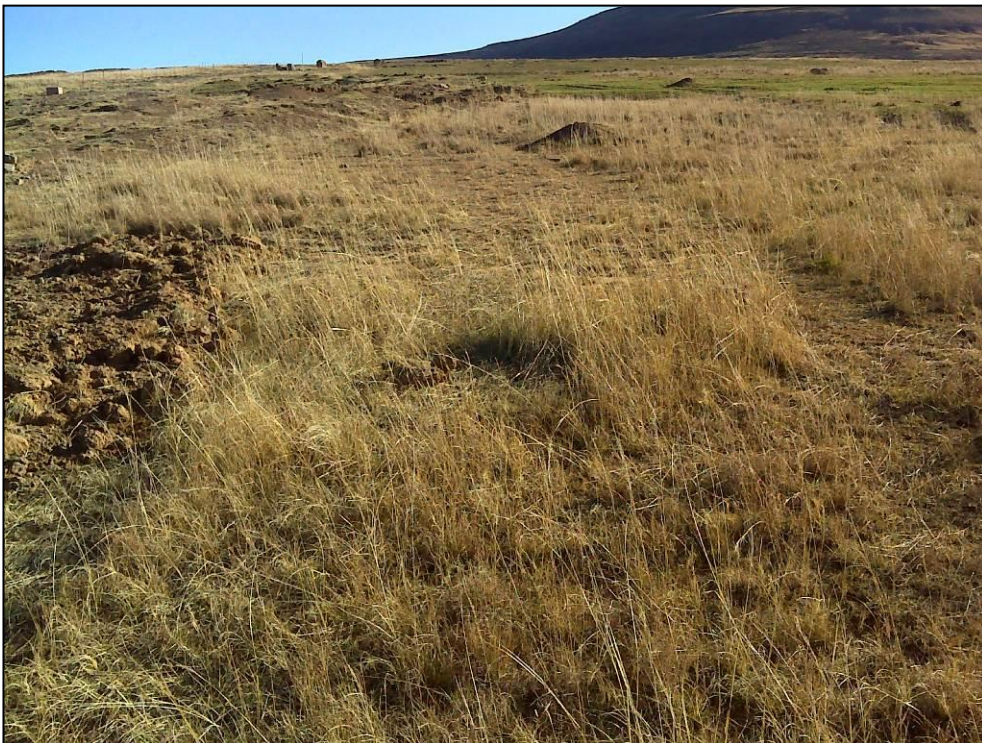
The vegetation cover is mainly a mixture of sparse and dense low grass cover that allowed for relatively good archaeological visibility (Figures 41-43). The exposed and disturbed surface and soil eroded areas were investigated for the possibility of encountering archaeological heritage remains.

No archaeological or other heritage resources were documented within the exposed areas. However, it is possible that stone artefacts may occur in primary context (*in situ*) 50 cm – 80 cm underneath the dense vegetation.

**Figure 41. View of the general landscape of the area proposed for the extension of Borrow Pit 192 (BP192) facing south-west.**

**Figure 42. View of the general landscape of the area proposed for the extension of Borrow Pit 192 (BP192) facing north-east.**

**Figure 43. View of the general landscape of the area proposed for the extension of Borrow Pit 192 (BP192) facing west.**

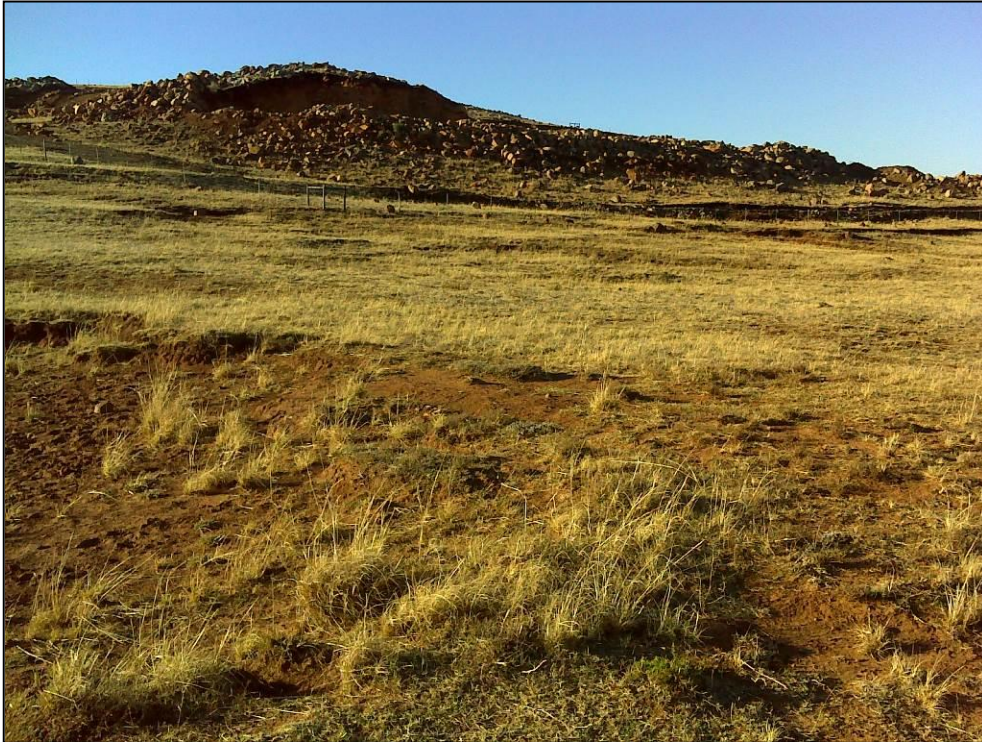
**Figure 45. View of the existing Borrow Pit 193 (BP193).**

The intention is to expand the existing borrow pit area. The existing borrow pit area is approximately 165 m x 130 m in extent (Figure 45). The proposed borrow pit area including the existing borrow pit is approximately 235 m x 230 m in extent.

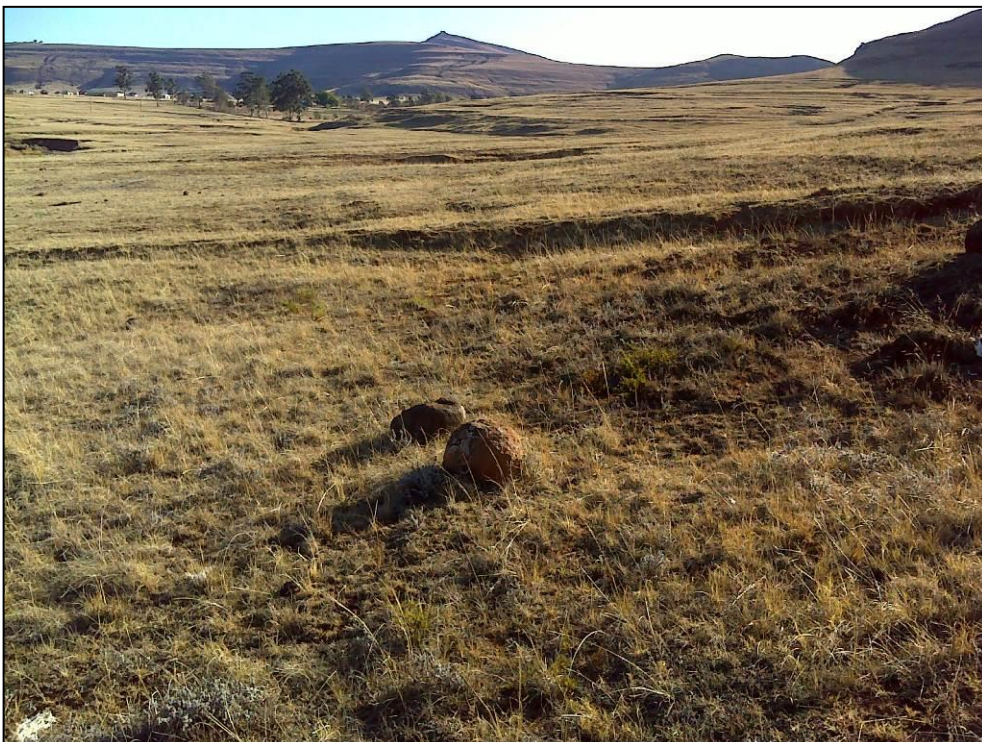
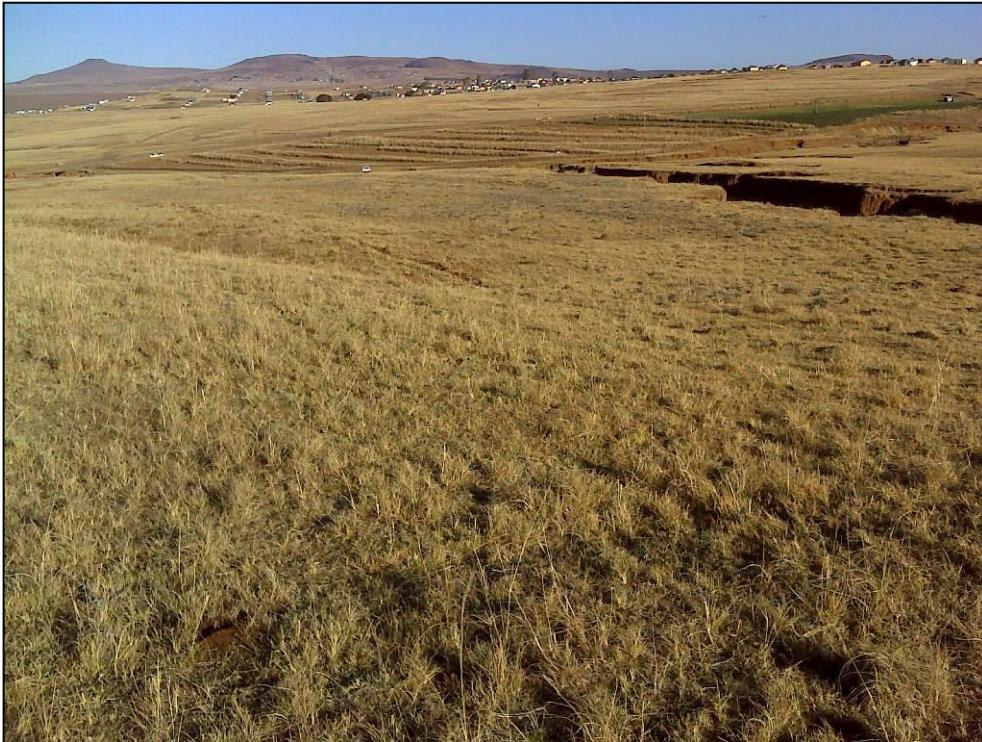
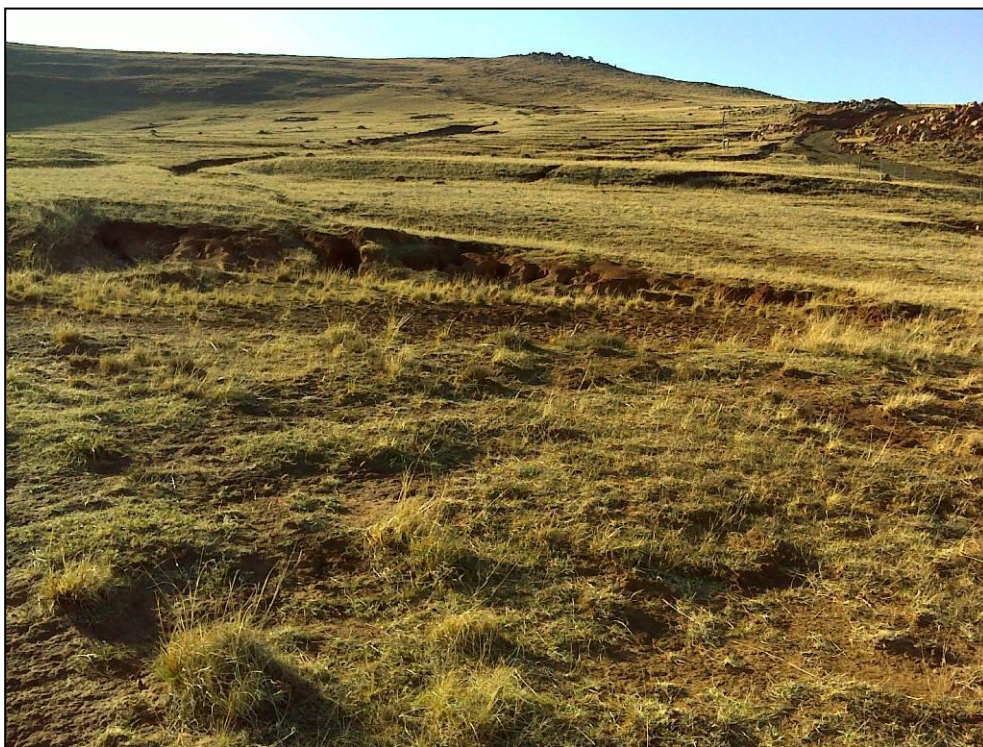
The vegetation cover is mainly dense low dense grass cover that made archaeological visibility difficult (Figures 46-48). The exposed and disturbed surface and soil eroded areas were investigated for the possibility of encountering archaeological heritage remains.

**Figure 46. View of the general landscape of the area proposed for the extension of Borrow Pit 193 (BP193) facing west.**

**Figure 47. View of the general landscape of the area proposed for the extension of Borrow Pit 192 (BP192) facing west.**

**Figure 48. View of the general landscape of the area proposed for the extension of Borrow Pit 193 (BP193) facing west.**

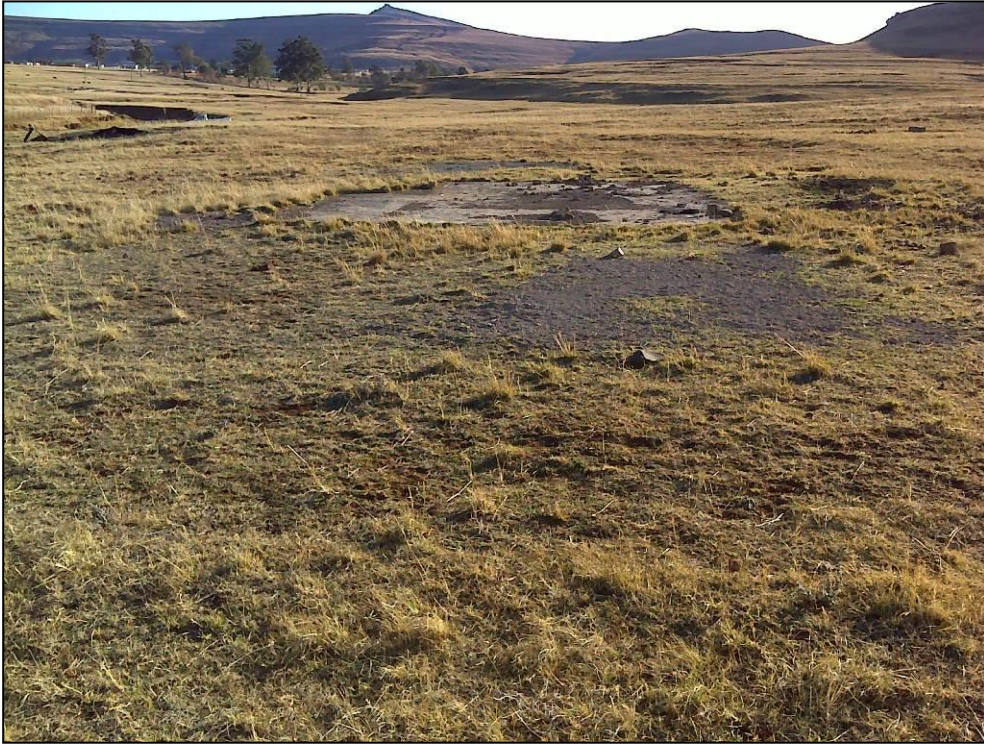
A dry packed stone walling complex occurs within the northern boundary of the existing borrow pit area. The concrete remains of an unknown built environment structure was documented in the southern area proposed for the mining activities.

**Figure 49. Remains of foundations situated within the area proposed for the extension of Borrow Pit 193 (BP193).**

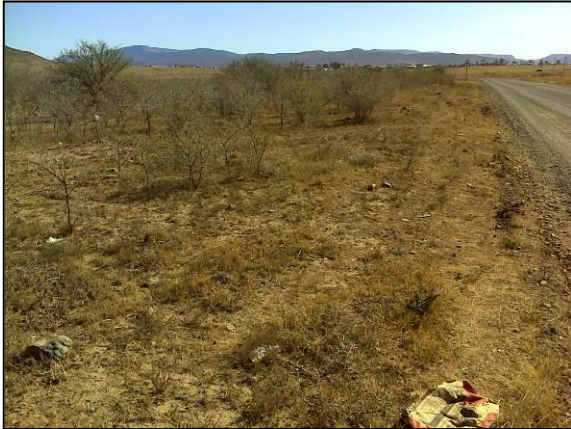
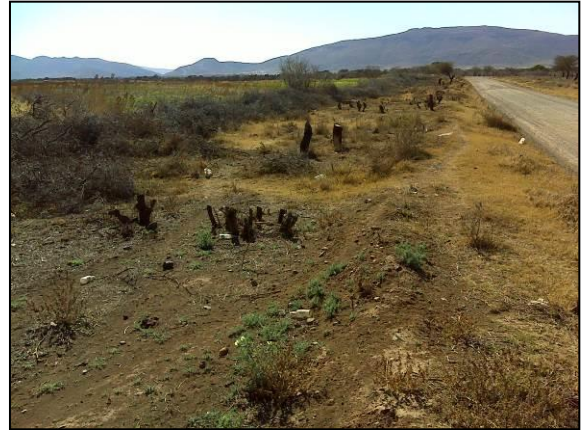
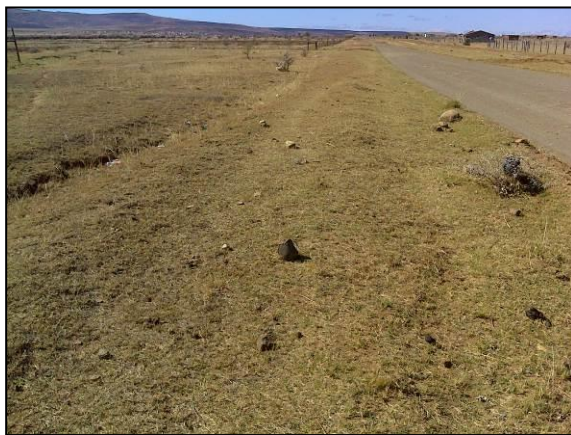
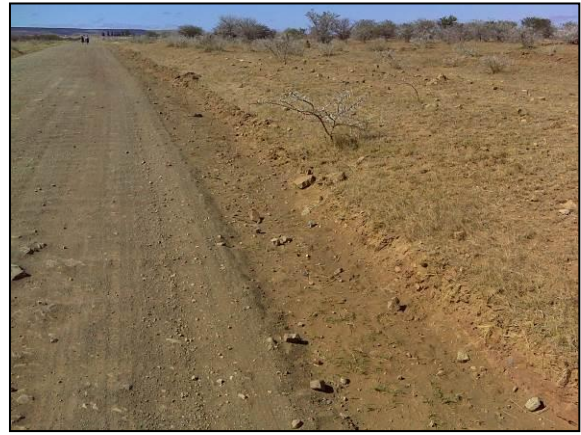
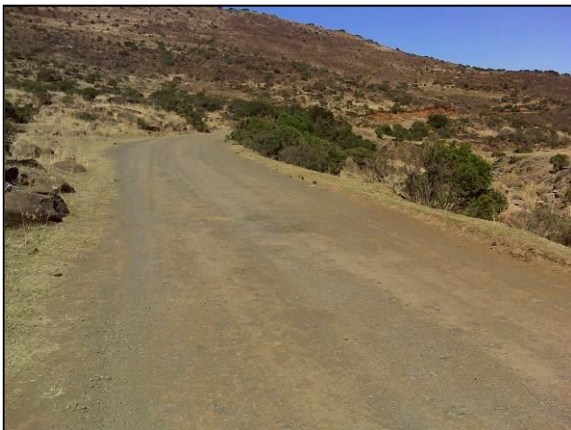
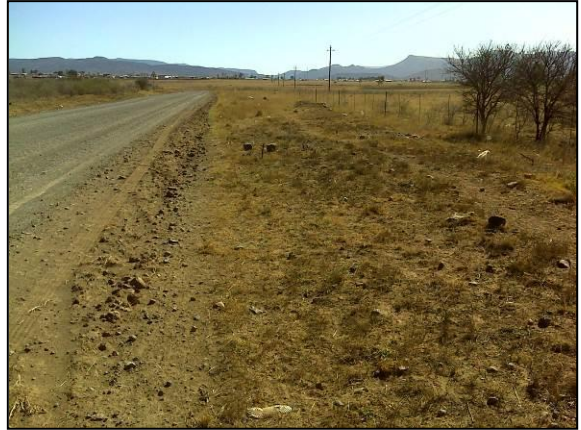
The proposed road upgrade extends from St Mark's Village at the R61 turn-off for about 19 km to Lower Sabalele Village (Figure 50). The vegetation cover of the area within and adjacent to the road reserve proposed for the upgrade of the DR03876 allowed for good archaeology visibility along the route (Figures 51-56). The area within the road reserve and immediately adjacent to the road reserve has in the past been heavily disturbed by the construction and continued maintenance of the existing DR 03876 provincial road as well as by the construction of road drainages channels, power lines, boundary fences, bridges, bus stops located along the route, and the establishment of residential dwellings (Figures .

**Figures 51-56. Views of the general landscape along the route proposed for the upgrade of the DR 08376 provincial road.**

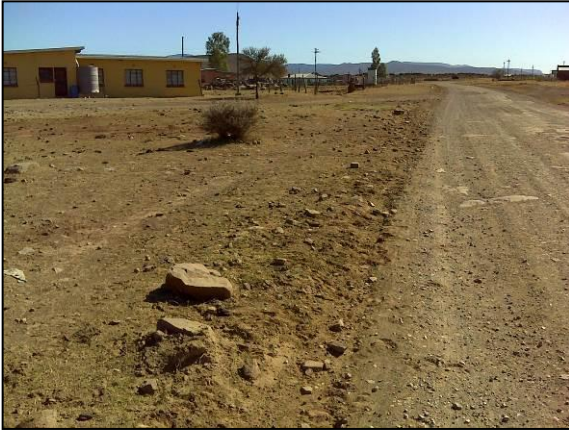
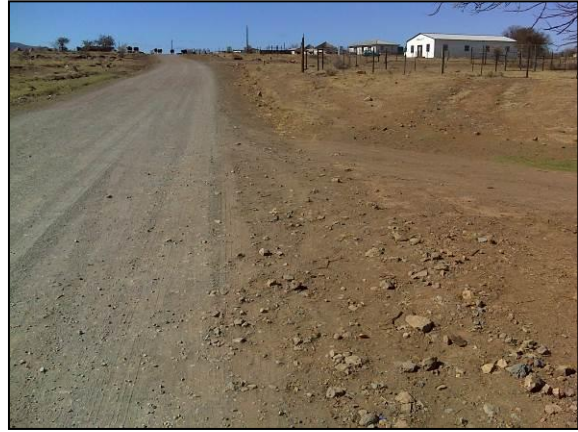
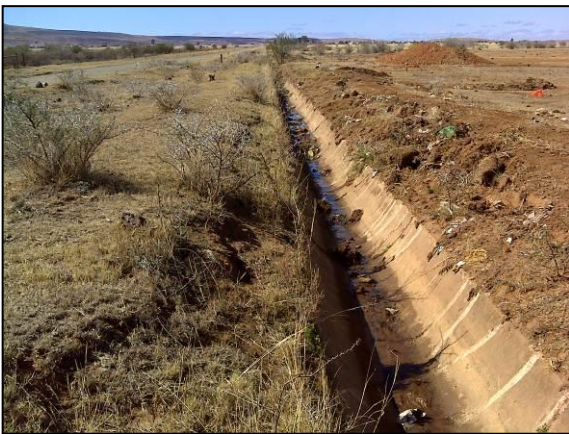
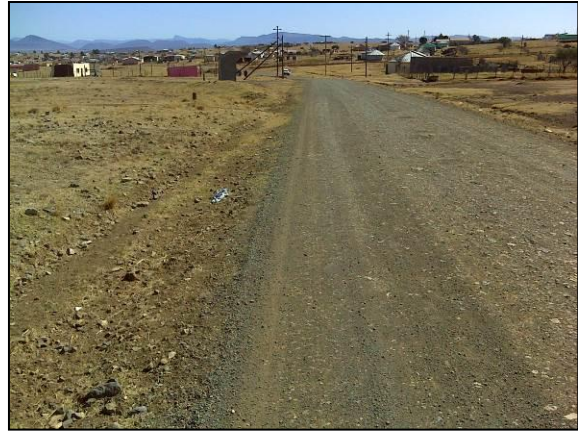
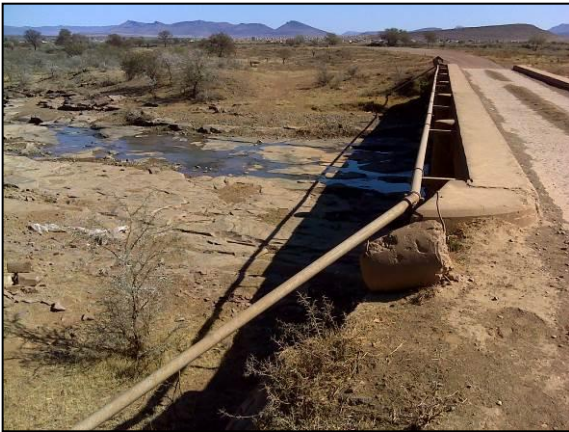
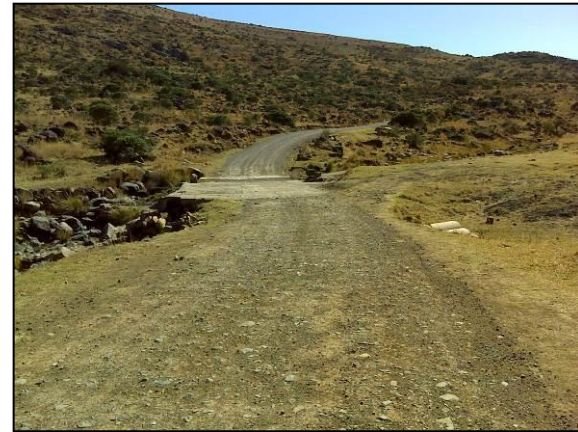
**Figures 57-62. Views of the disturbed areas along the route proposed for the upgrade of the DR 08376 provincial road.**

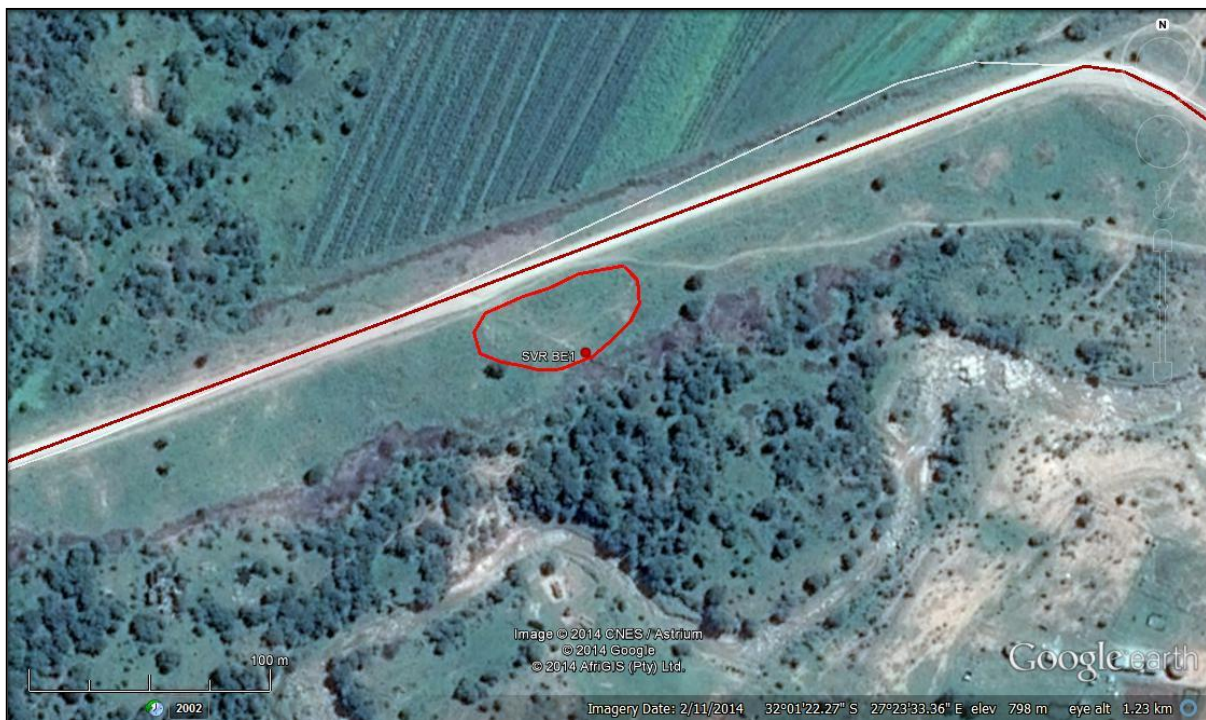
**Figure 63. Close-up aerial view of the location of the ruin of the structure (SVR BE1) situated along the route proposed for the upgrade of the DR 08376.**

SVR BE1 is situated about 3 km along route from St Mark's Village turn off the R61 between the villages of Tubeni, KwaManzi, and Nontengo (Figure 63). It is located on the southern side of the DR 08376 road. Only the broken remains of an unidentifiable concrete structure remains (Figures 64-65). It is unlikely that these remains still have any significant value for conservation. No other artefacts were associated with the built environment remains.

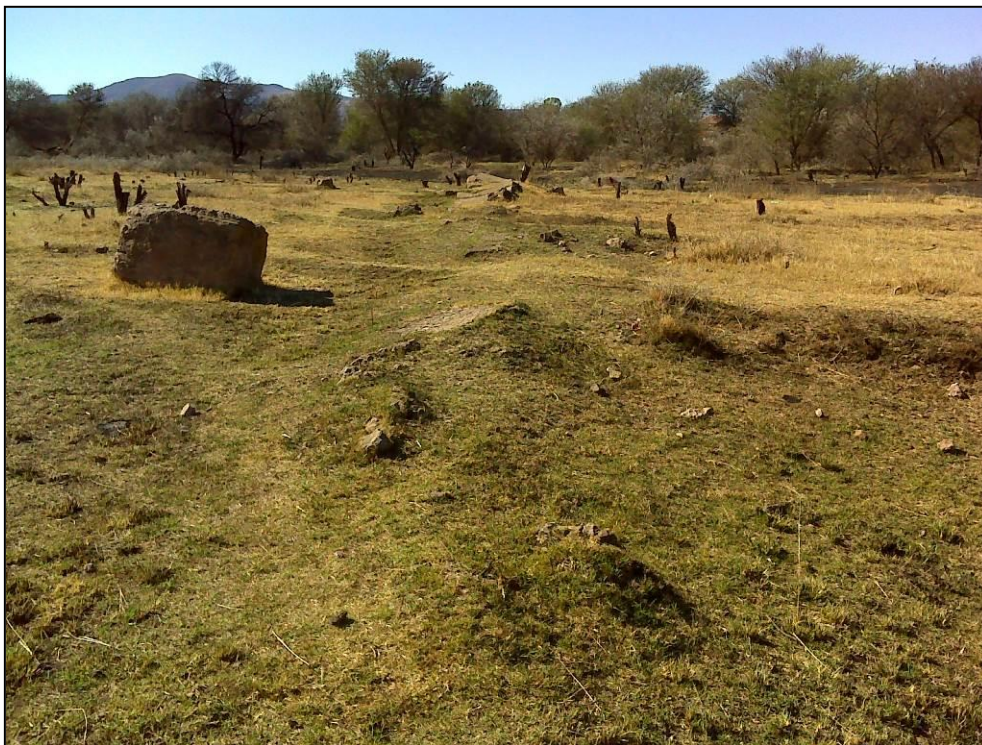
**Figure 64. View of the remains of the structure situated at SVR BE1 facing south.**

However, if it is deemed necessary that these structures be demolished for the proposed development to proceed, it is recommended that a specialist historical archaeologist or historical architect be appointed to assess the significance of the built environment structure.

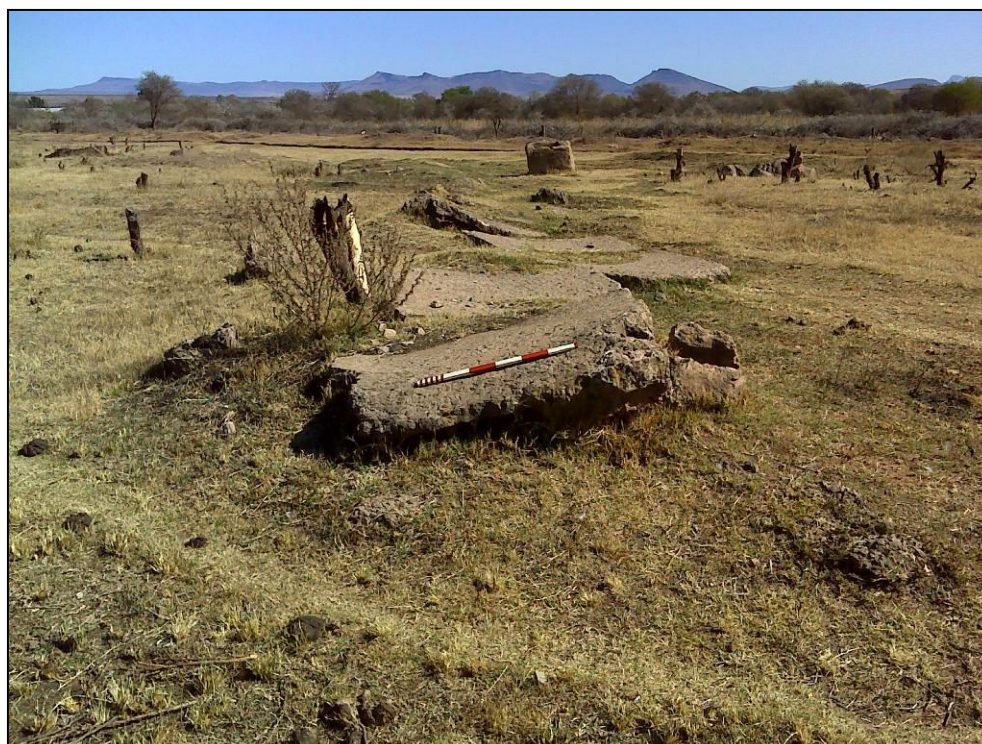
**Figure 65. View of the remains of the structure at SVR BE1 facing north.**

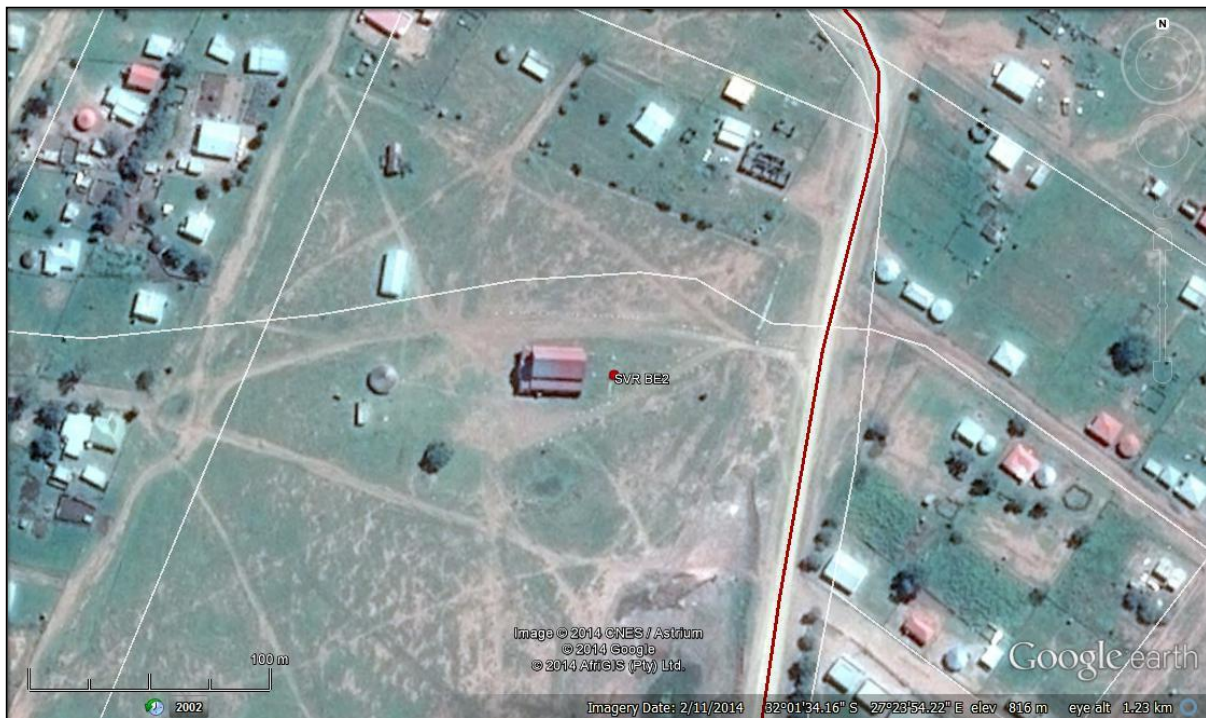
**Figure 66. Close-up aerial view of the location of the historical Anglican Church at St Marks Village.**

SVR BE1 is situated about 4 km along route from St Mark's Village turn off the R61 between the villages of Kwa Manzi, and Nontengo (Figure 66). It is located on the northern side of the DR 08376 road. The structure is the historical Anglican Church once part of the St Mark's mission station established in 1855 (Figure 67). The church is still being used by the local community. A monument dedicated to the first black Anglican priest in South African, Peter (Petrus) K. Masiza and the possible headstone of Henry Waters who established the St Mark's mission in 1855 are located in front of the Anglican Church within its property boundary (Figures 68-69).

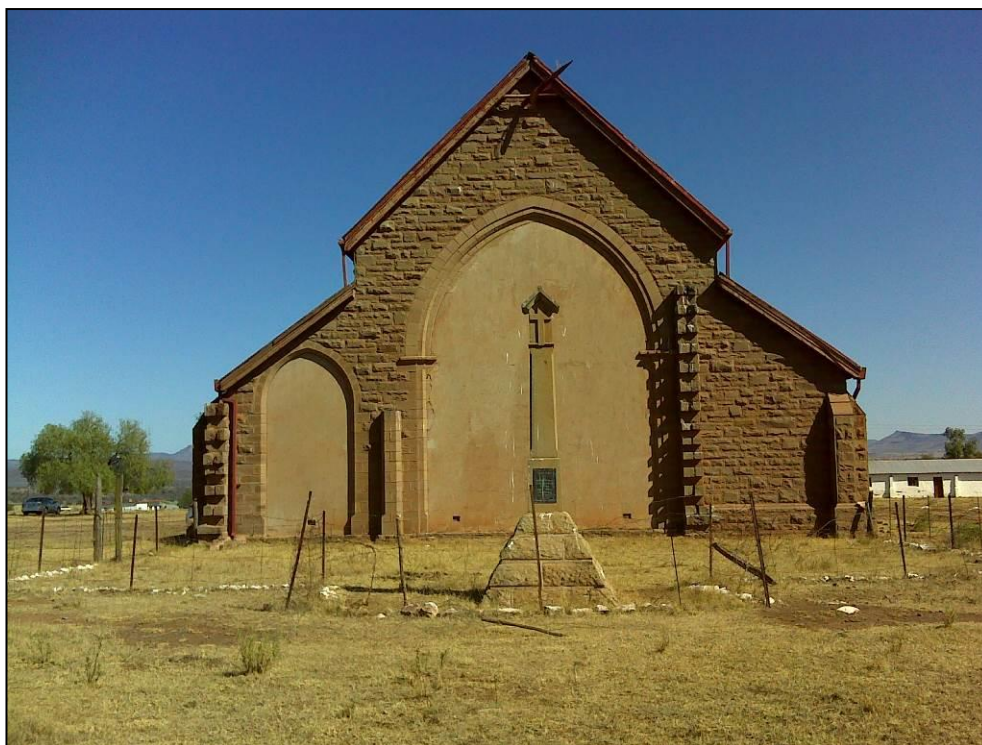
The church's property is fenced and should not be negatively affected by the proposed development.

**Figure 67. View of the historical Anglican Church at St Marks Village.**

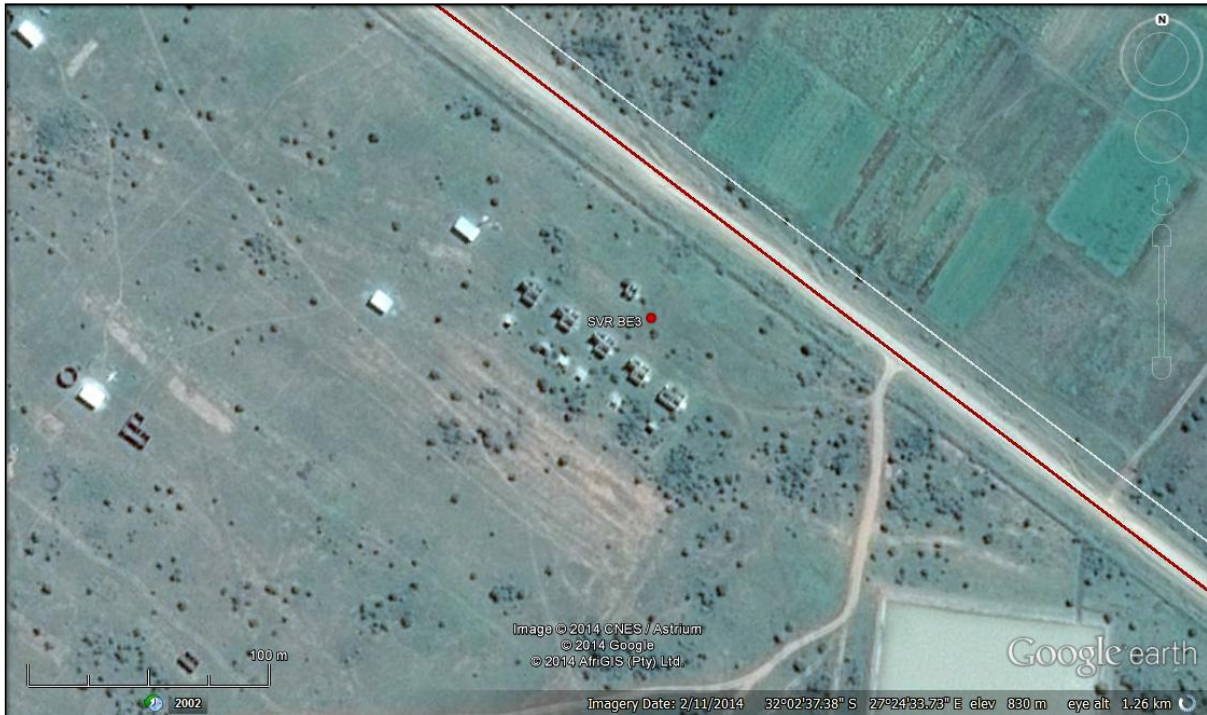
**Figure 70. Close-up aerial view of the location of the abandoned structures situated on the property St Marks Mission.**

SVR BE3 is situated about 6.5 km along route from St Mark's Village turn off the R61 between the villages of Nontengo and Luncwini (Figure 70). It is located about 45 m on southern side of the DR 08376 road. The roofs, doors, and windows have been stripped and only the abandoned structures remains (Figure 71). The buildings may be associated with the St Marks mission station. It is likely that the buildings should not be negatively affected by the proposed development.
