**A PHASE 1 ARCHAEOLOGICAL IMPACT ASSESSMENT (AIA) FOR THE PROPOSED ROAD UPGRADE OF THE DR 08376 FROM THE R61 AT ST MARKS TO SABALELE VILLAGE AND ASSOCIATED BORROW PITS, NEAR COFIMVABA, INTSIKA YETHU LOCAL MUNICIPALITY, EASTERN CAPE PROVINCE.**

**Date:** September 2014

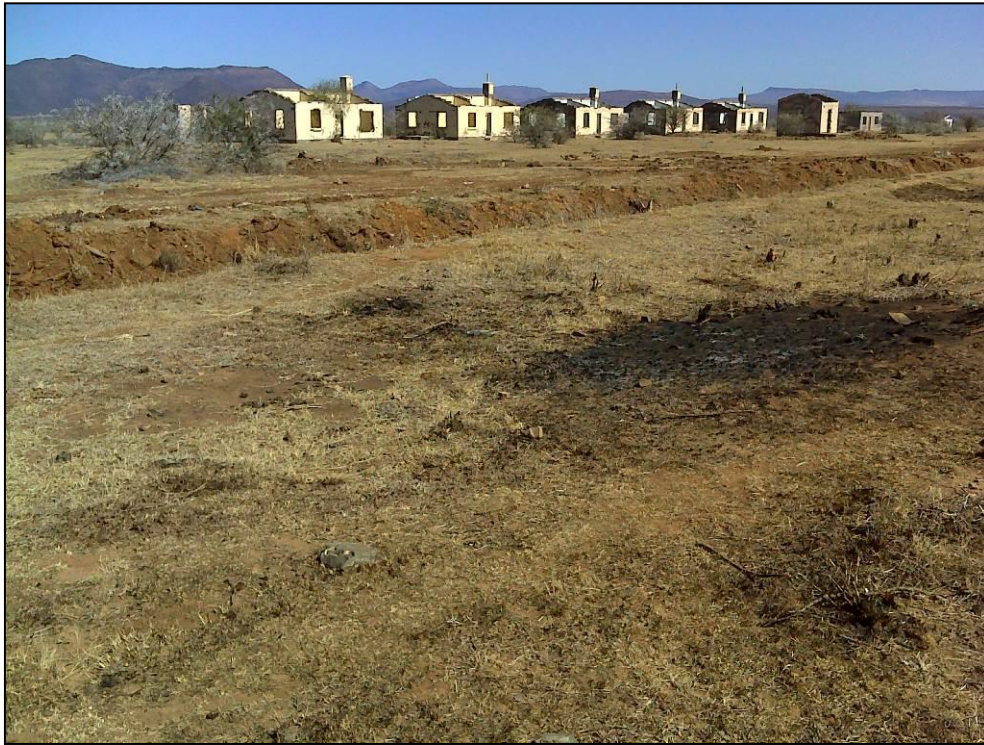
**Figure 71. View of the abandoned buildings on the property St Marks Mission.**

However, if it is deemed necessary that these structures be demolished for the proposed development to proceed, it is recommended that a specialist historical archaeologist or historical architect be appointed to assess the significance of the built environment structure.

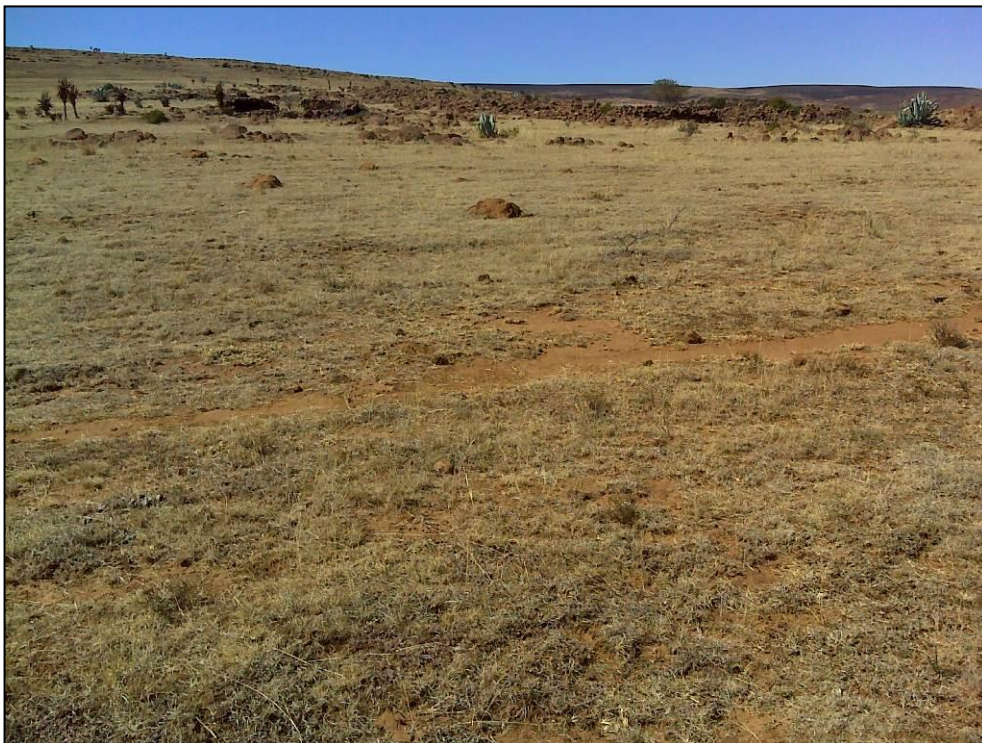
SVR SW1 is situated about 1.5 km south of the position of Borrow Pit 171 (BP171) where dry packed stone walling features were recorded during this survey along route from St Mark's Village turn off the R61 south of the village of Luncwini (Figure 72). Several dry packed stone walling features including rectangular and circular stone walling enclosures occur within the complex (Figures 73-76). This area is most probably an abandoned homestead as several more dry packed stone walling features occur on the landscape and the foundation remains of hut was identified within the area.

**Figure 73. View of the dry packed stone walling complex (SVR SW1) situated along the route for the proposed DR 08376 provincial road upgrade.**

**SVR SW1:** A dry packed stone walling complex comprising of relatively intact rectangular and circular enclosure as well as the possible remains of the foundation of a hut floor.

It is unlikely that the dry packed stone walling complex at SVR SW1 would be negatively impacted by the proposed development. The dry packed stone walling complexes BP171 SW1 and BP190 SW1 are situated within the proposed quarrying area and would probably be negatively affected by the proposed development. Therefore, the appropriate recommended mitigation measures must be considered before development may proceed. However, if it is deemed necessary that these structures be demolished for the proposed development to proceed, it is recommended that a specialist oral historian be appointed to assess the significance of the dry packed stone walling complexes.

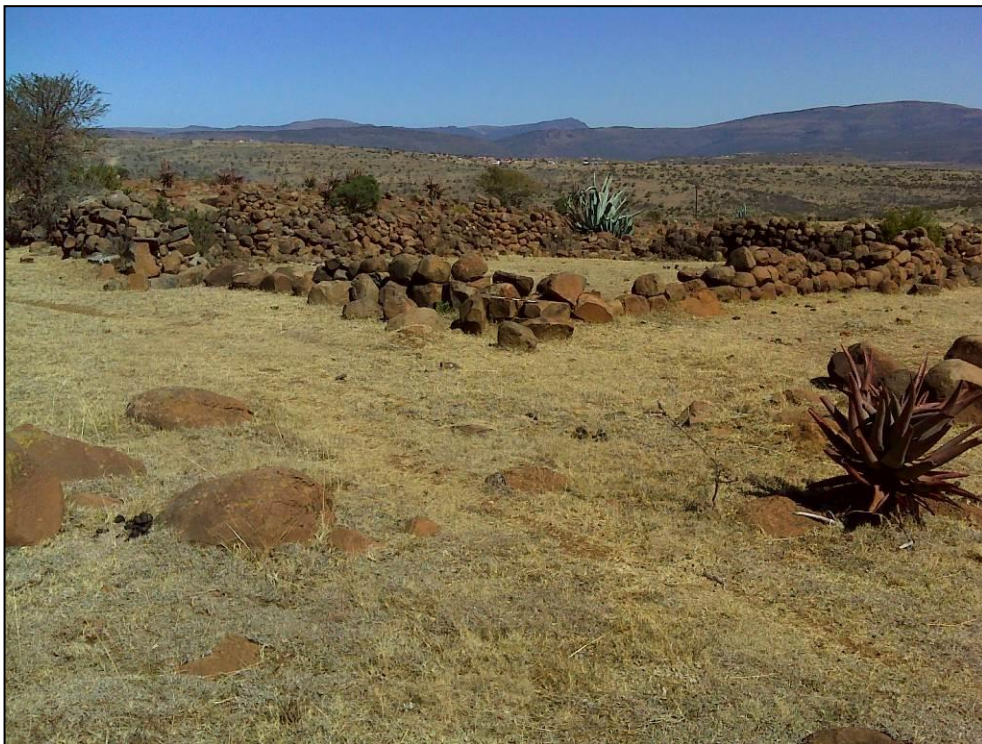
**Figure 74. View of one the rectangular enclosures situated within the complex SVR SW1.**

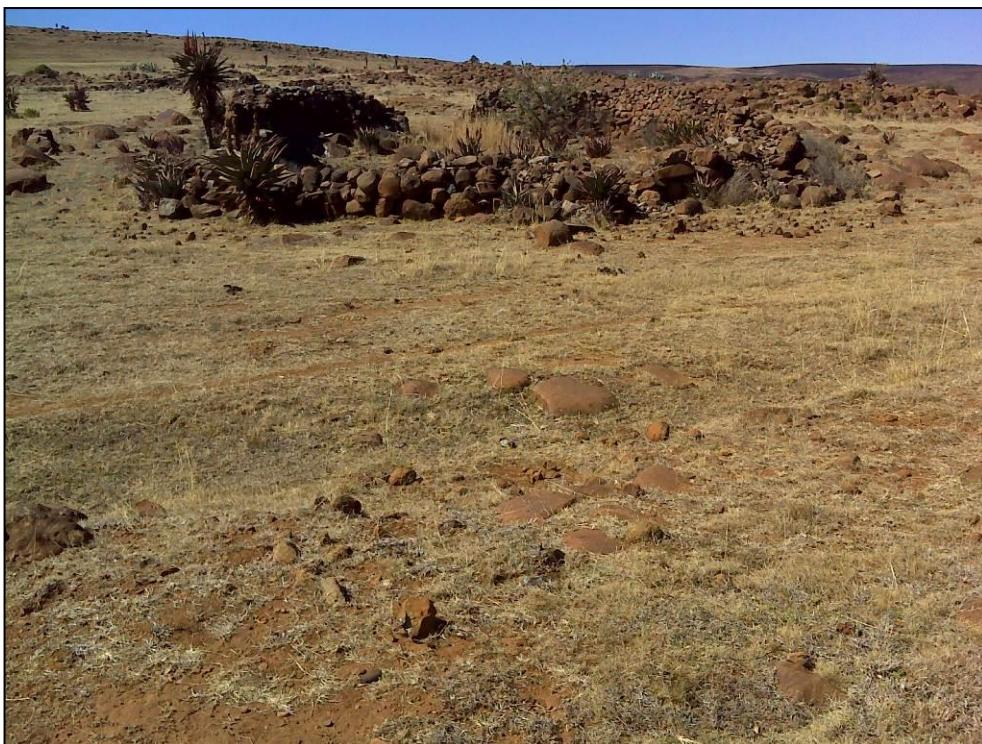
**Figure 75. View of one of the circular enclosures situated within the complex SVR SW2.**

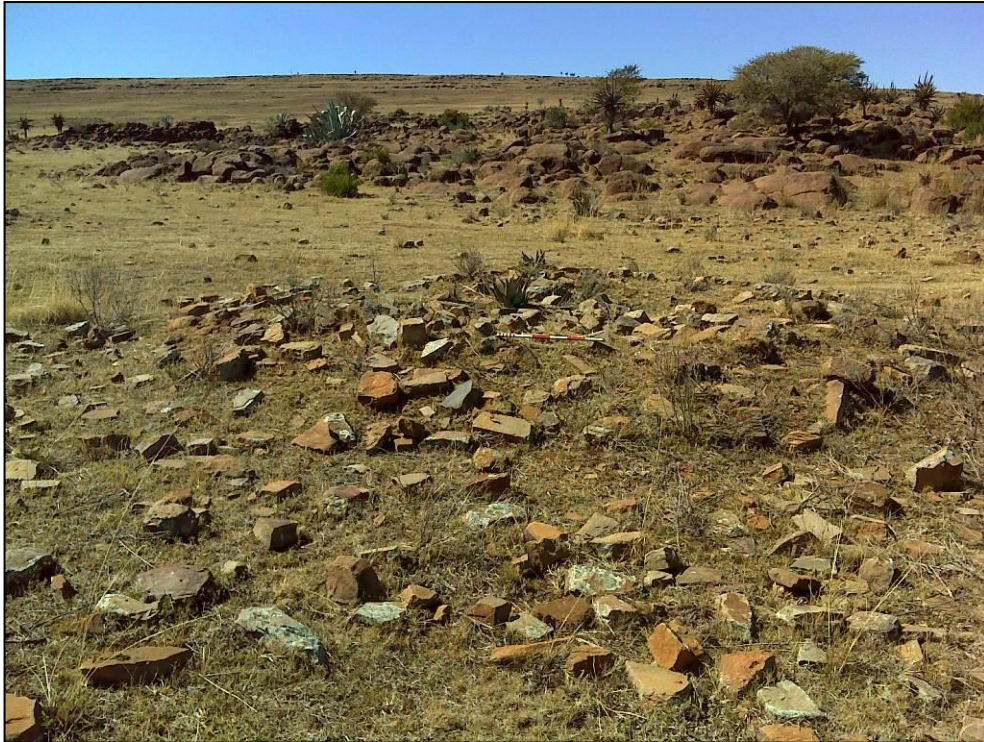
**Figure 76. View of one of the remains of a possible hut floor / foundation.**

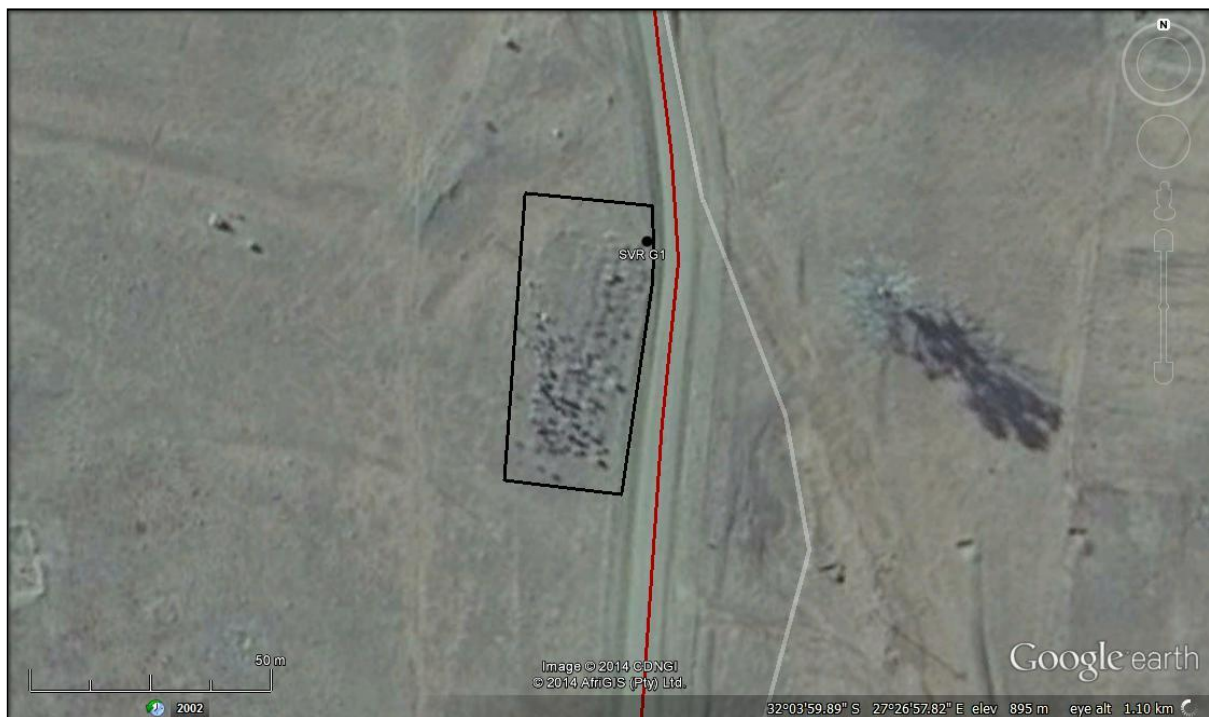
**Figure 77. Close-up aerial view of the location of the informal burial area along the route for the proposed DR 08376 provincial road upgrade.**

An informal burial ground is situated immediately adjacent to the DR 08376 within 50 m of the position of Borrow Pit 171 (BP171) (Figure 77). The burial ground comprises 132 burials, seven of the burials have been 'built up' and the remaining burials are stone packed with informal headstones (Figure 78-79).

**SVR G1:** The burial area is situated immediately next to the road proposed for the upgrade. It is highly likely that the burials will be negatively affected by the proposed development owing to the close proximity to the road. The appropriate recommended mitigation measures must be considered before development may proceed.

The appropriate mitigation and conservation measures must be considered. Informal burial areas are protected under the National Heritage Resources Act 25 of 1999. The first option is that the area be considered a no-go development zone is strongly recommended. Alternatively, consultative processes with the affected family members must be conducted to suggest the possibility of exhumation and reburial (see section 11 for full recommendations).

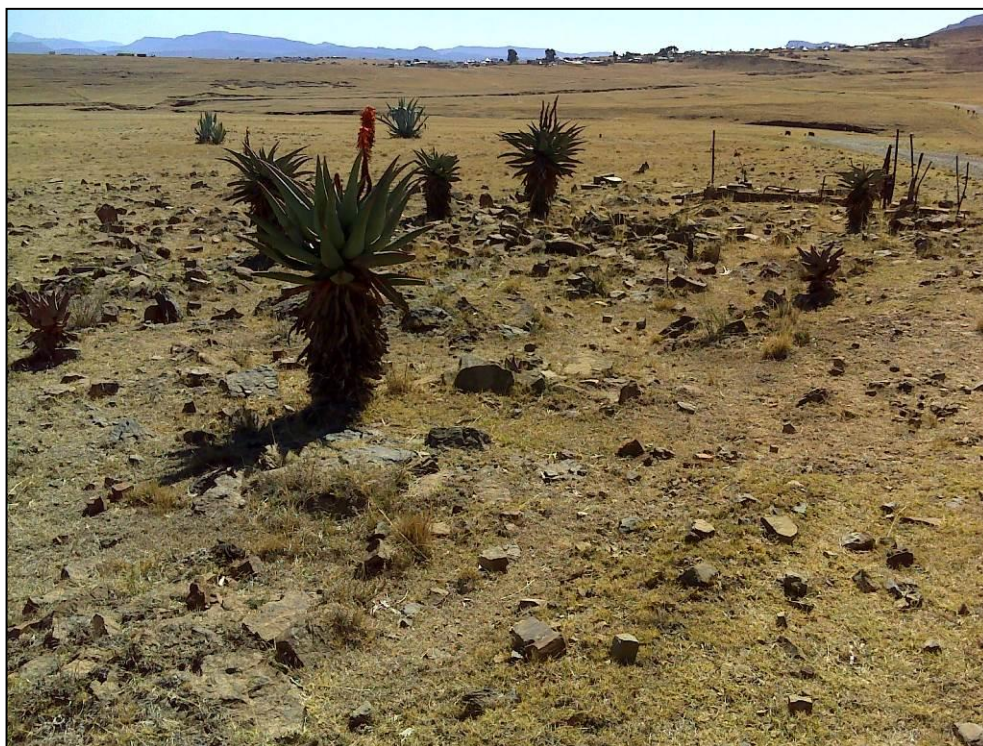
**Figure 78. View of the informal burial ground situated immediately next to the route proposed for the upgrade of the DR 08376 road facing north.**

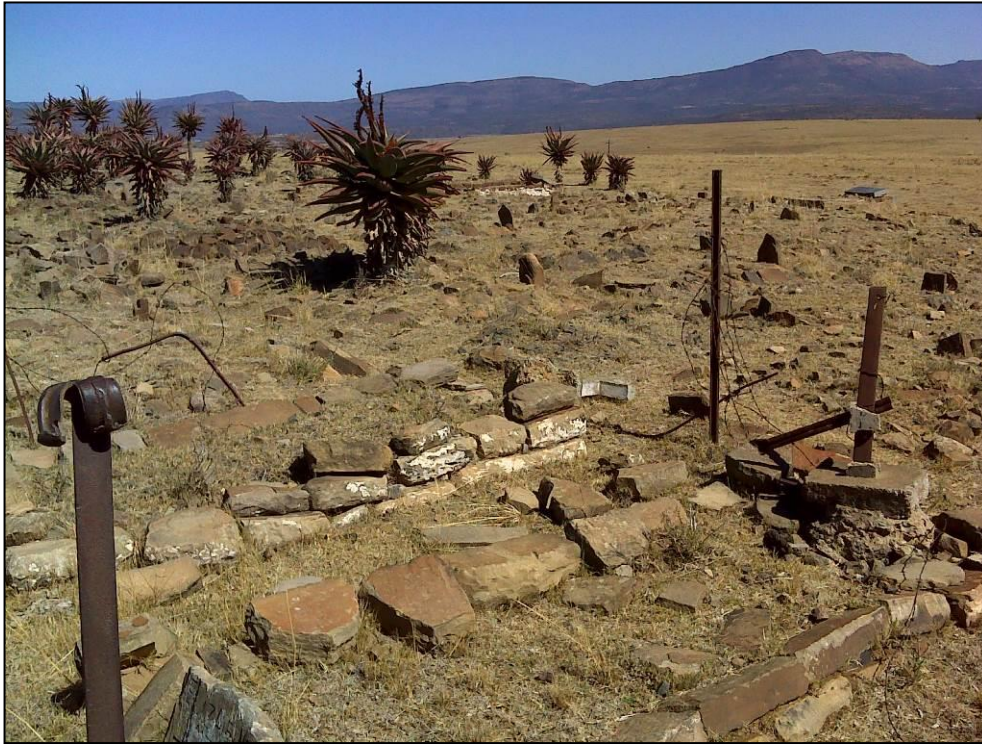
**Figure 79. View of the informal burial ground situated immediately next to the route proposed for the upgrade of the DR 08376 road facing south.**
