RENOVATION OF THE
SACRED HEART HOSTEL
HERITAGE REPORT

DIOCESE OF ALIWAL
EASTERN CAPE • SOUTH AFRICA

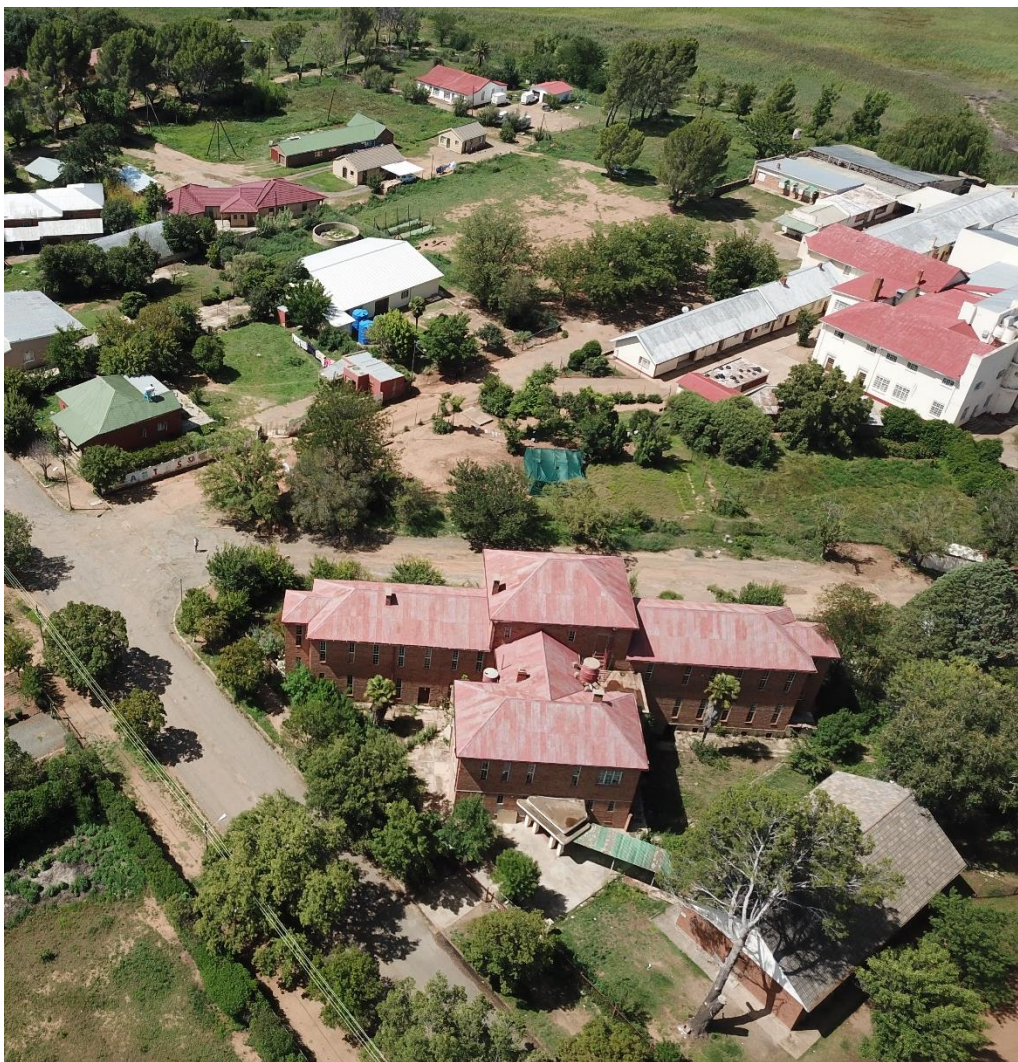
Aerial photo of the Sacred Heart Hostel (red face brick building in front centre) and ANTOS (white building in the top right corner)

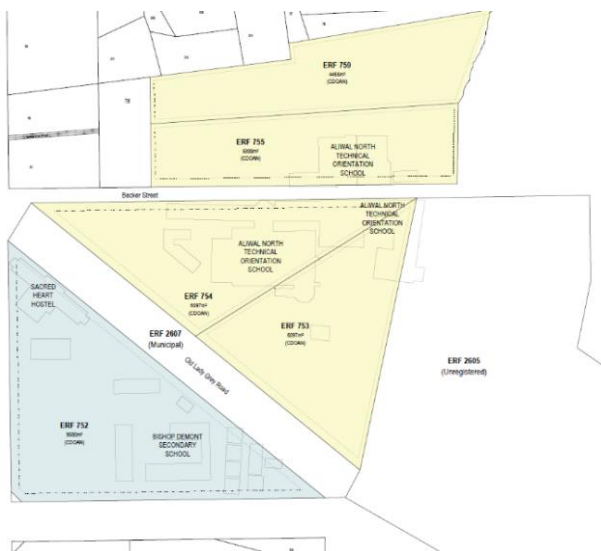
The Sacred Heart Hostel was located on Erf no 752, Aliwil North, Walter Sisulu Local Municipality. An application was prepared and submitted to consolidate erven 752, 753, 754, 755, 759, the road servitude / Old Lady Grey Road (2607), a section of Becker Street, a portion of erf 2605 and then subdivided to form erf X as depicted in the diagrams below.

The separate erven

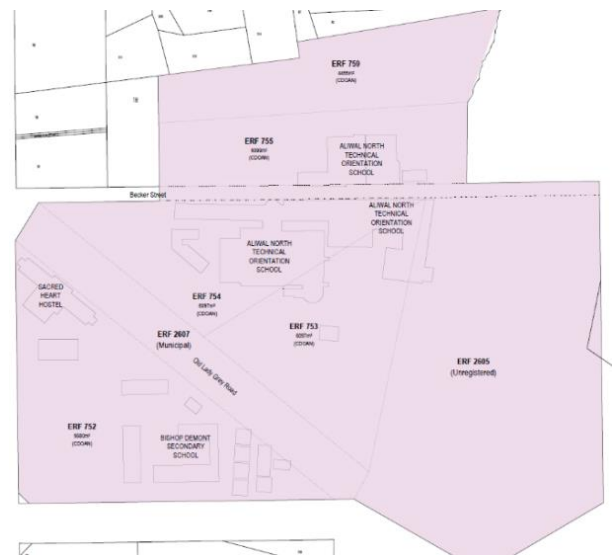
The consolidated erf

ANTOS, Bishop Demont Secondary School and the Sacred Heart Hostel as situated on the proposed Erf. The Deeds of Sale will remain in place and the erven will be sold separately. Running parallel to this process the land surveyor will prepare all documentation and once the erven have been transferred to DoE, the consolidation can be registered.

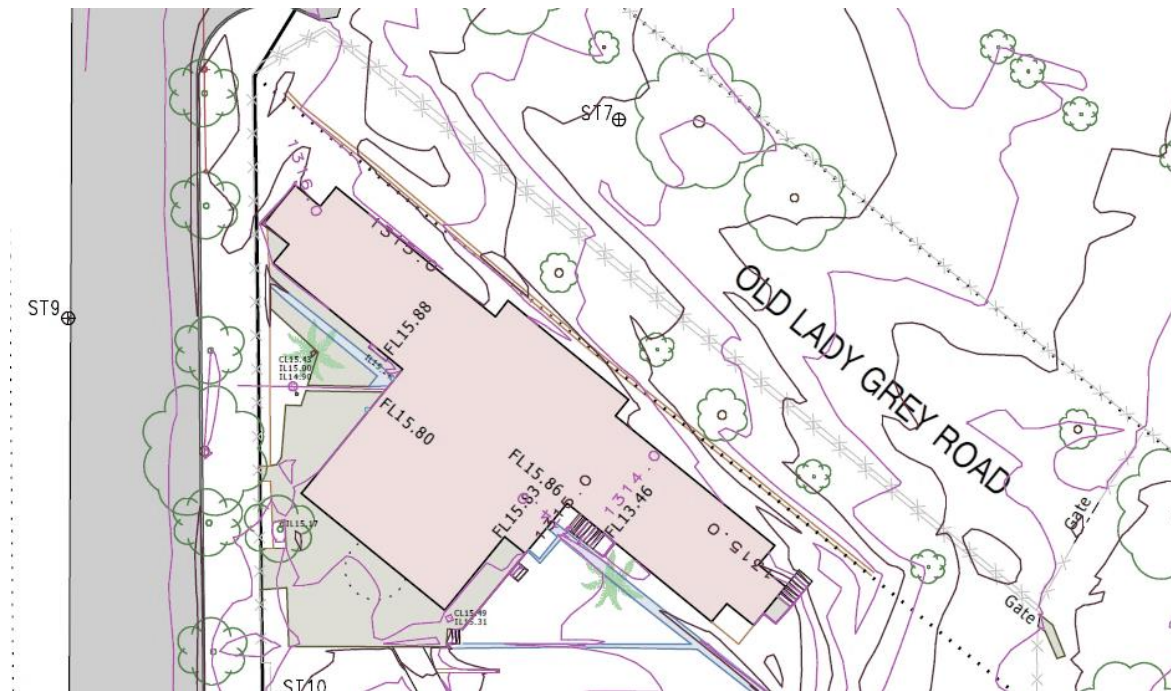
There is a 4m fall from the western side of the site to the eastern side.

From the northern boundary to the southern boundary there is a 3m fall.

Portion of Land Survey of ANTOS: Contours in 250mm increments. (Hansen, 2016: file 7582)

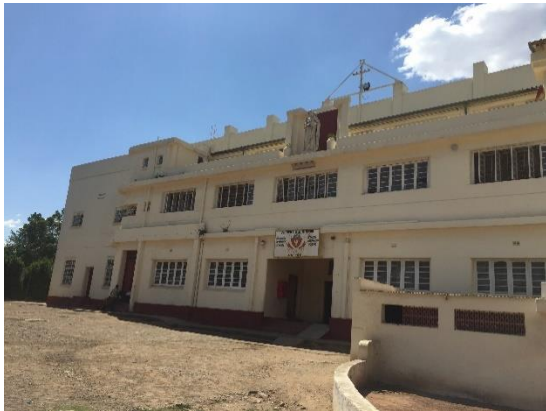
South (front) elevation of ANTOS

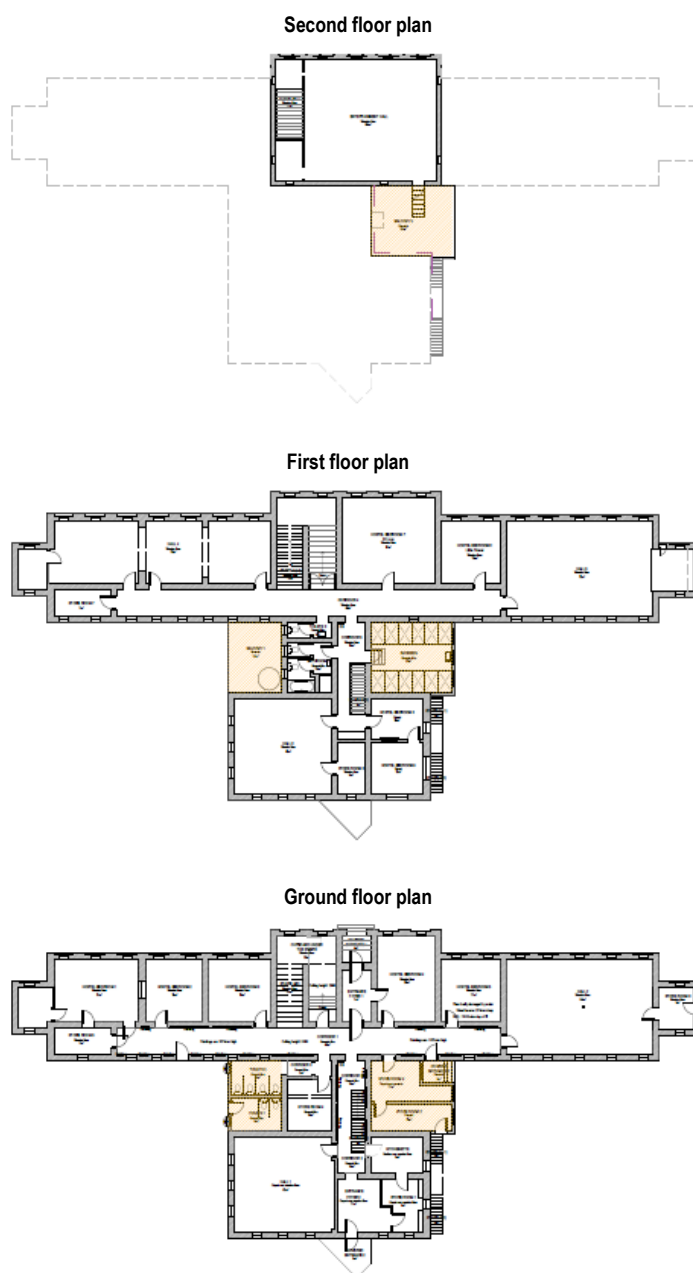
As-built floor layouts of the Sacred Heart Hostel

We believe that the original building was built in an I-shape. We assume that with the renovations of 1943 the following areas were added (indicated in yellow on the diagrams to the left):

- Toilets (Ground floor)
- Storerooms (Ground floor)
- Ablutions (1st floor)
- Balcony (2nd floor)

Although none of the original drawings were found, the fact that the areas mentioned above were built 220mm thick with burnt bricks compared to the other 440mm thick raw clay brick walls are evidence of this.

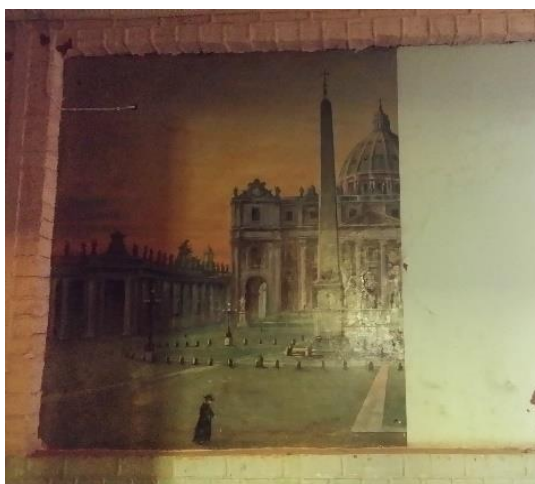
Unnamed mural (believed to be of St Peter's in Rome)
partially damaged by a coat of PVA paint

- Existing painted walls: Scrape off loose/flaking paint, wash with sugar soap and re-paint.
- Chip-off all existing damaged plaster and re-plaster according to specifications (lime mixture to compliment clay bricks and allow walls to breath).
- Install fire-resistant ceilings on entire ground floor (Fire requirement). Pressed ceilings on first floor and second floor to be renovated.
- **Ablutions 1, 2 & Toilets:** All wall tiles and all existing sanitary fittings to be replaced.
- The murals on the ground floor will be conserved and protected from further deterioration

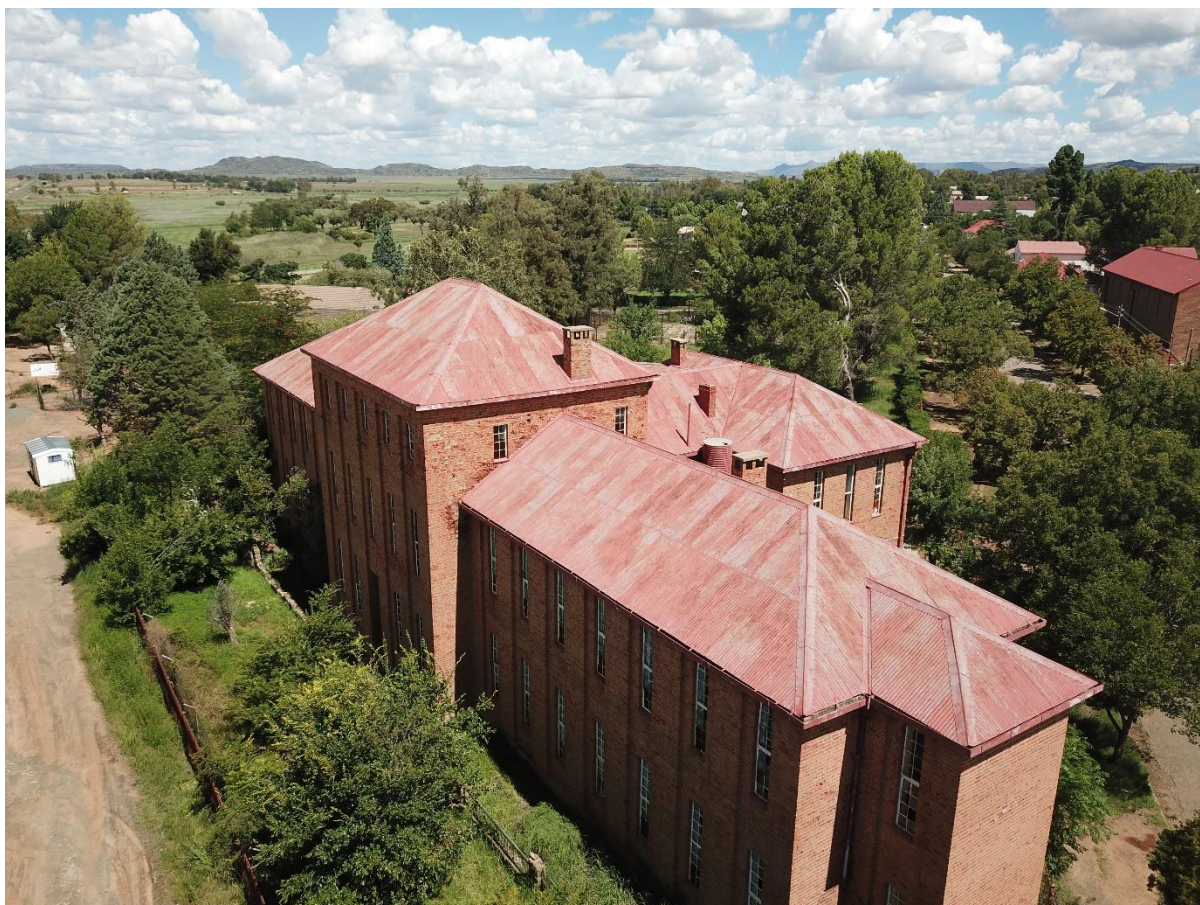
Exterior: North West aerial elevation indicating roof that requires attention

- Fix damaged roof sheeting. Seal and paint the roof with *Antique red* colour
- Remove all existing fascia boards, gutters and downpipes. Install new fascia boards and fix to timber rafters. Install new gutters and downpipes.
- Exposed rafters and purlins to be fixed and/or replaced where required and to be treated prior to installation of new fascia boards.
- Renovate disintegrated clay bricks using faggot bricks to match the existing.
- Existing clay bricks to be sealed with a clear matt brick sealer.

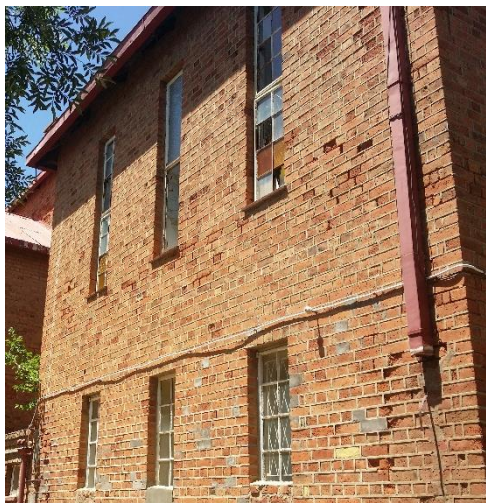
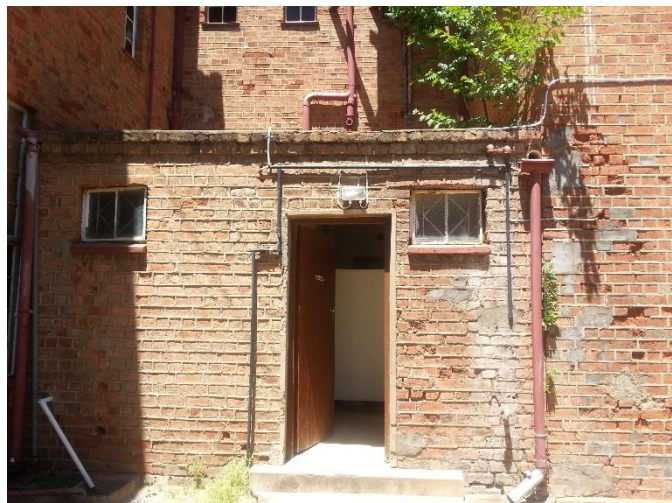
The state of preservation of the building is poor. The diagnosis was made from astute visual observations. The property presents numerous problems with moisture in the walls, visible cracks, disintegrated clay bricks, damaged plaster sections, missing sections of the wooden floor, ceilings with moisture damage, steel window frames with

Exterior: Raw clay bricks deteriorating, mainly due to moisture damage

Walls	→ Outside	→ Moisture damage visible. Recommend replacing damaged bricks and brick seal. Other options would be to plaster entire structure.

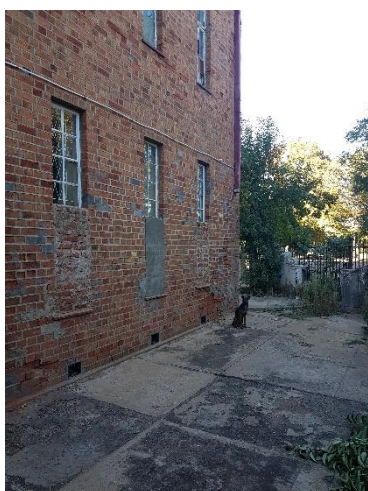
Exterior: Bottom of ground floor windows are bricked up to prevent vandalism

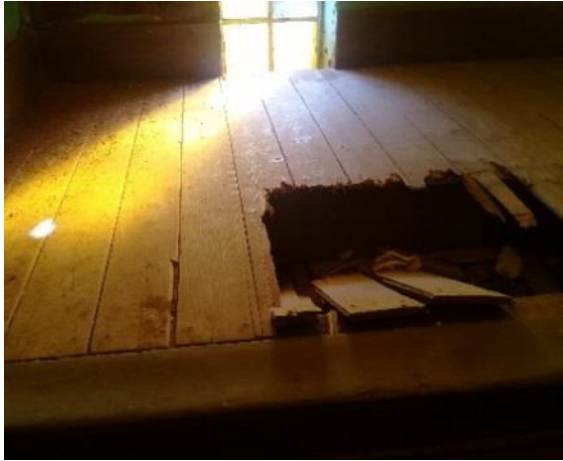
Interior: Damaged wooden floors

- Wooden floors are to be sanded lightly and carefully as not to damage the T & G structure. Thereafter it will be treated with a compatible oil-based varnish.
- Damaged floor boards will be replaced.
- All existing carpets, vinyl flooring and “Novilon” that were laid over the wooden floors will be removed and restore back to wooden floors.
- The existing ceramic tiles to be replaced (**Ablutions 1 & 2** and **Toilets**).
- Existing skirting (230mm high) to be replaced with new wooden skirting (250mm high) with matching profile.
- Damaged wooden treads to be replaced.
- Dado rail & picture rail to be replaced in certain areas with matching profiles.

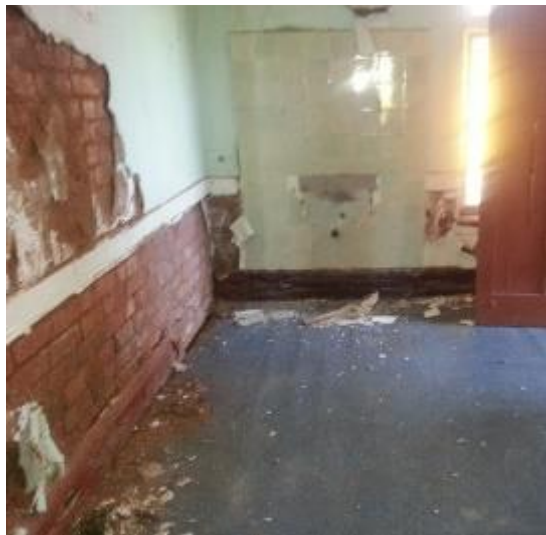
Interior: Damaged plaster

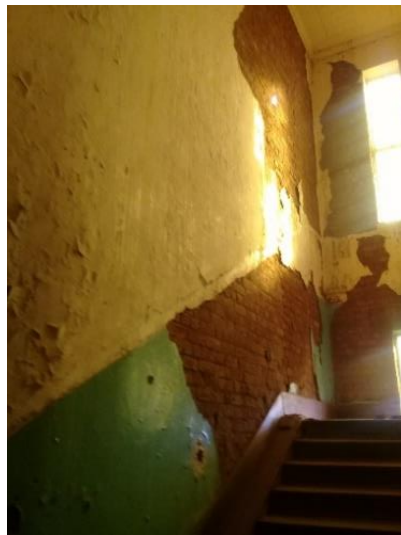
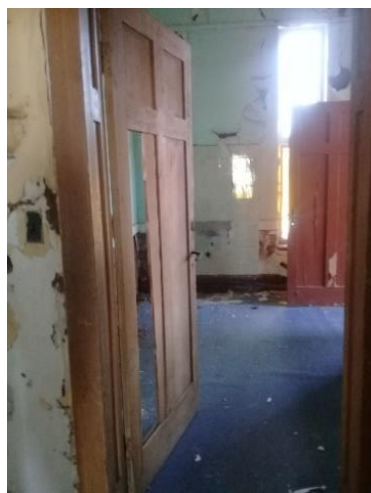
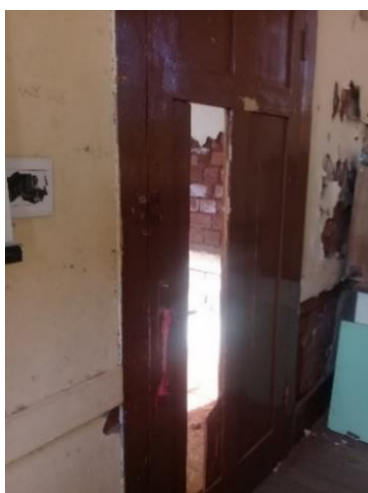
Interior: Vandalised doors

- Window frames: Sand steel frames by hand, coat with rust- inhibitive primer and paint with two layers of enamel paint. All glazing to be replaced.
- Renovate the existing wooden sills (interior) and quarry tile sills (exterior).
- Renovate the existing wooden doors. Where doors are damaged beyond repair, the new doors will be custom made to match the existing in size and style.
- New door handles and locks to match the existing.

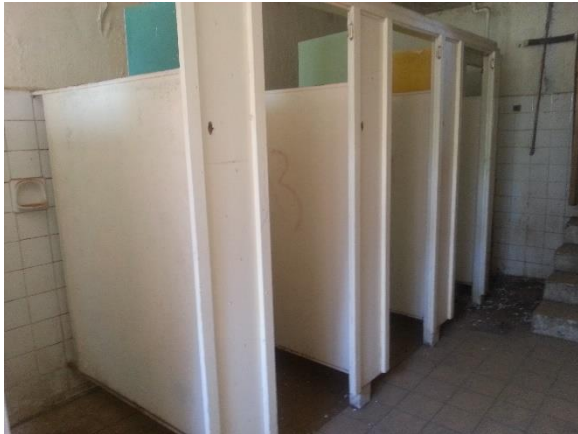
Interior: Ablutions

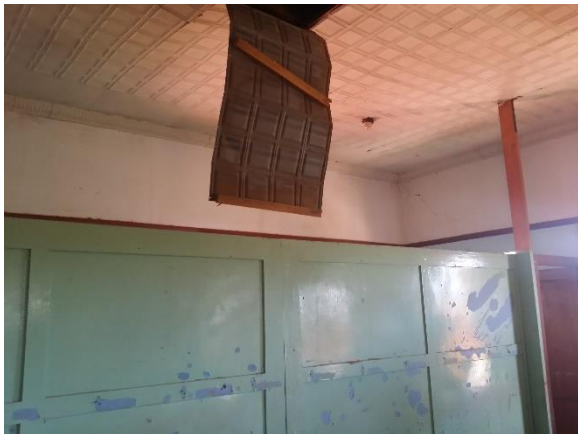
Interior: Pressed ceilings damaged by moisture and thieves

Level	Element		Observations and recommendations	Photos
Ground Floor	Roof Structure	→ Ceilings	→ Moisture and water damage visible. Replace to architect's specifications.

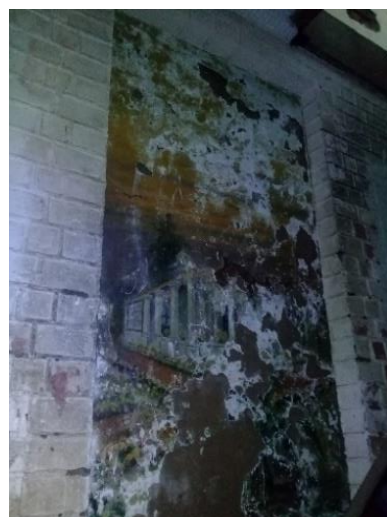
Interior: Murals damaged by moisture
