## **SAMORA MACHEL PLANE CRASH SITE MONUMENT & PUBLIC PARTICIPATION REPORT:**

**Compiled by:**

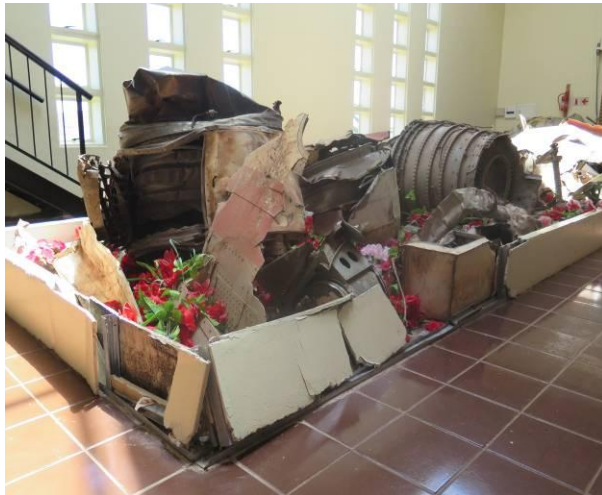
picture 4: interior of the museum

The design is congested and the material used to build the museum is already

wearing down. The funnels that represent 35 lives lost are already rusty and corroding. The harsh climatic condition characterised by strong winds, hot sun and sometimes rain makes it difficult to find materials that can withstand all this conditions. The fence has already fallen down, because of structural problems.

Overall, the monument is still in good shape. Constant monitoring is required to assess the damages caused by climatic conditions. The fence needs to be rebuilt. The following is recommended that the Department of Sport, Arts, Culture and Recreation and the Nkomazi Municipality adequately maintain and manage the site:

- ✓ A fund to be established to annually repair the site due to unfavourable climatic condition existing on the site.
- ✓ Continuous monitoring of the site in cooperation with the municipality and tribal authority.
- ✓ Finalise the management agreement with the municipality who are paying for the present staff members.
- ✓ Need to finalize a comprehensive Conversation Management Plan (CMP) to guide any repairs and maintenance.
