**A BRIEF HERITAGE REPORT ON POSSIBLE GRAVES IN SASOL'S  
BORROW PIT 07 ON THE EASTERN HIGHVELD IN THE  
MPUMALANGA PROVINCE**

**July 2013**

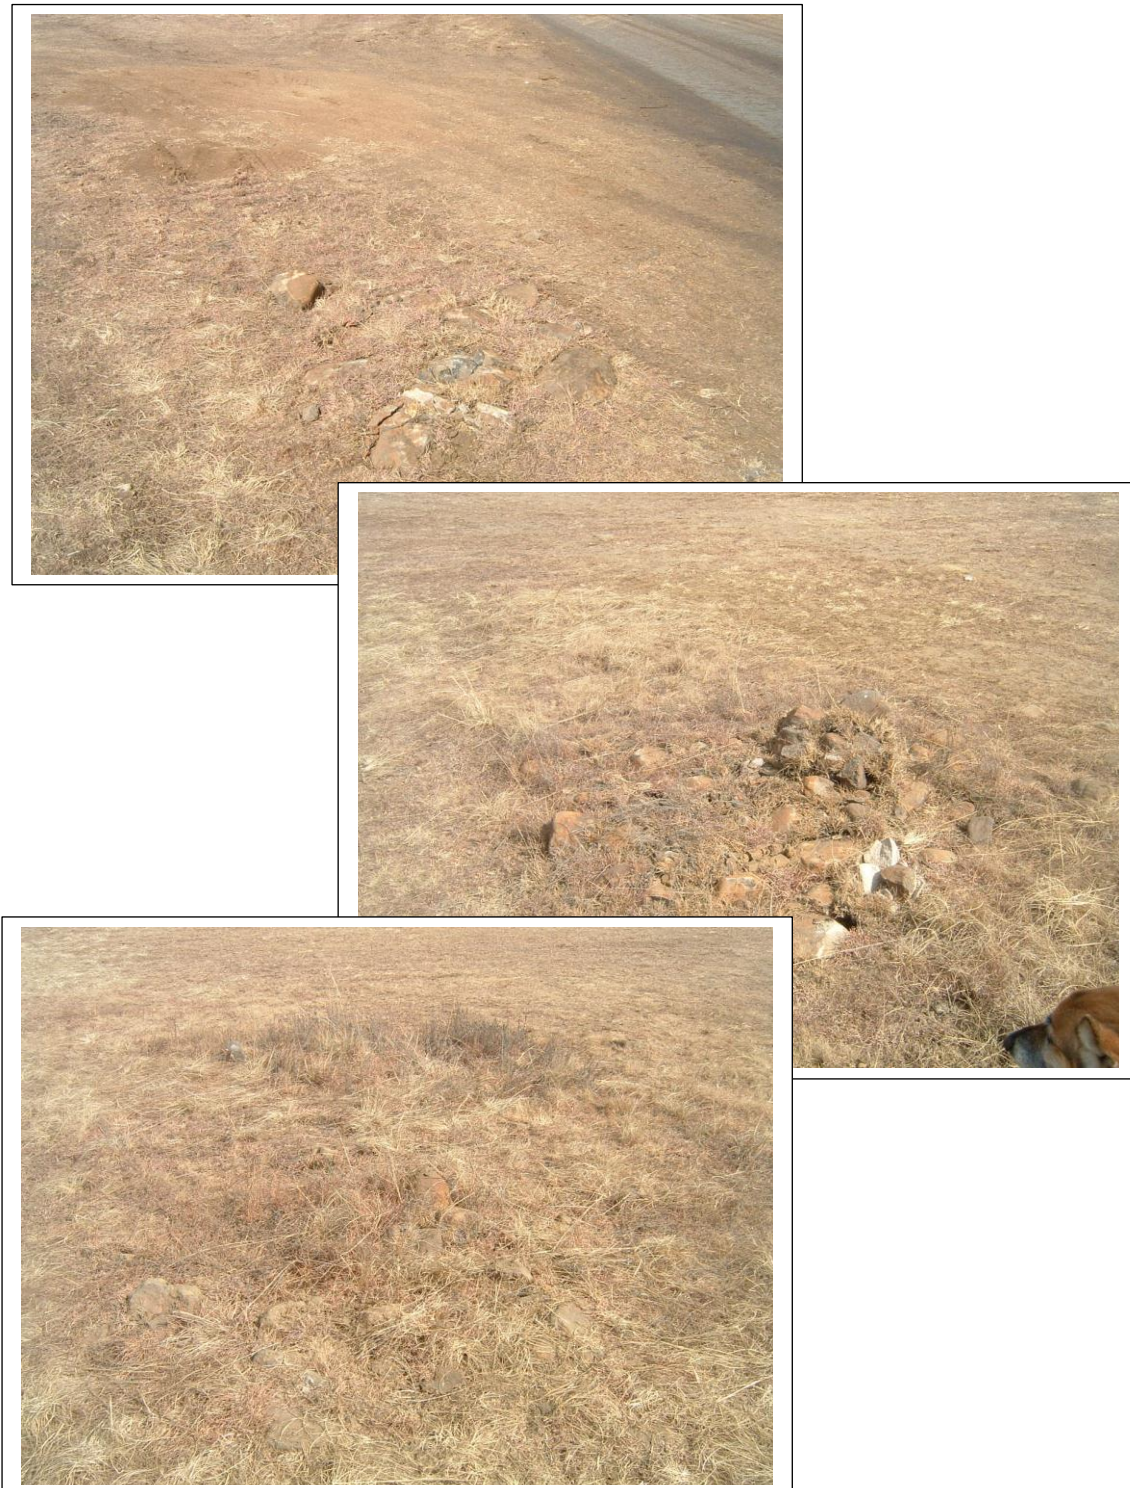
**Figures 1, 2 & 3- Three collections of stones (in no particular order) which were documented in BP07 (above, centre and below). Feature 07 (centre) has the closest resemblance to a possible grave than all the features that were recorded.**

The provisional recommendations that were made therefore no longer suffice: Construction activities at BP07 can continue and should only be stopped when any archaeological or human remains are exposed during the preparation, utilization and eventually closure of BP07.

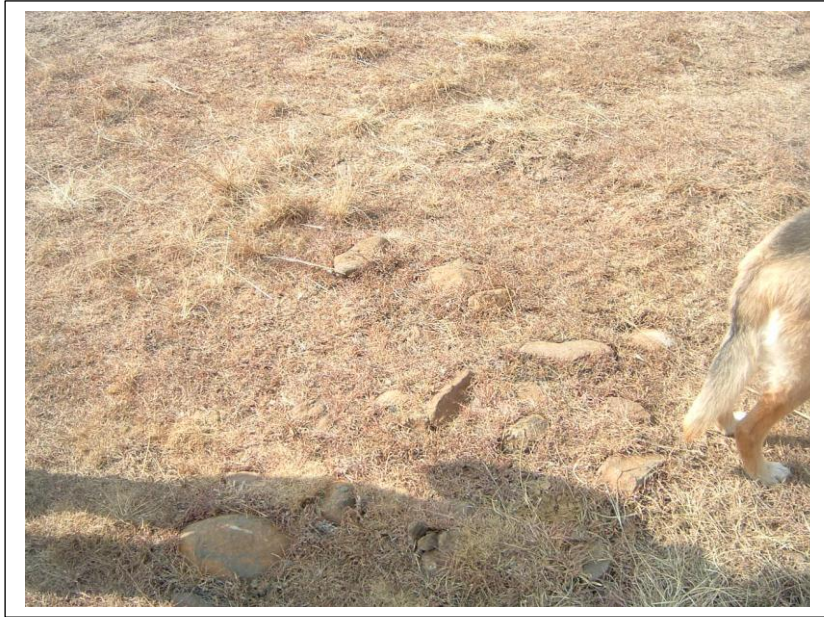
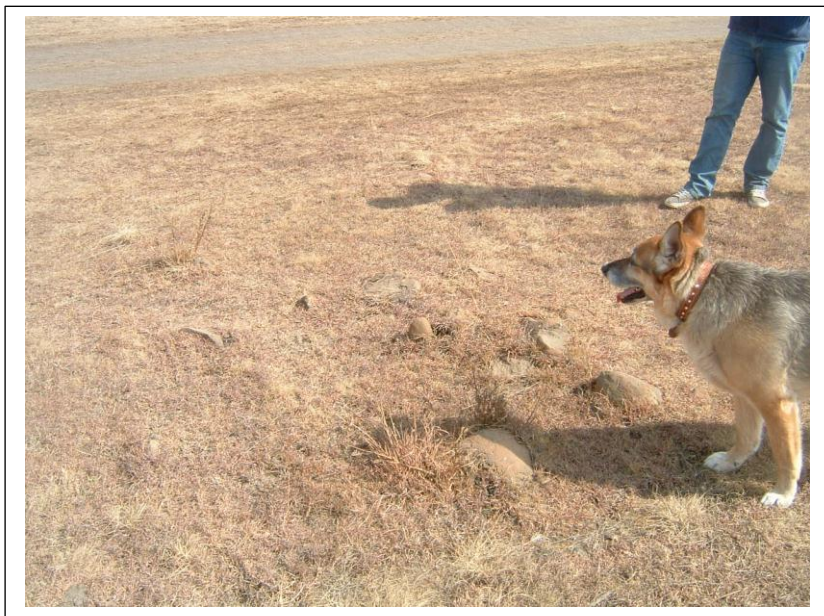
**Figures 4 & 5- Two more compilations of stones (in no particular order) which were documented in BP07 (above and below).**

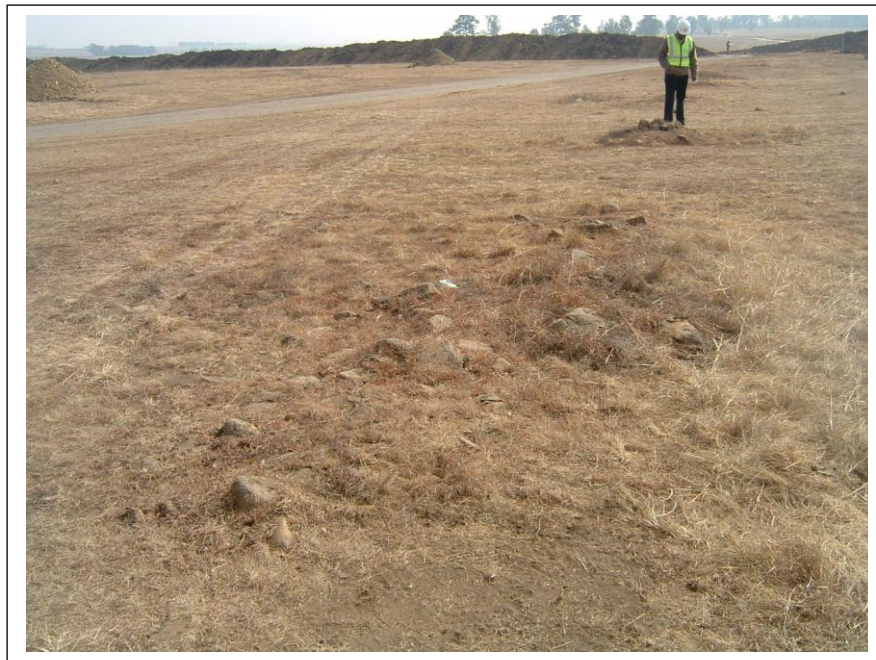
An investigation of the eleven compilations of stones (rudimentary stone piles) indicated that these features occur in a relatively straight line which stretches for approximately 60m across the surface of BP07. The compositions of stone revealed particular characteristics and features, namely:

**Figure 6- A wide angle view of the compilations of stones indicates the relatively straight line along which the composition of stones stretches across the surface of BP07 (above and below).**

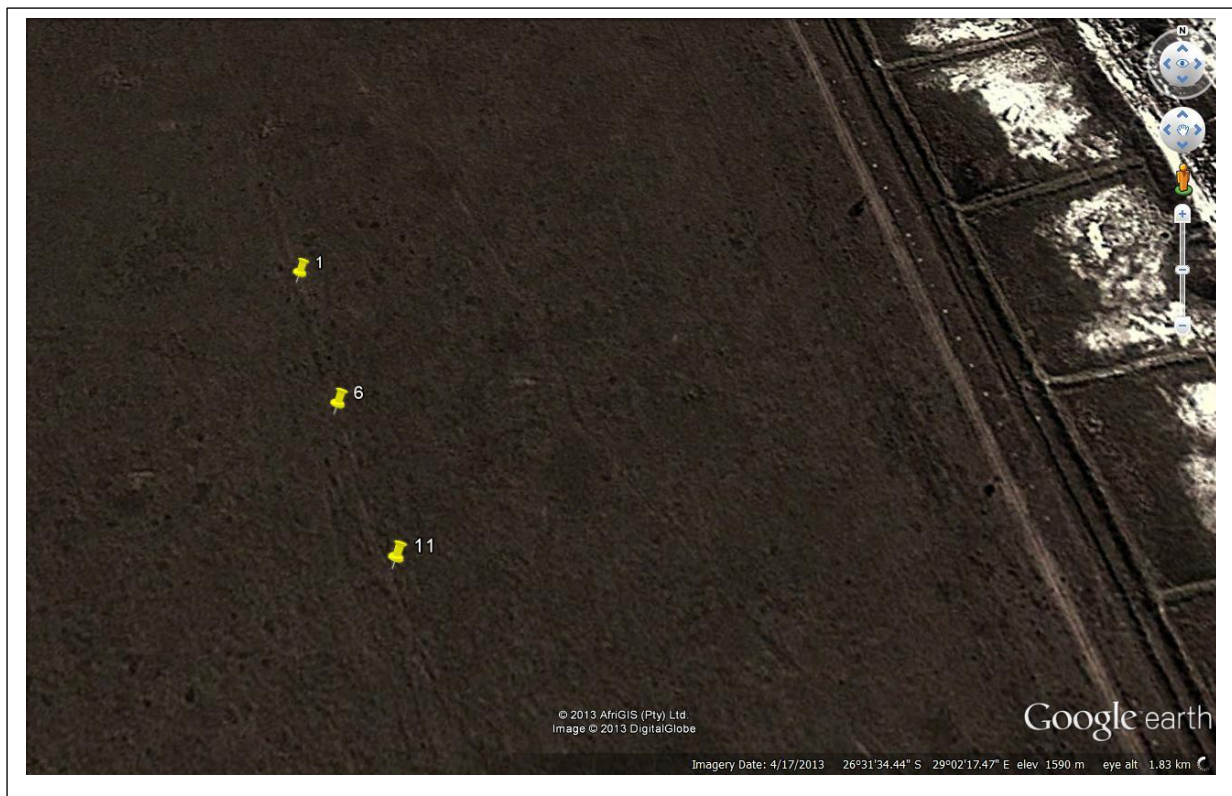
**Figure 7- Three of the compilations of stone (top, centre and bottom) which were plotted on Google Maps collate with what seems to be an old abandoned border fence which ran from the north to the south across the surface of BP07 (above).**

The confusion regarding the meaning and significance of the compilations of stones was cleared when the coordinates for these features were plotted on Google Maps (see Figure 7).

The eleven features appear in a straight line on the Google image which again collate with what seems like a (former) fence which used to stretch from the north to the south across the surface of Borrow Pit 07. It therefore appears as if the stone features may have served as some form of support for posts (possibly made from wood) on which a wire fence was erected.
