# ARCHAEOLOGICAL IMPACT ASSESSMENT REPORT

FOR THE SEEMA SECONDARY BULK WATER SUPPLY,  
MOKOPANE, LIMPOPO PROVINCE

215097

September 2015

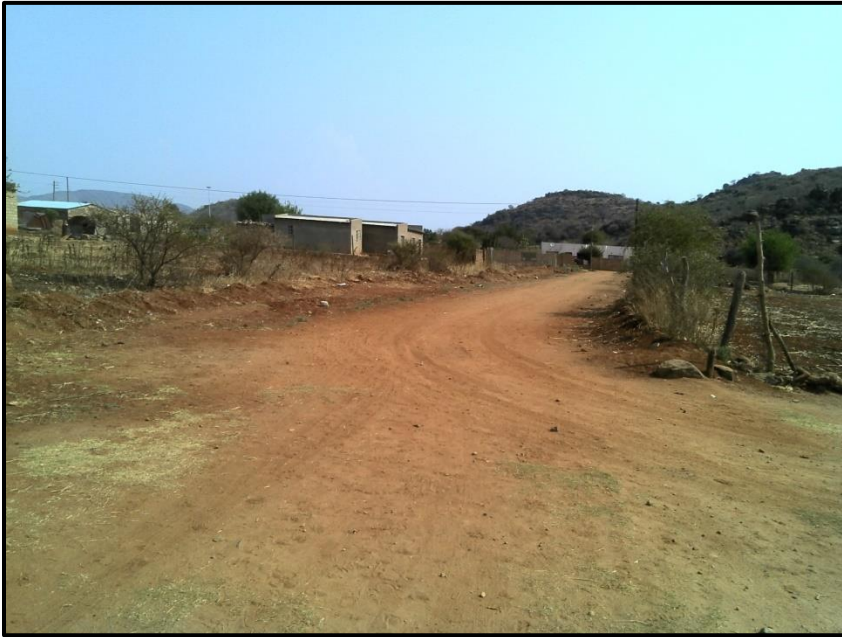
Figure 4. Existing roads that the pipeline follows in Ga-Mapela.

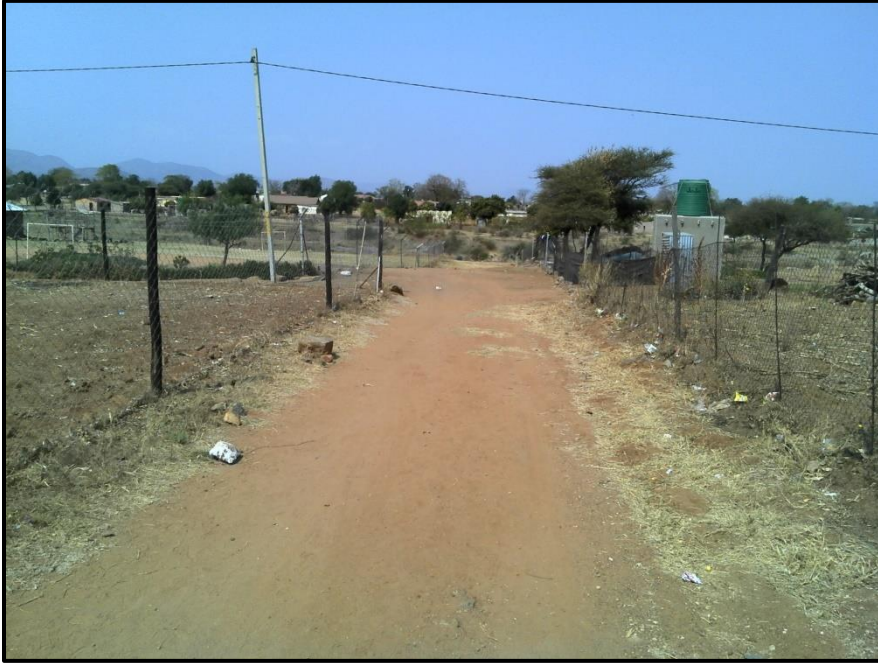
Figure 6. Existing roads, white stones mark pipeline.

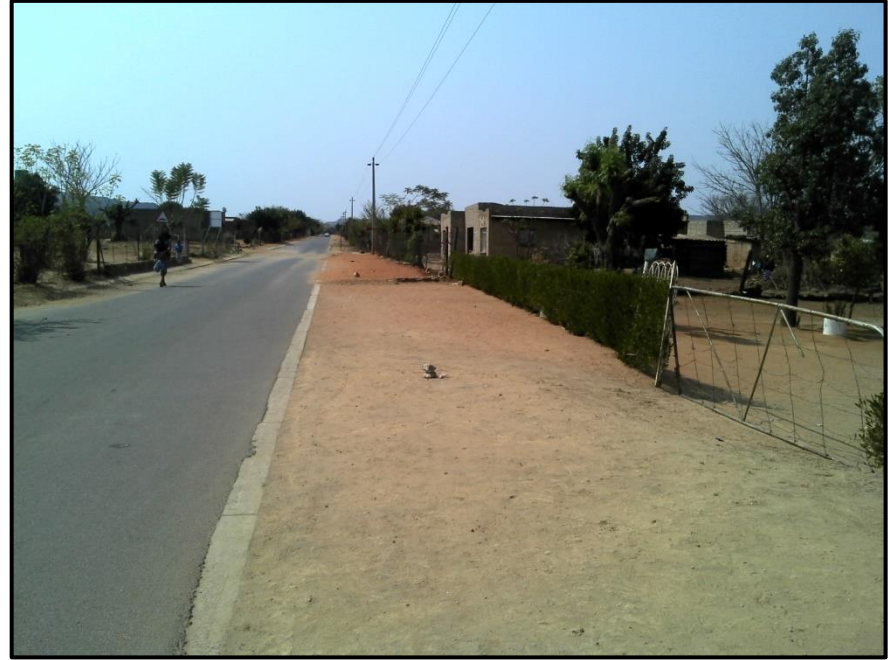
Figure 7: Road reserve that the proposed pipeline follows.

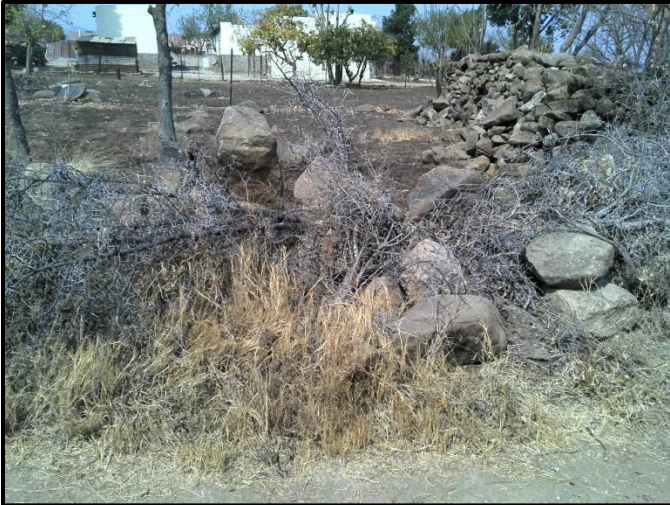
**Field Number 631**

The site comprises an historic/ recent rectangular stone packed cattle kraal located within an erf (Figure 9). The site is of low significance and will not be impacted on by the proposed road alignment.

**Field Rating:** Generally Protected C (GP.C)

Figure 9: Rectangular cattle kraal

Several locations contain ill-defined stone wall foundations (**Field No. 631, 633, 634 and 641 – 643**). The rectangular cattle kraal at **Field no. 631** is located within a residential stand and will not be impacted on directly by the proposed pipe line. **Field No. 633 and 634** consist of rectangular walls and are partially destroyed by a gravel road and large scale earth moving activities and will be further impacted on by the proposed pipeline. The stone wall foundations at the foot of a small kopje at **Field No. 640, 641 – 643** will also be directly impacted on by the proposed pipeline but was previously impacted on by a gravel road. Ephemeral stone walls like these occur throughout the larger study area and similar sites were given a low heritage significance by another specialist (Karodia et al 2013).

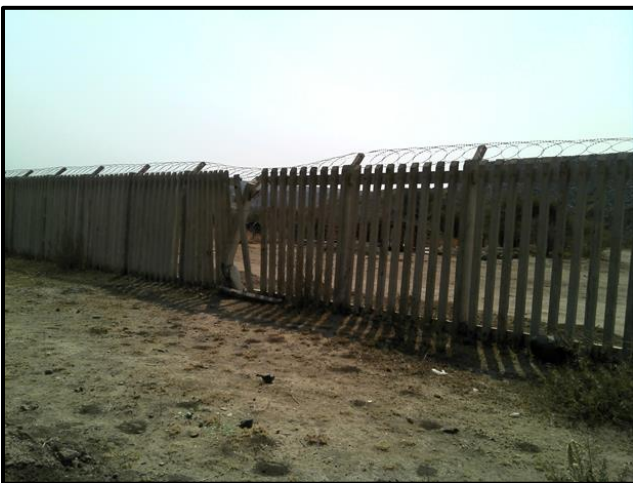
**Field Number 632**

The site comprises a large formal cemetery with a palisade fence close to the reservoir and north of the proposed pipeline. No impact is foreseen on the site. The site is of high social significance.

**Field Rating:** Generally Protected A (GP.A)

Figure 10 Fence protecting cemetery

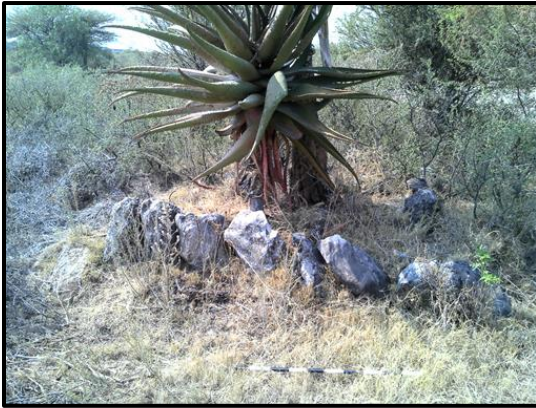
**Field number 633 to 635**

The site is located next to a gravel road and the proposed pipeline. The site includes elongated stone packed features (Figure 11) from dolomite and although unlikely could mark graves as well as the dolomite foundations of linear walls. The site is overgrown and several aloes mark the features. A dirt road and earth works impacted on the site and site layout could not be determined. The presence of graves on the site should be investigated through the community liaison officer. The site is of low heritage significance, however if there are graves on site the grave sites will be of high social significance.

**Field Rating:** Generally Protected C (GP.C) if graves are confirmed it will be Generally Protected A

Figure 11: Elongated stone packed features (Field no. 633)

- The grave at field no. 640 must be demarcated during bush clearing and construction with at least a 15 meter buffer zone. The Environmental Control Officer (ECO) must monitor earthworks in this area during construction to ensure no accidental damage to the site. The Community Liaison Officer (CLO) must also be present during earthworks in this area.
- Known grave sites must be plotted on to ensure no accidental damage occurs to these sites by construction camps etc.
- The community liaison officer should through community consultation determine if any graves exist at **Field no. 633 – 634**.

- The features at **Field no. 633 – 634** wall must be monitored during the construction phase. Earth works in this area should be minimised to the road reserve in order not to impact on the recorded features.
- The Stone walled sites (**Field number 640 - 643**) around the koppie must be mapped prior to construction and monitored during construction. It is also recommended that the community liaison officer should confirm the possibility of graves in this area. Earth works in this area should be minimised to the road reserve in order not to impact on the recorded features.
- If any archaeological features or deposit is exposed at these locations work should stop in these areas and a phase 2 mitigation permit applied for.

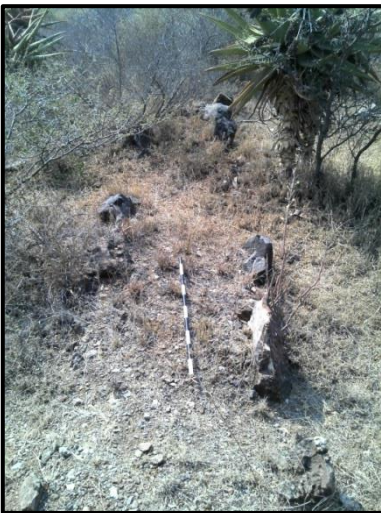
Figure 12: Linear stone packed walls at field no. 635

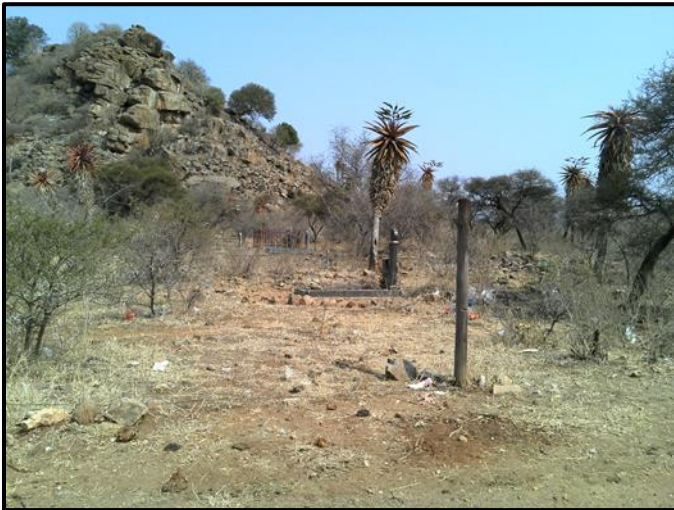
**Field number 636**

The site is located to the east and the south of an existing gravel road. The site consists of a large cemetery with numerous graves next to a small hill. No direct impact is foreseen on the site, the site is of high social significance.

**Field Rating: Generally Protected A (GP.A)**

Figure 13: Cemetery viewed from the west

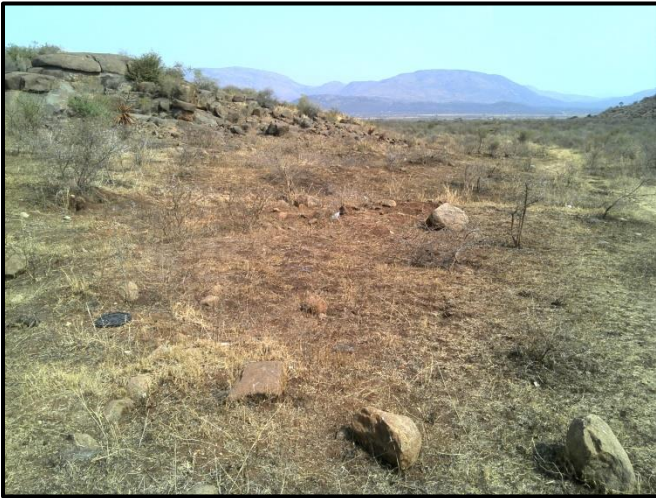
**Field number 639**

The site is highly disturbed by earthworks and consists of ephemeral stone wall foundations. No layout can be distinguished due to the extent of destruction of the site. Disturbed stone walled features, possibly the foundations of a residential dwelling. It is recommended that the site should be monitored during construction.

**Field Rating: Generally Protected B (GP.B)**

Figure 14: General site conditions

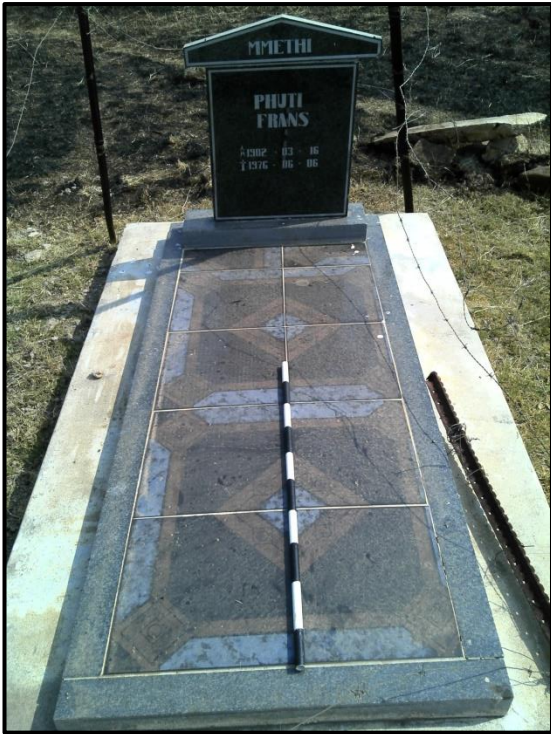
**Field number 640**

**Field Rating: Generally Protected C (GP.C) stone walled sites**

**Field Rating: Generally Protected (GP.A) grave site**

Figure 15: Grave at field no. 640

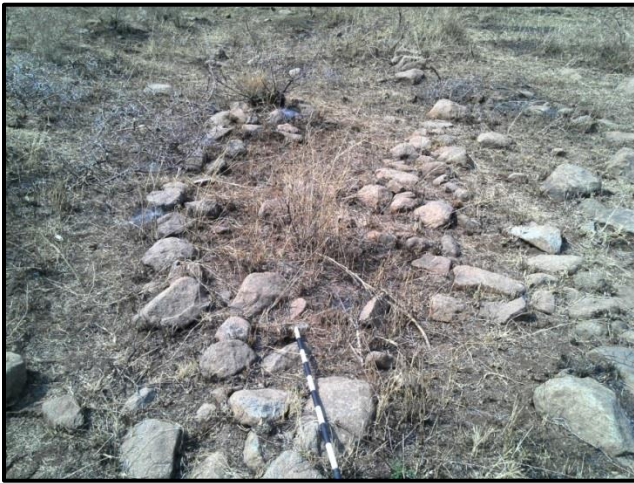
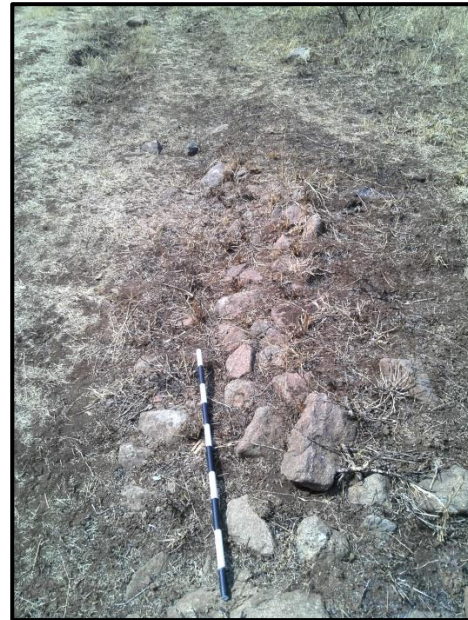
**Field number 641 - 643**

The site consists of ill-defined stone wall foundations located at the base of a small hill possibly dating to the Late Iron Age. The site has been disturbed by a gravel road and is highly overgrown and site layout cannot be determined. At field no. 642 the road cuts through the site with ephemeral walls on both sides of the road. Undecorated ceramics is scattered over the site. The site is of low – medium heritage significance as the road already impacted on the site and no features like *dagga*, middens etc. are visible.

**Heritage significance: Generally Protected B (GP.B)**

Figure 16: Ephemeral stone wall foundations

Figure 17: Ephemeral stone wall foundations foundations
