SITE INSPECTION REPORT: SHARPEVILLE MASSCRE MEMORIAL SITE

HERITAGE INSPECTORATE UNIT

07 March 2016

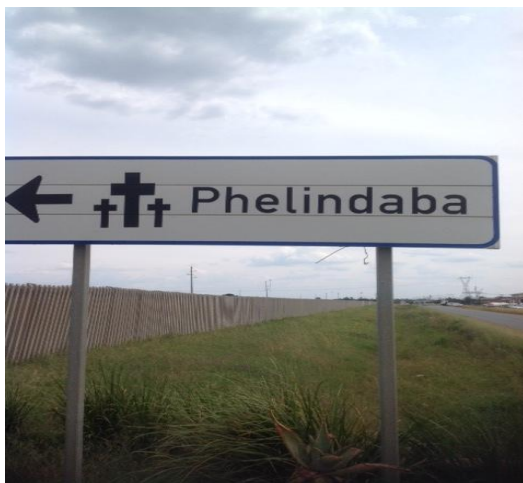
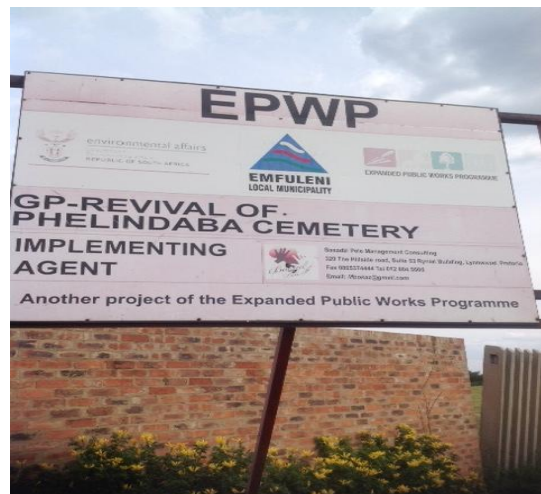
Picture 1: Phelindaba Cemetery

Sharpeville Memorial Garden is located in Phelindaba cemetery in Sharpeville Township. The memorial garden is a prime location, other locations that form part of the Sharpeville Heritage Precinct includes, old police station, graves of the 69 lives lost during massacre and protest route. These highlight areas of important cultural and significance in South African politics evolution.

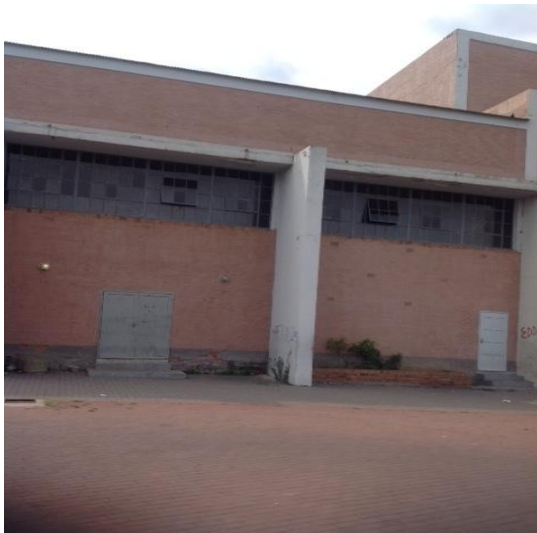
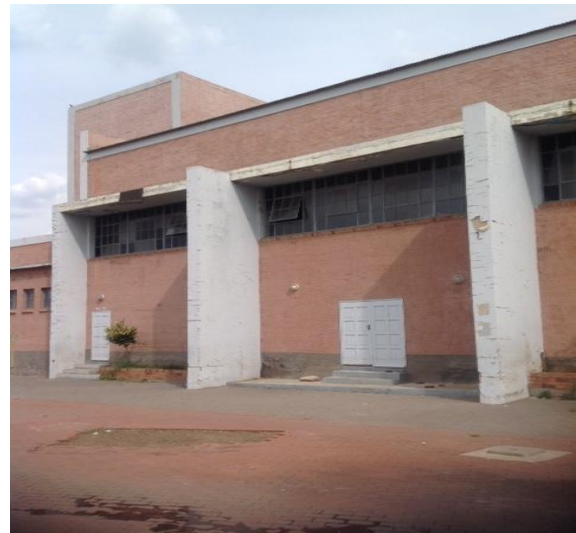
Picture2: The Old Sharpeville Police station

The design of the memorial park was meant to be as simple as possible to avoid further high maintenance cost. The memorial park is located in an existing cemetery which might have impacted on the design of the memorial garden. The protest route is not well marked and there is an ongoing debate on the exact protest route on the day of 21st March 1960. The old police station has been used as a craft centre warehouse, to stimulate the fading economy of the Sharpeville Township.

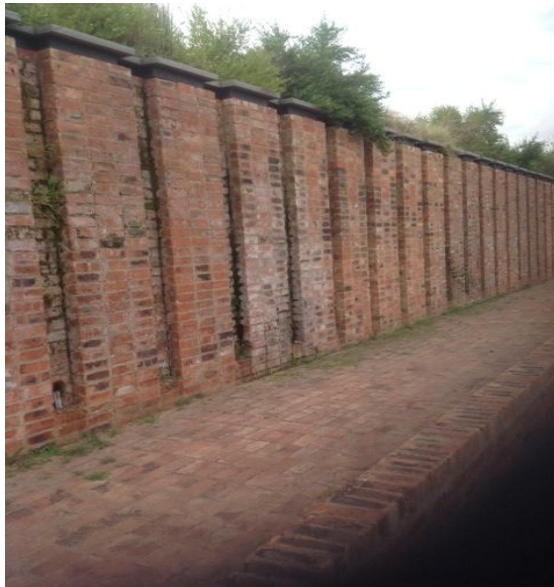
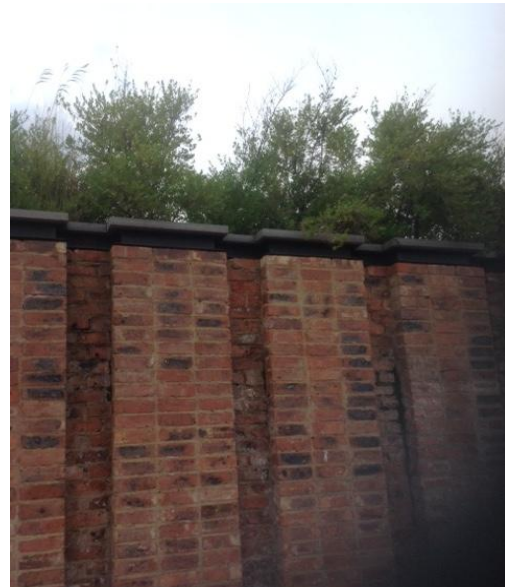
Picture 3: The Memorial Wall

The memorial park contains the memorial wall, gathering area, peripheral areas and poles. The top of the memorial wall contain a planter with flowers. The design of the planter on top of the wall should have considered the dripping of water to the wall. This dripping water damages the memorial wall which was not designed to be permeable.

Algae is already covering the wall and creating unpleasant view of the wall. The amphitheatre still intact and it only requires grass cutting.

1. SAHRA must redo the grave walls
2. The grass at the site must be cut at least three times a year
3. The memorial wall must be painted to prevent water

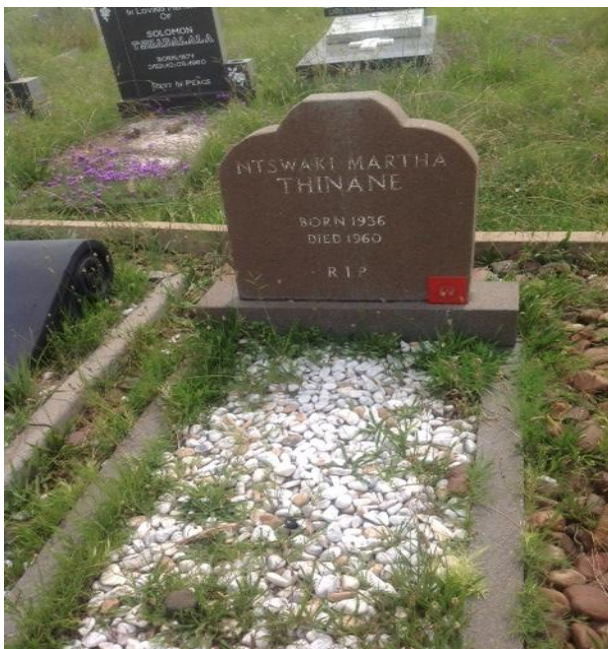
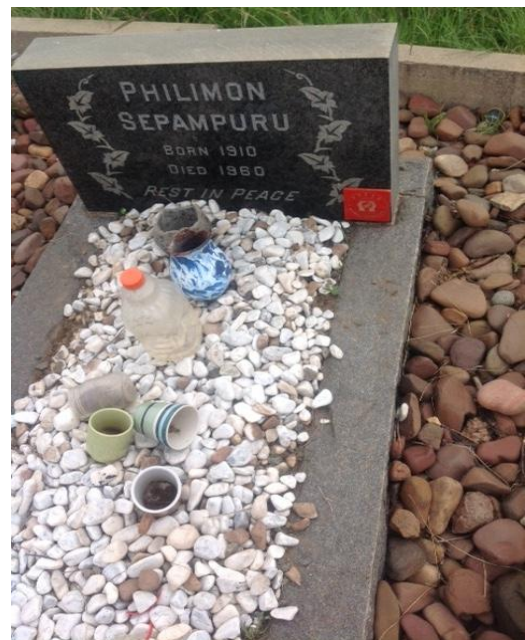
Picture 4: The Memorial Graves

One will assume that because of the existing adjacent graves, careful consideration was taken when designing the head stones. Some of the family members have replaced SAHRA's head stones with their own head stones.

Some of the head stones have since cracked and the surrounding lentils have fallen apart. On each head stone, there is a red badge indicating that the graves are National heritage resources. In terms of section 36, the graves fall under general protection. It is not even clear whether the site was ever been graded.
