Assessment and Mapping of Heritage Resources on the Shongweni Estate for Tongaat Hulett Properties

Prepared for: Tongaat Hulett Developments (Pty) Ltd
P O Box 22319
Glenashley
4022
May 2012

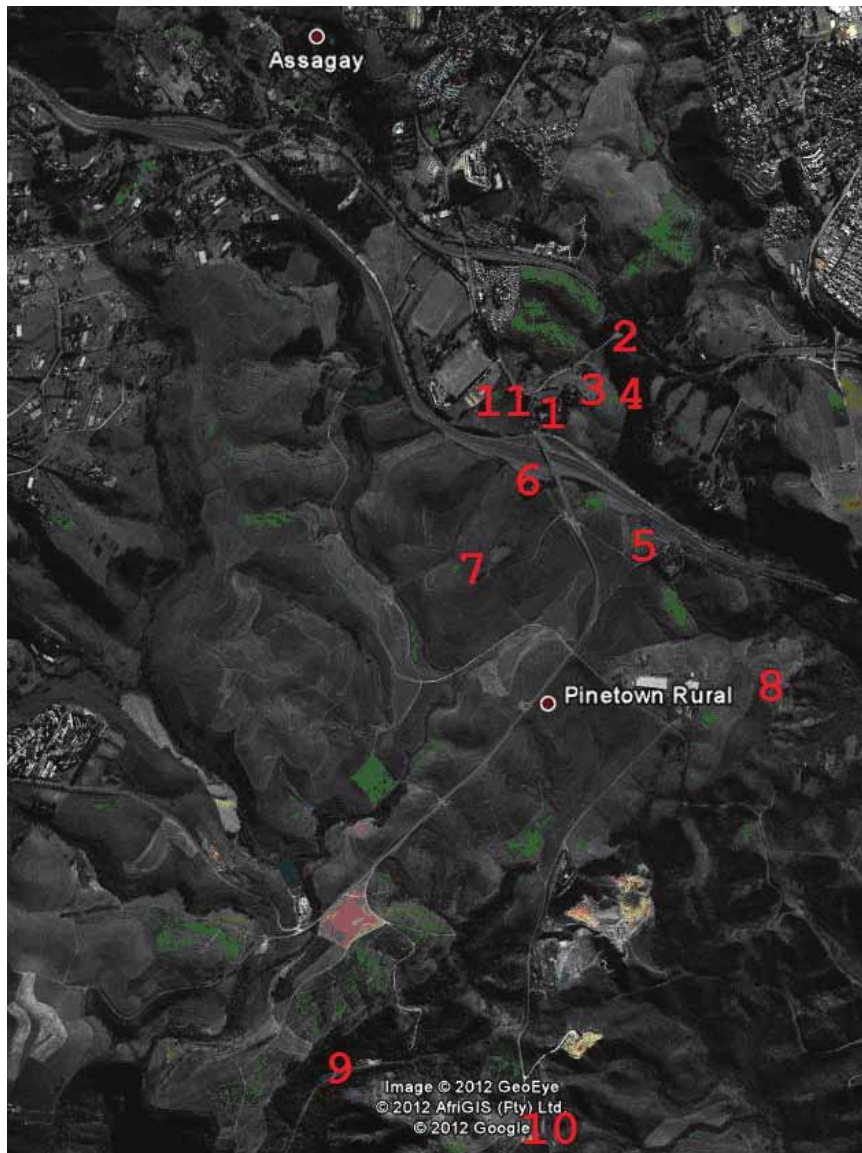
Fig 1: Sites identified for discussion

- 1: Waterfall Farmhouse- currently Tongaat Hulett Headquarters**
- 2: Site of ruin by Umhlatuzana River**
- 3: Estate Management House 1**
- 4: 2 Labour Cottages**
- 5: Full time labour cottages**
- 6: Estate Management House 2**
- 7: Seasonal Labour compound**
- 8: Fire Lookout tower**
- 9: Delville Wood Station**
- 10: Signal Tower**
- 11: Estate Management House 3**

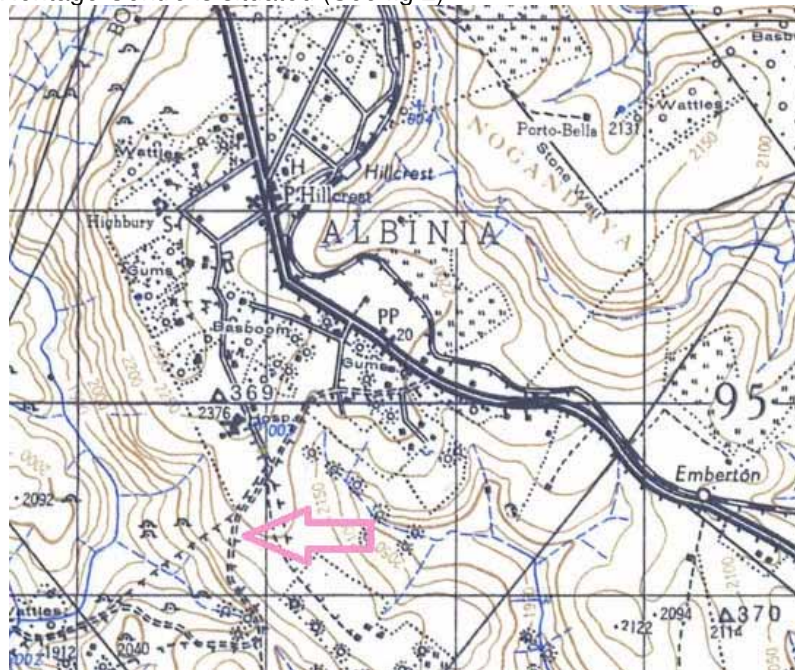
Fig 2: 1940 Topocadastral map 2930DD2931CC showing dotted tracks off towards Waterfall farm.

For the homestead, it is most likely that the core of the building was constructed around 1880 when James McIntosh purchased Subdivision A. Its access was not along the current Shongweni Road, but rather dipped down from the centre of Hillcrest beyond where the present day Heritage Centre is situated (See fig 2).

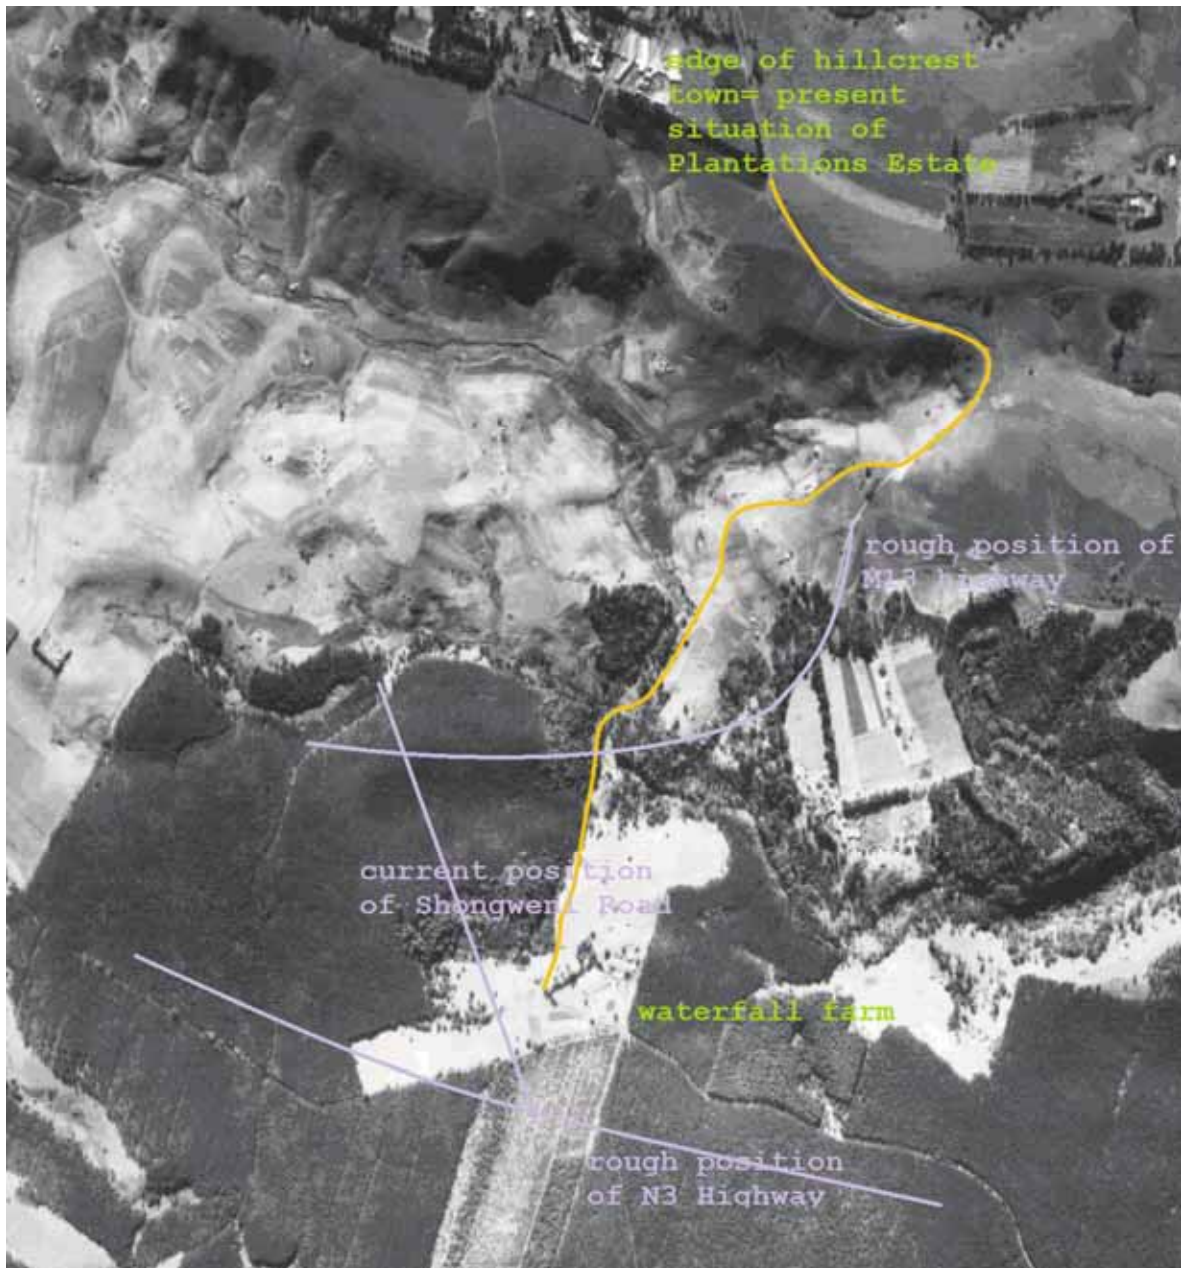
Fig 3: 1937 aerial photograph showing context of Waterfall farmhouse against its old access road (orange) and contemporary landmarks. Note intense afforestation.

Waterfall farmhouse² is currently situated between the M13 highway and the N3. It is located on a knoll overlooking the Mhlatusana River to the east. The north-east facing homestead consists of a large, sprawling and much altered farmhouse, and sundry farm buildings, all enclosed by a fence. It is currently the home of the Estate Manager employed by Tongaat Hulett. After an inspection of the many structures on site, it was established that the only buildings of interest in this complex on this site is the old farmhouse house and the stock pen, and for expedience sake, these shall be discussed.

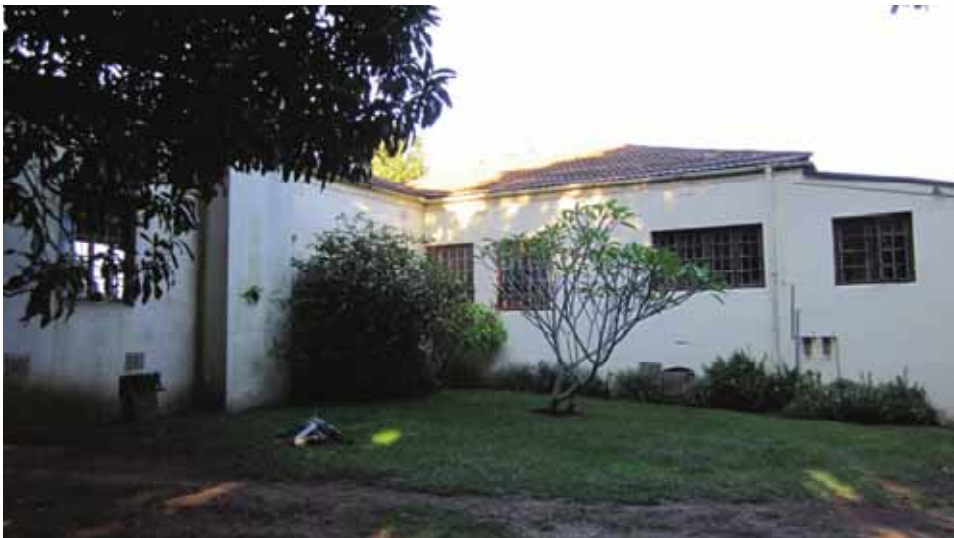
Fig 5: Entrance aspect to Waterfall Farmhouse

From the driveway the entrance is nondescript, possibly given the realignment of the Hillcrest Shongweni Road, removing the approach from the old road directly to the house. One is greeted with plastered walls containing meranti cottage pane windows.

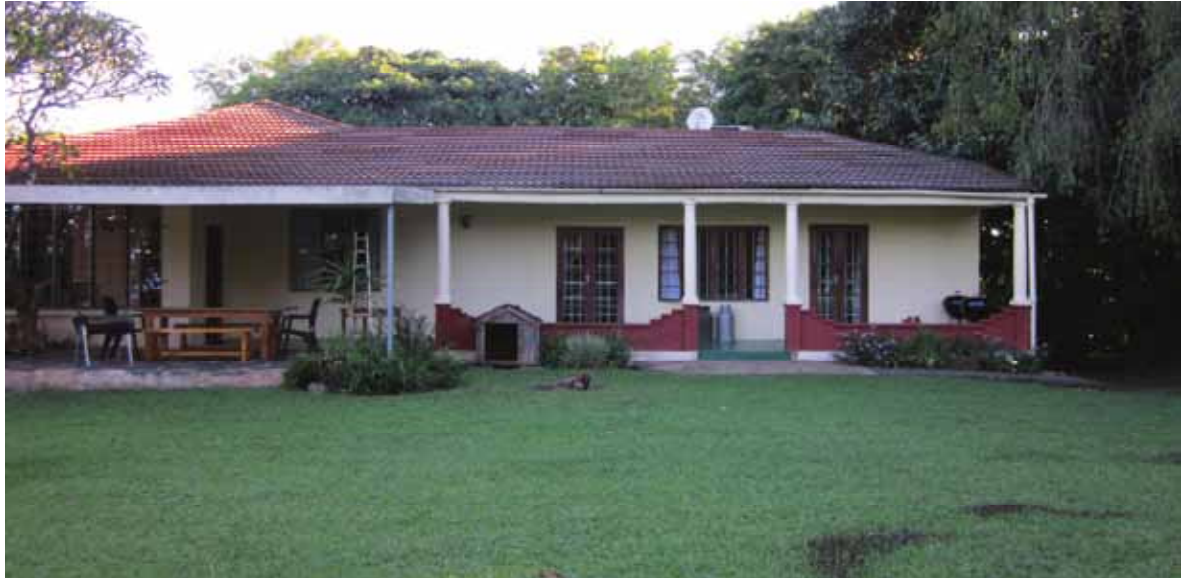
The north-east façade has a long veranda facing onto the garden, with a section consisting of four Tuscan columns on top of two low slung brick walls that flank an entrance onto the veranda- oddly aligned with a window rather than a door. The veranda has been further extended, and enclosed with *louvres*, distorting the proportions and the integrity of the façade (See Fig 6).

Fig 6: North East Facade of Waterfall Farmhouse

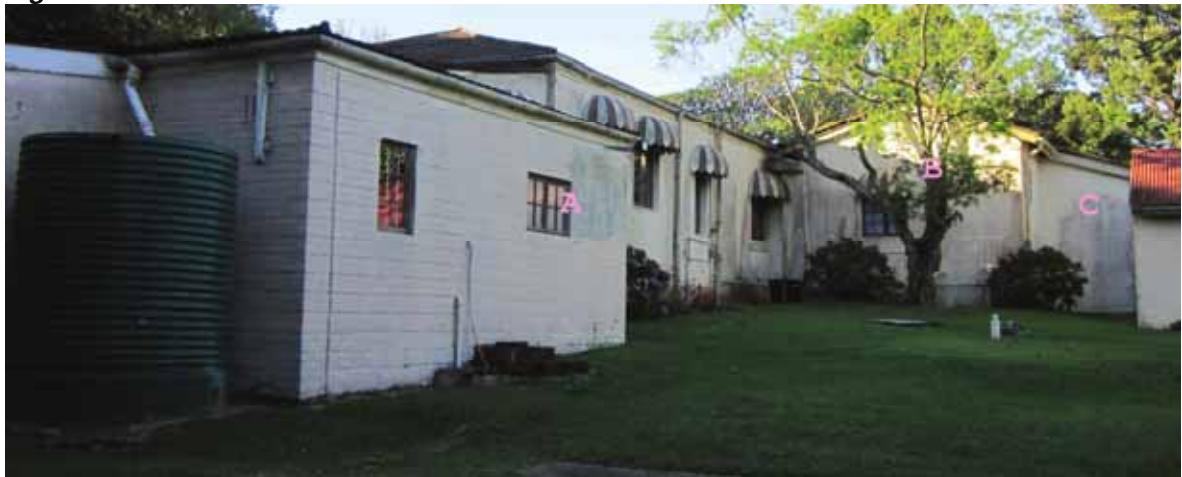
Fig 7: South East Elevation showing accretions: A, B and C.

The South East façade is equally discombobulated. The addition marked A is in raked pointing and bagwashed with meranti windows. Addition B is a double pitched accretion onto the edge of the veranda and C is a little portico with stone columns which has been enclosed (See Fig 8).

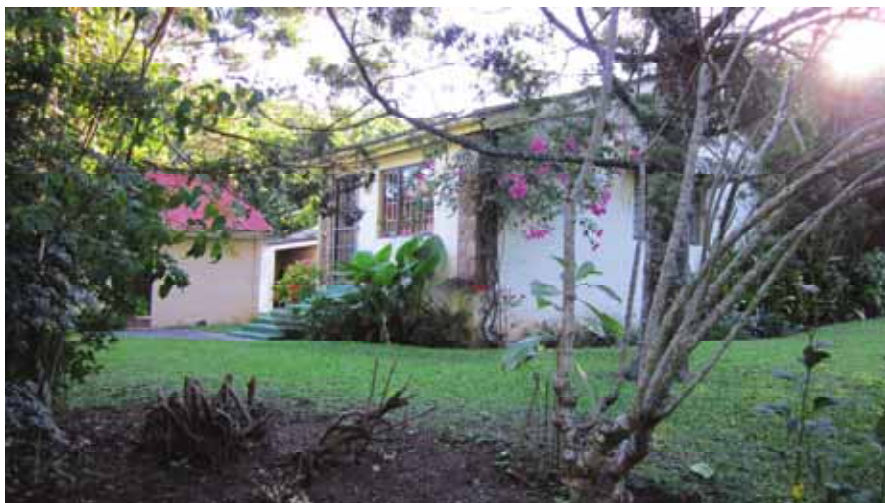
Fig 8: Enclosed portico on double pitched addition to veranda.

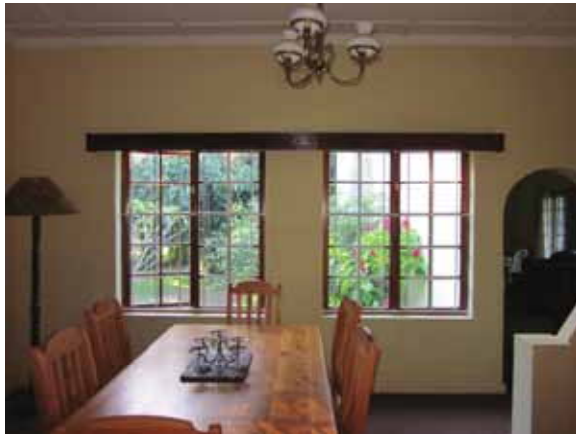
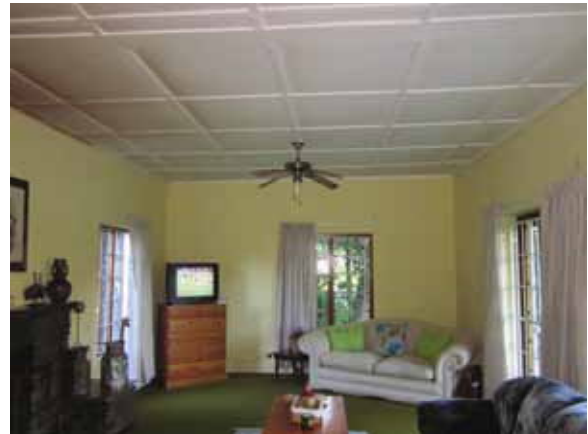
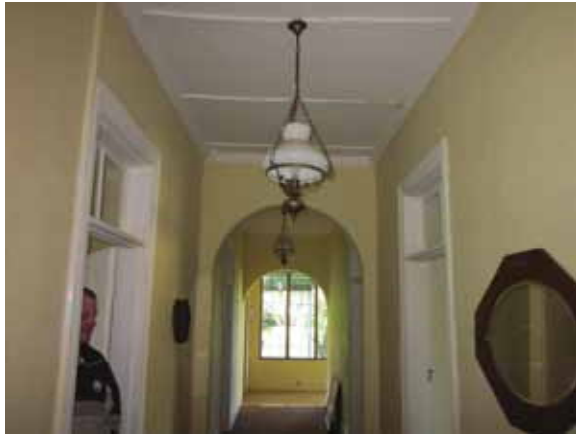
Internally, the core of the house retains some of the elegance which it must have had. Panelled doors with fanlights, timber floors (under carpet) and timber ceilings exist in those parts of the house that have not been added to or modernized (see figs 9, 10 and 11).

Fig 9. Room currently used as a dining room

Fig 10: Lounge made up of two rooms

Fig 11: Passage through house from back to front. Fig 12: 'Stock pen'

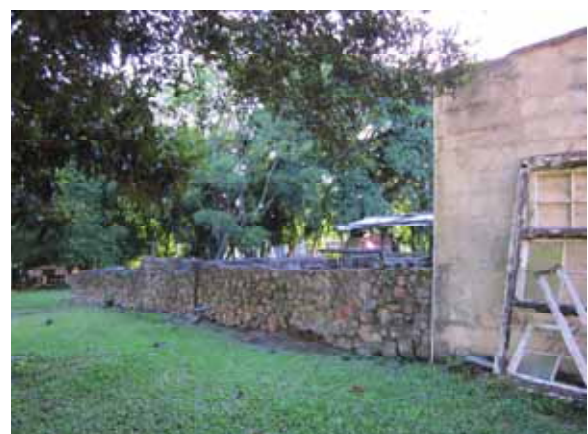
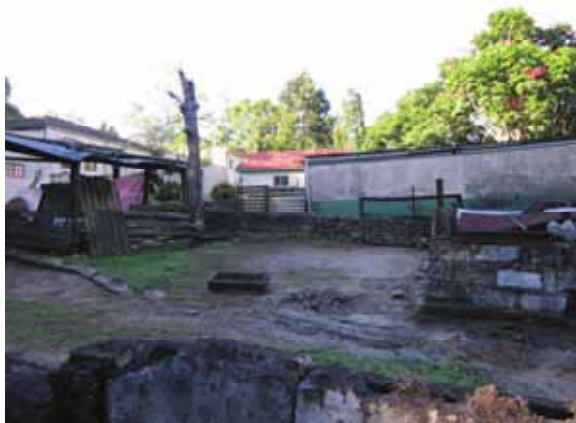
Fig 13: Stock pen looking towards the house

The 'stock pen' is of random rubble and roughly cemented at a fall close to the house (see Fig 13). It is adjacent to a bagwashed structure of block (see fig 12). It is not certain exactly what function this structure played, given its proximity to the house. Certainly the family is known to have kept ponies, and, one would assume have kept fowls and the like (Camp 1999:29).

Mitigation: Reuse House, Retain garden, demolish outbuildings

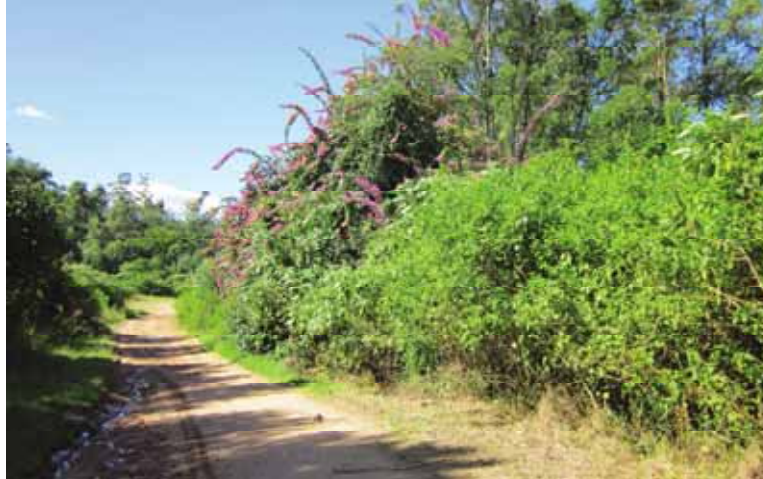
Identified by large and established *Bougainvillea sp.* the building that stood in its place was allegedly demolished about 15 years ago (Stroud pers.comm). Given that this was positioned on the old road to Hillcrest, this could have had some value. Nothing further is known about it at this point. It is recommended that during any bush clearing and excavation, an archaeologist is present in a monitoring capacity.

Fig 18: Site of demolished building

Demolished building Age: unknown	Local	Regional	National	International
Architectural	low	low	low	low
Historical	low	low	low	low
Social	low	low	low	low
Technical	low	low	low	low
Scientific	low	low	low	low

Mitigation: It is recommended that during any bush clearing and excavation, an archaeologist is present in a monitoring capacity.

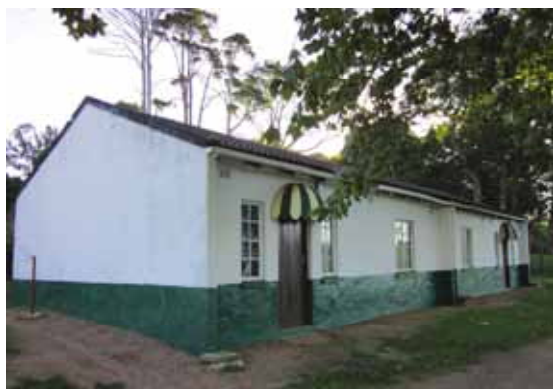
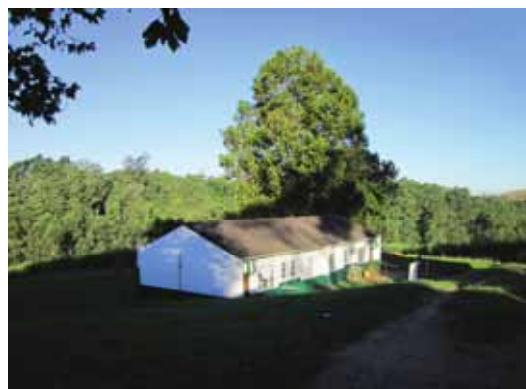
These two cottages are located close to the main farmhouse beyond the Estate Management House number 1. They are in a similar architectural mould as the Full-time labour cottages in section 5.5, and are situated on an upper and a lower terrace. They have Marseilles tiled roofs, are bagged and painted, and have standard steel section windows. Half-moon awnings have been positioned over the entrance ways.

The buildings are modest and well considered, well maintained, and are good examples of a labour village idiom. It is suspected that they were constructed in the 1960s, after the consolidation of Kirkfalls.

Fig 19 and 20: Labour cottages

Pair of labour cottages Age: circa 1960s	Local	Regional	National	International
Architectural	low	low	low	low
Historical	low	low	low	low
Social	low	low	low	low
Technical	low	low	low	low
Scientific	low	low	low	low

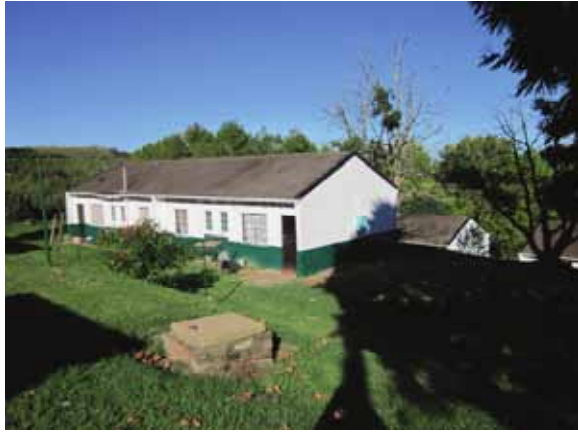
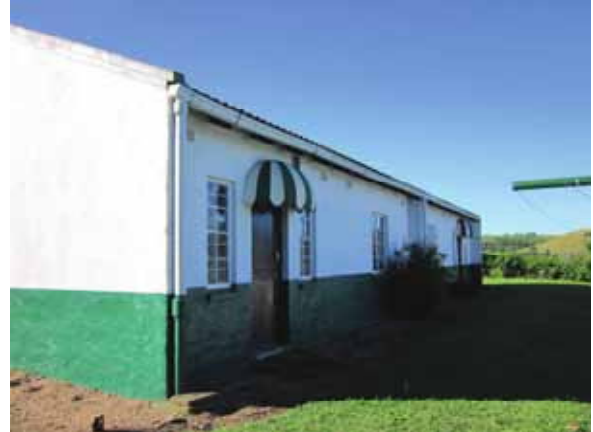
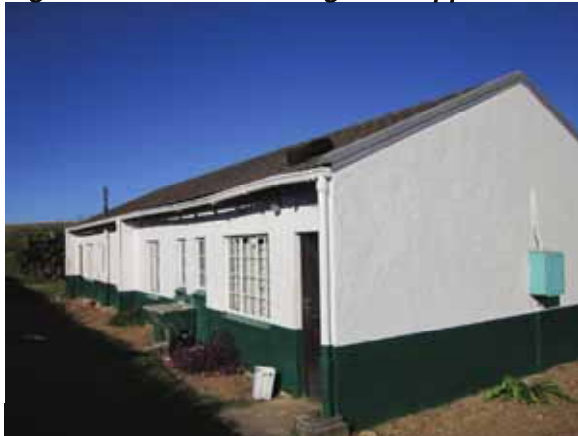
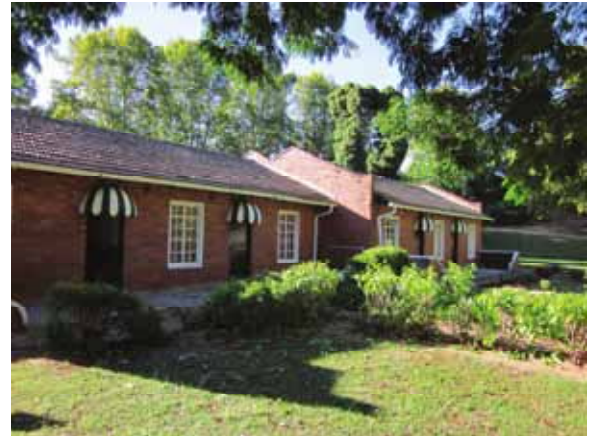
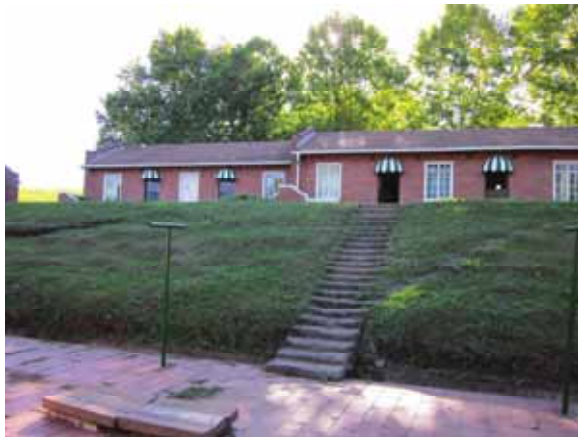
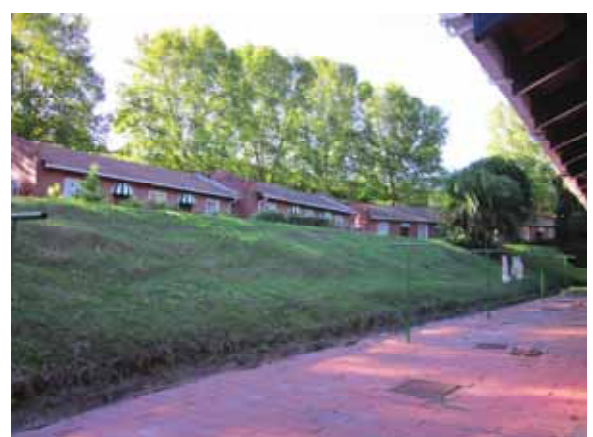
The structures on the lower terraces are smaller flatlets, most likely constructed at a later date. They are of face brick, with end gables under Marseilles tiles. There is a small patio at the entrance to each complex unit with a decorative low *stoep* wall defining space. As before, these structures are well designed and very good examples of a labour village.

Fig 21 & 22: Labour cottages on upper terrace

Fig 23: Labour cottage on upper terrace

Fig 24: Labour cottage on lower terrace

Fig 25 & 26: Cottages on lower terrace

Full time labour cottages Age: 1960's-1970's	Local	Regional	National	International
Architectural	medium	low	low	low
Historical	low	low	low	low
Social	medium	medium	low	low
Technical	low	low	low	low
Scientific	low	low	low	low

Labour villages are an important part of the history of KwaZulu-Natal and it is important that there is some record as to their contribution in the labour history of the province. It is suggested that even though these structures do not fall within the ambit of the KwaZulu-Natal Provincial Heritage Act No 4 of 2008, there is opportunity for reuse of what are, at face value, solid and well designed buildings.

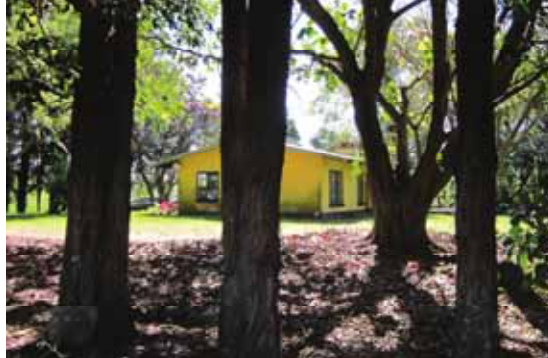
This is a ranch style suburban building of conventional construction and materials. It is of recent construction, possibly late 1960's to early 1970's. It has no architectural merit and is of similar ilk to the house described in section 5.3. Note, however, that this house is situated in a well-established garden.

Fig 27: Estate management house 2

Estate management house 2 Age: 1960's-1970's	Local	Regional	National	International
Architectural	low	low	low	low
Historical	low	low	low	low
Social	low	low	low	low
Technical	low	low	low	low
Scientific	low	low	low	low

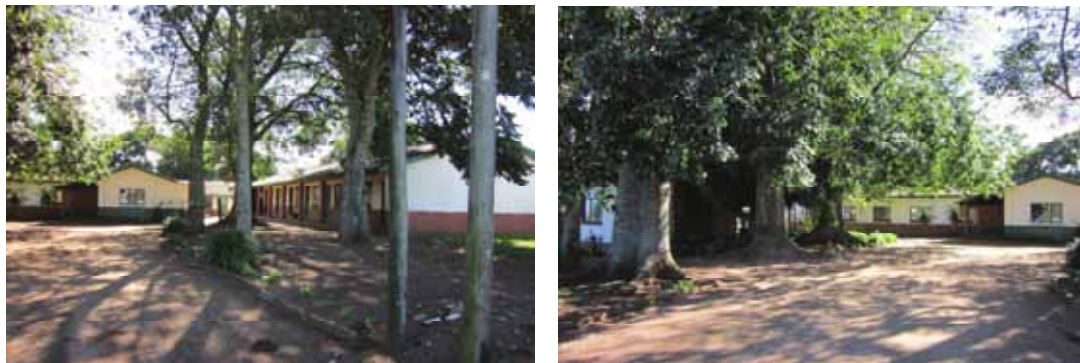
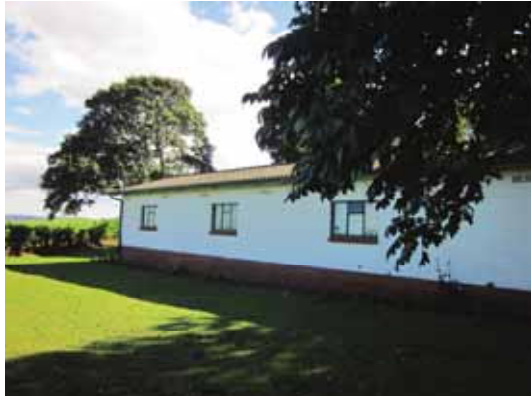
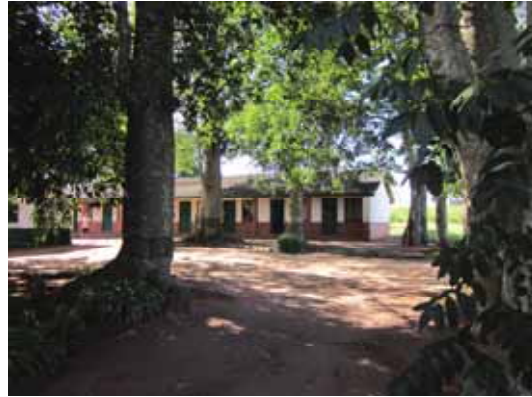
As with the Labour compound in 5.5 above, this compound is also well appointed and slightly elevated, and situated in the middle of the cane fields. It consists of a number of buildings, arranged around a series of courtyard spaces, with established trees in and around these courtyards. There is a football field to the north east of it.

Fig 28 & 29: Courtyard in seasonal labour compound

The buildings themselves are utilitarian, constructed out of stretcher bond brickwork, bagged and rule jointed with steel section standard windows, and 'Big Six' asbestos sheeting. Flippant elements of Modernism such as *brise soliel* and screens add privacy. Rooms lead onto the courtyards which assist in constructing a strong sense of place. As with the Full-time labour compound, this complex provides an opportunity for reuse.

Fig 30: Edge from the access road

Fig 31: Courtyard

Seasonal labour compound Age: 1960s?	Local	Regional	National	International
Architectural	low	low	low	low
Historical	low	low	low	low
Social	medium	medium	low	low
Technical	low	low	low	low
Scientific	low	low	low	low

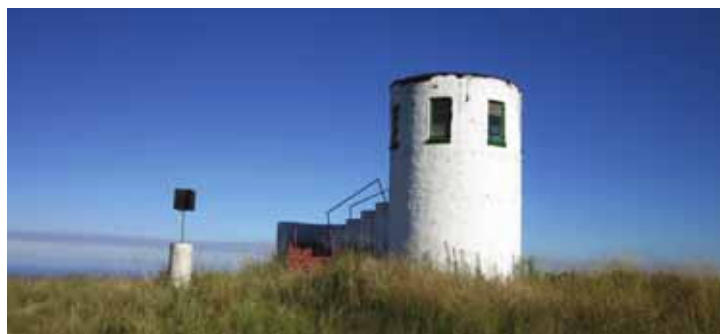
This is a circular tower of mixed construction visible from the N3 and situated adjacent to the Ntabankulu trigonometric beacon on top of the hill. It is apparently an old structure, which has been much altered in the past (Stroud: pers.comm). It is suspected that given its inaccessible position, it is generally safe from development, thus retaining its landmark quality.

Fig 32: Fire Lookout tower

Fire Lookout tower Age: unknown	Local	Regional	National	International
Architectural	low	low	low	low
Historical	low	low	low	low
Social	medium	low	low	low
Technical	low	low	low	low
Scientific	low	low	low	low

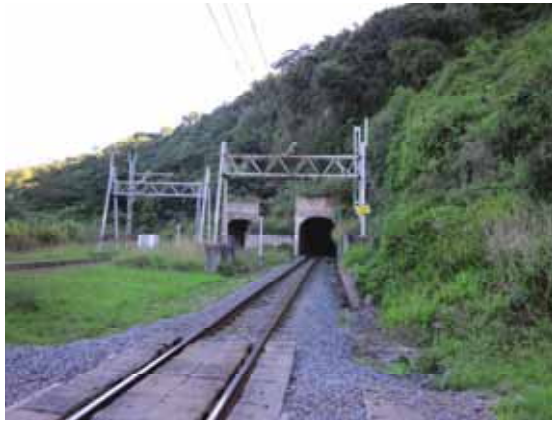
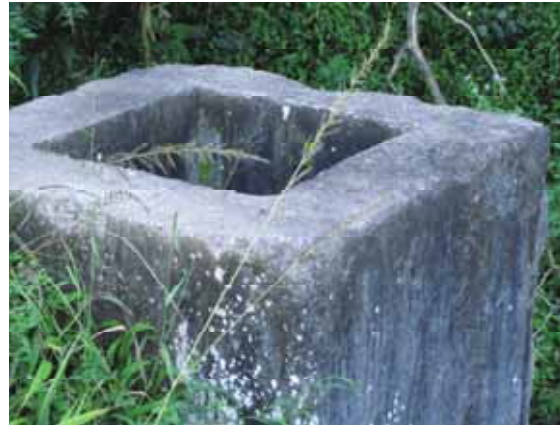
The railway tracks came through this area in the early 1920s. Significantly the blasting and tunneling made an impression on local residents, as noted by Camp in her work on the area (Camp 1999:29). However, little of any import remains as the current tunnel is dated to 1974 and the station is reduced to an electrical substation. A single element of its history exists in the square concrete structure in Fig 34 below, possibly used as a reservoir in the past.

Fig 33: Tunnels dated to 1974

Fig 34: Possible reservoir

Delville station and surrounds Age: 1960's-1970's	Local	Regional	National	International
Architectural	low	low	low	low
Historical	low	low	low	low
Social	low	low	low	low
Technical	low	low	low	low
Scientific	low	low	low	low

Mitigation: None

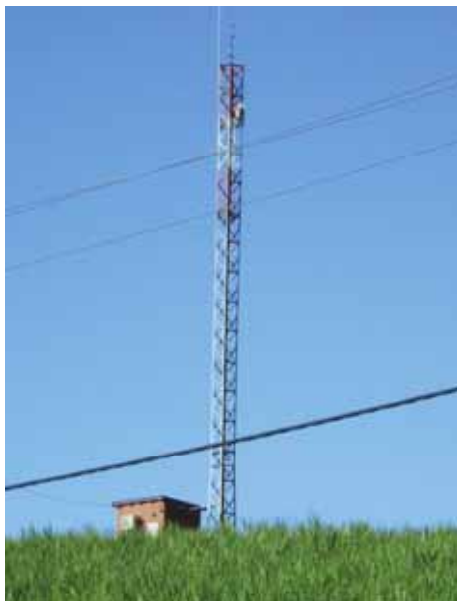
This is a steel framed tower of recent construction and function in the middle of canelands on the descent to Shongweni. At its base is a small, nondescript and utilitarian plant room constructed of stretcher bond brickwork. This has no architectural nor heritage value.

Fig 35: Microwave tower

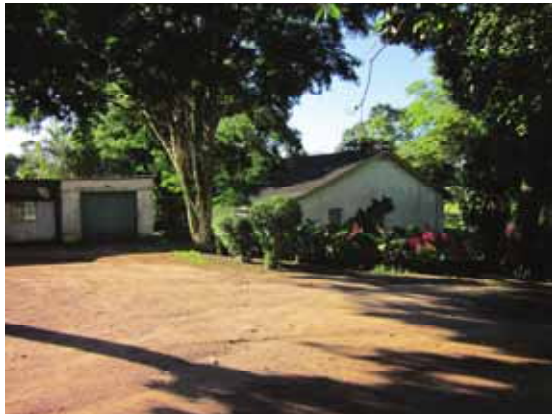
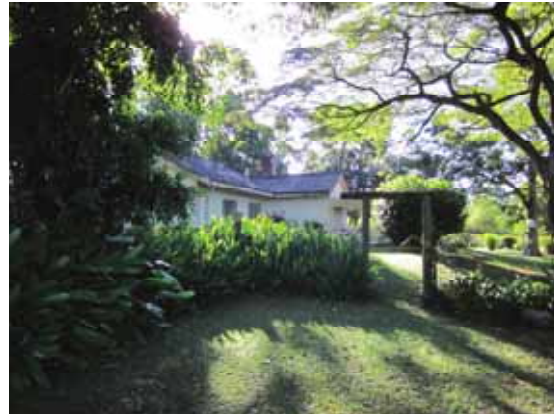
This is a ranch style suburban building of conventional construction and materials. It is of recent construction, possibly late 1960's to early 1970's. It has no architectural merit and is of similar ilk and period to the houses described in section 5.3 and 5.6. It is, however, set in a well- established and maintained garden.

Fig 36: House 3 from drive

Fig 37: House 3 from garden

Estate management house 3 Age: 1960's-1970's	Local	Regional	National	International
Architectural	low	low	low	low
Historical	low	low	low	low
Social	low	low	low	low
Technical	low	low	low	low
Scientific	low	low	low	low

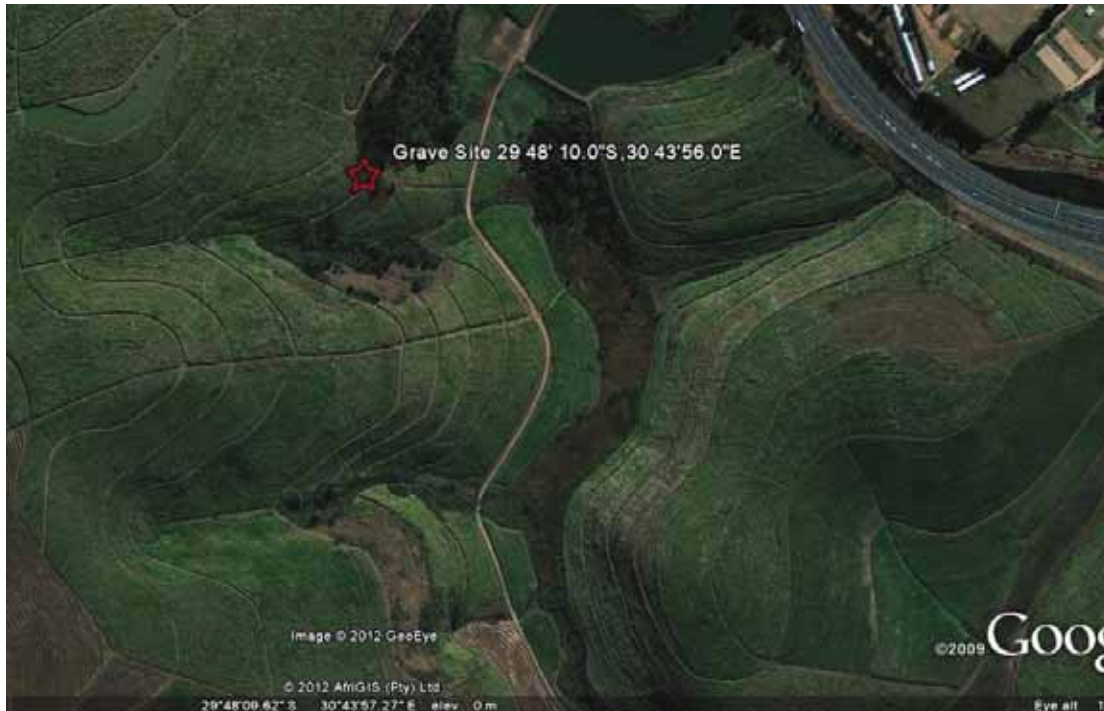
A grave site with three burials is recorded on the property at S29° 48.166'; E30° 43.930'. The location of the graves was provided to eThembeni from the Tongaat Hulett Graves and Cemeteries Data Base. Field inspection places these on the edge a thicket of uncultivated land above the dam adjacent to the N3. The graves are those of Nkunzi Mgwaba (died 1959), Anelia Mgwaba (died 1971) and a child that died 1965.

Fig 1: Showing grave sites superimposed on Google Earth

All graves have high heritage significance and are protected in terms of legislation. In the process of ongoing development of the property it is possible that further human remains may be exposed. The following legal guidelines are appended (see Appendix C1).
