ARCHAEOLOGICAL PERMIT APPLICATION FOR SITE LEVELLING

submitted in support of a permit application in terms of Section 35 of the NHRA (1999) for
SITE LEVELLING ON SEVERAL PARCELS AND VARIOUS ERVEN AHEAD OF REDEVELOPMENT,
DISTRICT SIX, CAPE TOWN

S35 Permit Application

March 2022

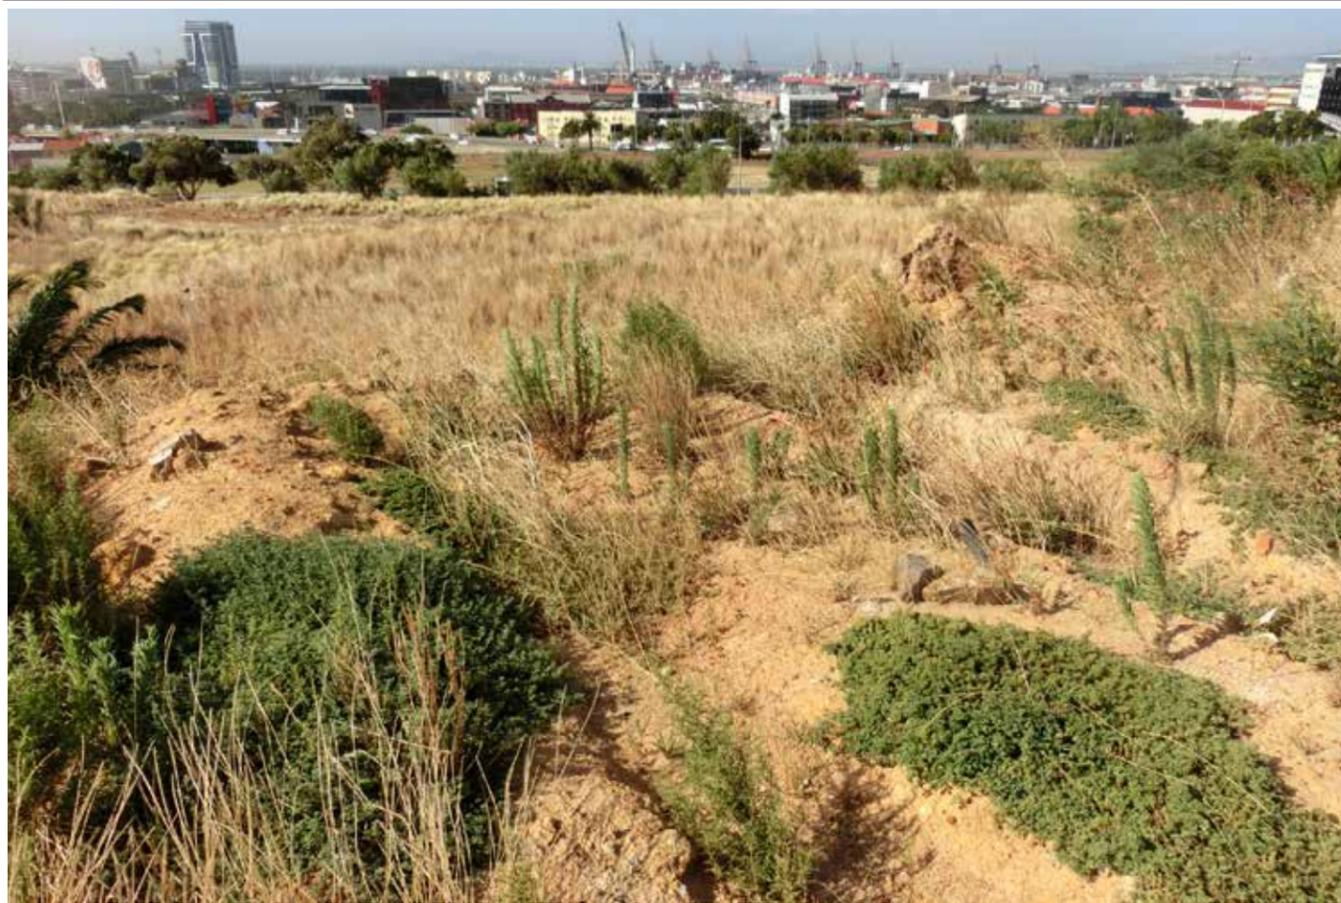
Figure 4. View across Phase 4 from south east of site, view to north (RSA, 2020).

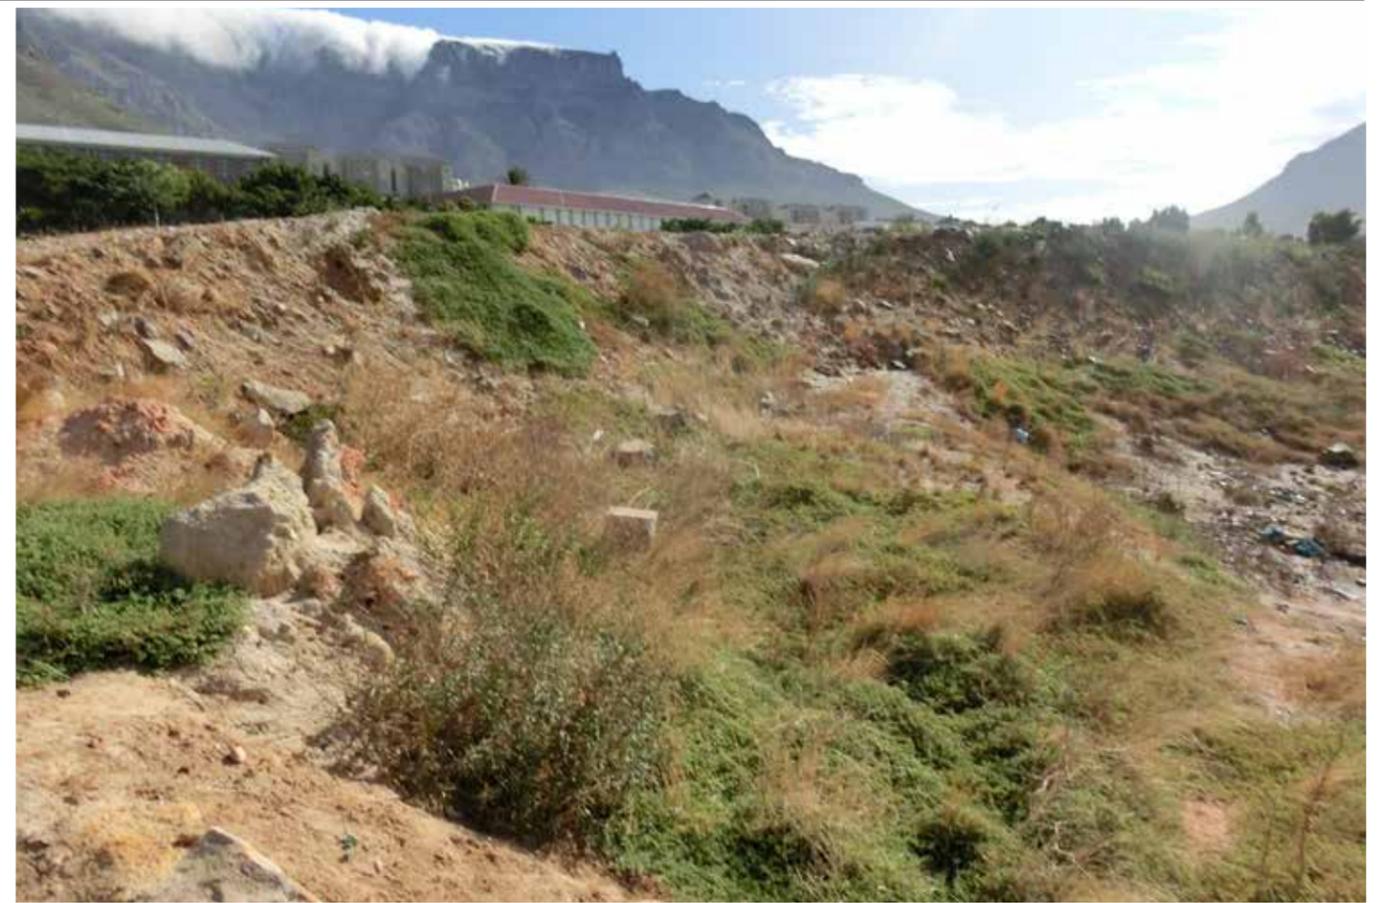
Figure 6. View across Phase 4 from Vogelgezang Street showing recent changes in site levels (RSA, 2020).

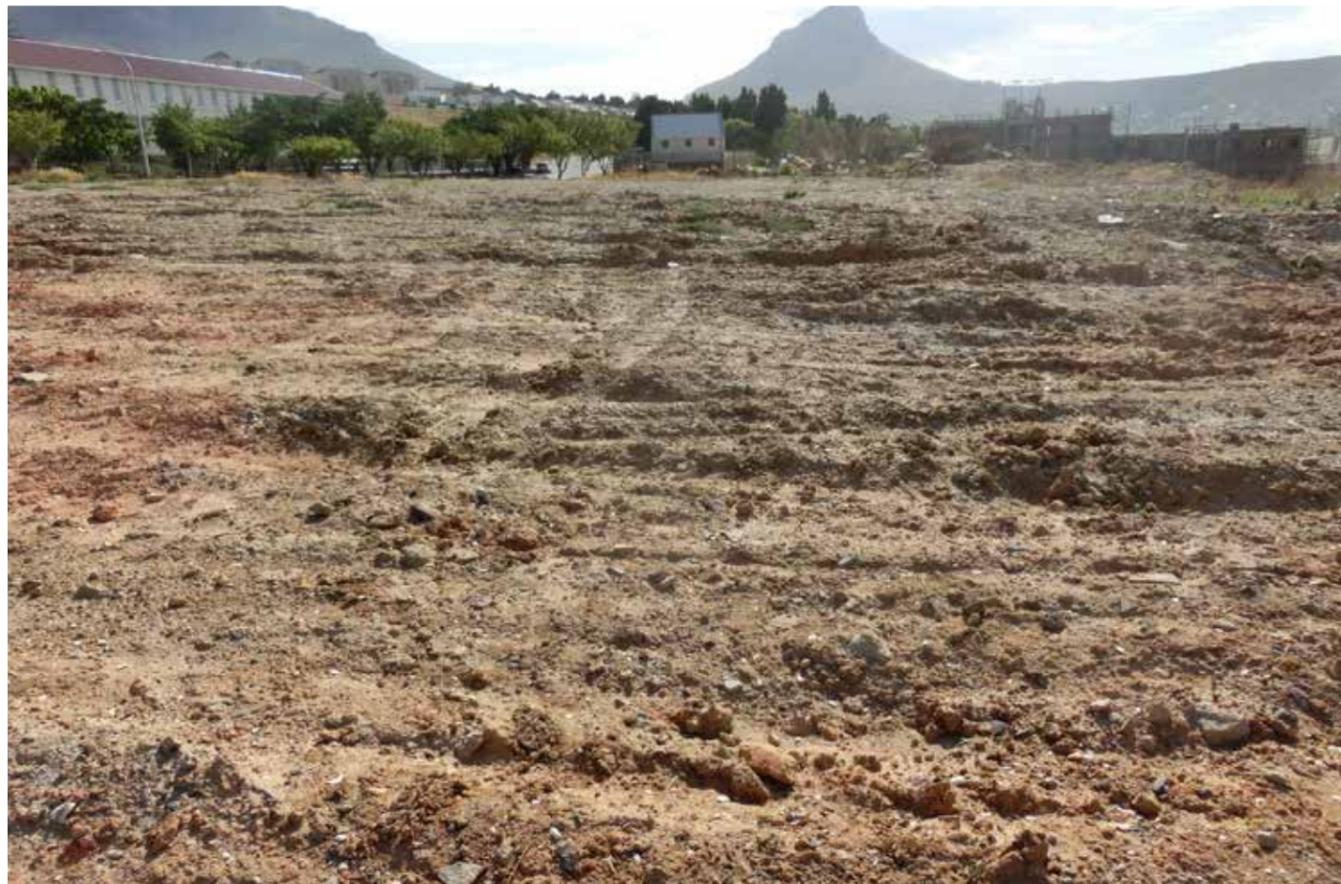
Figure 5. View across Phase 4 from east of site showing recent earthmoving activity, view to west (RSA, 2020).

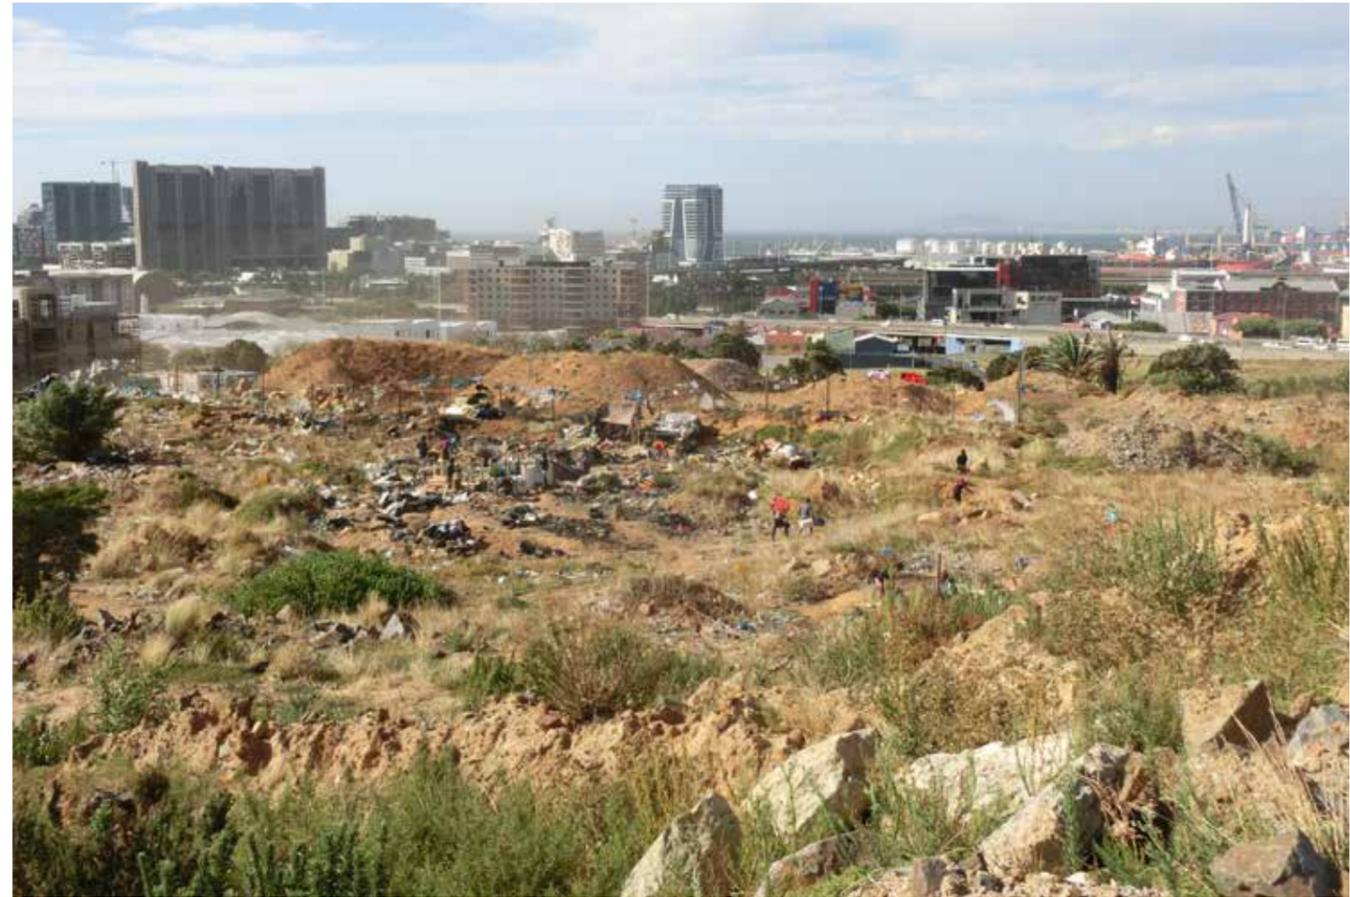
Figure 10. Disturbance across northern portion of Phase 4 related to development of Phase 3, view to north west (RSA, 2020).

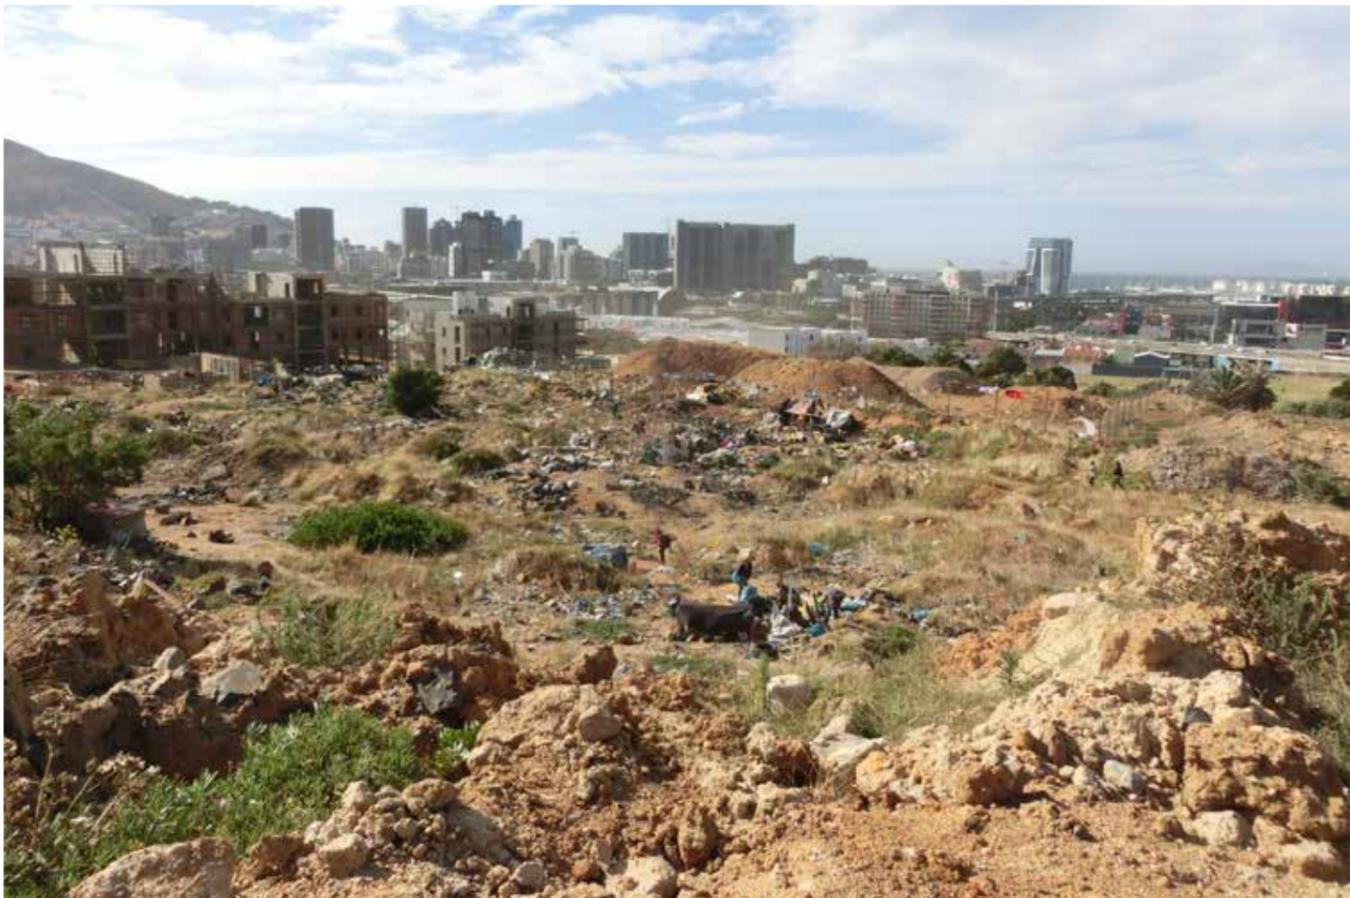
Figure 9. Evidence for extensive disturbance on Phase 4, view to north west (RSA, 2020)

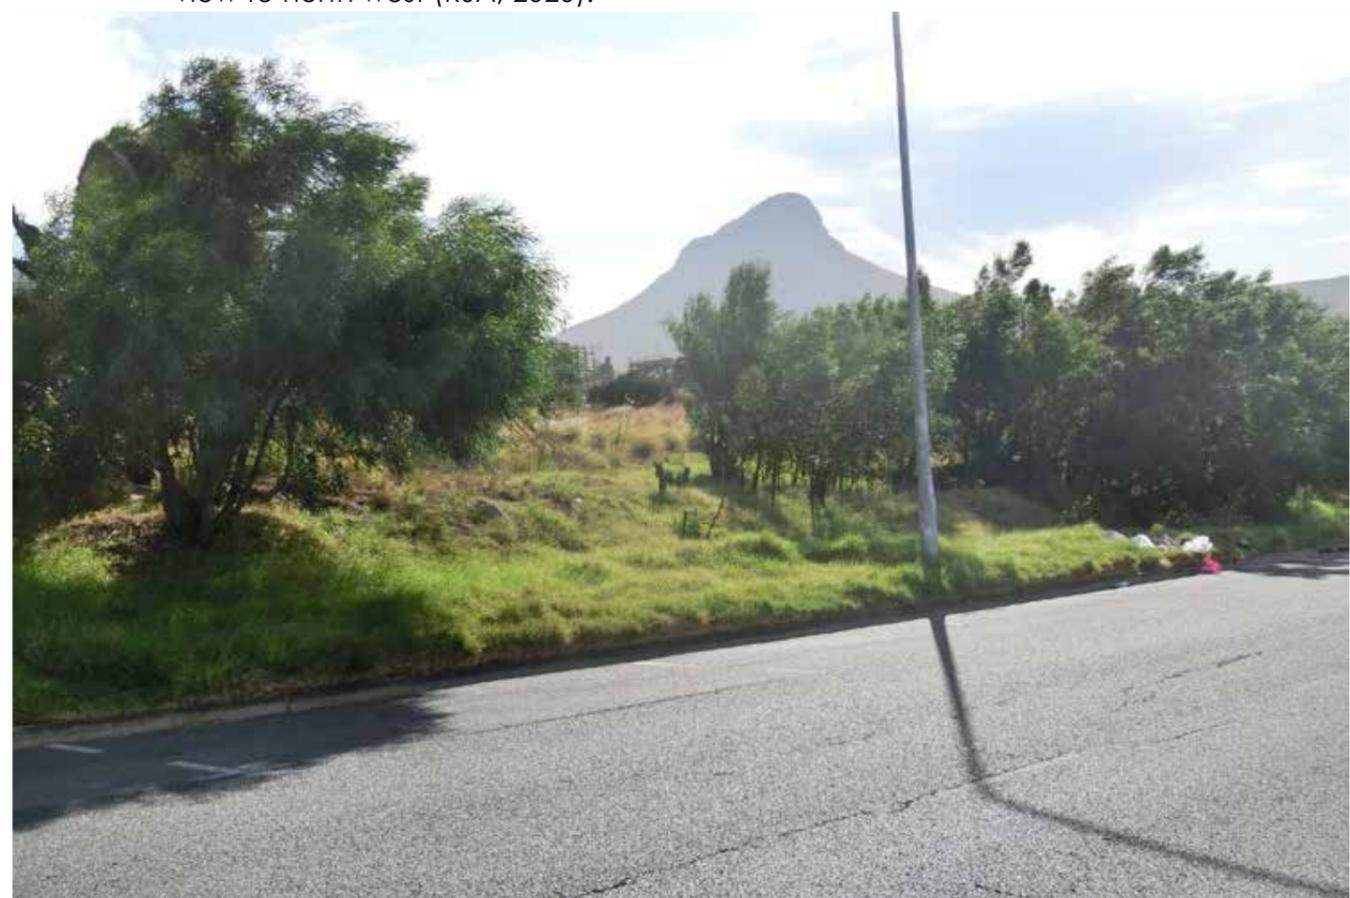
Figure 11. Embankment along what is now Hanover Street, view to south west (RSA, 2020).

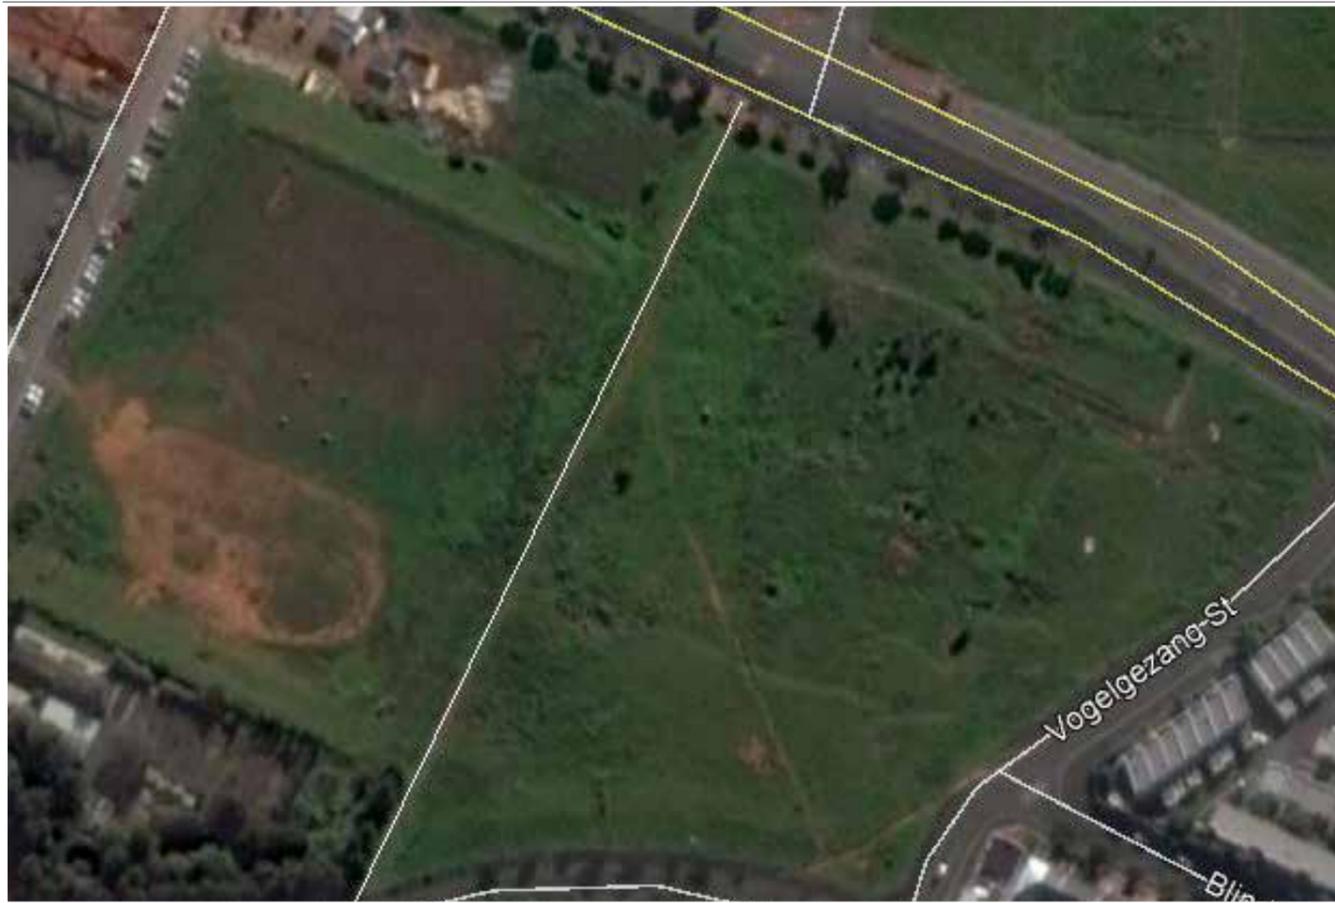
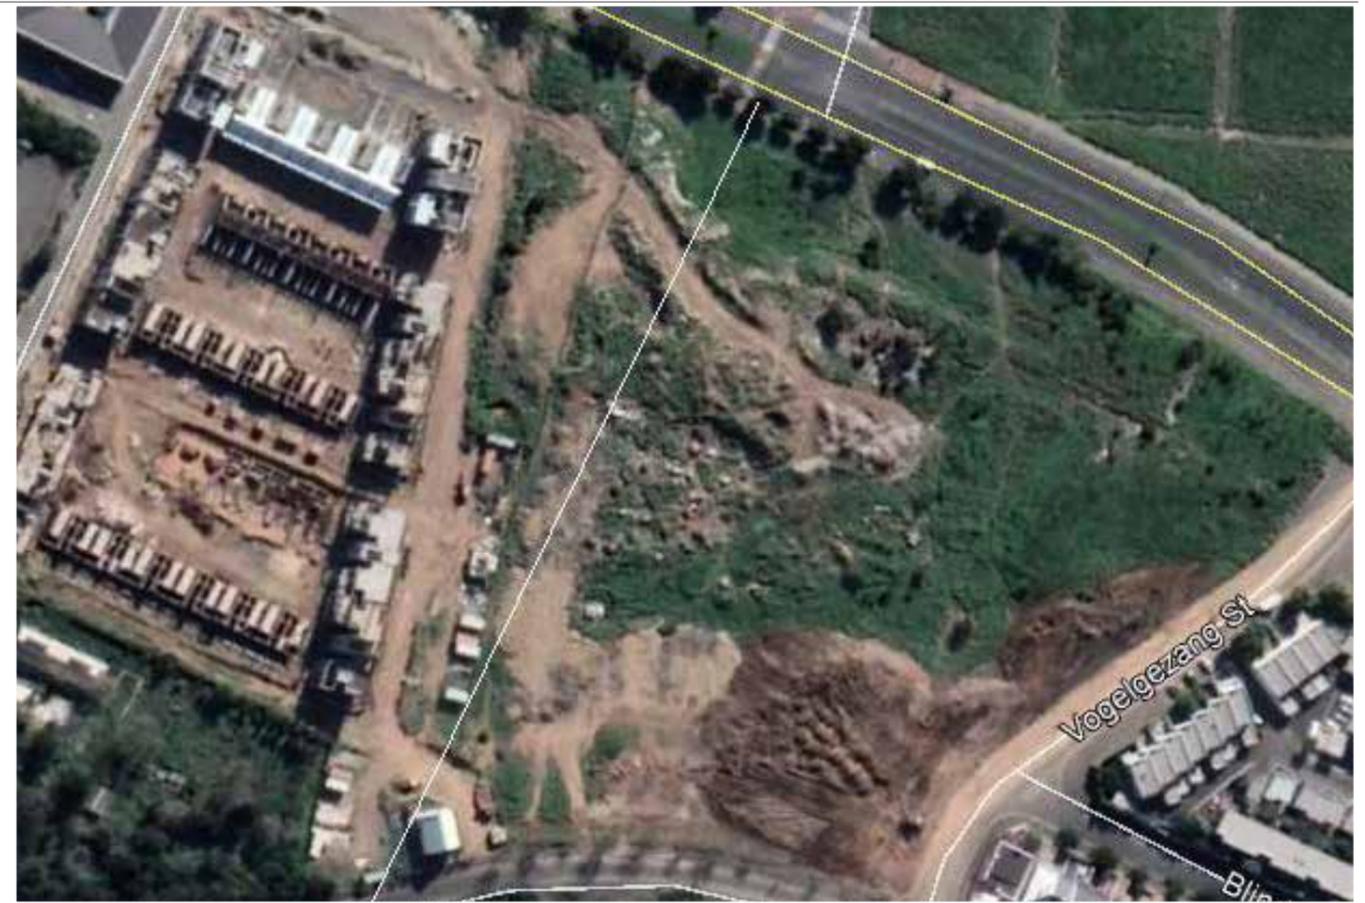
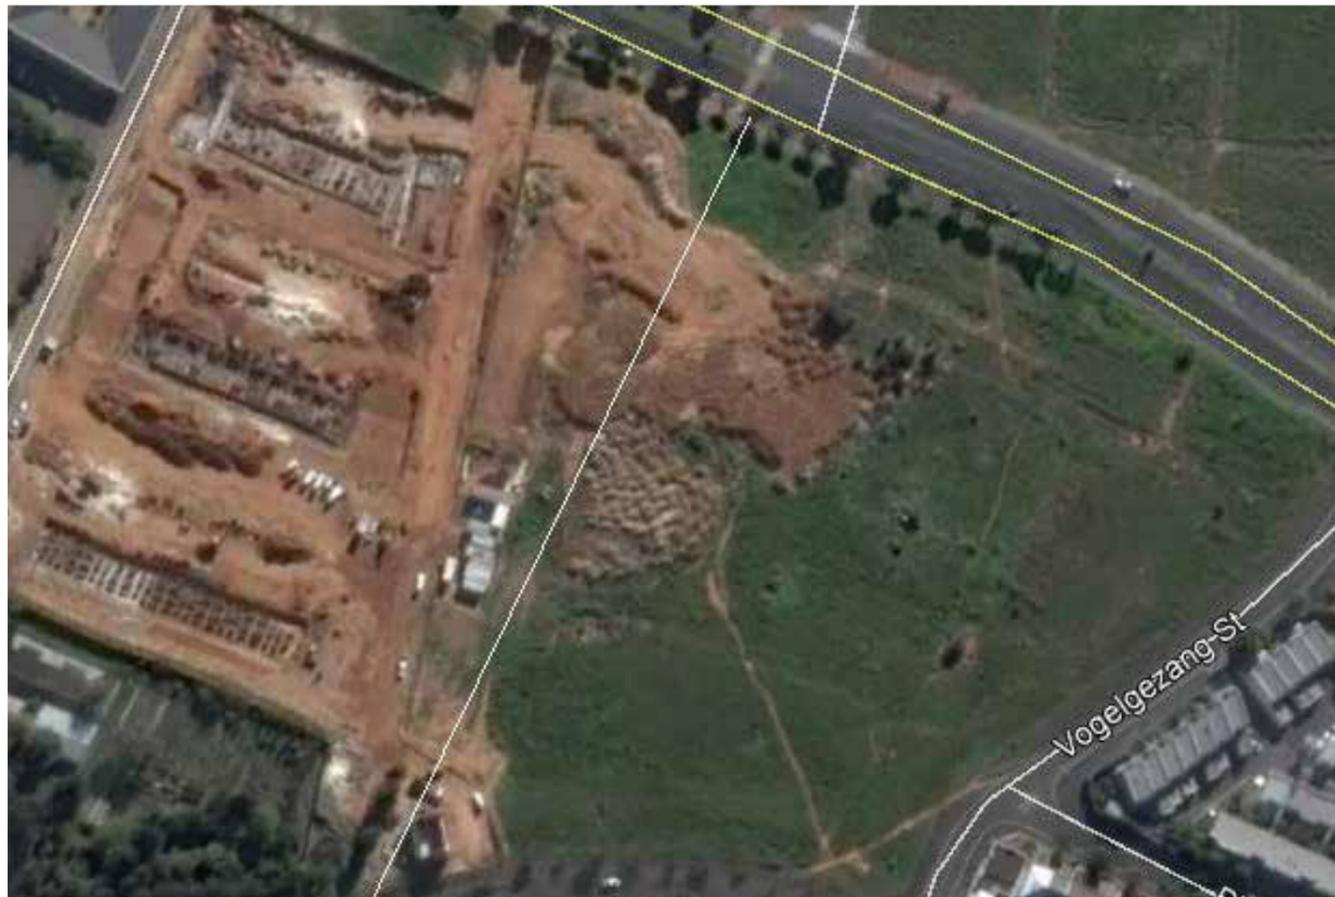
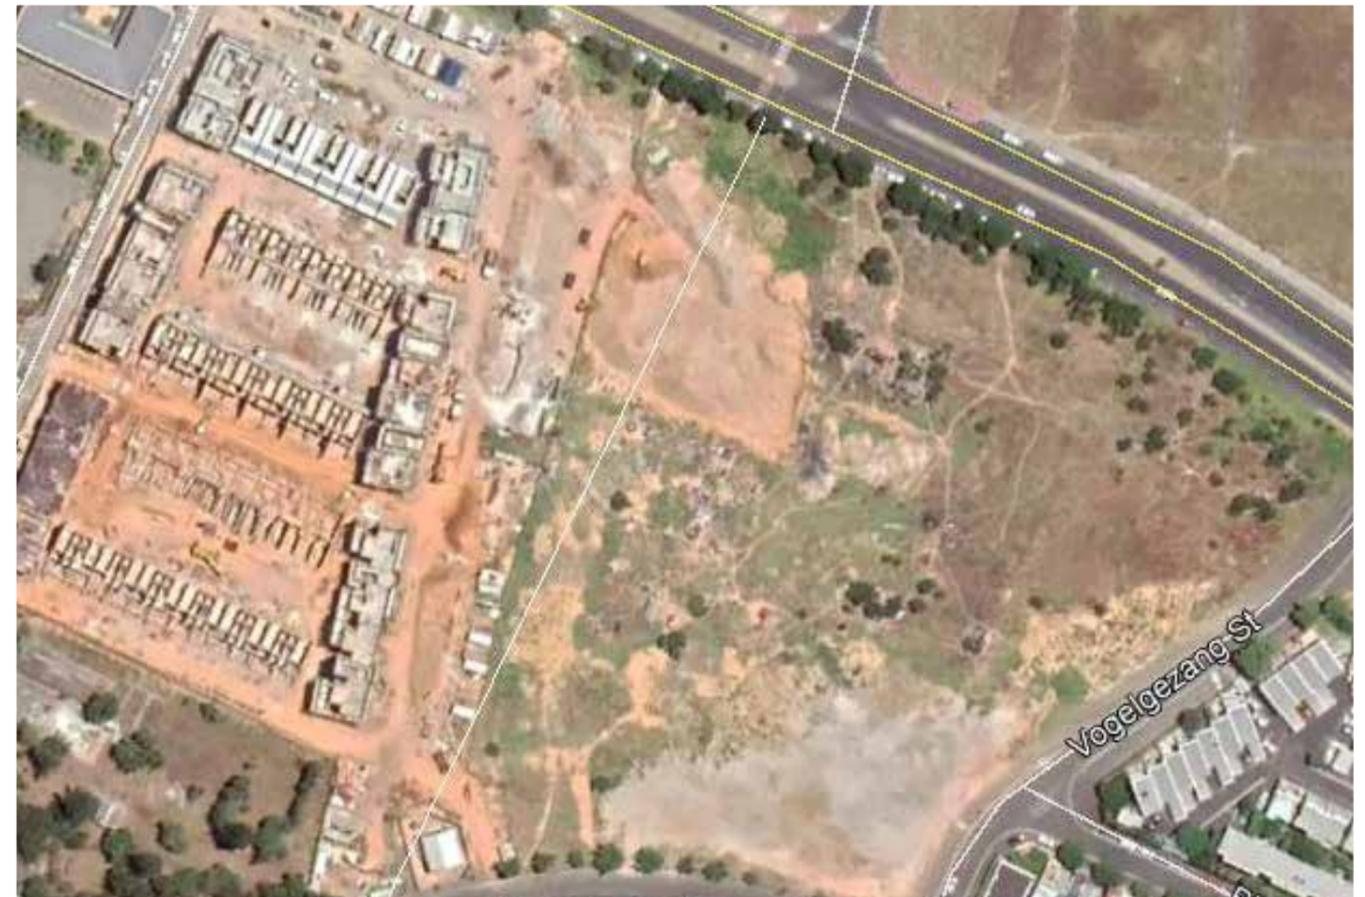
Figure 12. Evidence for disturbance of Phase 4 through time as a result of development activity on the adjacent site, Block Q2.. Google Images are: top left, June 2014; bottom left June 2016; top right July 2018; bottom right, November 2019 (Google Earth, 2020)

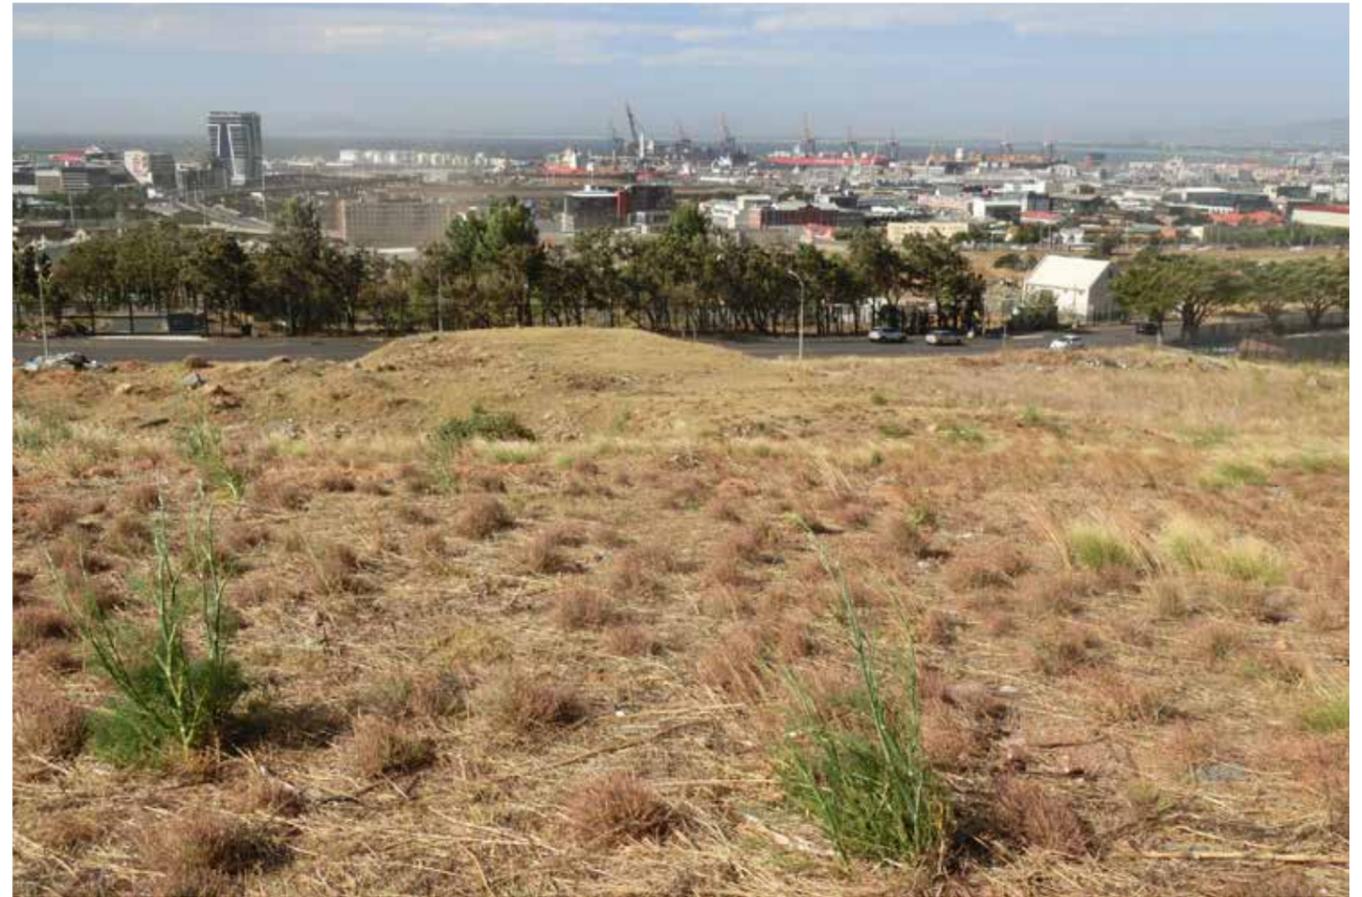
Figure 17. View across Phase 5 from west of Horstley Street, view to north east (RSA, 2020).

Prior to clearance, the site retained evidence for past earthmoving activities, particularly to the east, near Horstley Street, where there was a large, regular mound that appeared level on top as though it had been utilised by dump trucks for depositing large quantities of rubble (Figure 17 and Figure 19). This could have reflected 1960s activities related to clearance of the wider site, or have been evidence for more recent activity.

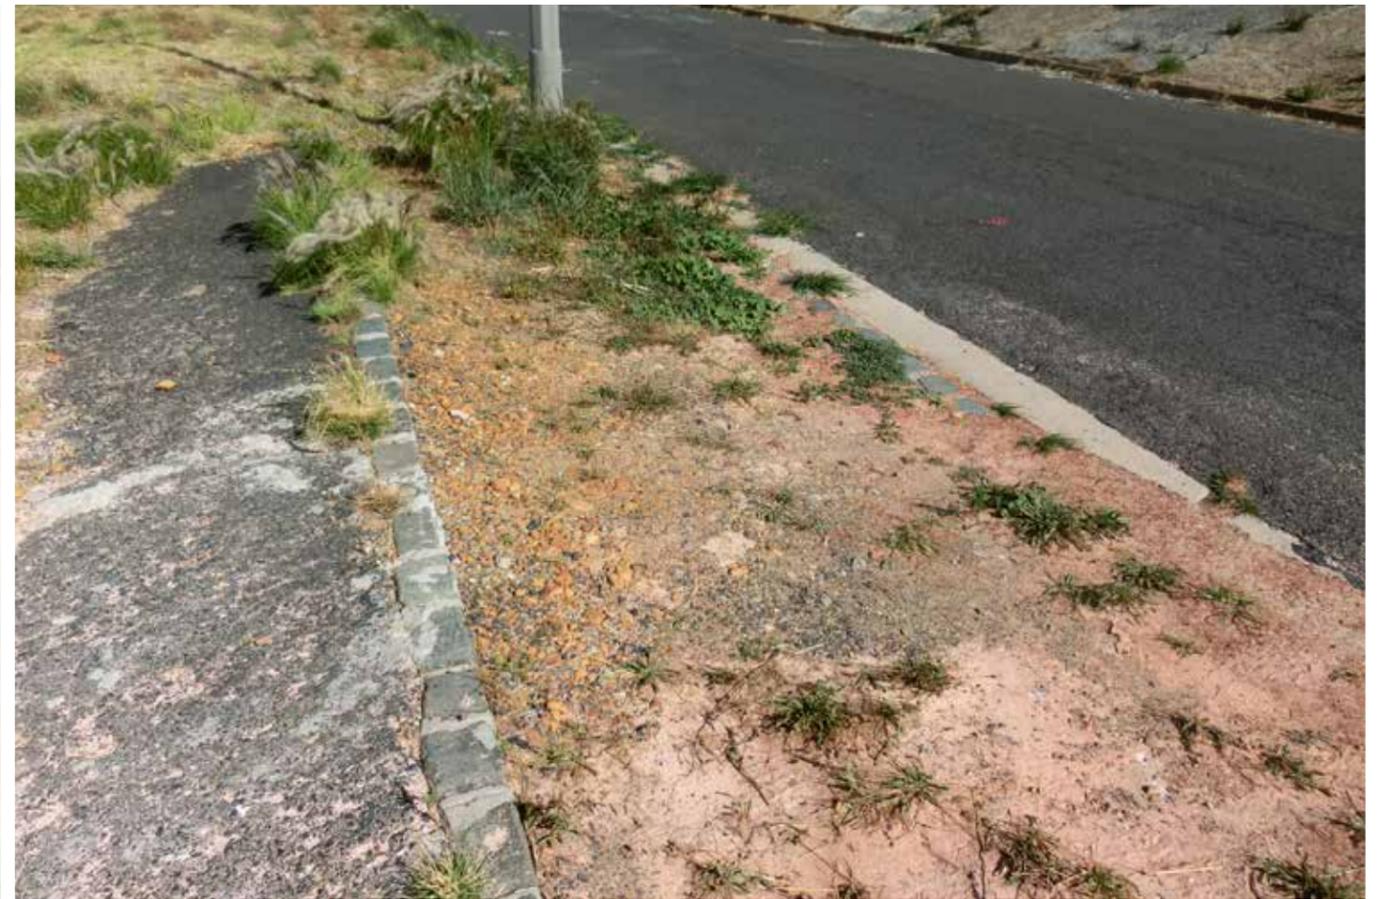
Figure 20. Old road edgings and alignments with preserved pavement levels, presumably of Upper Constitution Street, along Justice Walk, view to east (RSA, 2020).

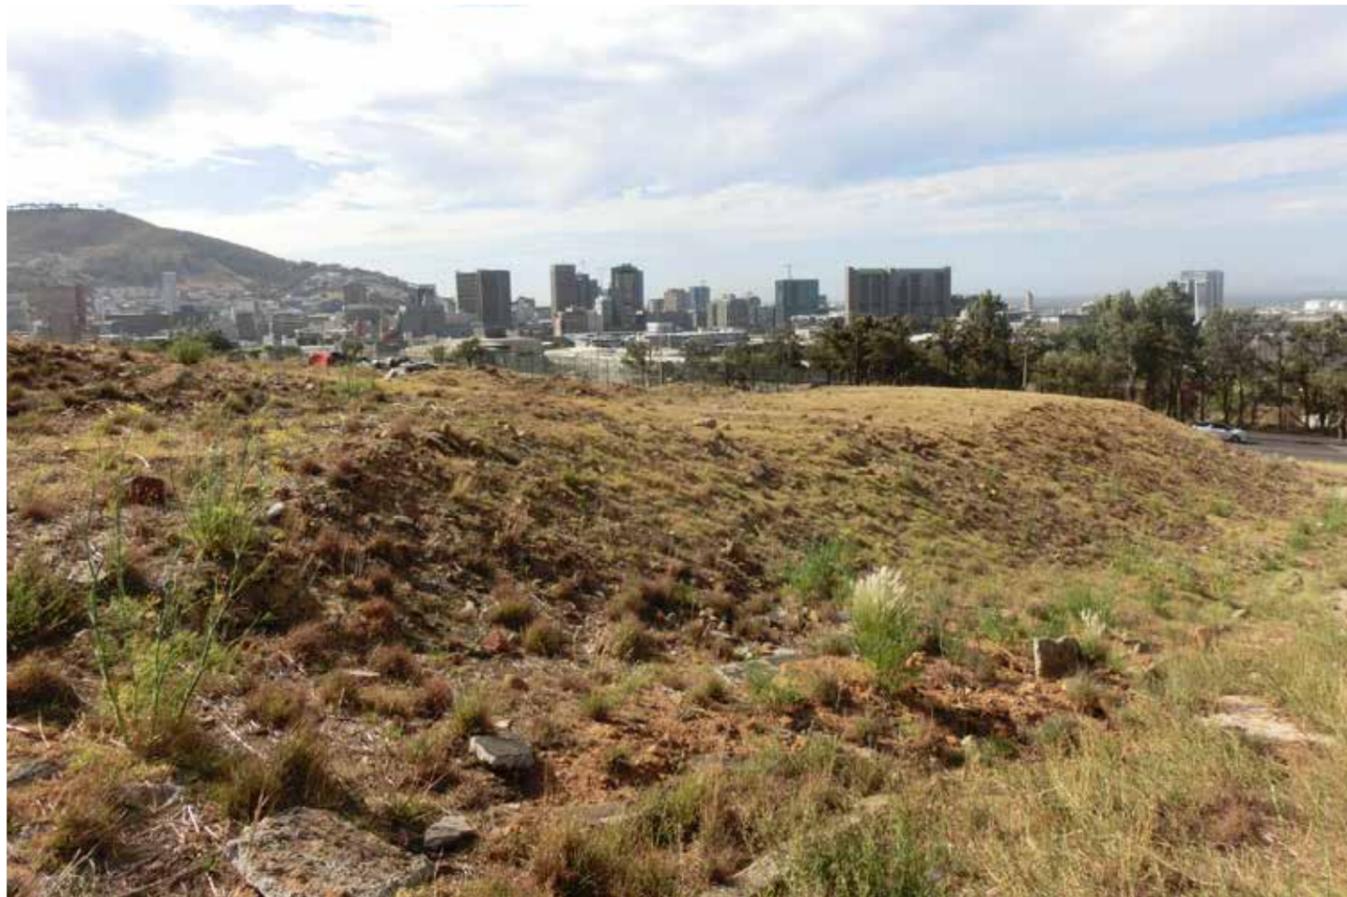
Figure 19. Evidence for past dumping and earthmoving across site (RSA, 2020).

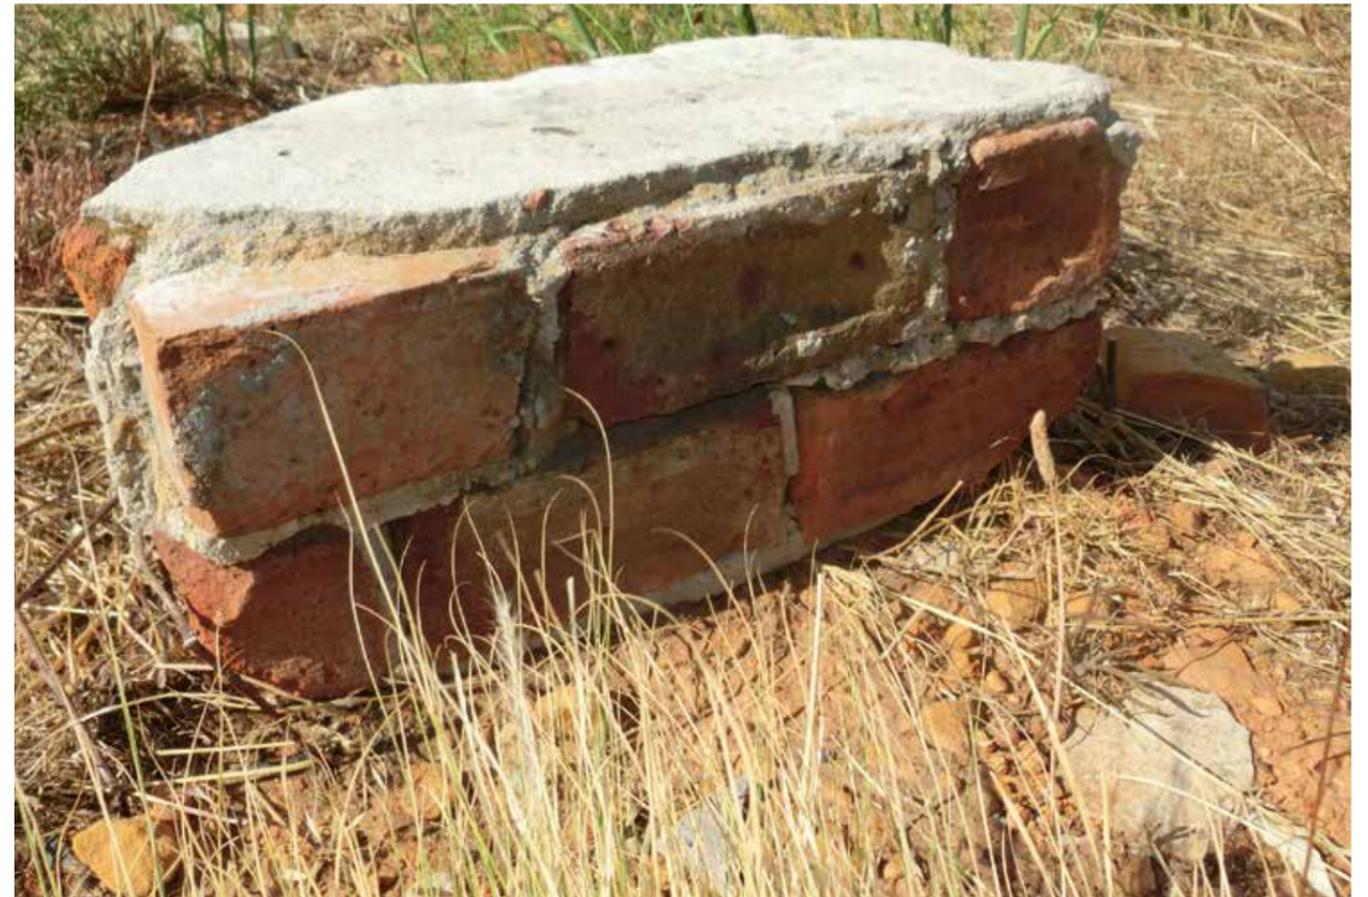
Figure 21. Historic building debris, with frogged bricks, likely early C20th (RSA, 2020).

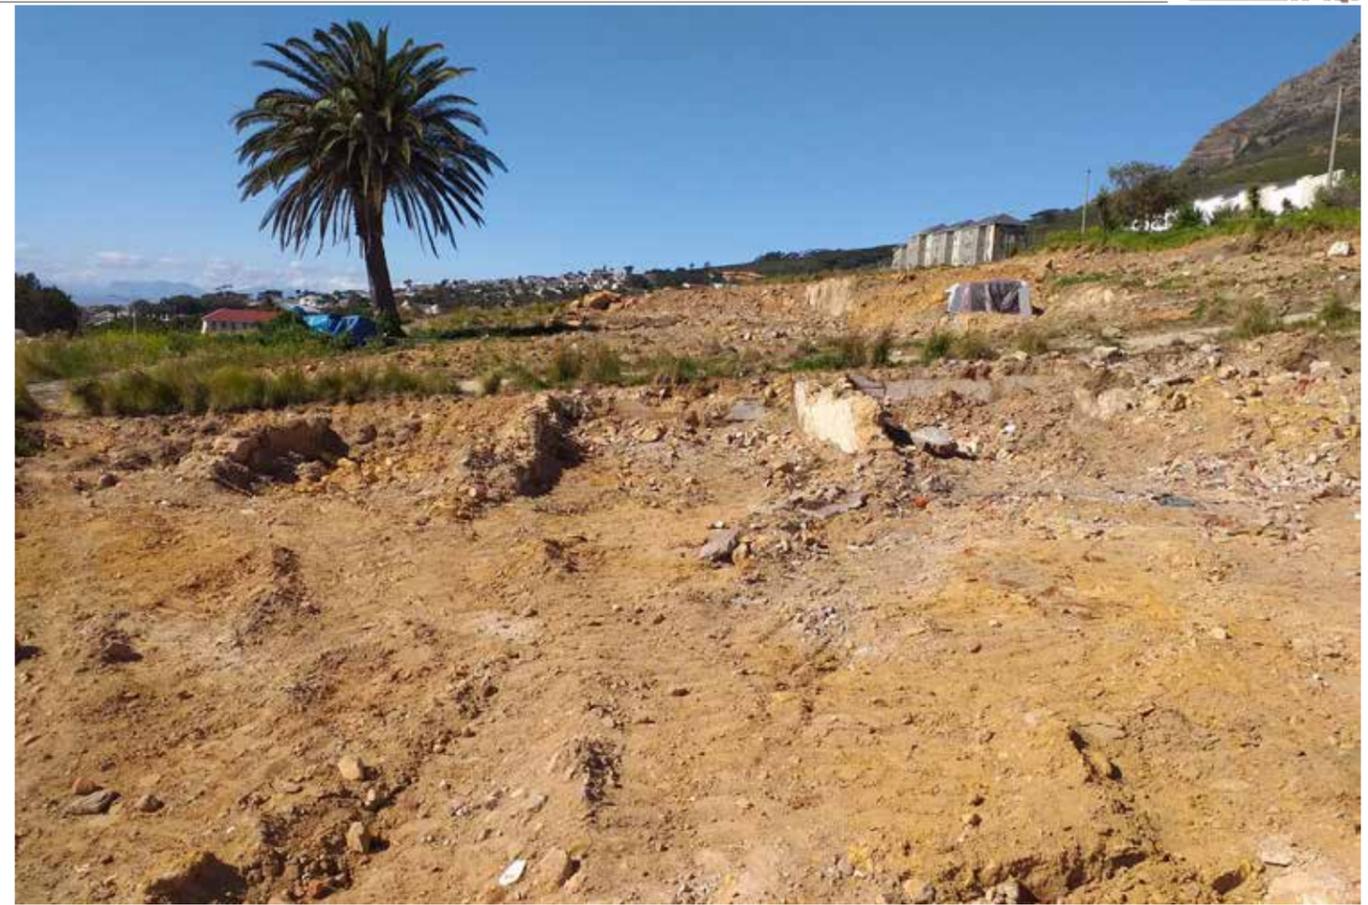
Figure 24. View across Phase 5 from Ellesmere Street, the tarred surface of Clifton is visible running north-south in front of the palm tree, view to east (RSA, 2020).

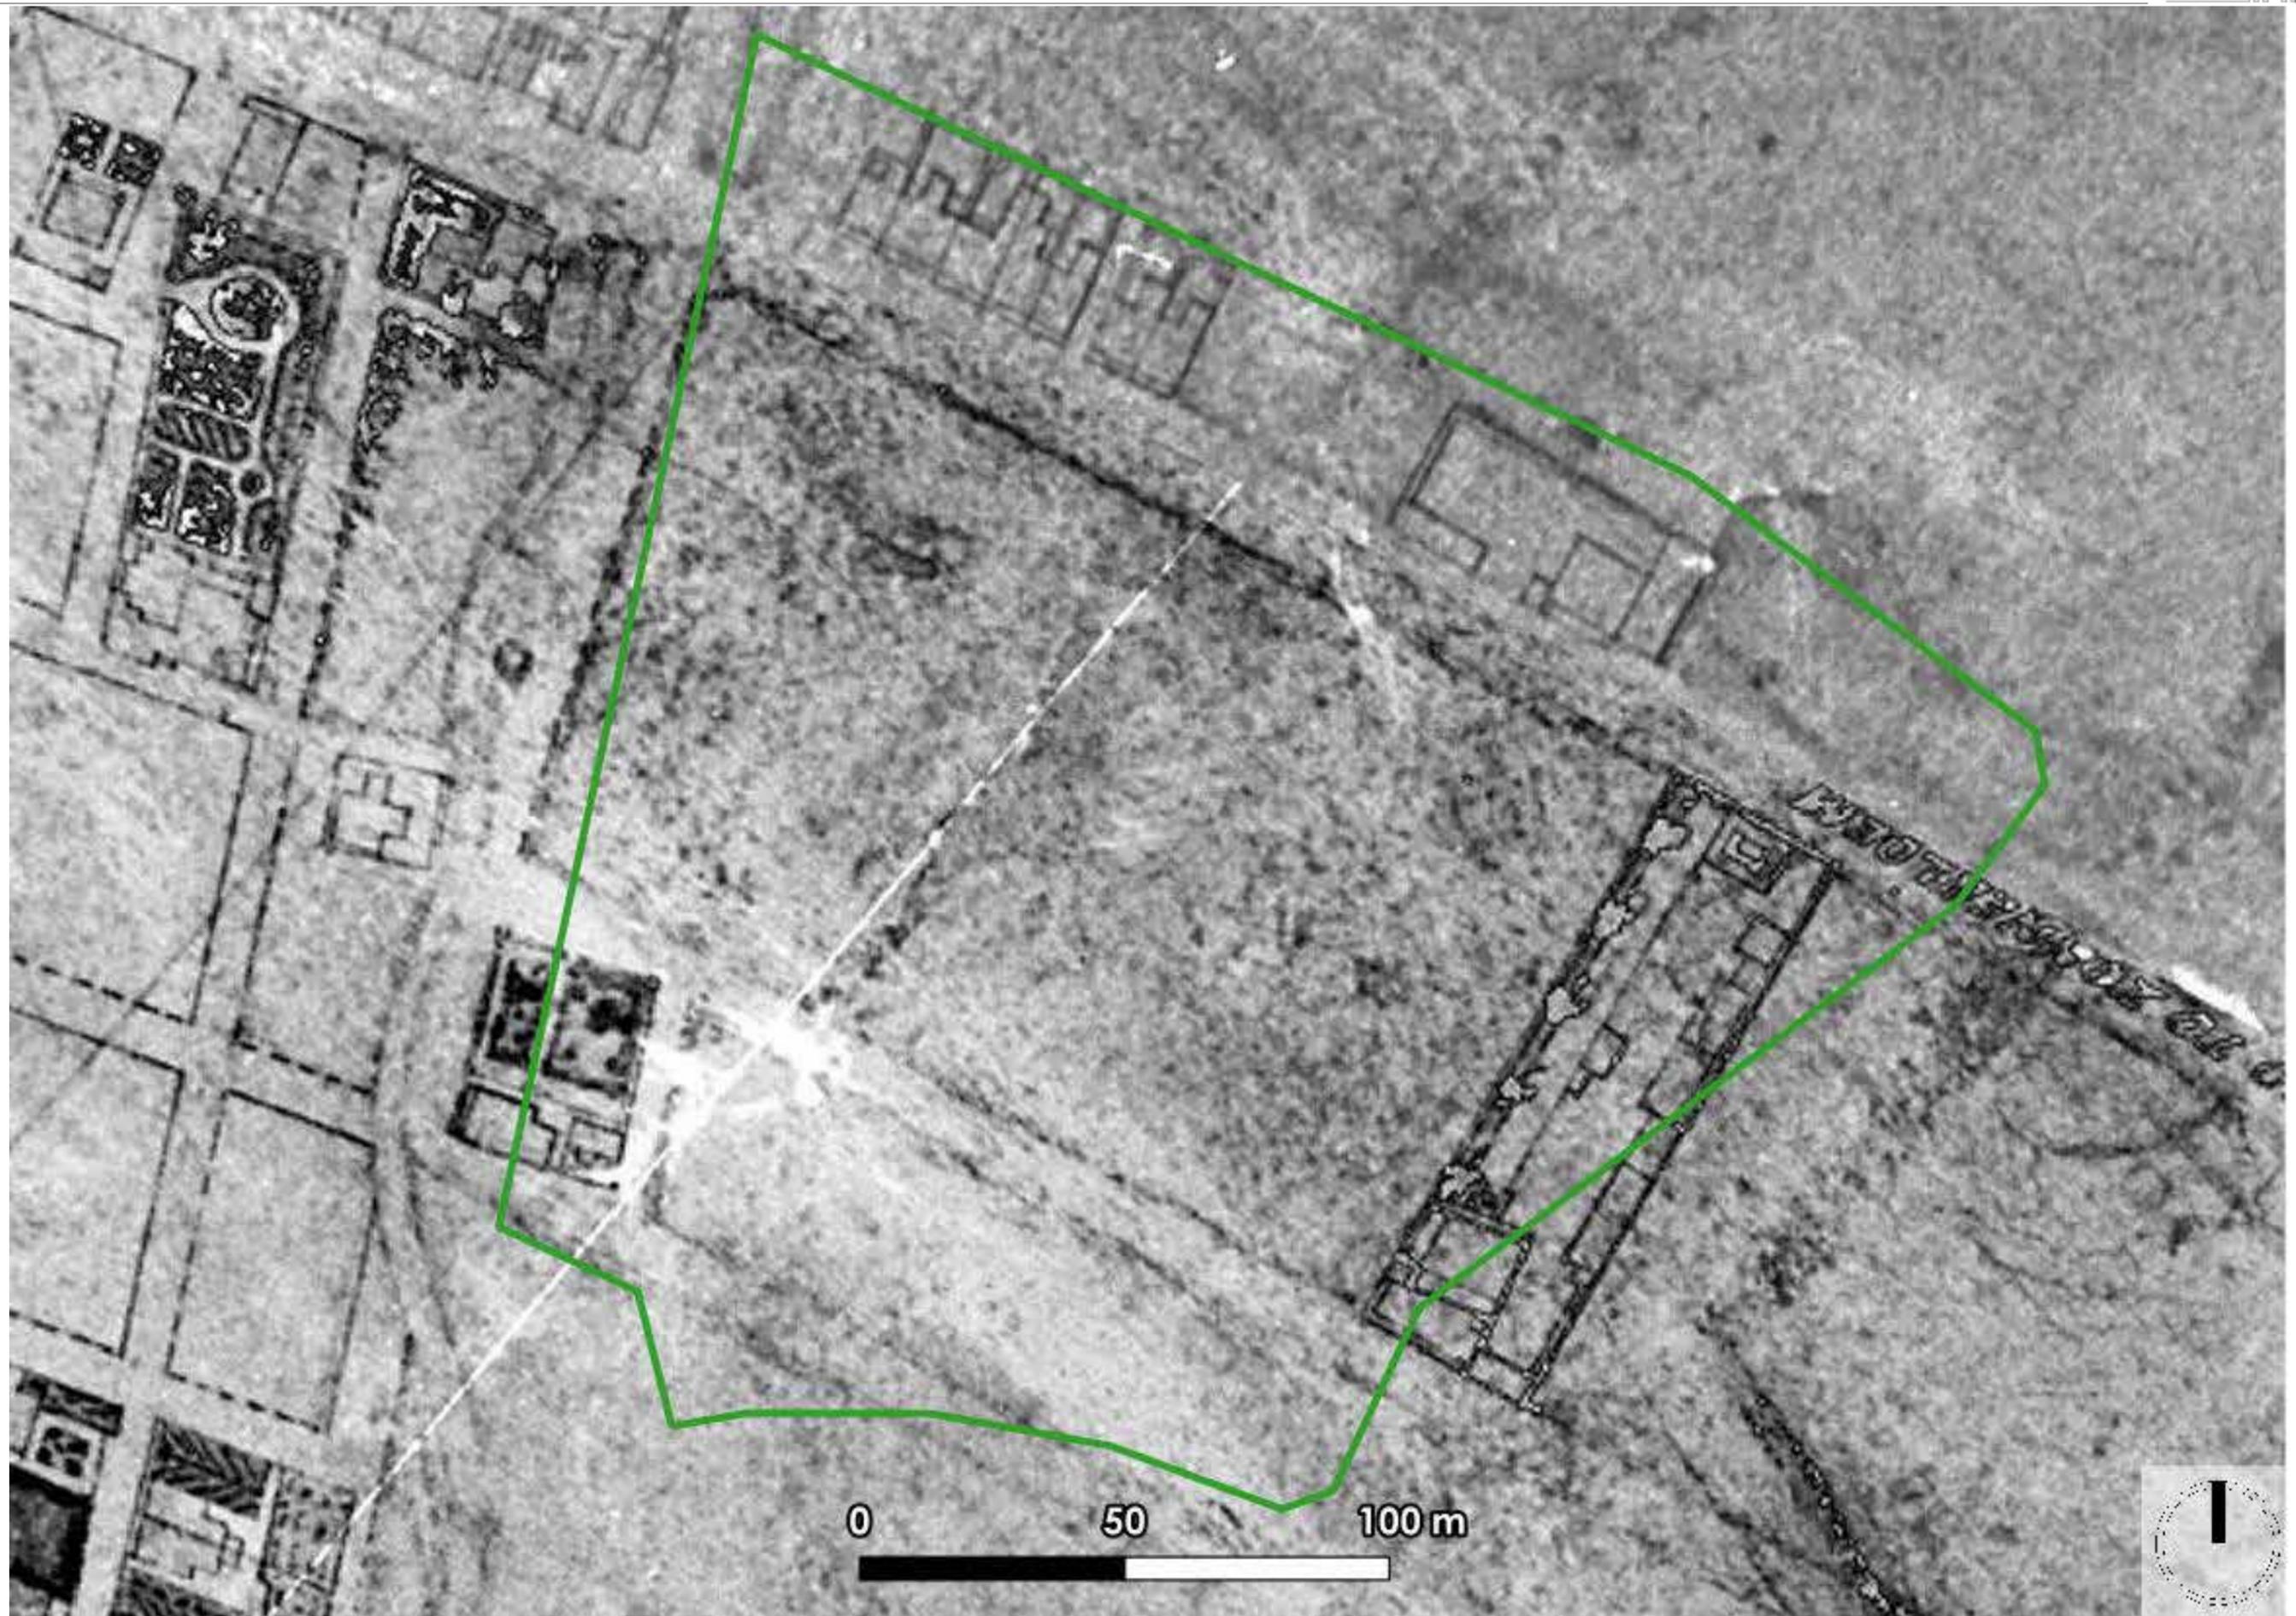
Figure 33. Detail of 1878 Wilson survey showing the layout of structures and roads within Phase 4 (RSA, 2022)
