ARCHAEOLOGICAL PERMIT APPLICATION FOR SITE LEVELLING

submitted in support of a permit application in terms of Section 35 of the NHRA (1999) for
SITE LEVELLING ON SEVERAL PARCELS AND VARIOUS ERVEN AHEAD OF REDEVELOPMENT,
DISTRICT SIX, CAPE TOWN

S35 Permit Application

March 2022

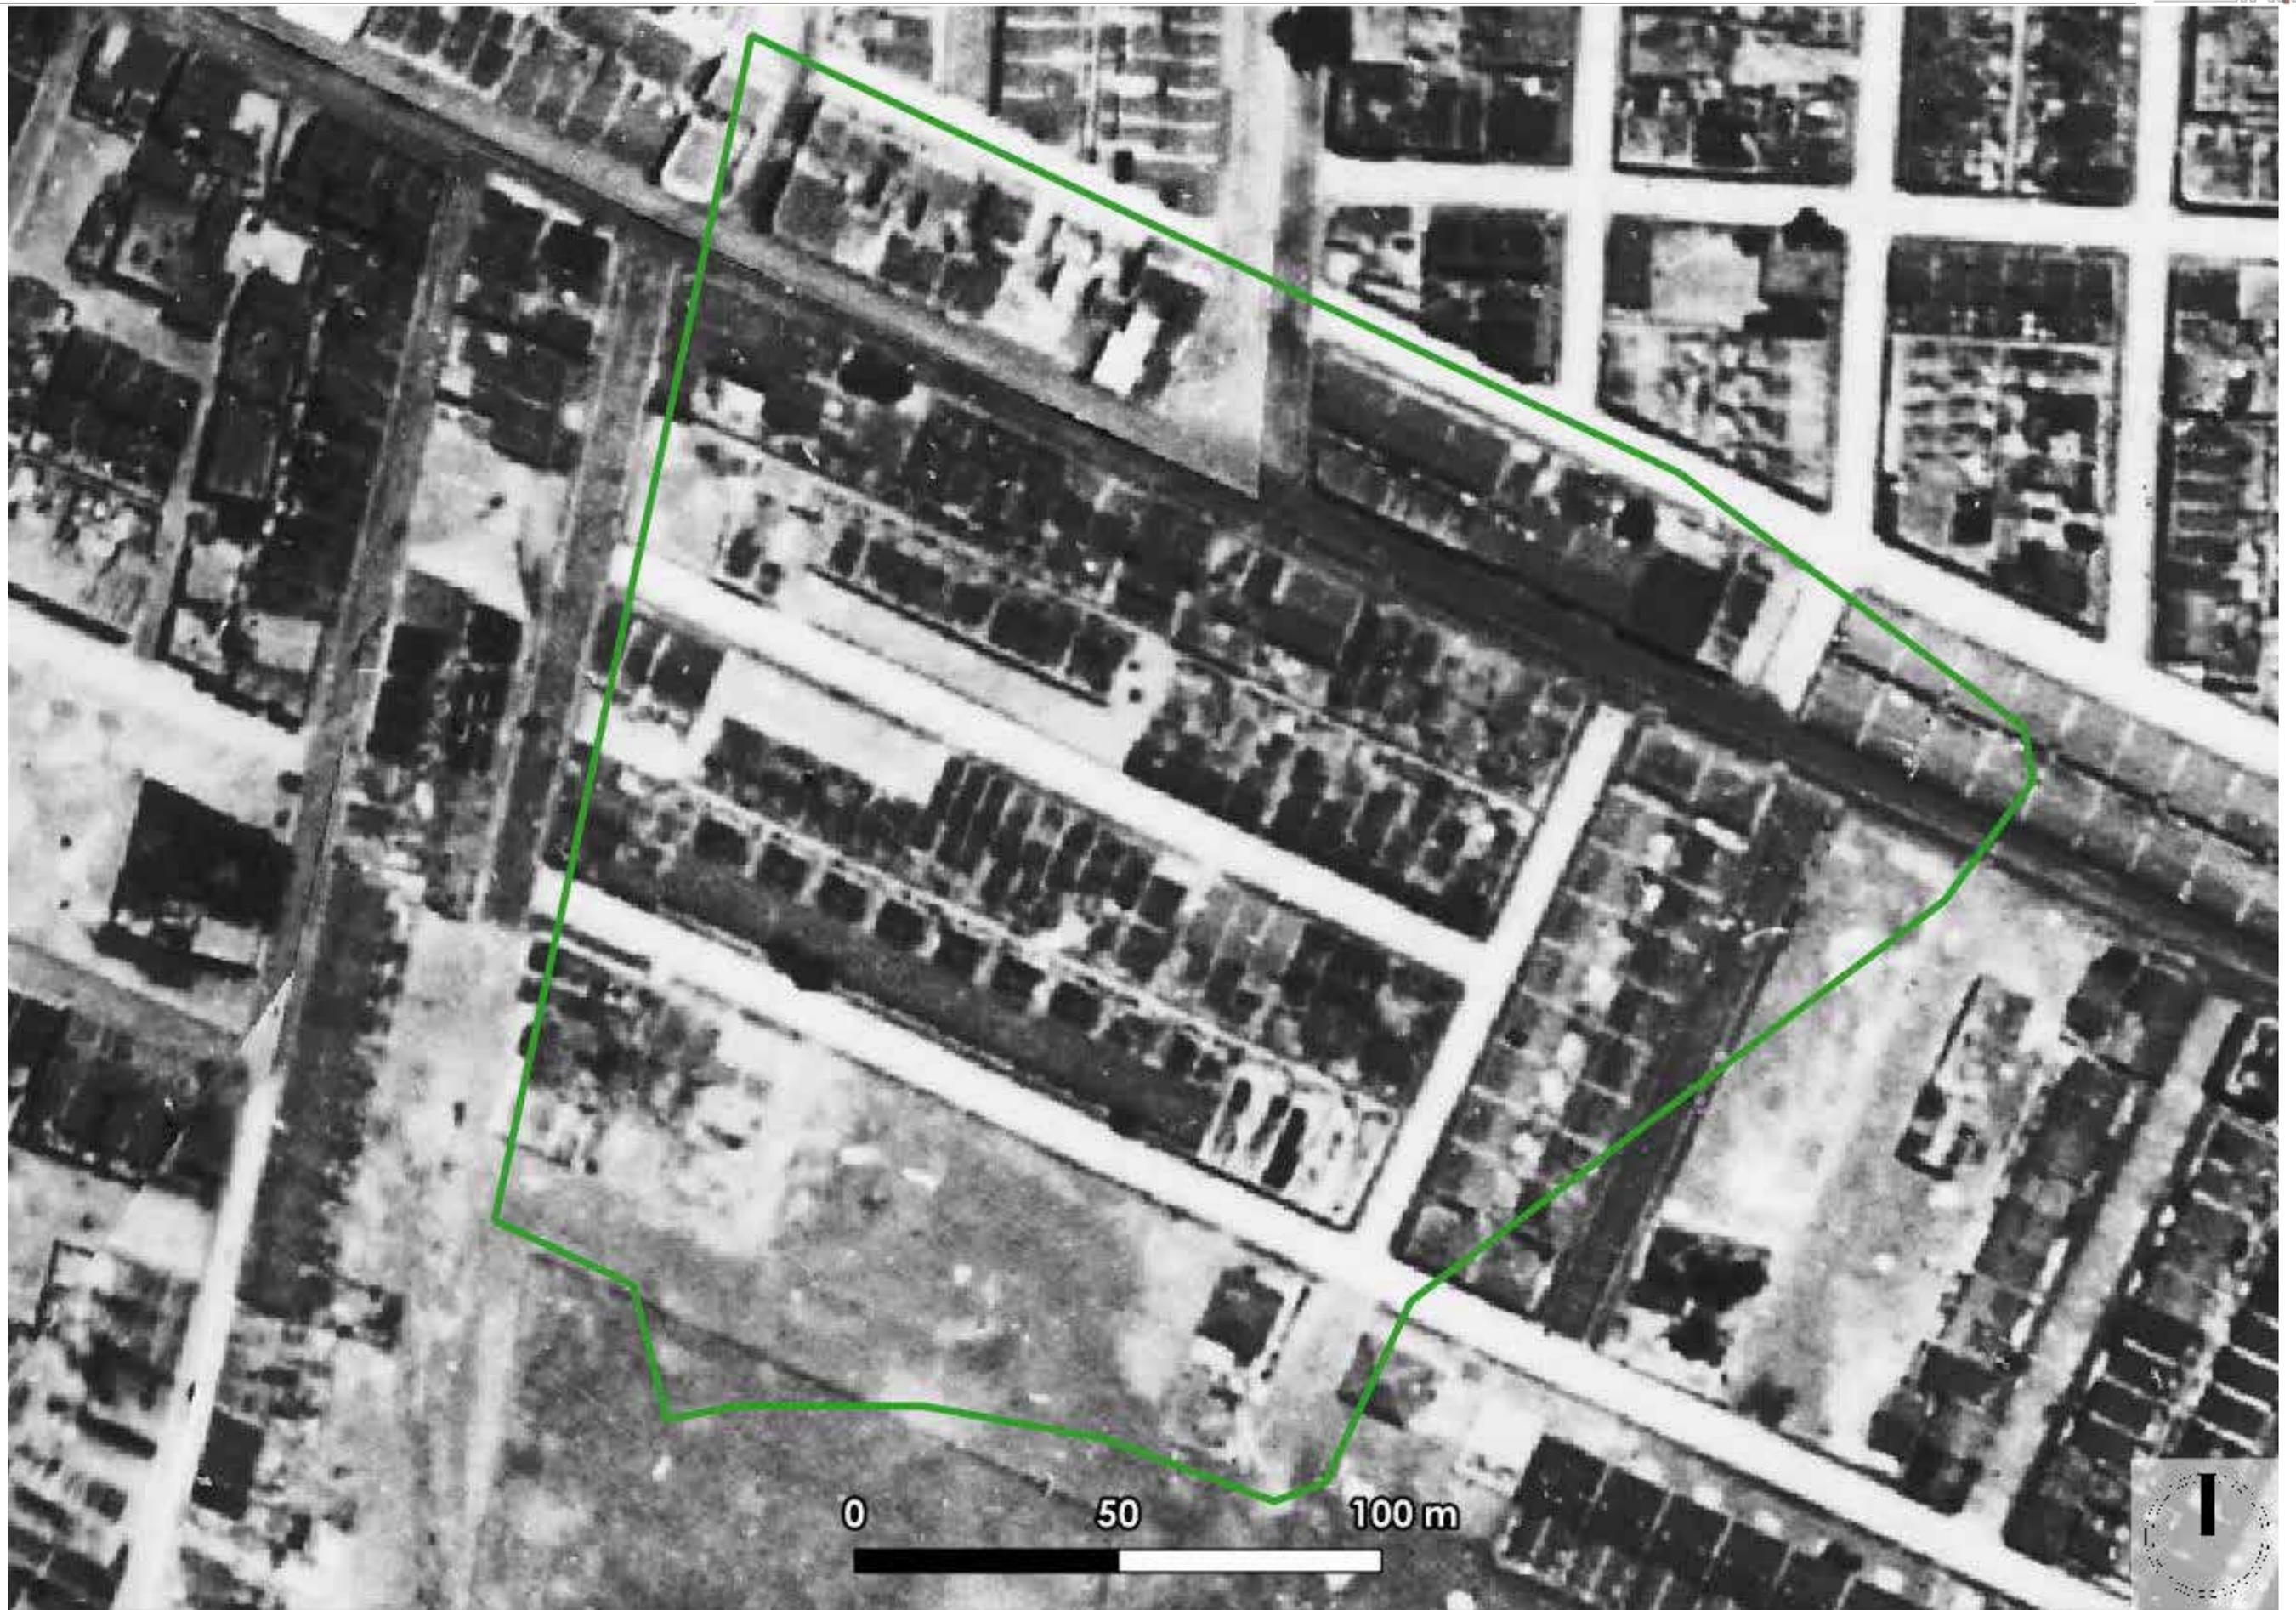
Figure 35. 1926 aerial photograph of the area of Phase 4 showing the layout of structures and roads in the early part of the C20th (NGI, 2020; RSA, 2022).

The layout evident in 1898 appears largely unchanged in the aerial photograph of the area from 1926, with the infill densification along the eastern extent of the parcel the only noteworthy difference (Figure 35)

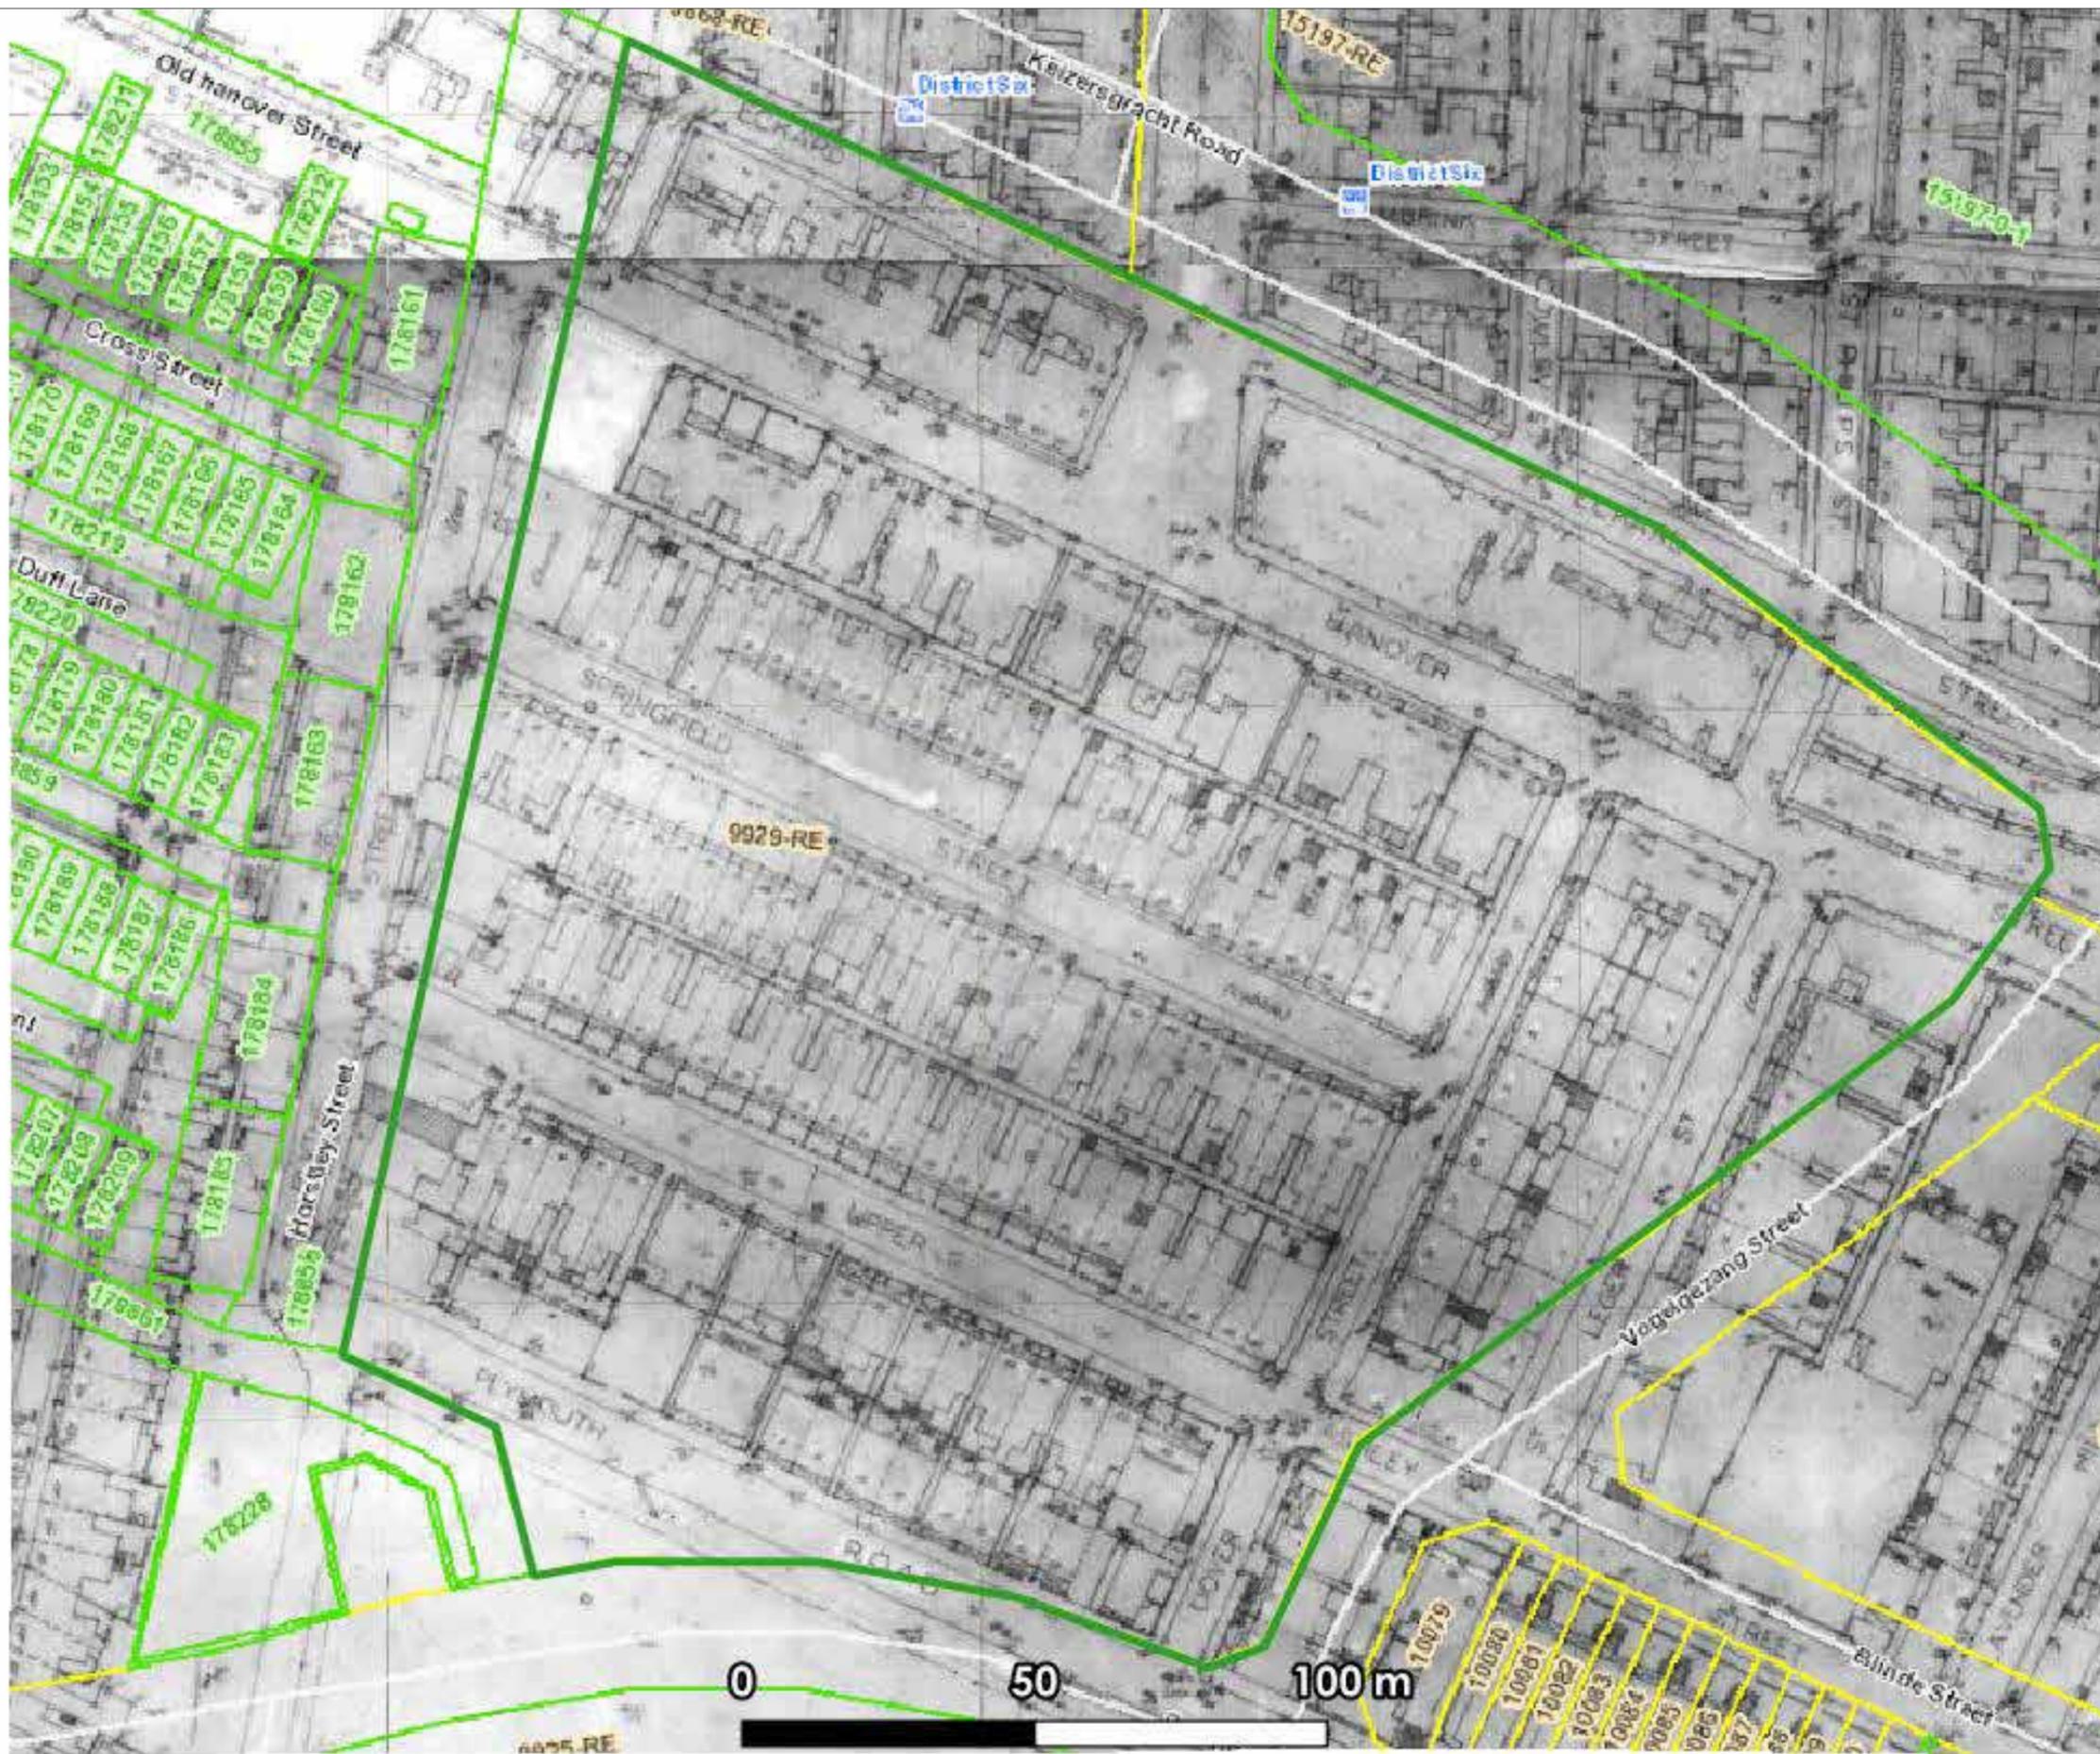
Figure 36. City of Cape Town survey of 1954 for Phase 4 showing the layout of structures and roads prior to the forced removals of 1966 (CoCT, 2020; RSA, 2022).

By the late 1960s, when the forced removals took place, the block of land designated as Phase 4 for the purposes of this application was densely populated, with more than 25 closely spaced shops and dwellings facing onto Hanover Street (Figure 36).

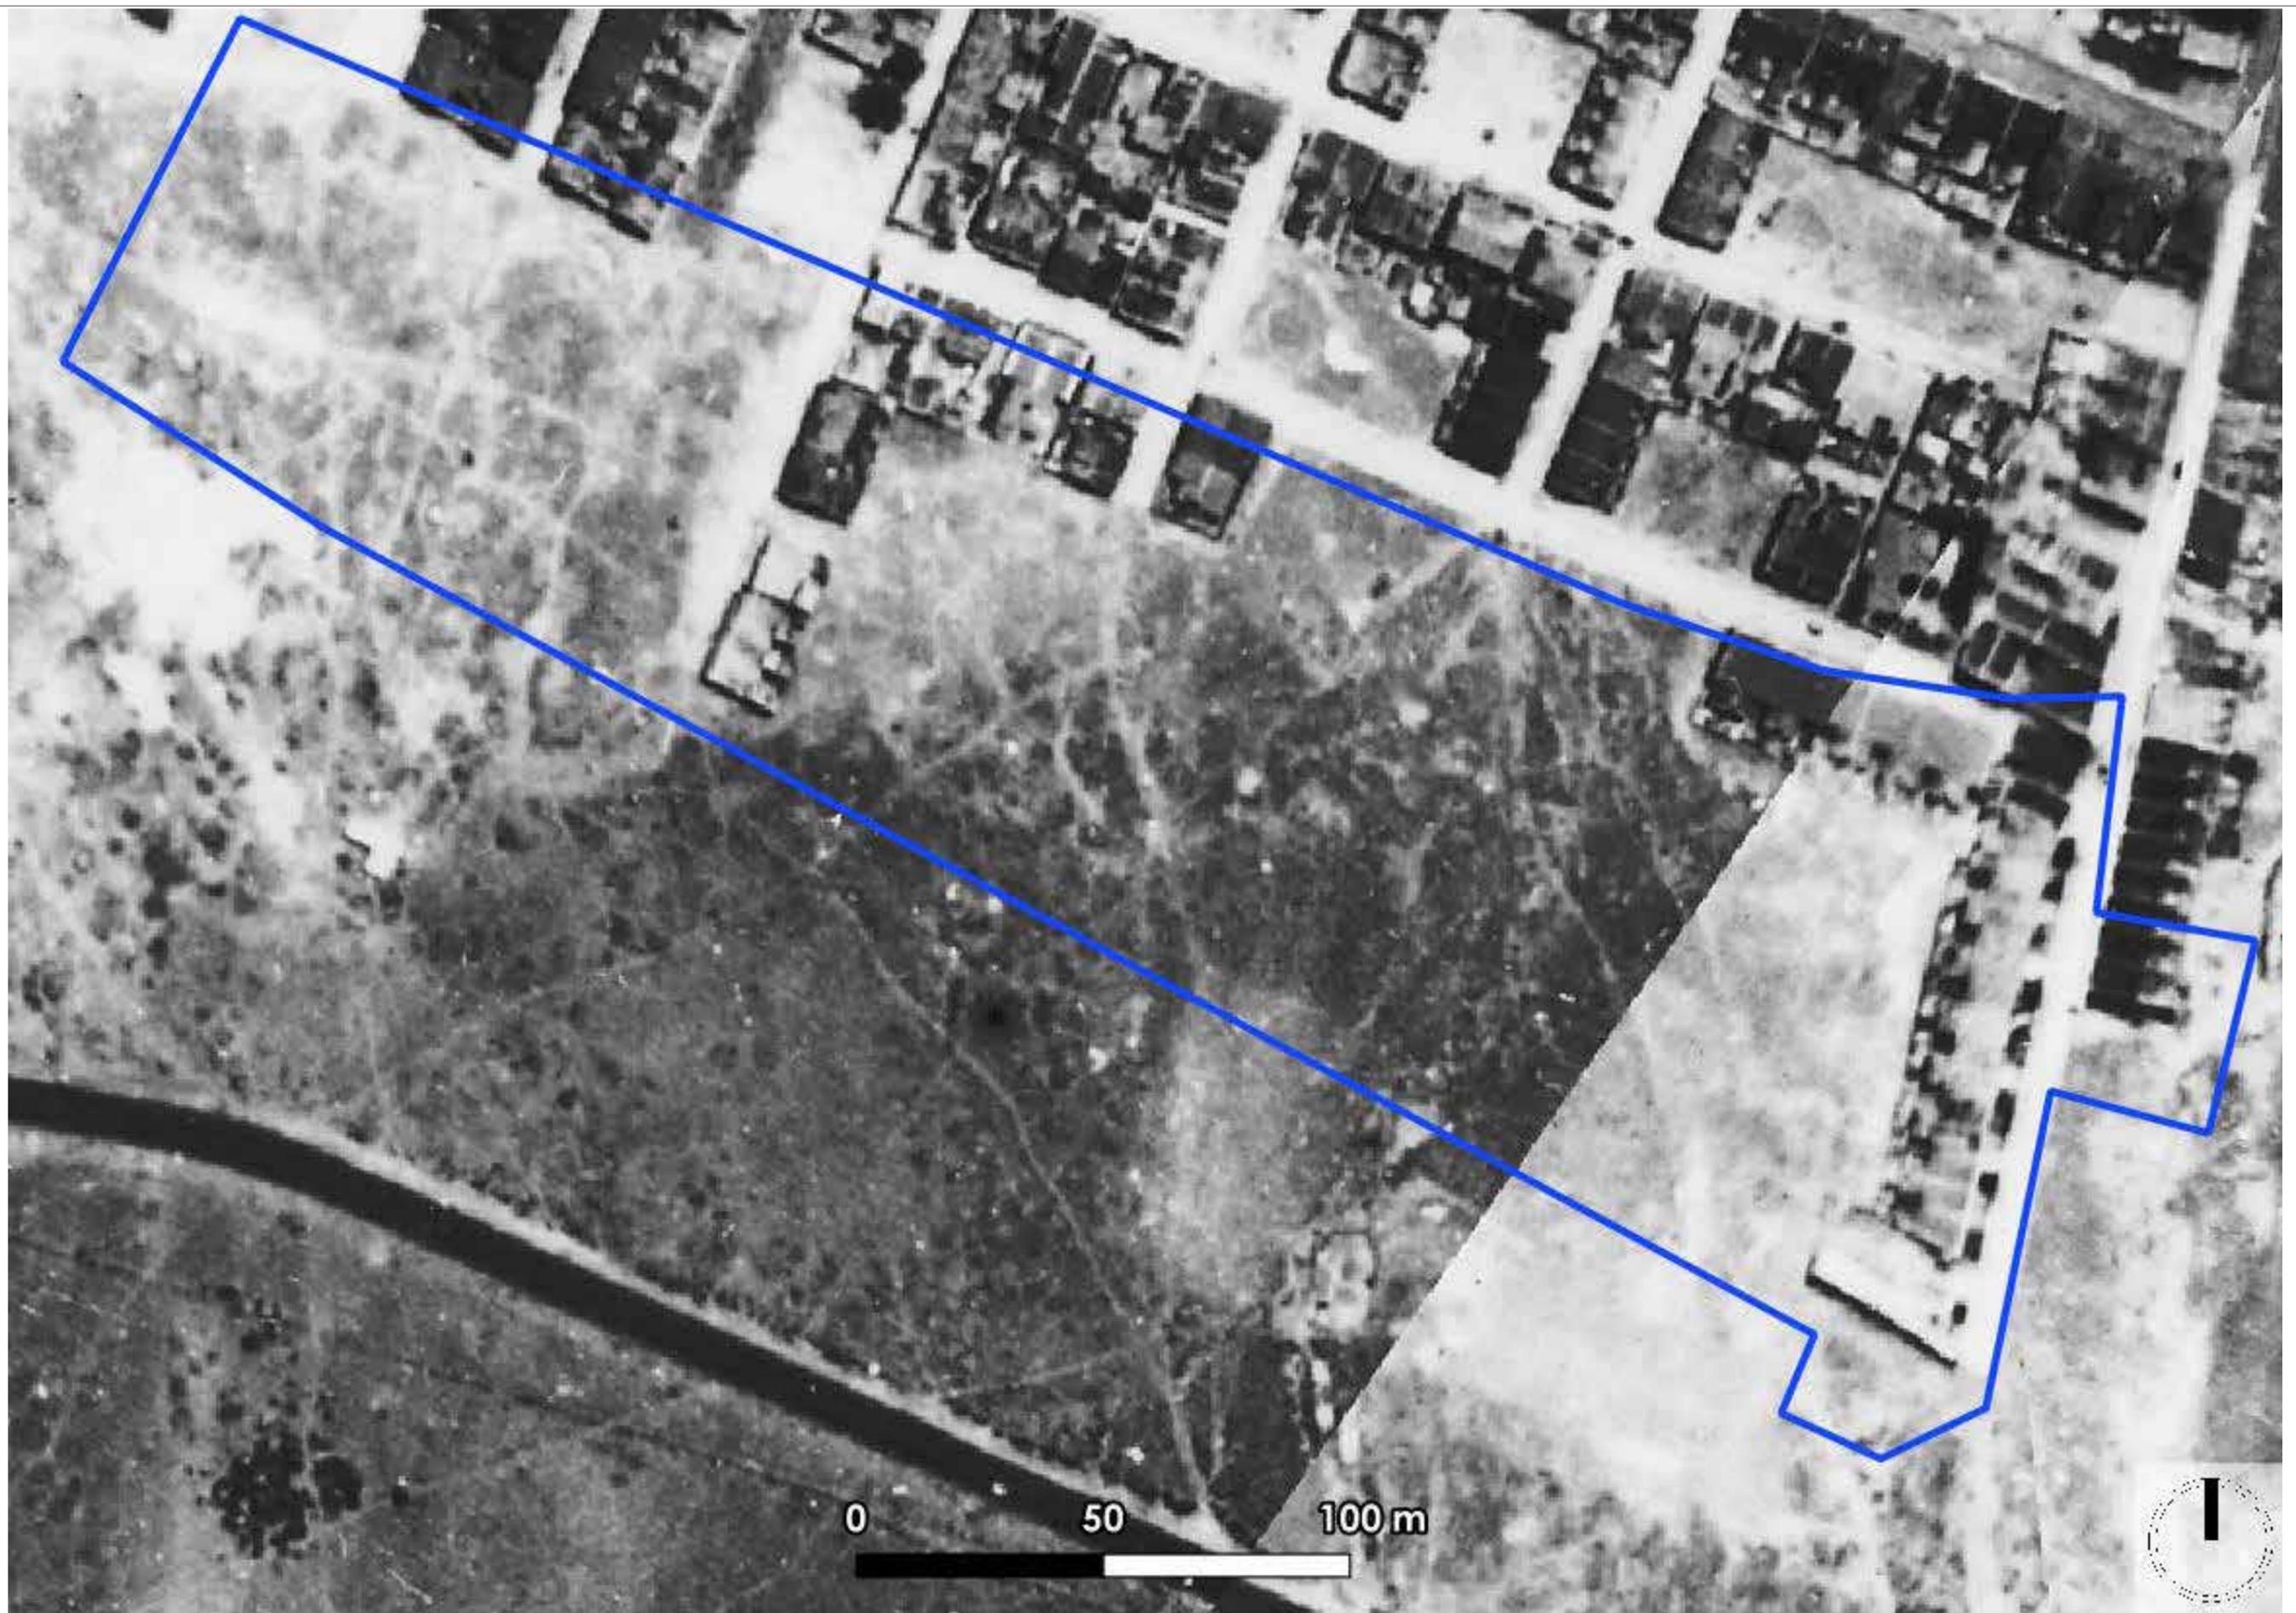
Figure 39. 1926 aerial photograph of the area of Phase 5 showing the layout of structures and roads in the early part of the C20th (NGI, 2020; RSA, 2022).

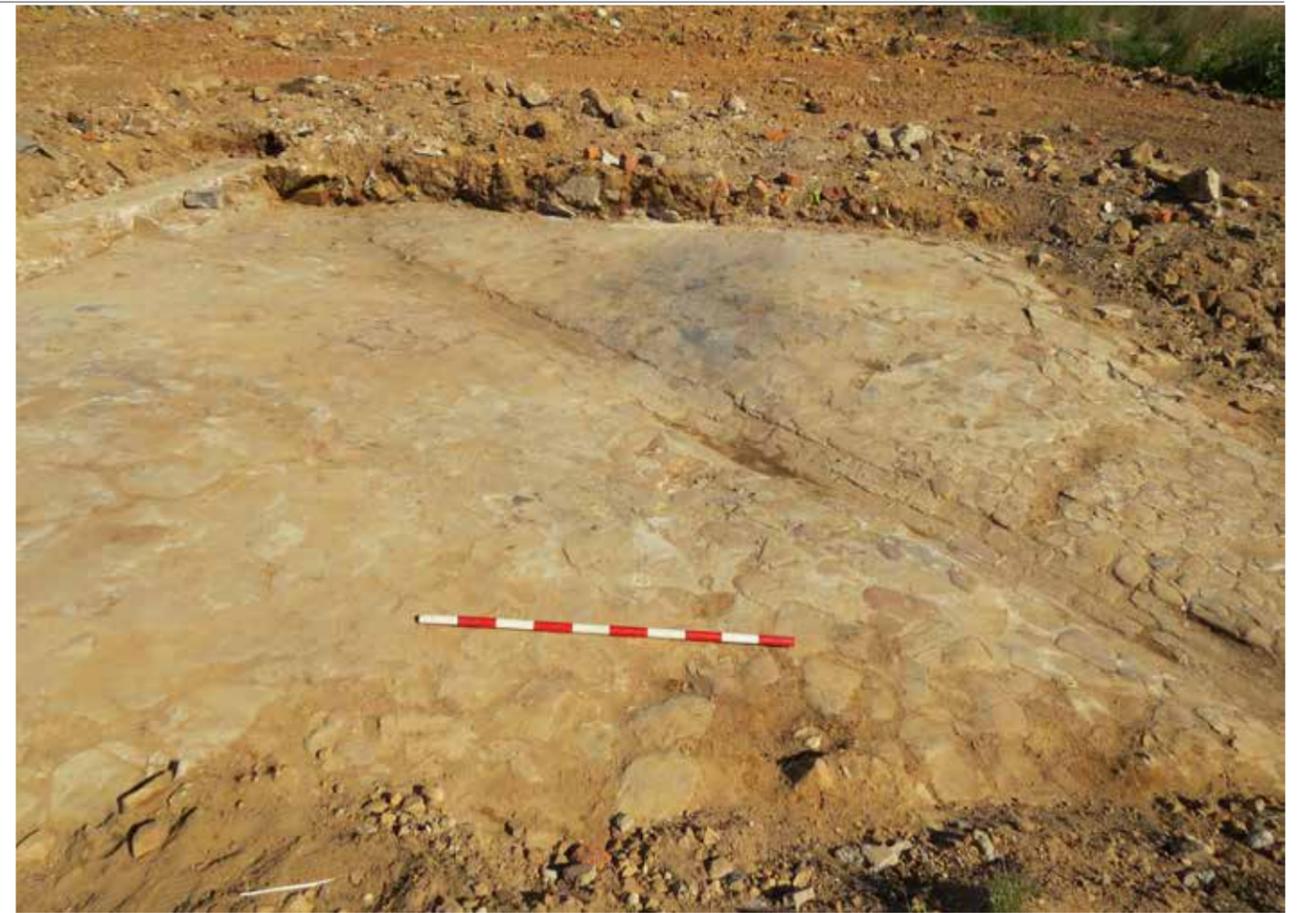
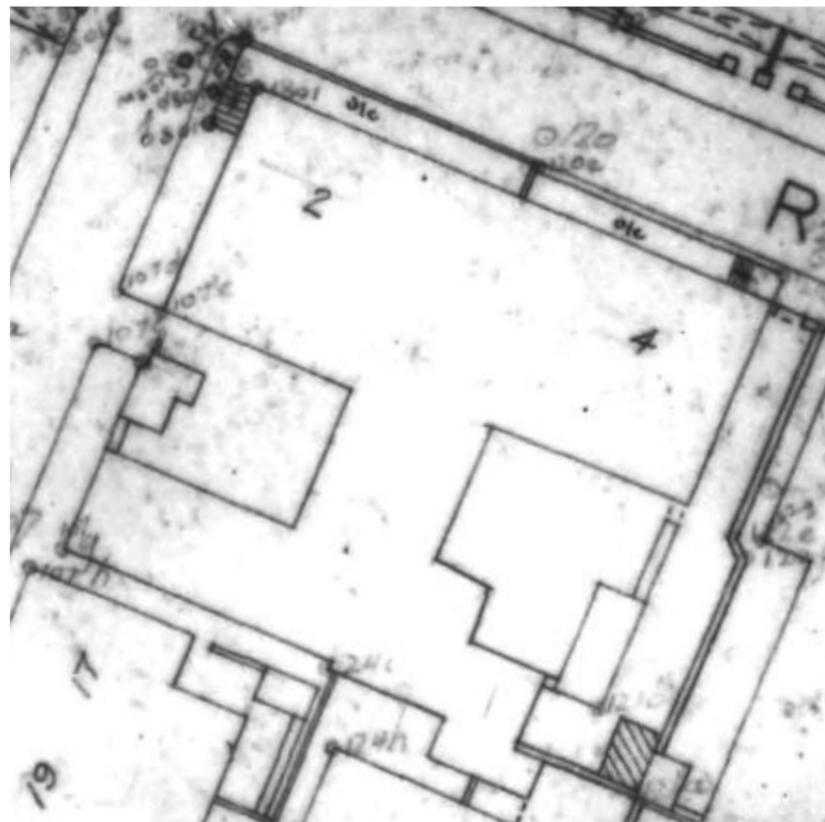
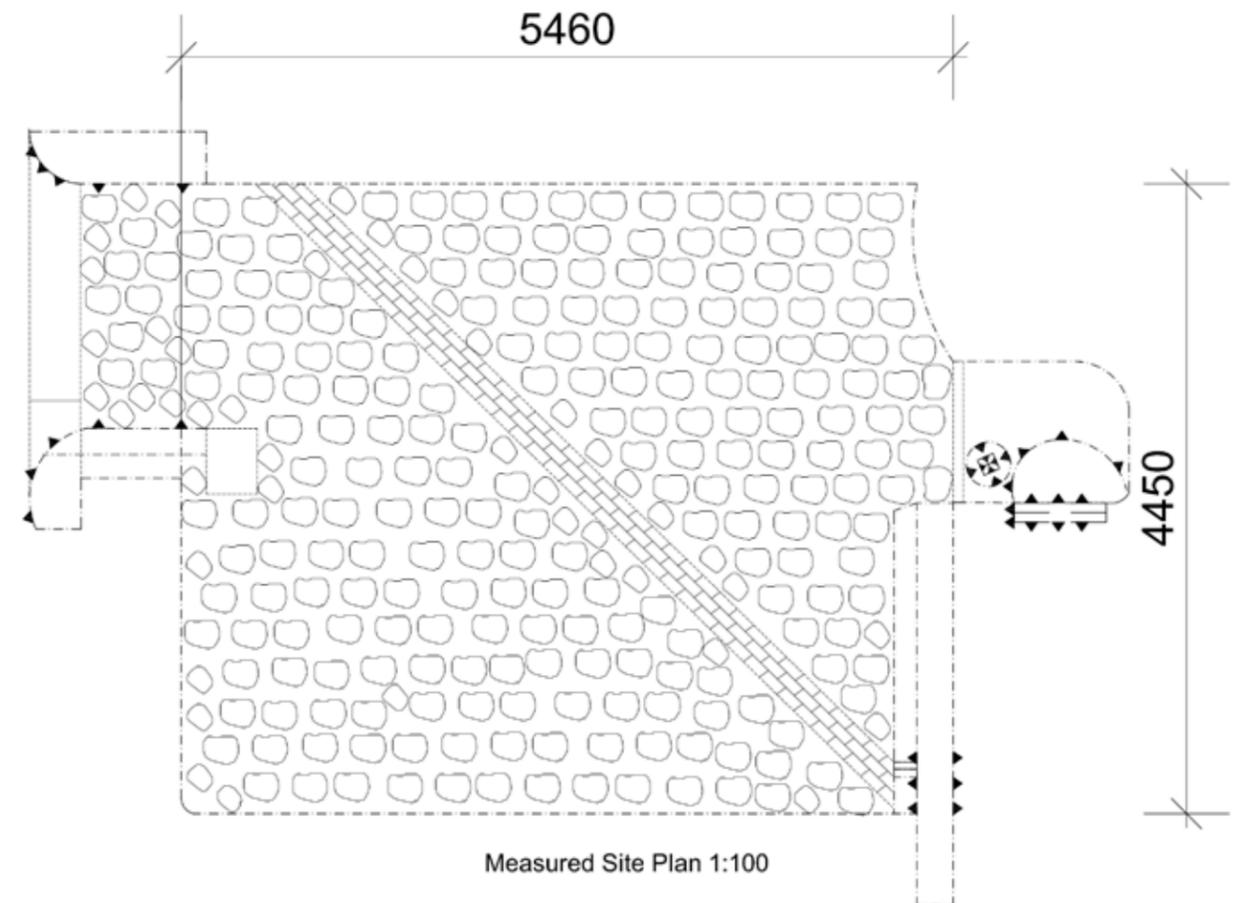
Figure 42. **Photograph of the cobbled yard (top) and plan of the feature (below) (RSA, 2020)**

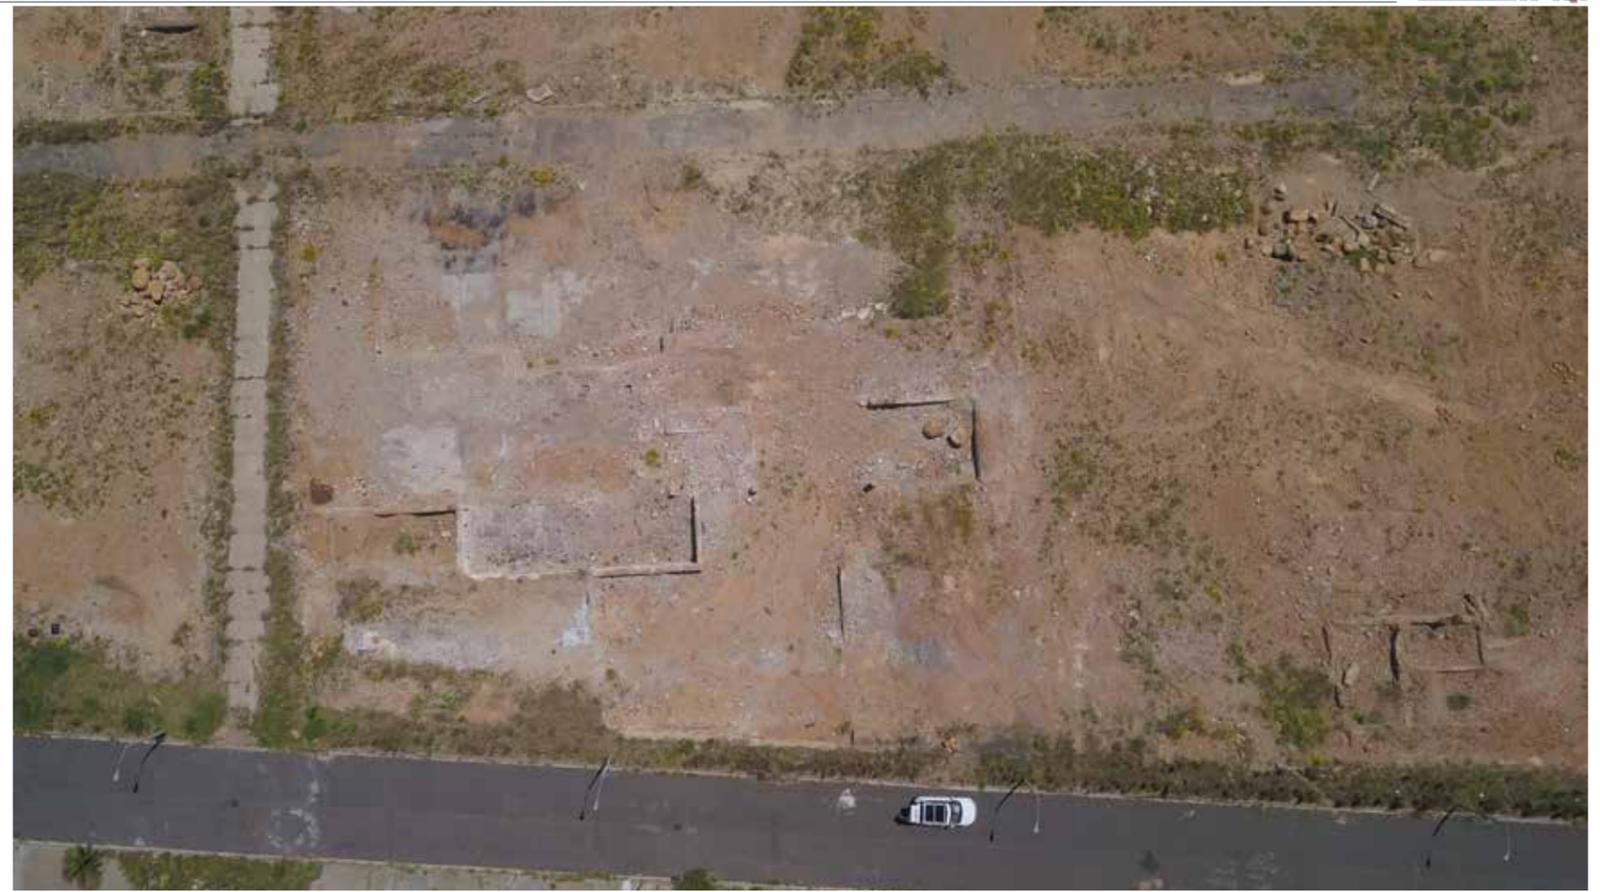
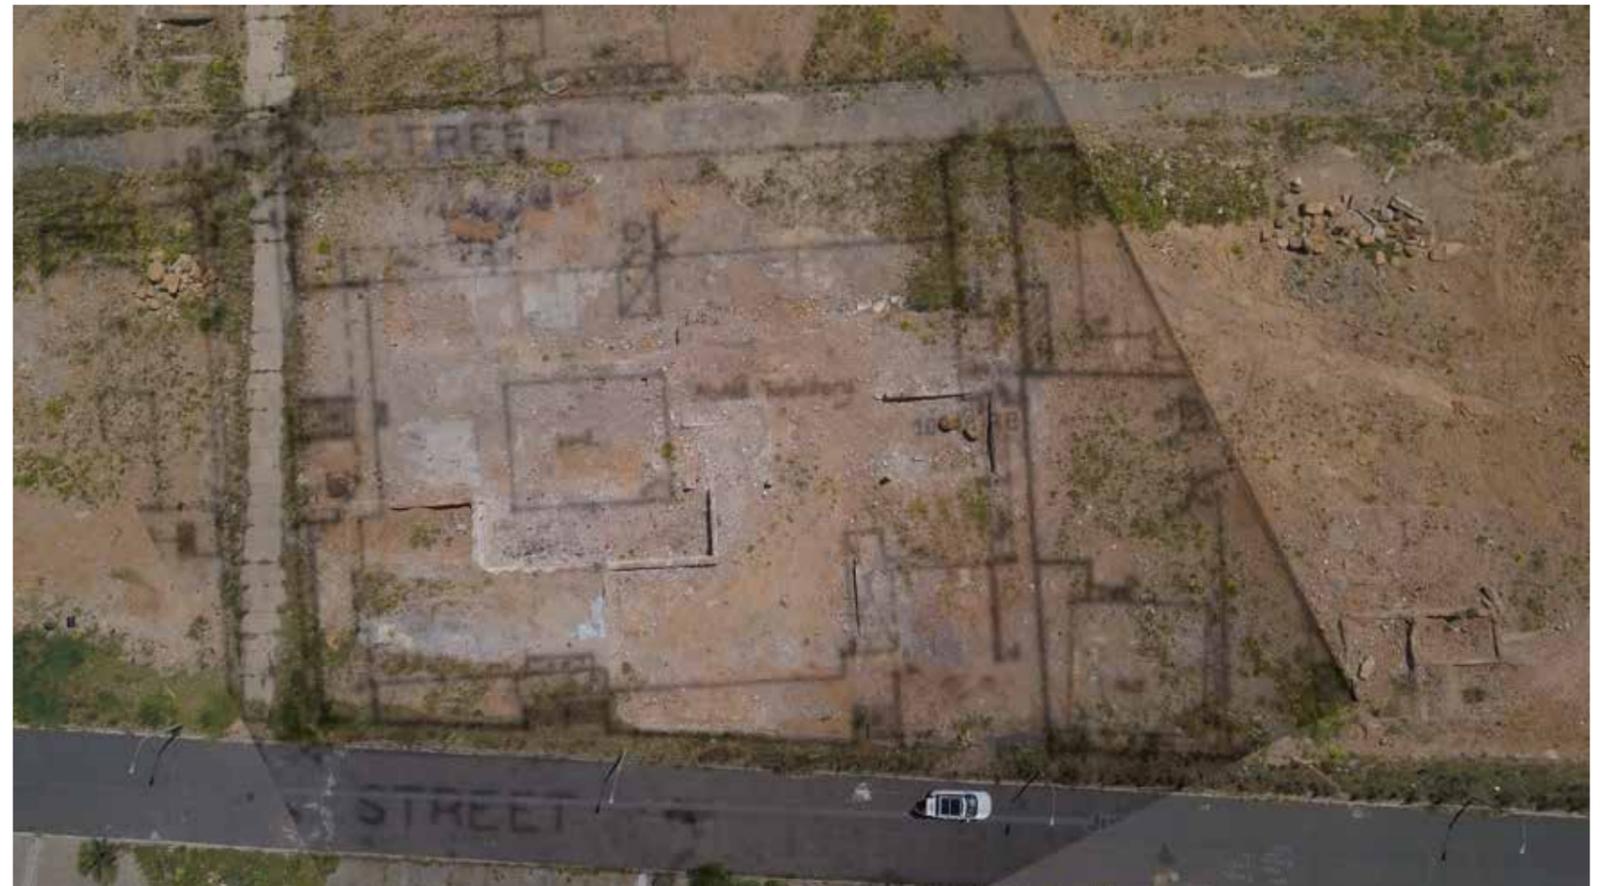
Figure 44. Drone image of the Hotel Tafelberg site after rubble removal (top) with the 1954 survey plan overlaid (below) (RSA, 2020)

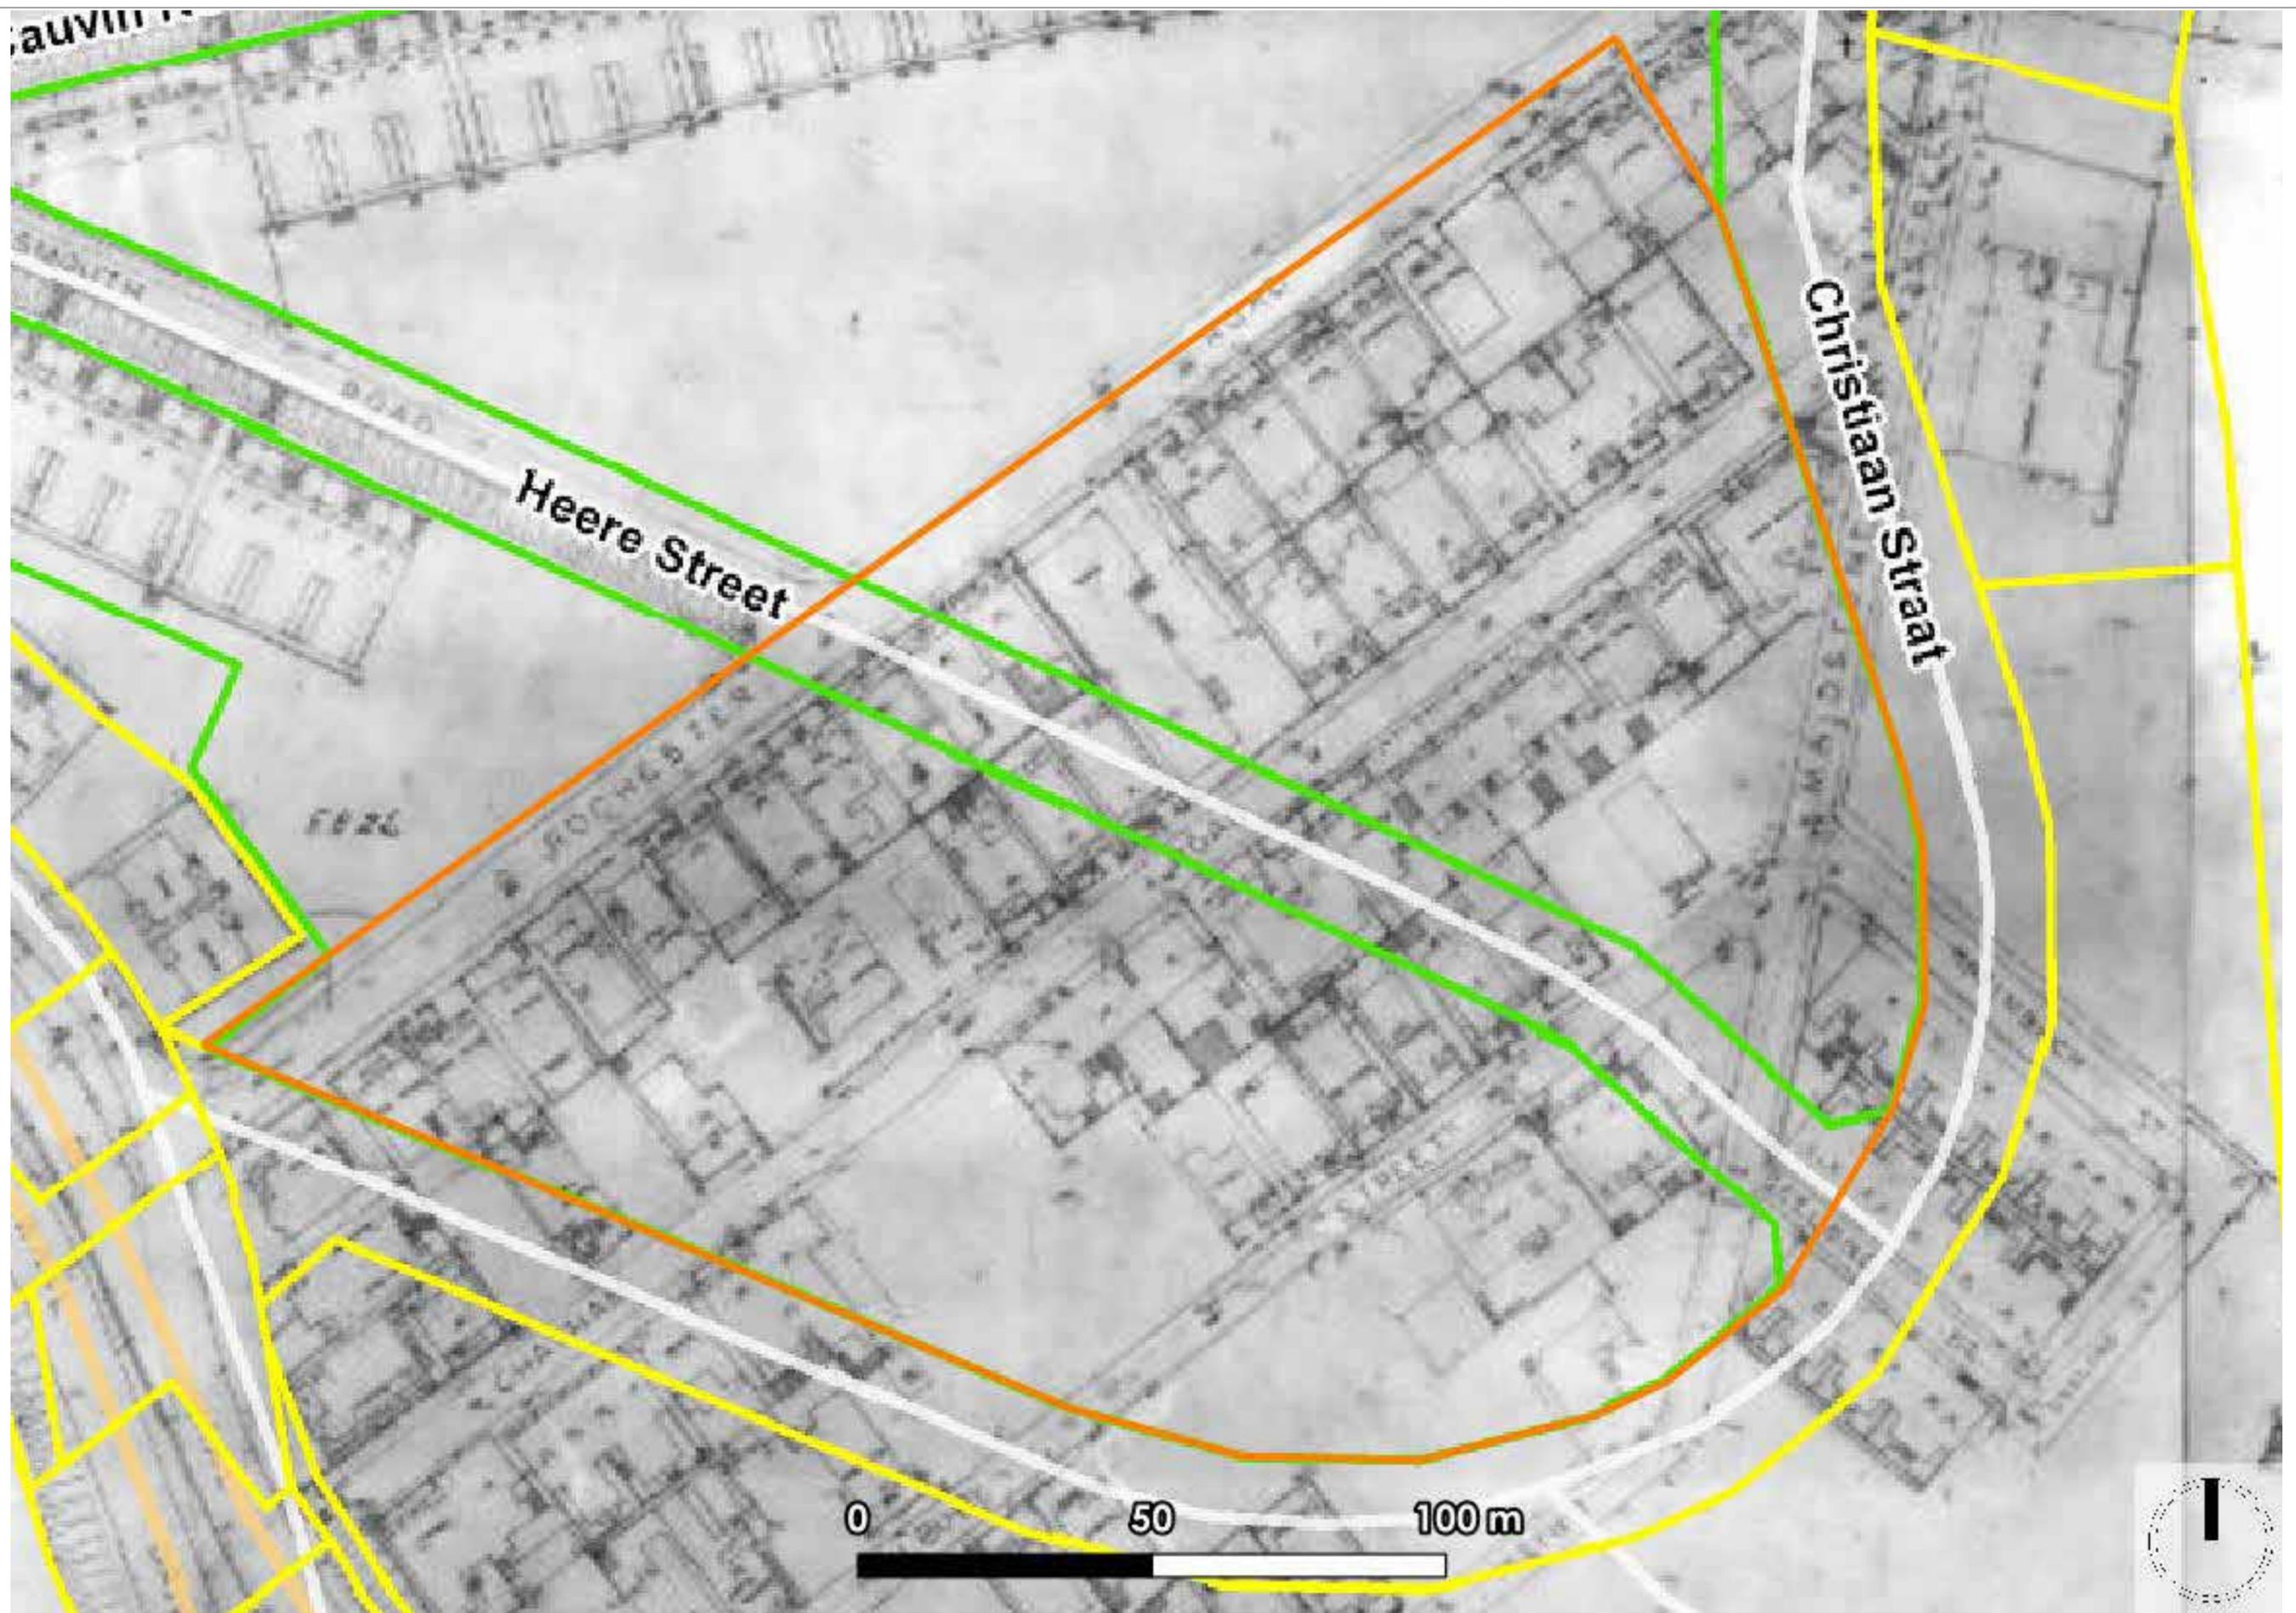
Figure 48. City of Cape Town survey of 1954 for Phase 6 showing the layout of structures and roads prior to the forced removals of 1966 (CoCT, 2022; RSA, 2022).
