ARCHAEOLOGICAL PERMIT APPLICATION FOR SITE LEVELLING

submitted in support of a permit application in terms of Section 35 of the NHRA (1999) for
SITE LEVELLING ON SEVERAL PARCELS AND VARIOUS ERVEN AHEAD OF REDEVELOPMENT,
DISTRICT SIX, CAPE TOWN

S35 Permit Application

March 2022

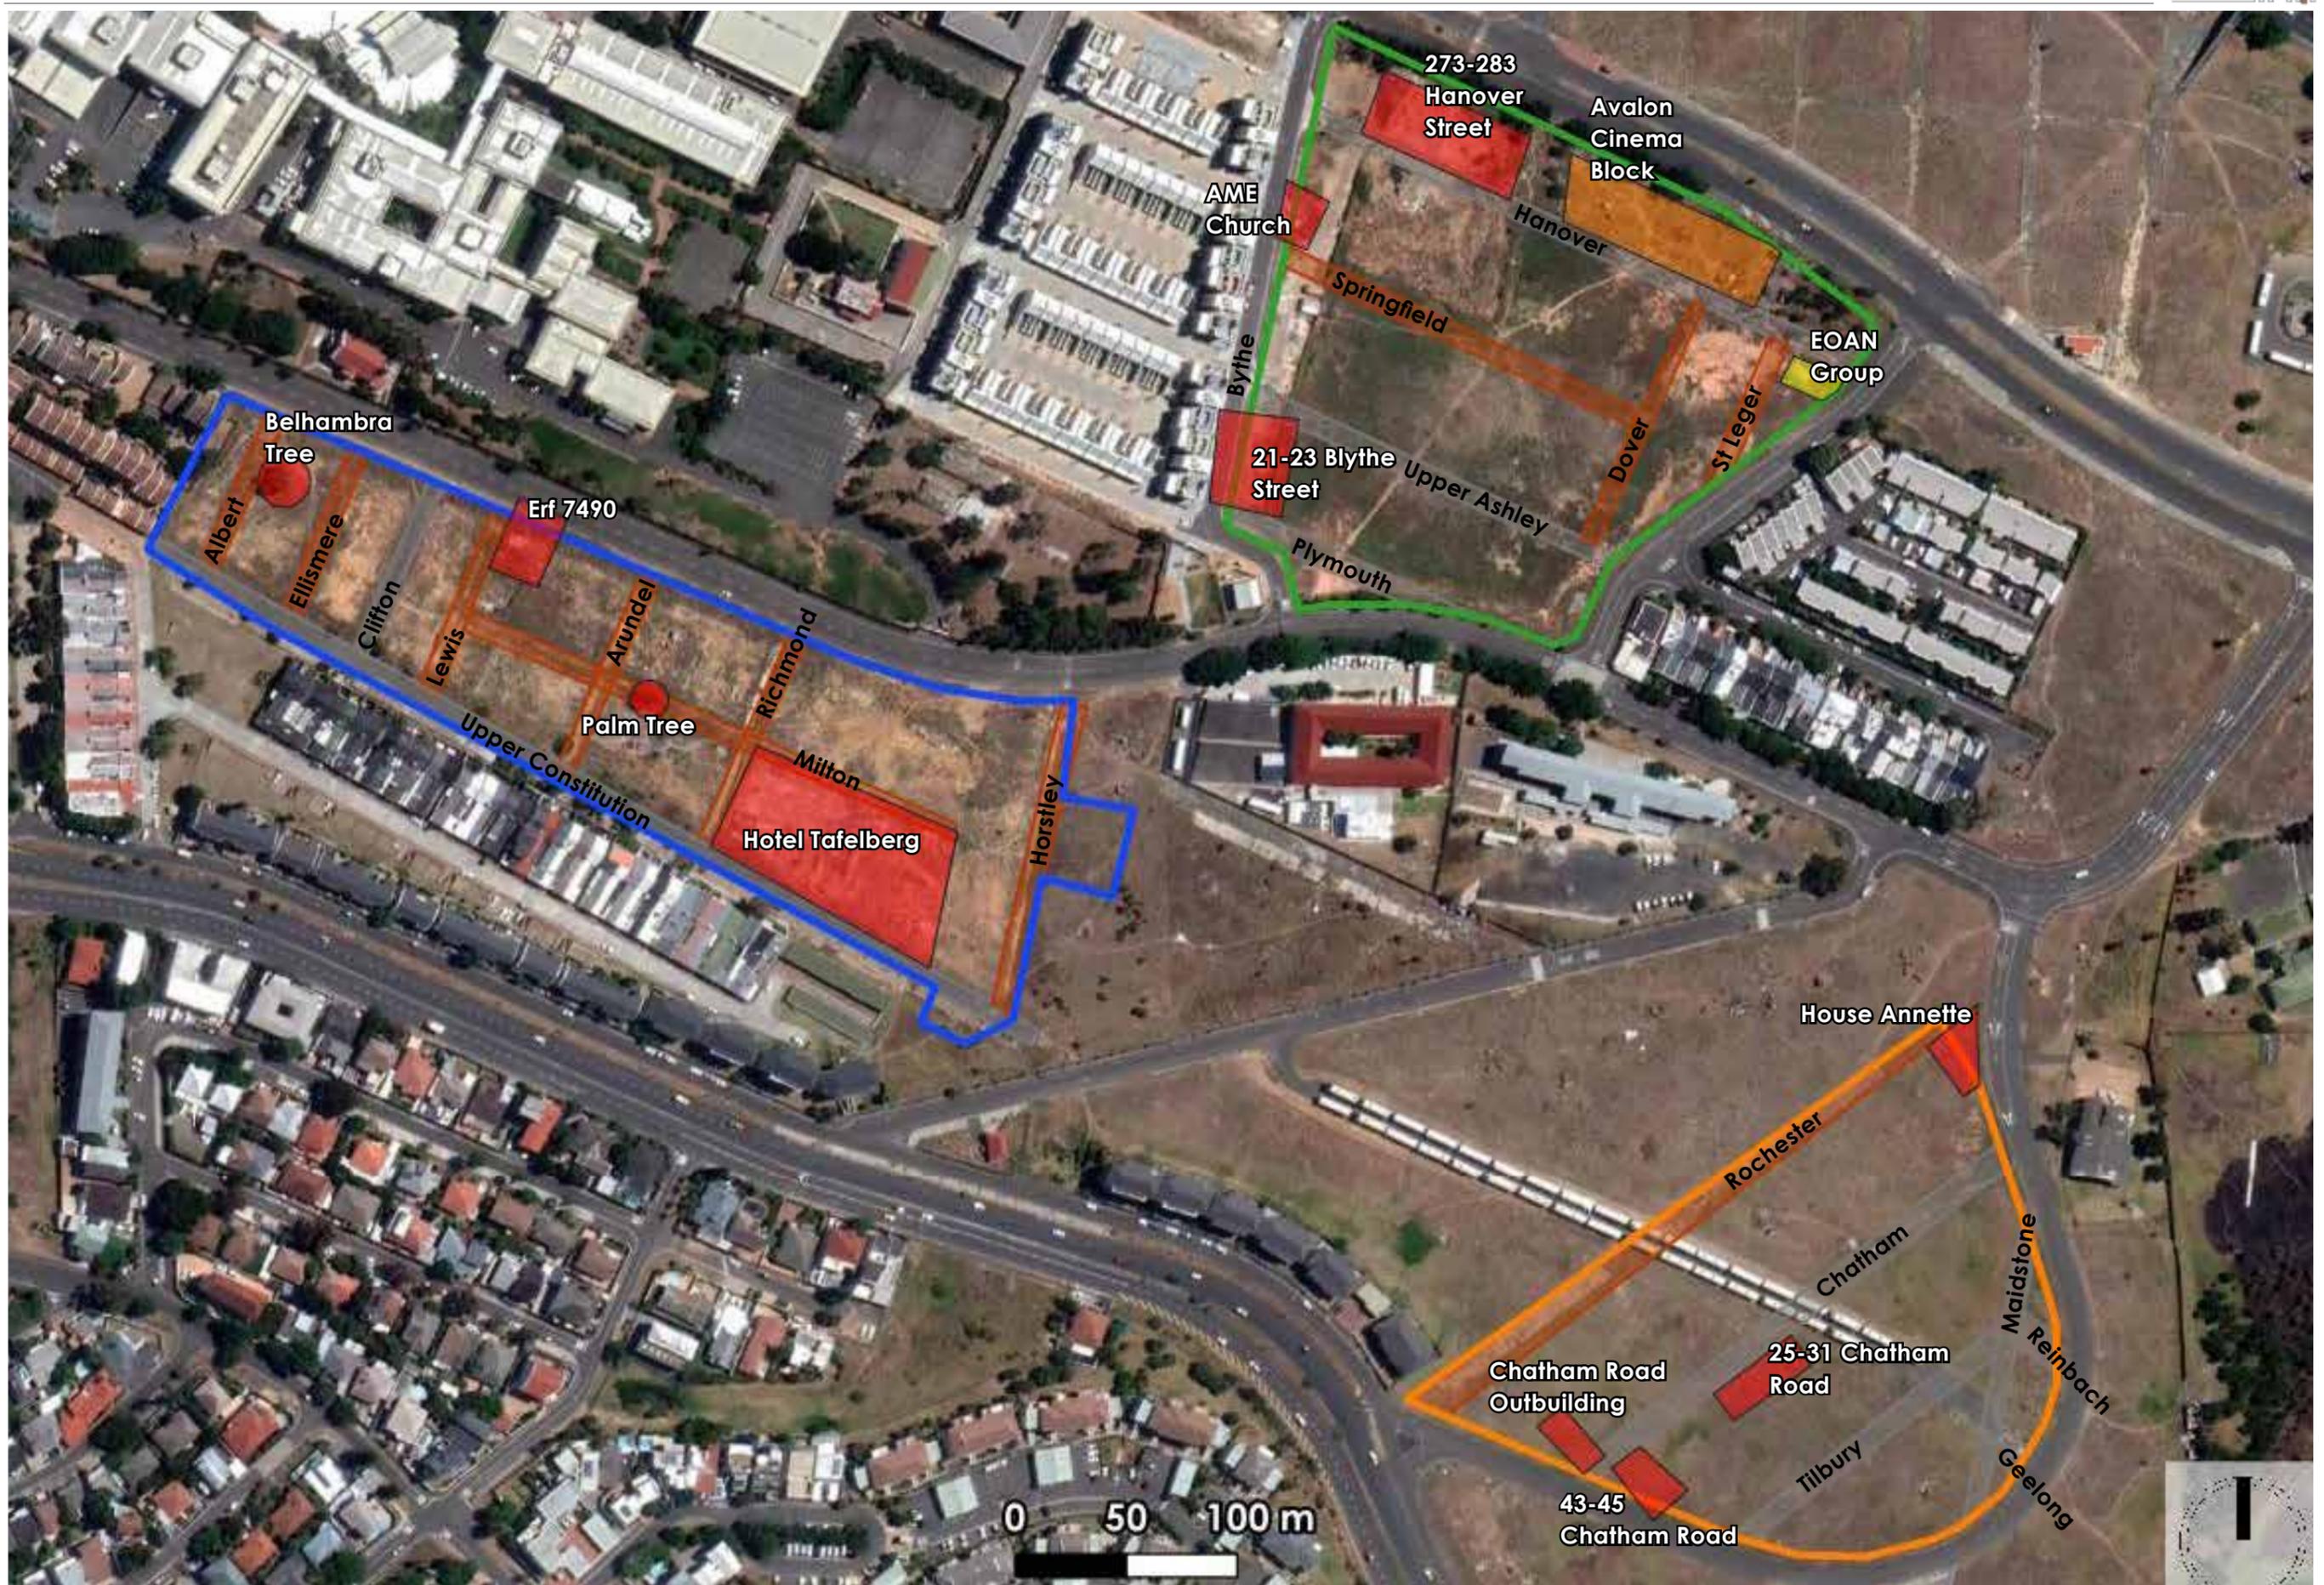
Figure 51. Sensitivity mapping of archaeological sensitivity derived from historic overlays, with sensitivities based on expected or known areas of old fabric or sites or features of social significance; red indicates areas of highest significance, orange moderate and yellow lowest. Historic road alignments are indicated, brown for concrete or cobbled surfaces, and grey for tar (RSA, 2022).

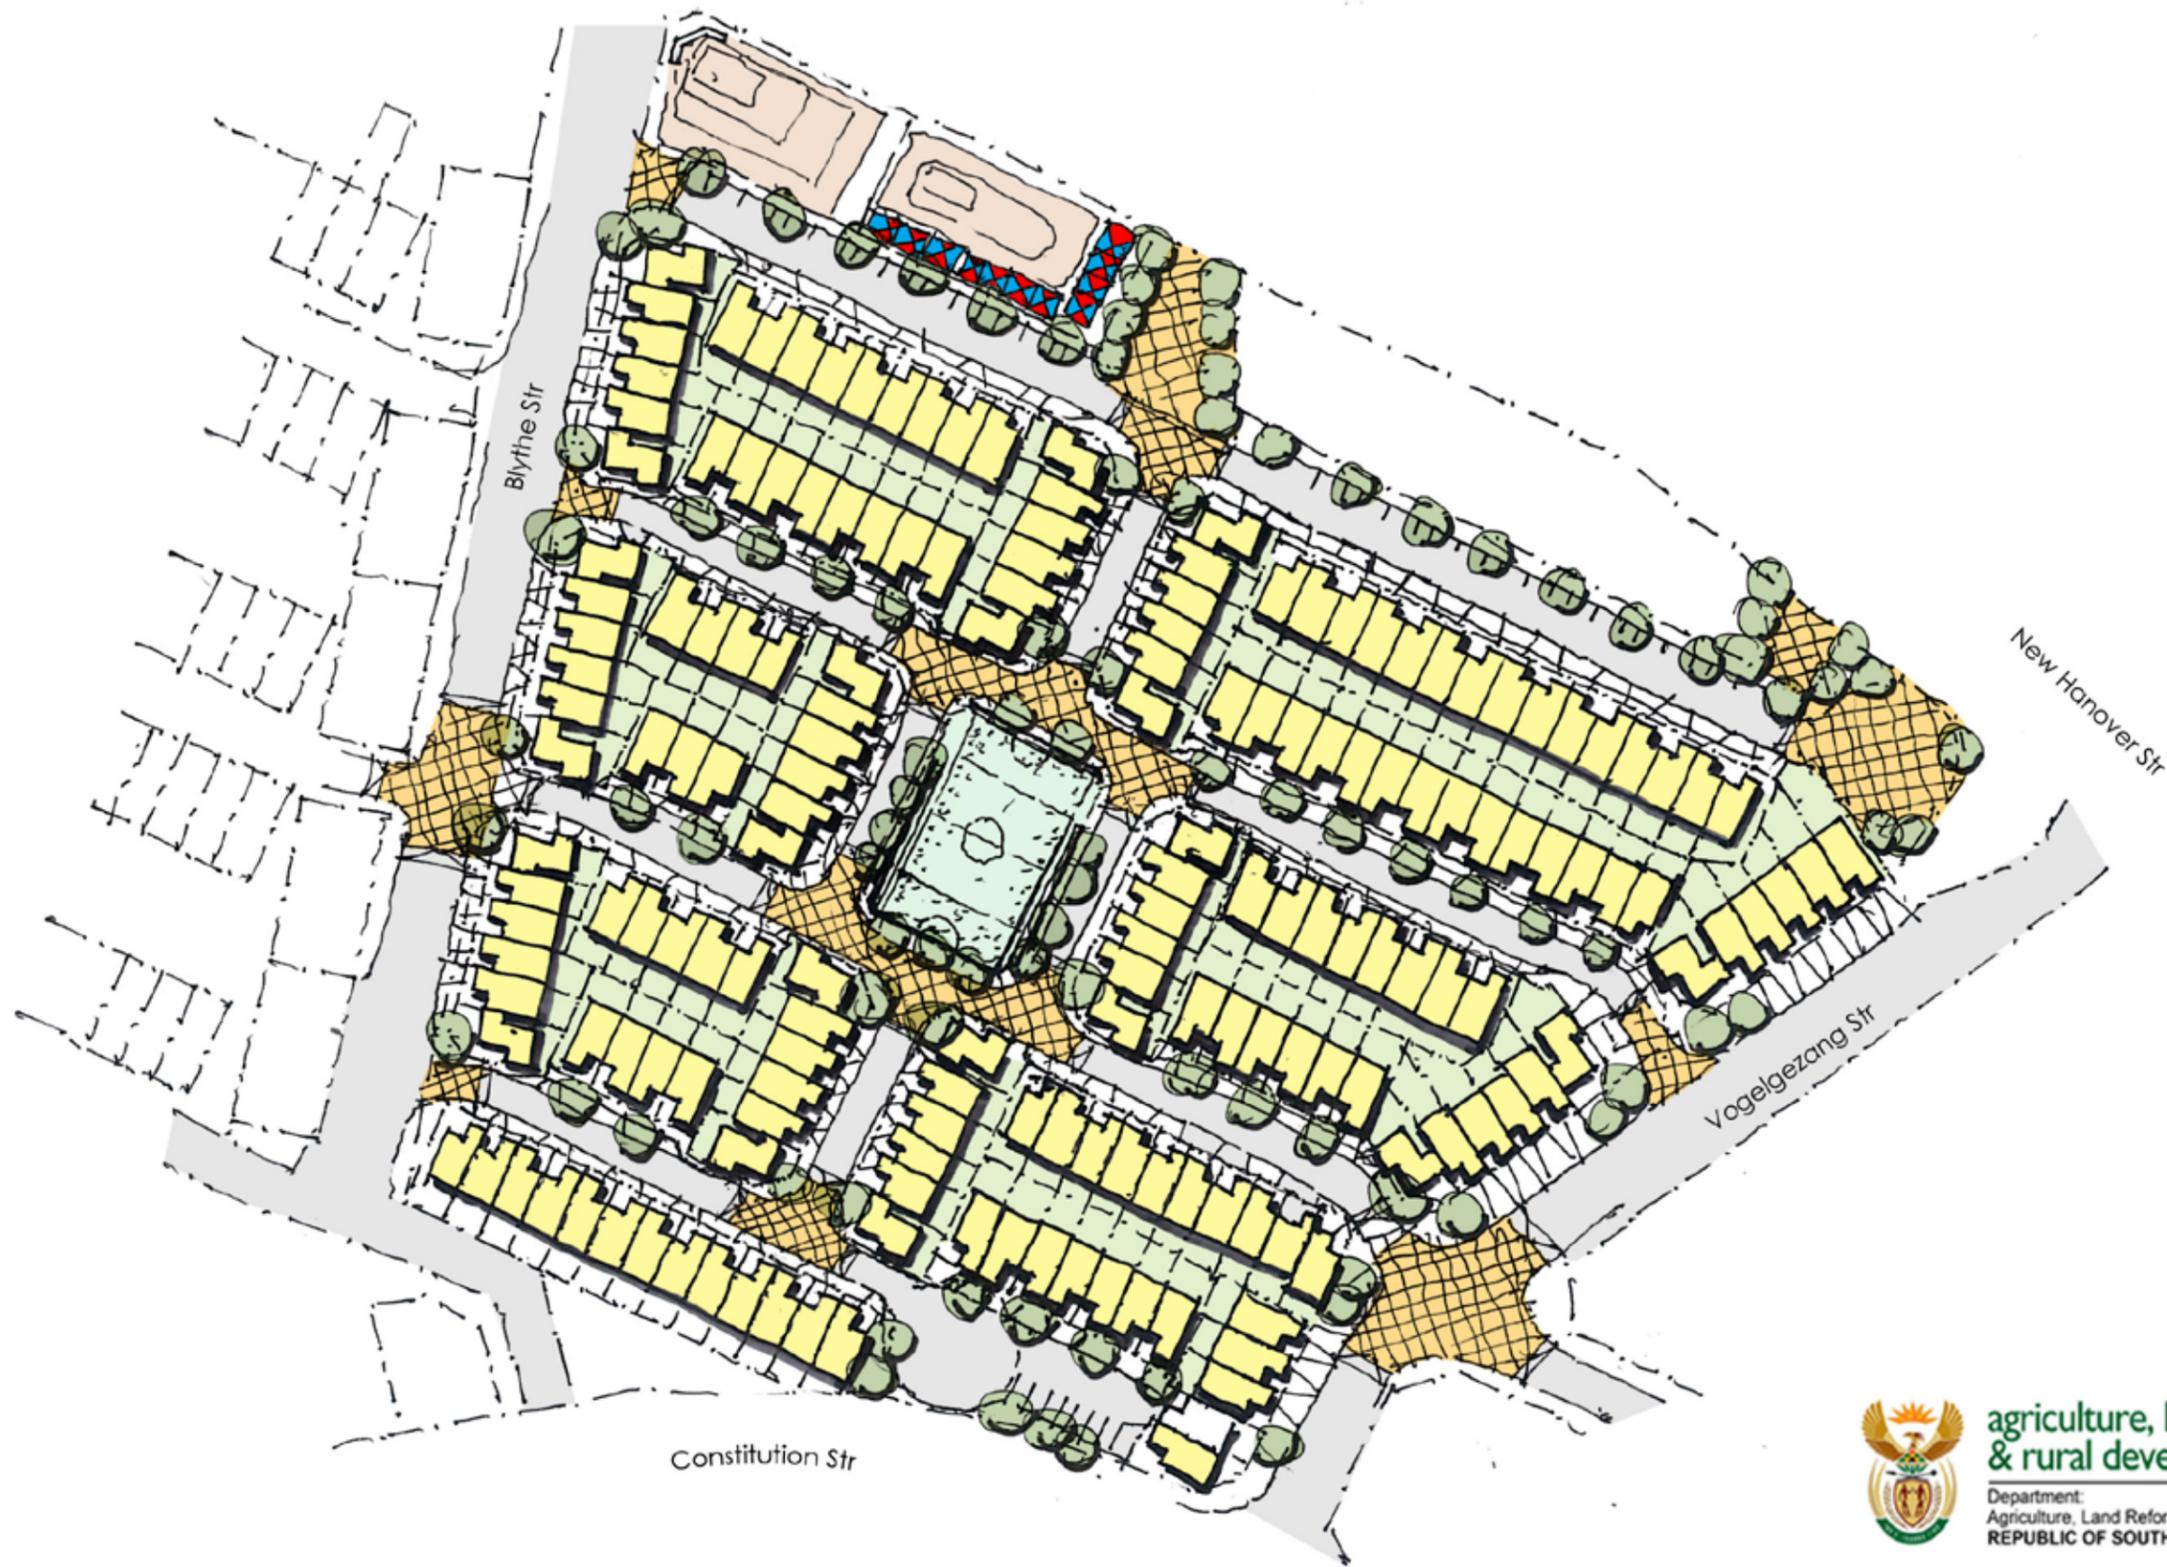
Figure 52. Concept layout for Phase 4 (CNdP, 2022)

CONCEPT LAYOUT - Rev 2	
D6 B1 Phase 4	
1:1000 @ A3	
0 10 20 30 40

At this early stage, particularly as the geotechnical testing has yet to be undertaken, the exact extent of the proposed works is not known. Further, the developers have opted for a staggered approach to the wider redevelopment project and are focusing on preparations for Phase 4 at this point, although surveys have been undertaken of the current ground surface across all parcels. The design and layout is being addressed in the HIA, and proposals presented here are concept sketches only; currently these have only been prepared for Phases 4 and 5 (Figure 52 and Figure 53)

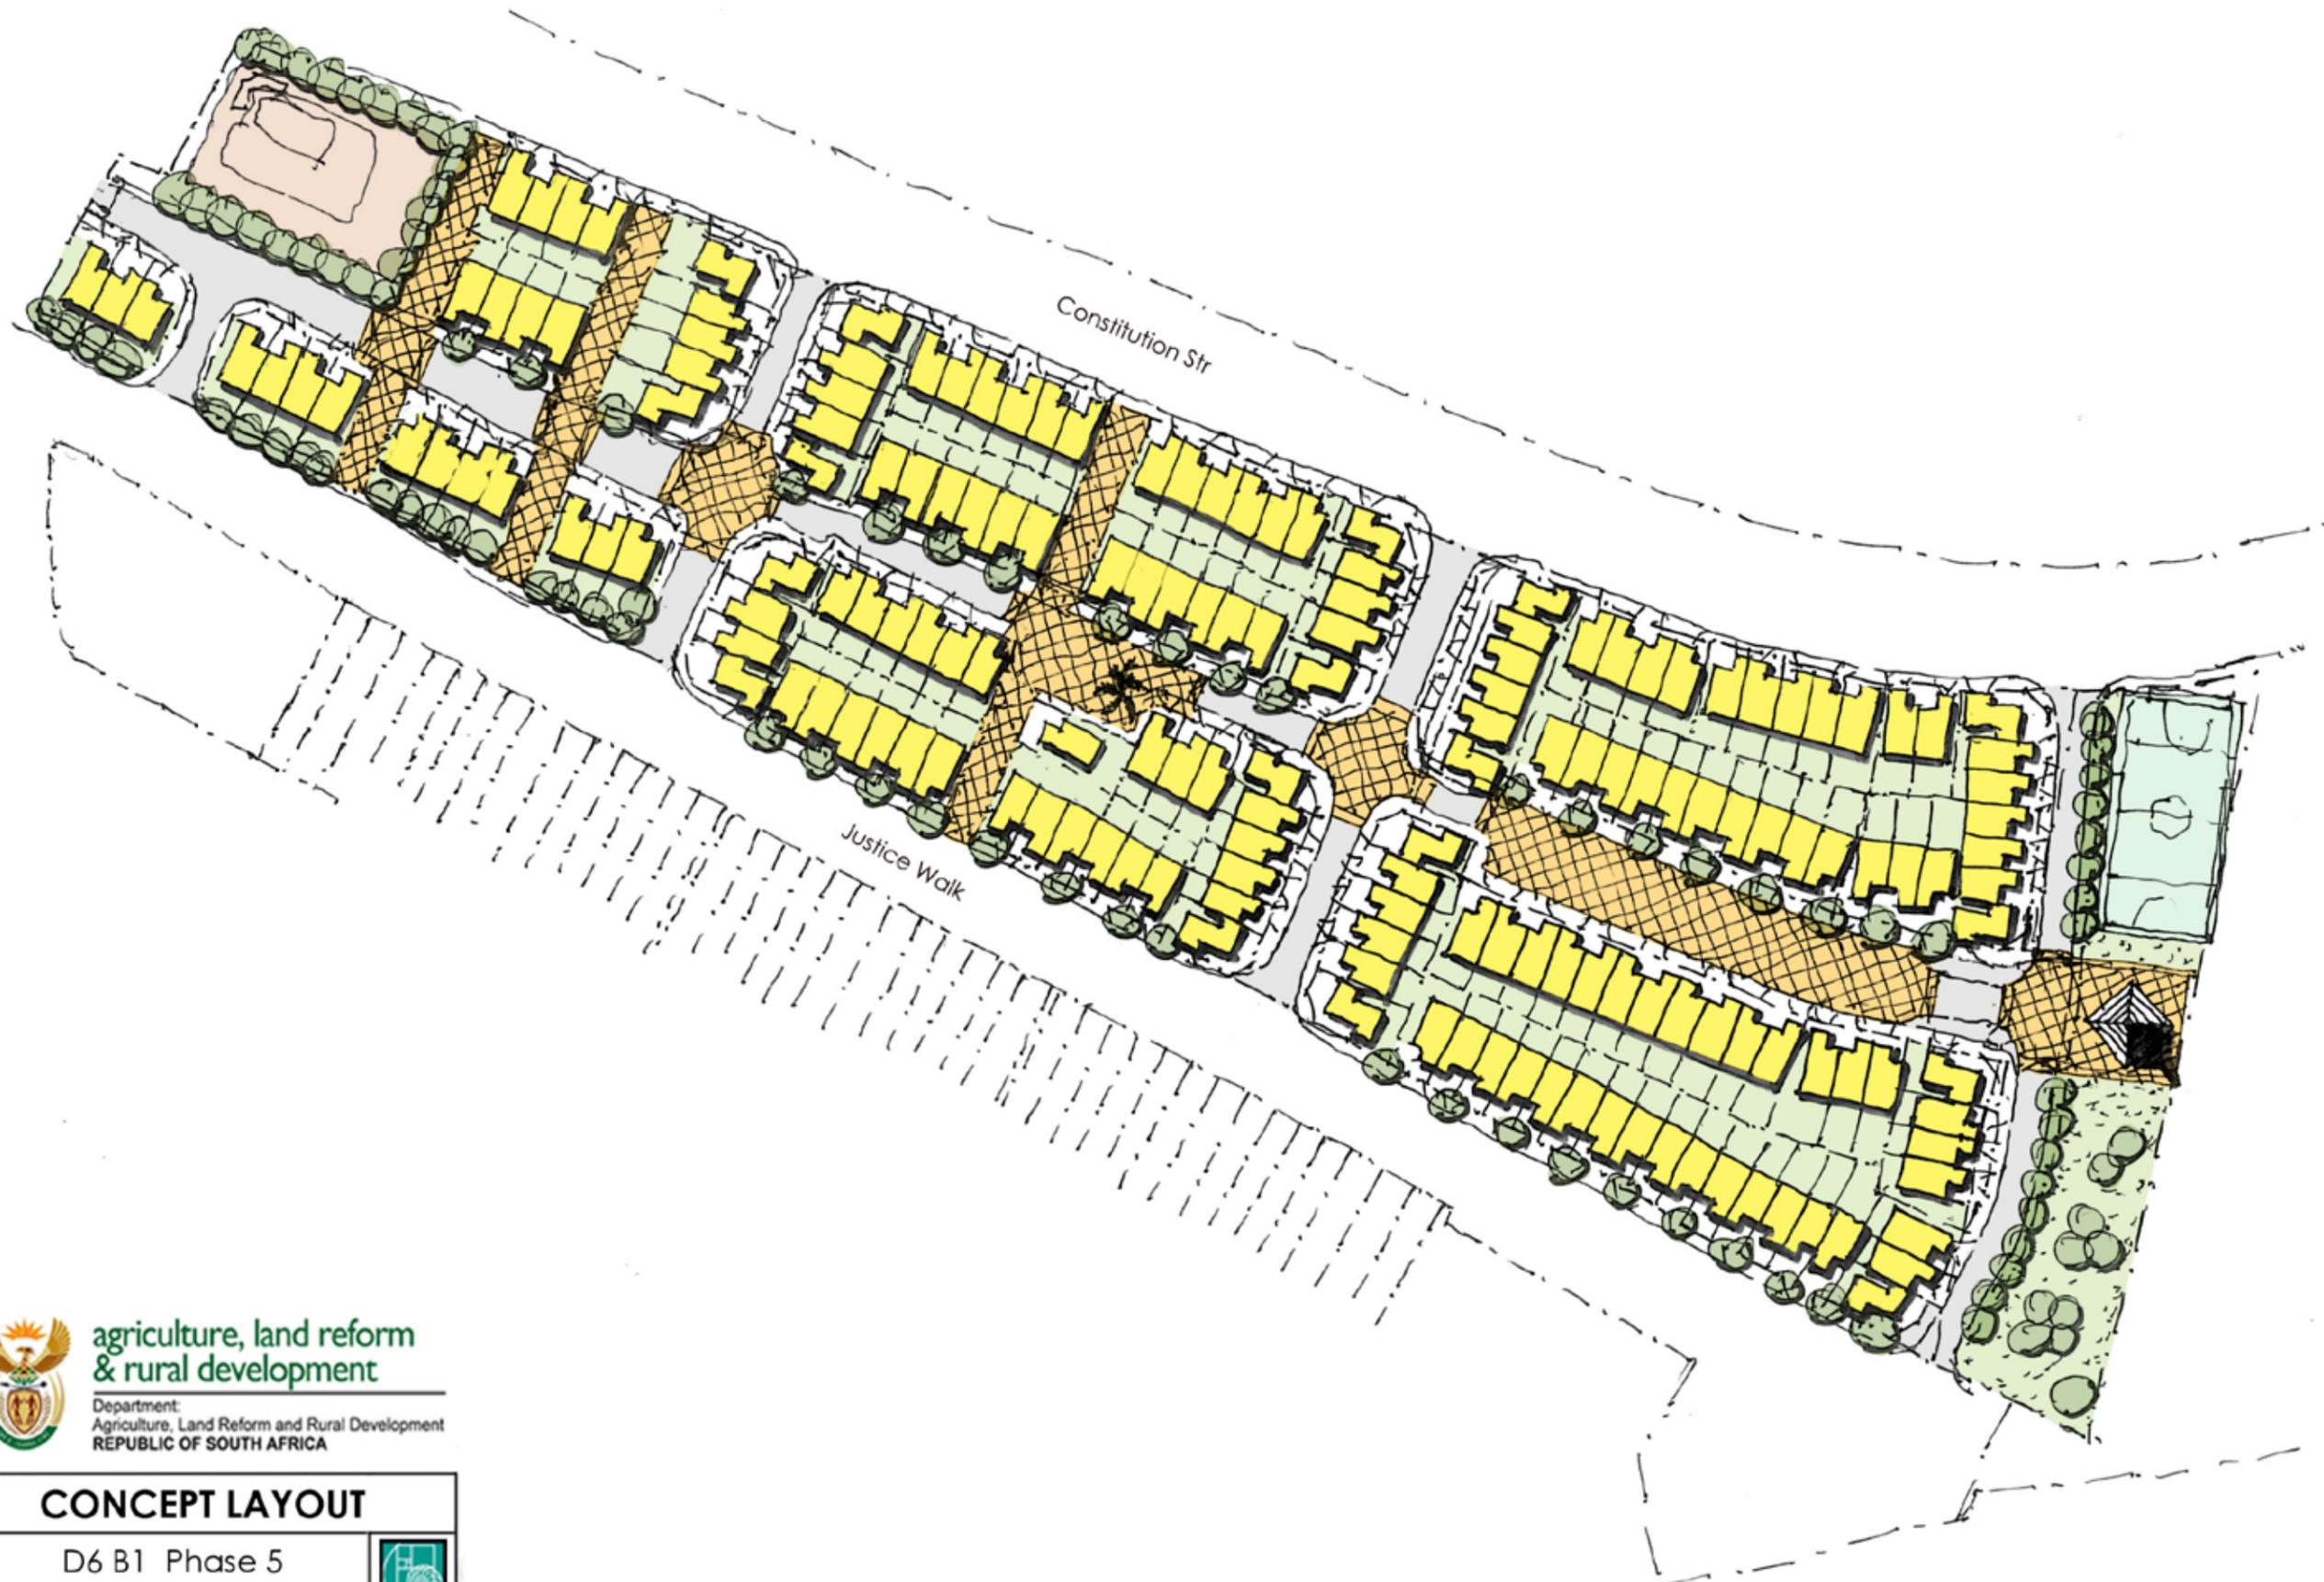
Figure 53. Concept layout for Phase 5 (CNdP, 2022)

CONCEPT LAYOUT	
D6 B1 Phase 5	
1:1000 @ A3

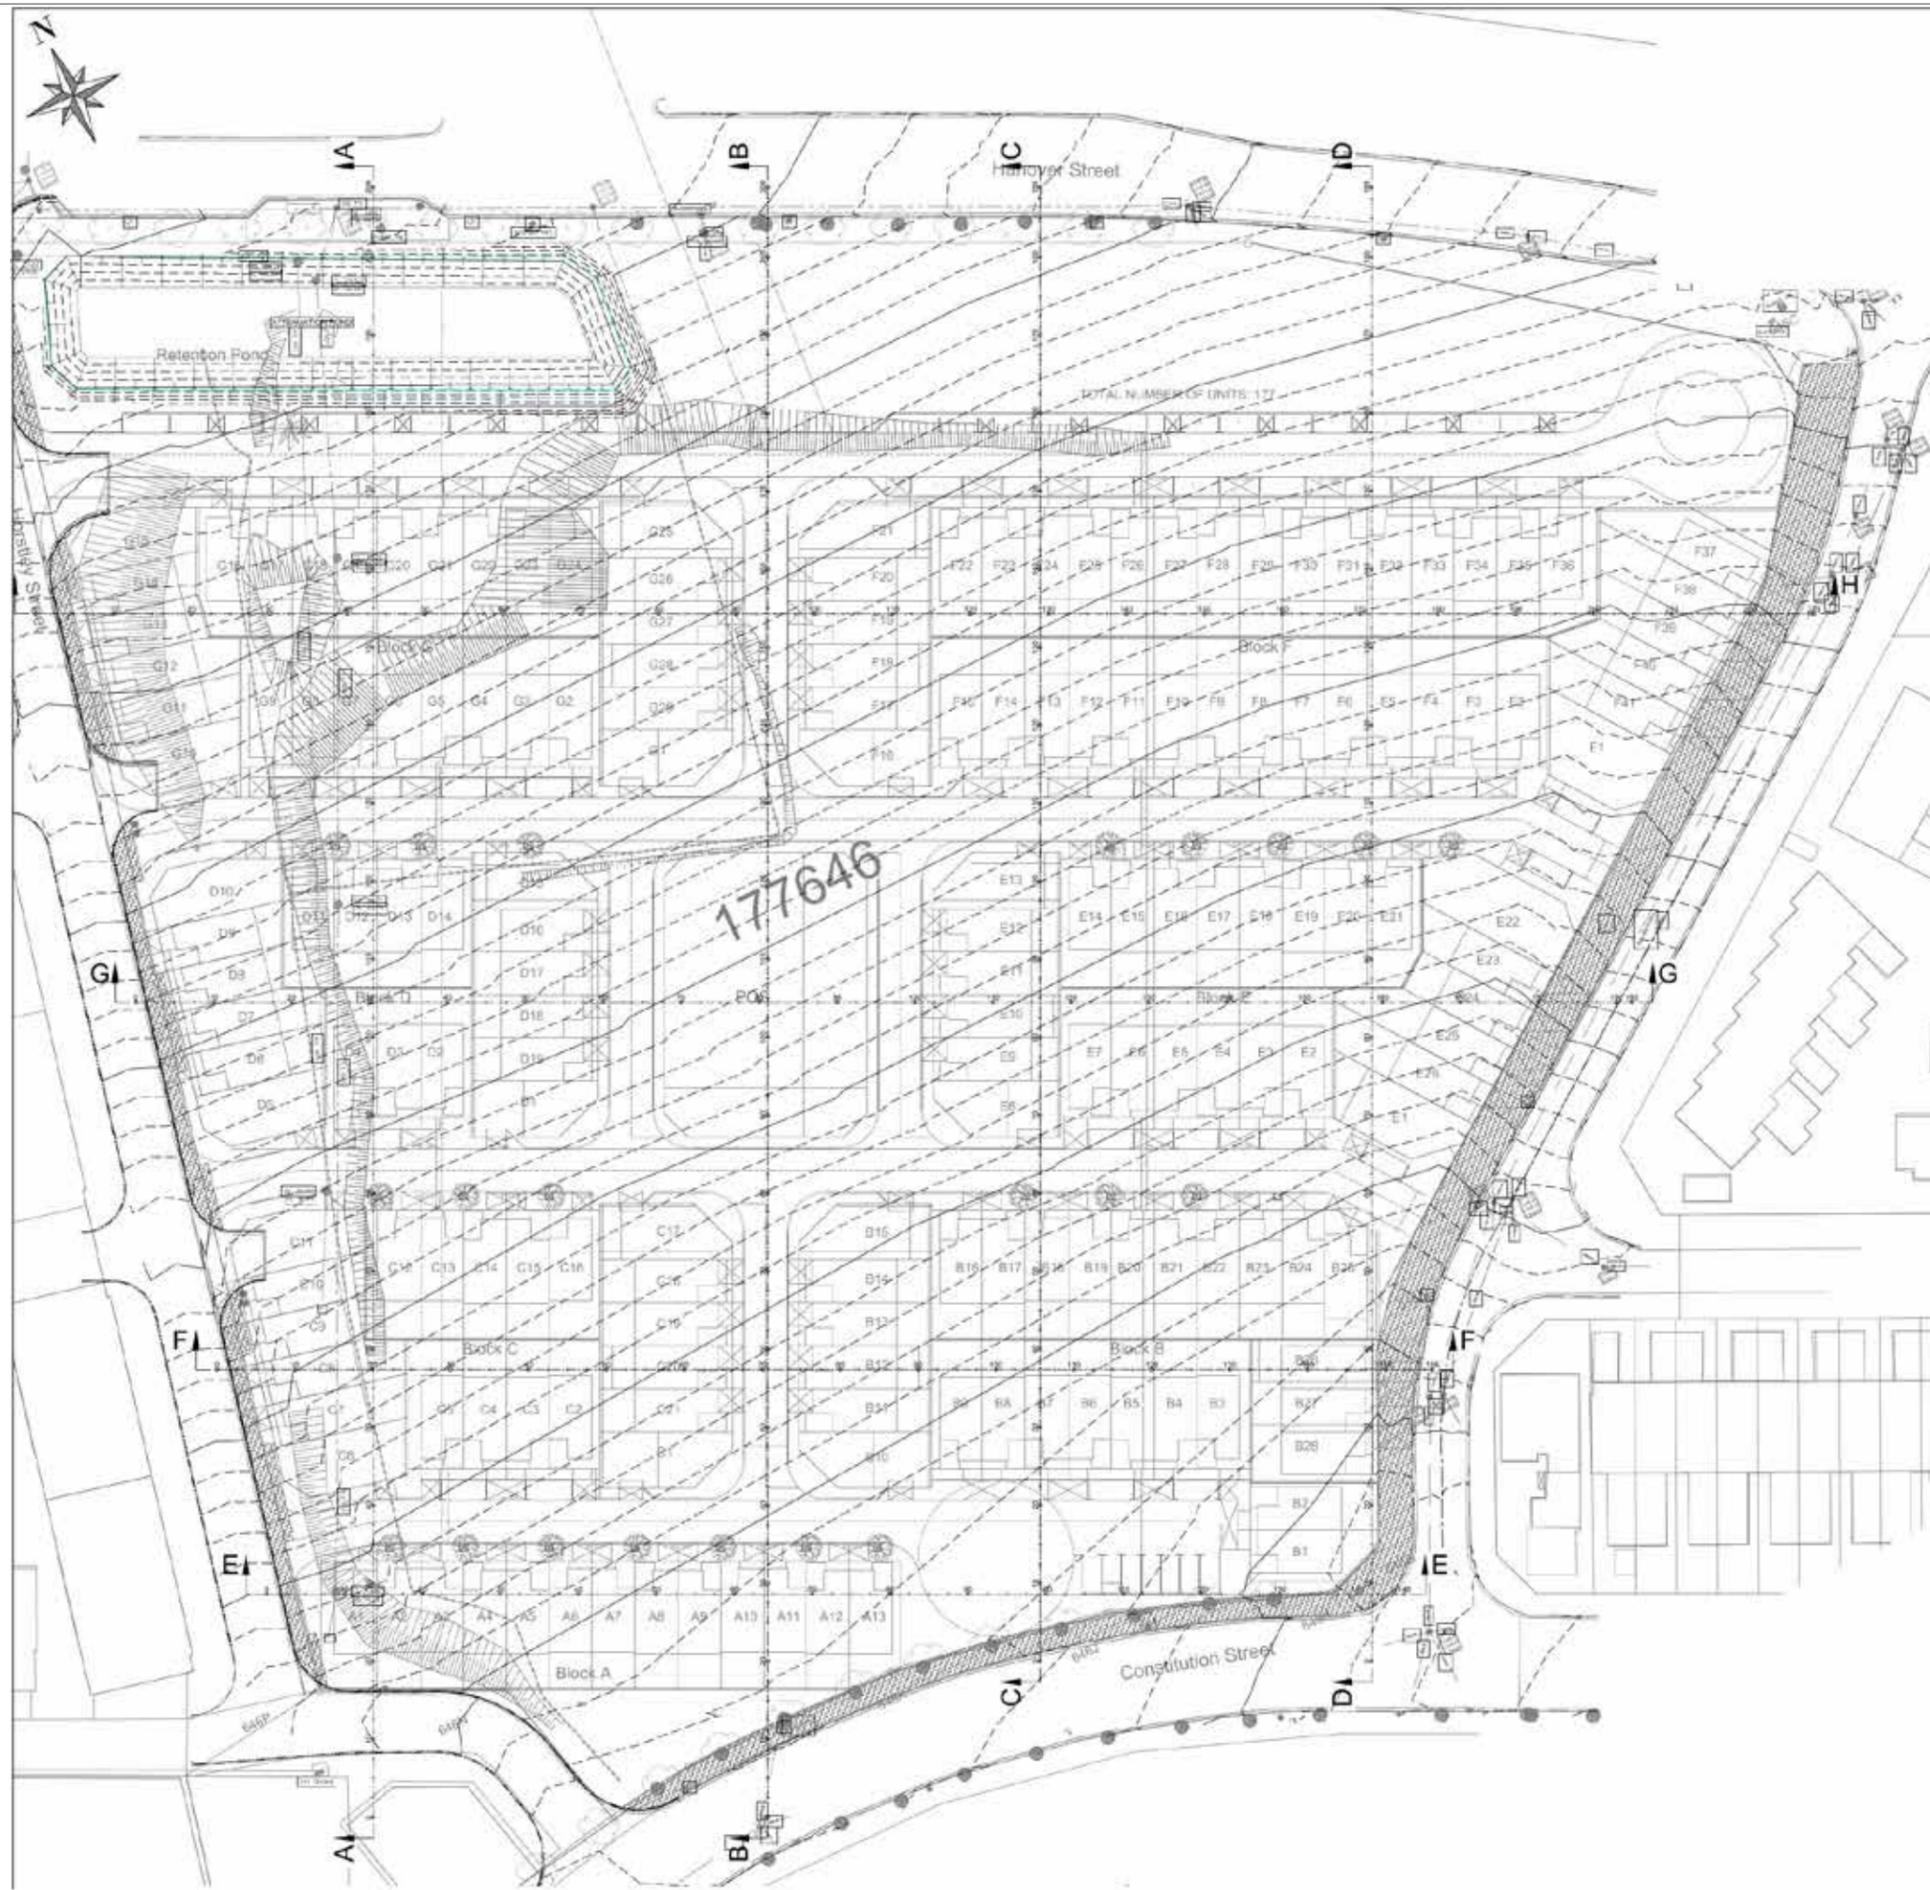
Figure 54. Draft layout of Phase 4 with inferred original levels indicated (ECENG, 2022)

Figure 55. Sections across site indicating inferred original ground level against current ground level (ECENG, 2022)

The activities proposed in terms of this application pertain to site levelling activities across all parcels. This earthmoving is necessary to clear the results of the initial demolition activities, as well as the accumulated overburden that has arisen due to activities across the three areas in the years since. In the case of Phase 5, much of the clearing work was already undertaken as part of the rubble removal activities in 2020; in the case of Phase 4, the condition and content of the overburden is uncertain due to the previous cut and fill activities, and more recent dumping and levelling on the site (Figure 54 to Figure 56).

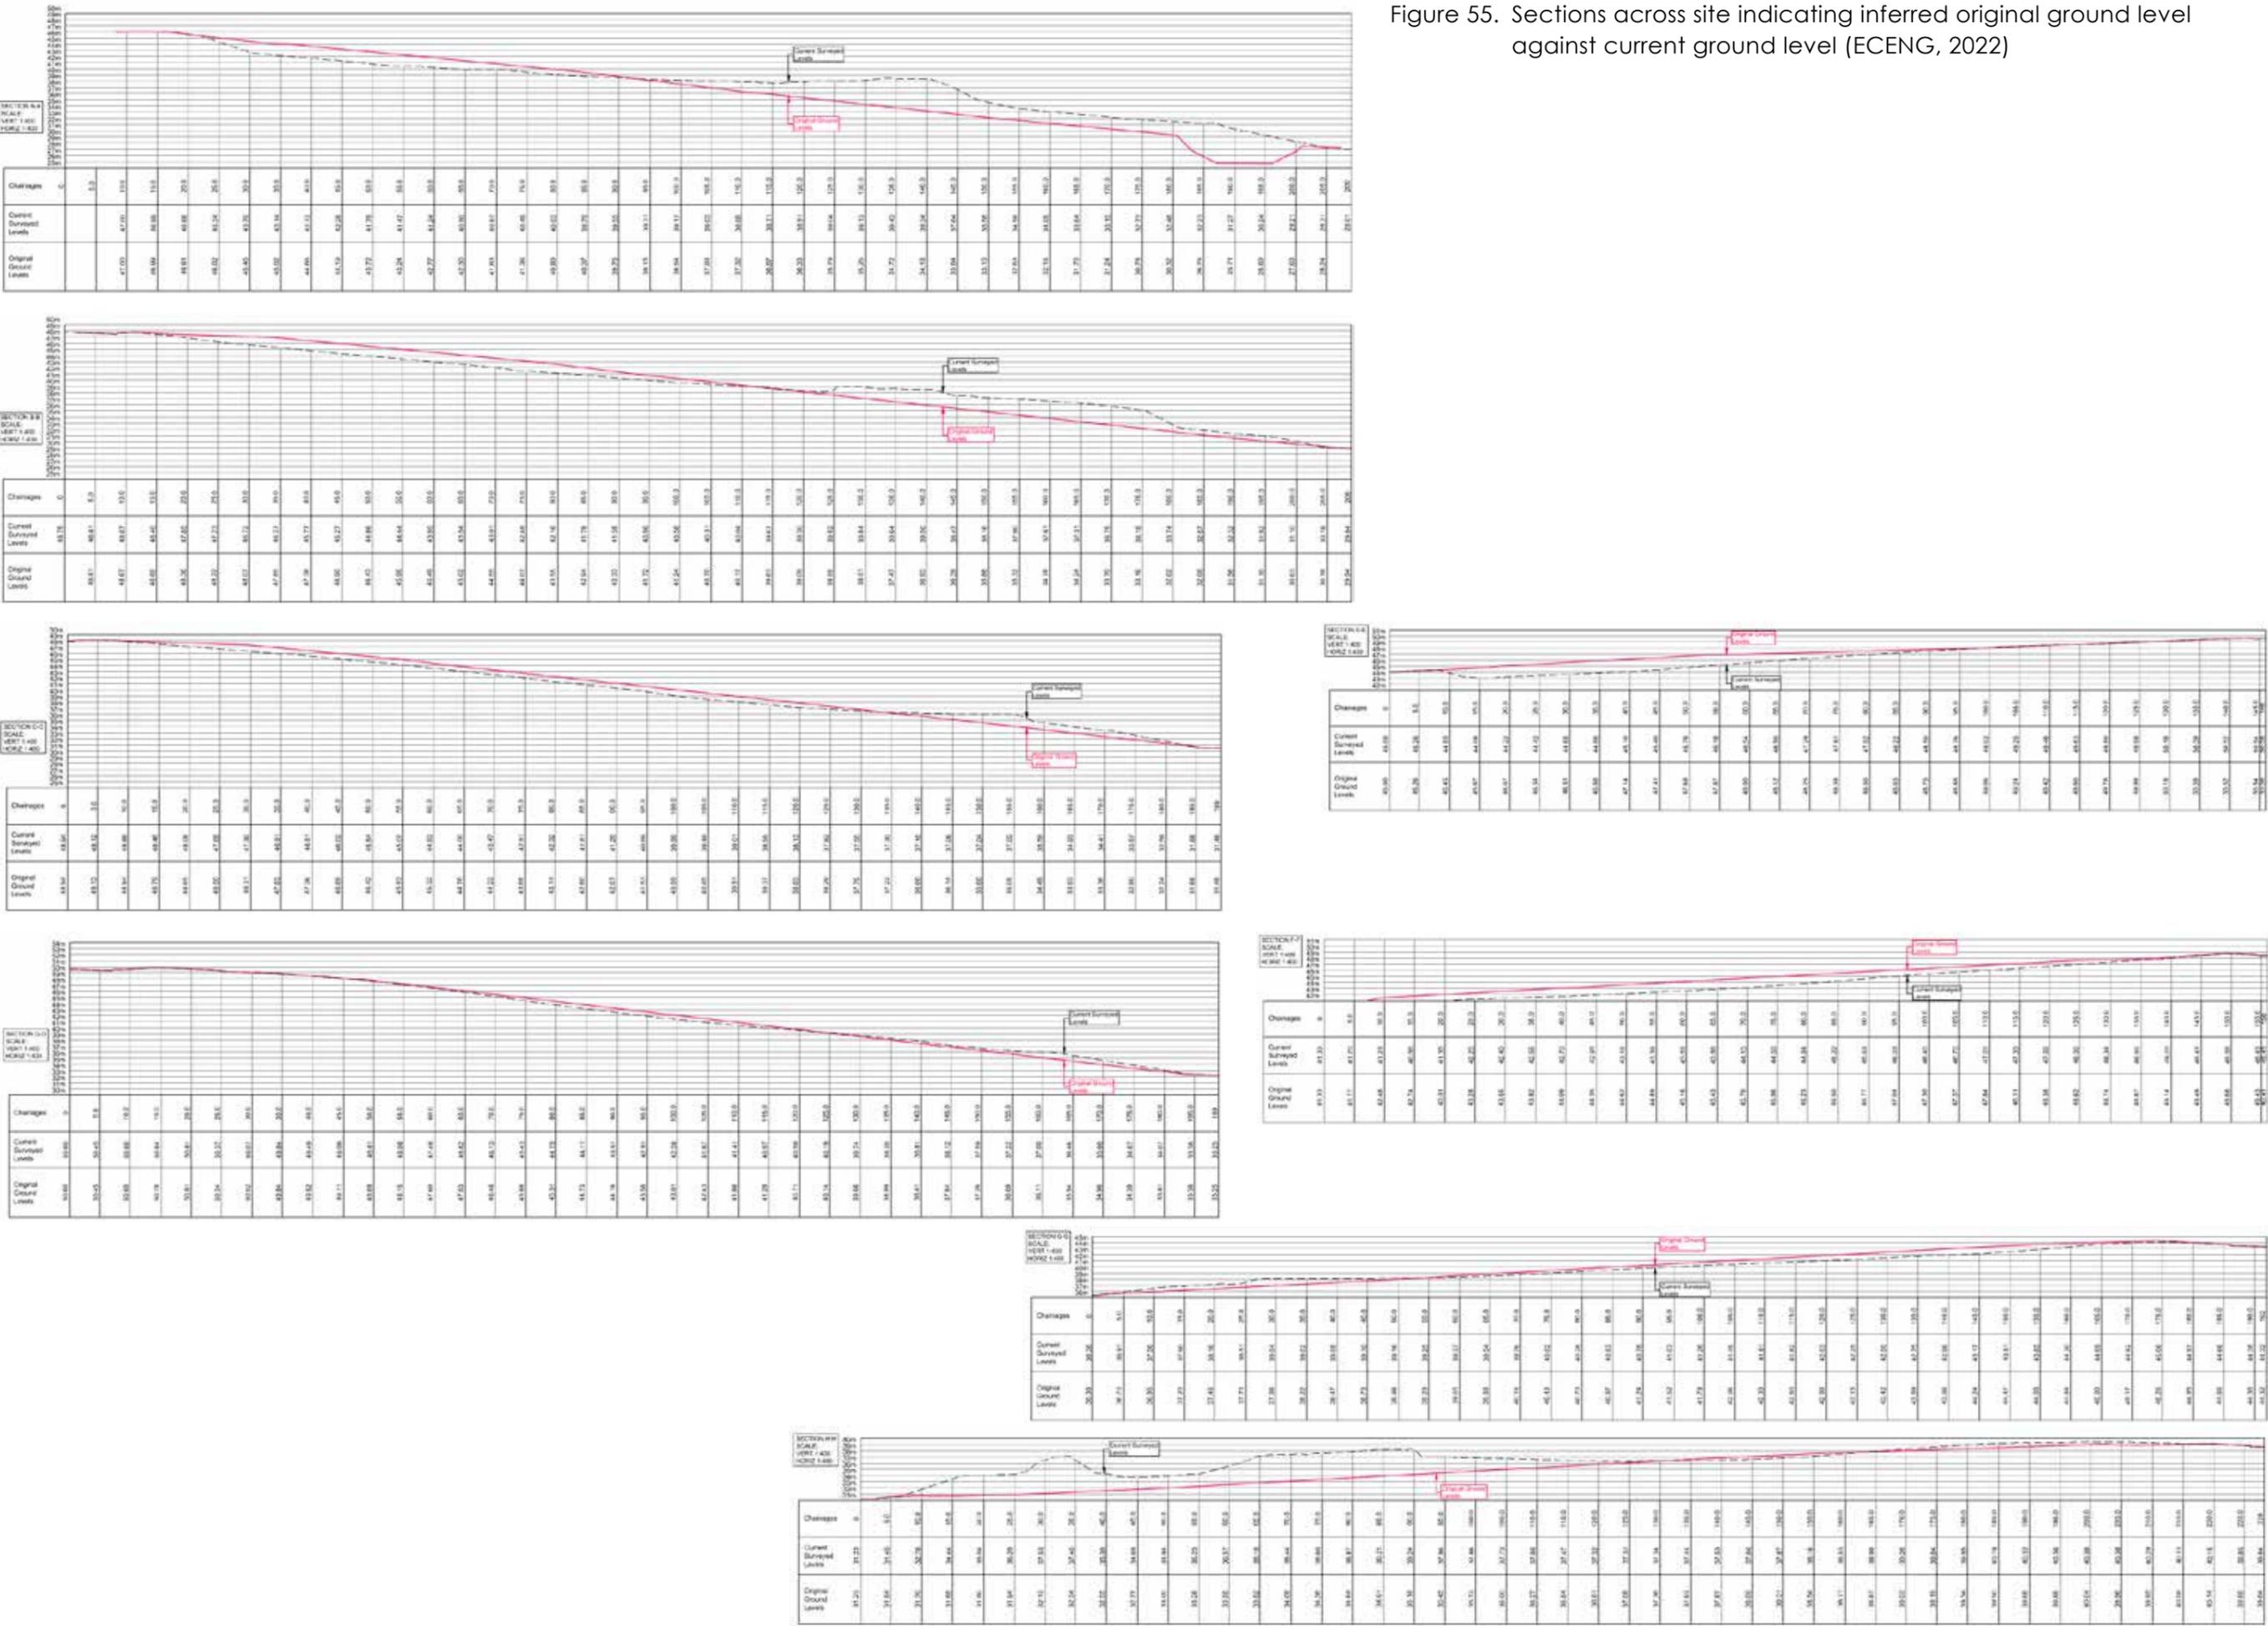
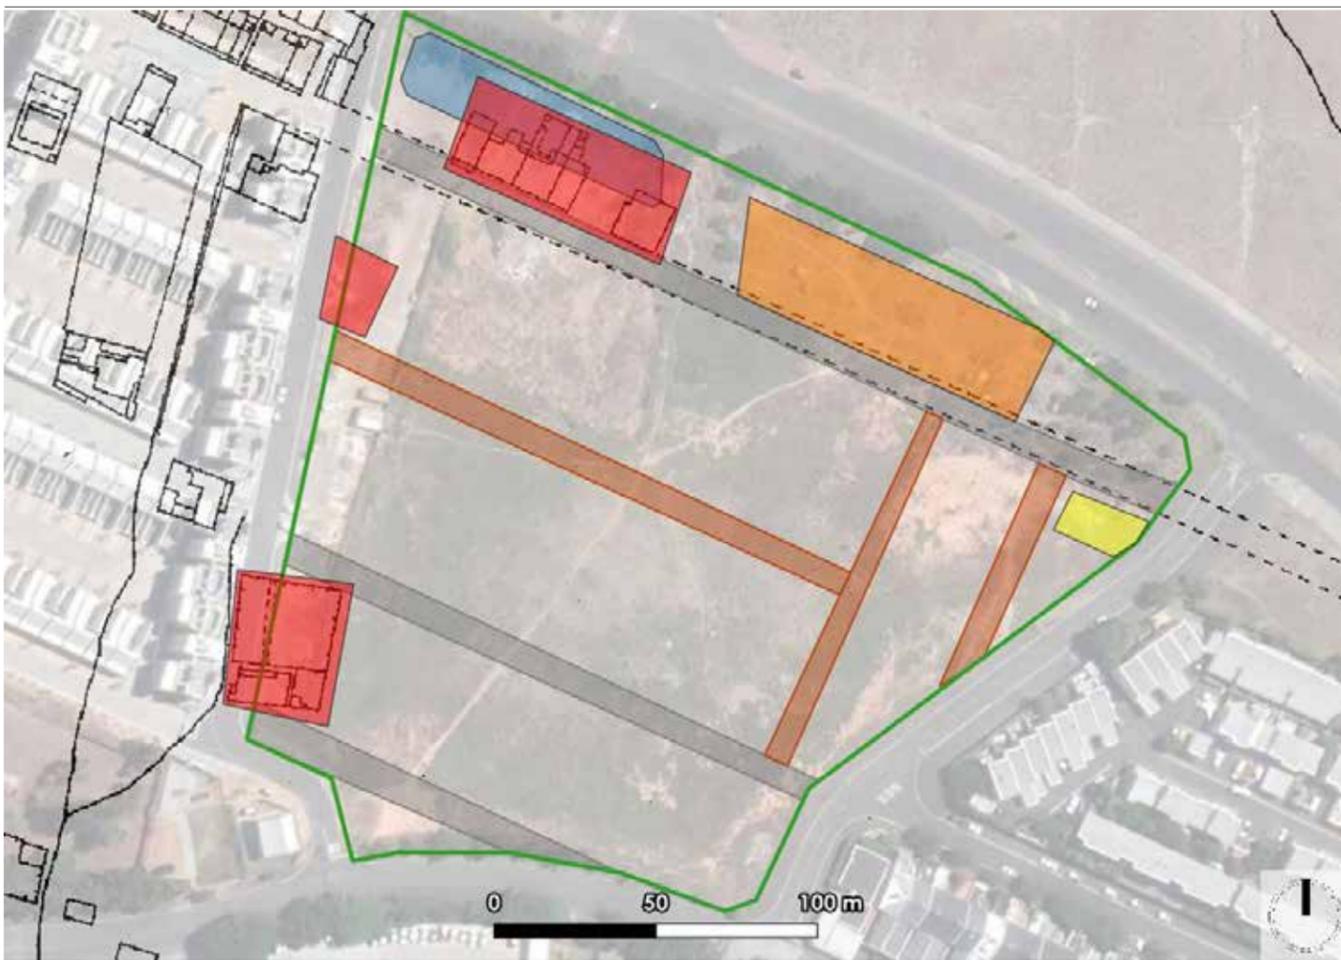
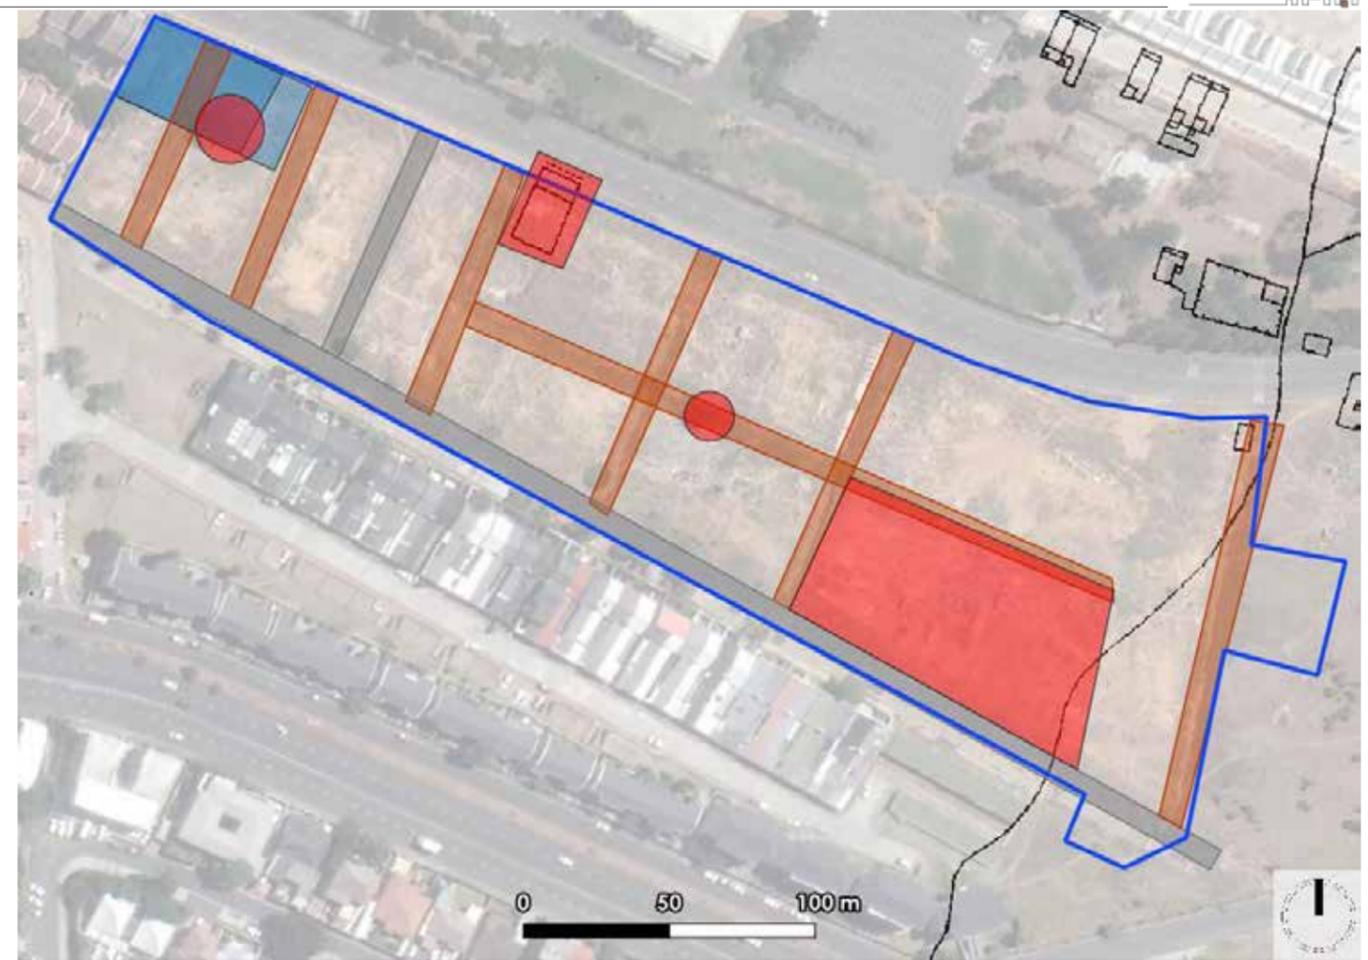
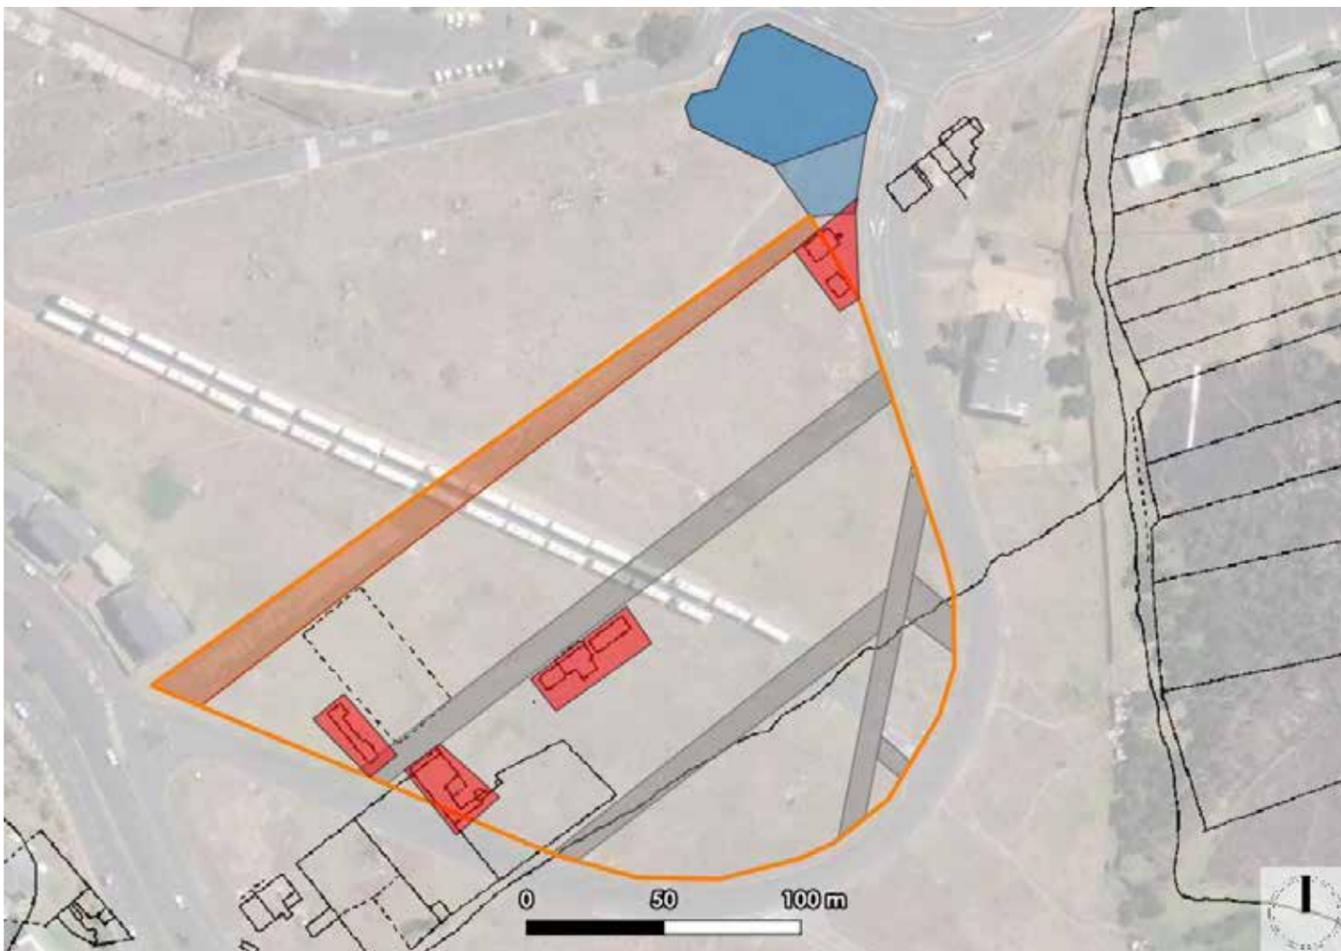
Figure 56. Proposed locations of detention ponds overlaid over the archaeological sensitivity maps for the three parcels; the base map shows Snow's 1860s survey overlaid on current satellite imagery. The darker pond area shows reduced attenuation, and the lighter area total attenuation (RSA, 2022 from ECENG, 2022)
