# HERITAGE IMPACT ASSESSMENT: PROPOSED SIYANQOBA 132kV POWERLINE, WITBANK MAGISTERIAL DISTRICT, MPUMALANGA

*Report for:*

**Ecosphere Environmental Management Services**

09 May 2021

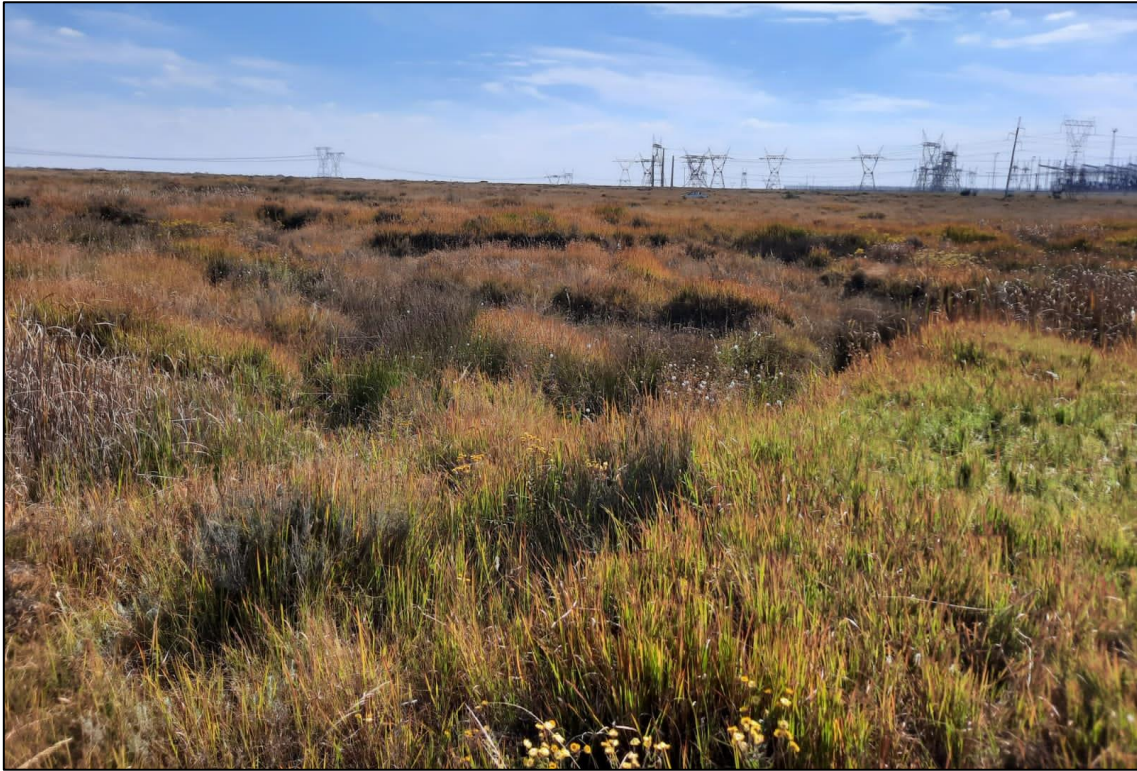
**Figure 4:** View towards the northwest showing the waterlogged wetland areas to the south of the Vulcan substation.

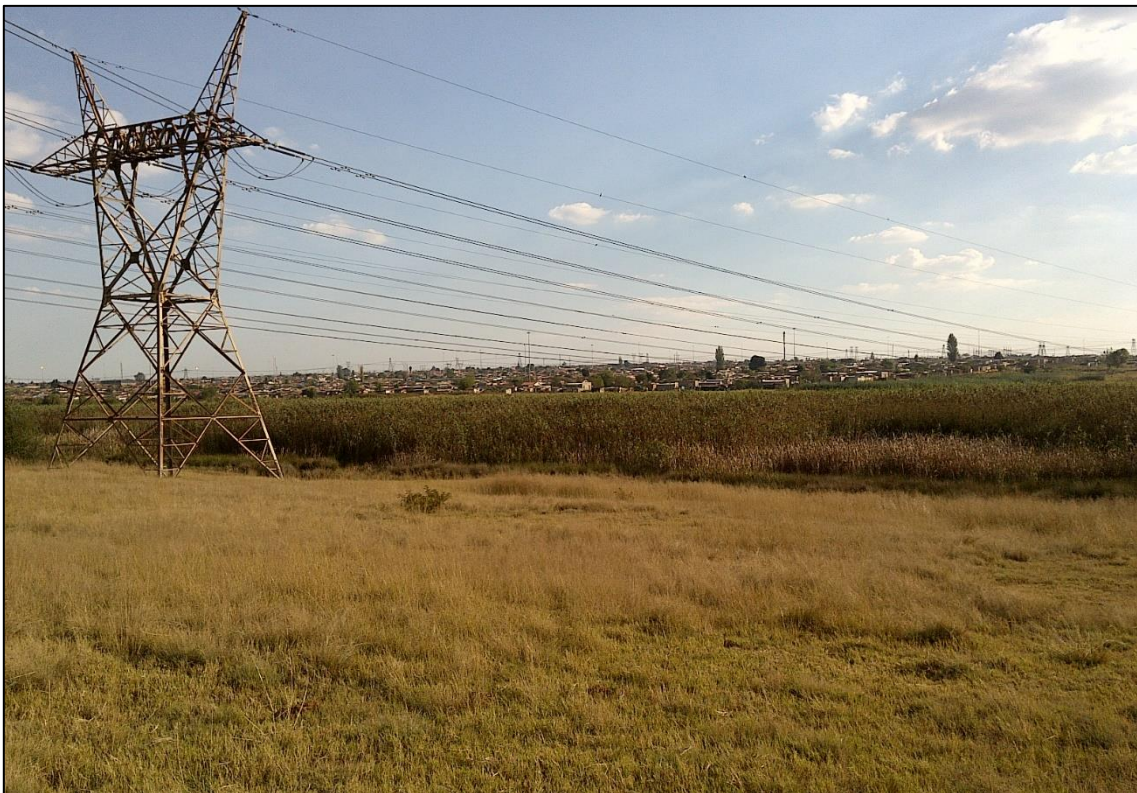
**Figure 5:** View towards the west looking across the Brugspruit River with dense grass cover in the foreground. Hlalanikahle is visible in the background. The new powerline would be in the immediate foreground.

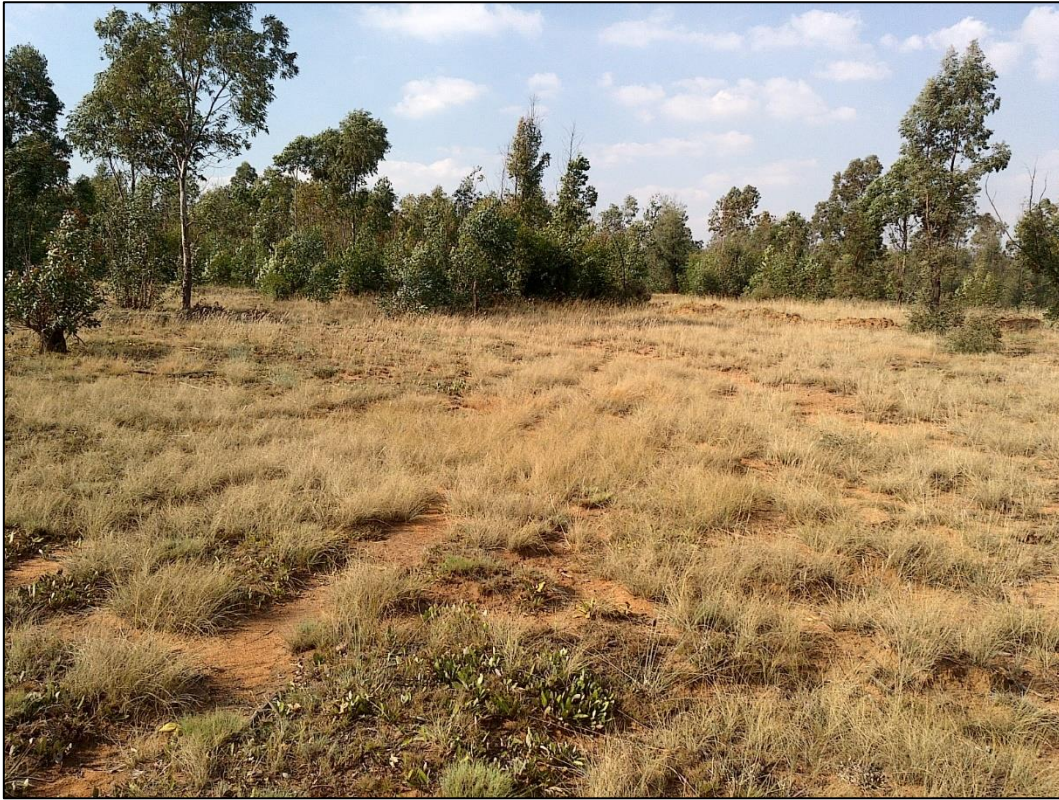
**Figure 6:** View towards the northeast in the central part of the study area where the powerline leaves the grass-covered fields and enters gum tree plantations.

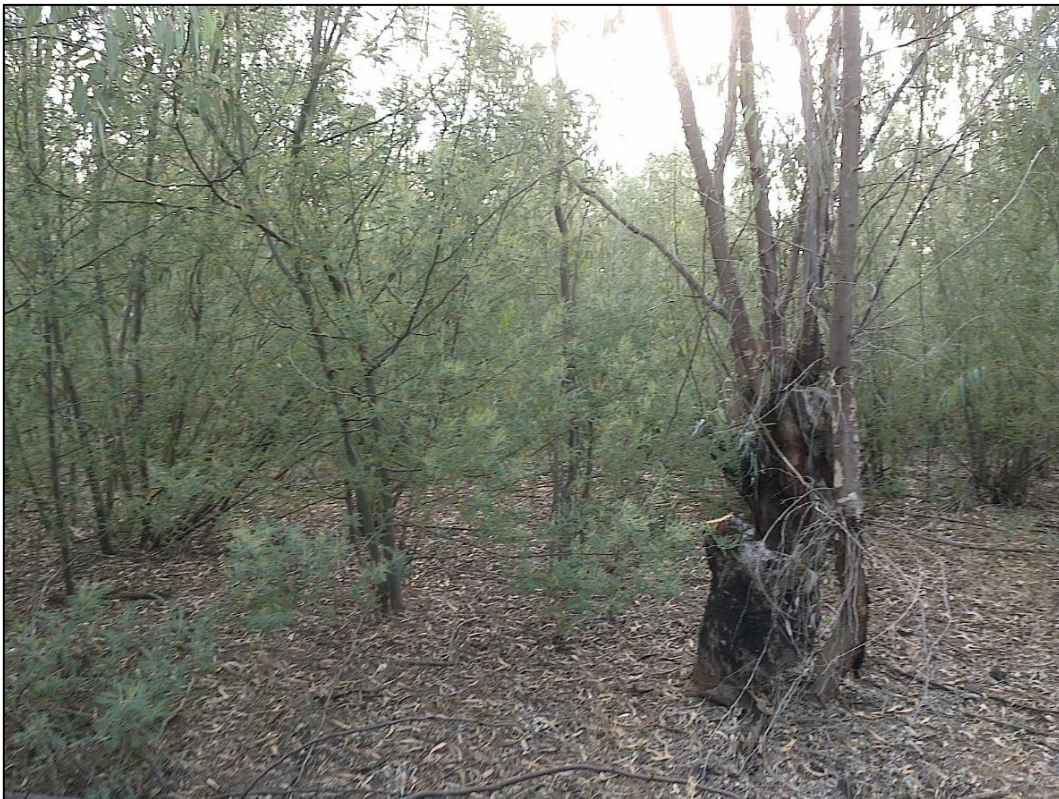
**Figure 7:** View through the Eucalyptus plantations showing tree density and the quantity of leaf litter coating the ground.

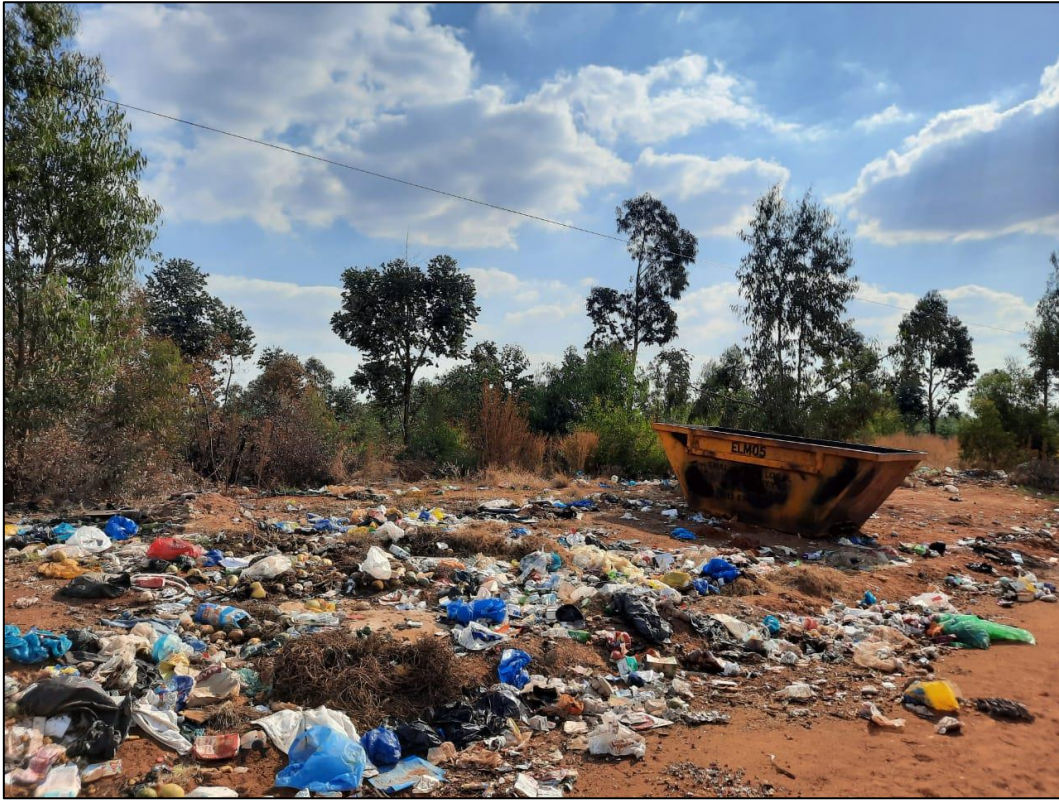
**Figure 8:** *Illegal dumping along the powerline route in the vicinity of the gum tree plantation.*

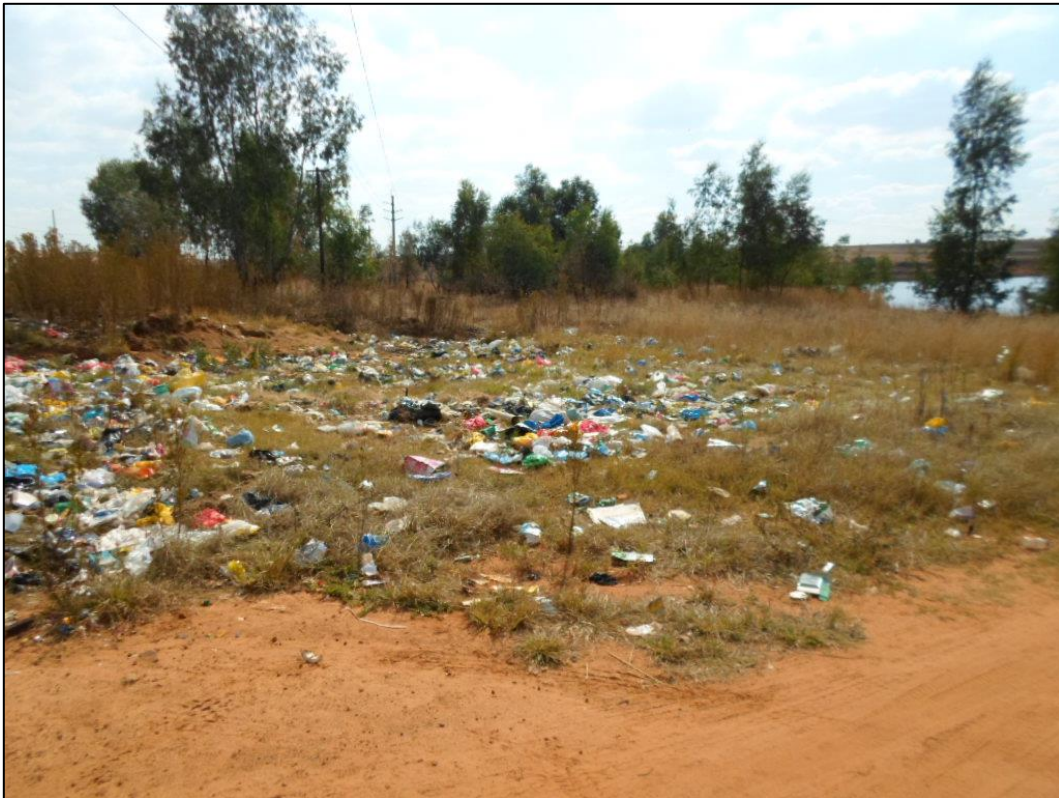
**Figure 9:** *View towards the northwest showing grass and bush cover as well as illegal dumping along the powerline route alongside the R544.*

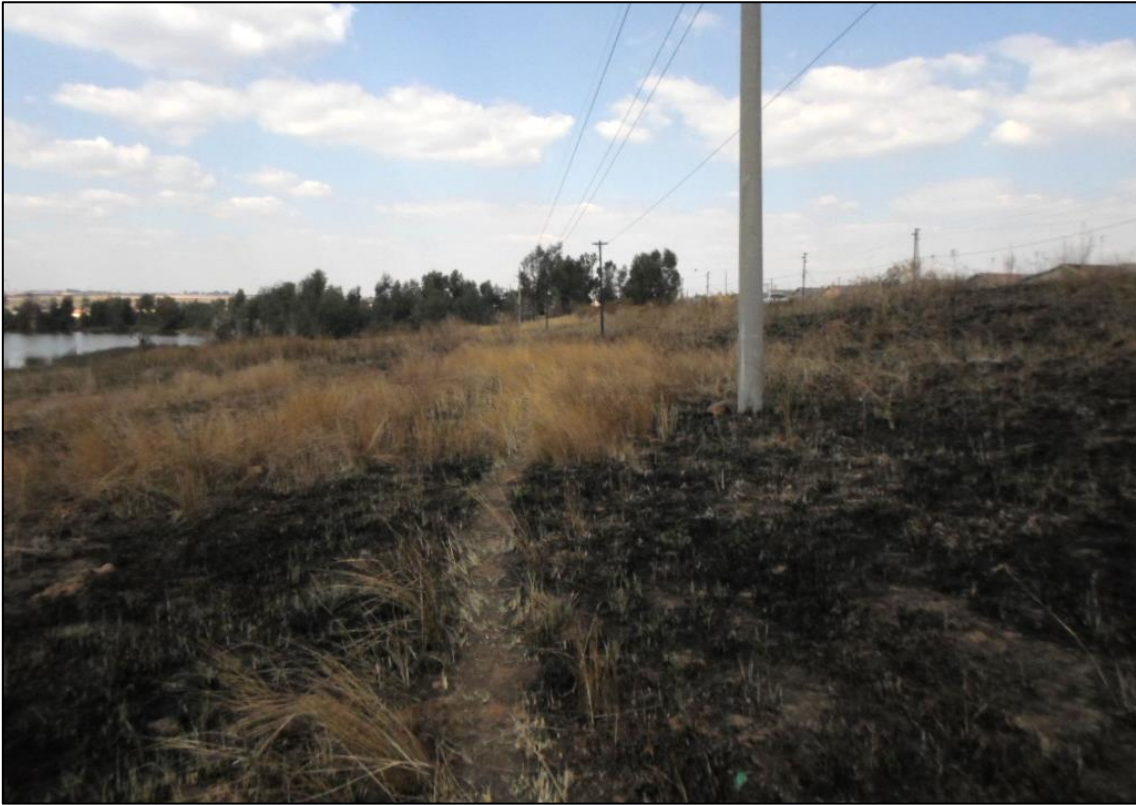
**Figure 10:** View towards the southeast showing site conditions along the eastern portion of the powerline. The R544 lies to the right.

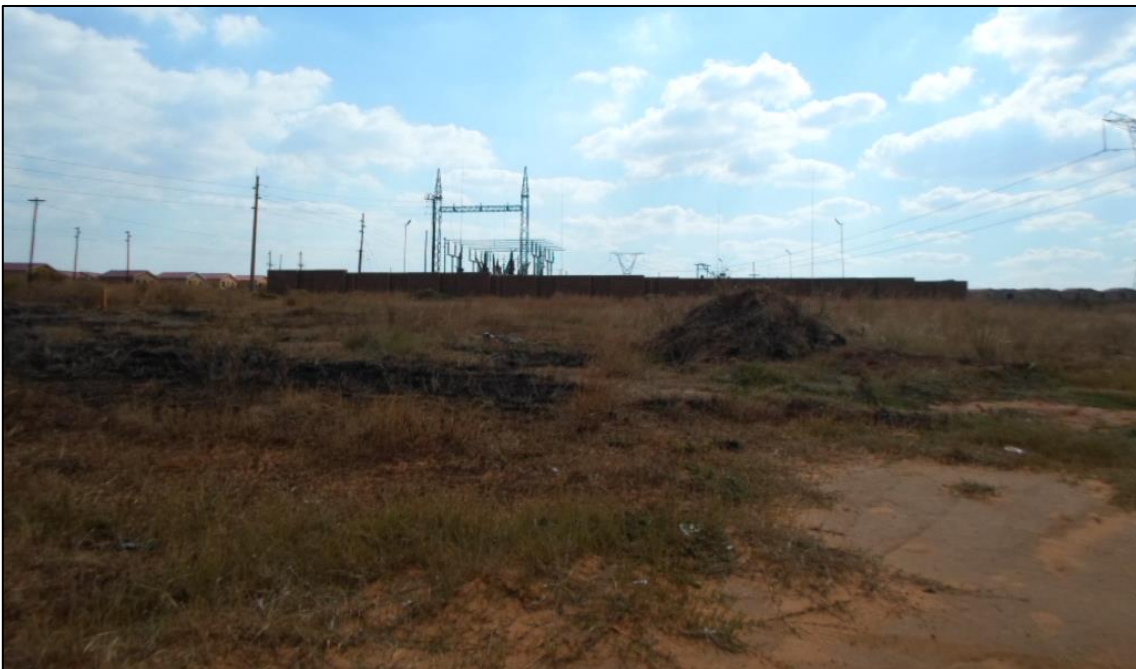
**Figure 11:** View towards the northwest towards the Siyanqoba Substation with the R544 being towards the left.

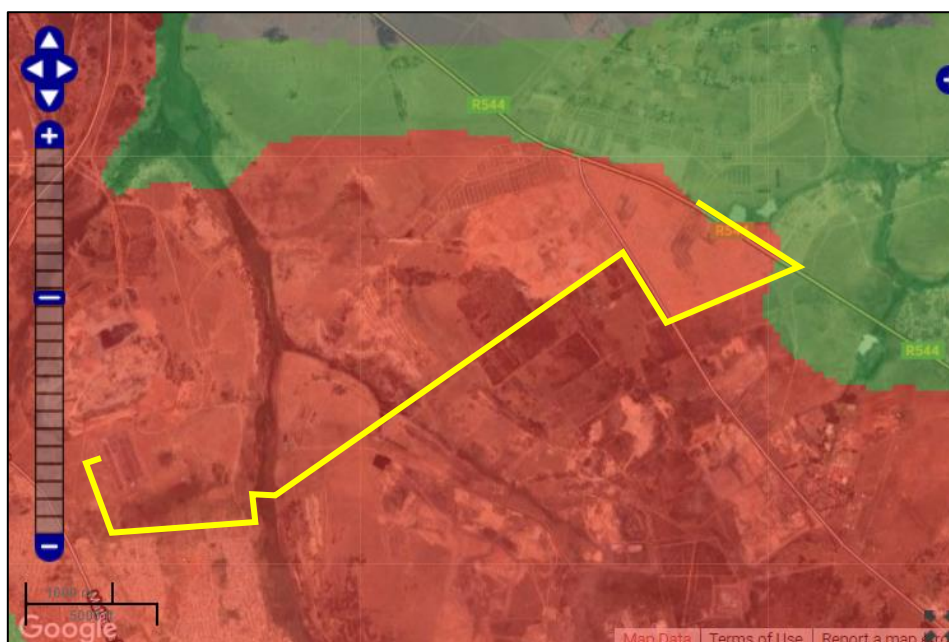
The SAHRIS Palaeosensitivity map shows the study area to be underlain by sediments of very high palaeontological sensitivity. However, because rock exposures were almost absent, Bamford (2021) has assessed the potential palaeontological impacts for this project from the desktop only. She found that the chances of significant fossils being impacted are very low.

**Figure 12:** Extract from the SAHRIS Palaeosensitivity map showing the study area (yellow line) to be largely of very high palaeontological sensitivity (red shading) but moderate (green shading) in the very far eastern part.

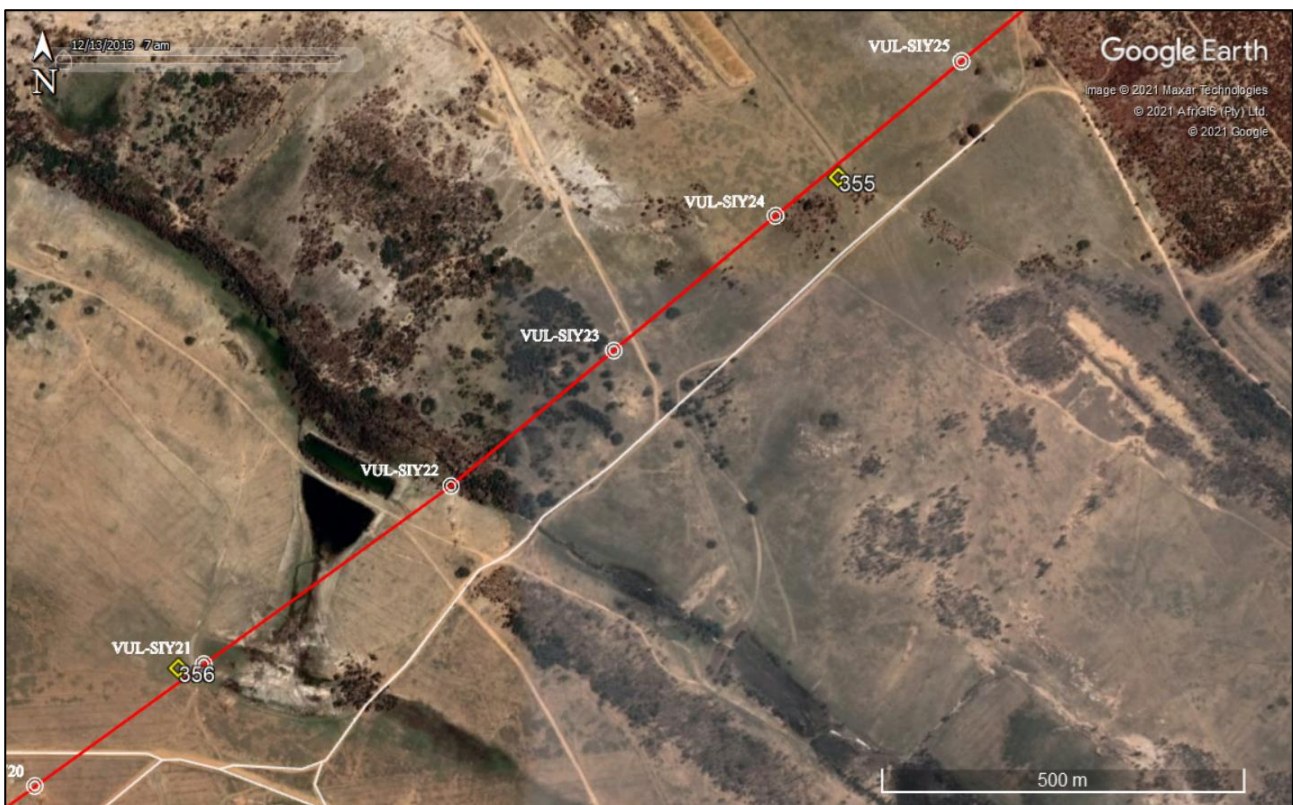
**Figure 13:** Aerial view of the central part of the study area showing the finds recorded during the survey (numbered yellow waypoints). The pylon positions are shown with white numbered symbols.

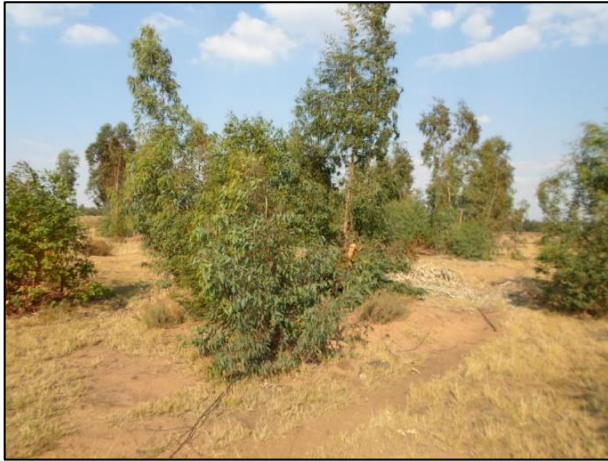
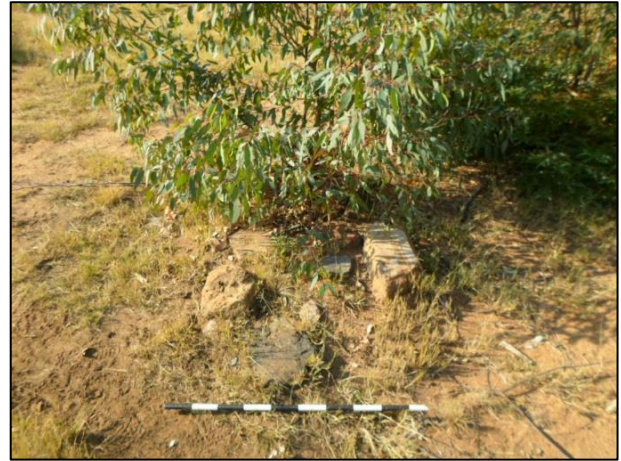
Waypoint	Location	Description	Significance	Grade
355	25° 49' 15.6684" S 29° 08' 43.1807" E	Stone cairn	Low unless proven to be a grave	GP C unless it is a grave then III A

**Figure 14:** General site conditions at Waypoint 355. **Figure 15:** Stone cairn at Waypoint 355.

- For precautionary reasons, the stone cairn at waypoint 355 must be identified on project maps and protected and avoided during construction;
- The powerline service road must avoid the waypoint 355 area, staying at least 10 m away from the cairn;
- Workers must be alerted to the possibility of uncovering fossils, archaeological materials (e.g. stone artefacts, pottery) or graves and instructed to stop work, protect any finds and report them to the heritage authorities. They may require inspection by an archaeologist. Such heritage is the property of the state and may require excavation and curation in an approved institution.

The location of the potential grave must be recorded and noted as a no-go area.

The environmental management program (EMPr) should note the possibility that the stone cairn at waypoint 355 might be a grave. The site should be mapped in the EMPr and noted as a no-go area for the duration of construction. If the service track associated with the power line avoids this location, then no impacts will occur during operation of the powerline. The EMPr should also note the possibility of encountering fossils, archaeological materials or human remains and include instructions on how to proceed in the event of such finds being made (see management measures

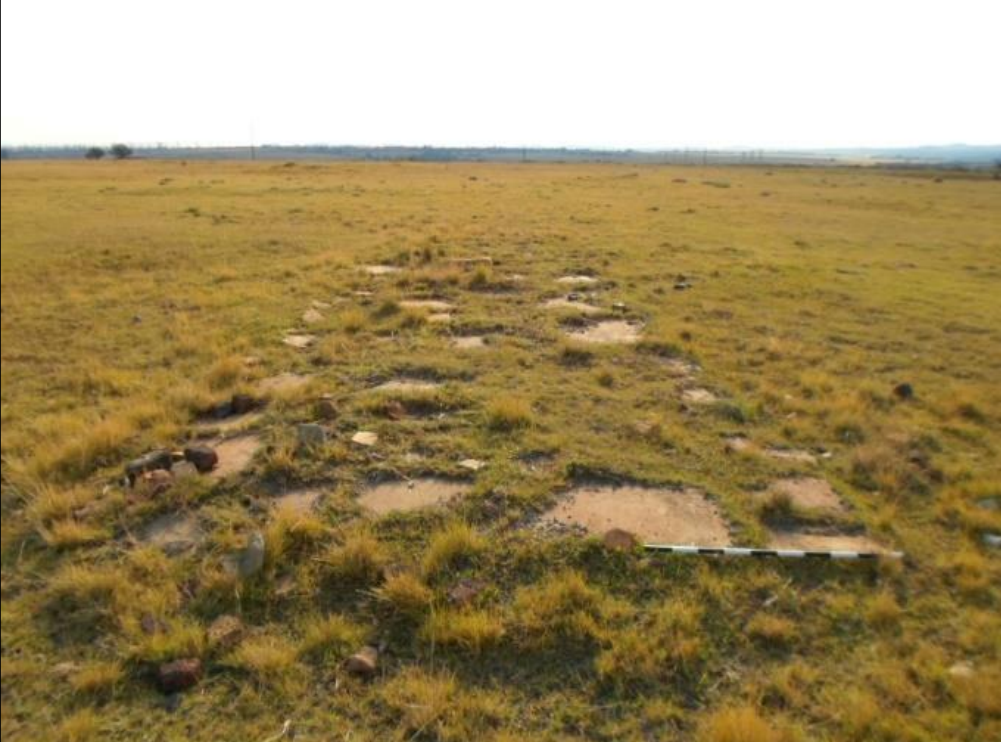
Waypoint	Location	Description	Significance	Grade
356	25° 49' 37.6429" S 29° 08' 10.2048" E	Cement slab	Low	GPC

**Figure 19:** View of the cement floor at waypoint 356.
