**SMERO/CALUZA HUMAN SETTLEMENT PROJECT,
UMSUNDUZI LOCAL MUNICIPALITY, KWAZULU-
NATAL**

Phase 1 Heritage Impact Assessment

March 2022

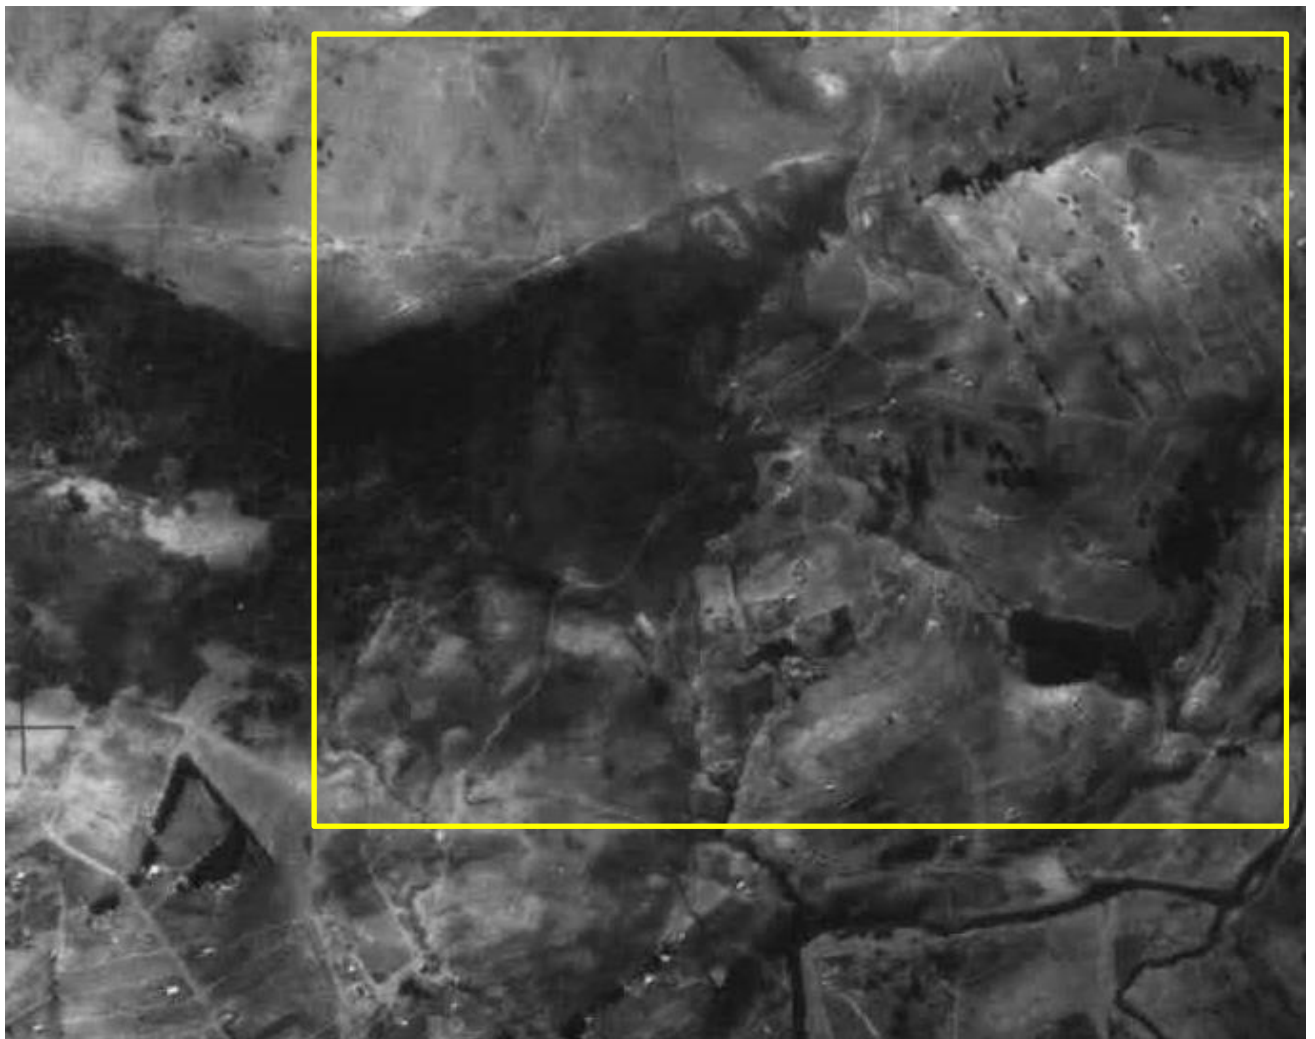
The 1937 aerial photograph of the project area and surrounds shows several homesteads in the north-eastern and eastern sides of the project area with evidence of cultivation whilst the area below the cliff and forest is largely undeveloped and uninhabited with a footpath running through it. The 1944 aerial image is very similar.

Figure 3: 1937 aerial image with project site outlined in yellow

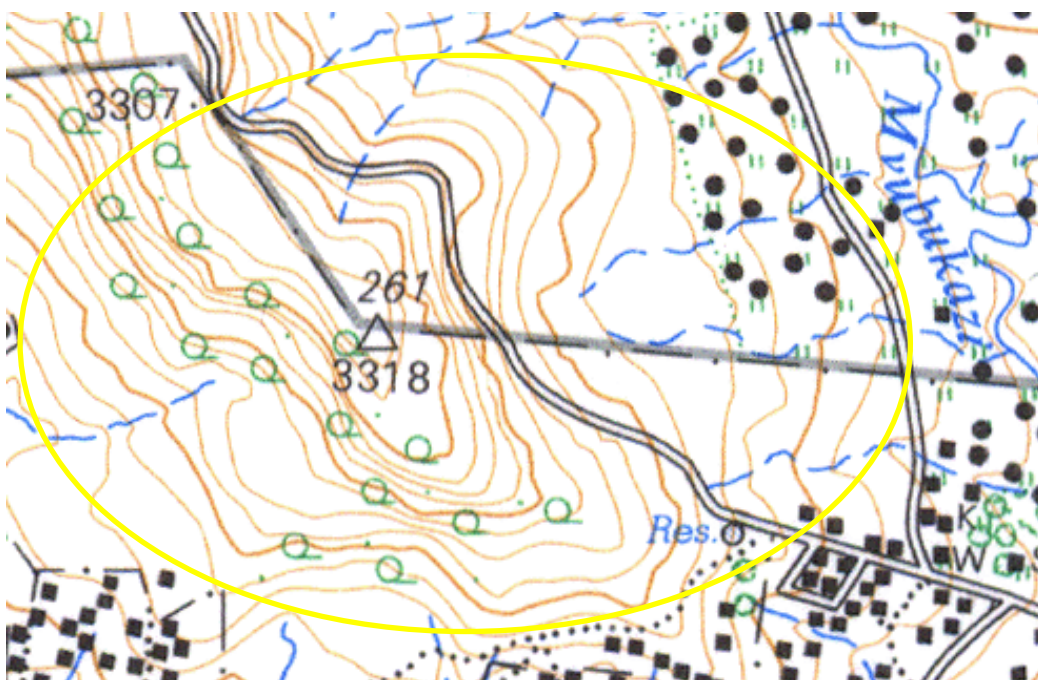
The 1968 topographic map (2930CB) shows the project area with more residences to the east and south of the project area with cultivated land amongst the dwellings and trees and bushes in the valley area below the cliff.

Figure 4: Section of topographic map with project area outlined in yellow

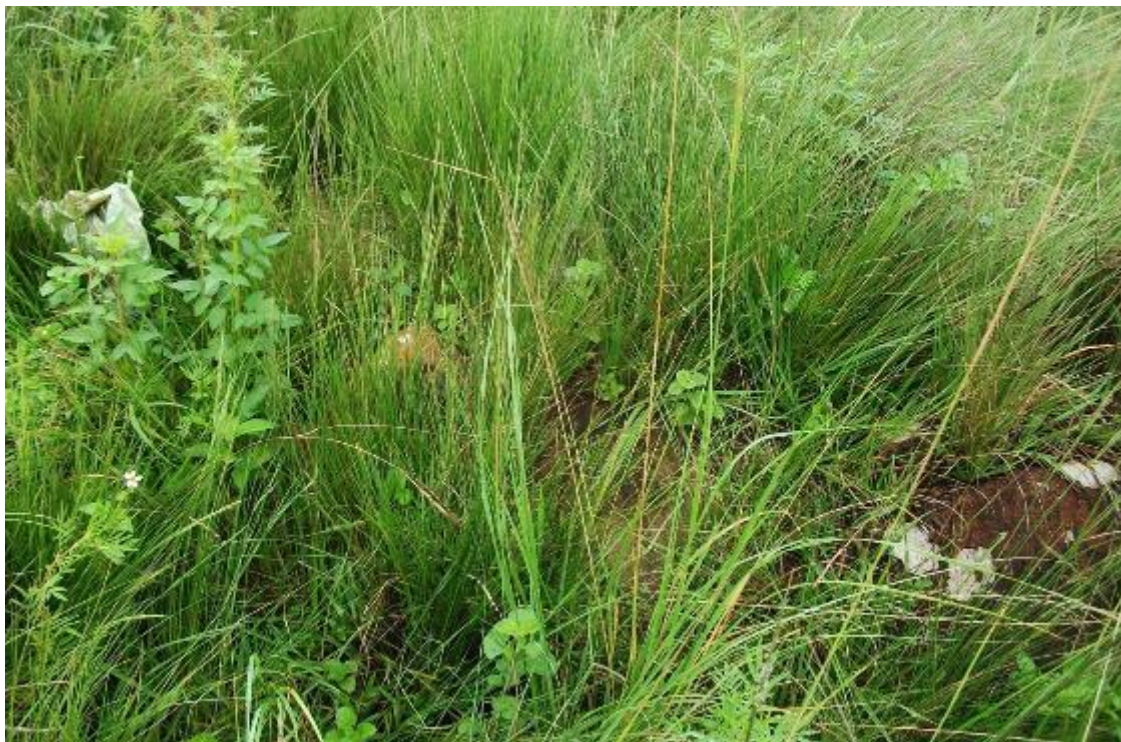
Residents told the specialist that there were old graves in the area in the vicinity of the northern-eastern boundary of the study area but that new people moving into the area were building over the graves as they were unaware of the graves' existence. Some of the remaining old graves were pointed out to the specialist by Philane Ngubane, a resident of the area. The area is overgrown with several rocks visible that were used at the time to mark the graves.

Figure 6: Old grave indicated by rocks

| COORDINATES | HERITAGE RESOURCE | SIGNIFICANCE + MITIGATION MEASURES |
|---|---|--|
| 29°38'04.2" S 30°17'51.5" E | Grave (Fig. 6) | High heritage significance; 20m buffer between grave & construction activity; recommended that burial site is fenced as a 'no-go' area |

| Nature: Alteration, damage, destruction of graves | | |
|---|---|---|
| Mitigation measures <ul style="list-style-type: none"> • Area where graves pointed out must be a 'no-go' area where no development activities take place. • This area must be clearly demarcated with fencing. No work within 5 m of the fencing can take place. • If grave/s are damaged during construction, then work must stop in the immediate vicinity and the grave must be rehabilitated to its previous condition. If the grave/s is >60 years, then the Institute must be informed and the necessary permits obtained from the Institute for the repair to the grave/s. • If it is decided that grave/s are to be moved, then the procedure stipulated in section 5 of the Draft KwaZulu-Natal & Research Institute Regulations, 2021 must be followed. The section refers to the application process to be undertaken for the damage, alteration, exhumation or removal from its original position or any other disturbance of a grave in a traditional burial place or not located in a formal cemetery | | |

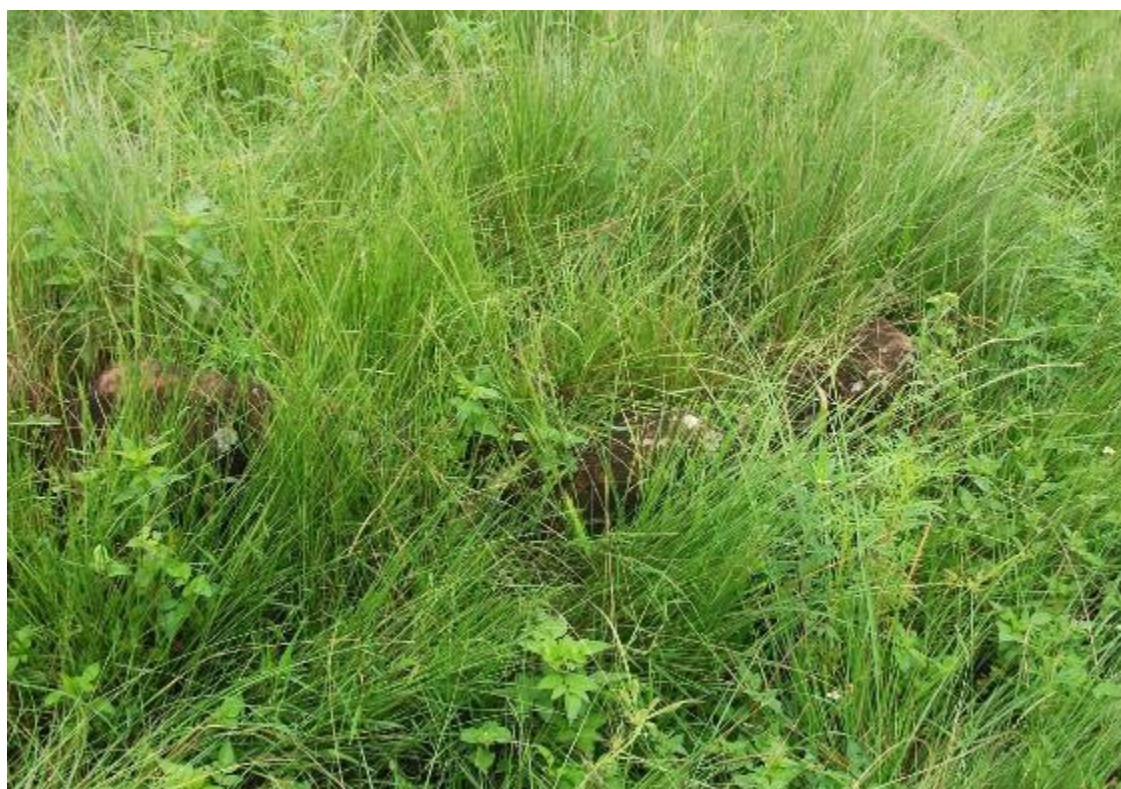
Figure 7: Grave indicated by rocks

| COORDINATES | HERITAGE RESOURCE | SIGNIFICANCE + MITIGATION MEASURES |
|---|---|--|
| 29°38'03.8" S 30°17'51.5" E | Grave (Fig. 7) | High heritage significance; 20m buffer between grave & construction activity; recommended that burial site is fenced as a 'no-go' area |

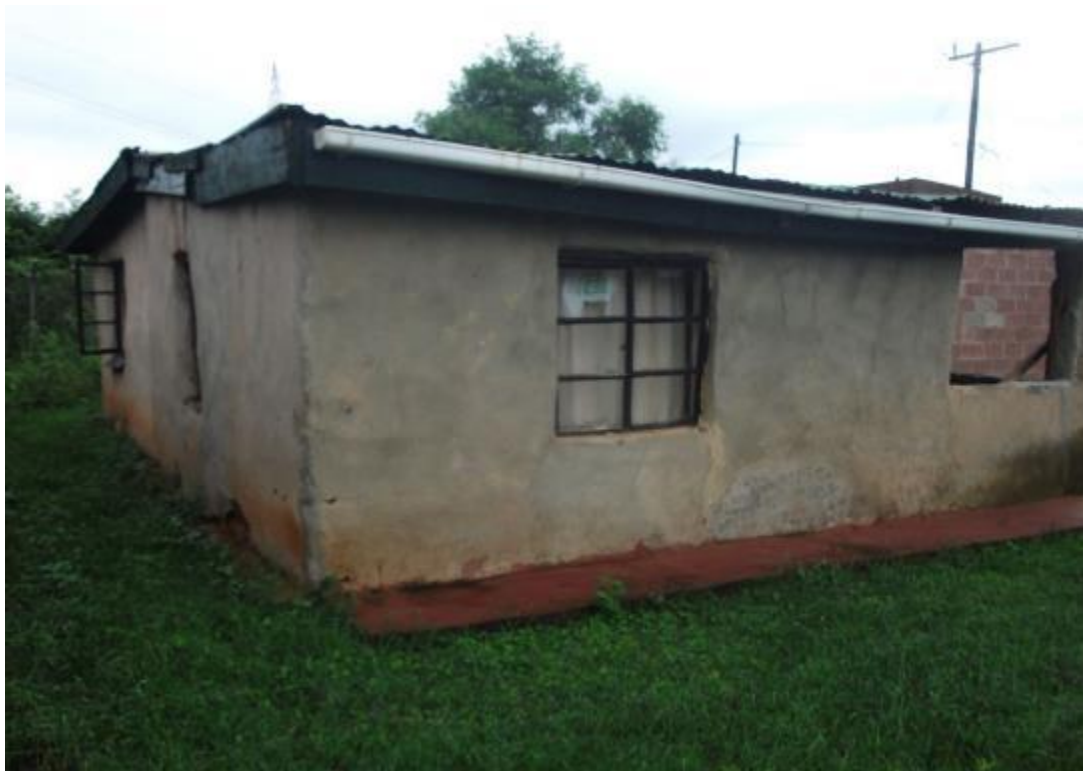
Amongst the existing residences, several structures were observed that could be older than 60 years.

Figure 9: Structure that could be >60 years

| <u>Mitigation measures</u> <ul style="list-style-type: none"> • <i>Prior to the alteration or destruction of any structures that could potentially be >60 years, a built heritage specialist must assess the structure to confirm it's age.</i> • <i>If the structure is >60 years and if it is possible, it should be left intact. However, if this is not possible, then written application must be made to the Institute according to the procedure stipulated in section 3 of the Draft KwaZulu-Natal & Research Institute Regulations, 2021.</i> • <i>If a protected structure is damaged accidentally, then all work must stop in the immediate vicinity of the damage structure, the Institute informed and a qualified specialist appointed to repair the building once all necessary permits have been obtained from the Institute</i> | | |

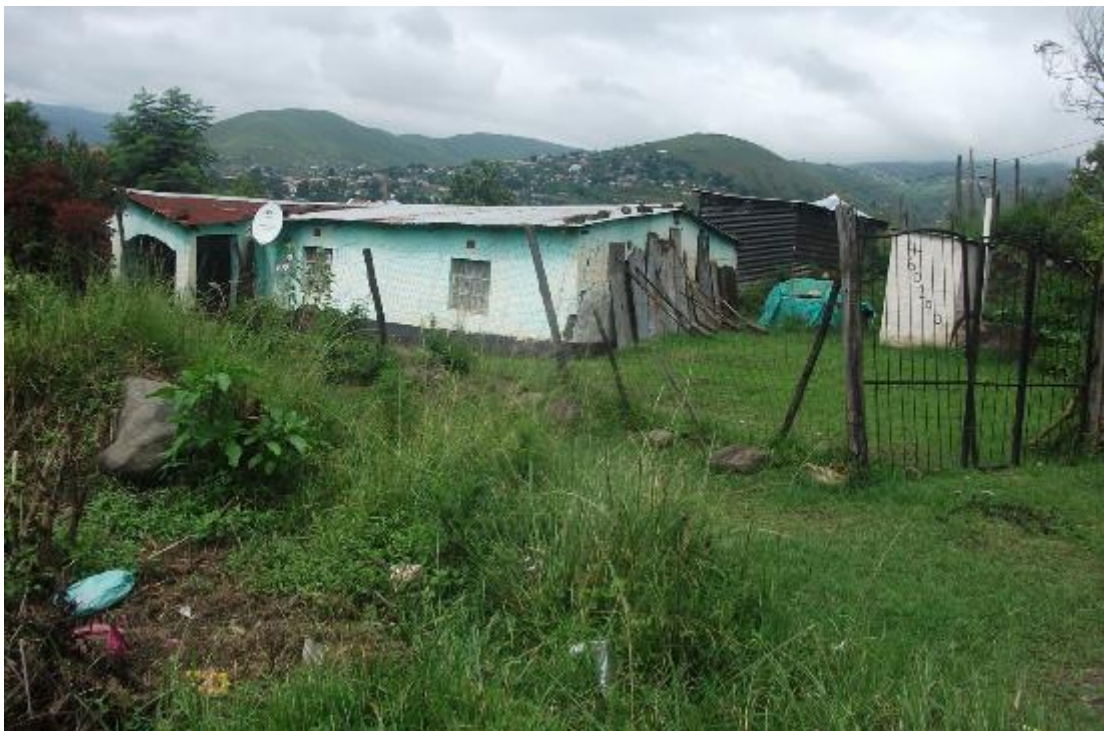
Figure 11: Dwelling possibly >60 years

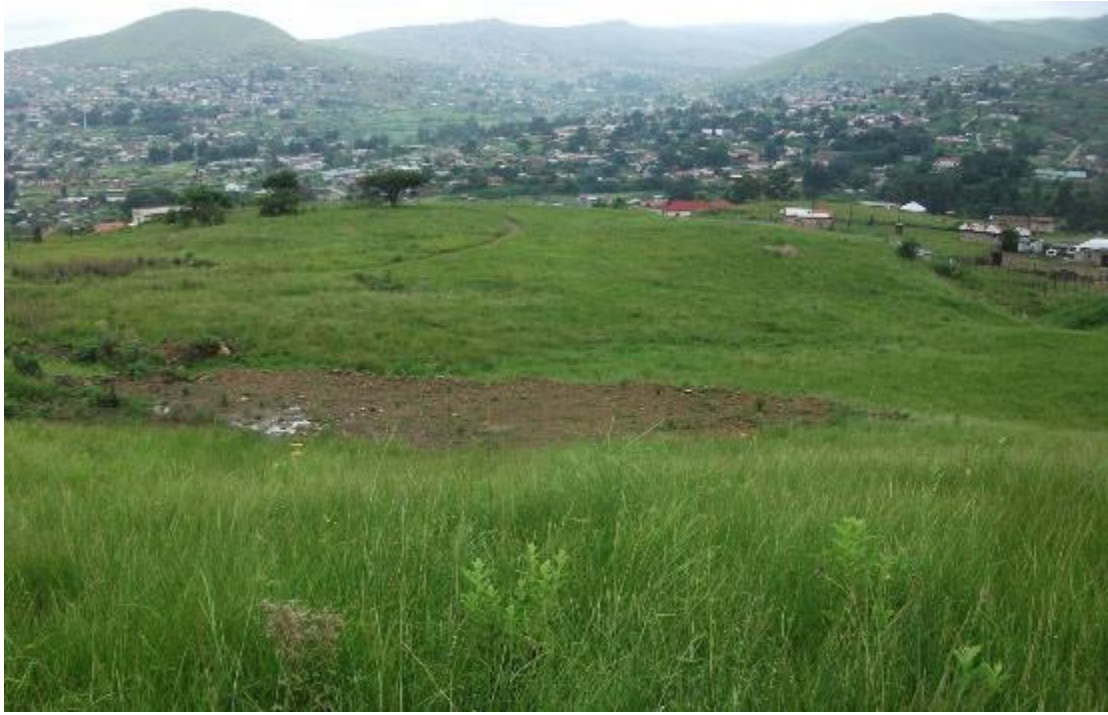
Figure 14: Area cleared for dwelling looking southwards across project area

the Mountain Rise cemetery. In addition, there is a cemetery located between the Msundusi River and Wadley Stadium on the southern boundary of the project area. At least one small area in this section of the project area had been cleared for the construction of a dwelling.
