Report on Research Excavation of the Stables Building at Solms Delta Farm, Groot Drakenstein, Western Cape

Conducted as Component of Masters of Philosophy (Archaeology)

Executive Summary

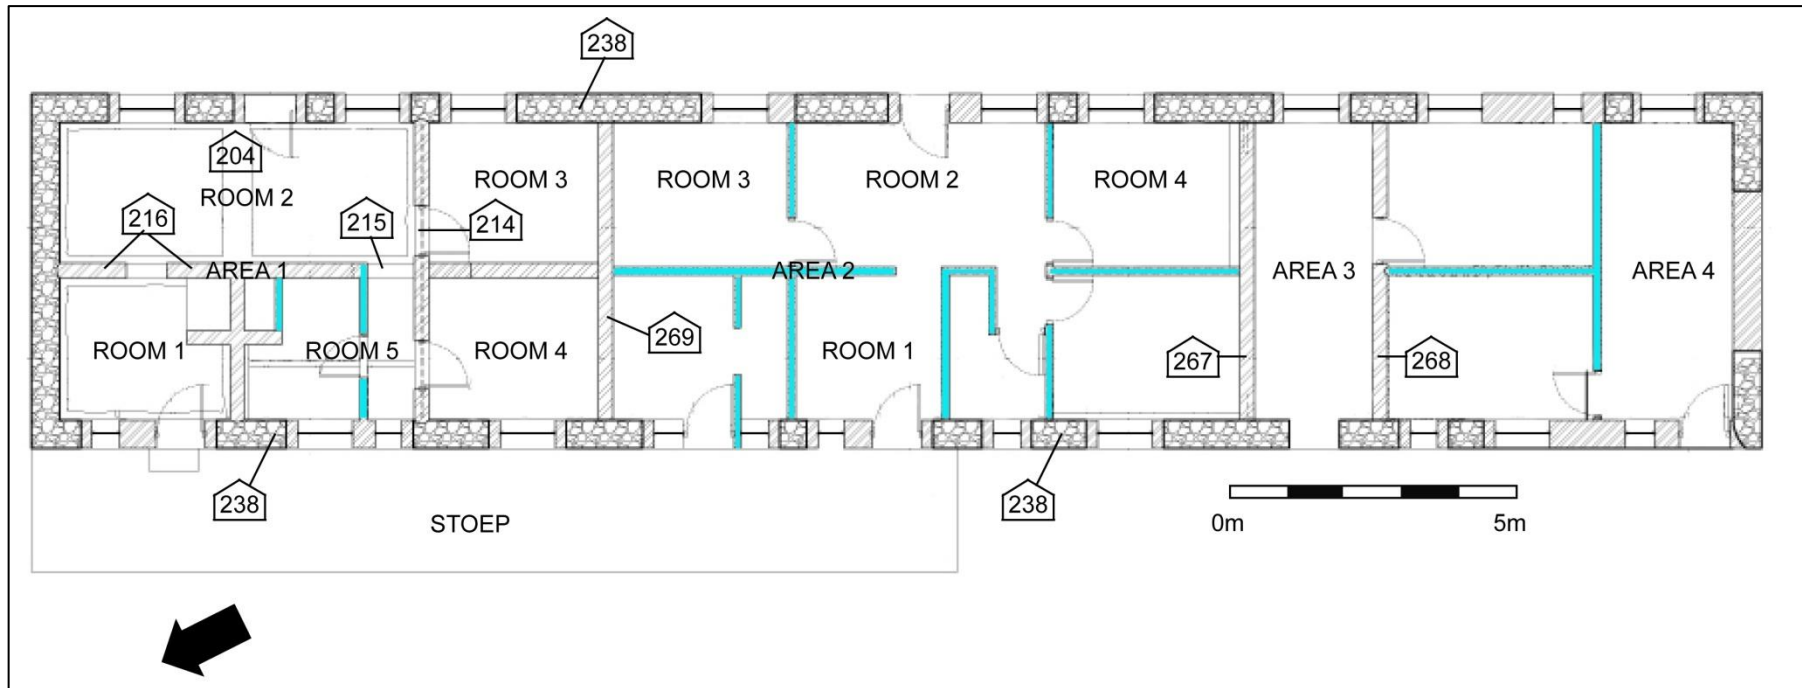
Figure 3: Plan of layout of Delta stable building prior to excavation. New walls indicated in blue. (Adapted from plans provided by Thorold Architects)

Although the stables building is aligned northeast-southwest, for simplicity, its alignment is described as north-south below; the true position of north is indicated on all plans.

Before excavation commenced, the plaster was stripped from all internal walls and the upper concrete flooring (200) was removed. The plaster stripping allowed us to determine which of the walls related to the conversion into workers' accommodation and which were original. There were three east-west original internal walls, dividing the building into four rooms (Figure 3). These four rooms were labelled Areas 1 to 4, from north to south, with the rooms created by original and modern dividing walls designated as numbered rooms within each Area. The northernmost room (Area 1) was divided into two three-roomed apartments. The central room (Area 2) was accessed through a doorway in the west façade and was a large open space. South of this was a narrow room (Area 3), also with access through a door in the western façade. The southernmost room (Area 4) was cobbled and had a large double doorway in the south gable wall that had subsequently been bricked up.

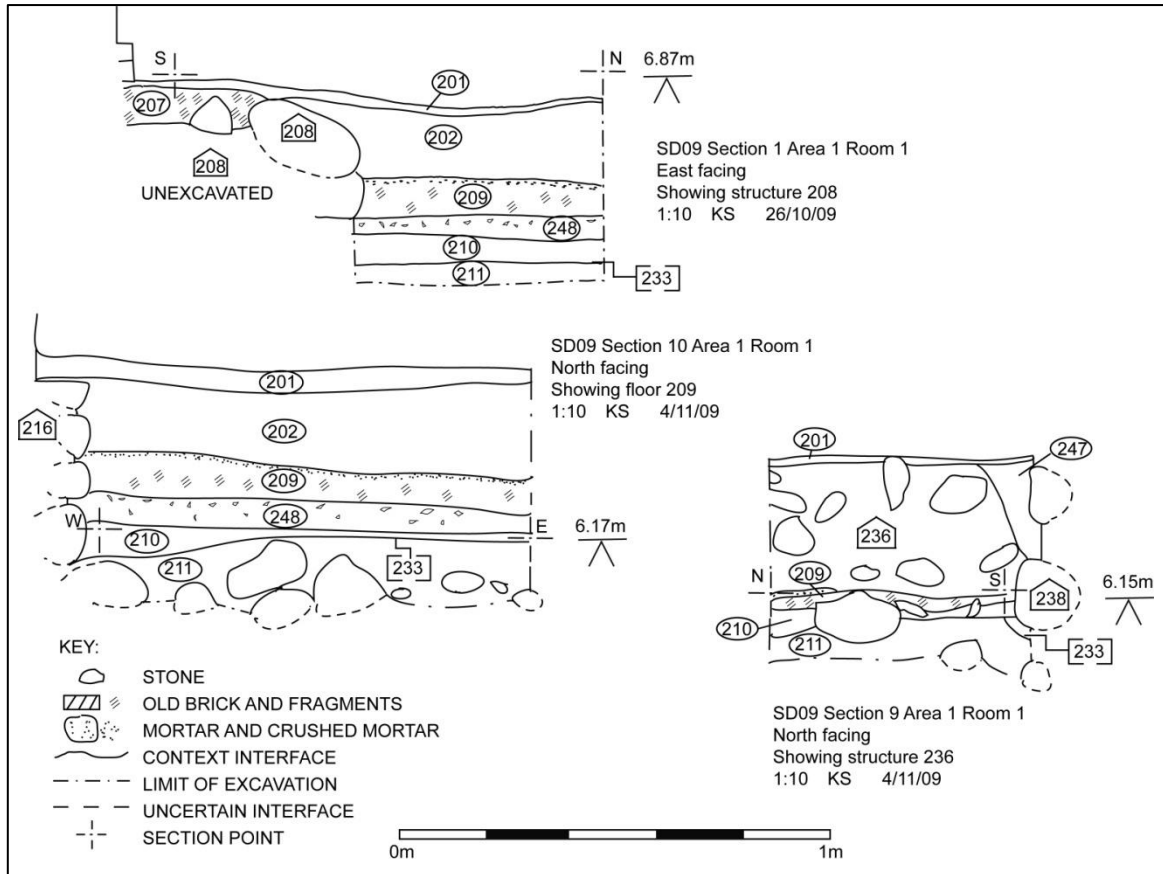
Figure 5: Sections through Room 1 deposits

Between cobbled layer 236 and the threshold of Room 1 (238), the cobbles had either been removed, or simply sloped away from the laid stones of the threshold. This lacuna had filled with a mottled silty material (247). The cobbles were laid above the floor surface (209) seen elsewhere in the room. Below this floor was levelling layer 210, which overlay the white sand and cobble substrate (211). The cut (233) for the foundation of the threshold (238) was visible in section, and had been cut from below levelling layer (210) and through natural layer 211. This cut (233) also truncated the topsoil in this area of site.

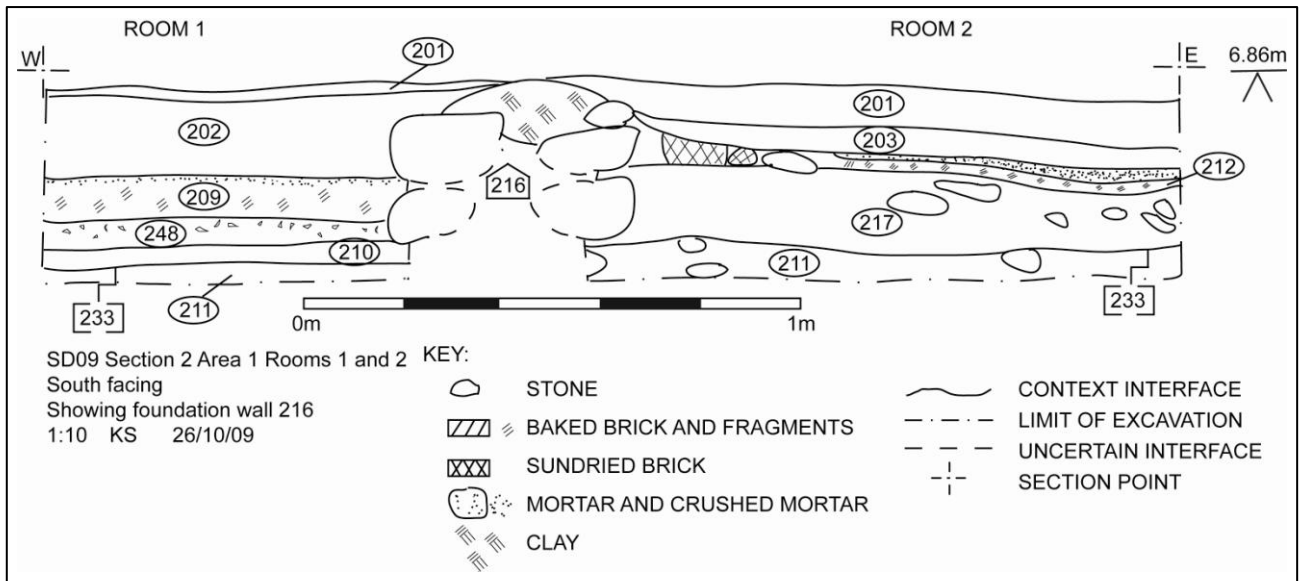
Figure 7: South facing section across threshold 216 showing floors 209 and 212

In Room 2, the yellow sandy bedding layer (201) was encountered again below the concrete floor (200) (Figure 7). Below this deposit, to the north of wall 204, was a dark silt layer (203) with a high concentration of organic materials –twigs, acorns and pine needles as in Room 1. South of wall (204) this deposit was numbered 205. In Room 2, these deposits contained several short wooden beams. The deposits, both north and south of wall (204), cleaned off onto an orange and white compacted gritty sand floor surface which was similar to 209, and was labelled (212) and (206) respectively. In section it appeared that the mortar component might have served as a repair to the crushed brick floor. Below the floor, a second dark silty layer (217) was encountered. This levelling layer (217) was the fill of cut 233 that truncated the topsoil layer and exposed the underlying natural river cobble stratum (211).

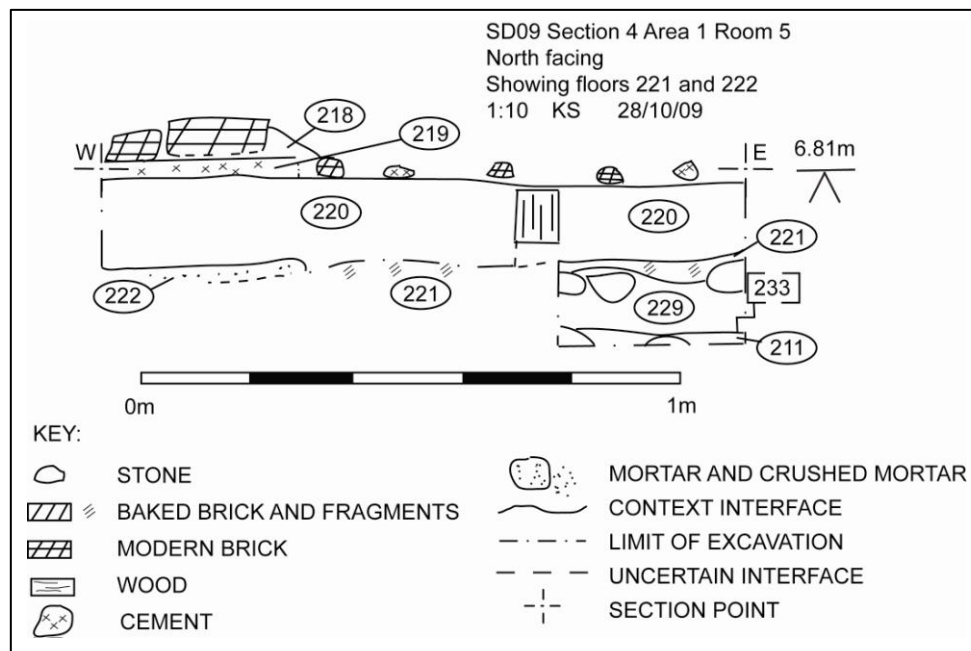
Figure 9: North facing section showing floor 221 with mortar repair 222

Room 5 had clearly had a wooden floor before the concrete flooring was laid. This was evident in the north of the room against the wall where a wooden joist and partial floorboard survived against the northern wall of the room (Figures 8 and 9). Concrete floor 200 had been laid over deposit of collapsed, high fired modern bricks (218) which had accumulated above a cement floor (219). This had been badly truncated both in Room 5 and the passageway, and it was not possible to determine its full extent in plan. Below this floor (219), was a layer of humic silt (220) with the organic debris component seen elsewhere in the Area. Within this deposit was a 2.80m long wooden beam that extended from 0.16m

south of the north wall of Room 5 and into the passage between Rooms 5 and 4. Below 220 was the floor surface (222) evident elsewhere. Here in Room 5, it seemed most apparent that the white mortar component of the floor had been a later repair to the original crushed brick surface, and here the mortar was given an individual context number (221). The floor (221/222) was laid on a levelling deposit of brown silt (229), which itself overlay the white sand and cobble matrix of the natural substrate (211). Again cut 233 served as the interface between these contexts. It is worth noting that in Room 5 there was no equivalent deposit to the cobbles found either north (208) or west (236) of the fireplace in Room 1, indicating that these two deposits were not foundations for the fireplace.

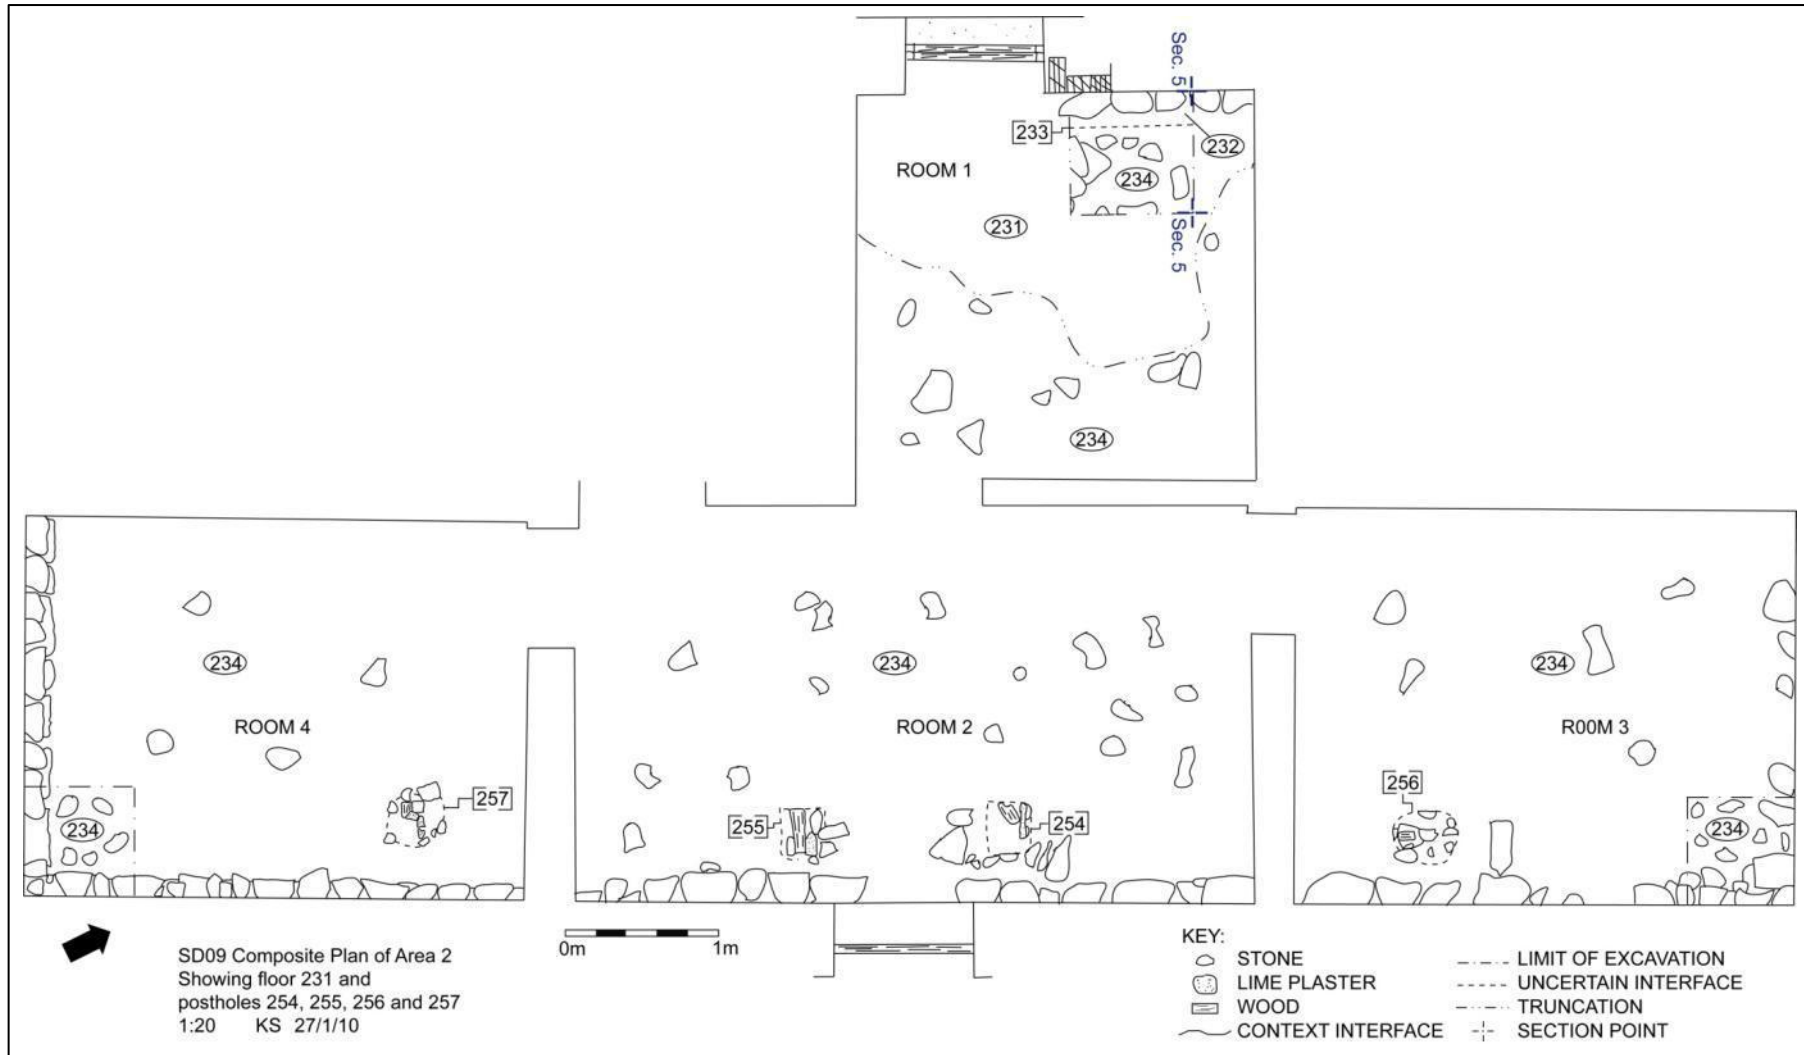
Figure 10: Composite plan of Area 2 showing floor 231 and post-holes 254, 255, 256 and 257.

Area 2 was the largest of the areas excavated, and had been divided into smaller spaces by modern apartment walls. There was no evidence for original internal divisions, making this space 11m long. The first two trenches were excavated in the northeast and southeast corners of the area, in Rooms 3 and 4 respectively (Figure 10). Neither of these trenches revealed any anthropogenic deposits, and the upper deposit beneath concrete floor 200 was the white sand and cobble natural substrate 234. Investigation of natural deposit 234 in Rooms 2, 3 and 4 did, however, reveal a series of features in the form of ephemeral post-holes (256, 254, 255 and 257 from north to south) against the eastern north-south wall. Three of the post-holes (254, 255 and 257) had chunks of mortared stone with evidence of fire blackening, while all four had traces of degraded wood in the base of the hole. These inclusions (270, 271, 272 and 273, respectively) would have served as post packing. Each hole measured between 0.20m and 0.40m in diameter and all were regularly spaced: 254 and 255 each 1.40m apart, with 256 and 257 each 2.20m beyond them to the north and south respectively. While the holes were barely recognisable as individual features, their shared characteristics as well as their uniform size, positioning and fill indicated that they were indeed anthropogenic.

In Area 2, the only apparent Phase I floor was a compacted clay surface 231 that was laid directly over the geological deposits (234) and this surface only partially survived in Room 1 (Figure 10). Other Phase I features in this area included four post-holes (256, 254, 255 and 257), forming an evenly spaced line some 0.20m from the eastern wall of the building. The fabric of the north and south end walls of Area 2 (269 and 267, respectively) retained the impressions of recesses in the brickwork at their eastern ends. These were interpreted as being related to the post-holes and were possibly vestigial traces of a feeding trough or tethering post that had run the length of the eastern wall.

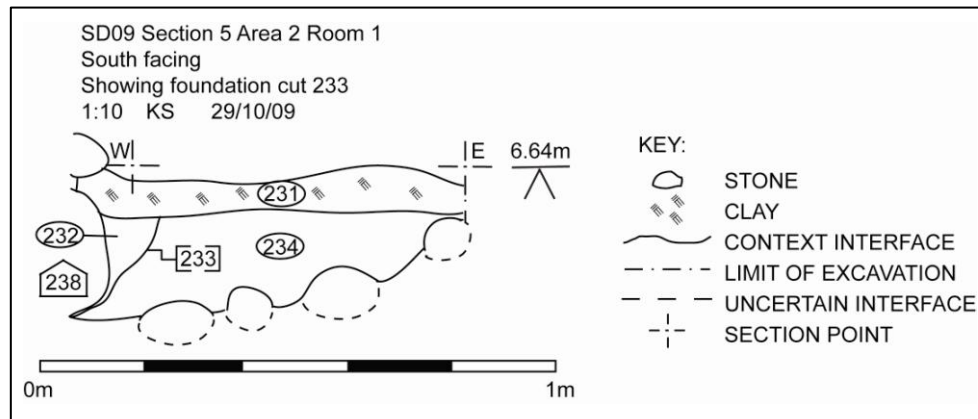
Figure 11: South facing section showing foundation trench 233

A third trench was opened in Room 1 of Area 2 where the deposit was clearly higher than elsewhere in this Area (Figure 11). The upper deposit of loose, grey sand (230) that had constituted the bedding layer for concrete floor 200 overlay a yellow brown clay floor (231) that had failed across much of the room, but was still present in parts. This floor surface was laid directly above the natural substrate (234). The floor also capped the mid-brown silty sand backfill (232) of foundation trench 233 of the western wall of the building.

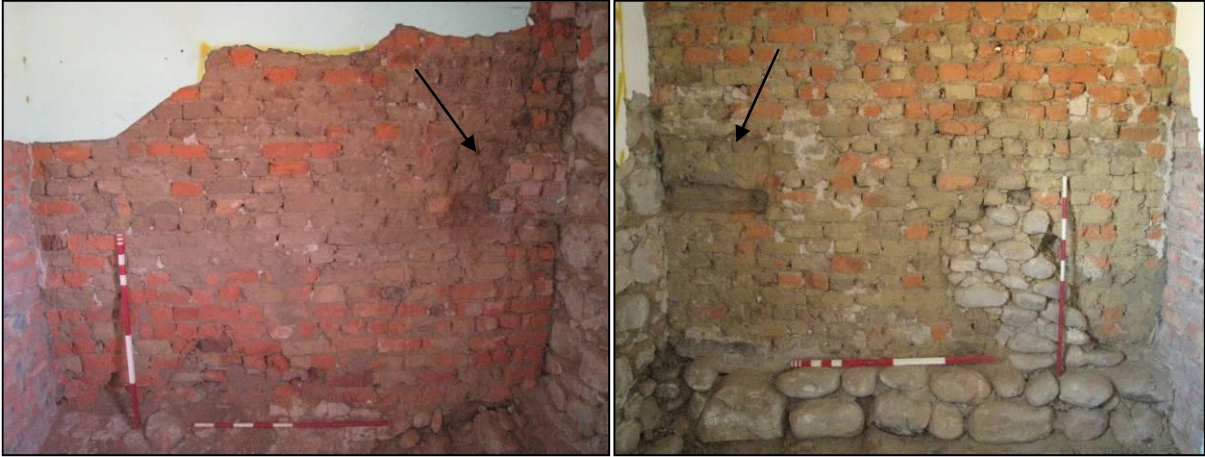
Figure 12: Recess in brickwork of wall 269, Area 2, view to north

Figure 13: Recess in brickwork of wall 267 and anomalous stone infill, Area 2, view to south

Further features were visible in the elevations of the north and south end walls of this Area (267 and 269 respectively). In both end walls, against the eastern north-south wall of the building were two recesses in the brick work (Figures 12 and 13). The hole in 269 had been filled in with modern brick, while the one in 267 had been left open. While the two holes were not of equal size, their position on the wall was clearly in alignment with each other and they probably relate to a feature that had been built into them and removed at a later date. Another interesting feature of wall 267 was the materials with which it was constructed. While, as stated, all the internal walls in the building were built of brick, this wall showed a portion constructed in stone. It was not possible to deduce whether this was the remnants of an earlier stone built wall that had been repaired in brick, or whether the stone itself represents the repair. As unlikely as it seems from appearances, it is probable that the stone is indeed a repair to the brick work as there is no other evidence for surviving stone work in this wall or any of the other internal ones.

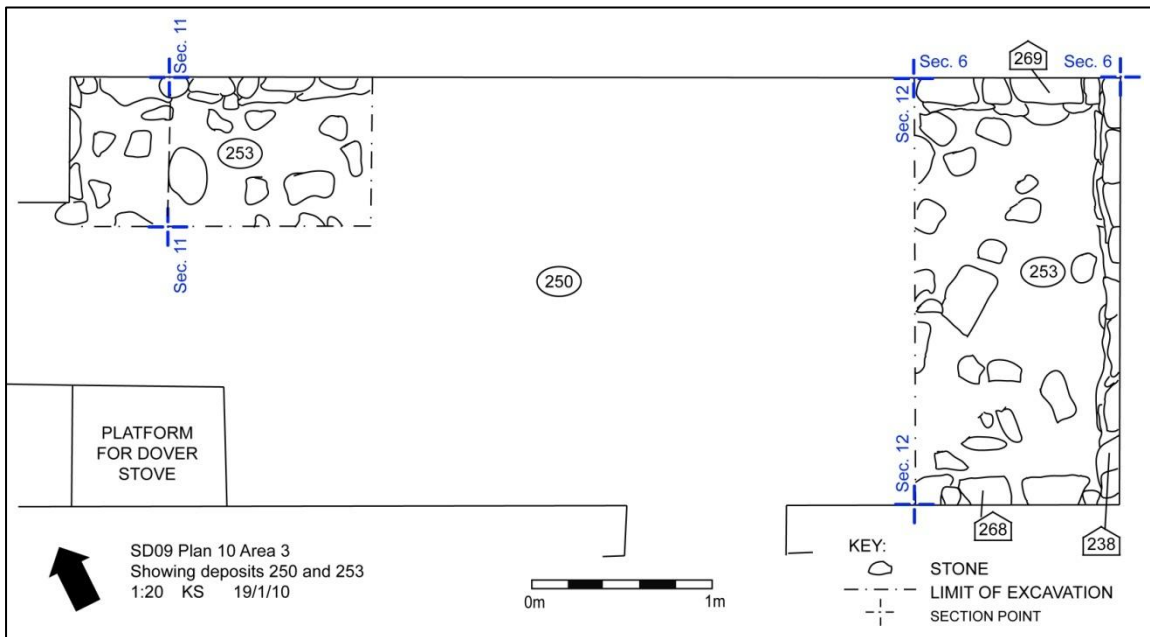
Figure 14: Plan of Area 3. Location of sections indicated in blue.

Area three was a narrow room only 2.10m wide. Two trenches were opened in this Area, one spanning the room's width at its eastern end and measuring 1m east-west, the other in the northwest corner of the room, measuring 1.60m east-west by 0.70m north-south (Figure 14). In Area 3, removal of the upper concrete (200) again revealed a bedding layer (250). This layer (250) overlay a crushed brick floor surface (251), which was laid on a bedding layer (252) (Figure 15). This was laid directly onto the natural substrate (253).

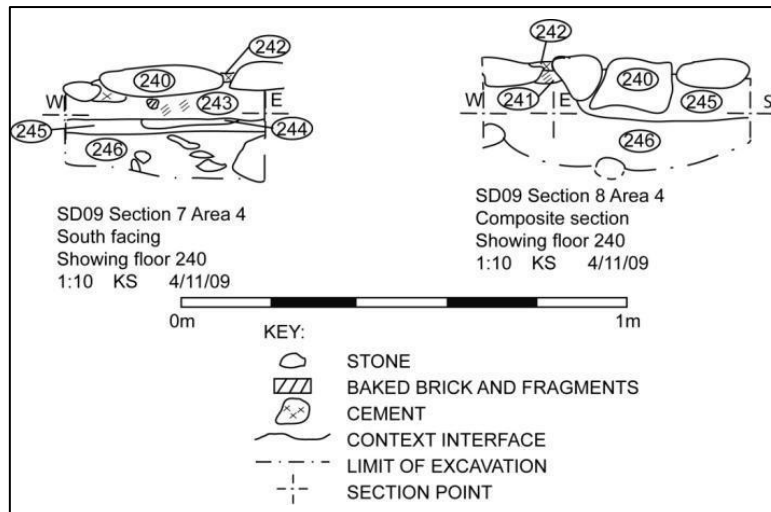
Figure 17: Sections through deposits in Area 4.

In Area 4, the upper concrete 200 cleaned off onto a cobbled surface (240) (Figure 17, Sect. 8). Although there were two rooms in this Area, only Room 1 was investigated. The two trenches opened were irregularly shaped, respecting the positioning of individual cobbles in order to disturb as little of the floor surface as possible (Figure 16). The cobbles were packed in with crushed brick (241) and laid on a dark matrix (243) that had the appearance of animal dung, rather than a dirt floor (Figure 17, Sect. 7). The cobble floor 240 had been repaired in patches with cement (242). Below bedding layer 243 for the cobbles (240) was a compacted yellow sand layer (244) that was above a second compacted layer of pale sand with dark silt flecks (245). This layer was the final layer above the natural substrate 246.

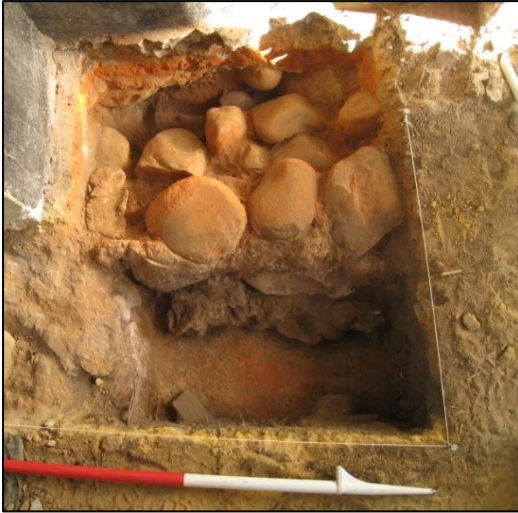
Figure 19: Structure 208 north of fireplace Area1Rm1; view to south (left)

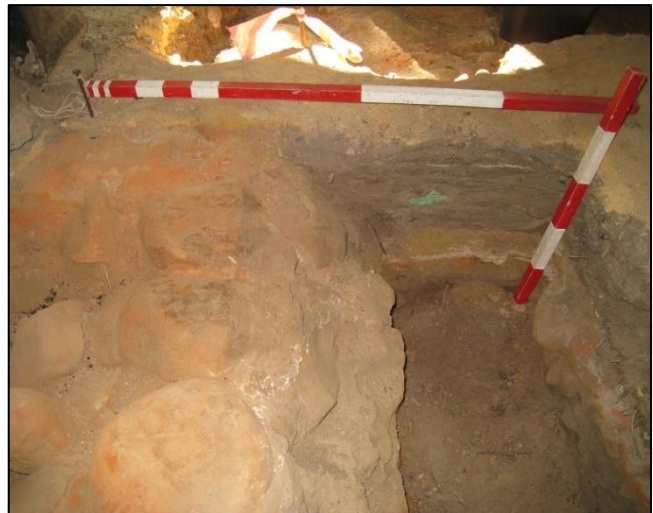
Figure 20: West facing section 1 showing floor 209 Area1Rm1; view to west (right)

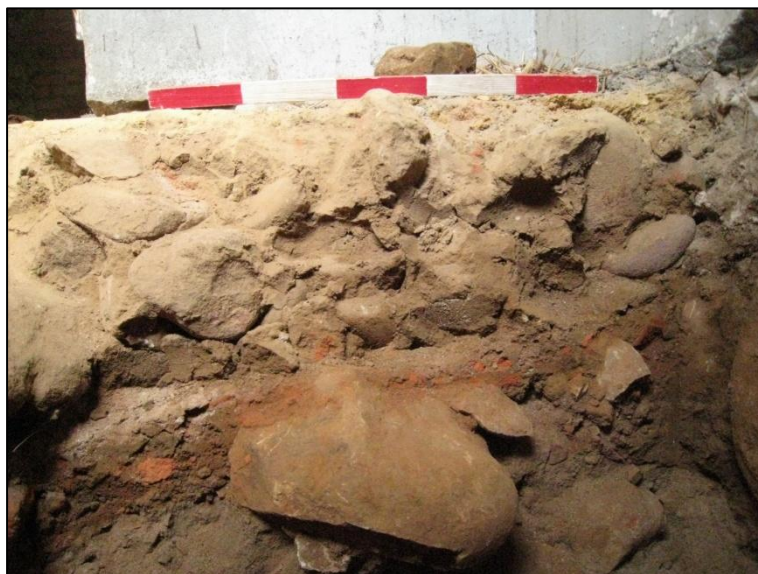
Figure 21: North facing Section 9 showing structure 236 Area1Rm1; view to south

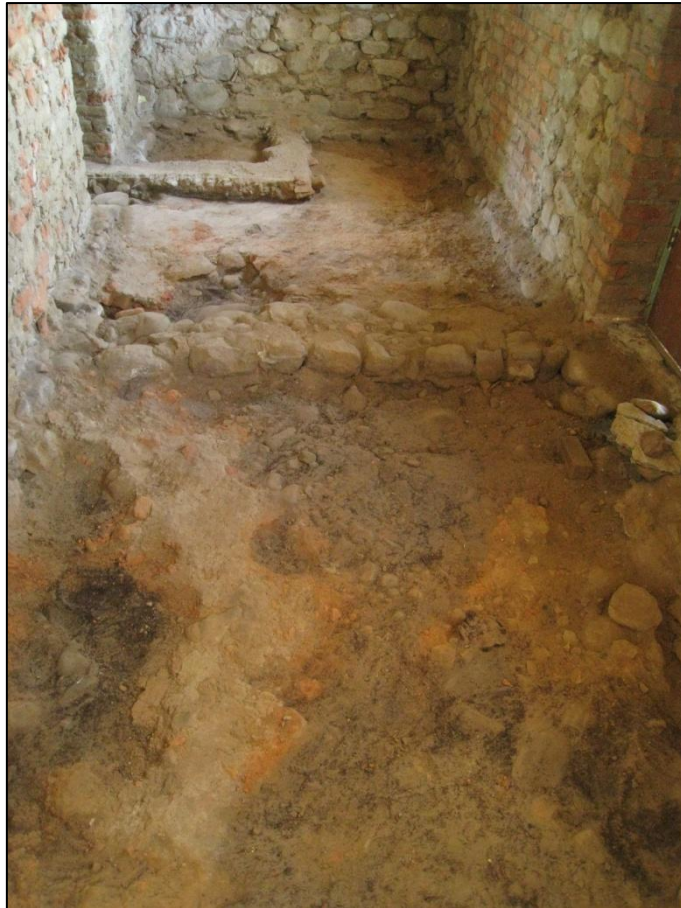
Figure 22: Wall 204 Area1Rm2, view to north

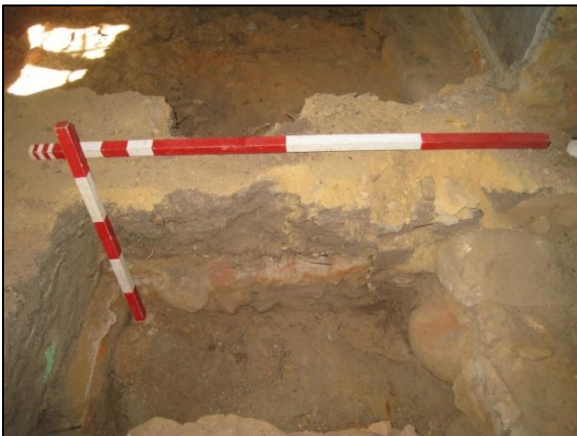
Figure 23: South facing Section 2 showing floor 209 Area1Rm1; view to north (left)

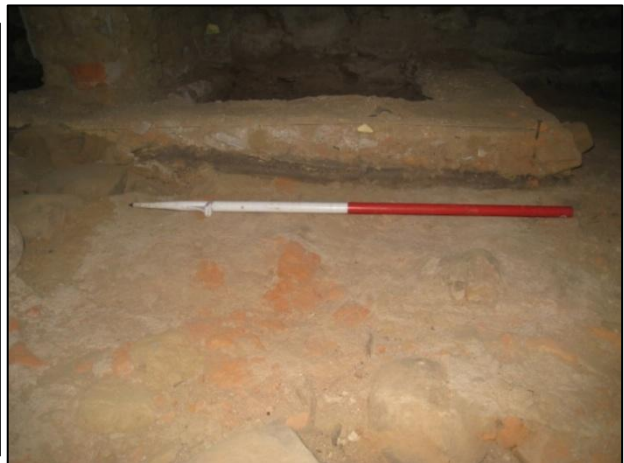
Figure 24: South facing Section 2 showing floor 212 Area1Rm2; view to north (right)

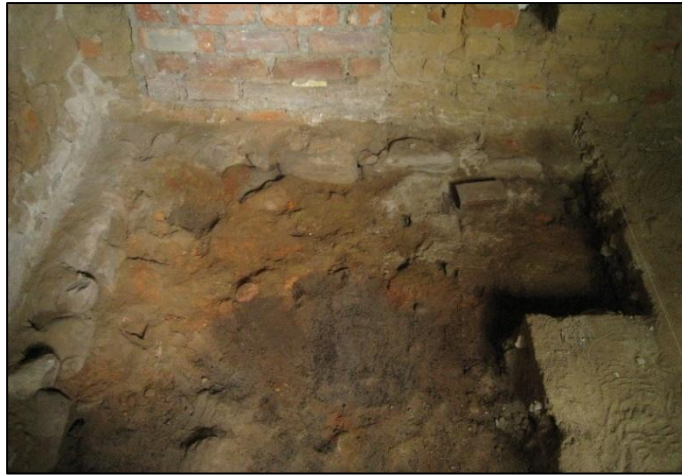
Figure 25: Trench showing floor 224 Area1Rm4; view to east

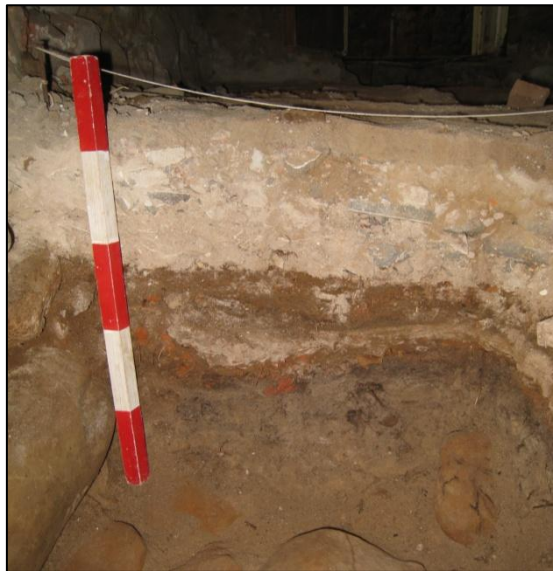
Figure 26: Deposit 235, floor 224 and red brown sand 225 Area1Rm4; view to north

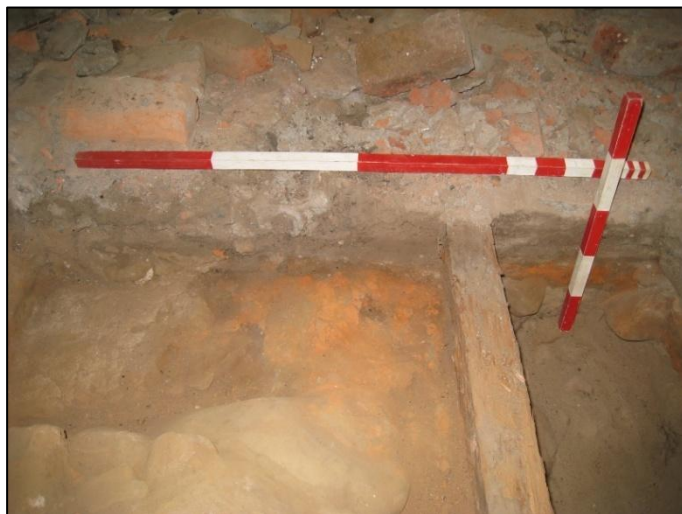
Figure 27: North facing Section 4 showing floor 222/221 Area1Rm5; view to south

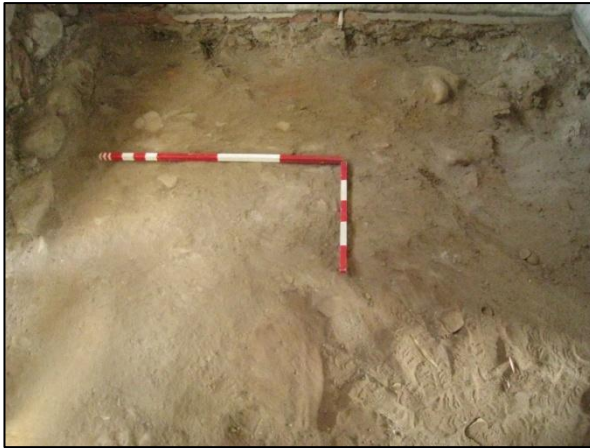
Figure 28: Plan view of remnant floor 231 Area2Rm1; view to north

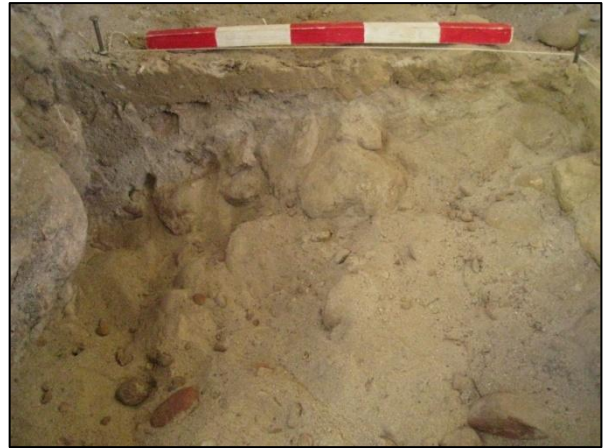
Figure 29: South facing Section 5 showing floor 231 and foundation cut 233 Area2Rm1; view to north

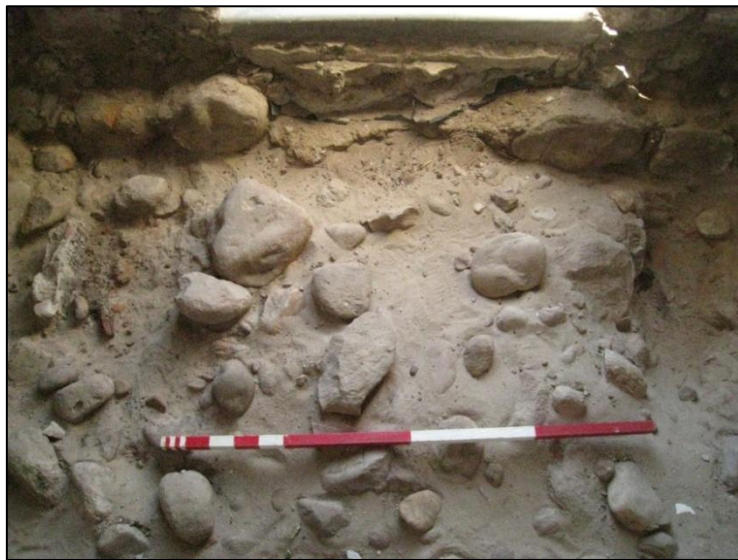
Figure 30: Post-holes 254 and 255 Area2Rm2; view to east

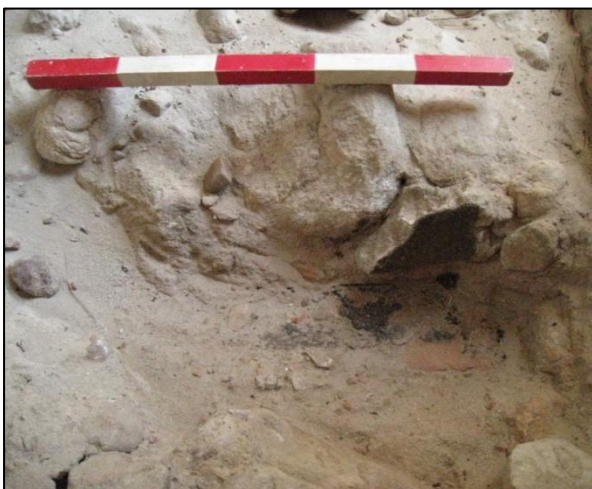
Figure 31: Detail of Post-hole 255 Area2Rm2; view to north

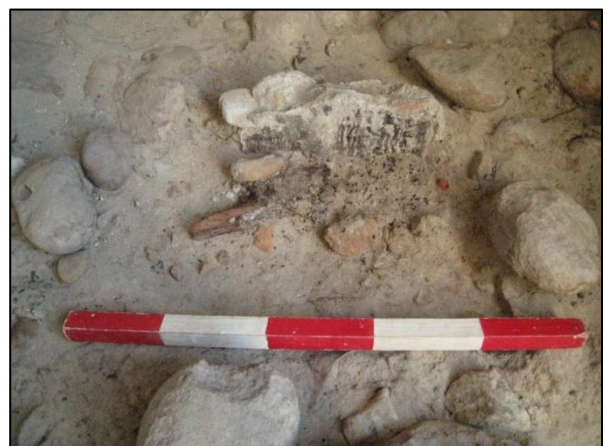
Figure 32: Detail of Post-hole 254 Area2Rm2; view to north

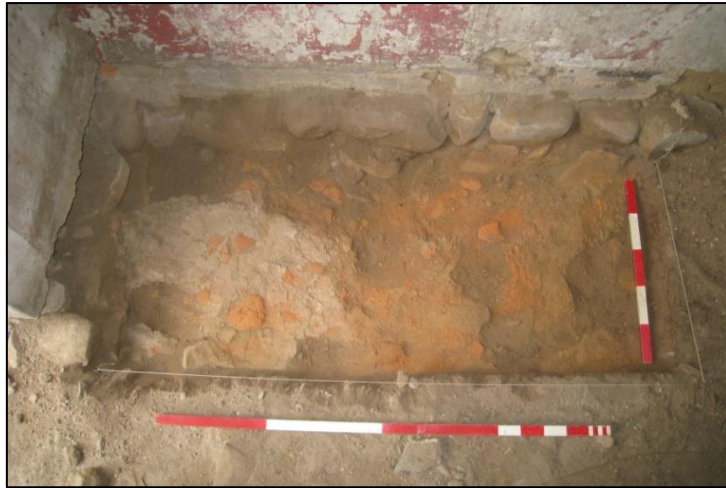
Figure 33: Plan view of Trench in northwest Area3; view to north

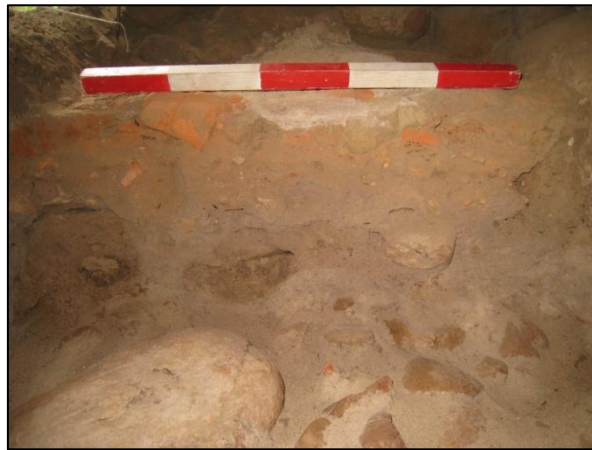
Figure 34: East facing Section 11 through floor 251 Area3; view to west

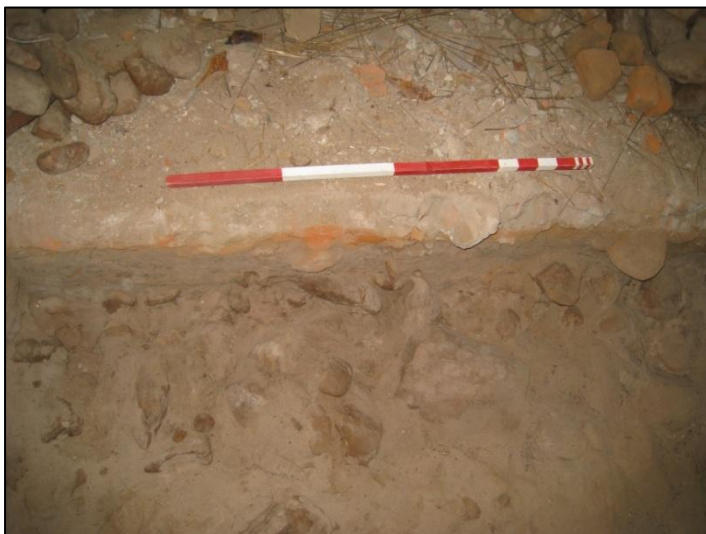
Figure 35: East facing Section 12 through floor 251 Area 3; view to west (left)

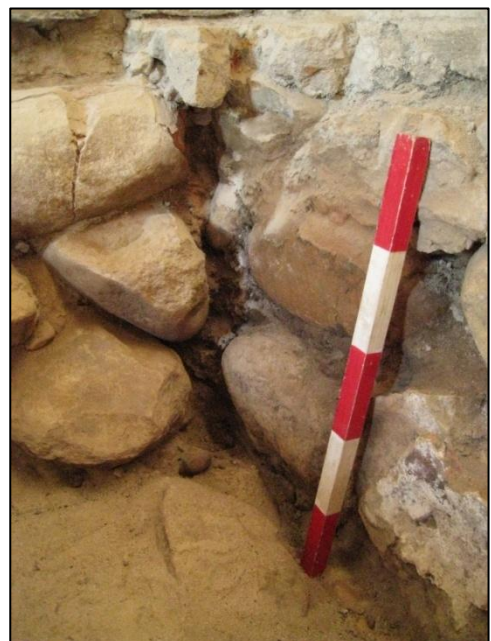
Figure 36: Eastern extent of Section 6 showing wall 267 abutting wall 238; view to northeast (right)

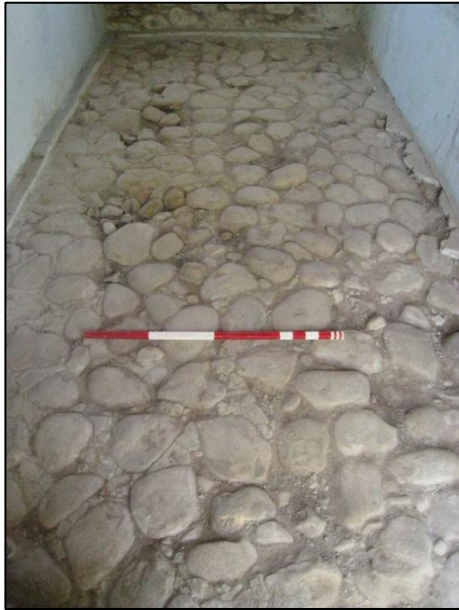
Figure 37: Plan view of cobbled floor 240 Area4; view to east (left)

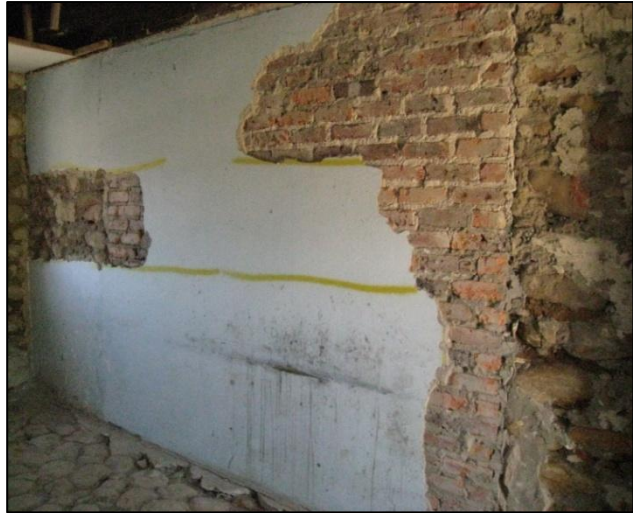
Figure 38: Bricked up double doorway in southern end gable wall Area4; view to southeast (right)

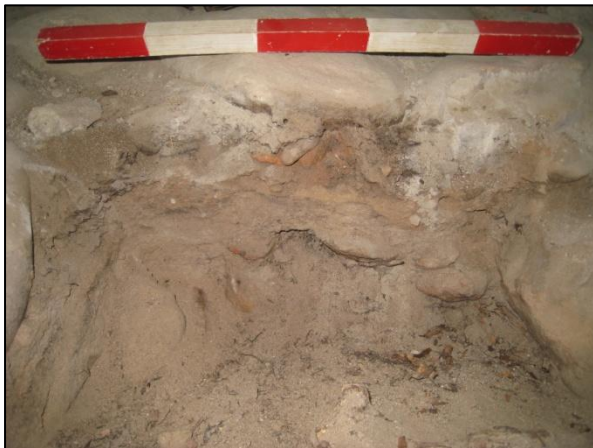
Figure 39: South facing Section 7 through cobbled floor 240 Area4; view to north (left)

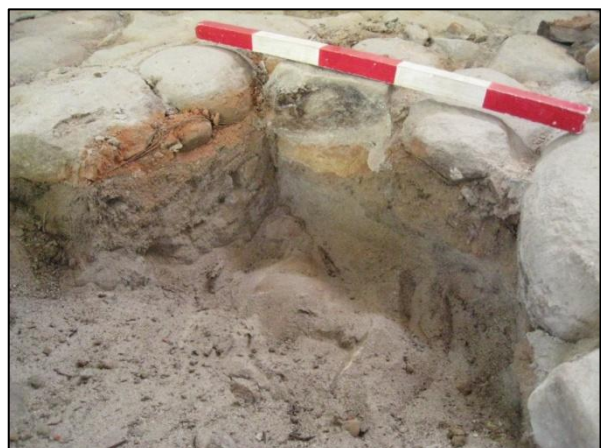
Figure 40: Composite Section 8 through cobbled floor 240 Area4; view to northeast (right)
