# HERITAGE SURVEY OF THE PROPOSED SOUTHWELL WIND TURBINE DEVELOPMENT

FOR C.E.S.

DATE: 27 NOVEMBER 2009

Umlando: Archaeological Tourism and Resource  
Management

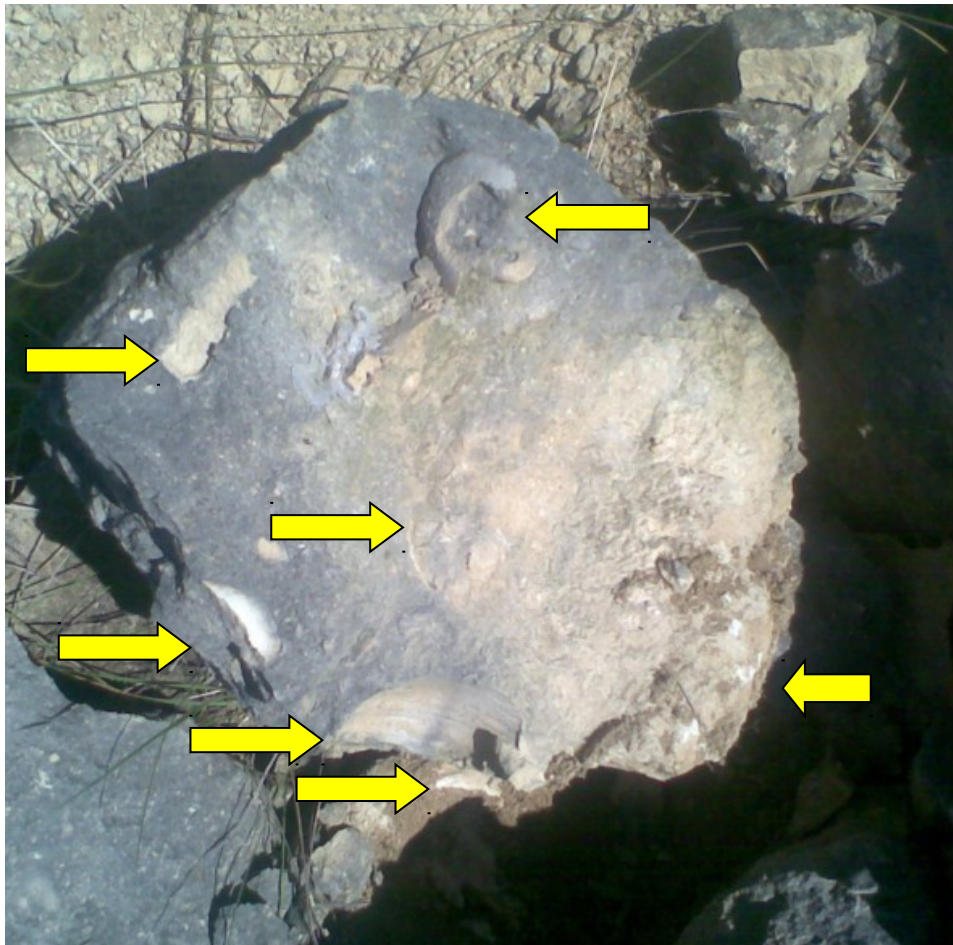
**FIG. 4: FRAGMENT OF LIMESTONE WITH MARINE SHELL<sup>3</sup>**

The limestone quarry has a marine palaeontological deposit. I noted various marine shells at various levels in the quarry. Any subsurface construction activity will thus affect these deposits. Fig. 4 shows some of the marine shell. I spoke to Dr G. Groenewald, a palaeontologist, who believed that the marine deposits may contain...xxx.

in the existing quarry would assist in site assessment; this is where I noted the fossils (fig. 4).

<sup>3</sup> Yellow arrows indicate some marine shell

Significance: The MSA artefacts are of low significance. The significance of the palaeontological remains will need to be undertaken by a palaeontologist.

Mitigation: No further mitigation is required for the MSA artefacts. The site will need to be assessed and sampled by a palaeontologist. The palaeontological site is unlikely to be of high significance in the order of a red flag. The palaeontologist is in a “catch 22” situation, in that they cannot observe what types of fossils will occur below the area of the wind turbine, and can only make direct assessments once the deposits have already been removed. I would suggest that a palaeontologist is on site during any subsurface activity where fossils may be sampled and/or excavated during the course of the excavation. The cuttings

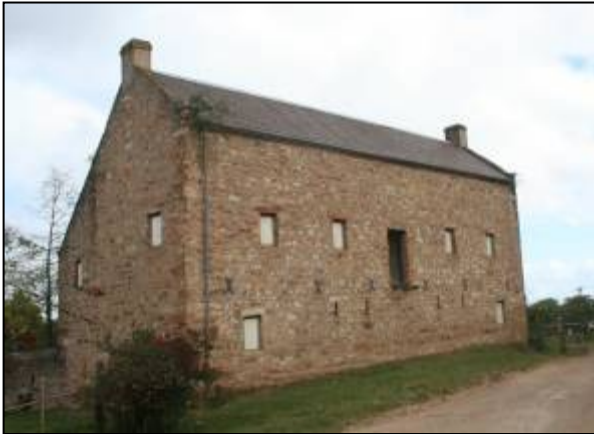
**Lombard's Post**

Wind Turbine #3 is located ~280m northwest of these buildings. The turbine is to be placed higher up on the hill and will be in visual line of the buildings.

Significance: The farm complex is registered as a national monument, and it is thus of high **HERITAGE** significance. Although Lombards Post is of highly significant historical importance, there will be no actual impact on this heritage resource associated with the proposed project and as such, the significance of the impact is LOW with and without mitigation

Mitigation: There is no direct impact on this national monument.

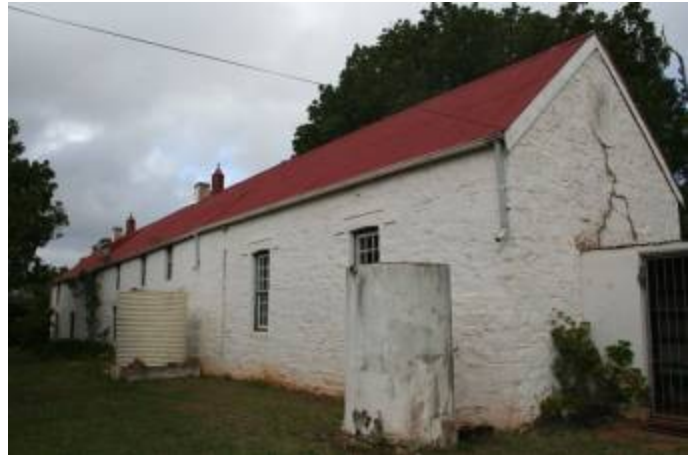
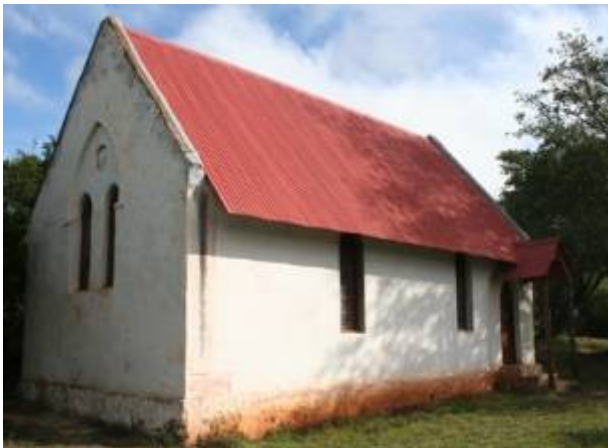
**Southwell School**

- Southwell school (1844)
- St James Church (1851)
- Mission Church (1868)
- St James Church Cemetery (c. 1870s if not prior)
- More recent teachers accommodation (in wattle and daub technique)
- Contemporary school buildings
- Several graves presumed to be related to farm labourers – these are undated.

The buildings are on the top of the hill and the wind turbines will be in full view of the various buildings at a distance of 1.4 – 1.7km.

Significance: The buildings are significant in terms of their age, historical reference to the people of the area, and mostly well preserved features.

Mitigation: No mitigation is required since the wind towers are not directly affecting the buildings.
