**RE: CONFIRMATION THAT THE HERITAGE SPECIALIST ASSESSMENT OF THE SPRINGHAAS GRID CONNECTION PROJECT HAS MET THE REQUIREMENTS OF THE STANDARD FOR THE DEVELOPMENT AND EXPANSION OF POWER LINES AND SUBSTATIONS WITHIN IDENTIFIED GEOGRAPHICAL AREAS, 2022**

*HERITAGE IMPACT ASSESSMENT: PROPOSED DEVELOPMENT OF COLLECTOR SUBSTATION A WITHIN THE PROPOSED SPRINGHAAS GRID CONNECTION CORRIDOR NEAR DEALESVILLE IN THE FREE STATE PROVINCE (J. Orton, June 2022)*

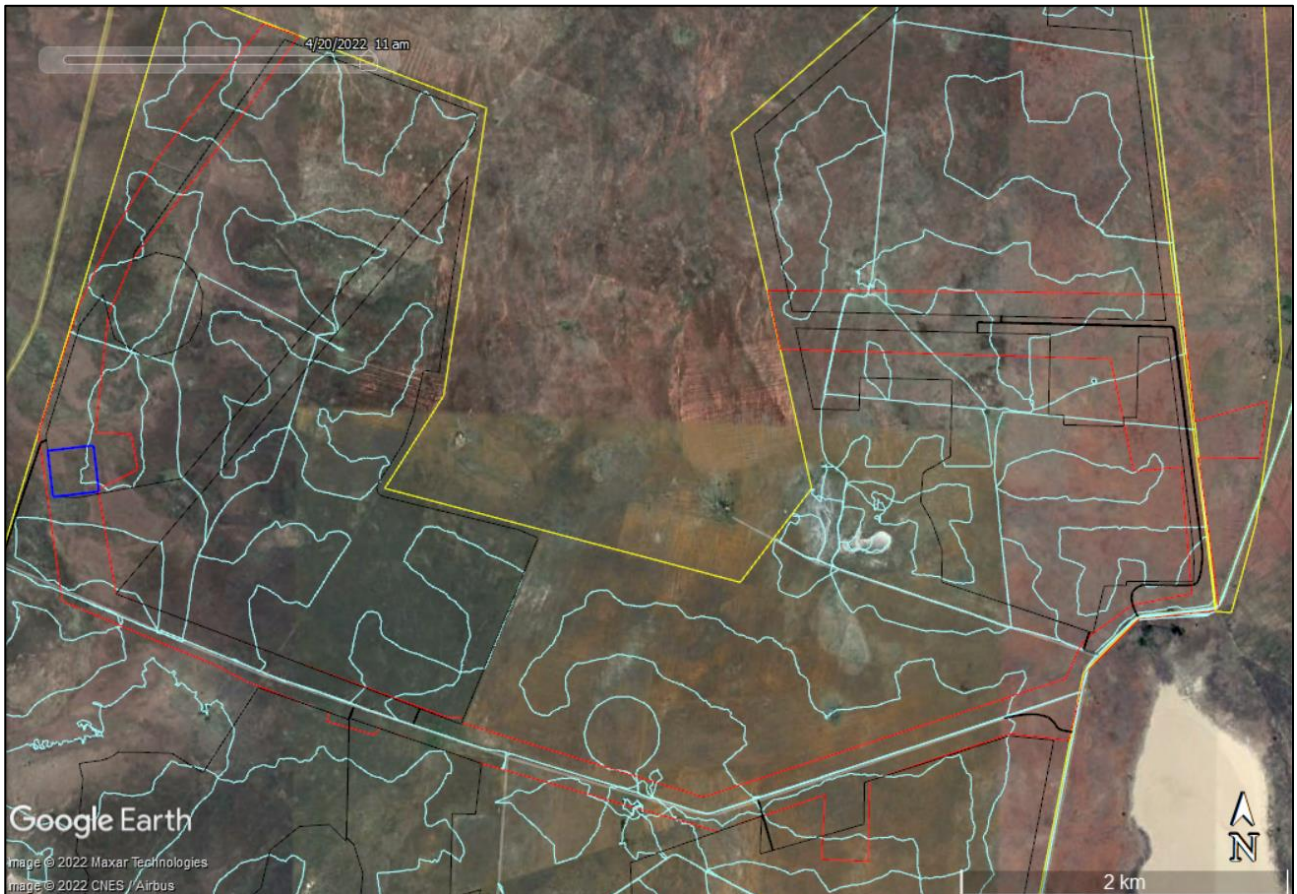
**Figure 4:** Aerial view of the study area (key as per Figure 3) showing the survey tracks (light blue lines).
