RE: CONFIRMATION THAT THE HERITAGE SPECIALIST ASSESSMENT OF THE SPRINGHAAS GRID CONNECTION PROJECT HAS MET THE REQUIREMENTS OF THE STANDARD FOR THE DEVELOPMENT AND EXPANSION OF POWER LINES AND SUBSTATIONS WITHIN IDENTIFIED GEOGRAPHICAL AREAS, 2022

HERITAGE IMPACT ASSESSMENT: PROPOSED DEVELOPMENT OF COLLECTOR SUBSTATION B WITHIN THE PROPOSED SPRINGHAAS GRID CONNECTION CORRIDOR NEAR DEALESVILLE IN THE FREE STATE PROVINCE (J. Orton, June 2022)

Springhaas Grid Connection: Collector Substation B, a Collector/ Switching/ Transformation Substation with a Capacity of up to 400kV and associated infrastructure, near Dealesville, Bloemfontein, Free State (Collector Substation B)

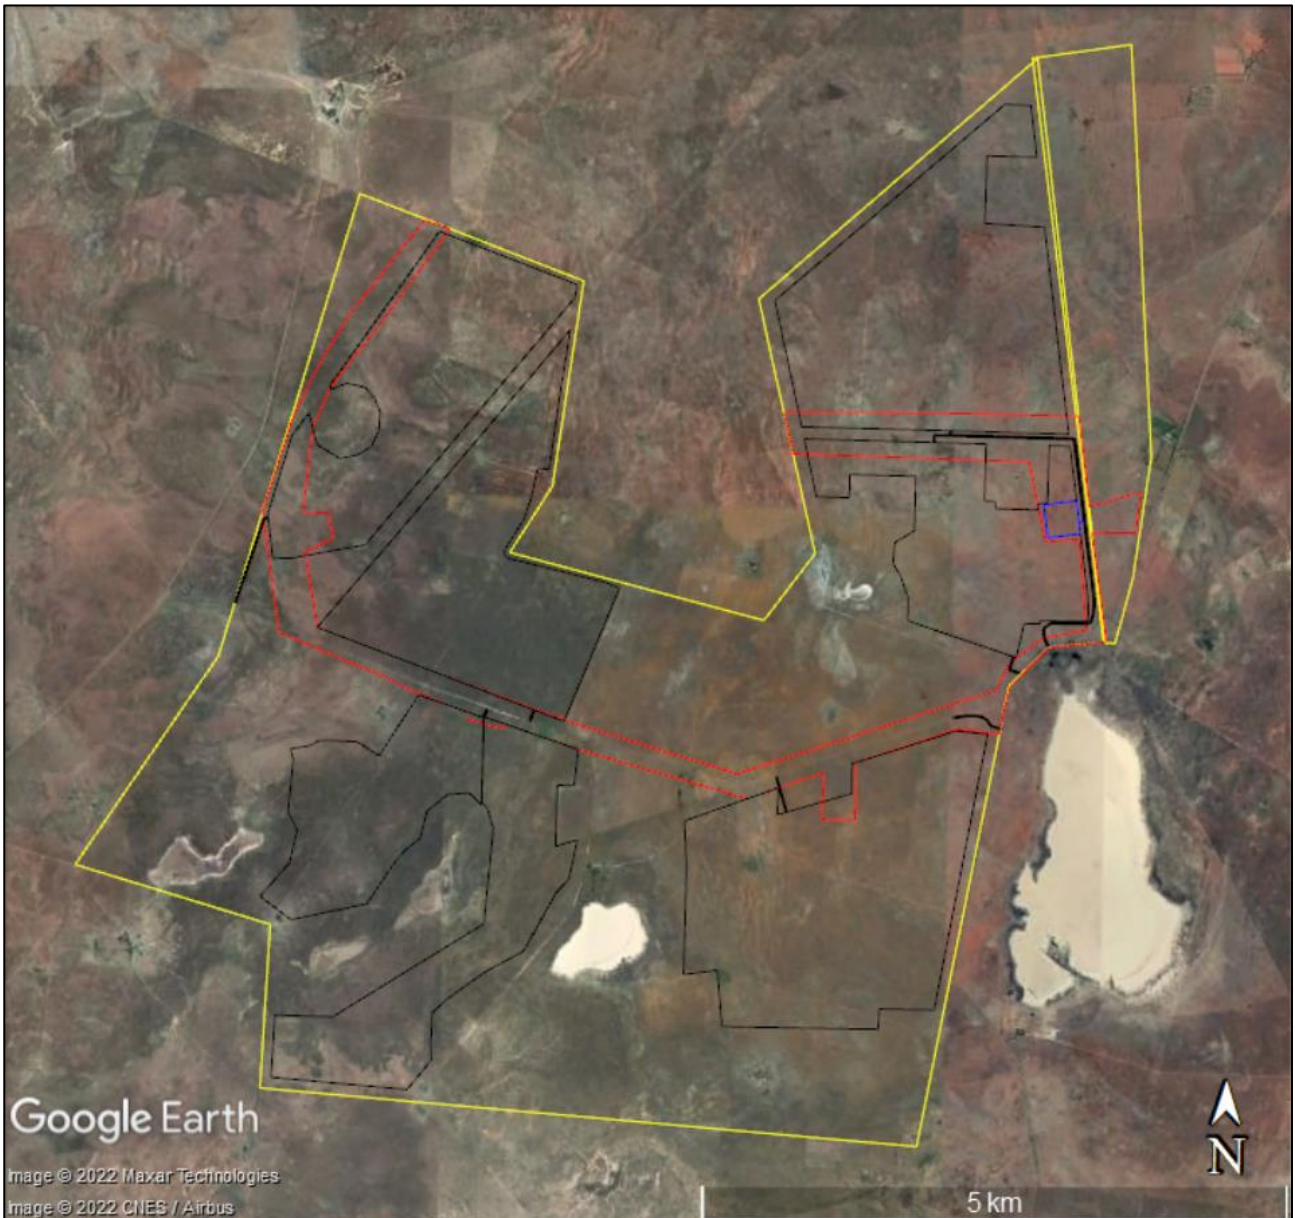
Figure 3: Aerial view of the study area showing the broader study area (yellow polygons), the PV locations and their access roads (black) and the proposed grid connection corridor (red). Collector B (assessed in this report) is shown in blue.

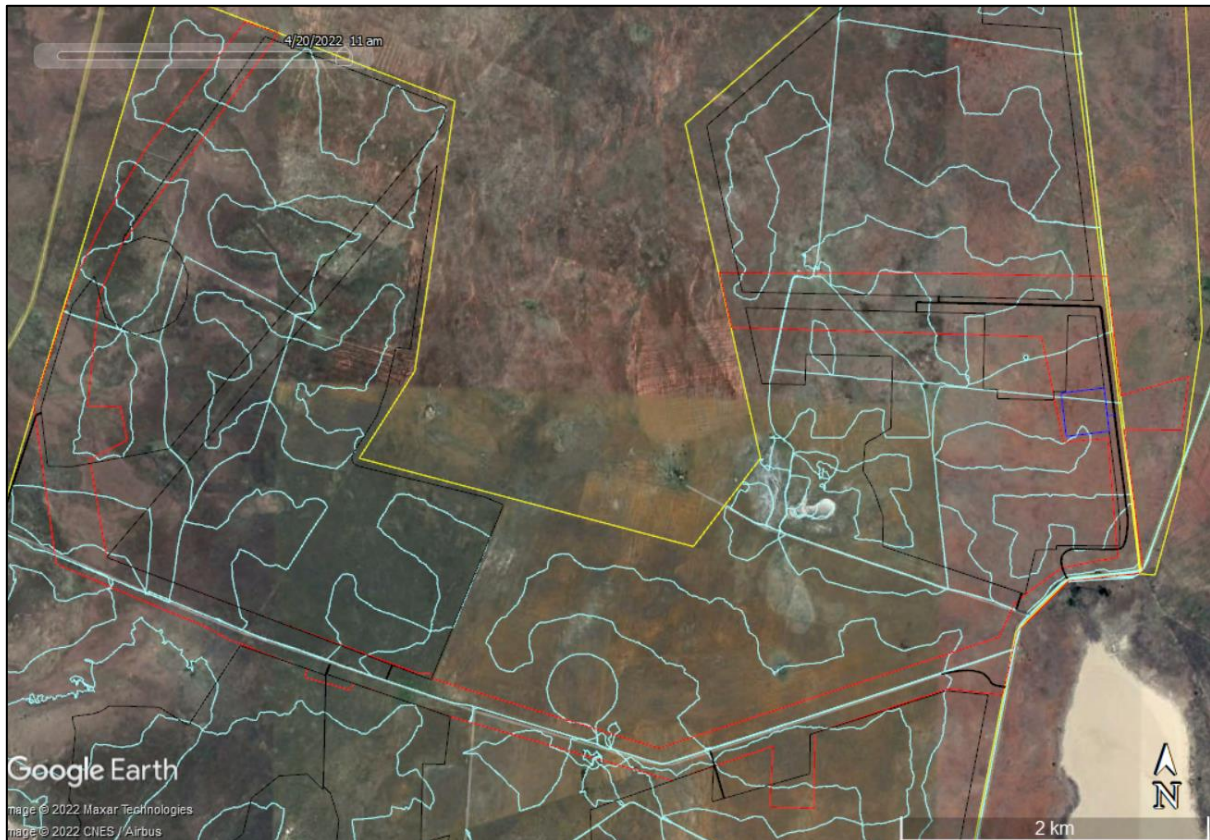
Figure 4: Aerial view of the study area (key as per Figure 3) showing the survey tracks (light blue lines).

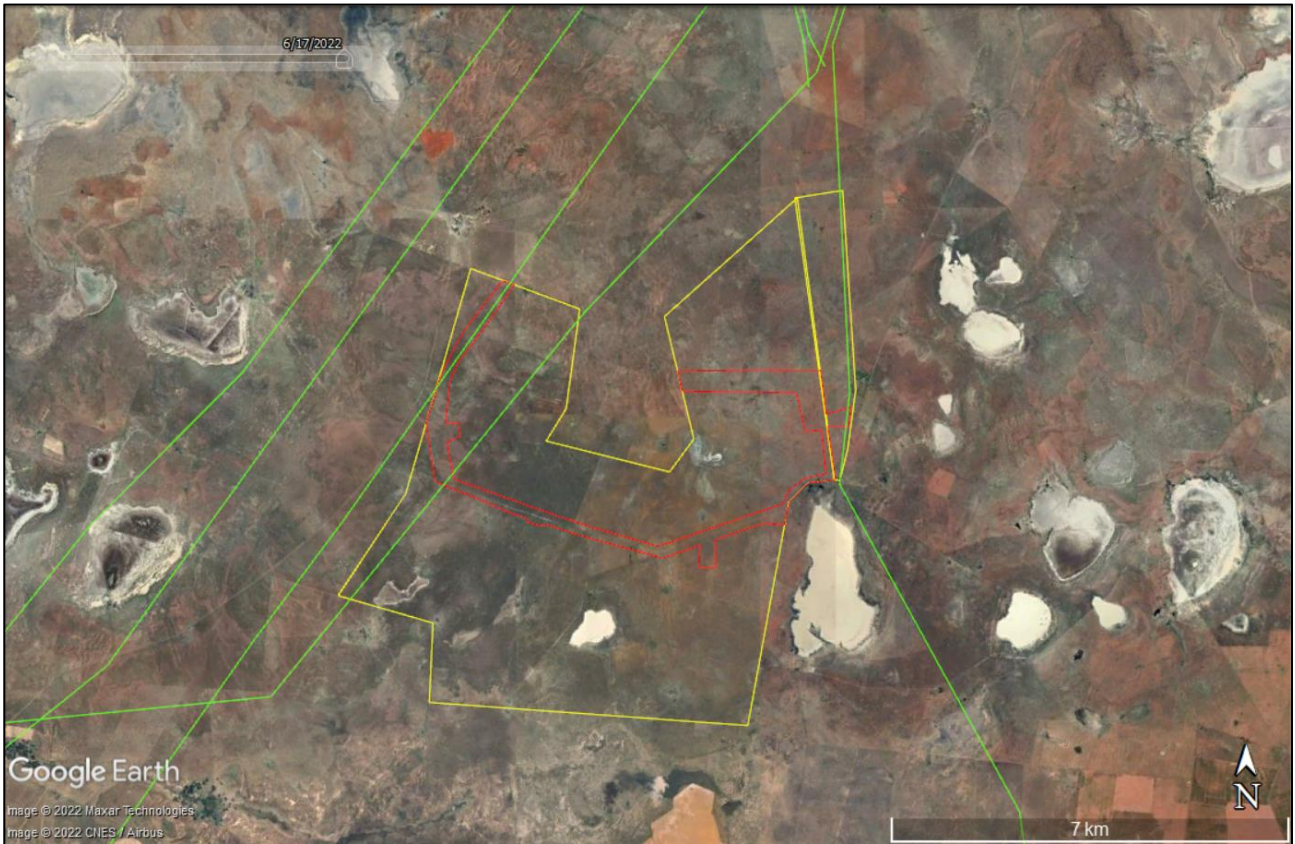
Figure 5: Existing HV lines (green) in the vicinity of the broader study area (yellow) and grid connection corridor (red).

two large substations. Beta Substation is located 4.5 km north of the study area, while Perseus is 14 km to the north. Two HV lines cross the western part of the study area and another runs past its eastern edge (Figure 5).

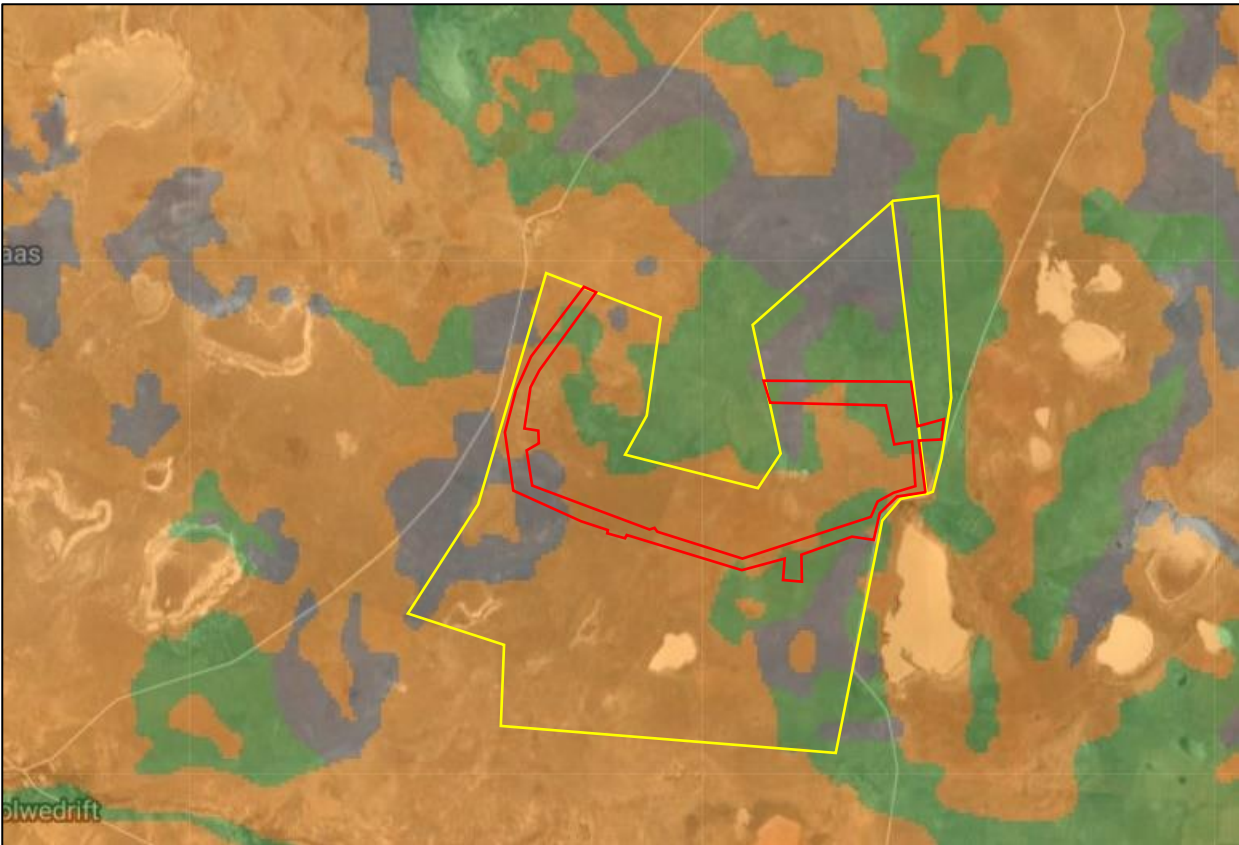
Figure 14: Extract from the SAHRIS PalaeoSensitivity map showing the broader study area (yellow polygons) and proposed grid connection corridor (red polygon) to be of variably zero (grey), moderate (green) and high (orange) sensitivity (source: <https://sahris.sahra.org.za/map/palaeo>).

The SAHRIS PalaeoSensitivity map shows the site to be largely of high palaeontological sensitivity (Figure 14). This sensitivity is likely linked to the calcrete that underlies the surface over much of the study area. No fossils were seen on site and it is unlikely that any would be visible at the surface in this environment. A desktop palaeontological study has been undertaken to determine what measures may need to be incorporated into the Environmental Management Program (EMPr) for the project. Palaeontology will not affect the feasibility or layout of the project.

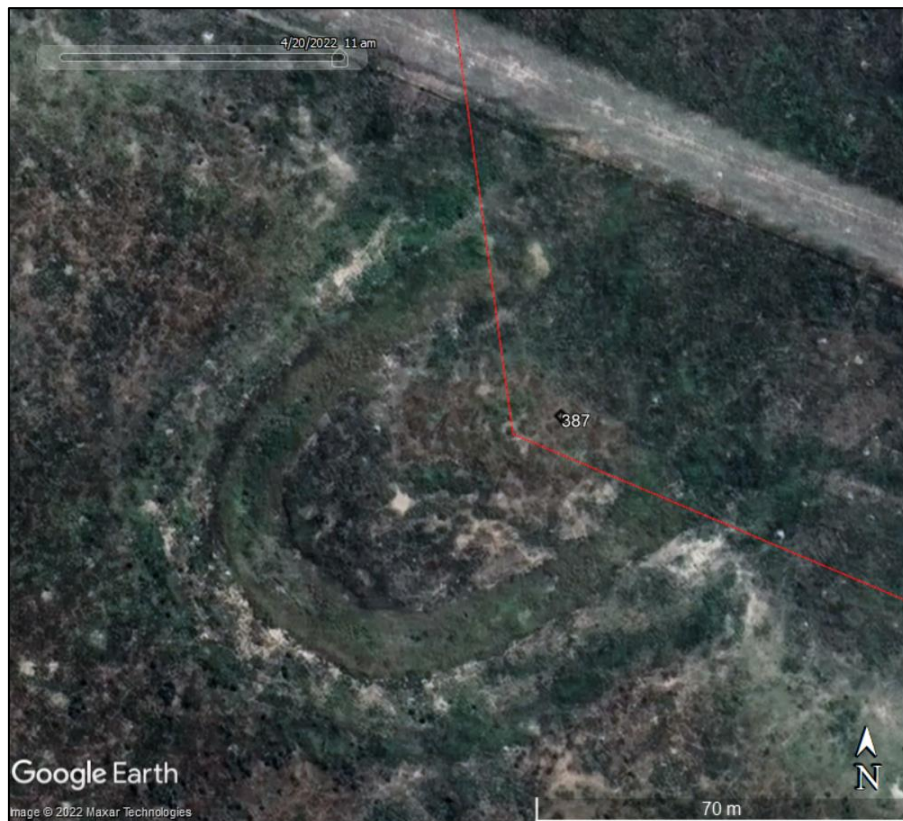
Figure 15: Aerial view of the earthen dam at waypoint 387.

A number of water reservoirs were seen. These are hollows in the ground that have been lined with rocks, and presumably also clay which has now weathered away. Some of these reservoirs had defunct wind pumps standing alongside them which, in the absence of any other source of water, is an indication of their age post-dating the mid-19th century introduction of wind pumps to South Africa (Walton & Pretorius 1998). A shallow earth dam lies at, and largely outside, the south-western corner of the corridor but it is not under threat from any infrastructure. Barely visible on the ground, it was far easier to see from the air (Figure 15).

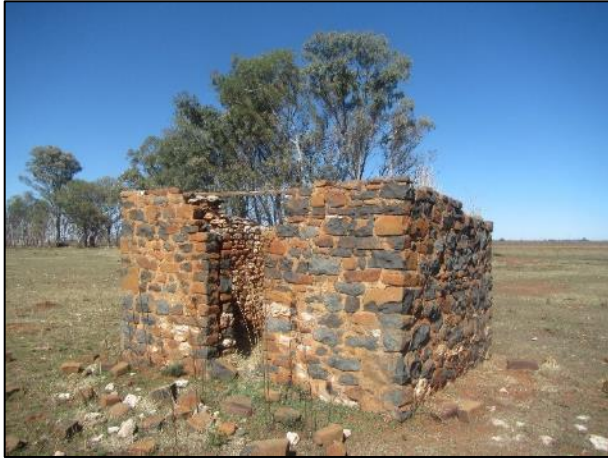
Figure 16: Stone ruin at waypoint 293.

Figure 16 shows a small cottage at waypoint 293 (just outside the corridor) built with the typical double skin method. Interestingly, while the outer skin is made almost entirely from dolerite cobbles with rare calcrete inclusions, the inner skin is the reverse pattern (Figure 17). This may have been due to the availability of stone but, given that calcrete does appear in the outer skin of this and several other ruins, it seems more likely to have been a stylistic decision. The door frame is missing but the wooden window frame survives. The flat roof is entirely missing.

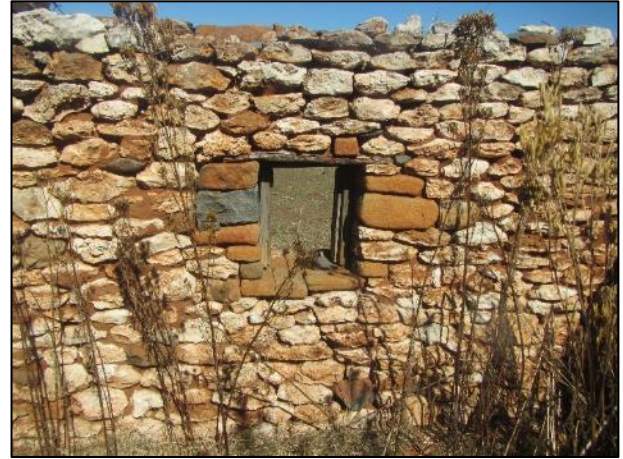
Figure 17: Detail at waypoint 293.

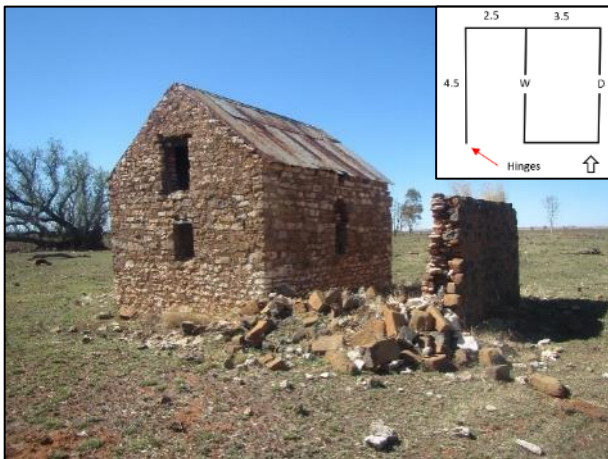
Figure 18: Stone ruin at waypoint 294. Inset: plan view showing door hinge location.

Another small gabled stone cottage with a loft under a tin roof was better preserved, although an addition to its west face was partially collapsed (waypoint 294 just outside the corridor; Figure 18). There are again patterns in the walling. The lowermost 1 m is almost all of calcrete, while above this there is a mix of calcrete, dolerite and shale. Shale blocks have been used for the windowsill and display some wear (Figure 19). Alongside this cottage was a brick ruin with at least half its walls collapsed and its roof missing (waypoint 295 on the edge of the corridor; Figures 20 to 22). This was undoubtedly the main house of this farm complex. The bricks, being softer than stone, have dissolved in the rain with the result that this ruin is far more poorly preserved than the stone ruins. Nearby is another outbuilding built of calcrete. Its function is indeterminate as it is too poorly preserved but it may have been a kraal (waypoint 298 just outside the corridor; Figure 23).

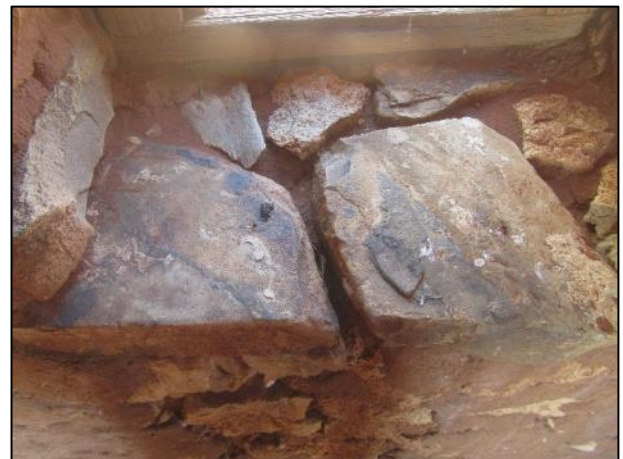
Figure 19: Windowsill in the cottage at waypoint 294.

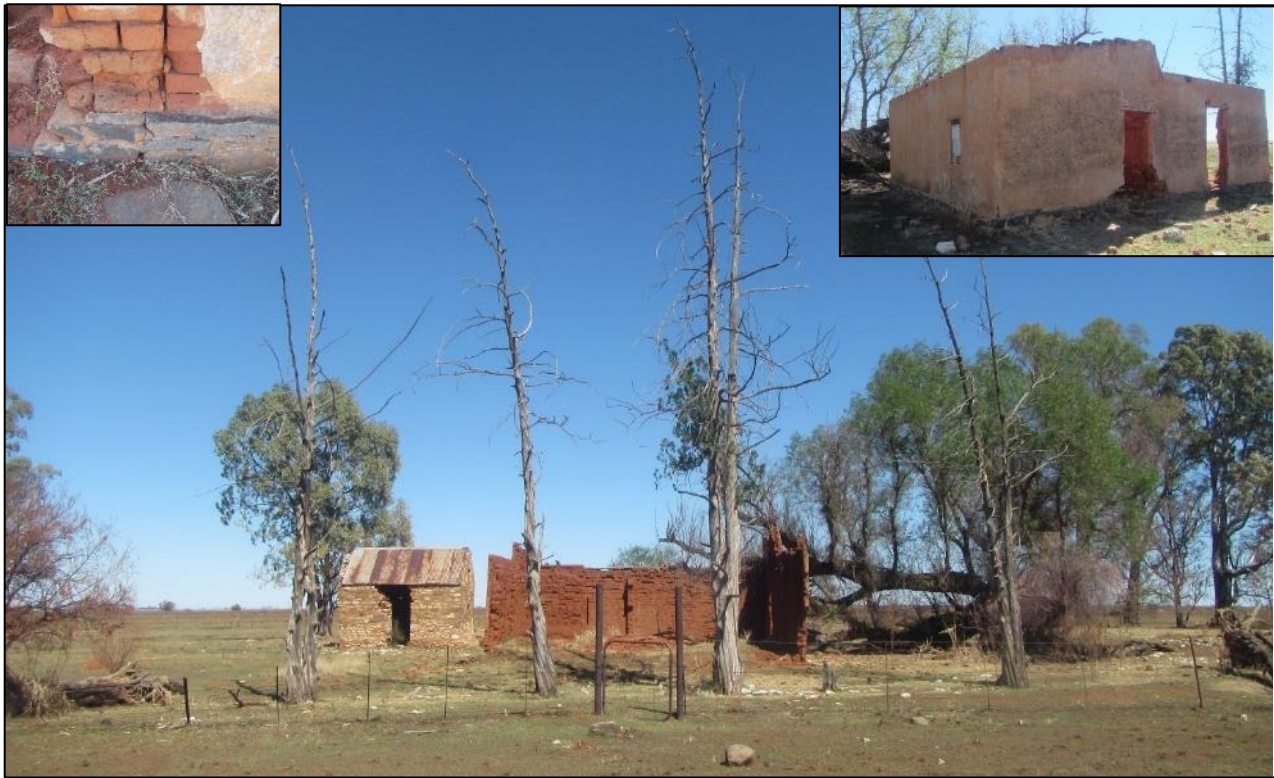
Figure 20: View of the farm complex with associated trees at waypoint 294 (roofed ruin) and 295 (red brick ruin). A line of cypress trees stands in the foreground, just behind the fence. Left inset: Brick wall on stone plinth. Right inset: southwest corner of house.

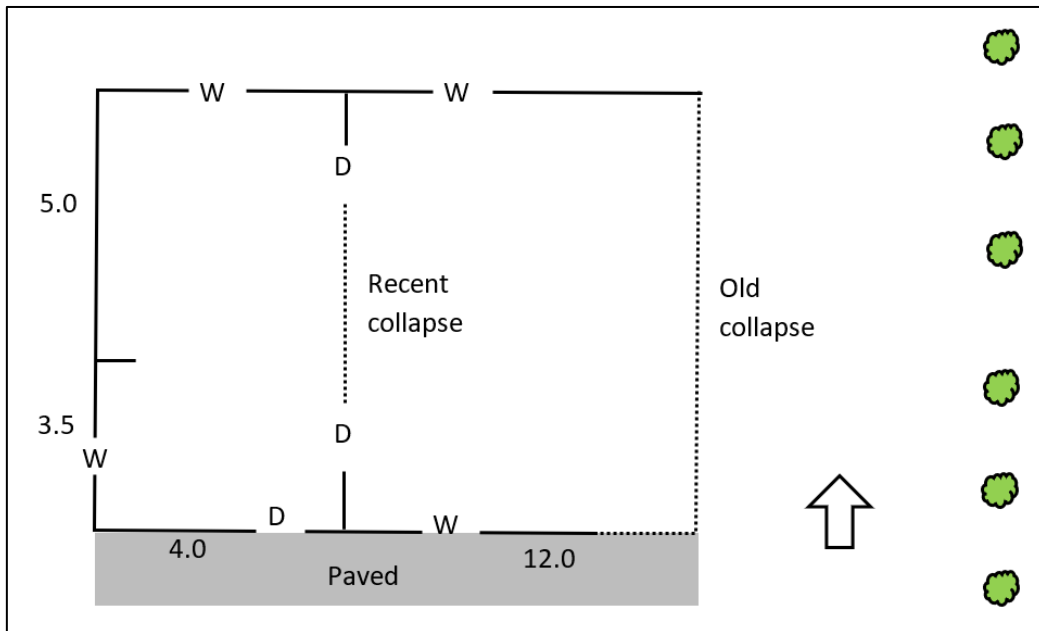
Figure 21: Plan of the remains of the house at waypoint 295. Six cypress trees (now dead) stand to the east of the house.

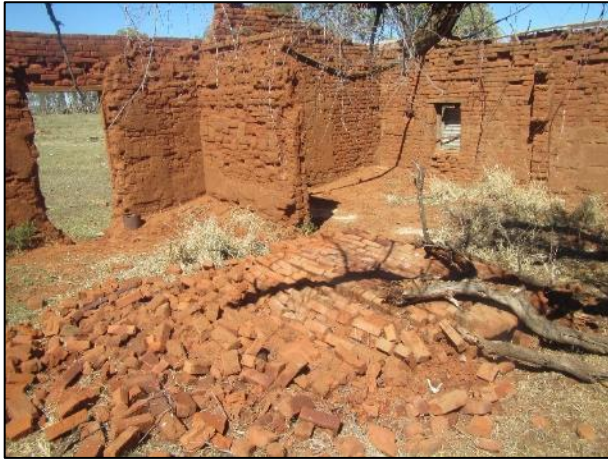
Figure 22: Interior of the brick house at waypoint 295.

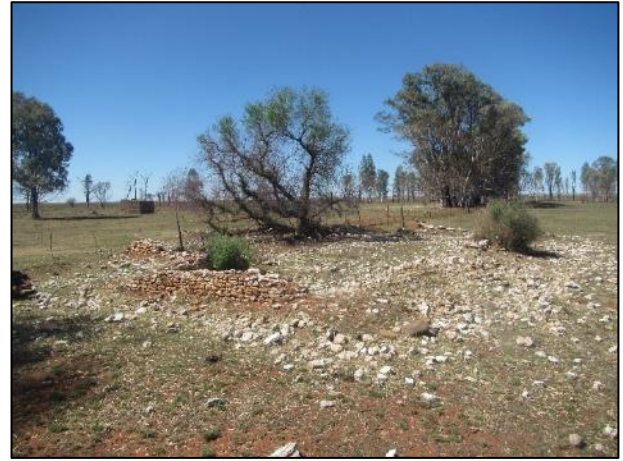
Figure 23: The remains of a calcrete-walled structure at waypoint 298.

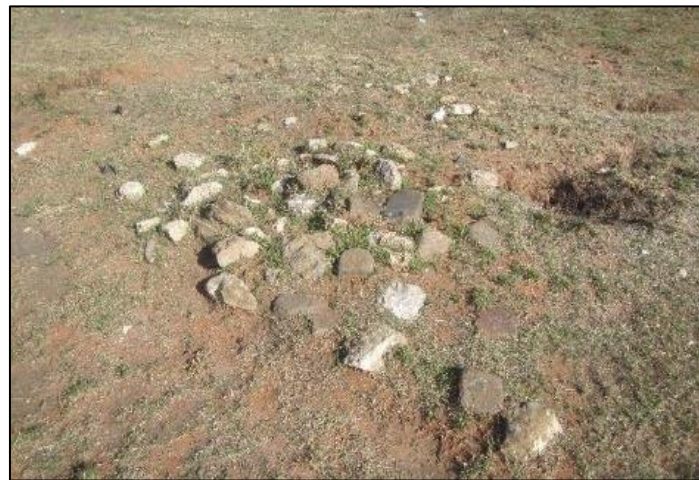
Figure 24: Possible grave at waypoint 384.

Graves were seen in four locations in the broader study area, with another marked as a possible grave. Only the latter is relevant here as it lies very close to, but just outside of, the grid connection corridor and well away from the proposed development. This was a loose pile of stones with no apparent function (waypoint 384; Figure 24) but, being located very close to a ruined structure, it seems unlikely to be a grave but, for precautionary reasons, it has been treated as one.

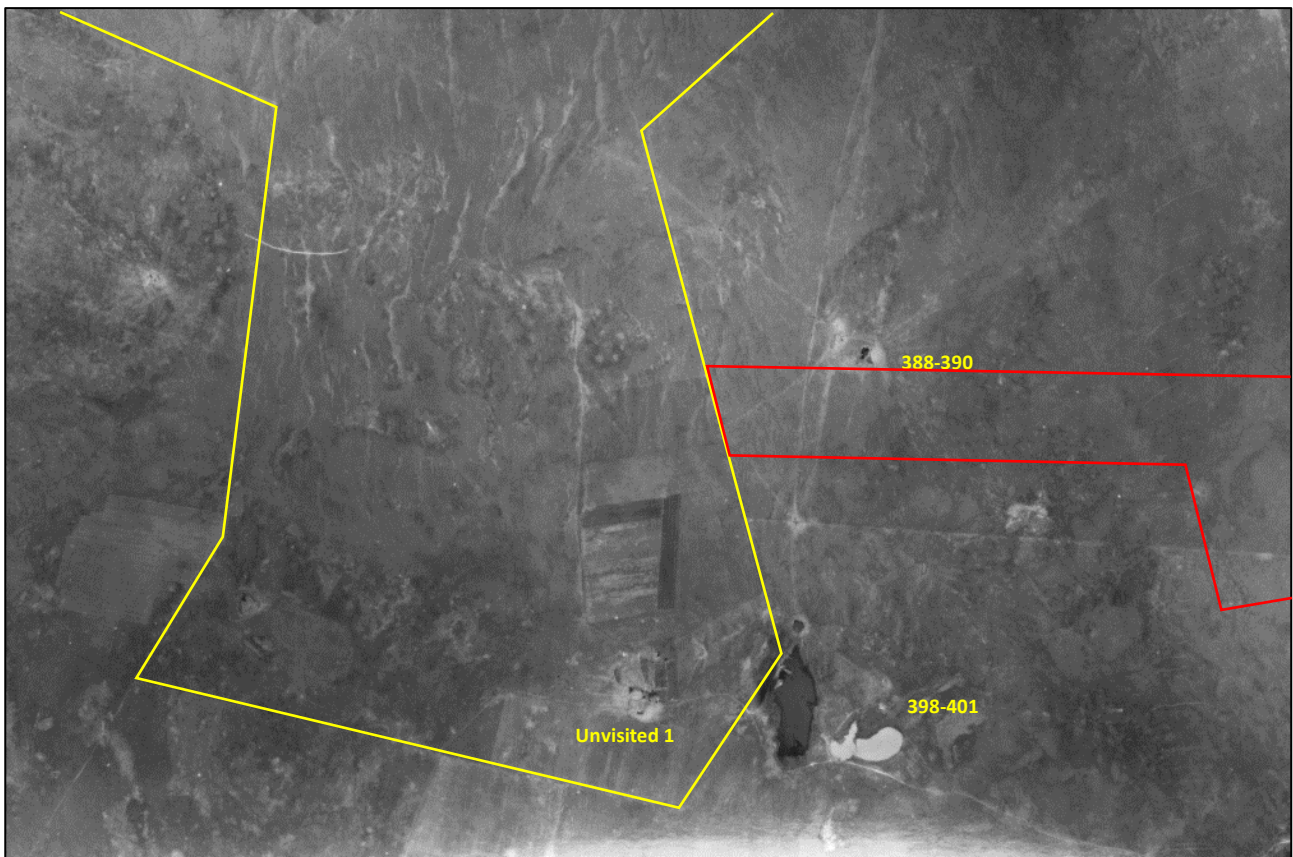
Figure 26: Aerial photograph from 1956 (377_002_05062) showing three farmsteads in the north-eastern part of the broader study area outside the grid connection corridor and proposed development footprint (waypoint numbers indicated).

Figures 26 and 27 show aerial views of the broader study area from 1956. Some change is evident over the last 65 years. The ruin at waypoint 388 (just outside the corridor) was still in use and the adjacent modern house and shed were not yet built. The waypoint 398-401 complex (outside

corridor) was already disused (as indicated by the lack of desire lines in the grass) and had probably already been in ruin for some time. The same applies to the one at waypoints 315-324 (outside corridor), although its dam was still intact. The complexes at waypoints 368-377 (just outside corridor), 299-307 (outside corridor) and 291-298 (along southern edge of corridor) appear to have been still fully functional. All three of these are now completely ruined. The latter is shown as having had a single labourer's cottage to the west with another to the north and a third to the east. While a ruin marks the location of the eastern one, the other two have both been completely removed. It is evident from these images that structures built without cement can deteriorate very quickly once their roofs are removed. It is likely that joinery and rocks were frequently removed for reuse elsewhere which greatly exacerbates the degradation.

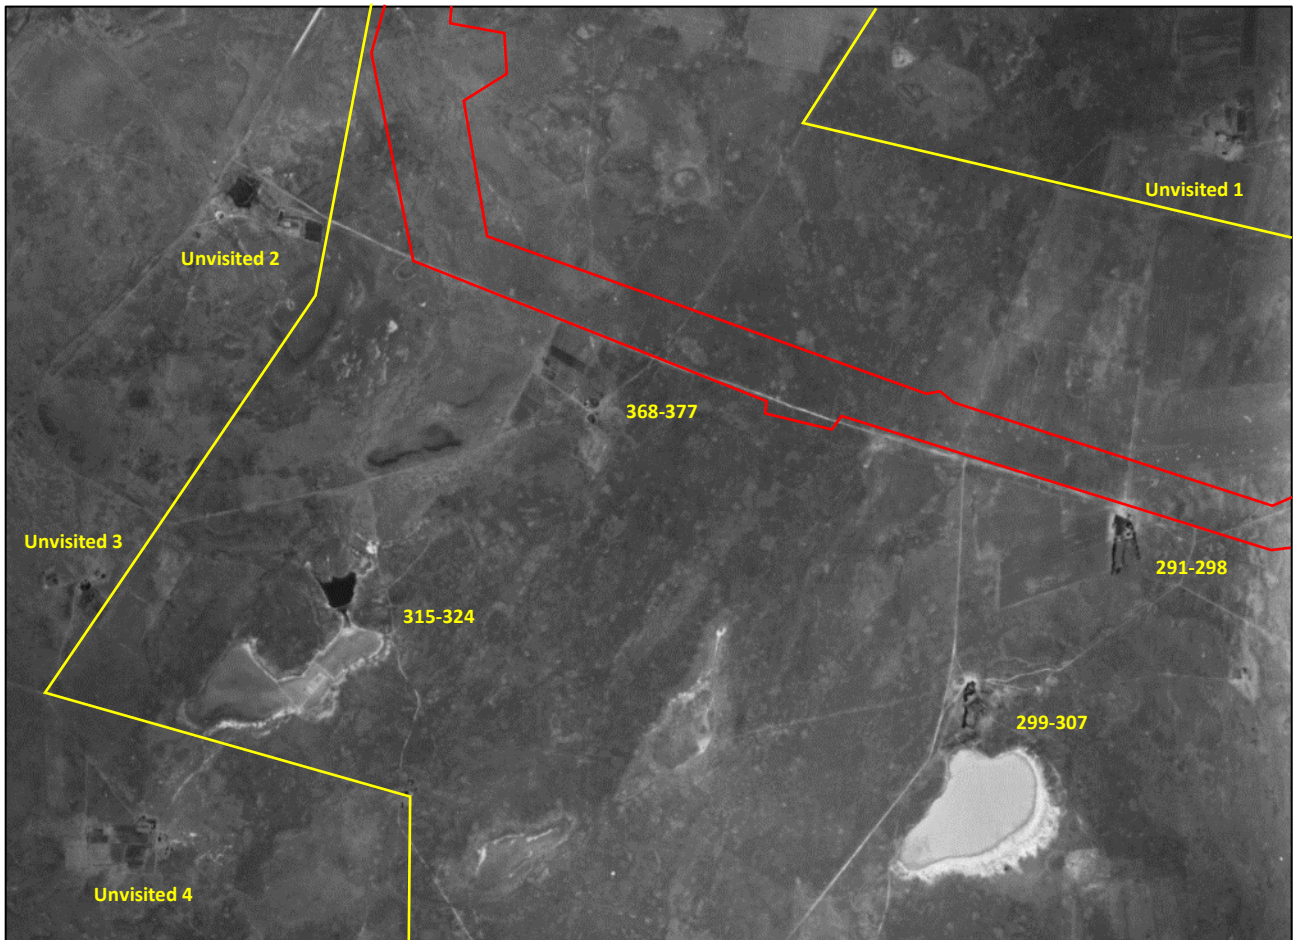
Figure 27: Aerial photograph from 1956 (377_003_05103) showing four farmsteads in the southern part of the broader study area (waypoint numbers indicated).
