RE: CONFIRMATION THAT THE HERITAGE SPECIALIST ASSESSMENT OF THE SPRINGHAAS GRID CONNECTION PROJECT HAS MET THE REQUIREMENTS OF THE STANDARD FOR THE DEVELOPMENT AND EXPANSION OF POWER LINES AND SUBSTATIONS WITHIN IDENTIFIED GEOGRAPHICAL AREAS, 2022

HERITAGE IMPACT ASSESSMENT: PROPOSED LI-LO CONNECTION FROM SPRINGHAAS COLLECTOR SUBSTATION B TO THE BETA/DELPHI 400kV OHL WITHIN THE PROPOSED SPRINGHAAS GRID CONNECTION CORRIDOR NEAR DEALESVILLE IN THE FREE STATE PROVINCE

Springhaas Grid Connection: LiLo Connection of up to 400kV in capacity from Springhaas Collector Substation B to Beta/Delphi 400kV overhead line, near Dealesville, Bloemfontein, Free State (LiLo 2)

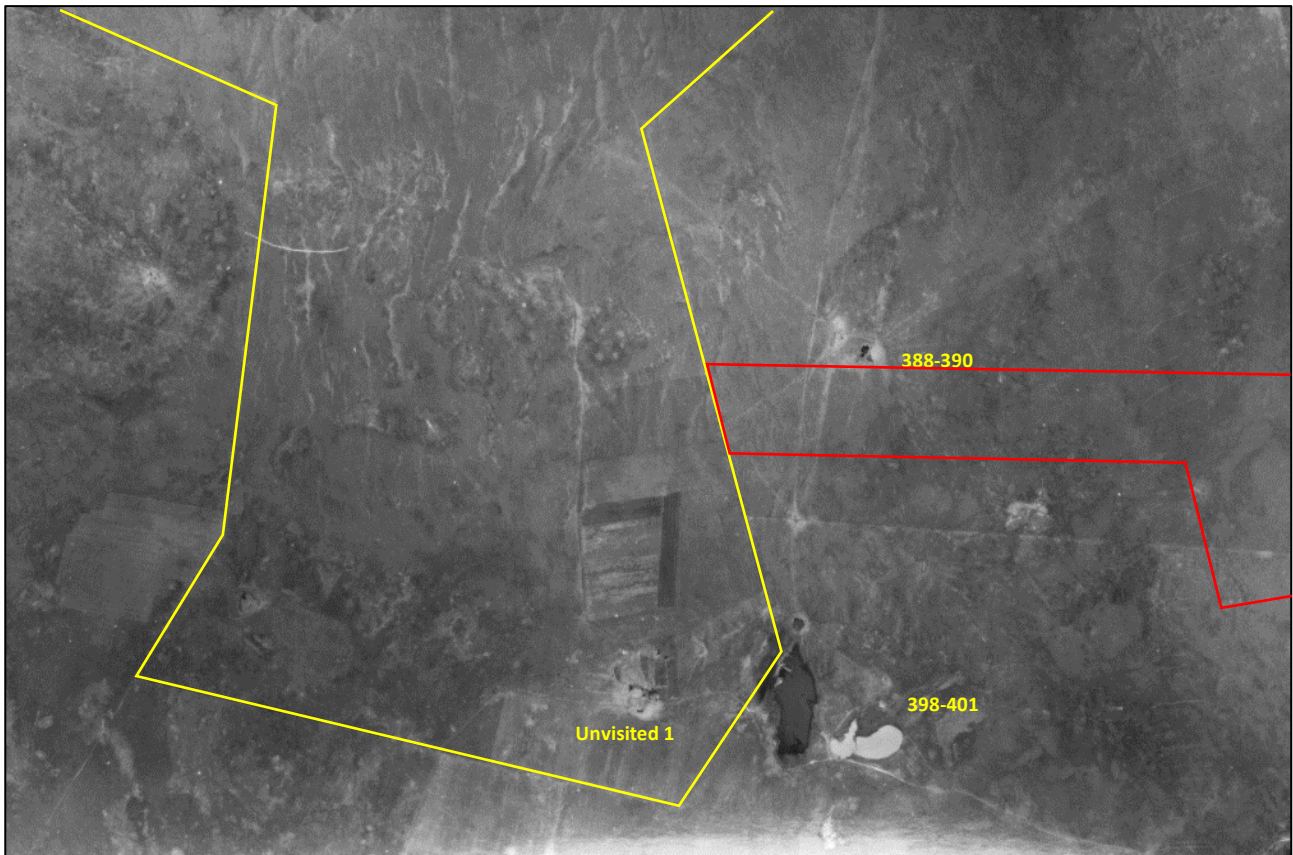
Figures 26 and 27 show aerial views of the broader study area from 1956. Some change is evident over the last 65 years. The ruin at waypoint 388 (just outside the corridor) was still in use and the adjacent modern house and shed were not yet built. The waypoint 398-401 complex (outside

corridor) was already disused (as indicated by the lack of desire lines in the grass) and had probably already been in ruin for some time. The same applies to the one at waypoints 315-324 (outside corridor), although its dam was still intact. The complexes at waypoints 368-377 (just outside corridor), 299-307 (outside corridor) and 291-298 (along southern edge of corridor) appear to have been still fully functional. All three of these are now completely ruined. The latter is shown as having had a single labourer's cottage to the west with another to the north and a third to the east. While a ruin marks the location of the eastern one, the other two have both been completely removed. It is evident from these images that structures built without cement can deteriorate very quickly once their roofs are removed. It is likely that joinery and rocks were frequently removed for reuse elsewhere which greatly exacerbates the degradation.

Figure 26: Aerial photograph from 1956 (377_002_05062) showing three farmsteads in the north-eastern part of the broader study area outside the grid connection corridor and proposed development footprint (waypoint numbers indicated).
